# RENAULT MASTER FOURGON

## MASTER FGN TRAC F3300 L2H2 DCI 135

VIN NO VF1MA000966517672  
Registration Number FX497DH

#### Inspection Report Summary

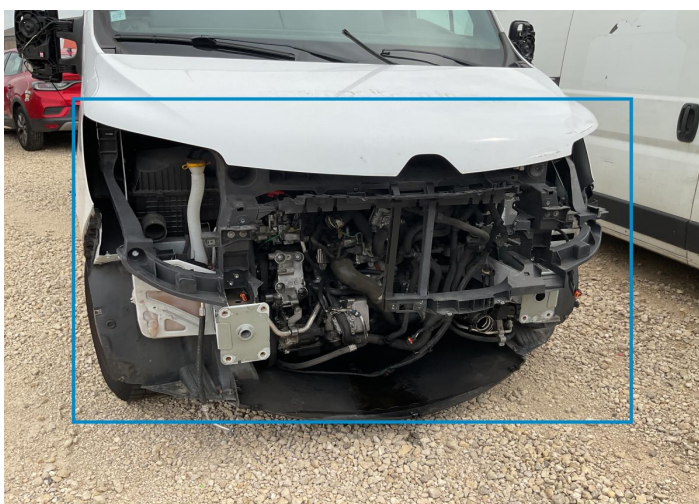
| Component | | Damage | Comments |
|---|---|---|---|
| 1 | Bumper / Front | Bodywork / Breakage / Crack | |

1. Bumper / Front  
Bodywork / Breakage / Crack -

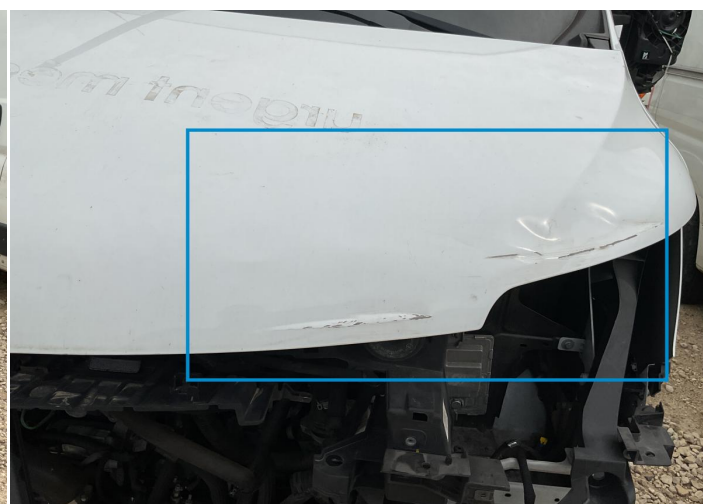
| Component | | Damage | Comments |
|---|---|---|---|
| 2 | Hood | Bodywork / Dent / Dent | |

2. Hood  
Bodywork / Dent / Dent -

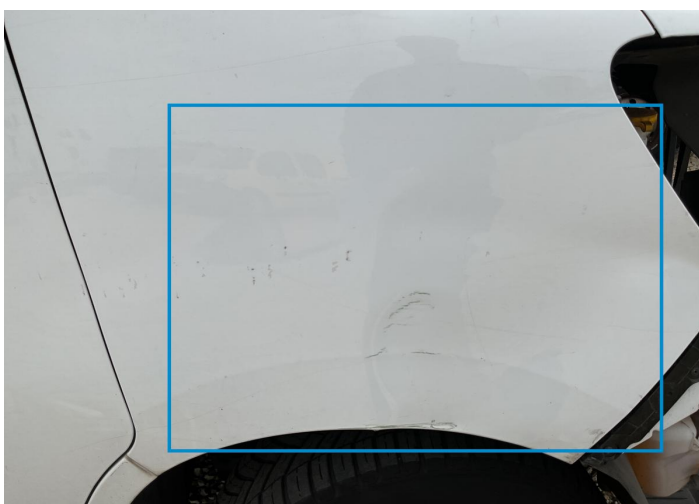
| Component | | Damage | Comments |
|---|---|---|---|
| 3 | Fender / Front Right | Bodywork / Dent / Dent | |

3. Fender / Front Right  
Bodywork / Dent / Dent -

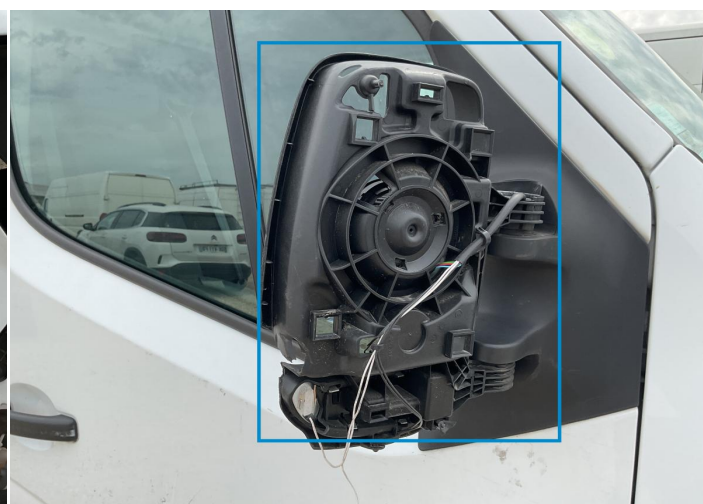
| Component | | Damage | Comments |
|---|---|---|---|
| 4 | Mirror / Front Right | Bodywork / Breakage / Hole | |

4. Mirror / Front Right  
Bodywork / Breakage / Hole -

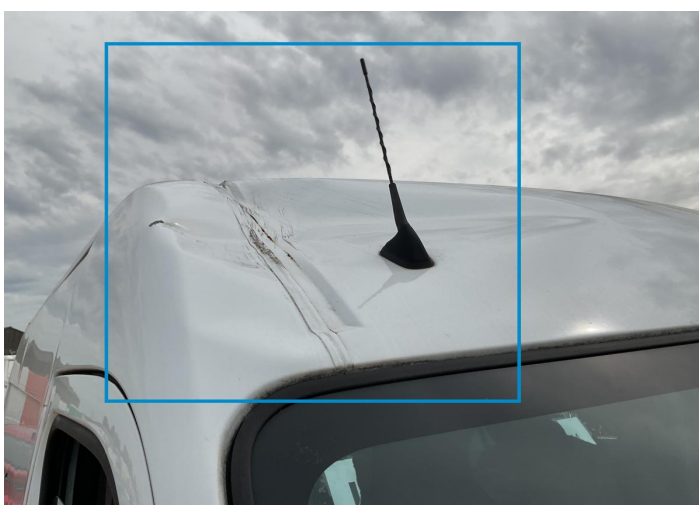
| Component | | Damage | Comments |
|---|---|---|---|
| 5 | Panoramic Roof | Bodywork / Dent / Dent | |

5. Panoramic Roof  
Bodywork / Dent / Dent -

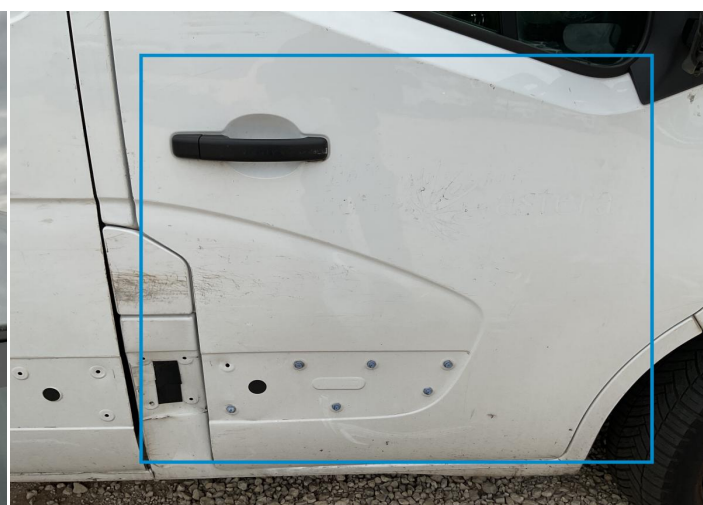
| Component | | Damage | Comments |
|---|---|---|---|
| 6 | Door / Front Right | Paint / Scratch / Line | |

6. Door / Front Right  
Paint / Scratch / Line -

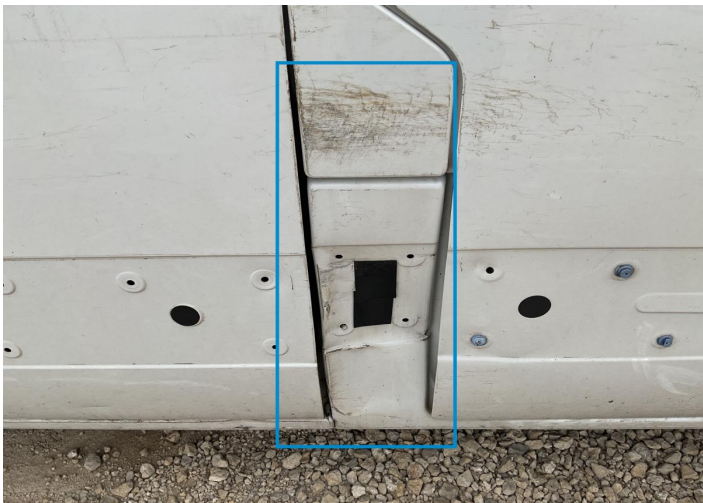
| Component | | Damage | Comments |
|---|---|---|---|
| 7 | B Pillar / Center Right | Bodywork / Dent / Dent | |

7. B Pillar / Center Right  
Bodywork / Dent / Dent -

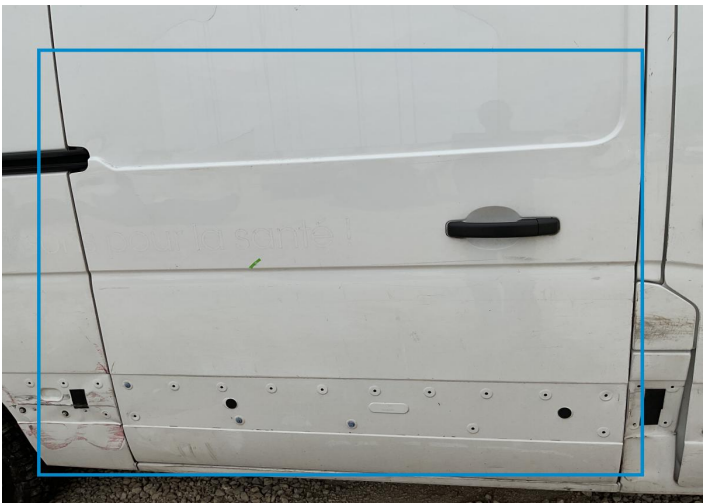
| Component | | Damage | Comments |
|---|---|---|---|
| 8 | Door / Back Right | Paint / Scratch / Line | |

8. Door / Back Right  
Paint / Scratch / Line -

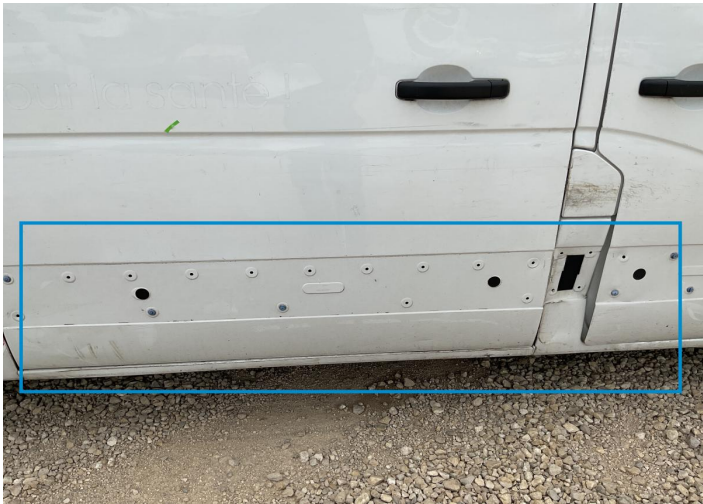
| Component | | Damage | Comments |
|---|---|---|---|
| 9 | Door Side Molding / Front Right | Bodywork / Breakage / Hole | |

9. Door Side Molding / Front Right  
Bodywork / Breakage / Hole -

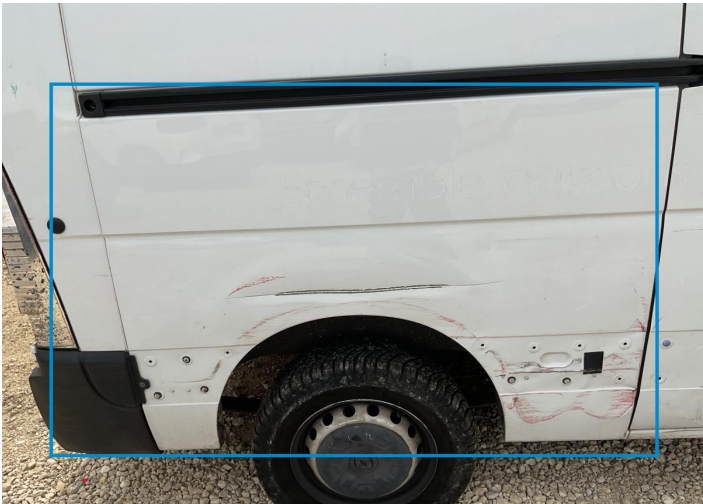
| Component | | Damage | Comments |
|---|---|---|---|
| 10 | Side Panel / Back Right | Bodywork / Dent / Dent | |

10. Side Panel / Back Right  
Bodywork / Dent / Dent -

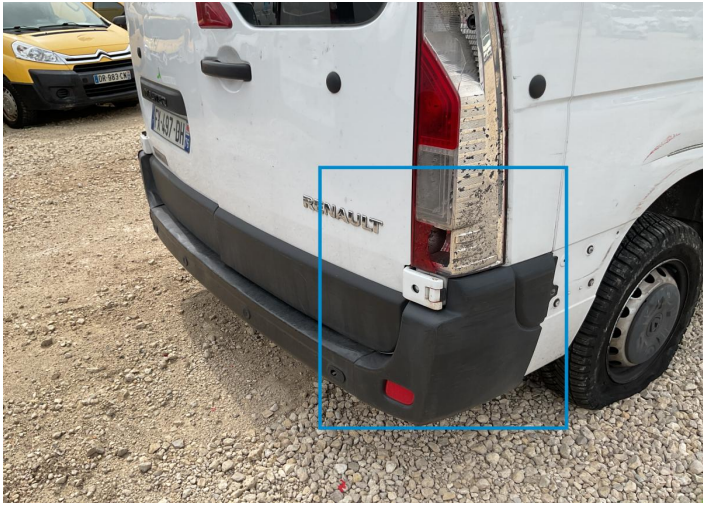
| Component | | Damage | Comments |
|---|---|---|---|
| 11 | Bumper / Back | Paint / Scratch / Line | |

11. Bumper / Back  
Paint / Scratch / Line -

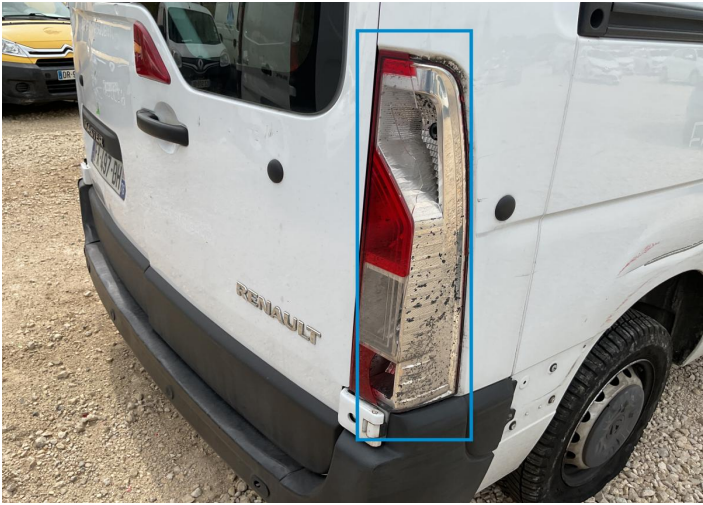
| Component | | Damage | Comments |
|---|---|---|---|
| 12 | Tailgate Light / Back - Right | Bodywork / Breakage / Hole | |

12. Tailgate Light / Back - Right  
Bodywork / Breakage / Hole -

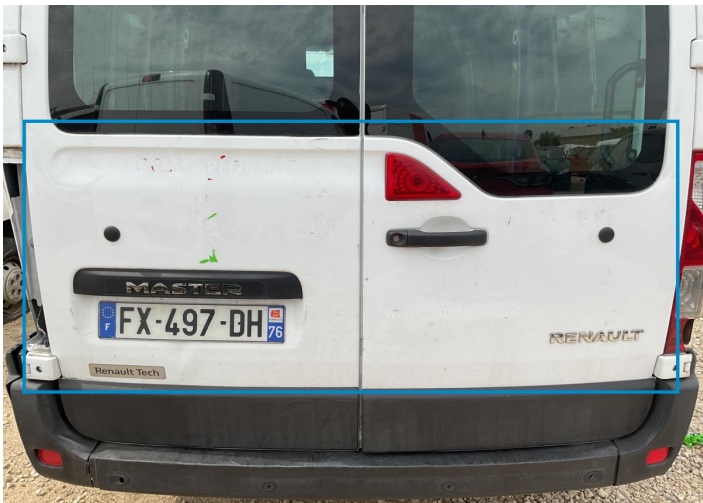
| Component | | Damage | Comments |
|---|---|---|---|
| 13 | Tailgate | Paint / Scratch / Line | |

13. Tailgate  
Paint / Scratch / Line -

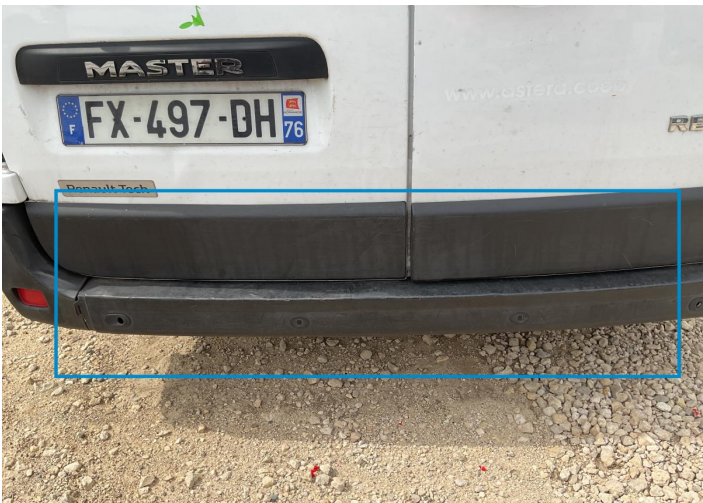
| 14 | Bumper / Back | Paint / Scratch / Line |

14. Bumper / Back  
Paint / Scratch / Line -

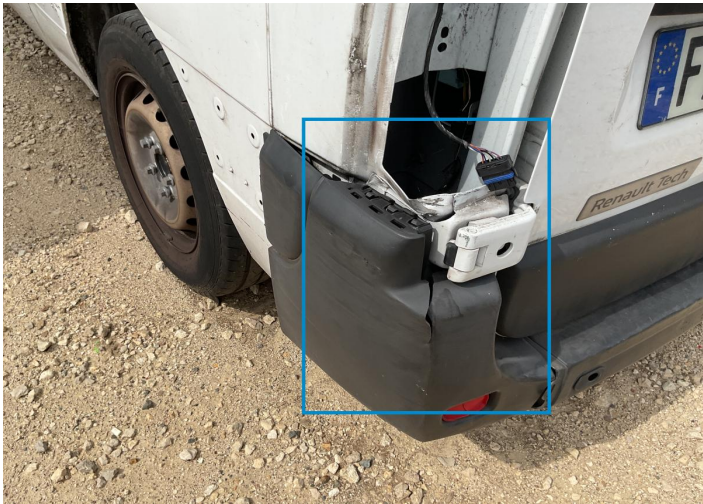
| 15 | Bumper / Back | Bodywork / Breakage / Hole |

15. Bumper / Back  
Bodywork / Breakage / Hole -

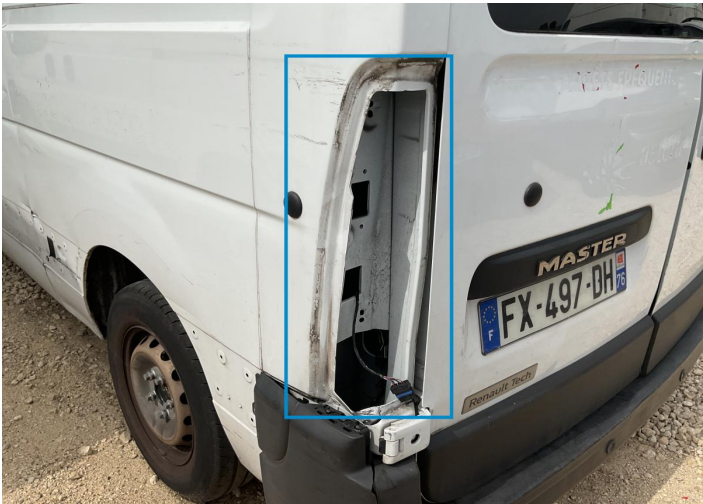
| 16 | Tailgate Light / Back - Left | Bodywork / Breakage / Hole |

16. Tailgate Light / Back - Left  
Bodywork / Breakage / Hole -

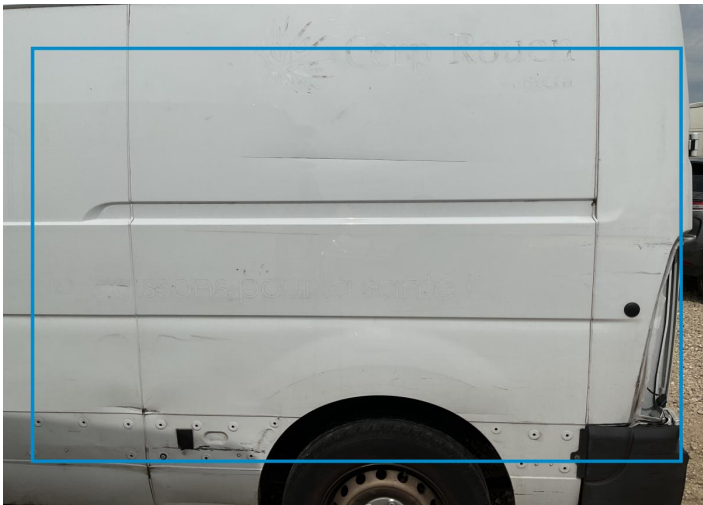
| 17 | Side Panel / Back Left | Paint / Scratch / Line |

17. Side Panel / Back Left  
Paint / Scratch / Line -

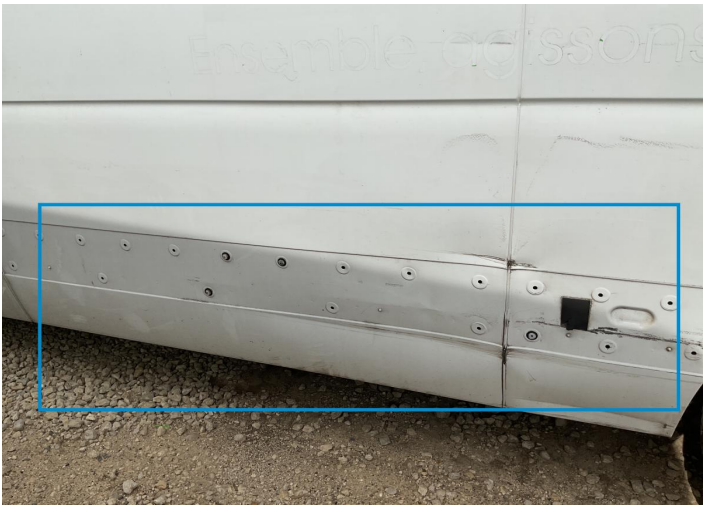
| 18 | Door Side Molding / Front Left | Bodywork / Breakage / Hole |

18. Door Side Molding / Front Left  
Bodywork / Breakage / Hole -

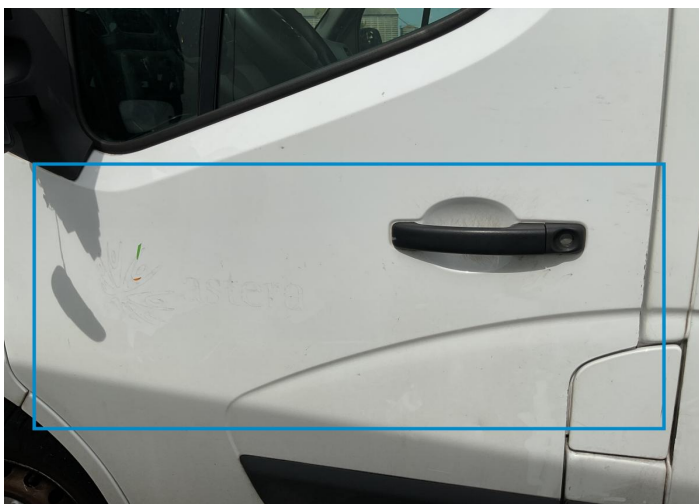
| 19 | Door / Front Left | Paint / Scratch / Line |

19. Door / Front Left  
Paint / Scratch / Line -

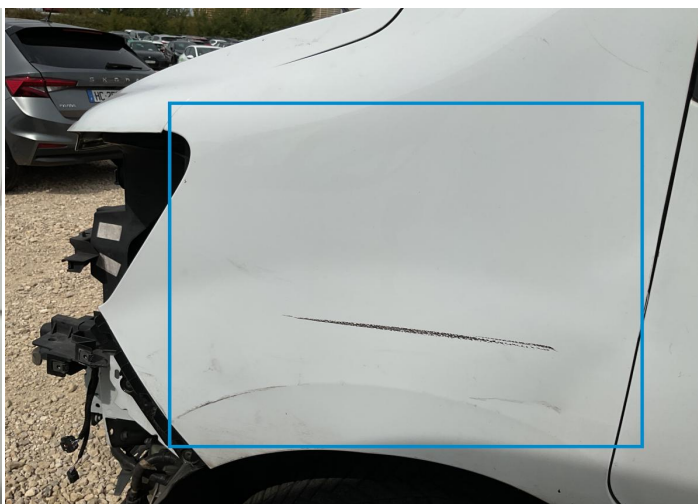
| 20 | Fender / Front Left | Paint / Scratch / Line |

20. Fender / Front Left  
Paint / Scratch / Line -

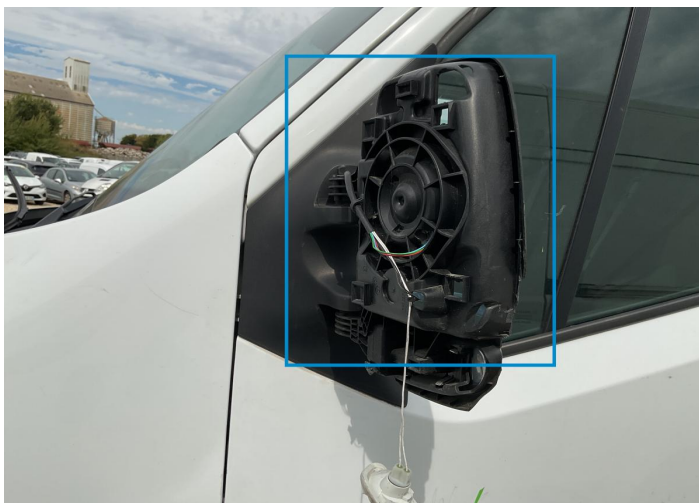
| 21 | Mirror / Front Left | Bodywork / Breakage / Hole |

21. Mirror / Front Left  
Bodywork / Breakage / Hole -

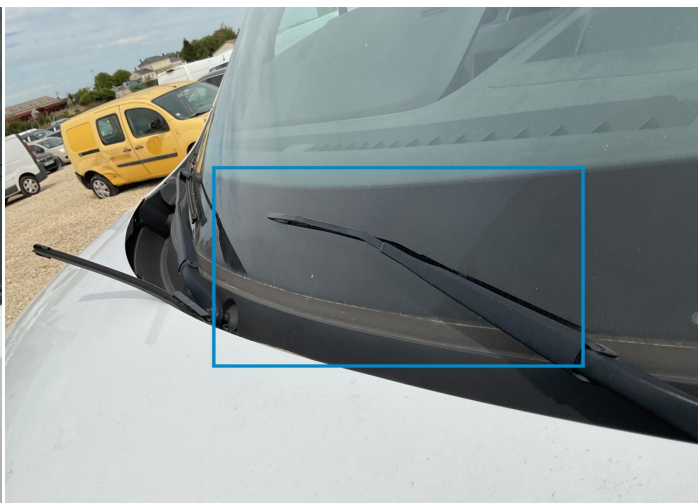
| 22 | Wiper / Front Left | Bodywork / Breakage / Hole |

22. Wiper / Front Left  
Bodywork / Breakage / Hole -

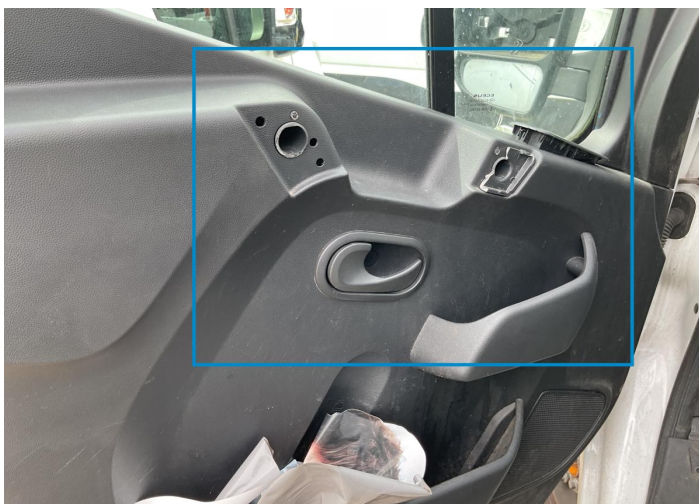
| 23 | Interior door handle Front left | Interior / Broken |

23. Interior door handle Front left  
Interior / Broken -

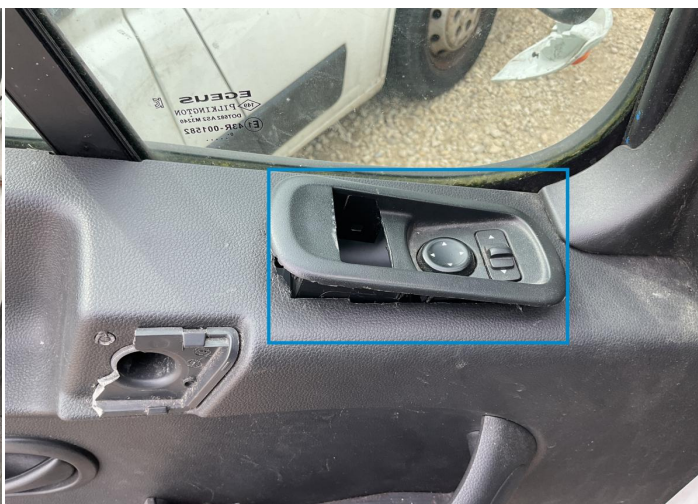
| 24 | Window Switch / Front Left | Interior / Broken |

24. Window Switch / Front Left  
Interior / Broken -
