## status report

#### Renault Master III Kasten L2H2 HKa 3,5t

| Vehicle identification number | <b>VF1MAF4SC56045620</b> | mileage read: | <b>126169 km</b> |

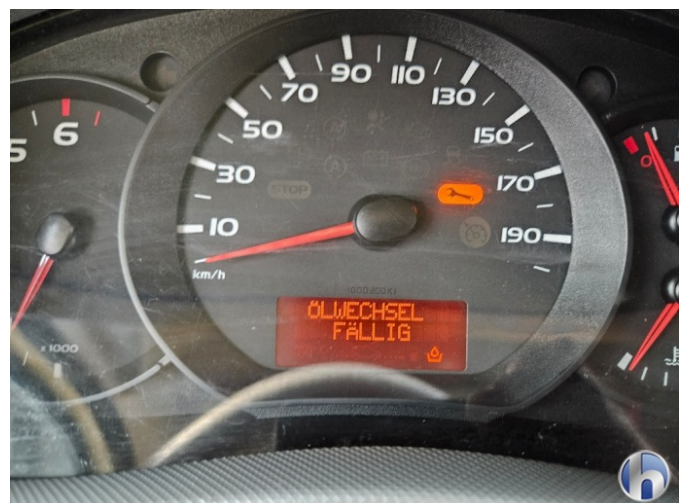
2. Wartung

| | <b>component</b> | <b>Damage</b> | <b>Rep kind</b> |
|---|---|---|---|
| 2. | Wartung | Due | Replace |

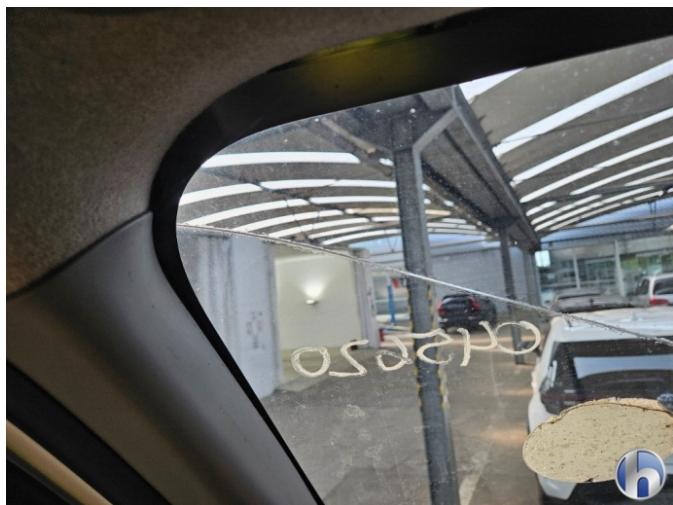
3. Windshield

| <b>Note Road Safe:</b> | Riss Frontscheibe |

| | <b>component</b> | <b>Damage</b> | <b>Rep kind</b> |
|---|---|---|---|
| 3. | Windshield | Crack | Replace |

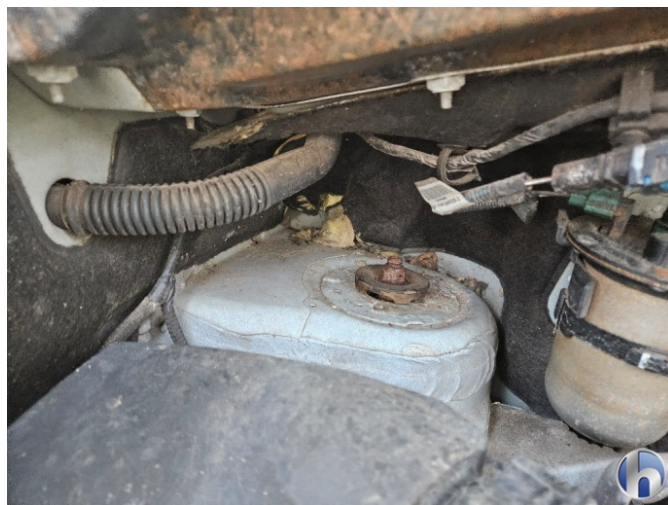
4. Motordämmmaterial

| | <b>component</b> | <b>Damage</b> | <b>Rep kind</b> |
|---|---|---|---|
| 4. | Motordämmmaterial | Damaged | Replace |

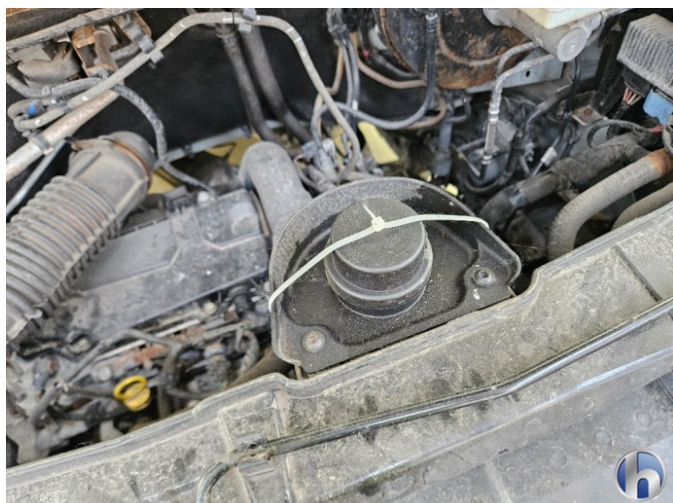
5. Motorraum

| | <b>component</b> | <b>Damage</b> | <b>Rep kind</b> |
|---|---|---|---|
| 5. | Motorraum | Wear and tear | acceptable |

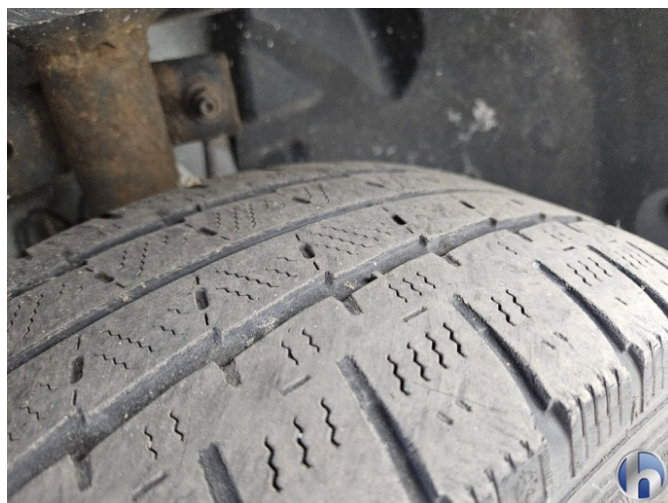
6. Reifen 4x

| mounted tires | | |
|---|---|---|
| traffic Safety: | <b>not roadworthy</b> | |

| | <b>component</b> | <b>Damage</b> | <b>Rep kind</b> |
|---|---|---|---|
| 6. | Reifen 4x | Not safe for road traffic | Replace |

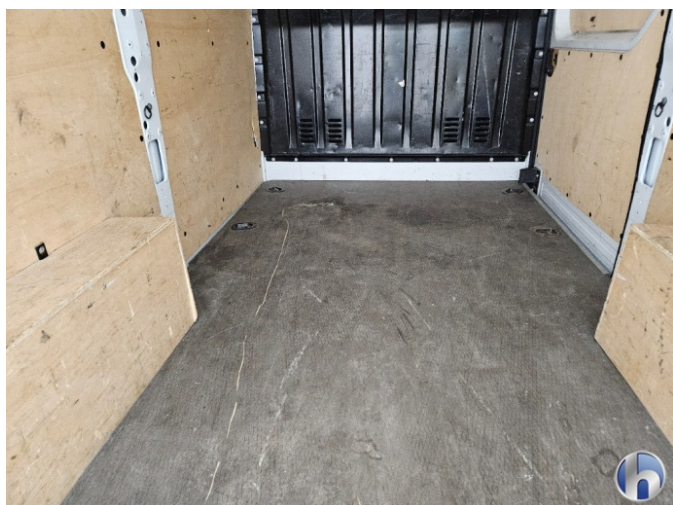
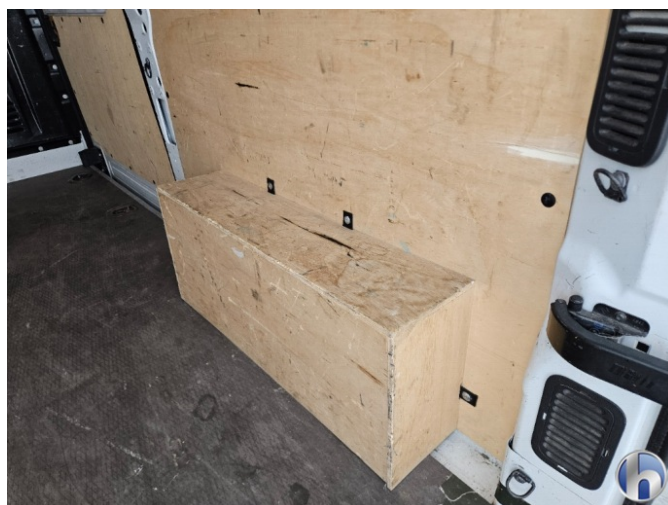
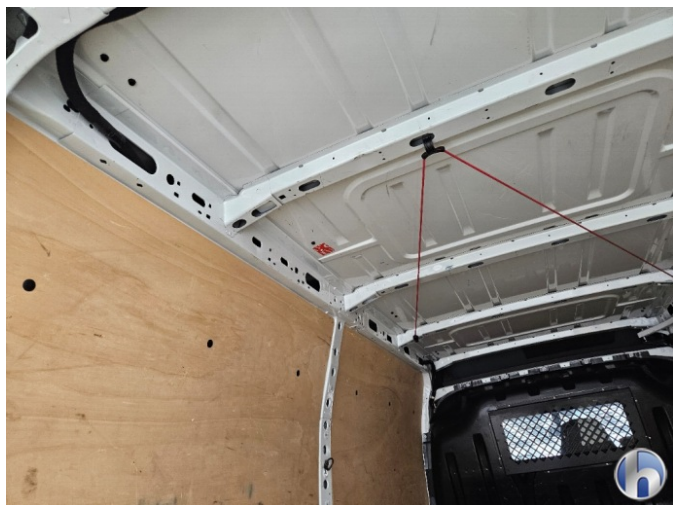
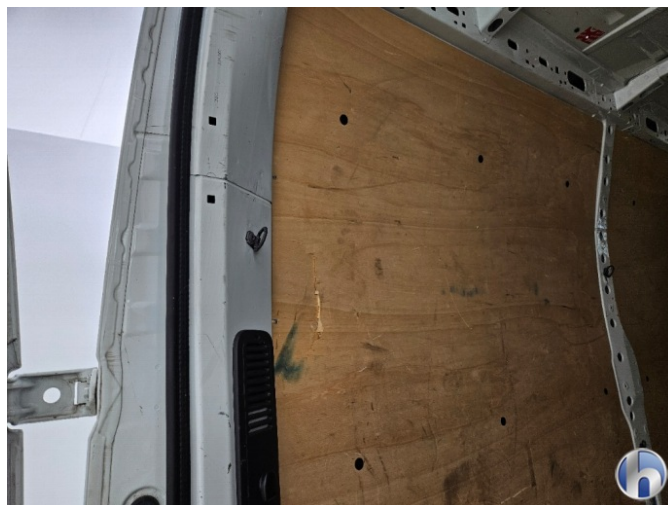
| | <b>component</b> | <b>Damage</b> | <b>Rep kind</b> |
|---|---|---|---|
| 7. | Laderaum | Wear and tear | acceptable |

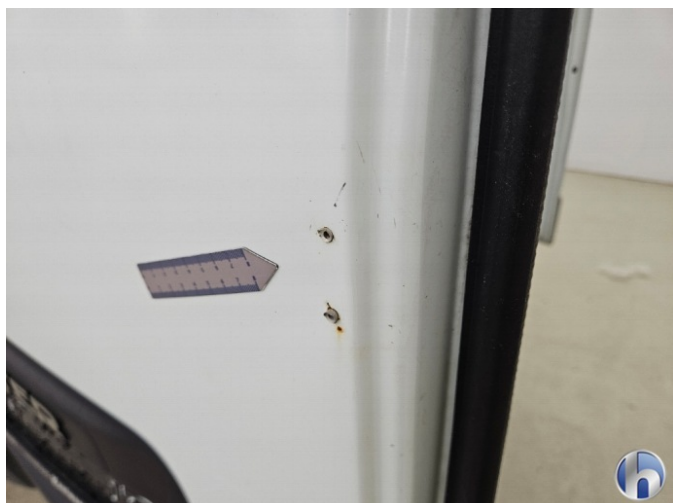
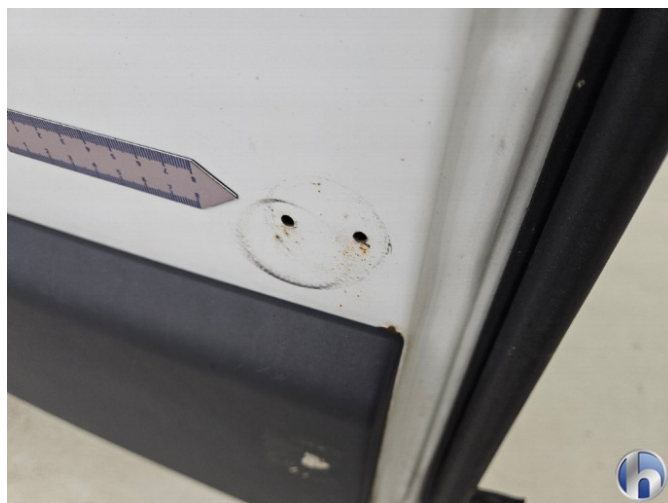
| | <b>component</b> | <b>Damage</b> | <b>Rep kind</b> |
|---|---|---|---|
| 8. | Hecktür li. | Damaged | Replace |

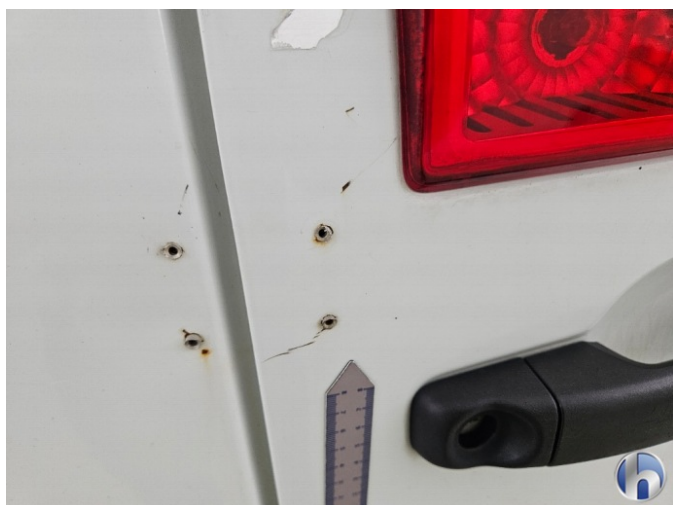
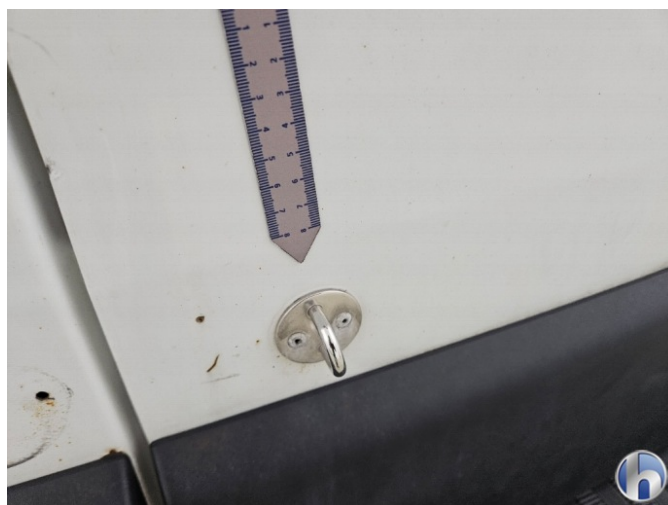
| | <b>component</b> | <b>Damage</b> | <b>Rep kind</b> |
|---|---|---|---|
| 9. | Hecktür re. | Damaged | Replace |

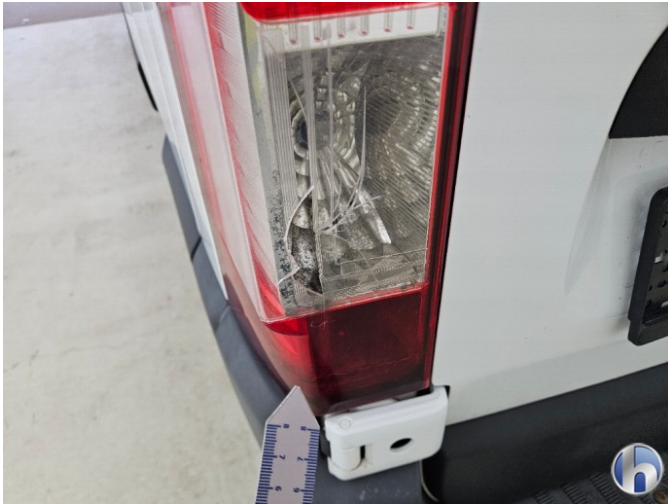
10. Taillight left

| | <b>component</b> | <b>Damage</b> | <b>Rep kind</b> |
|---|---|---|---|
| 10. | Taillight left | Damaged | Replace |

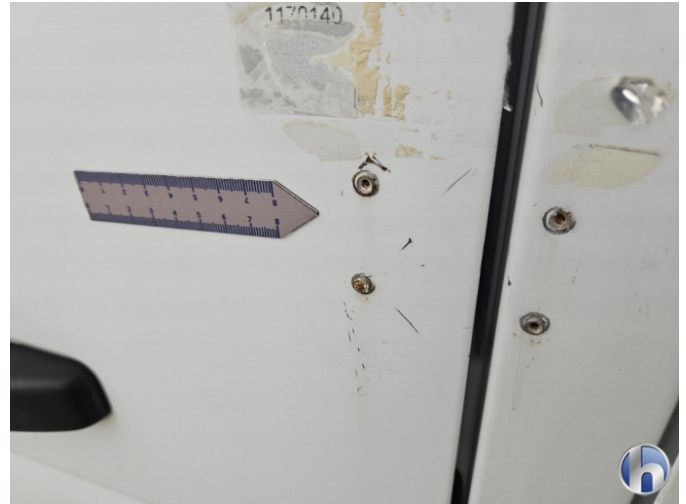
11. Door Rear - right

| | <b>component</b> | <b>Damage</b> | <b>Rep kind</b> |
|---|---|---|---|
| 11. | Door Rear - right | Damaged | Replace |

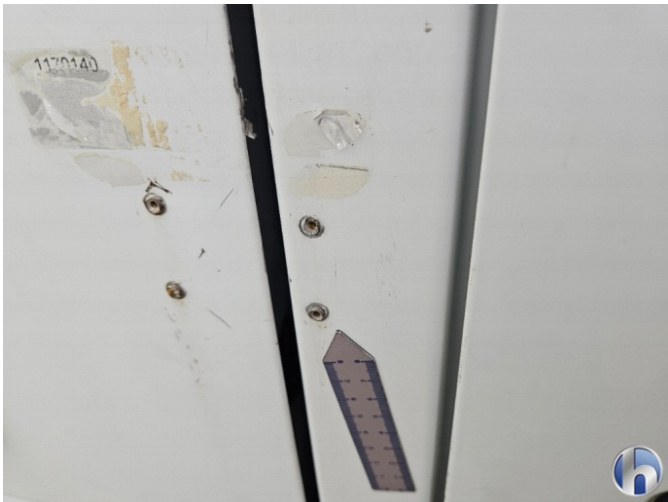
12. B-pillar center - right

| | <b>component</b> | <b>Damage</b> | <b>Rep kind</b> |
|---|---|---|---|
| 12. | B-pillar center - right | Hole | Refurbish and paint |

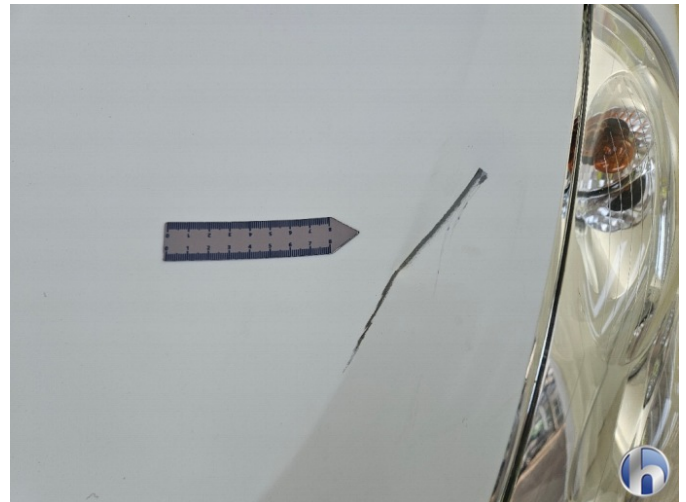
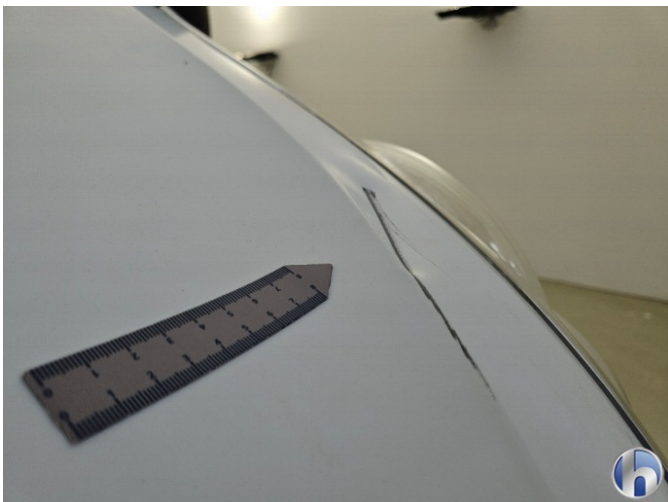
| | <b>component</b> | <b>Damage</b> | <b>Rep kind</b> |
|---|---|---|---|
| 13. | hood | Damaged | Refurbish and paint |

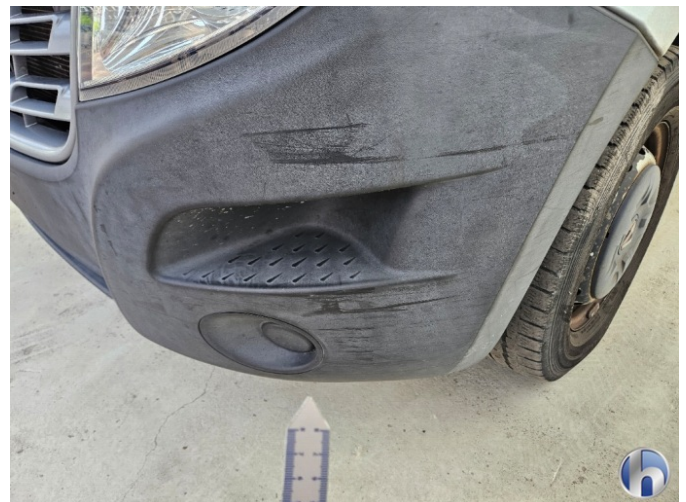
14. Front bumper

| | <b>component</b> | <b>Damage</b> | <b>Rep kind</b> |
|---|---|---|---|
| 14. | Front bumper | Wear and tear | acceptable |

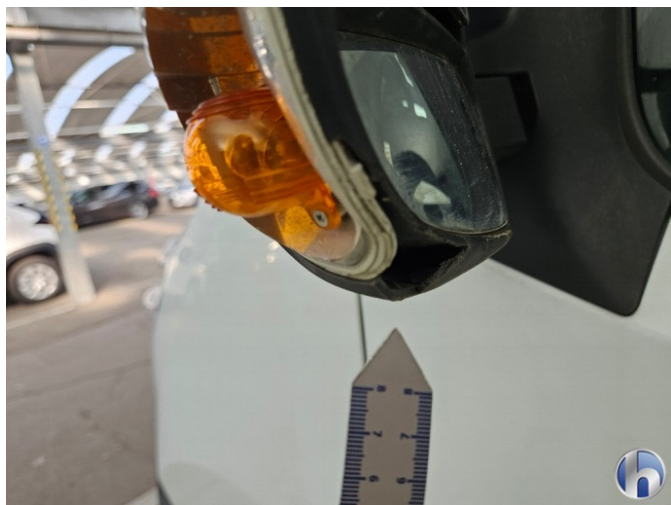
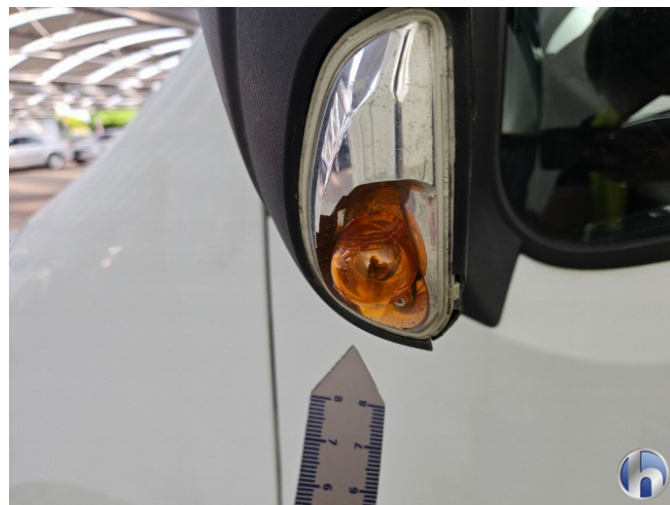
| | <b>component</b> | <b>Damage</b> | <b>Rep kind</b> |
|---|---|---|---|
| 15. | Außenspiegel li. | Damaged | Replace |

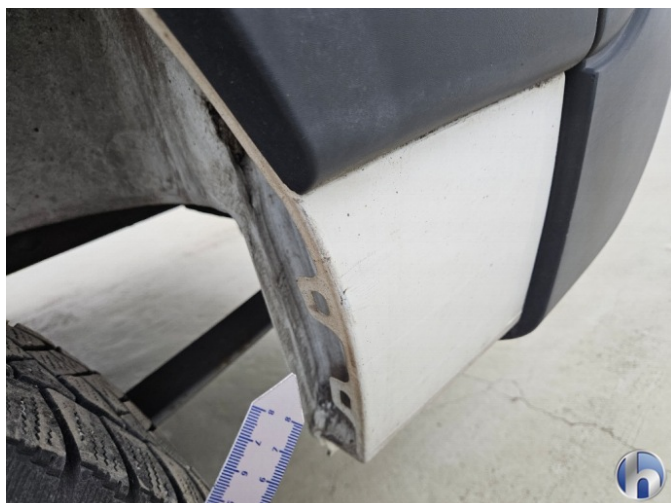
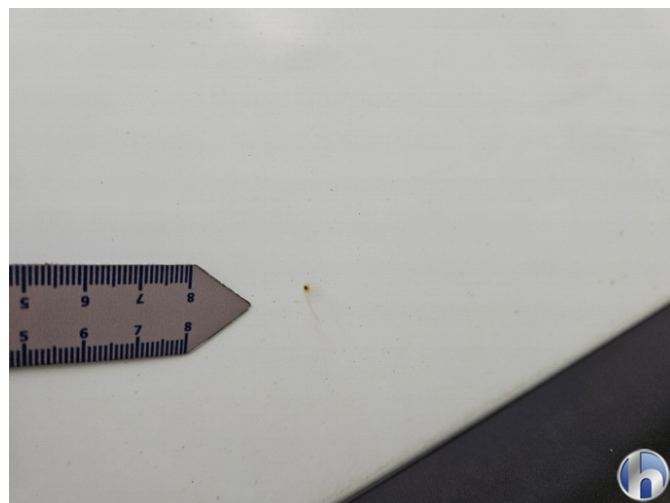
| | <b>component</b> | <b>Damage</b> | <b>Rep kind</b> |
|---|---|---|---|
| 16. | Sidewall - Rear - Left | Wear and tear | acceptable |

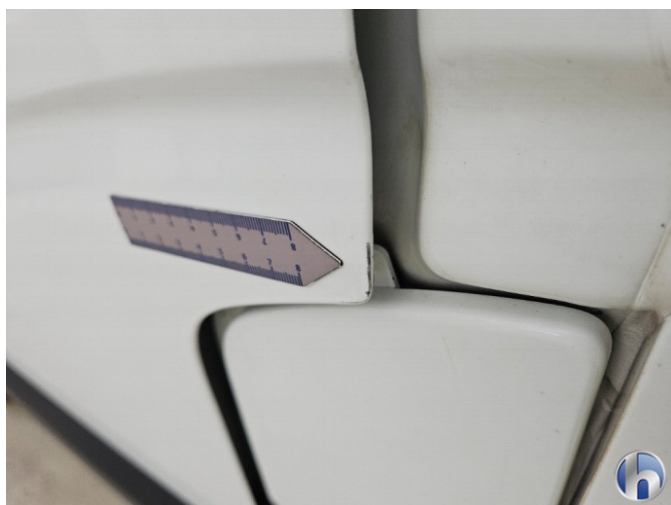
17. Front door - left

| | <b>component</b> | <b>Damage</b> | <b>Rep kind</b> |
|---|---|---|---|
| 17. | Front door - left | Wear and tear | acceptable |

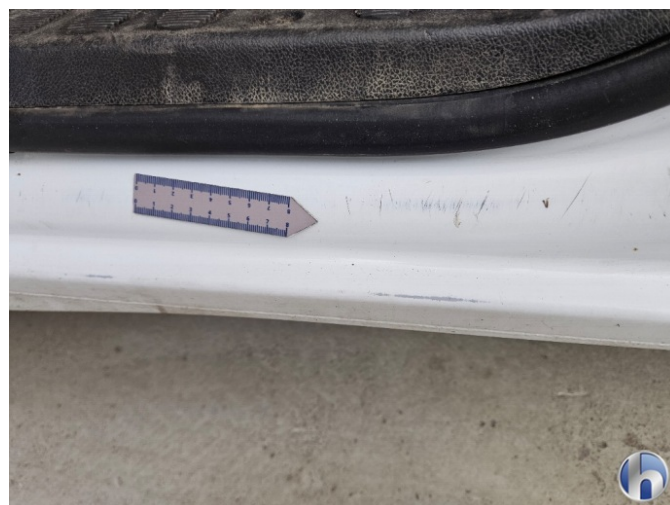
18. Türeinstieg v.l.

| | <b>component</b> | <b>Damage</b> | <b>Rep kind</b> |
|---|---|---|---|
| 18. | Türeinstieg v.l. | Scrape | Paint |

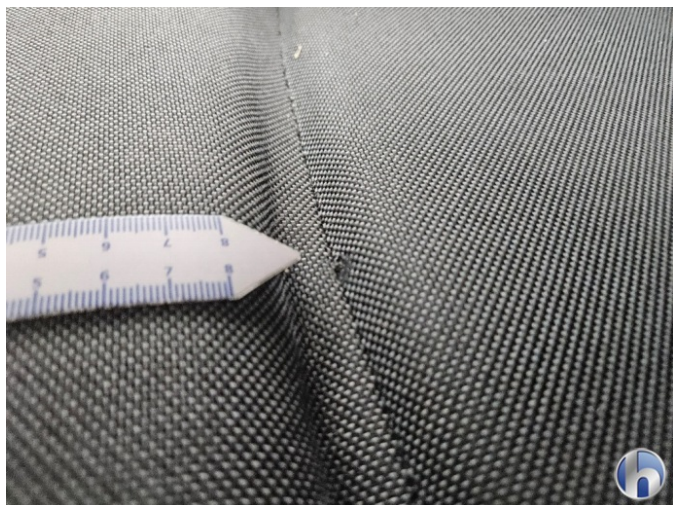
19. Fahrersitz

| | <b>component</b> | <b>Damage</b> | <b>Rep kind</b> |
|---|---|---|---|
| 19. | Fahrersitz | Burn hole | Replace |
