Expertise

Protocol number: 41585716  
Order No. / Reference: 25179191  
Inspection date: 16 Sept 2025

Manufacturer: Renault

Model: Talisman Grandtour BLUE dCi 150 BUSINESS EDITION

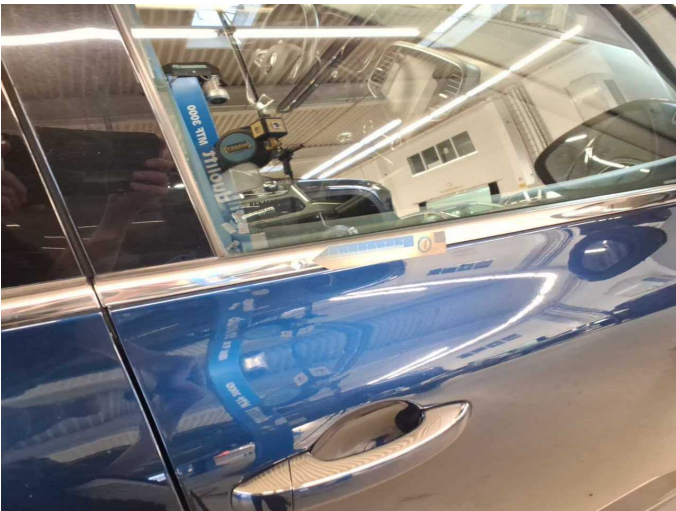
Damage 1: Door - front right side: Strip - outer - Deformed - Replace

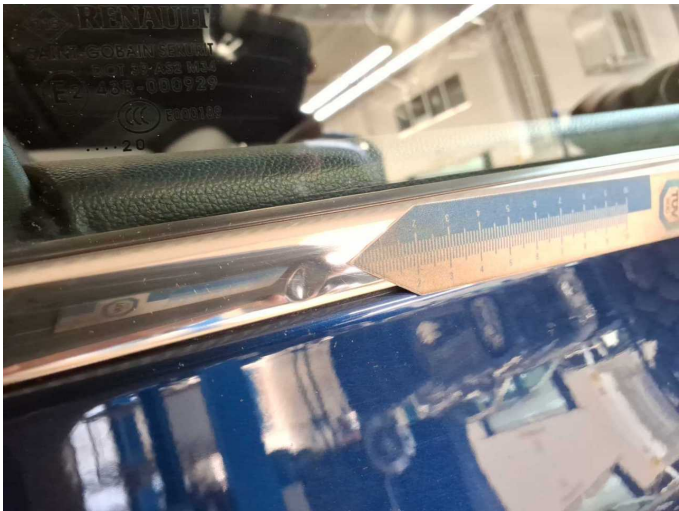
Damage 1: Door - front right side: Strip - outer - Deformed - Replace

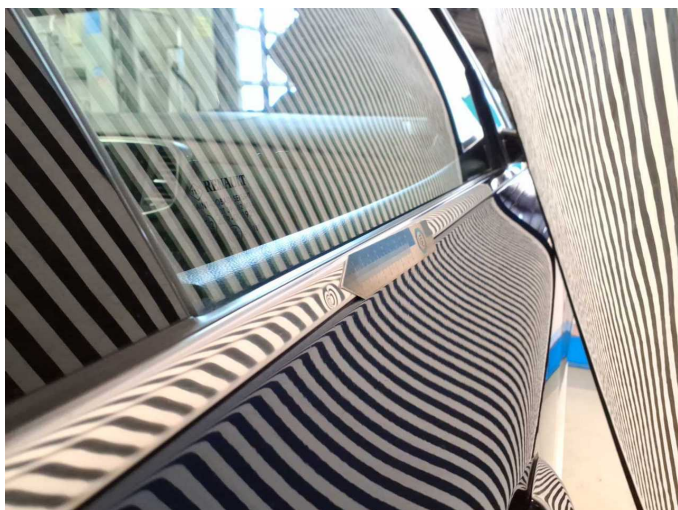
**Damage 1:** Door - front right side: Strip - outer - Deformed - Replace

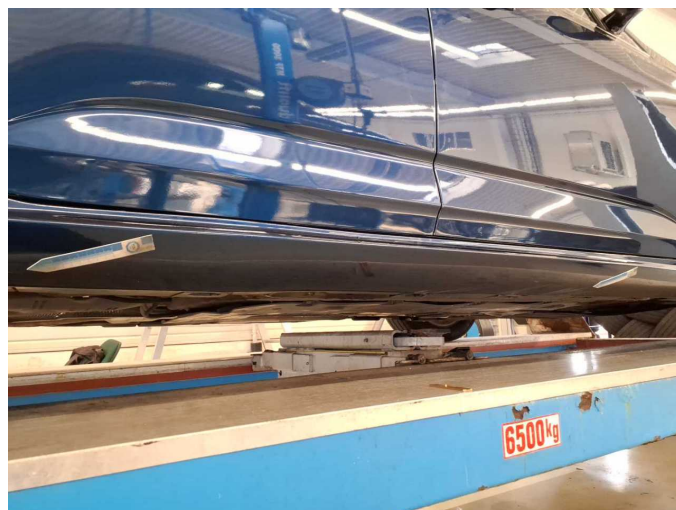
**Damage 2:** Sill - right side: Trim - Scratched - Repair and paint

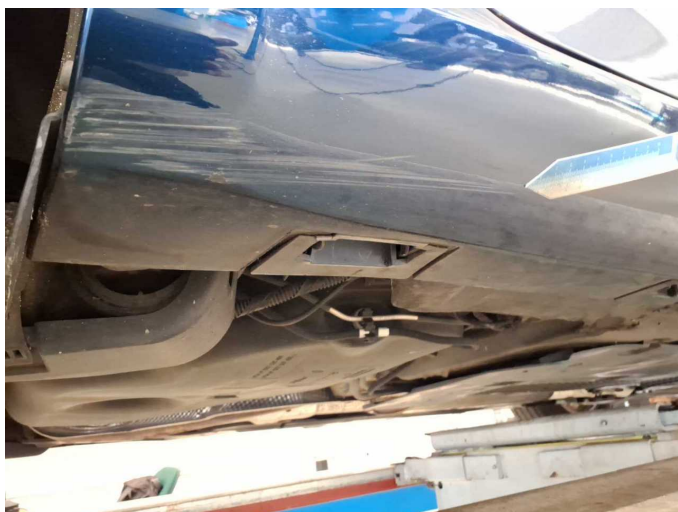
**Damage 2:** Sill - right side: Trim - Scratched - Repair and paint

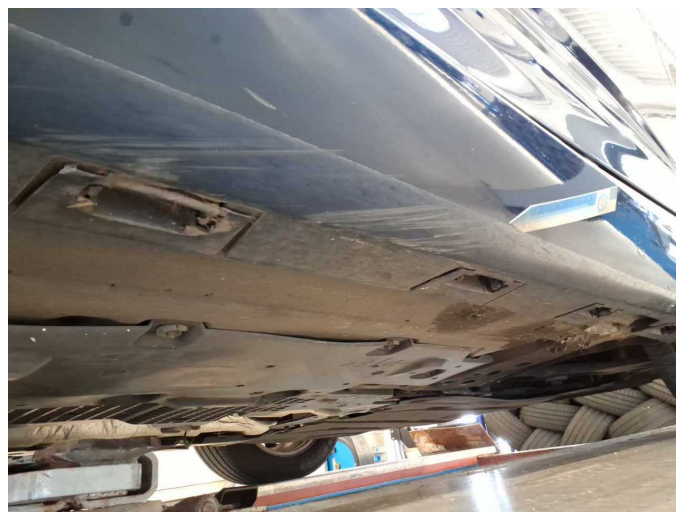
**Damage 2:** Sill - right side: Trim - Scratched - Repair and paint

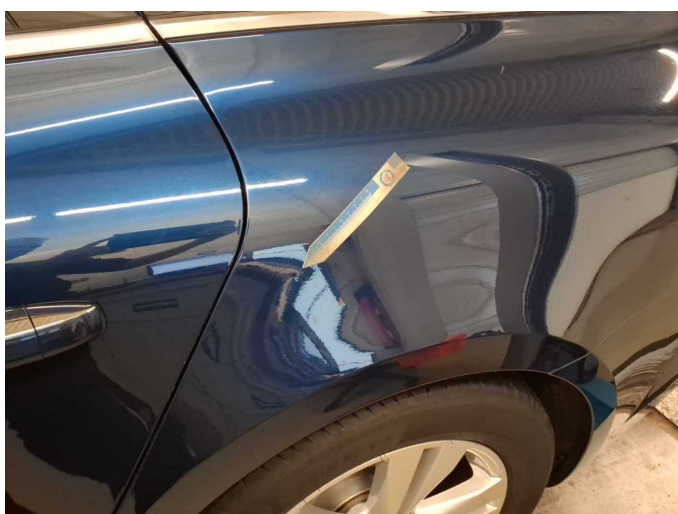
**Damage 3:** Side panel - rear left side: Side panel - Dent / paintcoat damage - Smart repair

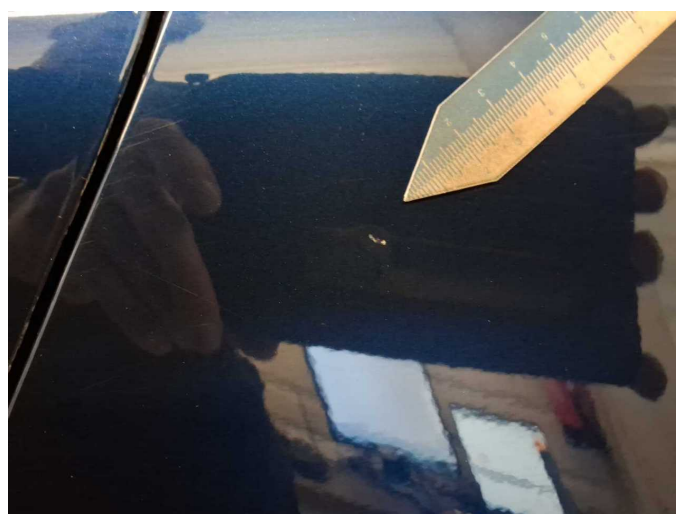
**Damage 3:** Side panel - rear left side: Side panel - Dent / paintcoat damage - Smart repair

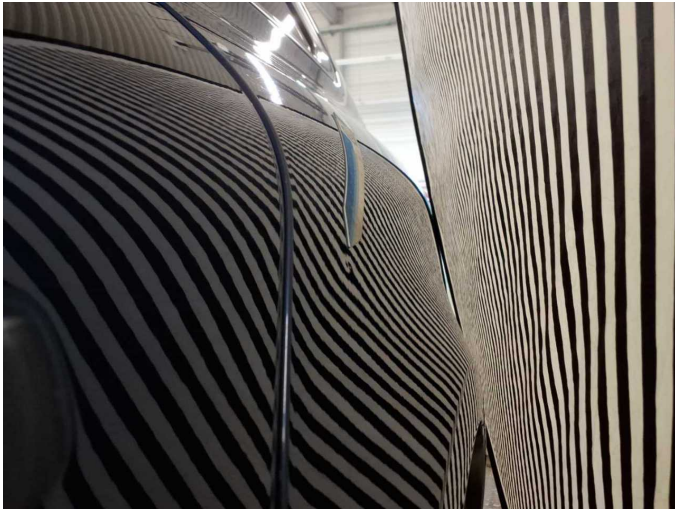
**Damage 3:** Side panel - rear left side: Side panel - Dent / paintcoat damage - Smart repair

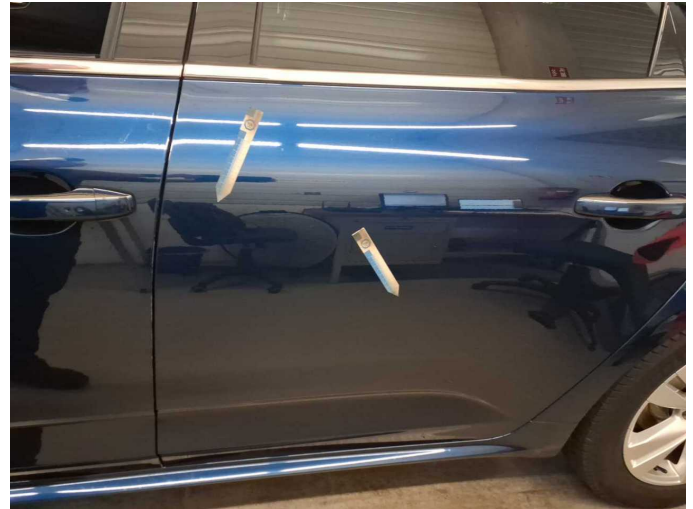
**Damage 4:** Door - rear left side: Door - Scratch(es) - Paint

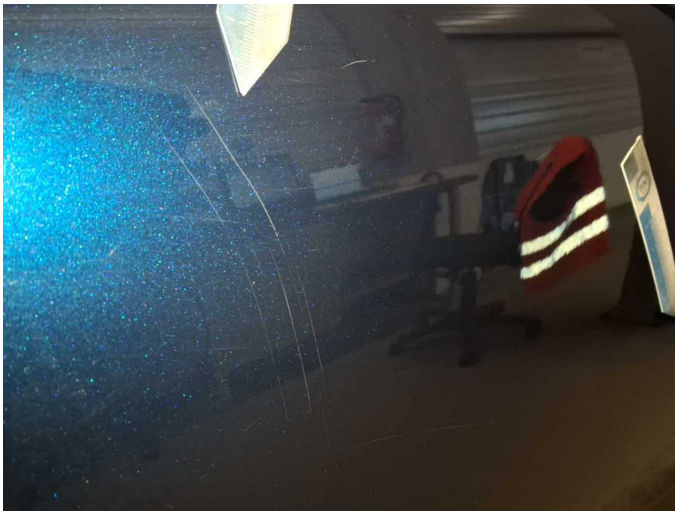
**Damage 4:** Door - rear left side: Door - Scratch(es) - Paint

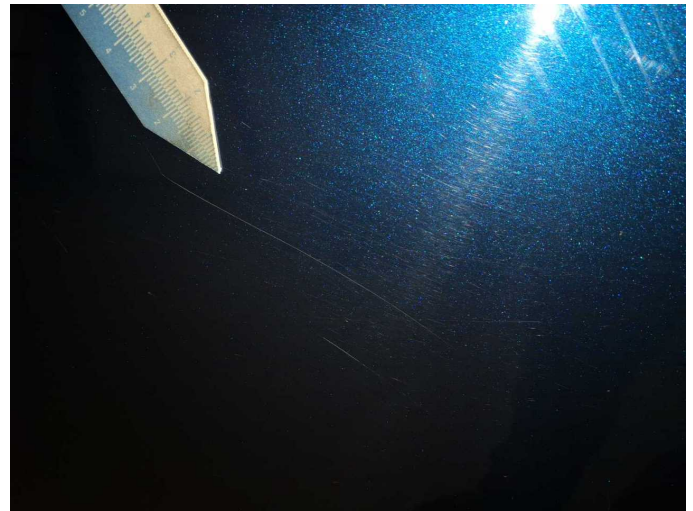
**Damage 4:** Door - rear left side: Door - Scratch(es) - Paint

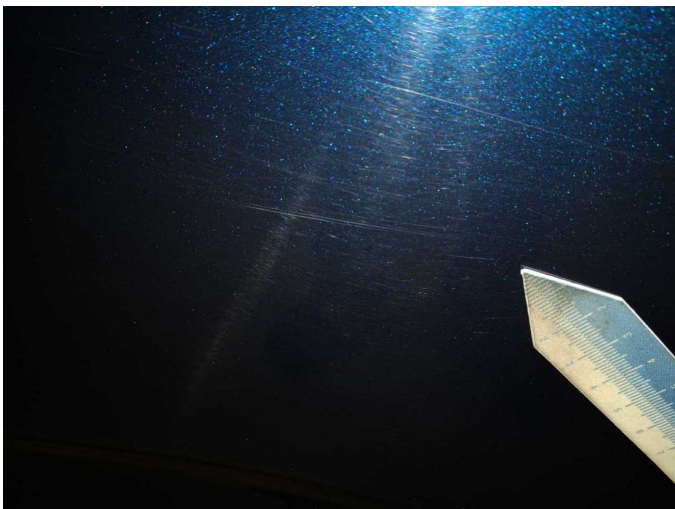
**Damage 4:** Door - rear left side: Door - Scratch(es) - Paint

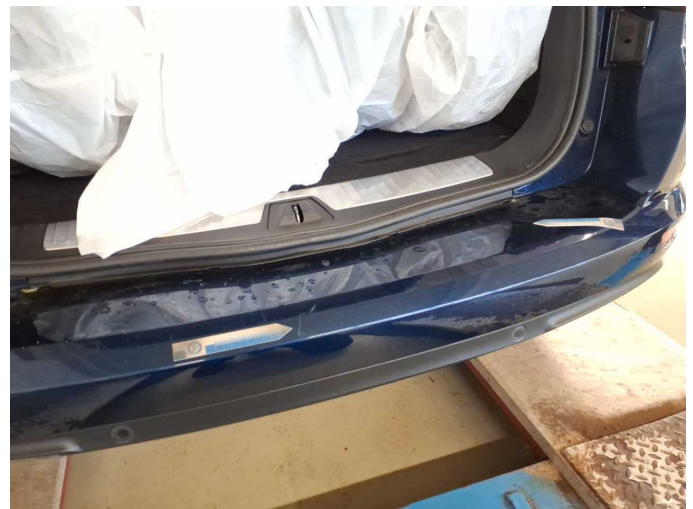
**Damage 5:** Rear bumper: Bumper with Parktronic - Scratch(es) - Paint

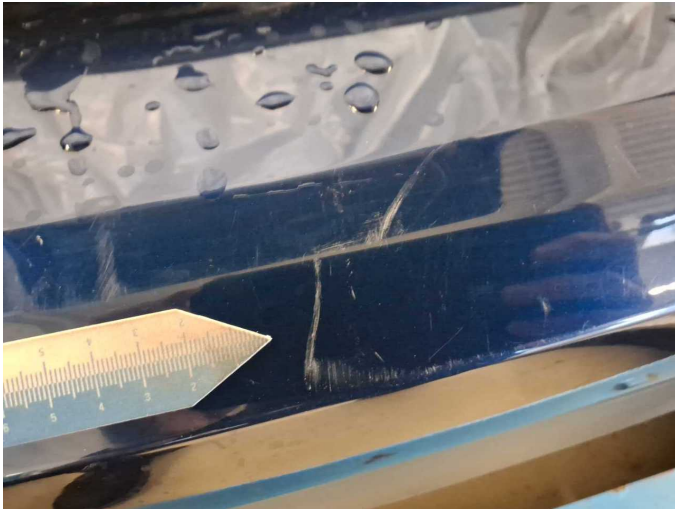
**Damage 5:** Rear bumper: Bumper with Parktronic - Scratch(es) - Paint

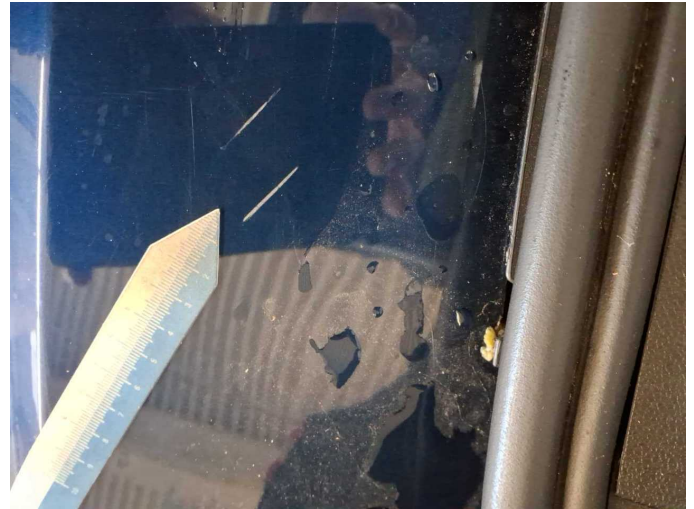
**Damage 5:** Rear bumper: Bumper with Parktronic - Scratch(es) - Paint

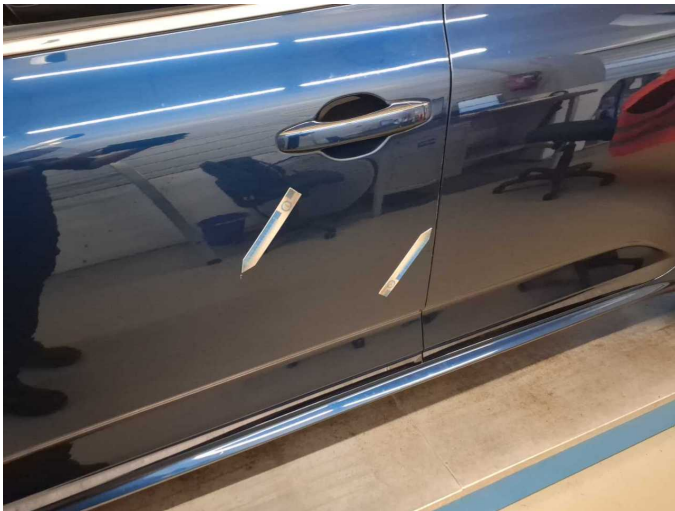
**Damage 6:** Door - front left side: Door - Scratch(es) - Paint

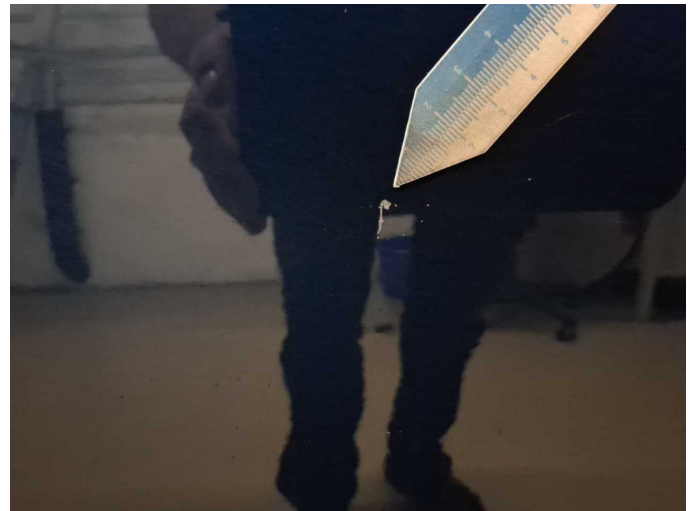
**Damage 6:** Door - front left side: Door - Scratch(es) - Paint

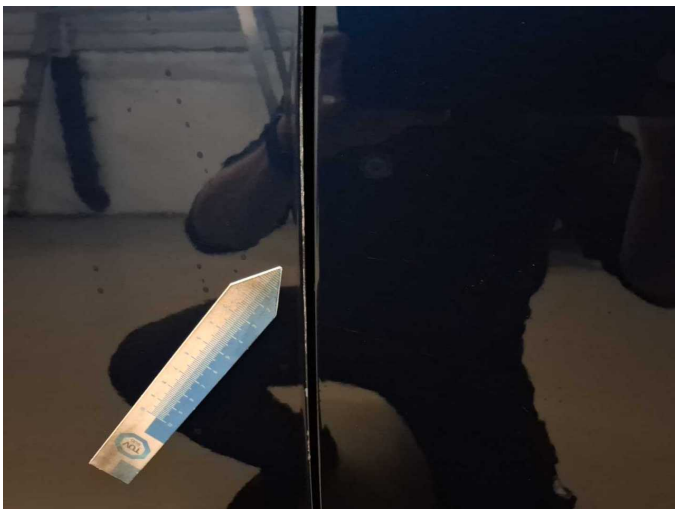
**Damage 6:** Door - front left side: Door - Scratch(es) - Paint

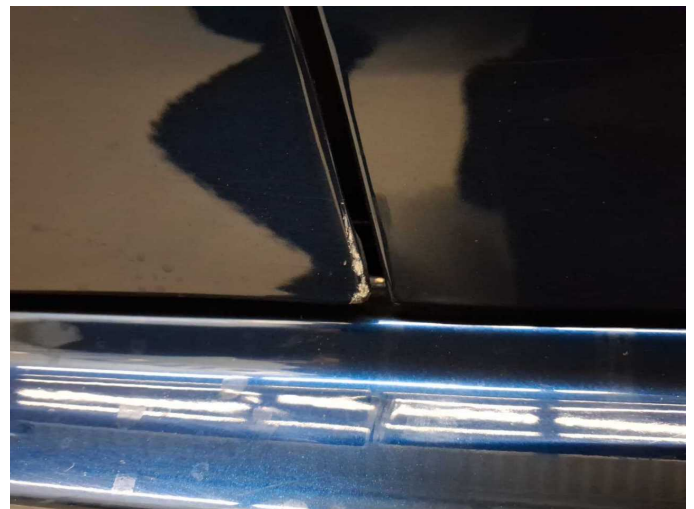
**Damage 6:** Door - front left side: Door - Scratch(es) - Paint

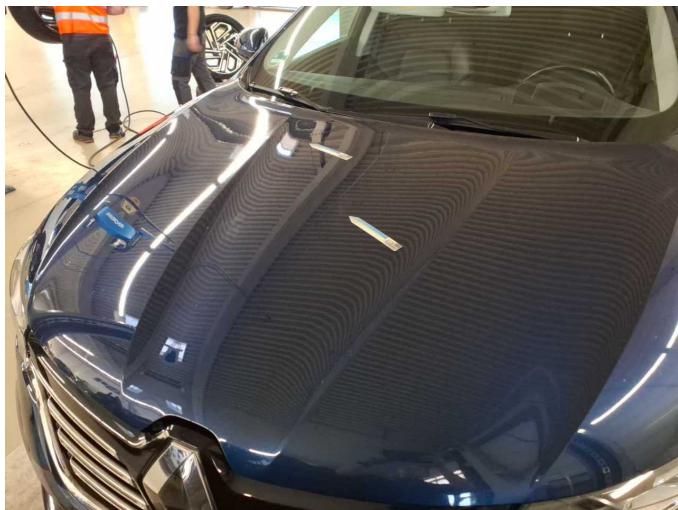
**Damage 7:** Bonnet: Bonnet (+ Kratzer) - Paint defect - Paint

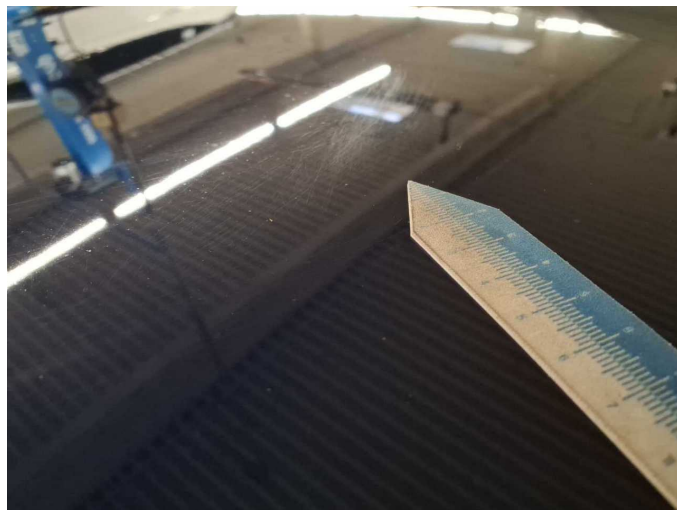
**Damage 7:** Bonnet: Bonnet (+ Kratzer) - Paint defect - Paint

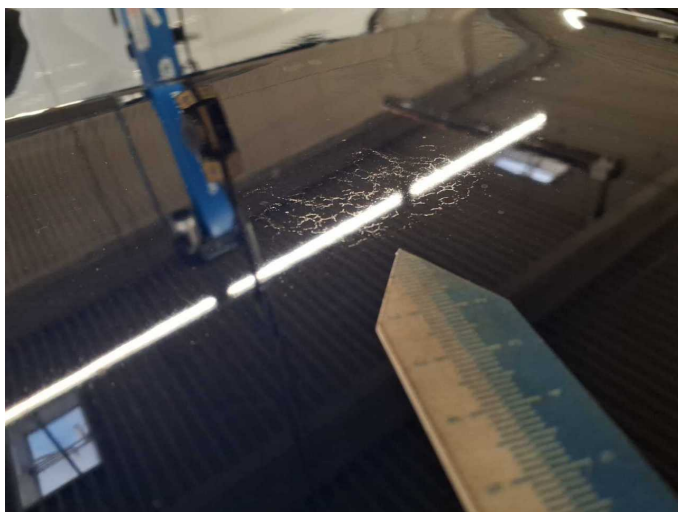
**Damage 7:** Bonnet: Bonnet (+ Kratzer) - Paint defect - Paint

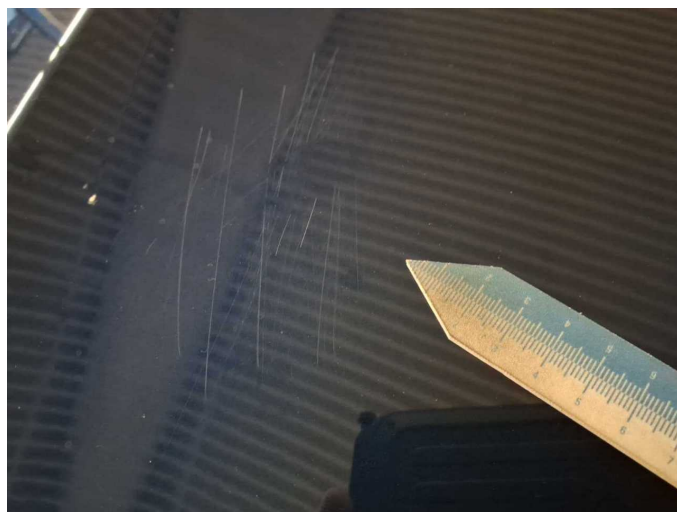
**Damage 7:** Bonnet: Bonnet (+ Kratzer) - Paint defect - Paint

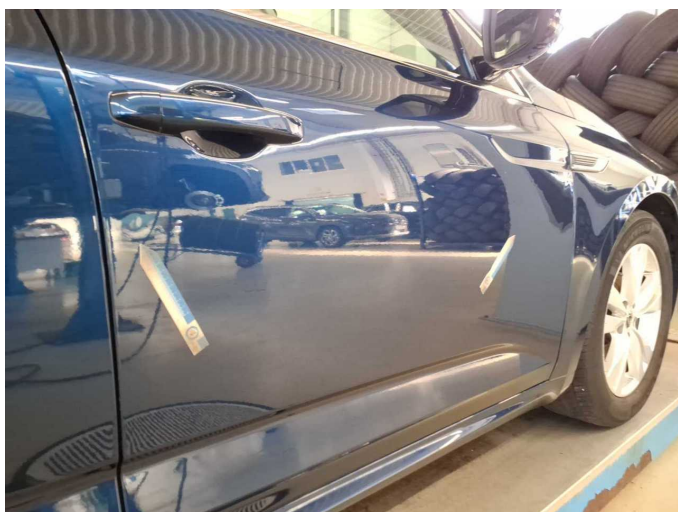
**Damage 8:** Door - front right side: Door (wellig + Folgeschaden) - Unprofessionally repaired - Repair and paint

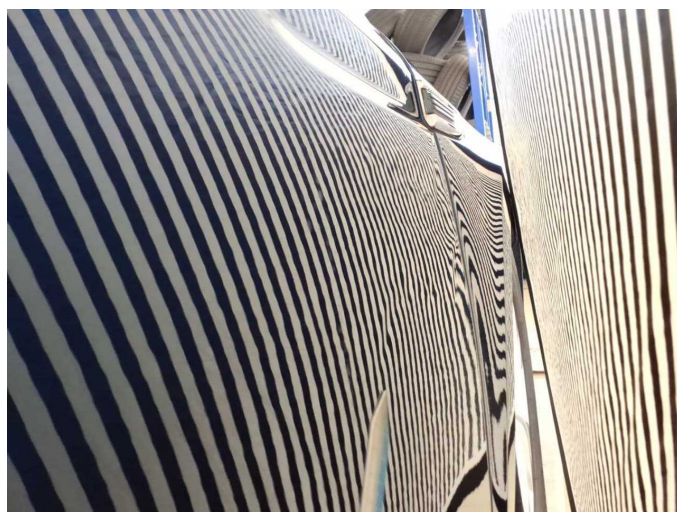
**Damage 8:** Door - front right side: Door (wellig + Folgeschaden) - Unprofessionally repaired - Repair and paint

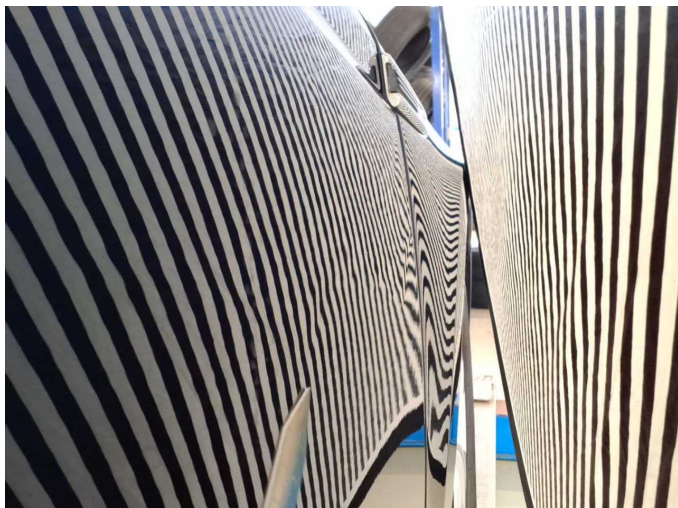
**Damage 8:** Door - front right side: Door (wellig + Folgeschaden) - Unprofessionally repaired - Repair and paint

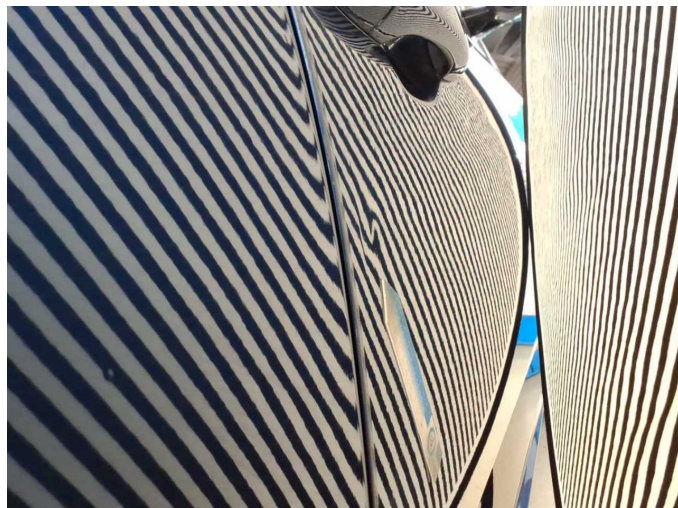
**Damage 8:** Door - front right side: Door (wellig + Folgeschaden) - Unprofessionally repaired - Repair and paint

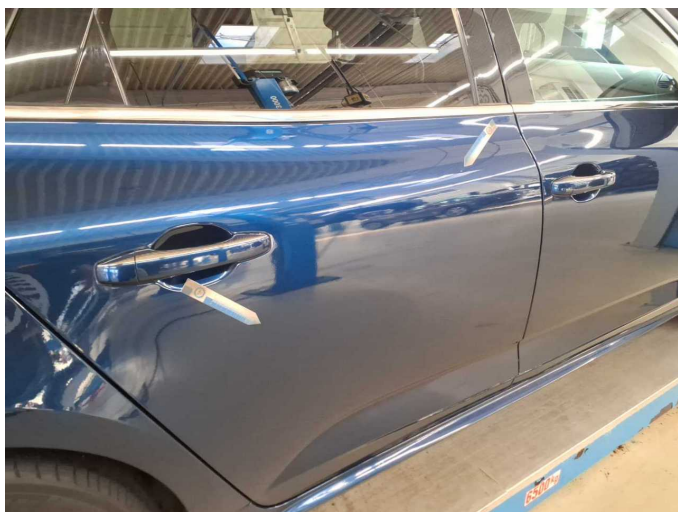
**Damage 9:** Door - rear right side: Door (wellig + Folgeschaden) - Unprofessionally repaired - Repair and paint

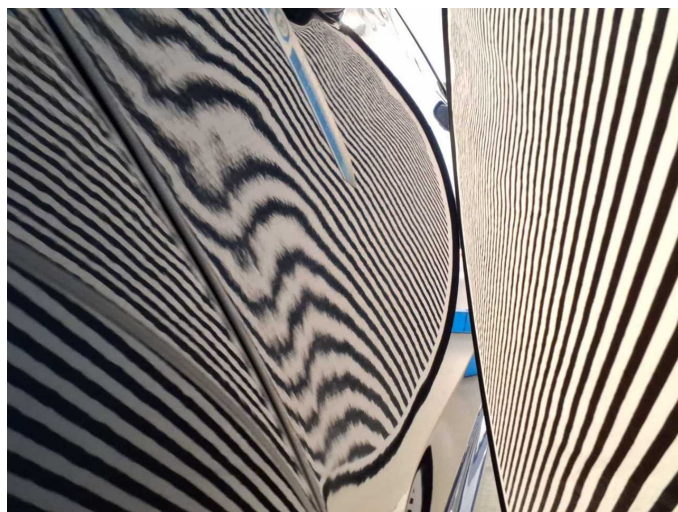
**Damage 9:** Door - rear right side: Door (wellig + Folgeschaden) - Unprofessionally repaired - Repair and paint

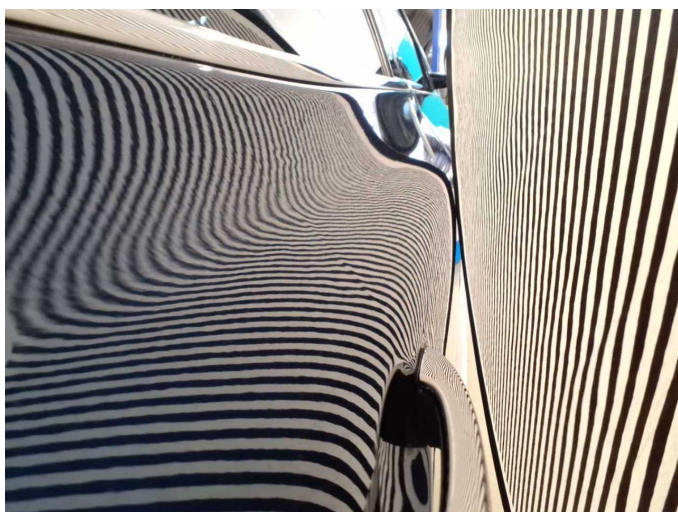
**Damage 9:** Door - rear right side: Door (wellig + Folgeschaden) - Unprofessionally repaired - Repair and paint

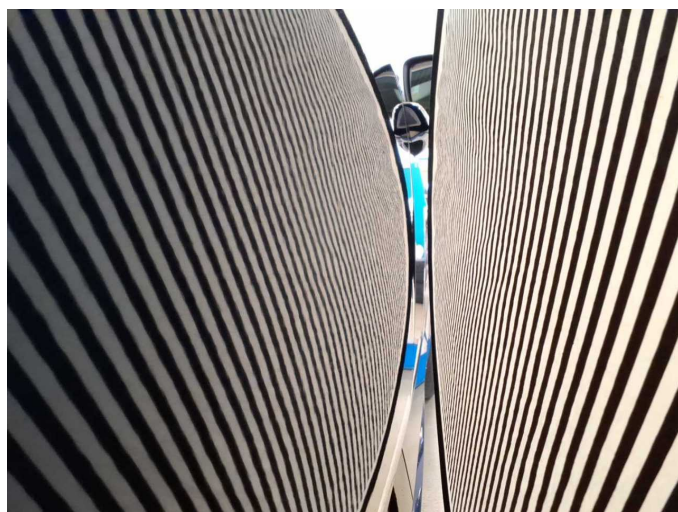
**Damage 9:** Door - rear right side: Door (wellig + Folgeschaden) - Unprofessionally repaired - Repair and paint

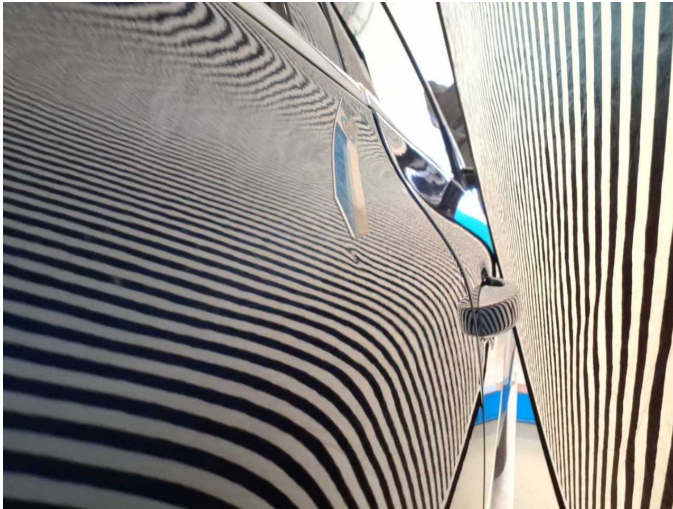
**Damage 9:** Door - rear right side: Door (wellig + Folgeschaden) - Unprofessionally repaired - Repair and paint

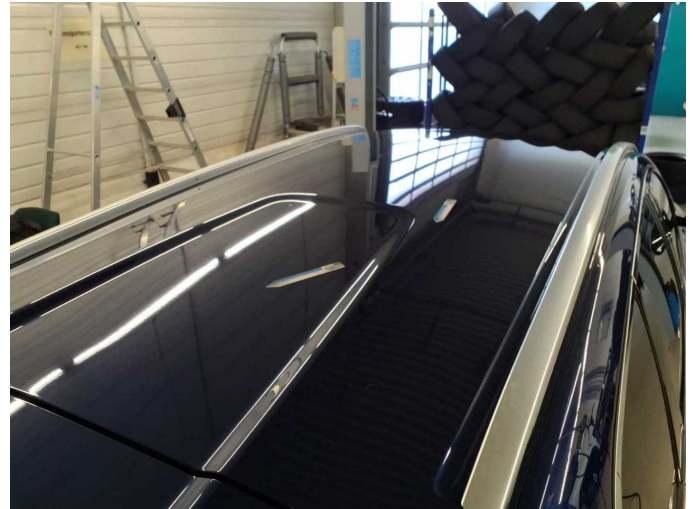
**Damage 10:** Roof: Roof (+ Lackmängel) - dent(s) - Repair and paint

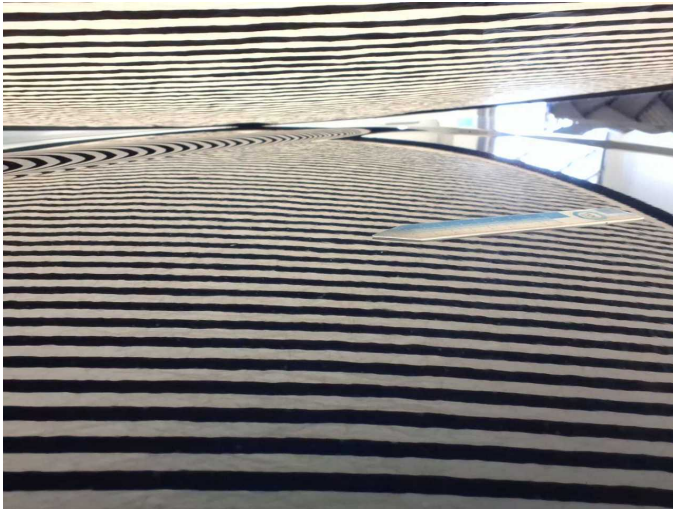
**Damage 10:** Roof: Roof (+ Lackmängel) - dent(s) - Repair and paint

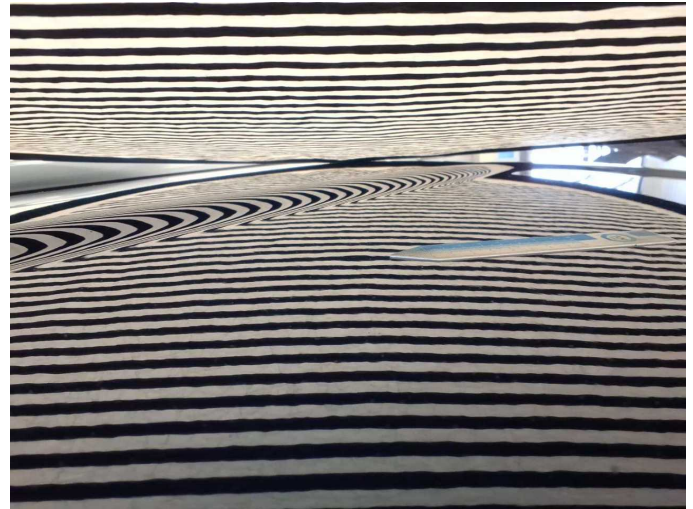
**Damage 10:** Roof: Roof (+ Lackmängel) - dent(s) - Repair and paint

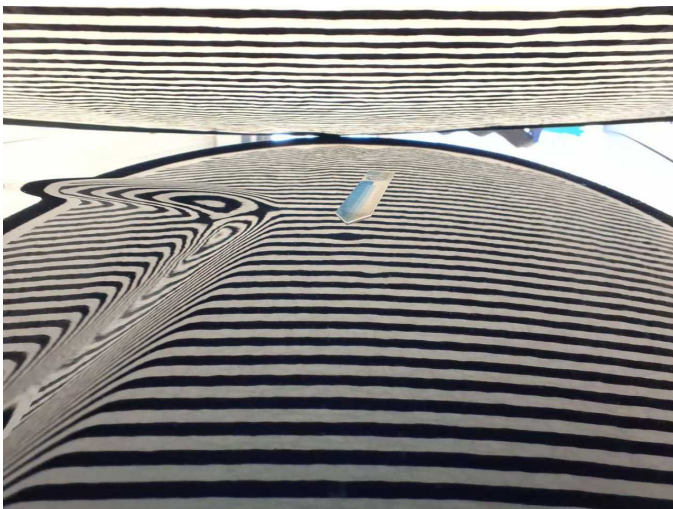
**Damage 10:** Roof: Roof (+ Lackmängel) - dent(s) - Repair and paint

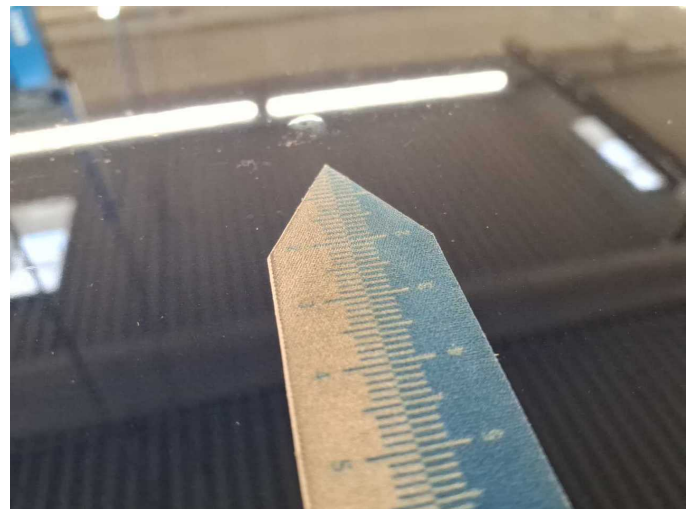
**Damage 10:** Roof: Roof (+ Lackmängel) - dent(s) - Repair and paint

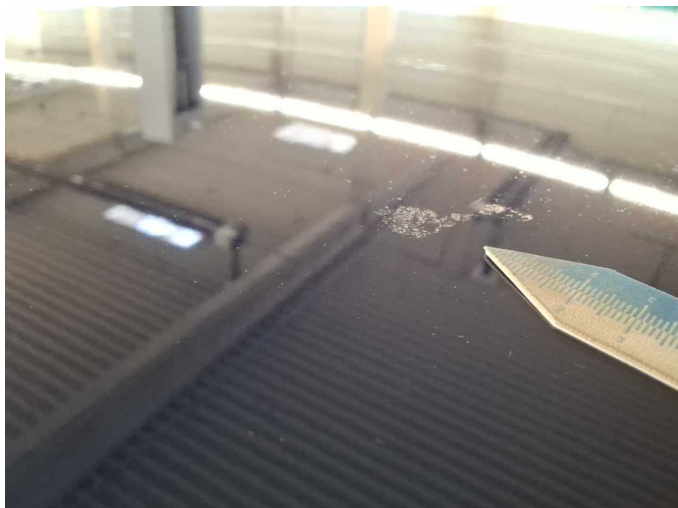
**Damage 10:** Roof: Roof (+ Lackmängel) - dent(s) - Repair and paint

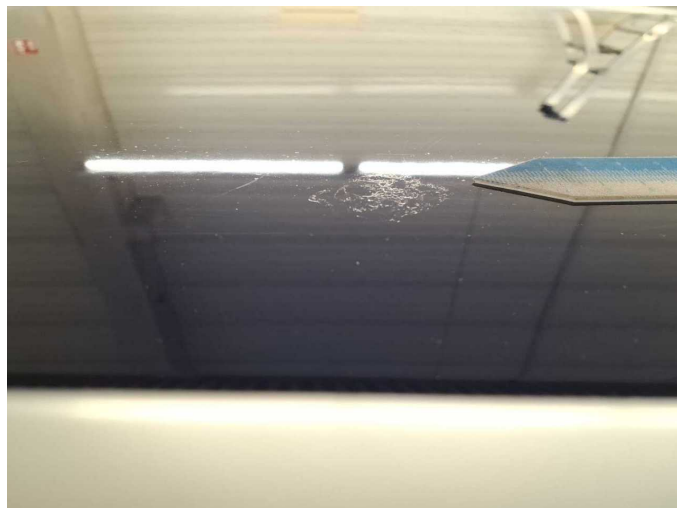
**Damage 10:** Roof: Roof (+ Lackmängel) - dent(s) - Repair and paint

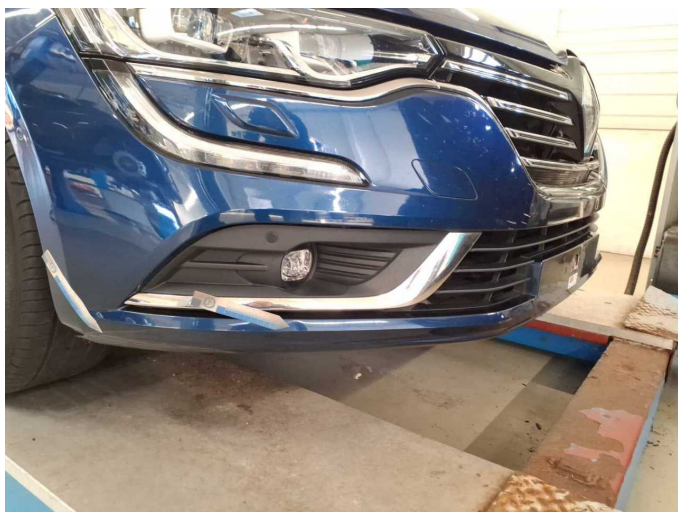
**Damage 11:** Front bumper: Bumper with Parktronic (+ verschürft) - Deformed - Replace

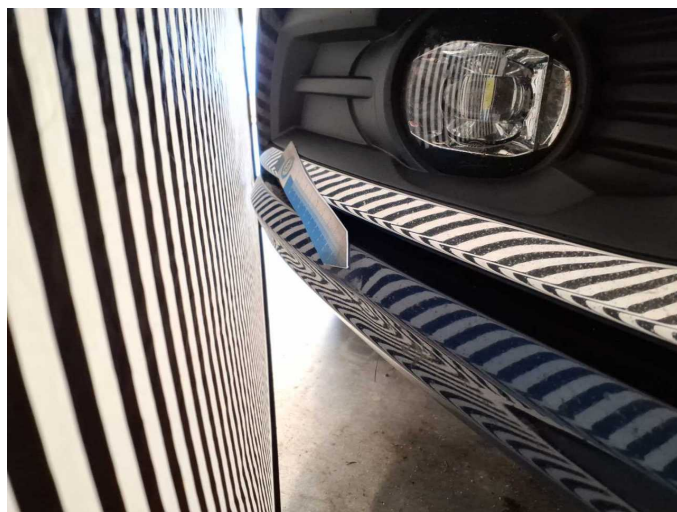
**Damage 11:** Front bumper: Bumper with Parktronic (+ verschürft) - Deformed - Replace

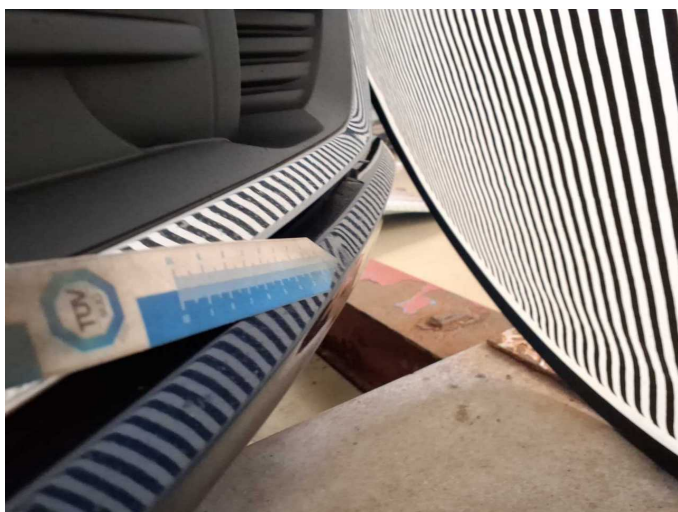
**Damage 11:** Front bumper: Bumper with Parktronic (+ verschürft) - Deformed - Replace

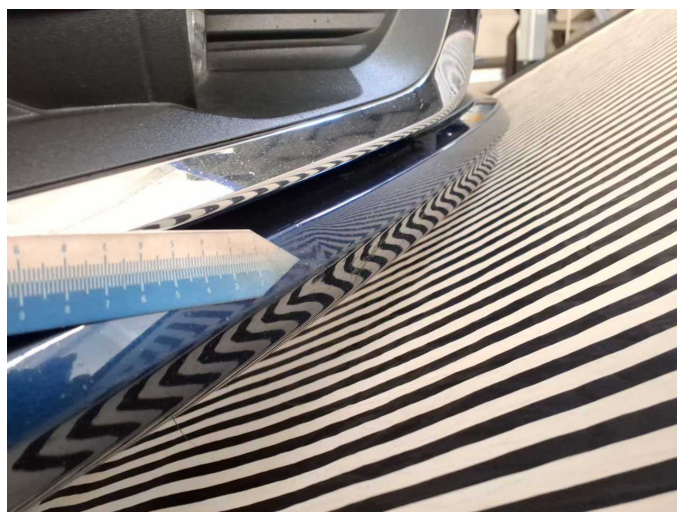
**Damage 11:** Front bumper: Bumper with Parktronic (+ verschürft) - Deformed - Replace

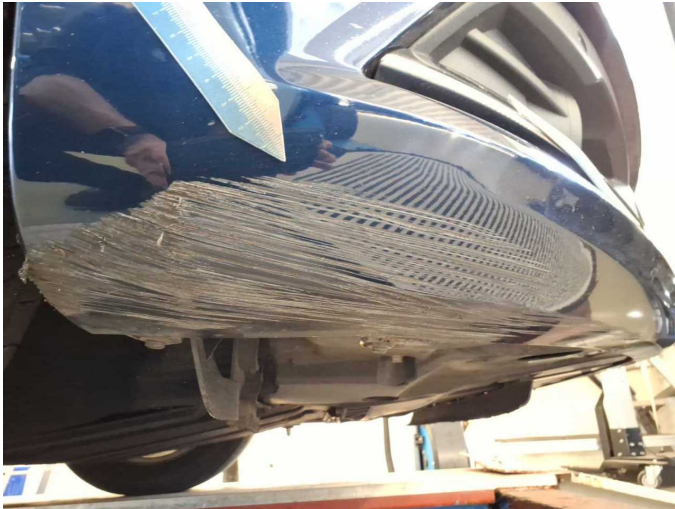
**Damage 11:** Front bumper: Bumper with Parktronic (+ verschürft) - Deformed - Replace

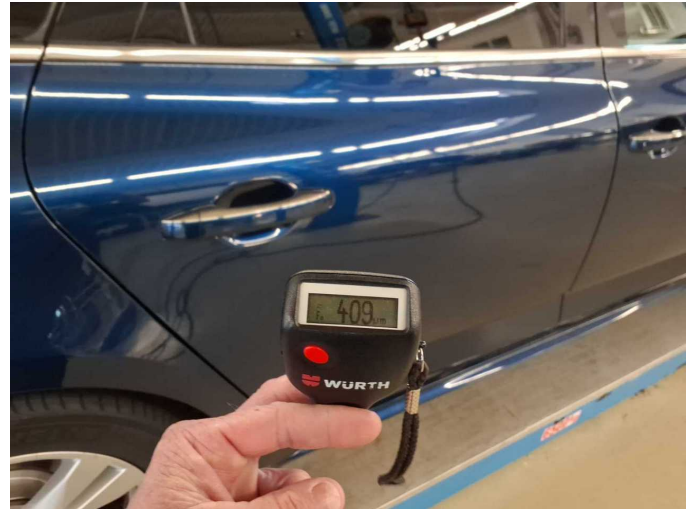
No.	Repainting
1	Door - rear right side, Door - front right side, Unprofessionally carried out

**Door - rear right side:** 409 µm

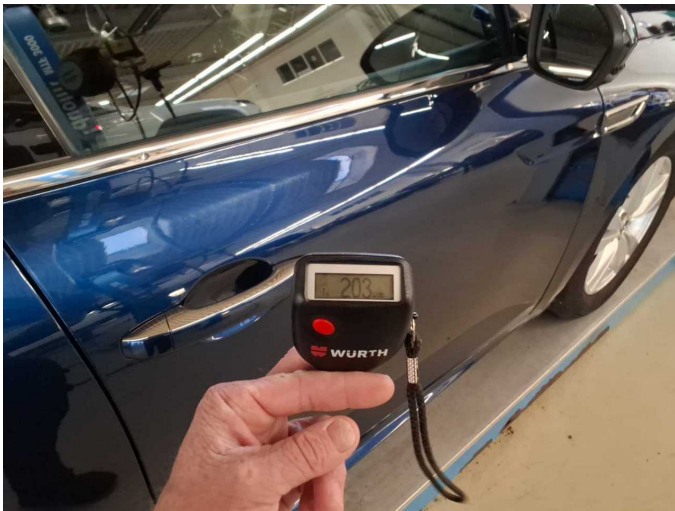
**Door - front right side:** 203 µm
