## status report

**customer:** Bank 11, Neuss  
**contract number:** 807114430  
**reference:**

#### Renault Kadjar Intens

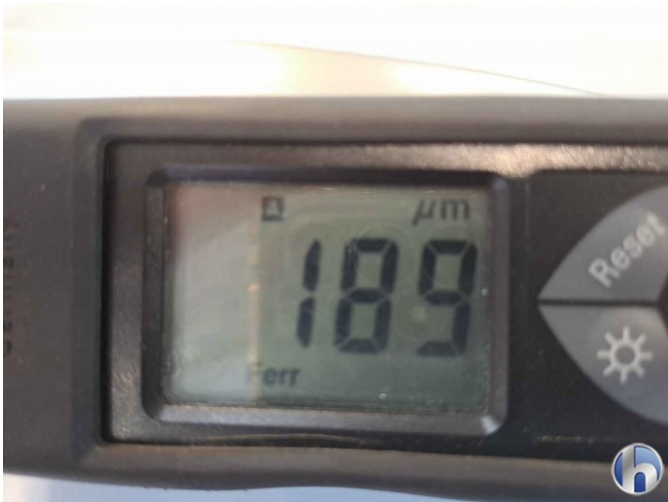
| component | Damage | Rep kind |
|---|---|---|
| 1. Roof frame - left | Subsequently painted | acceptable |

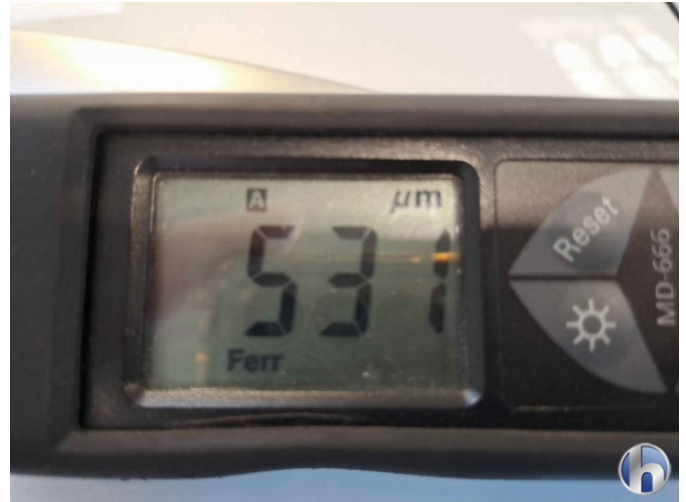
| component | Damage | Rep kind |
|---|---|---|
| 2. Sidewall - Rear - Left | Subsequently painted | acceptable |

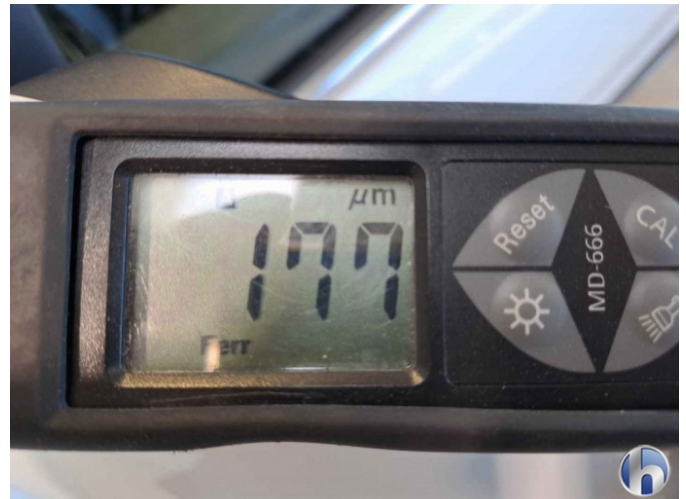
| component | Damage | Rep kind |
|---|---|---|
| 4. A-pillar Front - Left | Subsequently painted | acceptable |

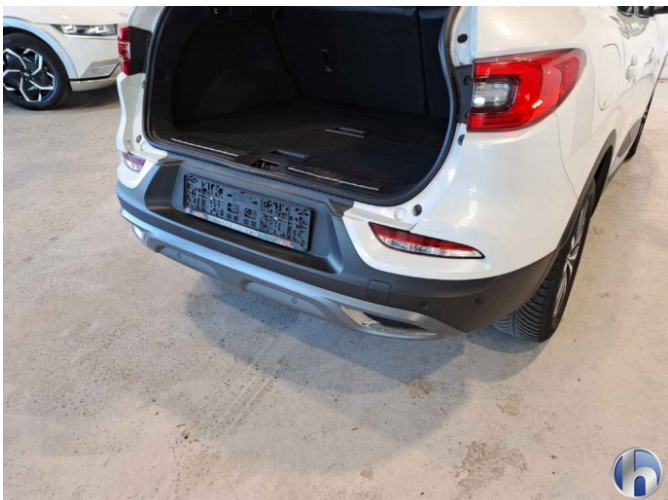
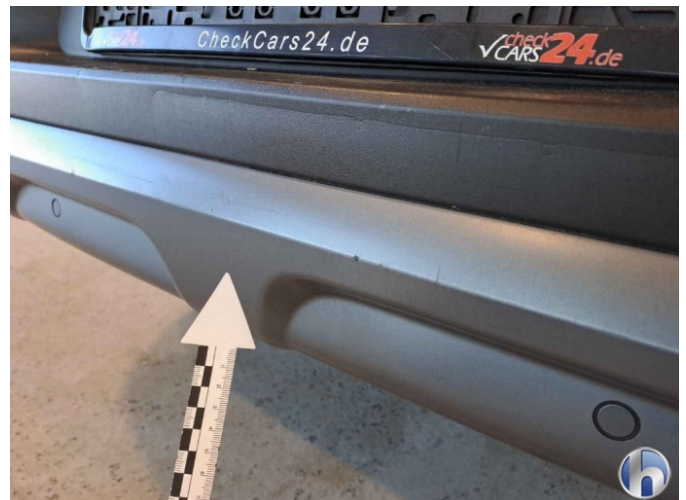
| component | Damage | Rep kind |
|---|---|---|
| 7. Rear bumper | Scrape | Replace |

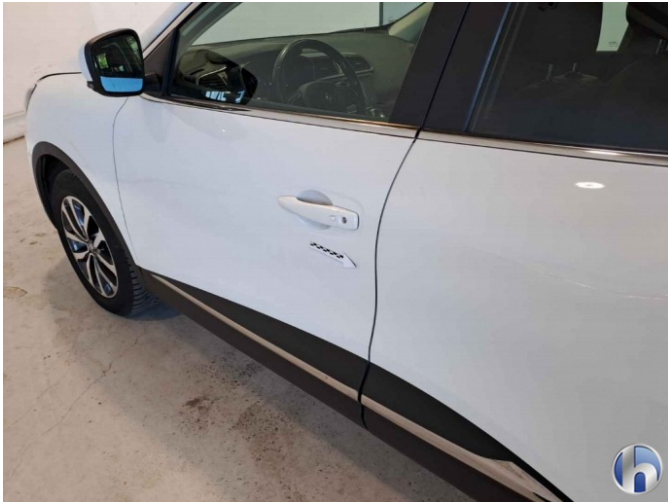
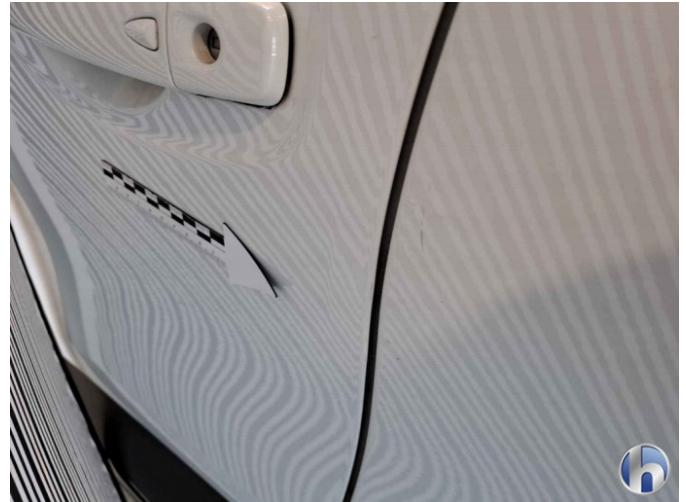
| component | Damage | Rep kind |
|---|---|---|
| 8. Front door - left | Deformed | Refurbish and paint |

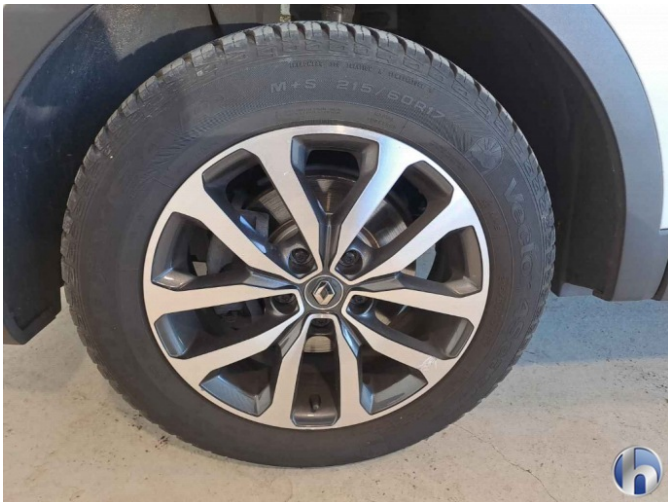
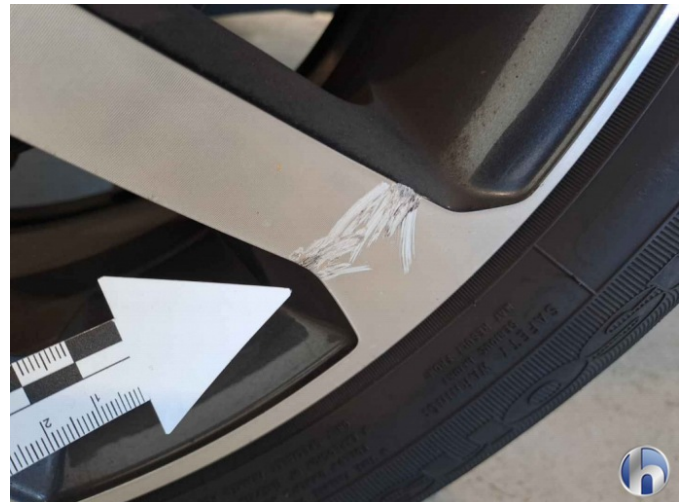
| component | Damage | Rep kind |
|---|---|---|
| 9. Rim front - left | Damaged | Replace |

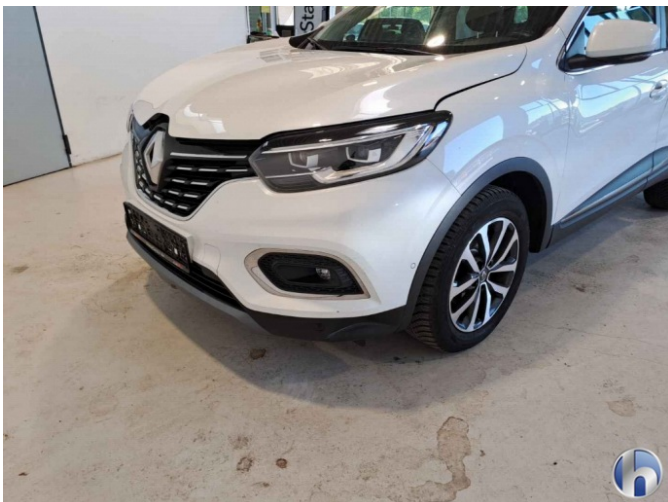
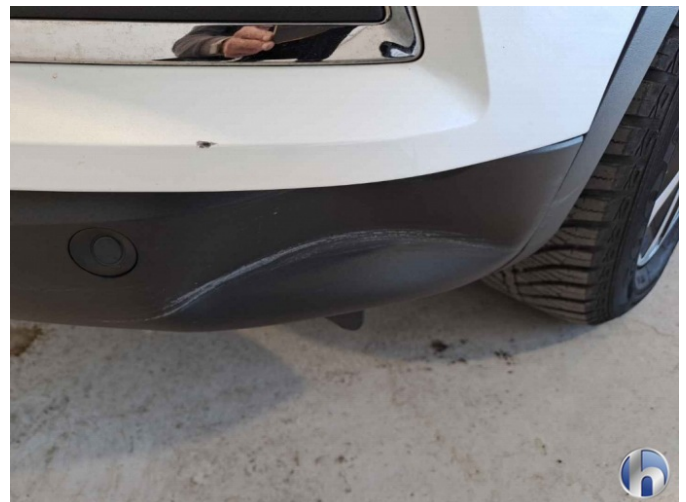
| Performed testing technology | |
|---|---|
| <b>reference:</b> | *Fahrzeug hat Alter und Laufleistungs bedingte Gebrauchsspuren innen und außen Marderbiss<br>Motorraum Unfallschaden Stoßfänger vorne Schaden und Kosten Erweiterung möglich |

| component | Damage | Rep kind |
|---|---|---|
| 10. Front bumper | Accident damage | Replace |

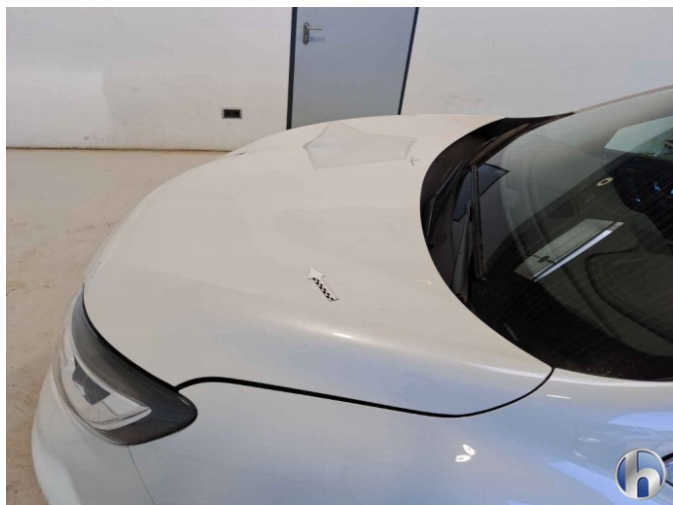
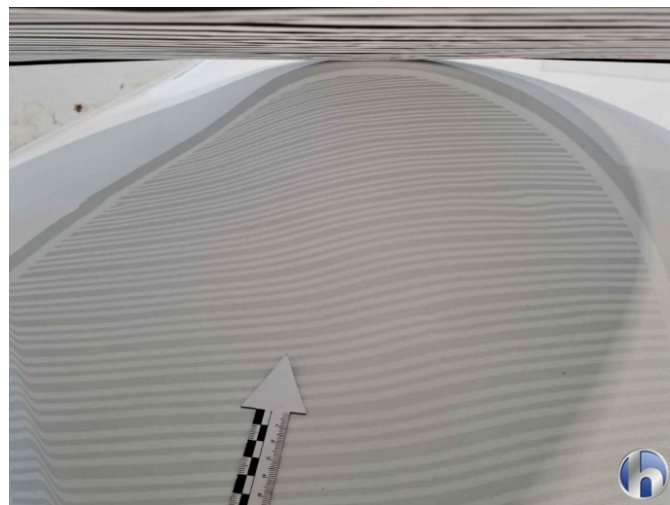
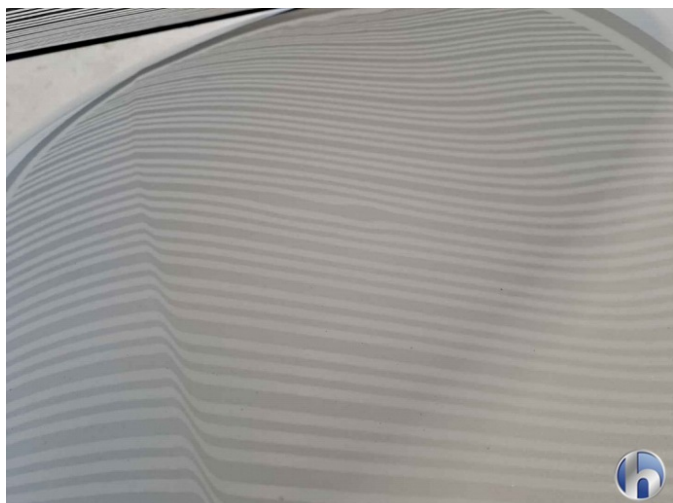
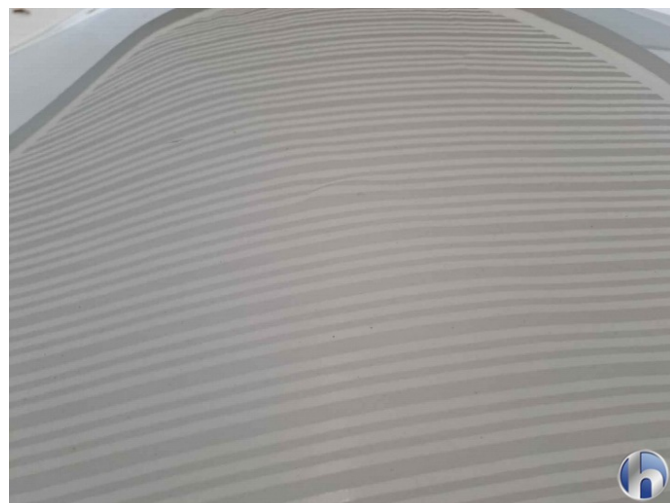
| component | Damage | Rep kind |
|---|---|---|
| 11. hood | Deformed | Refurbish and paint |

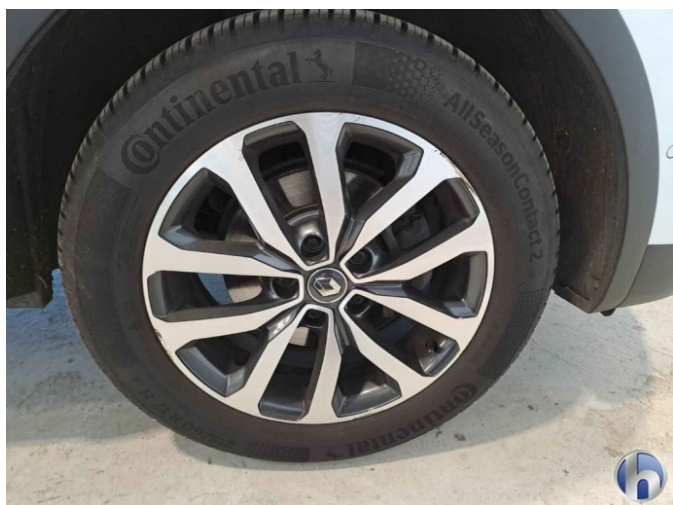
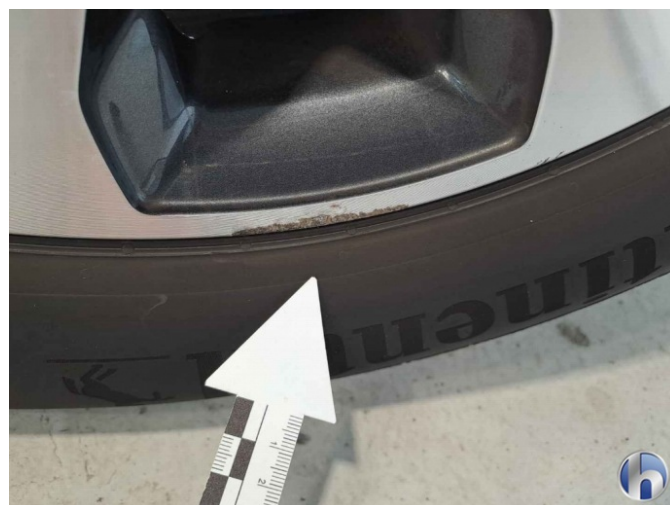
| component | Damage | Rep kind |
|---|---|---|
| 12. Rim front - right | Damaged | Replace |

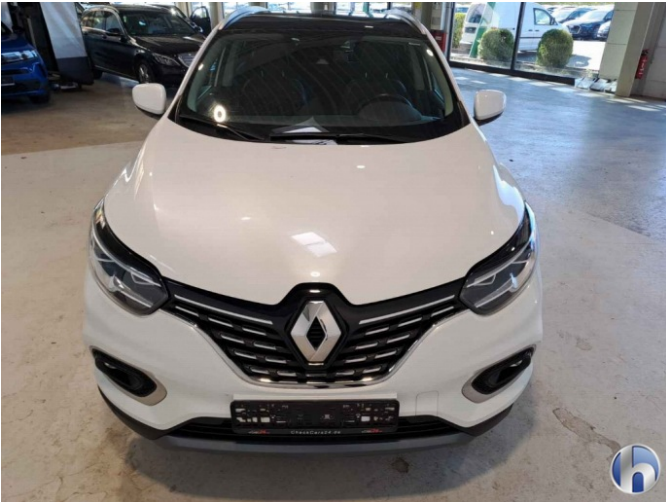
| component | Damage | Rep kind |
|---|---|---|
| 13. exterior body | Surface scratch(es) | |

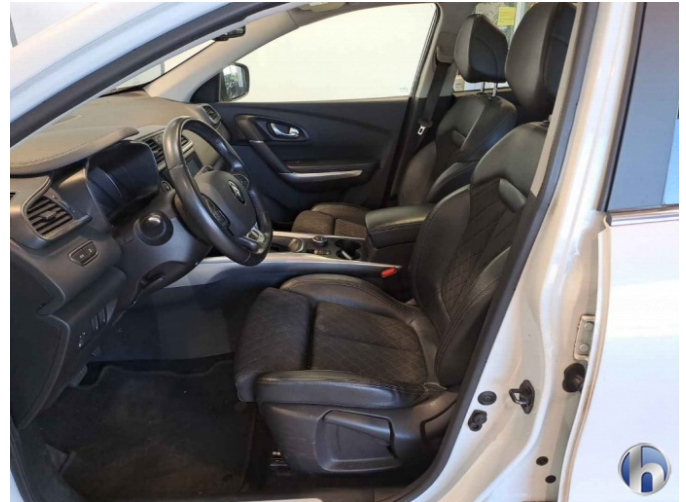
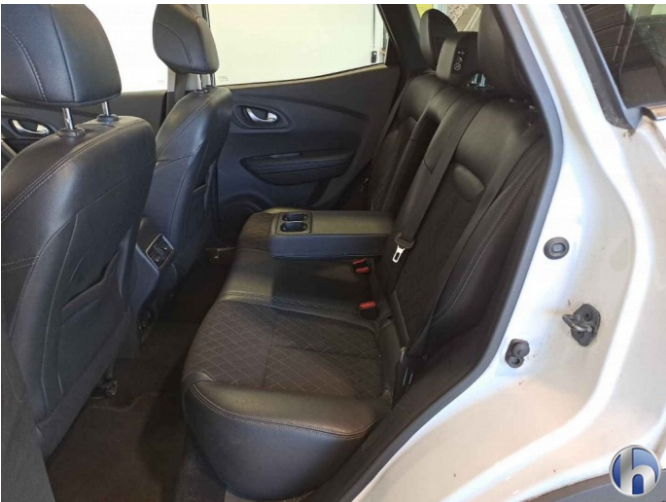
| component | Damage | Rep kind |
|---|---|---|
| 14. | Wear and tear | acceptable |

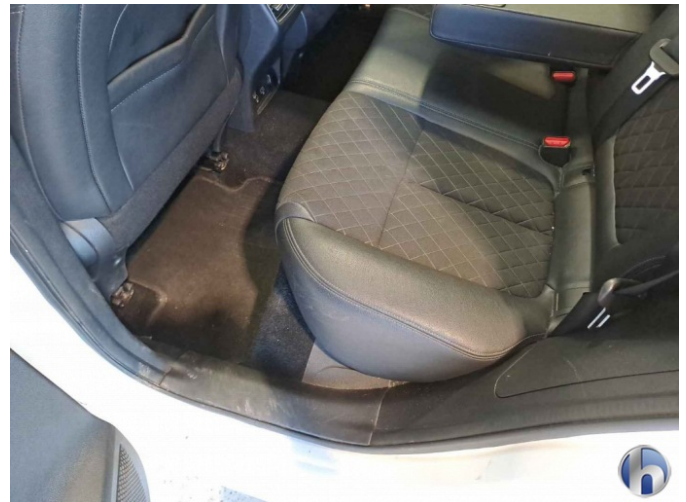
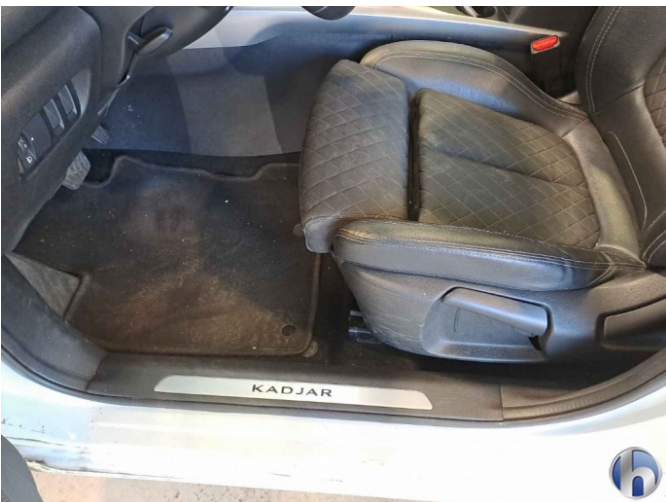
| component | Damage | Rep kind |
|---|---|---|
| 15. | Dirty | |

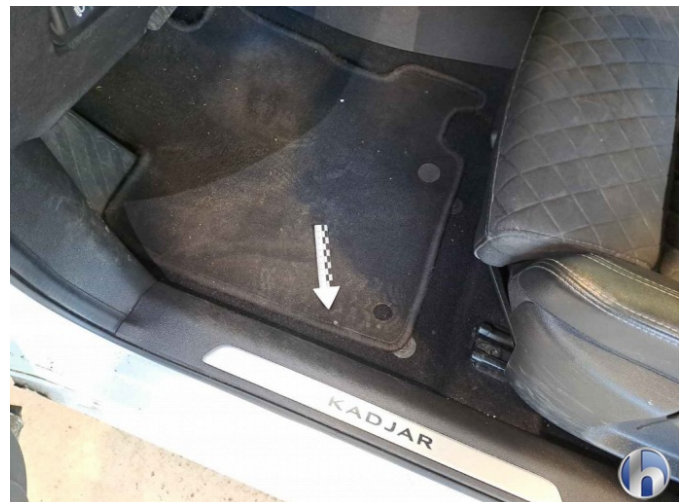
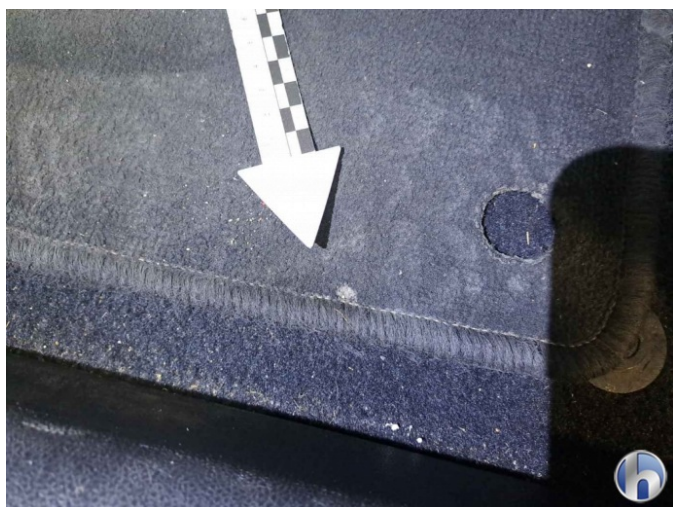
| component | Damage | Rep kind |
|---|---|---|
| 17. | Burn hole | Replace |

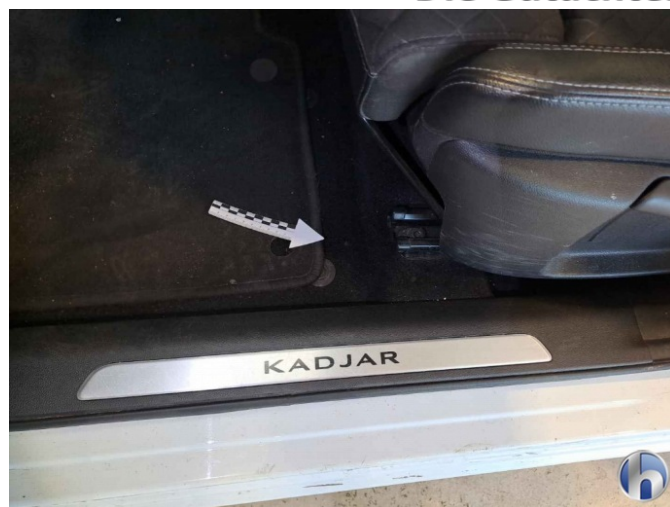
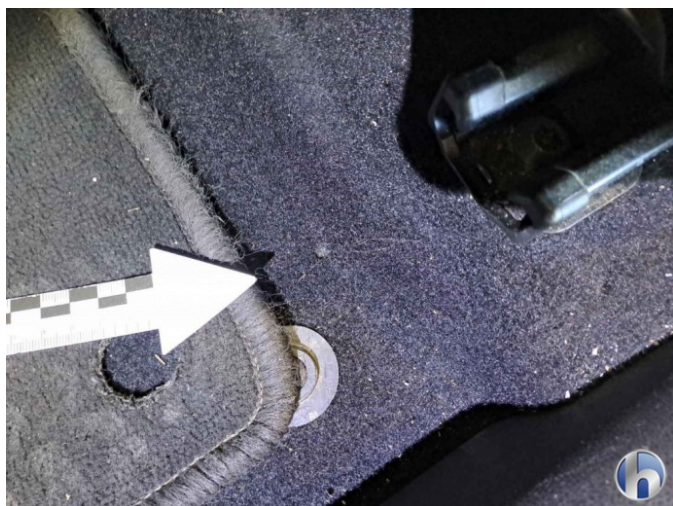
| component | Damage | Rep kind |
|---|---|---|
| 18. flooring | Burn hole | Replace |

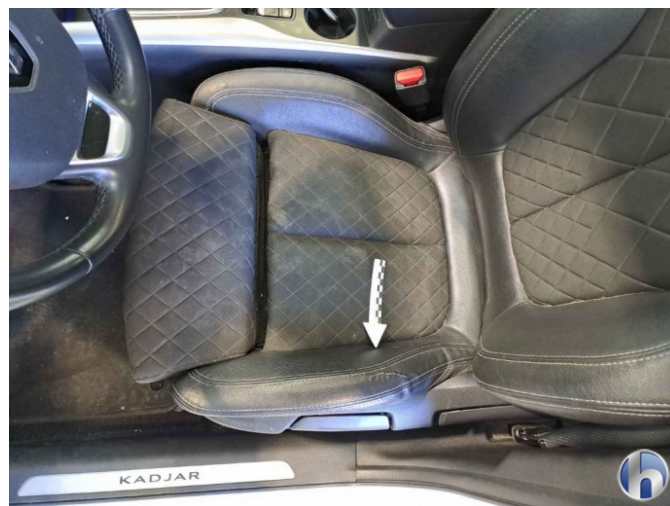
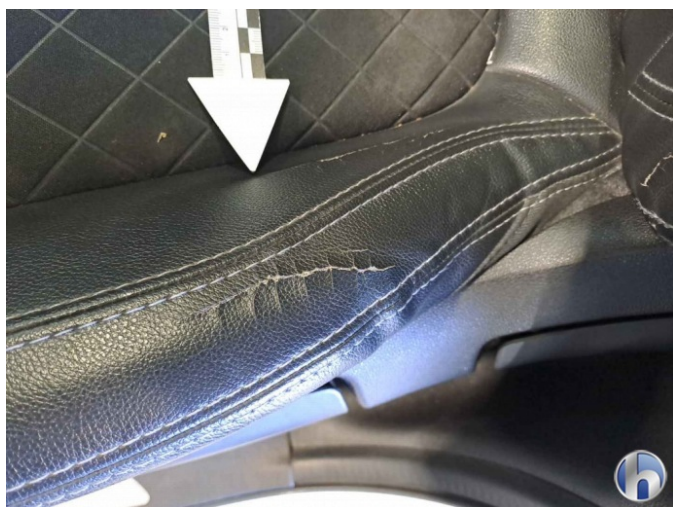
| component | Damage | Rep kind |
|---|---|---|
| 19. | Damaged | Replace |

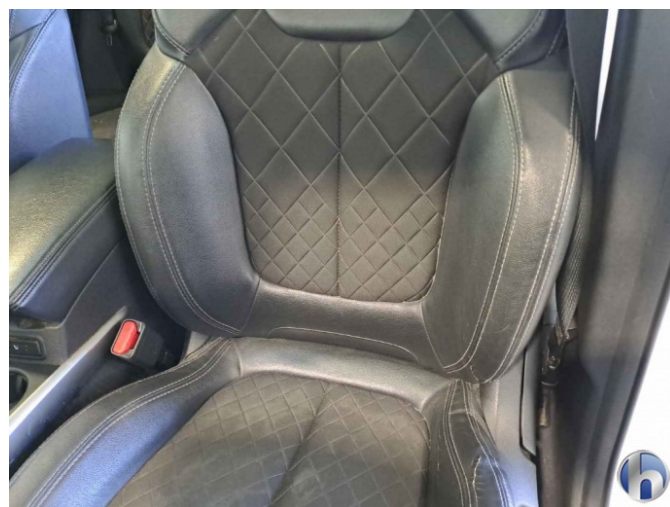
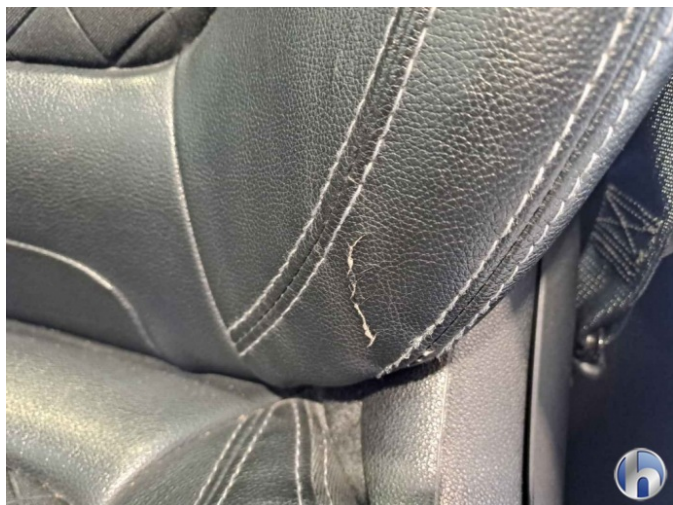
| component | Damage | Rep kind |
|---|---|---|
| 20. | Damaged | Replace |

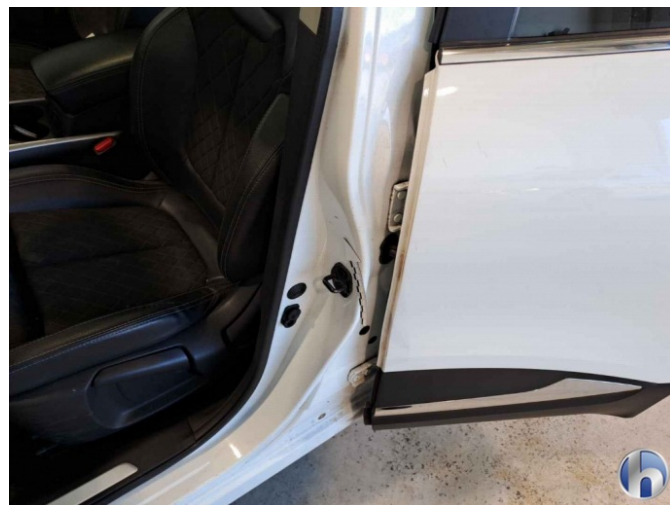
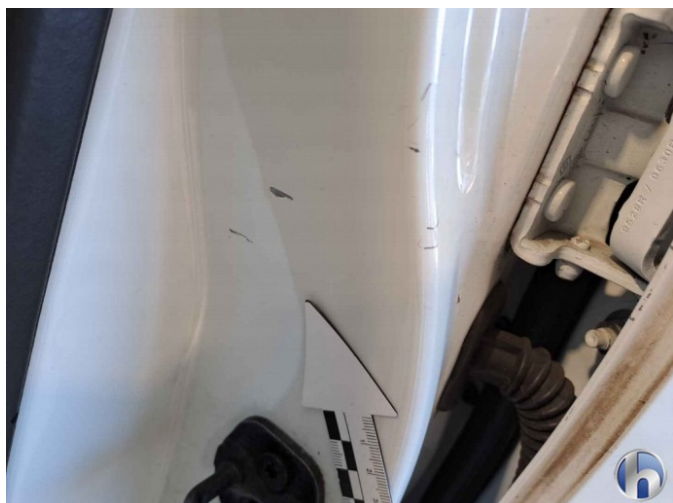
| component | Damage | Rep kind |
|---|---|---|
| 21. Türeinstieg Vorne - Links | Damaged | Smart repair |

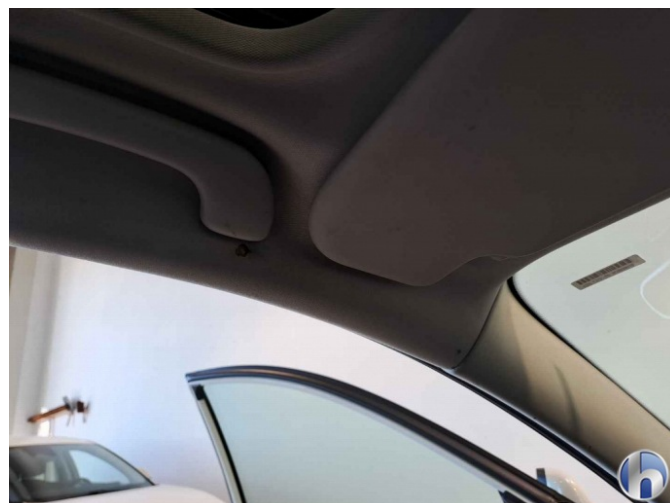
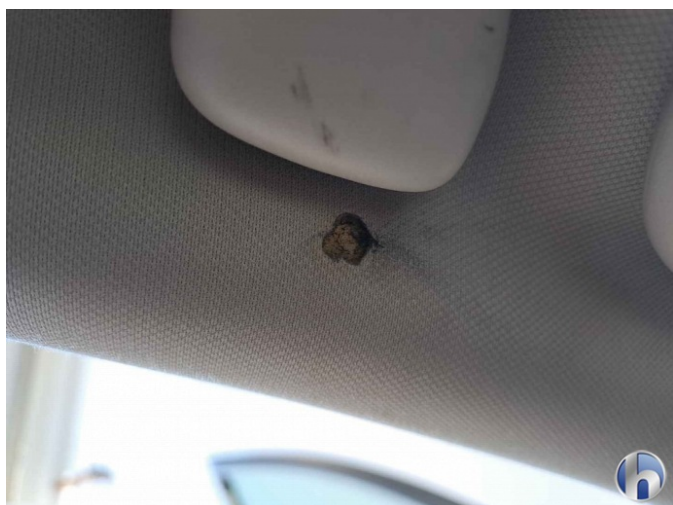
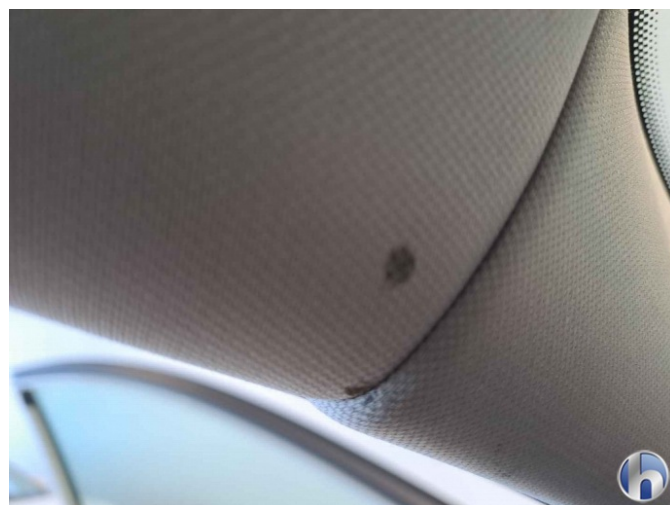
| component | Damage | Rep kind |
|---|---|---|
| 22. headlining | Burn hole | Replace |

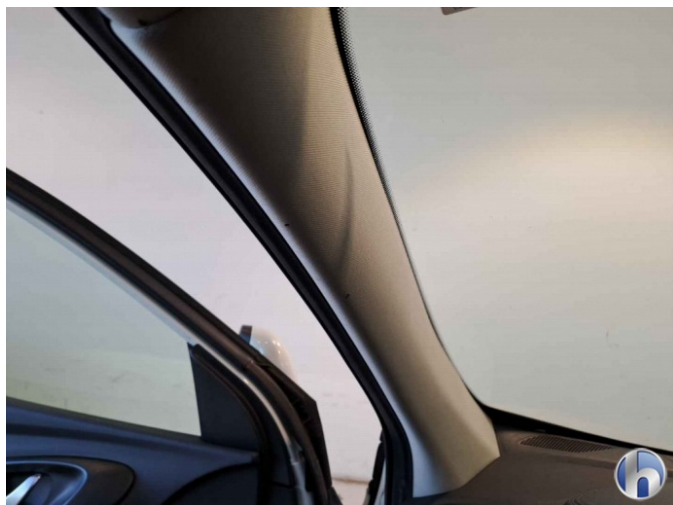
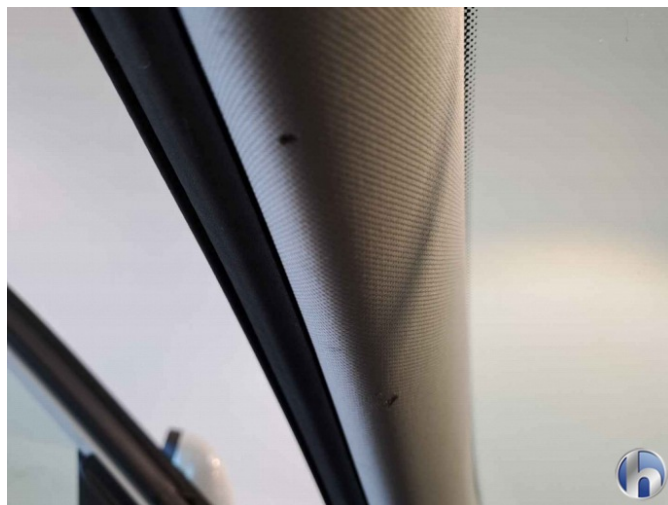
| component | Damage | Rep kind |
|---|---|---|
| 23. Verkleidung A-säule links | Burn hole | Replace |

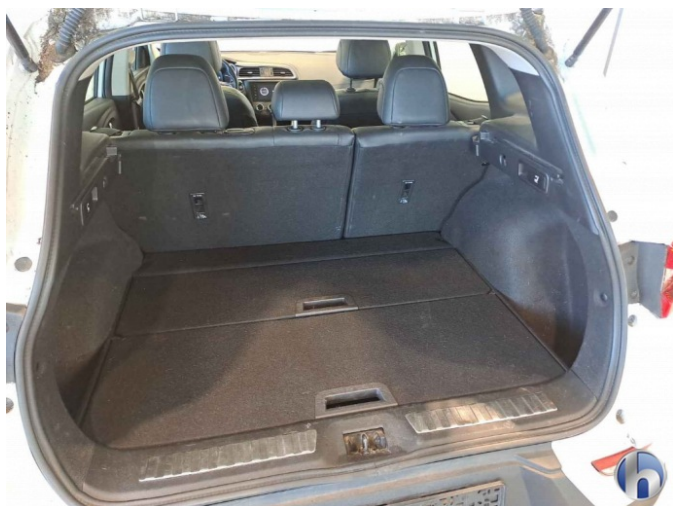
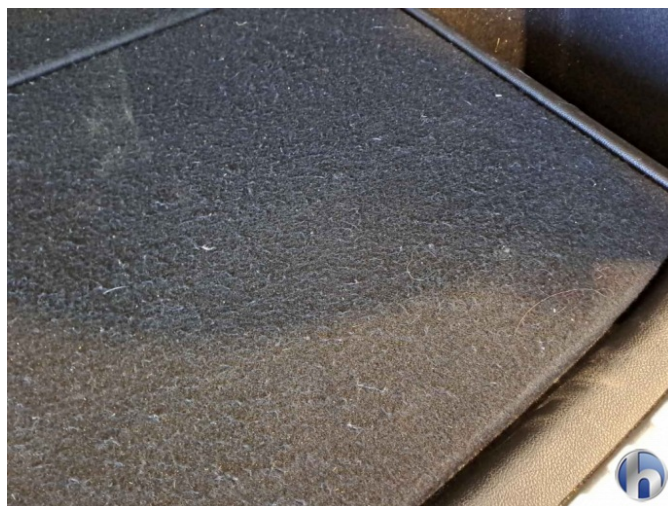
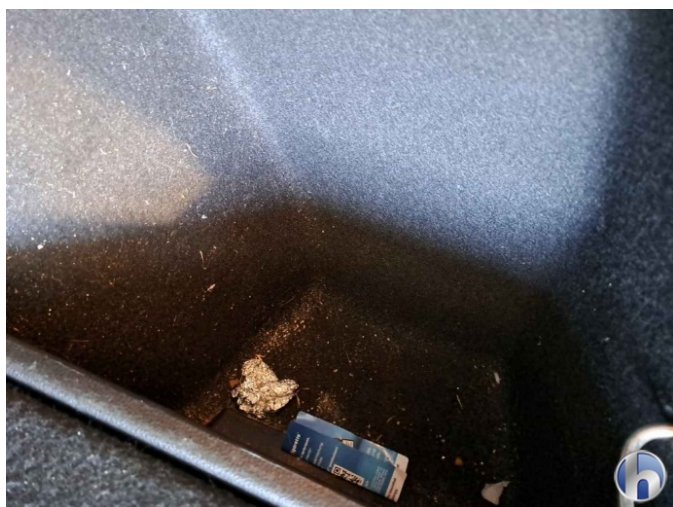
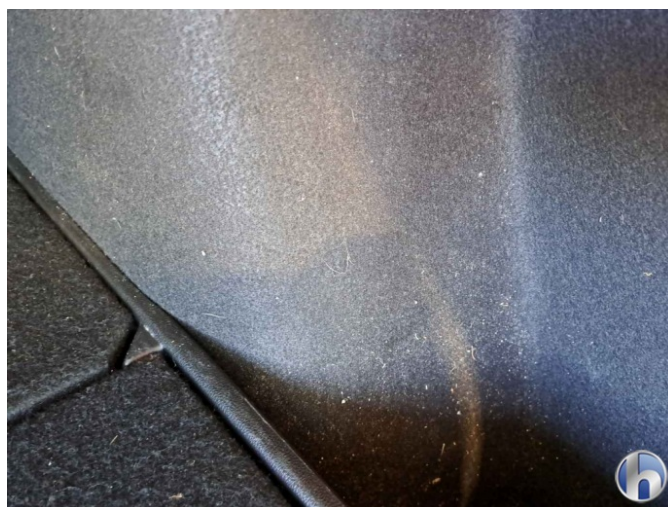
| component | Damage | Rep kind |
|---|---|---|
| 24. | Dirty (animal hair) | |

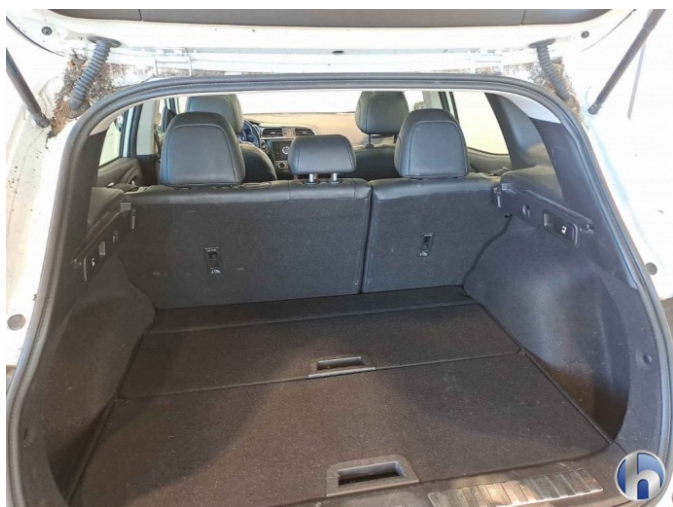
| component | Damage | Rep kind |
|---|---|---|
| 25. Cargo cover | Missing | Replace |

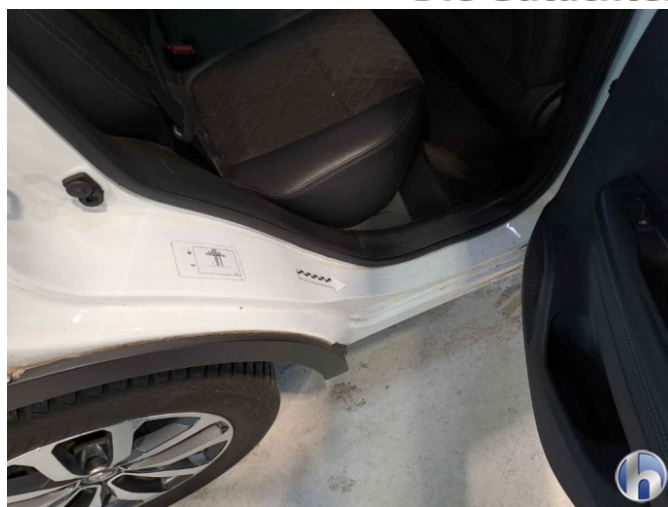
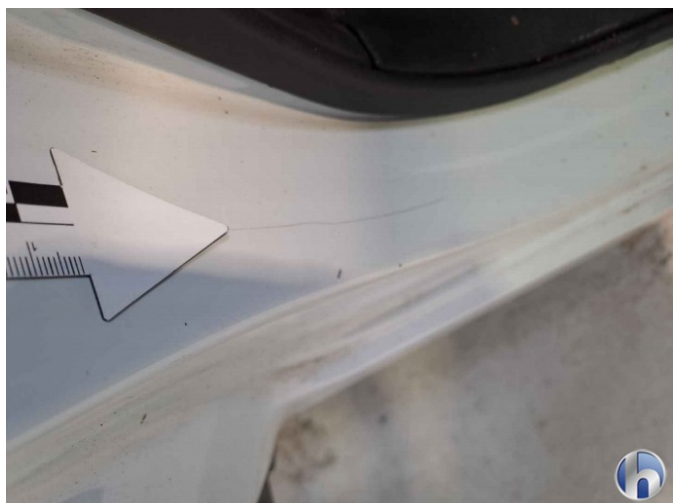
| component | Damage | Rep kind |
|---|---|---|
| 26. Türeinstieg Hinten - Rechts | Scratch(es) | Smart repair |

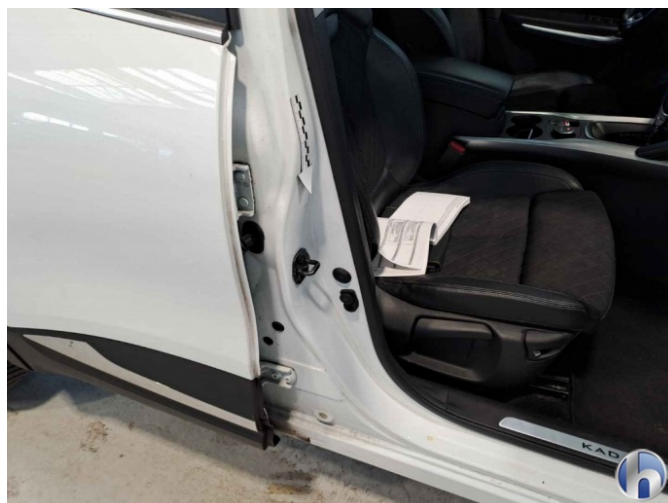
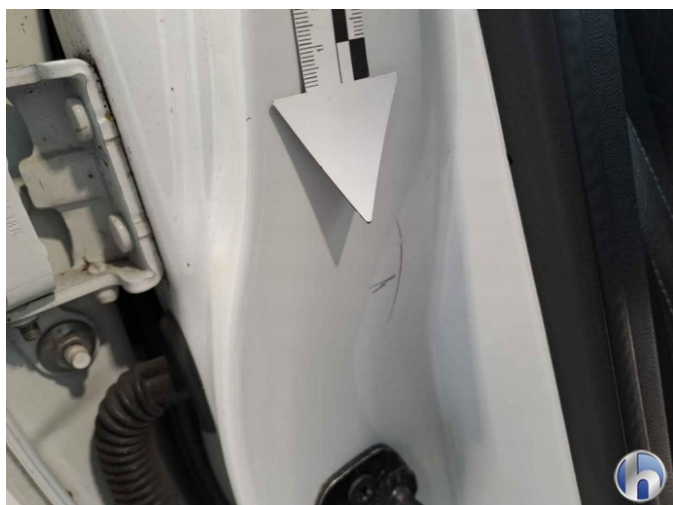
| component | Damage | Rep kind |
|---|---|---|
| 27. Türeinstieg Vorne - Rechts | Damaged | Smart repair |

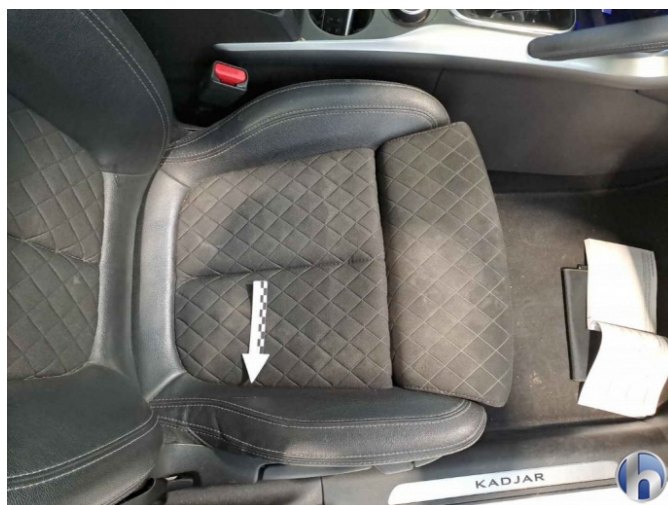
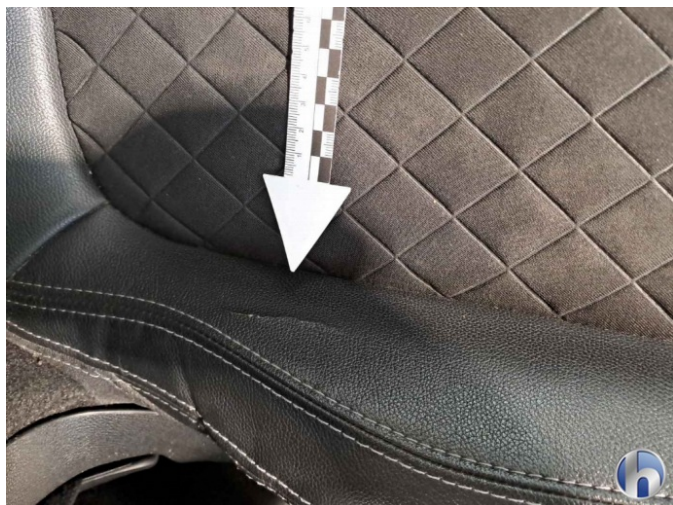
| component | Damage | Rep kind |
|---|---|---|
| 28. | Damaged | Replace |

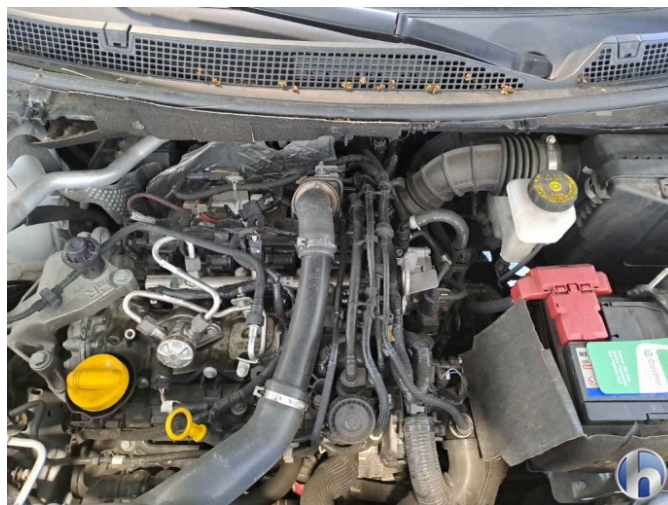
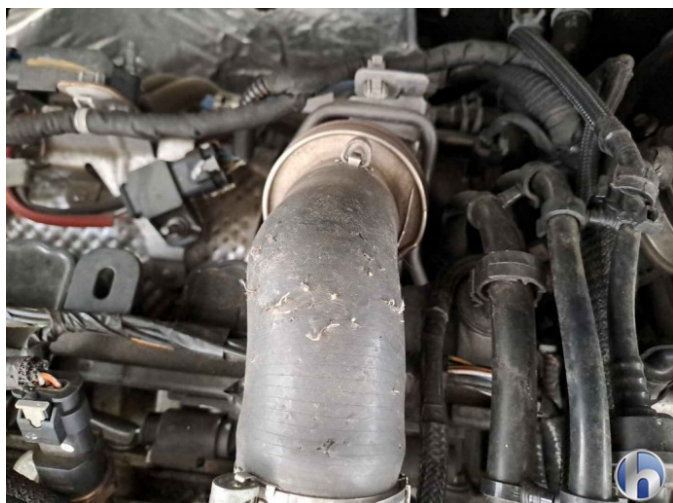
| component | Damage | Rep kind |
|---|---|---|
| 29. Ladeluftschlauch | | Replace |

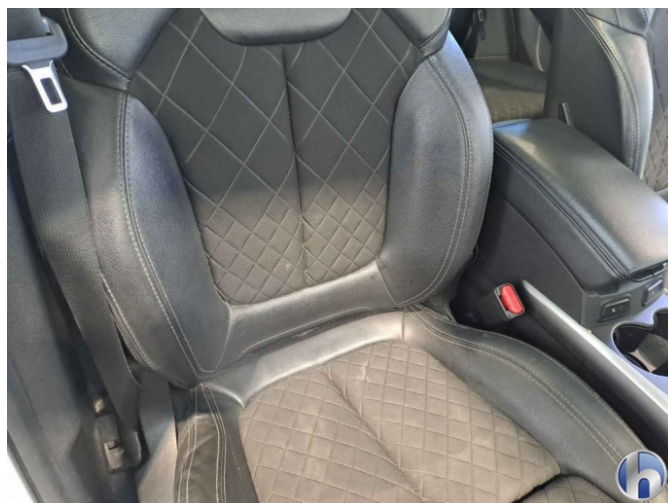
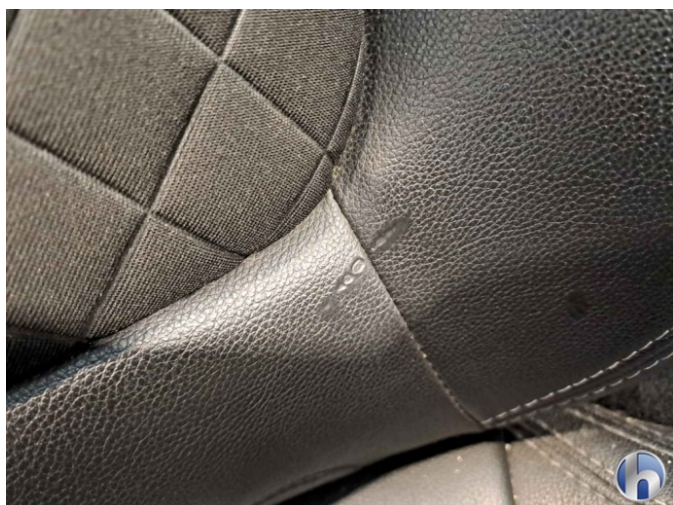
| component | Damage | Rep kind |
|---|---|---|
| 30. | Damaged | Replace |
