Expertise

Protocol number: 41595676  
Order No. / Reference: 25240834  
Inspection date: 18 Sept 2025

Manufacturer: Renault

Model: Clio TCe 90 BUSINESS EDITION

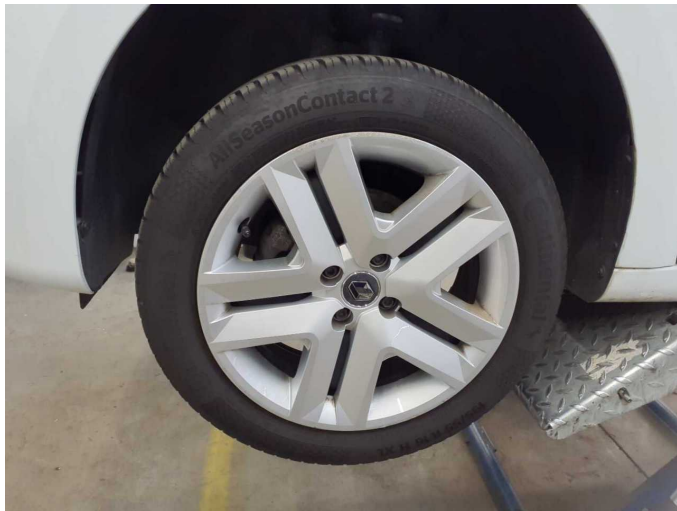
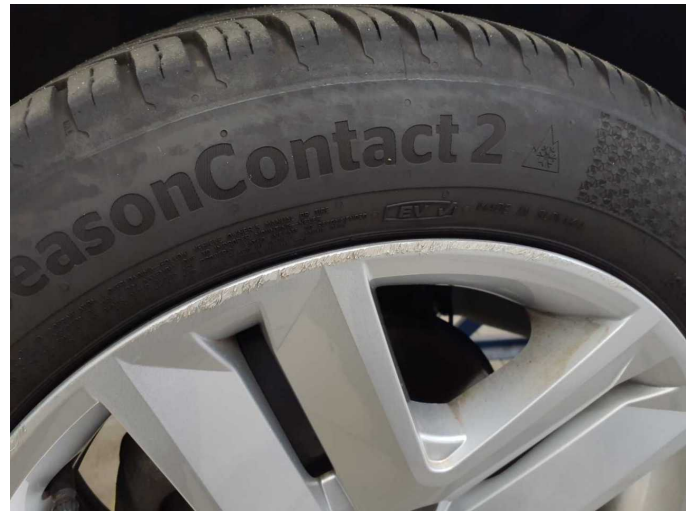
No.	Component group	Description
1	Wheel / tyres	Wheel cover - front left side - Scratched - Replace
2	Bonnet	Bonnet (Seilzug ohne Funktion) - Sub-function - Diagnosed and repair if necessary

**Damage 1:** Wheel / tyres: Wheel cover - front left side - Scratched - Replace

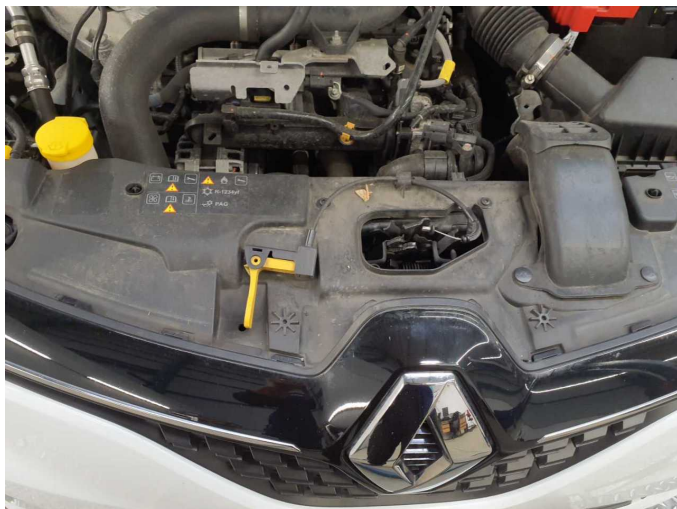
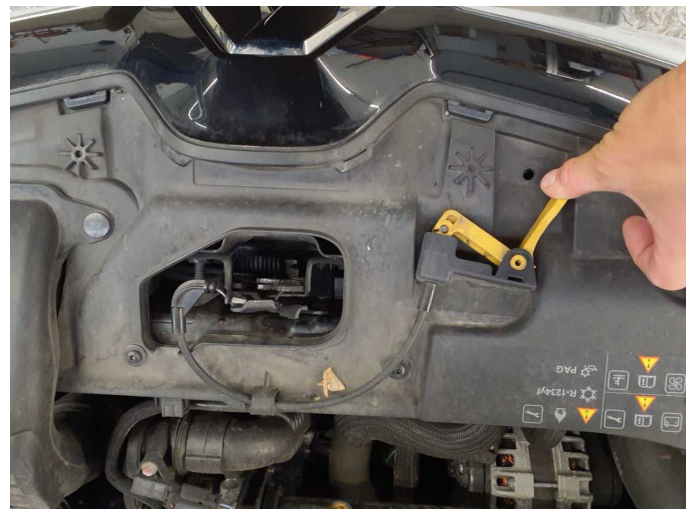
**Damage 2:** Bonnet: Bonnet (Seilzug ohne Funktion) - Sub-function - Diagnosed and repair if necessary
