Expertise

Protocol number: 41850648
Order number / reference: 25262023
Inspection date: 7 Oct 2025

Manufacturer: Renault	Model: Clio TCe 90 BUSINESS EDITION
VIN: VF1RJA00268828232

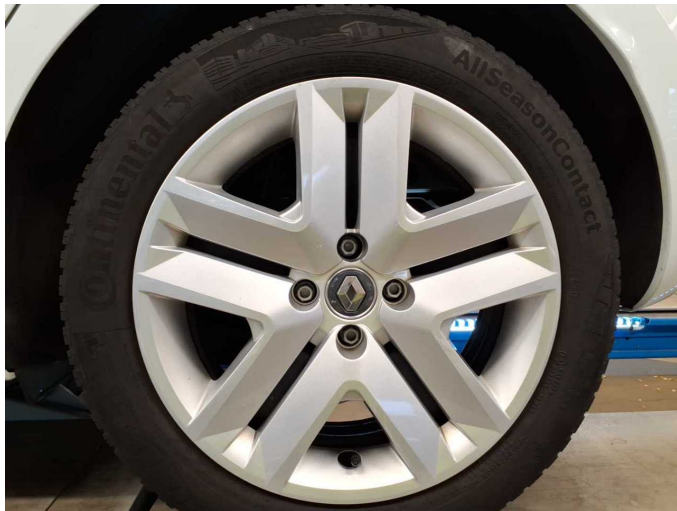
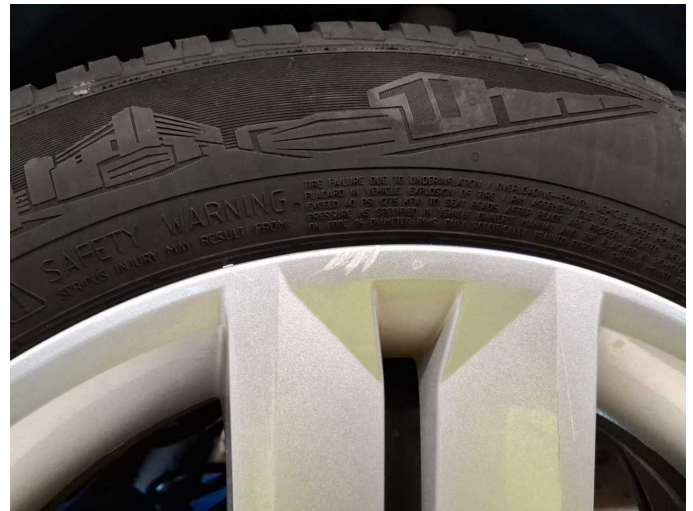
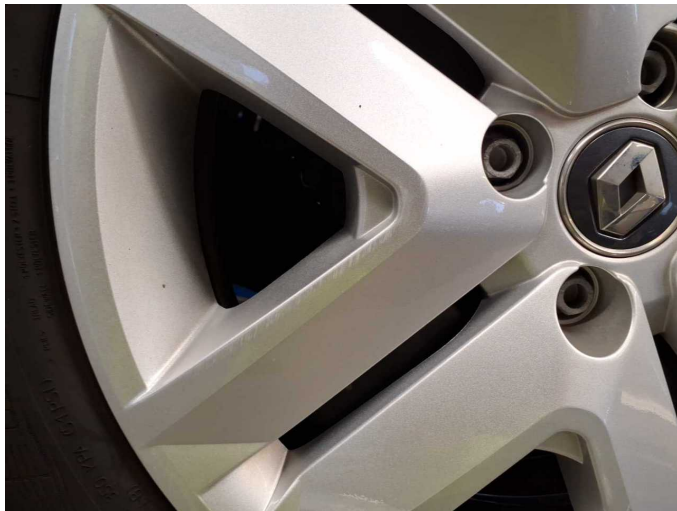
Damage 1: Wheel / tyres: Wheel cover - rear left side - Scratch(es) - Loss in value

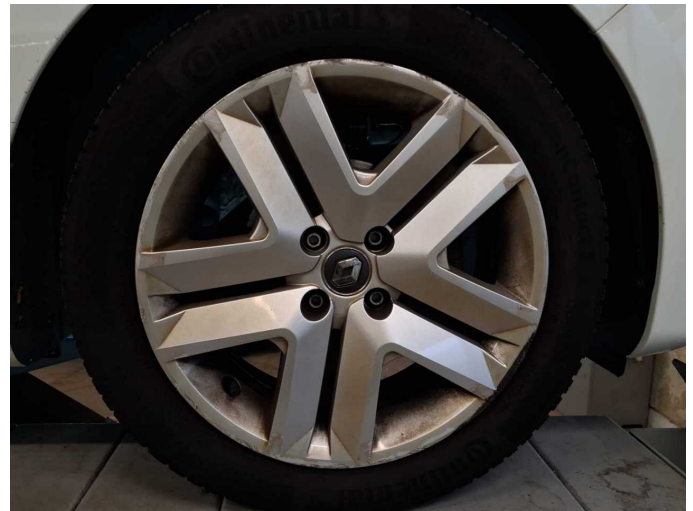
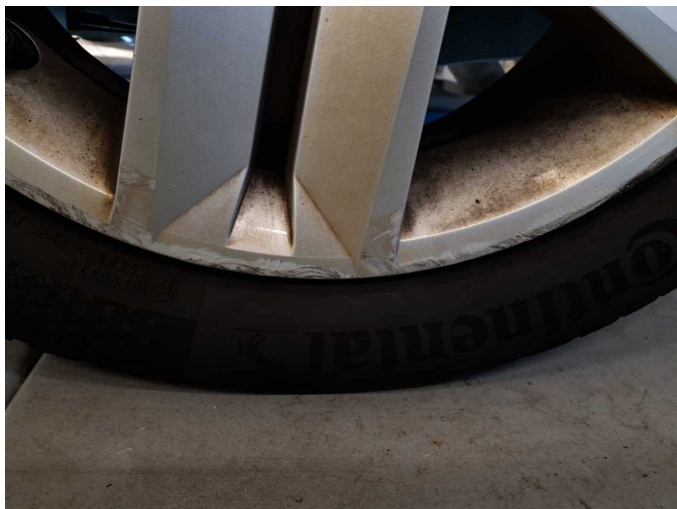
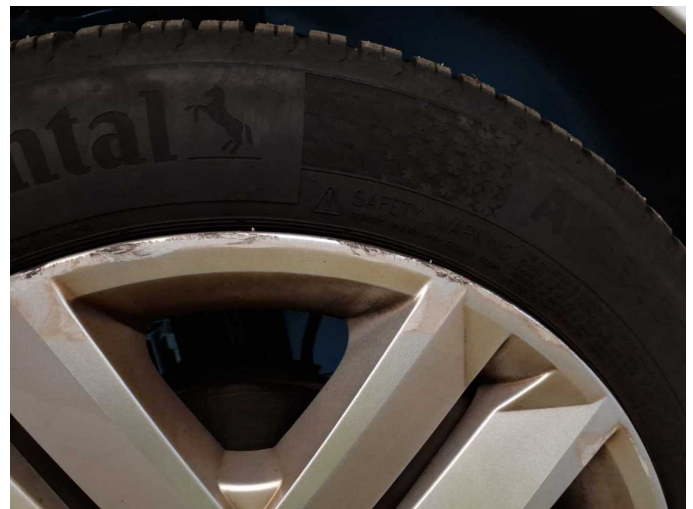
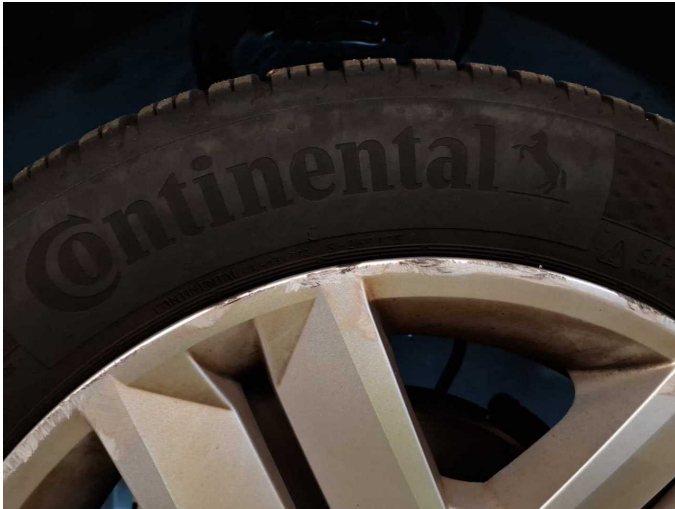
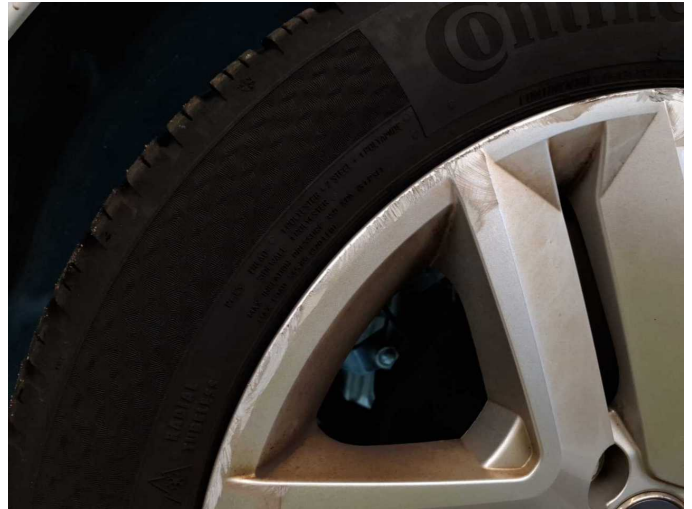
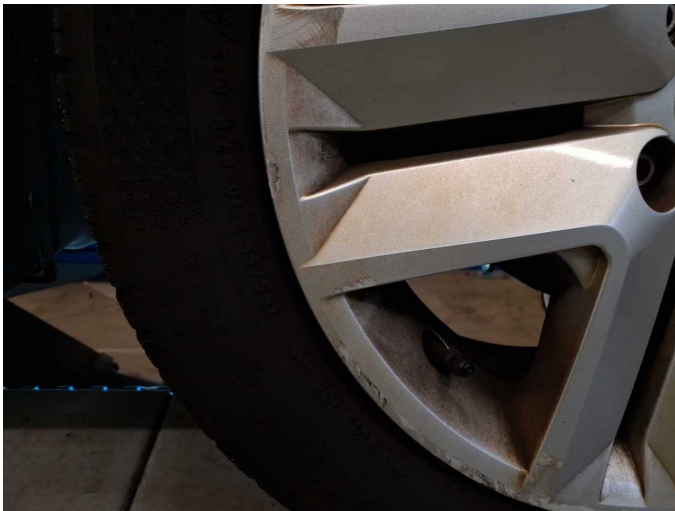
Damage 2: Wheel / tyres: Wheel cover - front right side - Scratch(es) - Replace

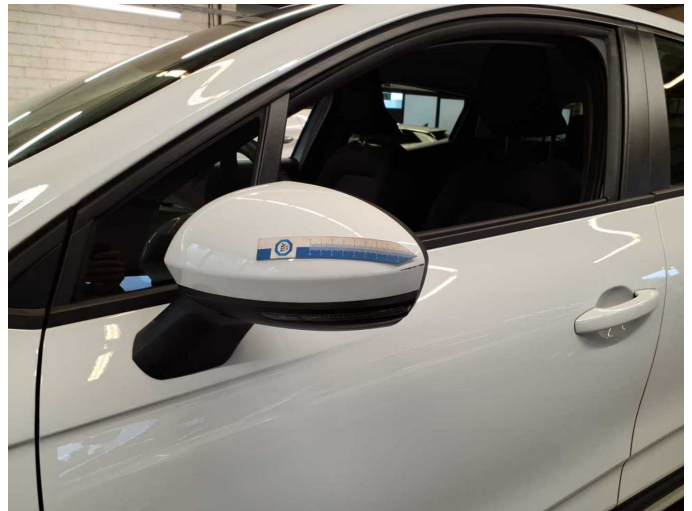
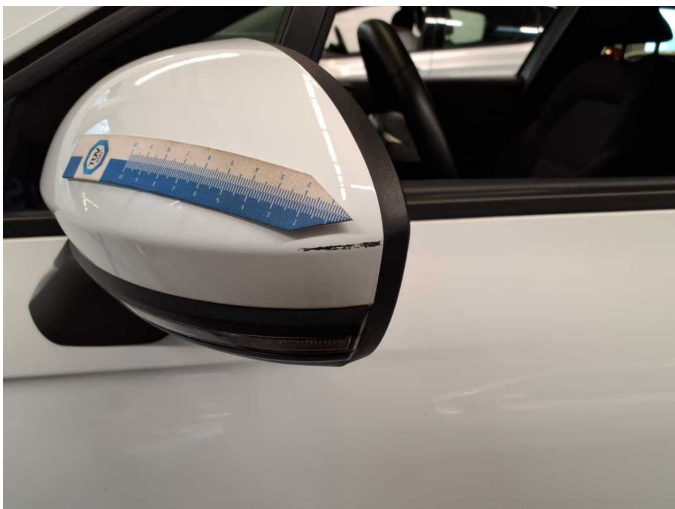
Damage 3: Wing mirror - left side: Cap - Scratch(es) - Smart repair

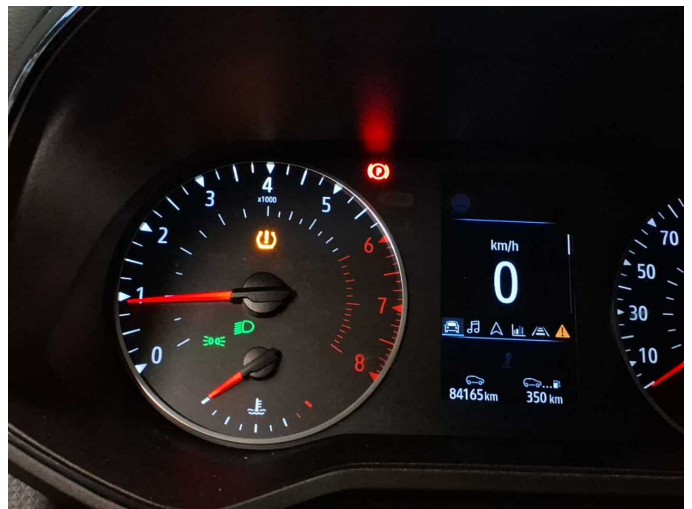
Damage 4: Wheel / tyres: Pressure sensor - on - Perform diagnosis

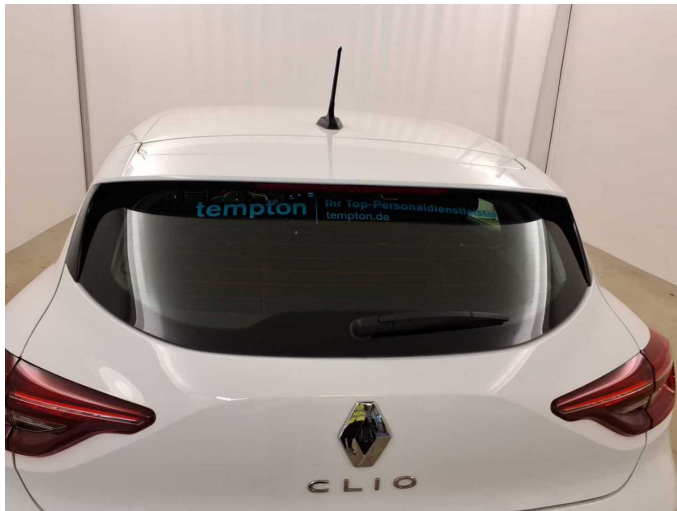
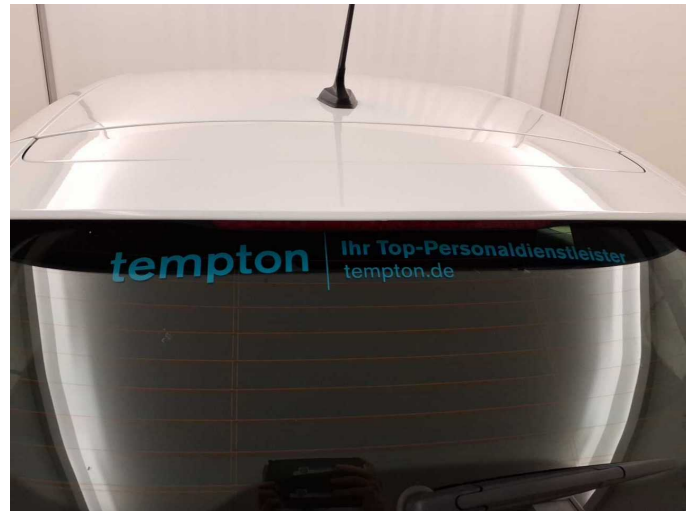
Damage 5: Boot lid / rear door: Boot lid - Glued / labelled - De-glue / neutralise

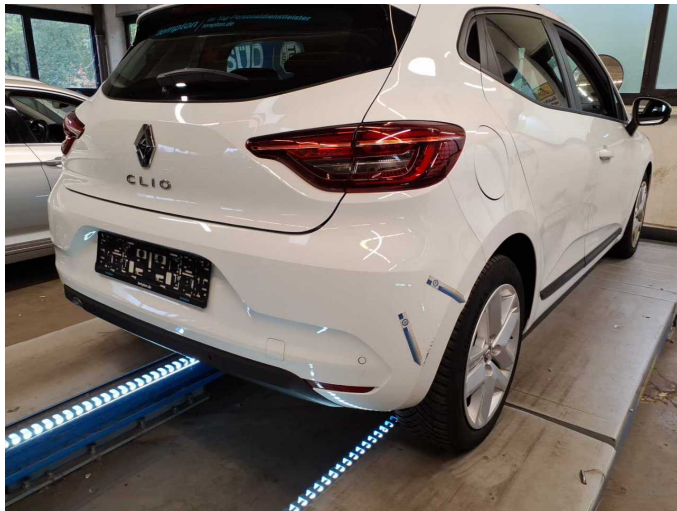
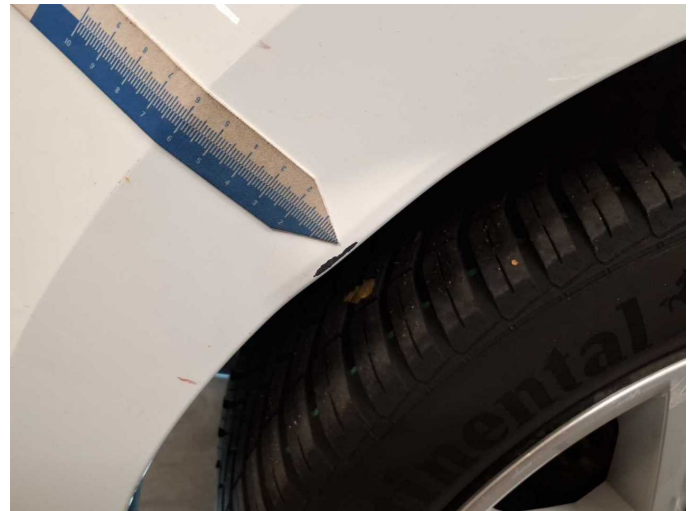
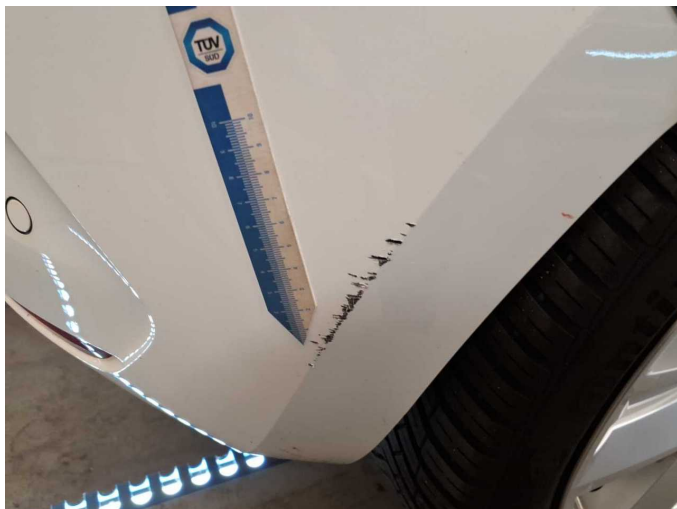
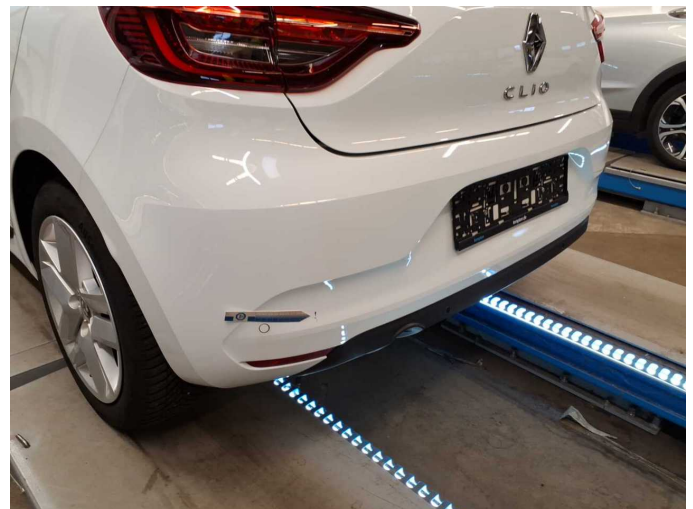
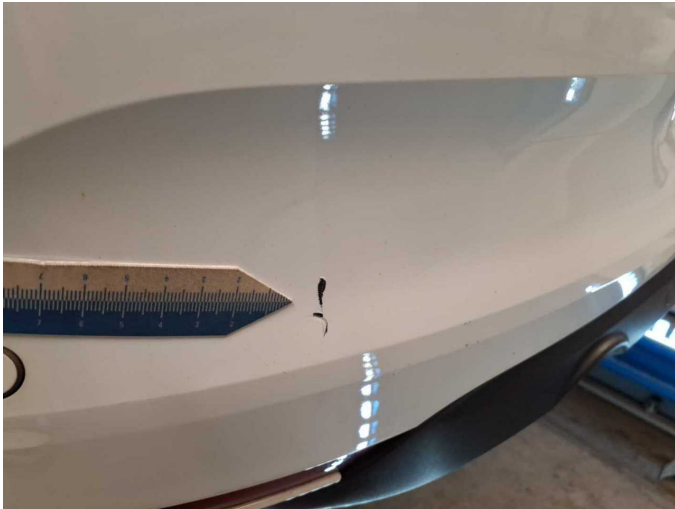
Damage 6: Rear bumper: Rear bumper - Scratch(es) - Paint

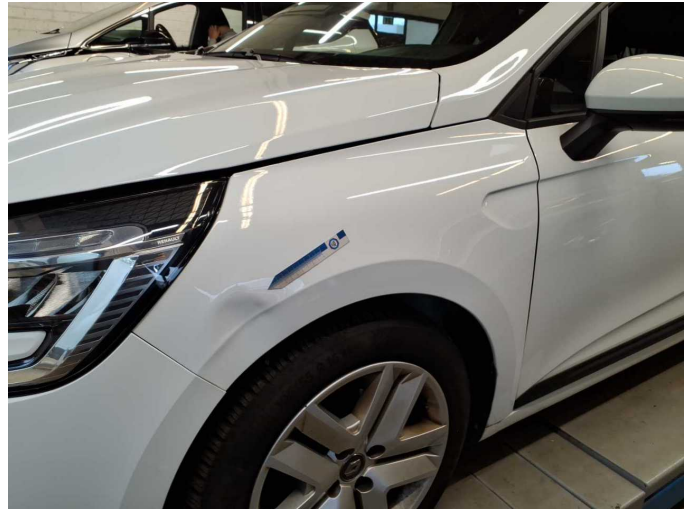
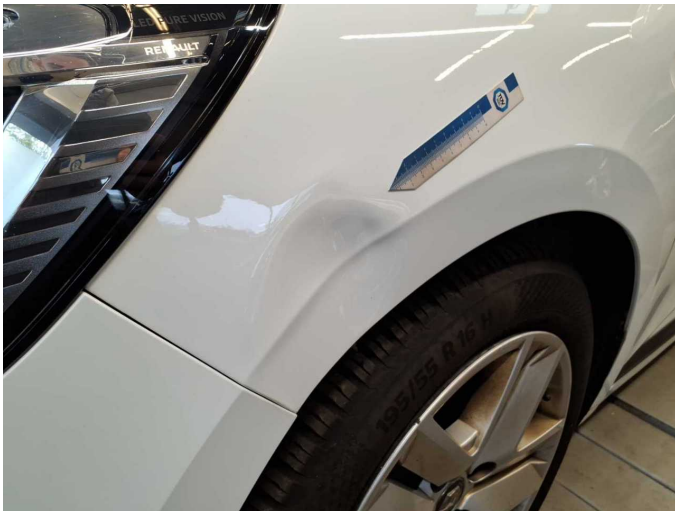
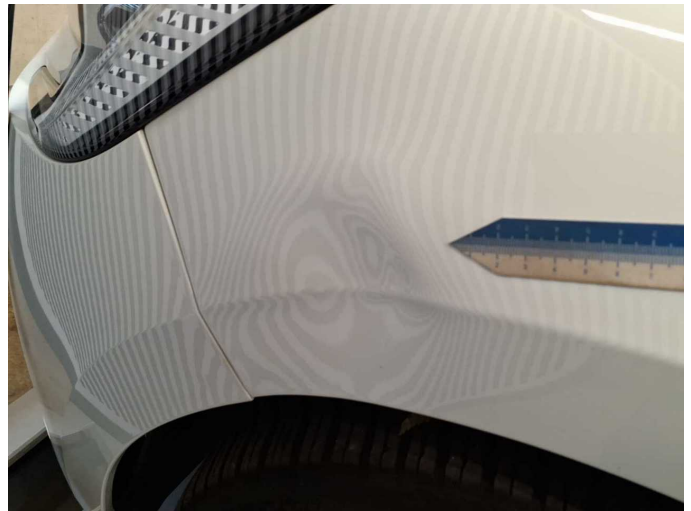
Damage 7: Mudguard - left side: Mudguard - left side - Deformed - Repair and paint

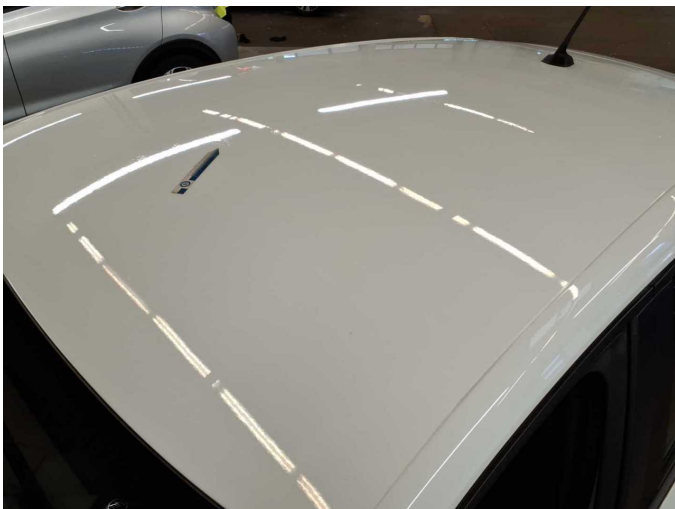
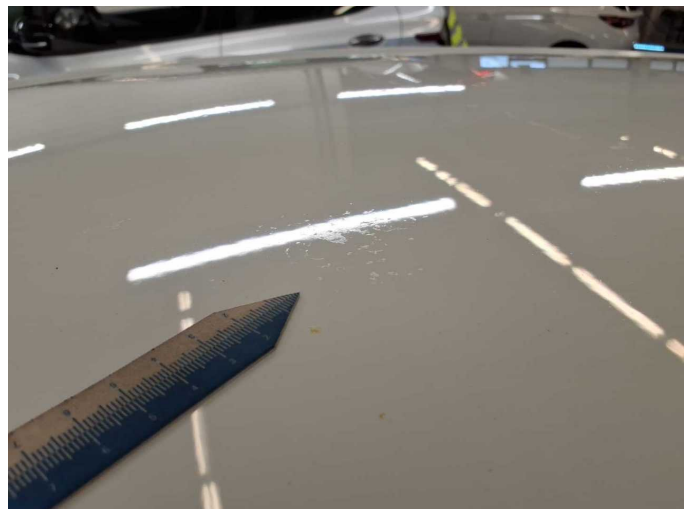
Damage 8: Roof: Roof (Vogelkotverätzung) - Paint defect - Paint

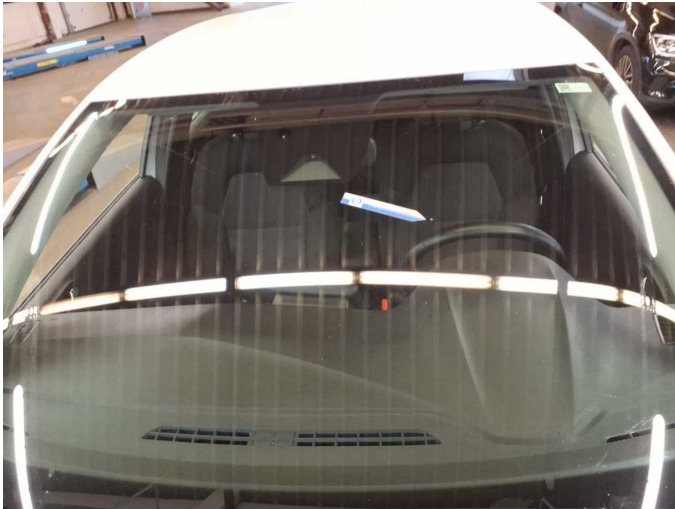
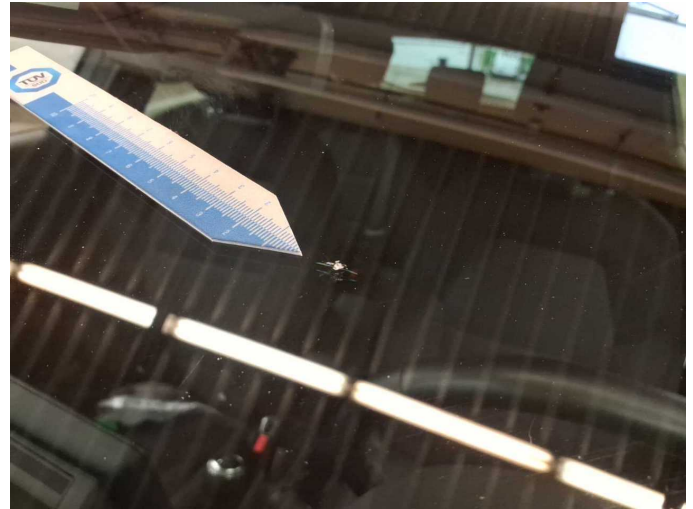
Damage 9: Vehicle glazing: Windscreen (Im Sichtfeld) - Stone chips - Replace

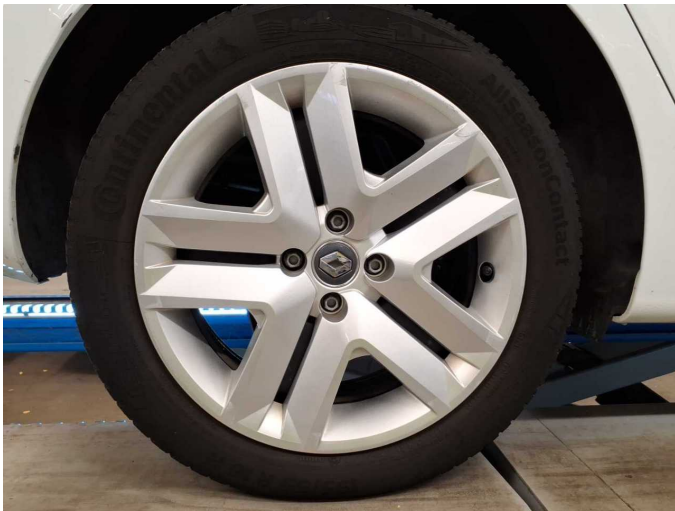
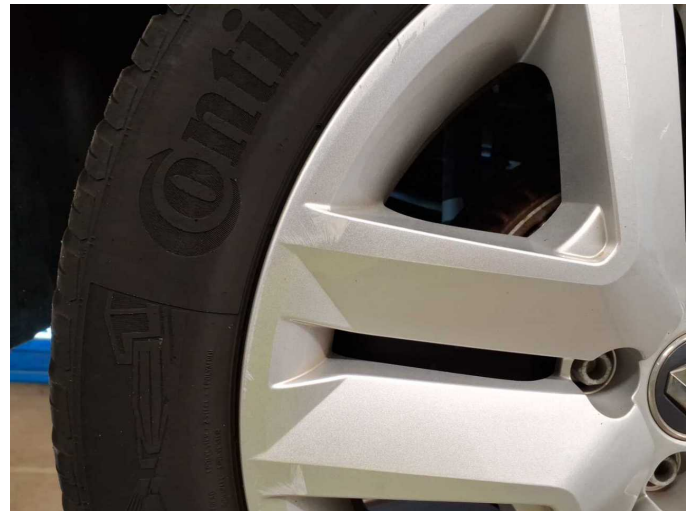
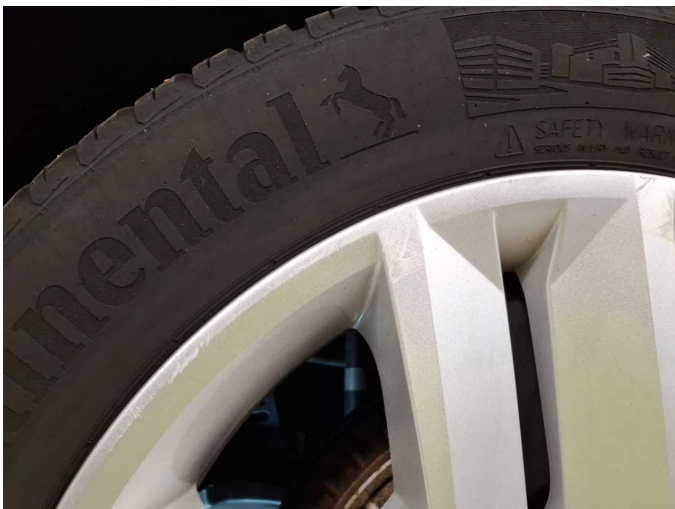
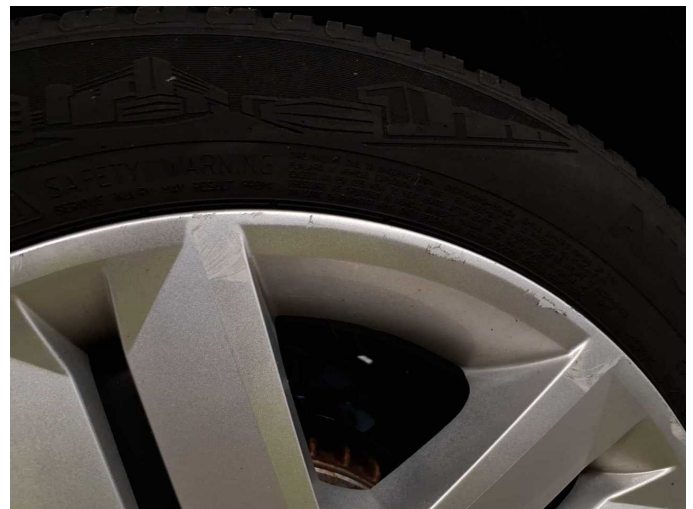
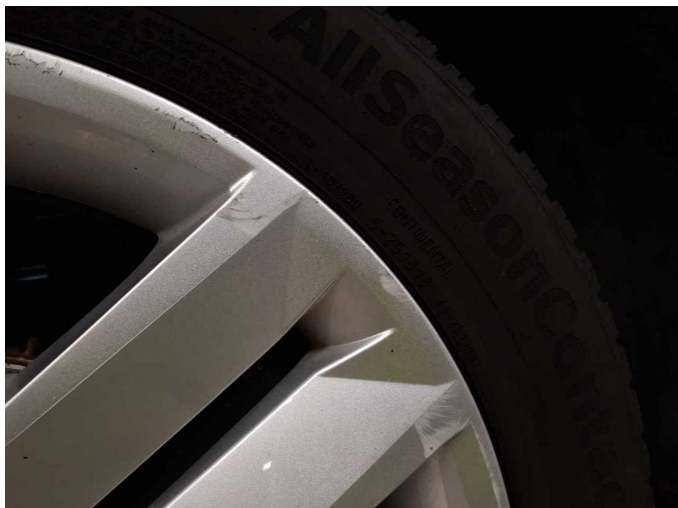
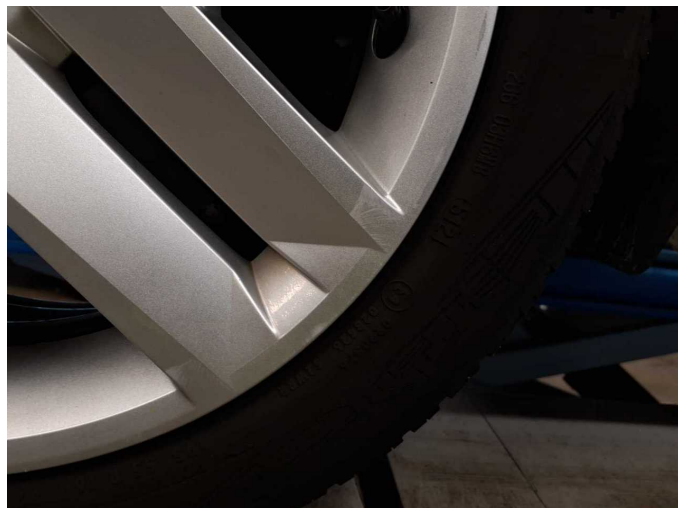
Wear and tear 6: Wheel / tyres: Wheel cover - rear right side - Scratch(es) - No deduction

Wear and tear 6: Wheel / tyres: Wheel cover - rear right side -
Scratch(es) - No deduction
