RENAULT CLIO  
Clio E-Tech full hybrid 145 GSR2 Techno

VIN NO VF1RJA00474678522  
Registration Number HC965ZM

Inspection Report Summary

Customer	BCAuto Encheres	Report Number	P20250723153511
Inspection Date / Place	2025-07-23 / BCA GARONS	Cosmetic Grade	5

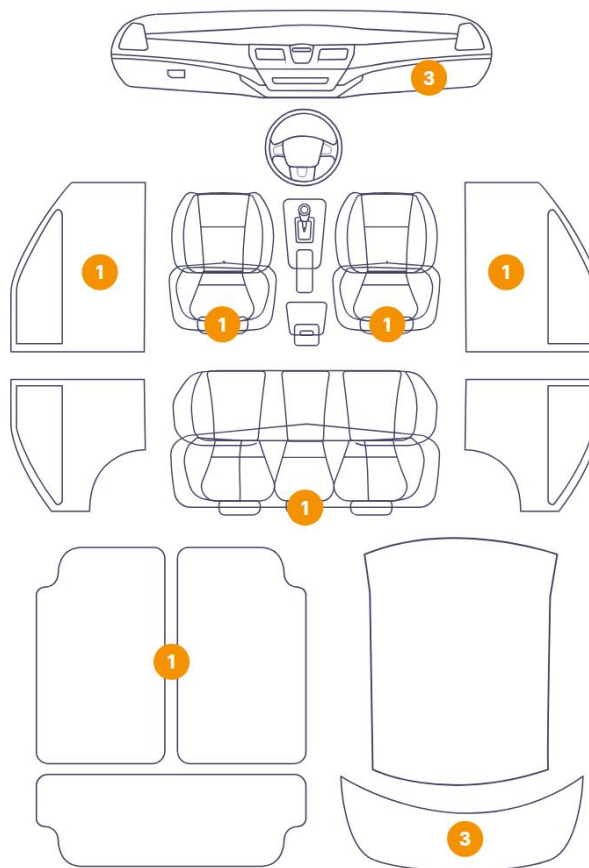
## 12 Dommages

13	Tailgate Upholstery / Back	Interior / Missing
14	Tailgate Upholstery / Back	Interior / Missing
15	Seat / Back Center	Interior / Missing
16	Seat / Front Left	Interior / Missing
17	Seat / Front Right	Interior / Missing
18	Panel Filling / Front Left	Interior / Missing
19	Floor Carpet	Interior / Ripped
20	Tire / Front Left	Tire
21	Rim / Front Left	Out of Bodywork / Scratch
22	Hood	Paint / Scratch / Line
23	Windshield / Front	Glass Break
24	Bumper / Front	Bodywork / Dent / Deformation
25	Bumper / Front	Missing Part
26	Bumper / Front	Bodywork / Breakage / Crack
27	Rim / Front Right	Out of Bodywork / Scratch
28	Tire / Front Right	Tire
29	Side Window / Front Right	Glass Break
30	Panel Filling / Front Right	Interior / Missing
31	Tire / Back Right	Tire
32	Side Window / Front Left	Glass Break

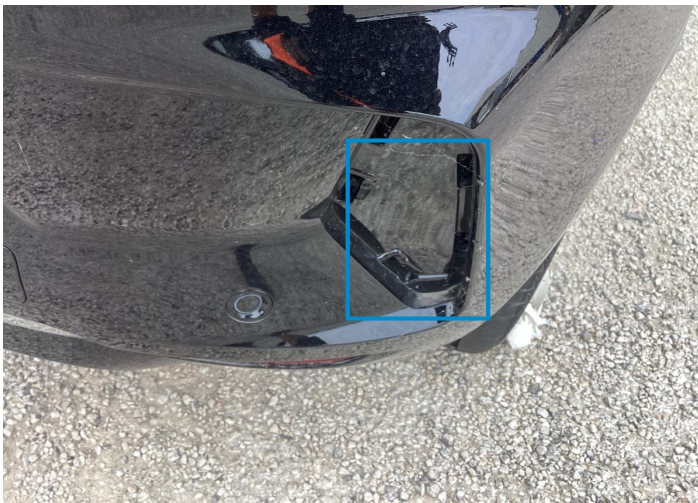
1. Reflector / Back Right  
Missing Part -

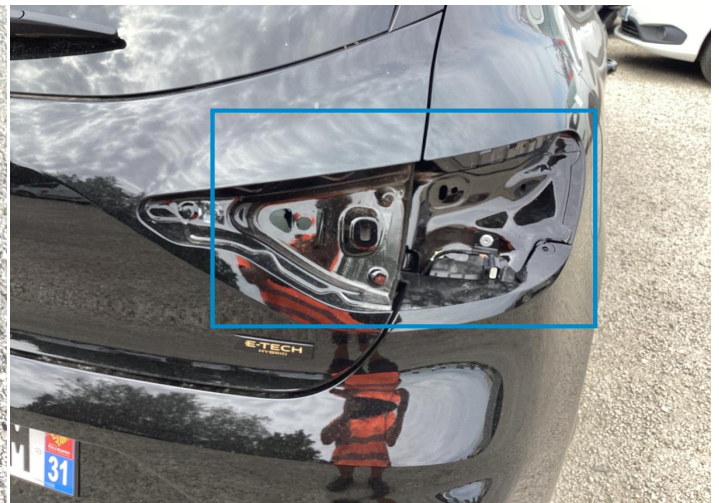
2. Back Light / Right  
Missing Part -

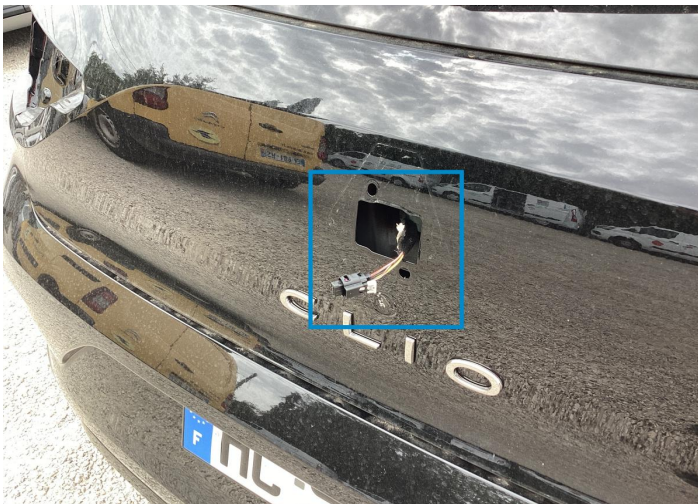
3. Tailgate  
Missing Part -

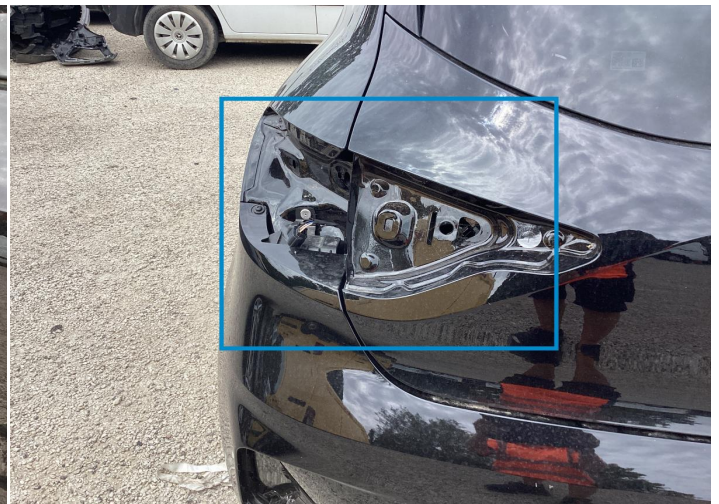
4. Back Light / Left  
Missing Part -

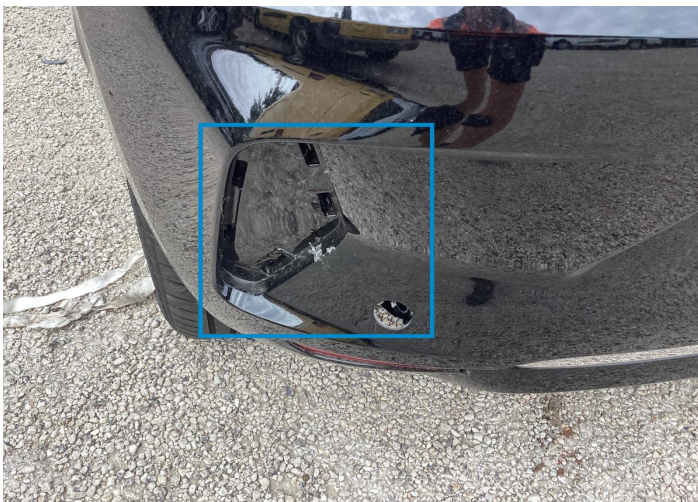
5. Reflector / Back Left  
Missing Part -

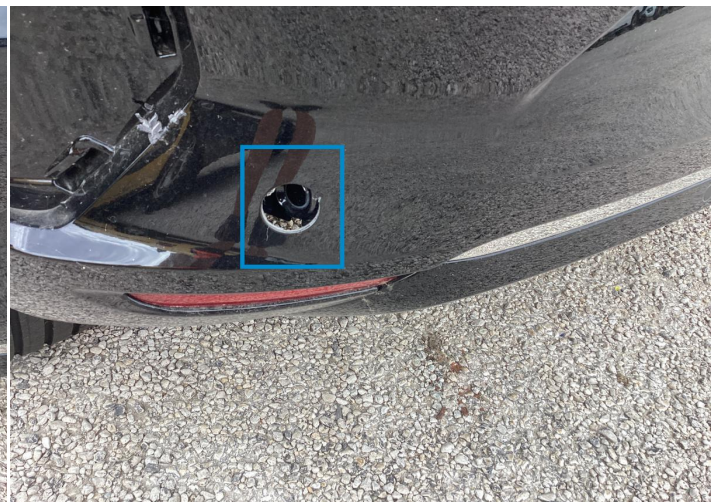
6. Outside Sensor / Back  
Bodywork / Breakage / Crack -

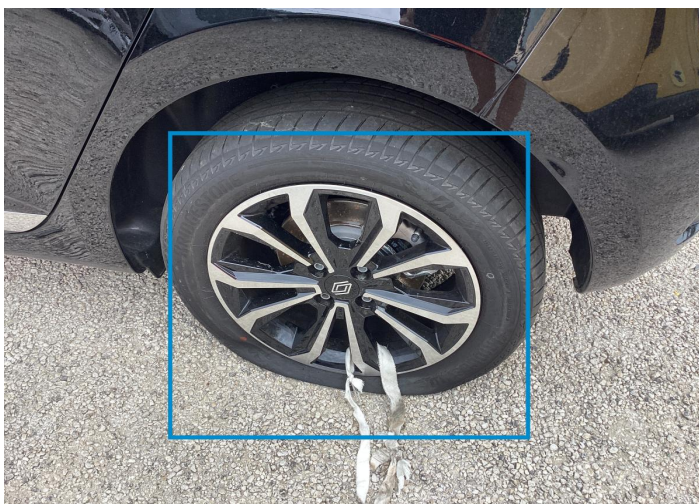
7. Tire / Back Left  
Tire -

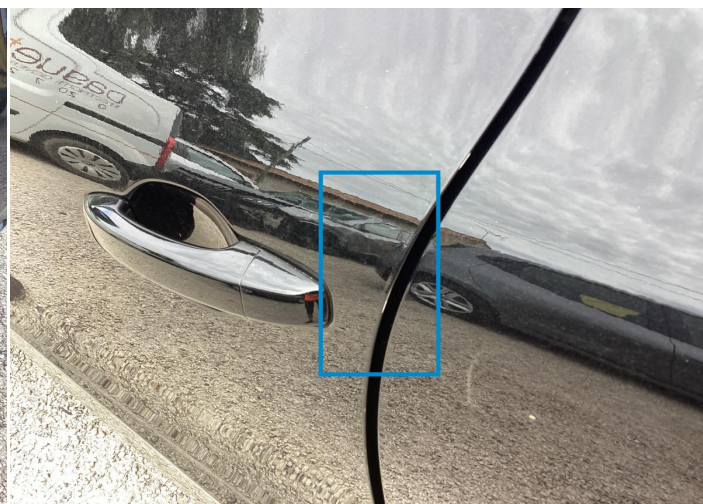
8. Door / Front Left  
Paint / Scratch / Line -

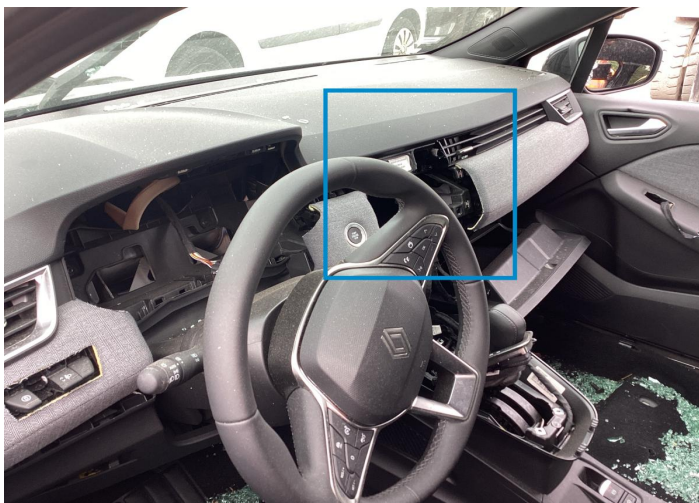
9. Dashboard / Front  
Interior / Missing -

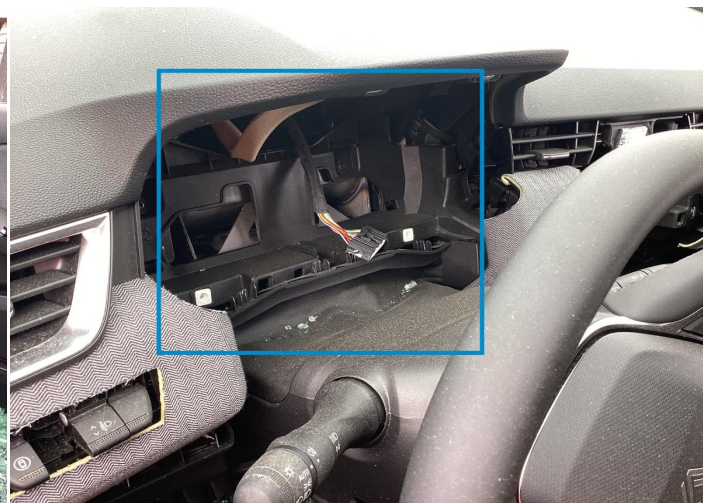
10. Digital Combined Instrument Panel  
Interior / Missing -

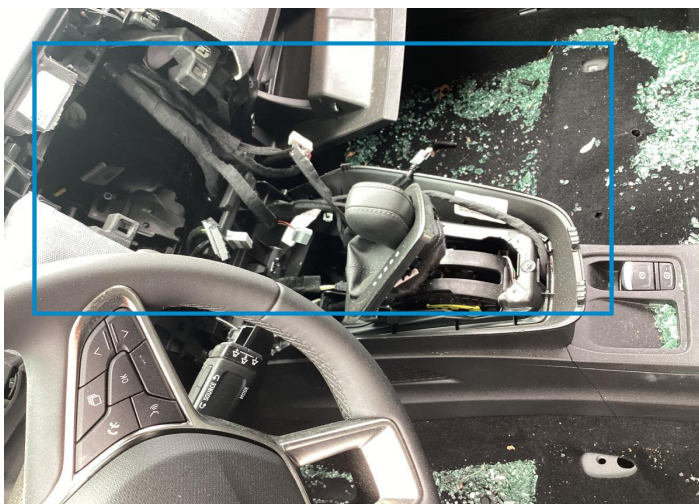
11. Center Console  
Interior / Missing -

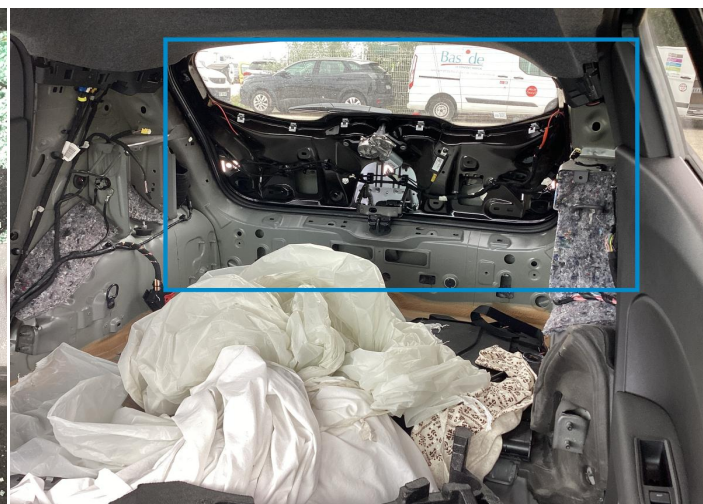
12. Tailgate Upholstery / Back  
Interior / Missing -

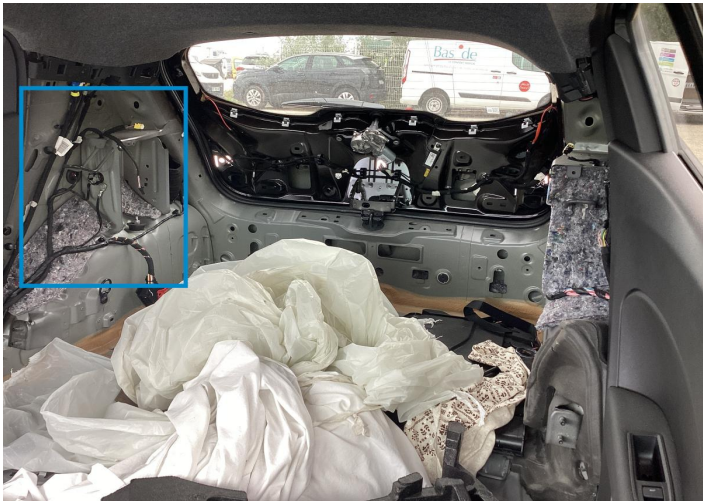
13. Tailgate Upholstery / Back Interior / Missing -

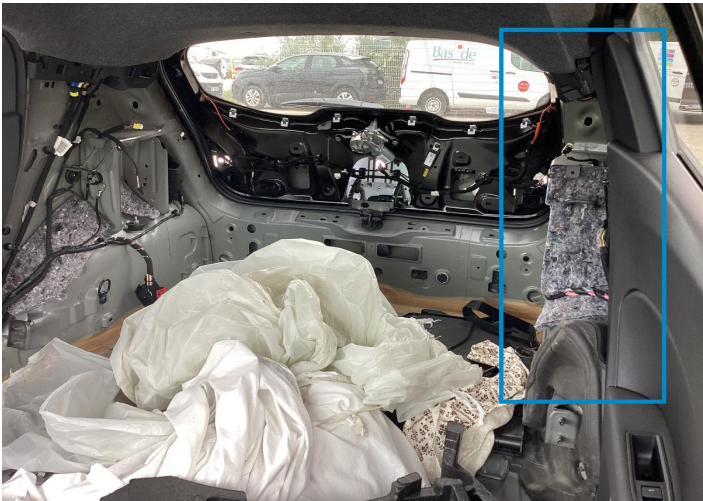
14. Tailgate Upholstery / Back Interior / Missing -

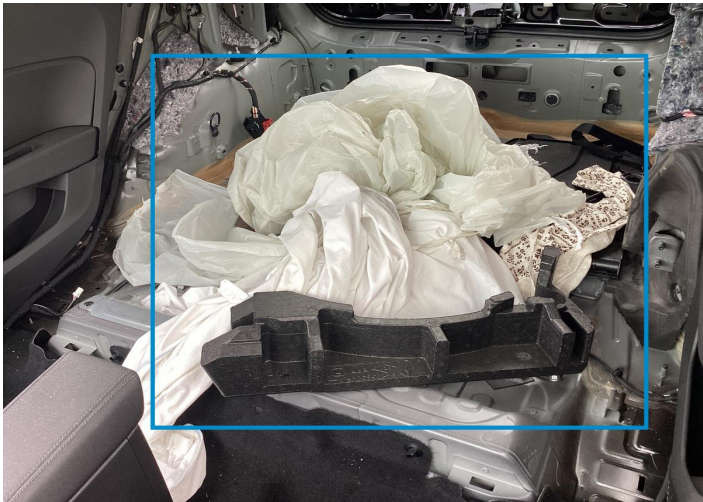
15. Seat / Back Center Interior / Missing -

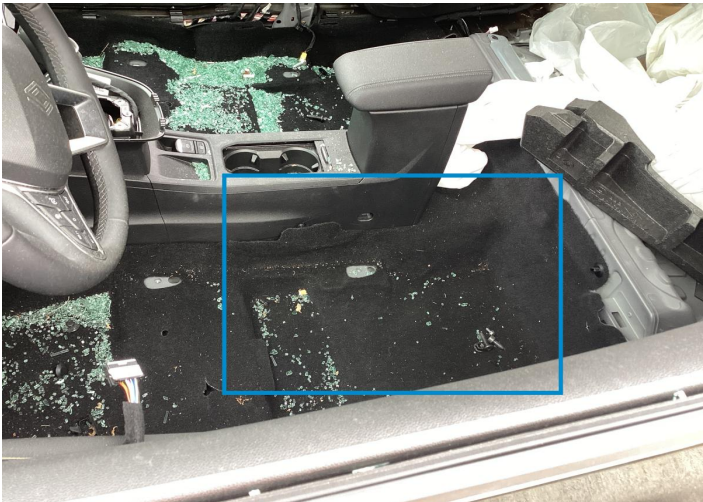
16. Seat / Front Left Interior / Missing -

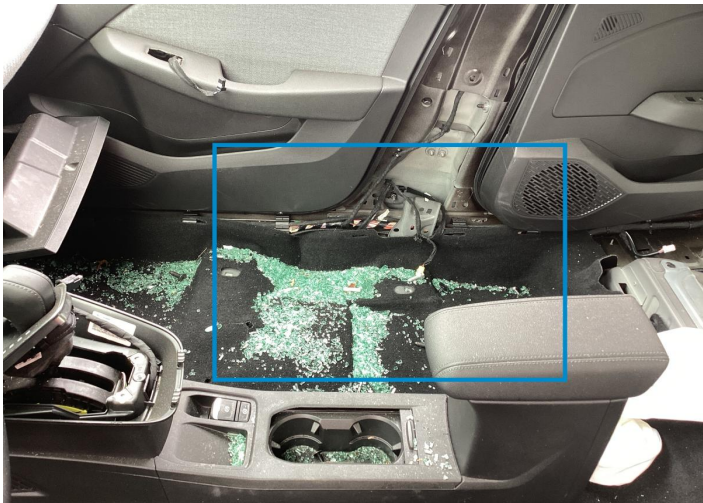
17. Seat / Front Right Interior / Missing -

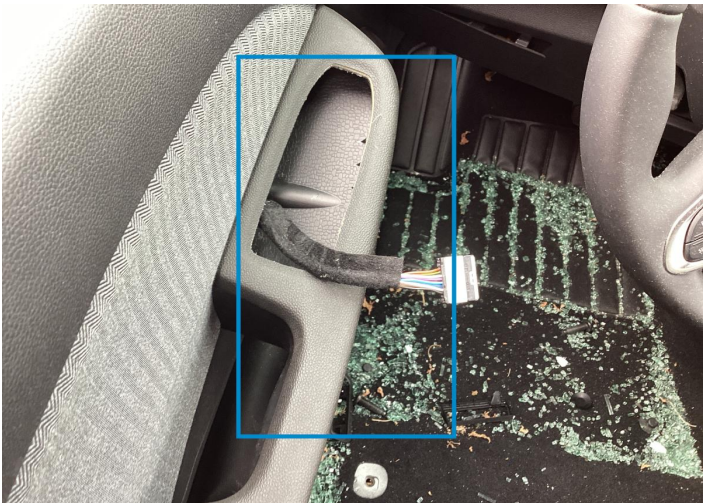
18. Panel Filling / Front Left Interior / Missing -

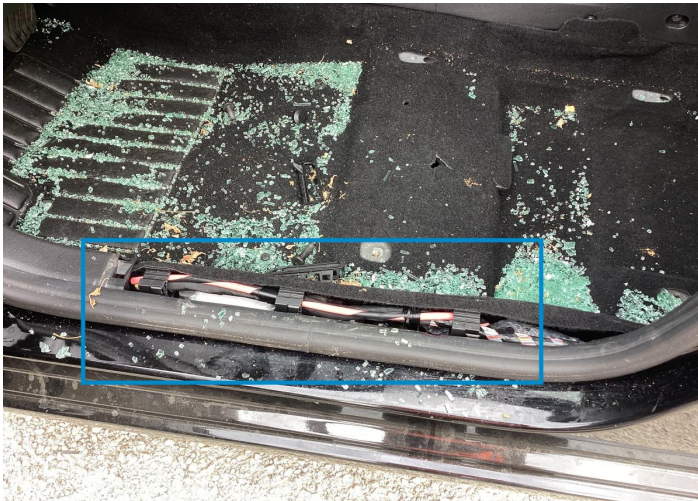
19. Floor Carpet  
Interior / Ripped -

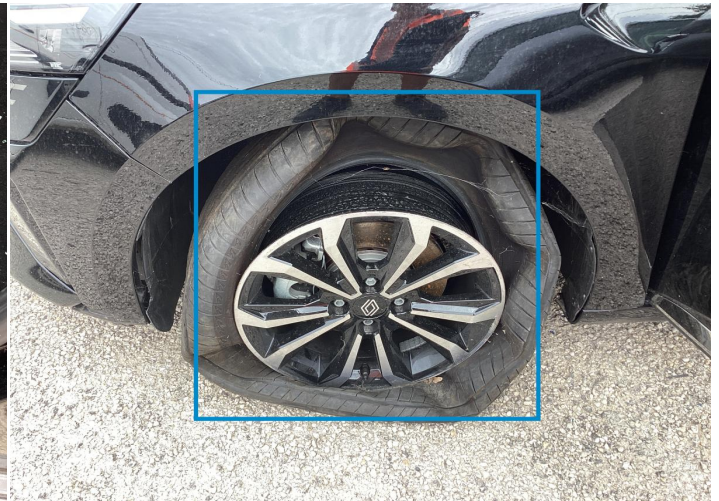
20. Tire / Front Left  
Tire -

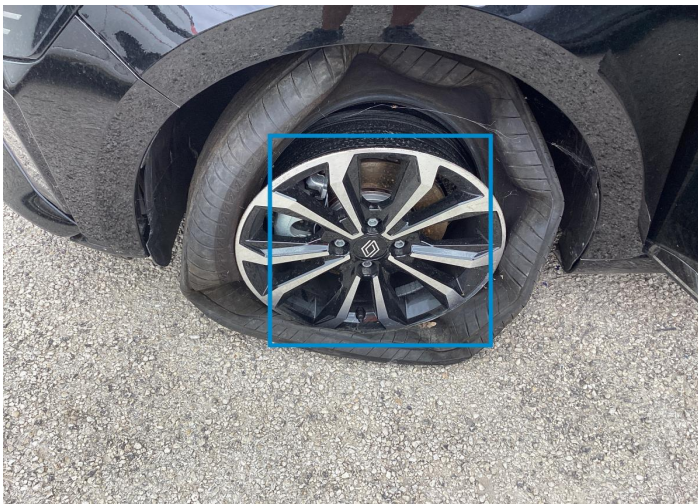
21. Rim / Front Left  
Out of Bodywork / Scratch -

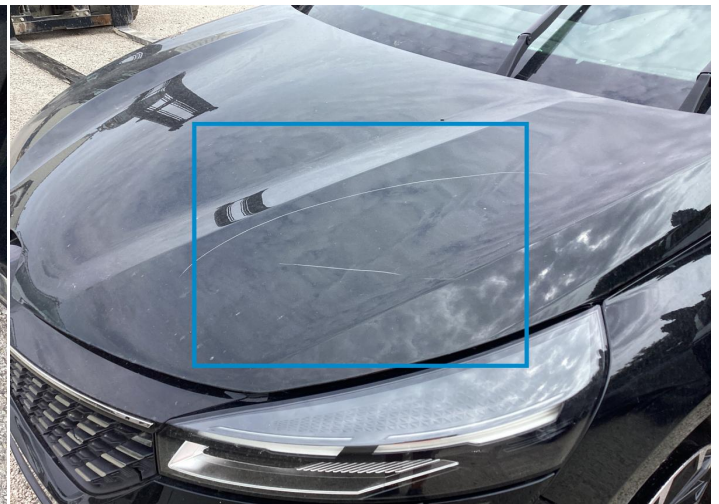
22. Hood  
Paint / Scratch / Line -

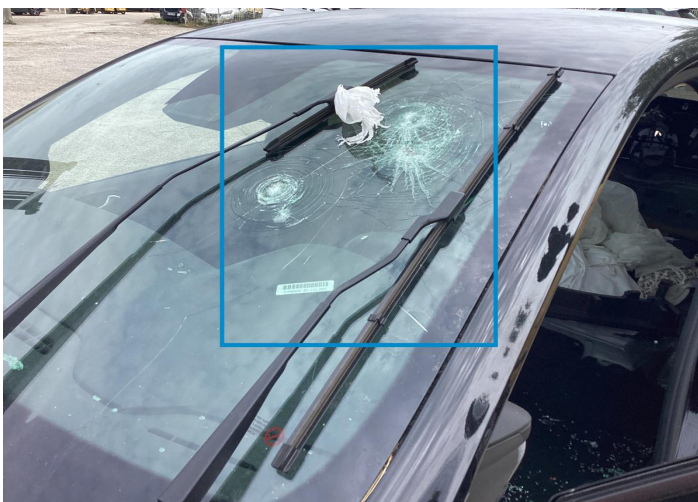
23. Windshield / Front  
Glass Break -

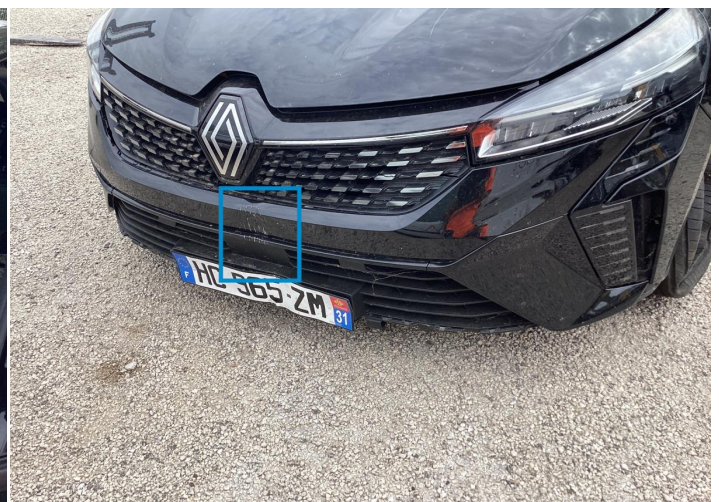
24. Bumper / Front  
Bodywork / Dent / Deformation -

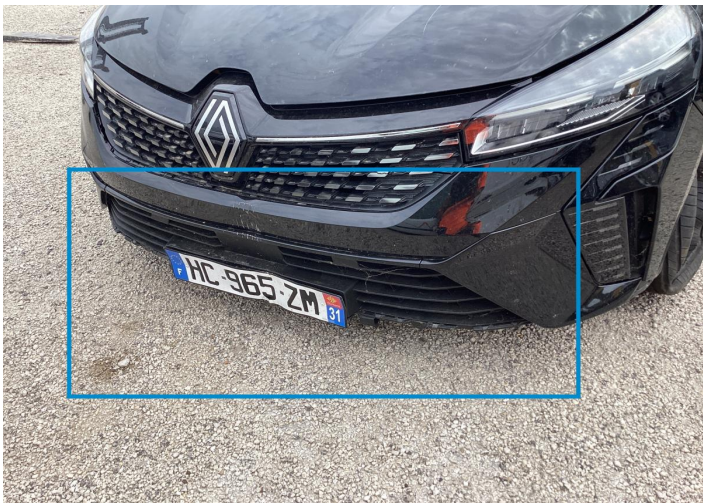
25. Bumper / Front  
Missing Part -

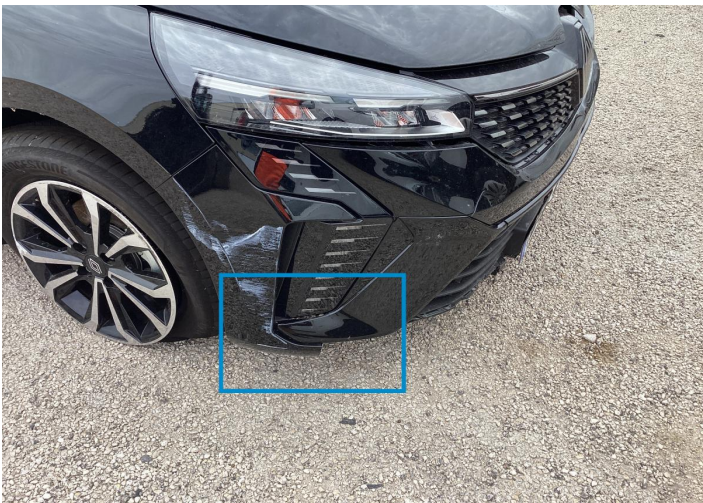
26. Bumper / Front  
Bodywork / Breakage / Crack -

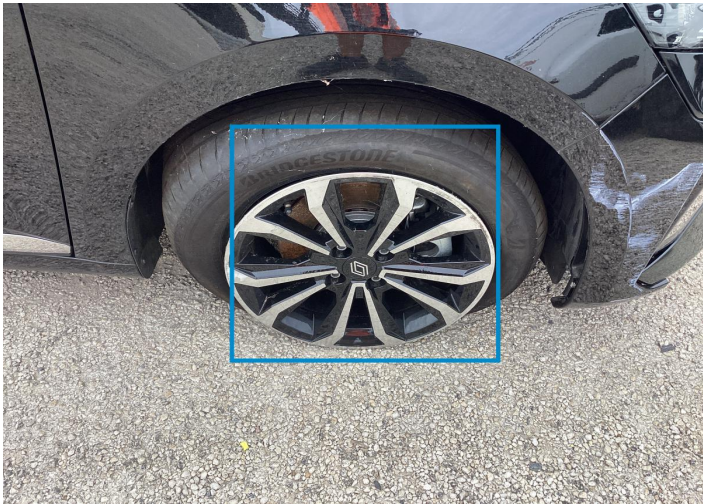
27. Rim / Front Right  
Out of Bodywork / Scratch -

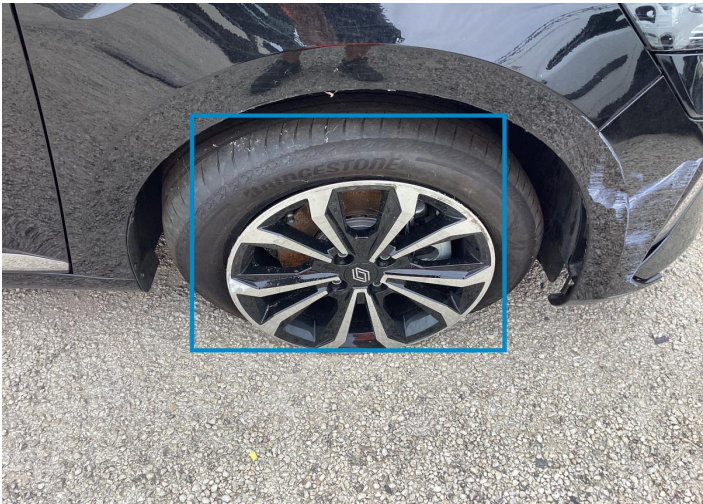
28. Tire / Front Right  
Tire -

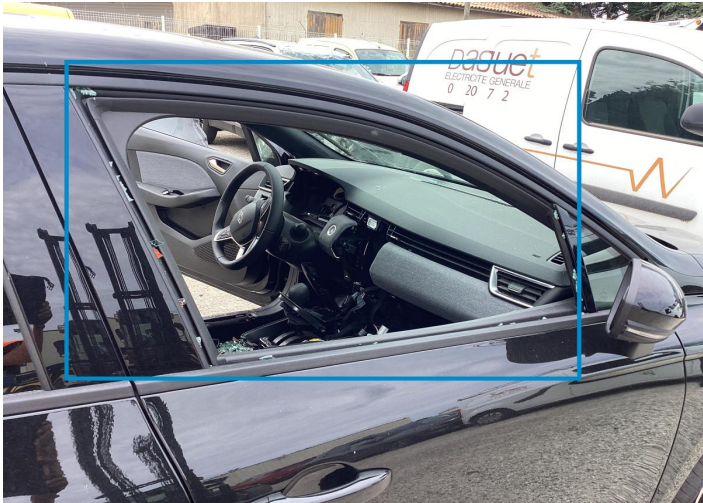
29. Side Window / Front Right  
Glass Break -

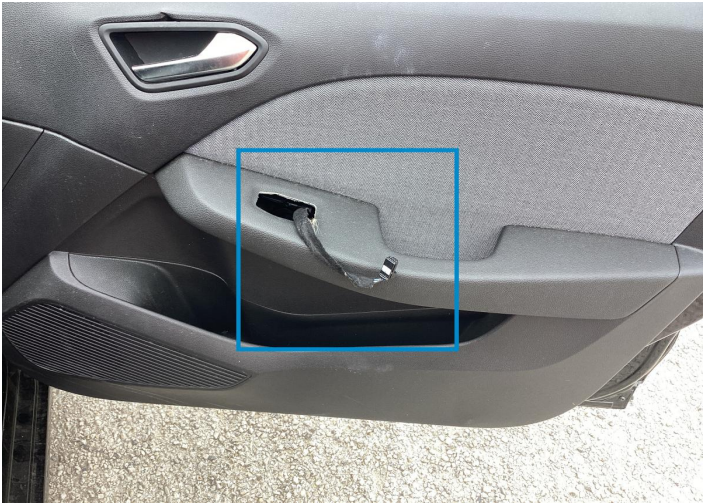
30. Panel Filling / Front Right  
Interior / Missing -

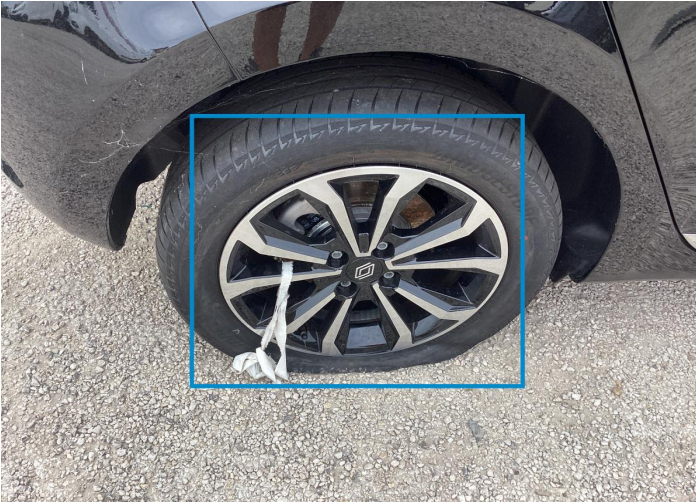
31. Tire / Back Right  
Tire -

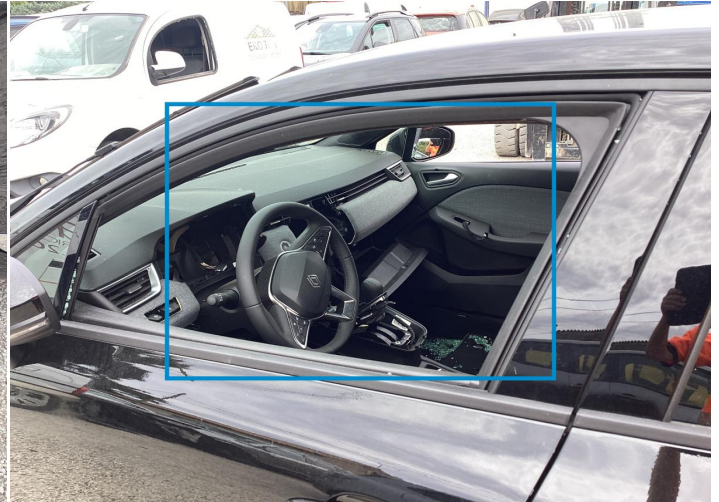
32. Side Window / Front Left  
Glass Break -
