# Renault

CLIO TCE 90 FR TECHNO

VIN: VF1RJA00872942191

## Statement details

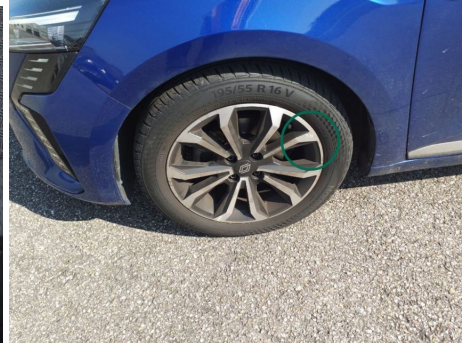
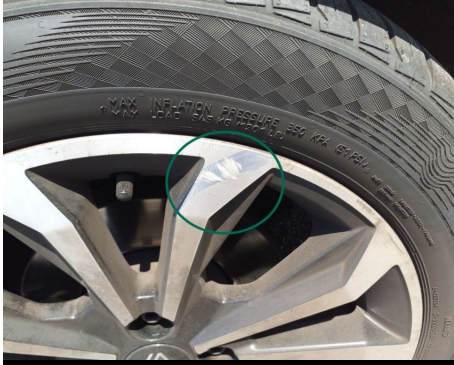
Rim / Front Left / Scratched

#	Element	Defect	Correction
001	Rim / Front Left Material : Aluminium alloy / Rim/Tyre diameter : 16 "	Scatched	Painting

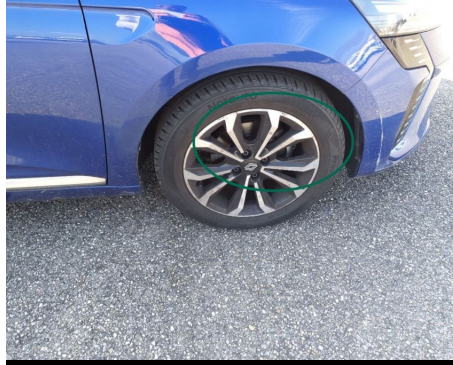
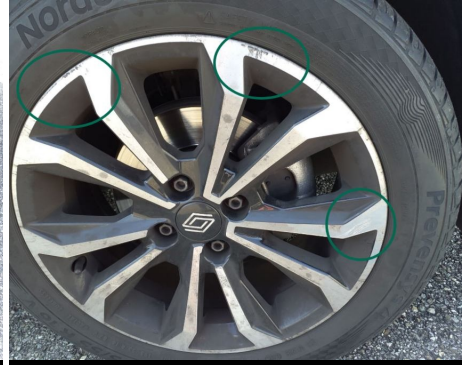
Rim / Front Right / Scratched

<p>002</p>	<p>Rim / Front Right Material : Aluminium alloy / Rim/Tyre diameter : 16 "</p>		<p>Scratched</p>	<p>Painting</p>

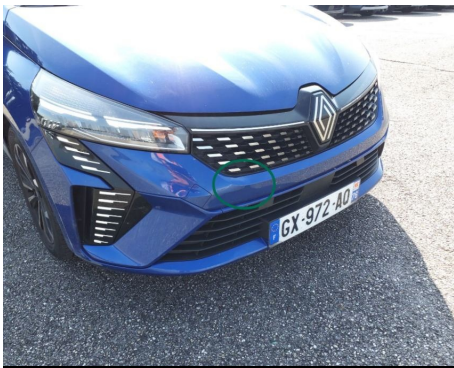
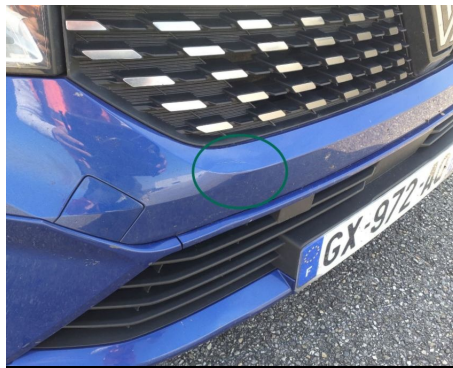
Bumper / Front / Dent

<p>003</p>	<p>Bumper / Front</p>		<p>Dent</p>	<p>Repair</p>

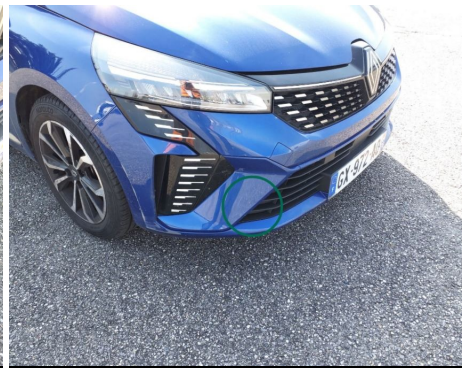
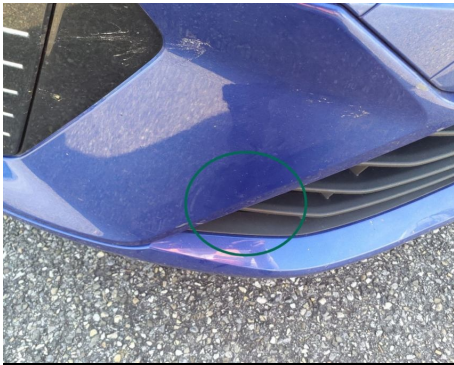
Bumper moulding / Front Right / Dent

<p>004</p>	<p>Bumper moulding / Front Right</p>		<p>Dent</p>	<p>Repair</p>

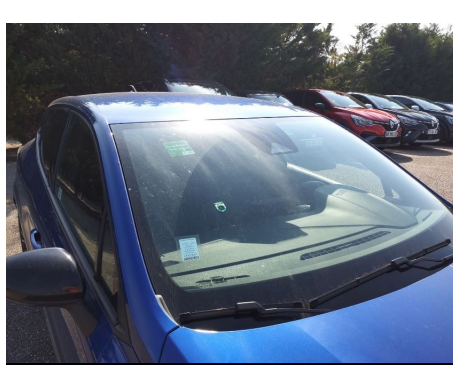
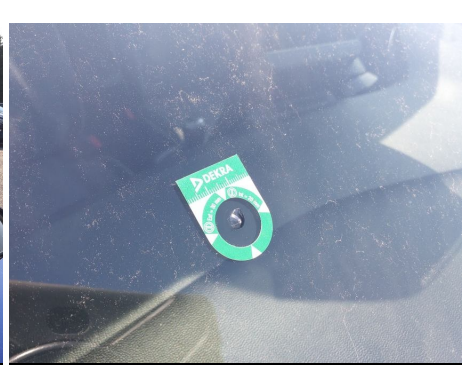
Windscreen / - / Chip

<p>005</p>	<p>Windscreen / - Rain sensor : Yes</p>		<p>Chip</p>	<p>Smart repair</p>

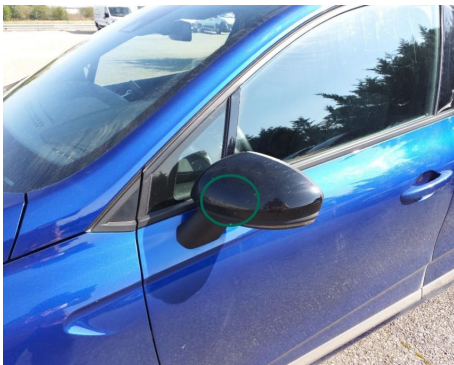
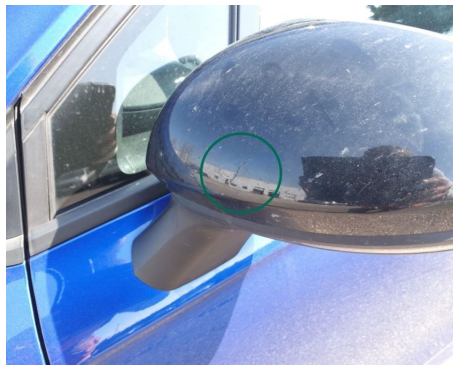
Exterior door mirror shell / Left / Broken

<p>006</p>	<p>Exterior door mirror shell / Left</p>		<p>Broken</p>	<p>Replace</p>

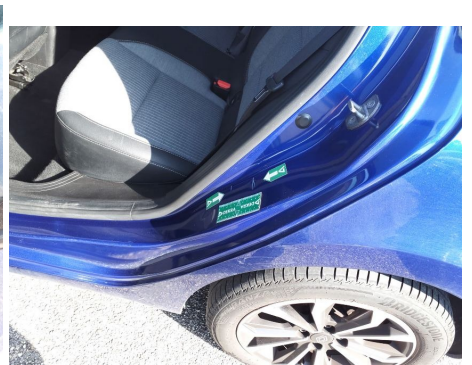
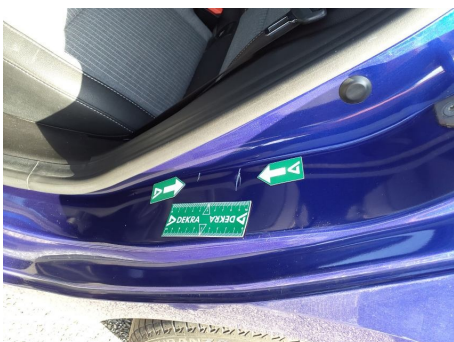
Door sill / Back Left / Dent

<p>007</p>	<p>Door sill / Back Left</p>		<p>Dent</p>	<p>Repair</p>

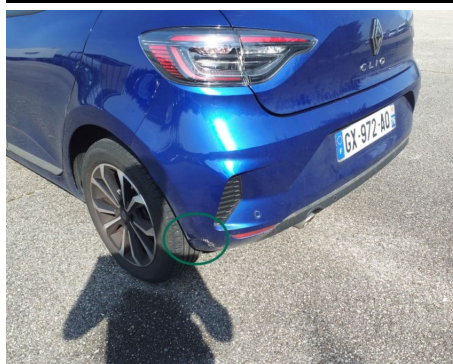
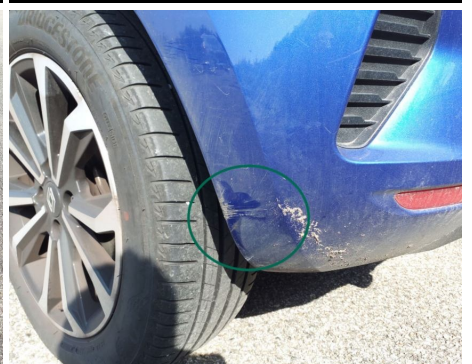
Bumper / Back / Scratched

008	Bumper / Back	Scratched	Painting
009	Tailgate / Boot door / -	Dent	Smart repair
010	Door / Back Right	Dent	Smart repair
011	Roof / -	Scratched	Polishing

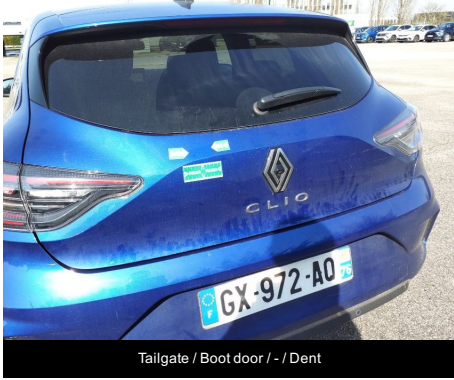
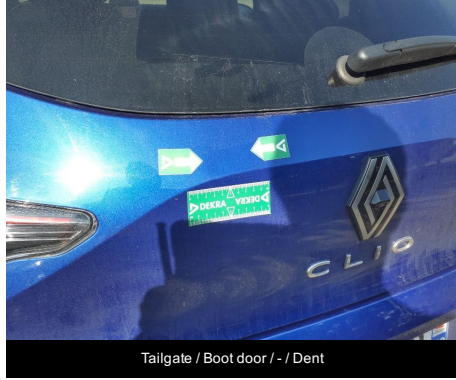
Tailgate / Boot door / - / Dent

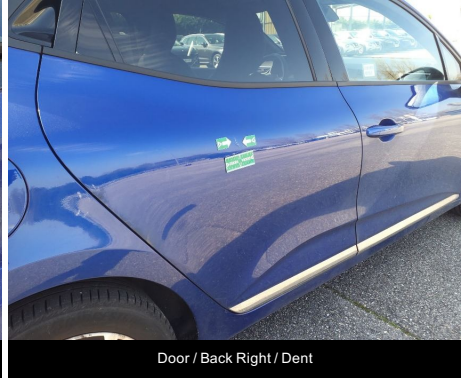
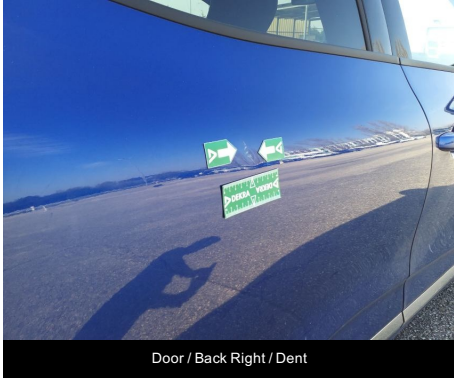
Door / Back Right / Dent
