RENAULT CAPTUR

Captur Eco-G 100 Techno

VIN NO VF1RJB00074553555
Registration Number HC018KB

Inspection Report Summary

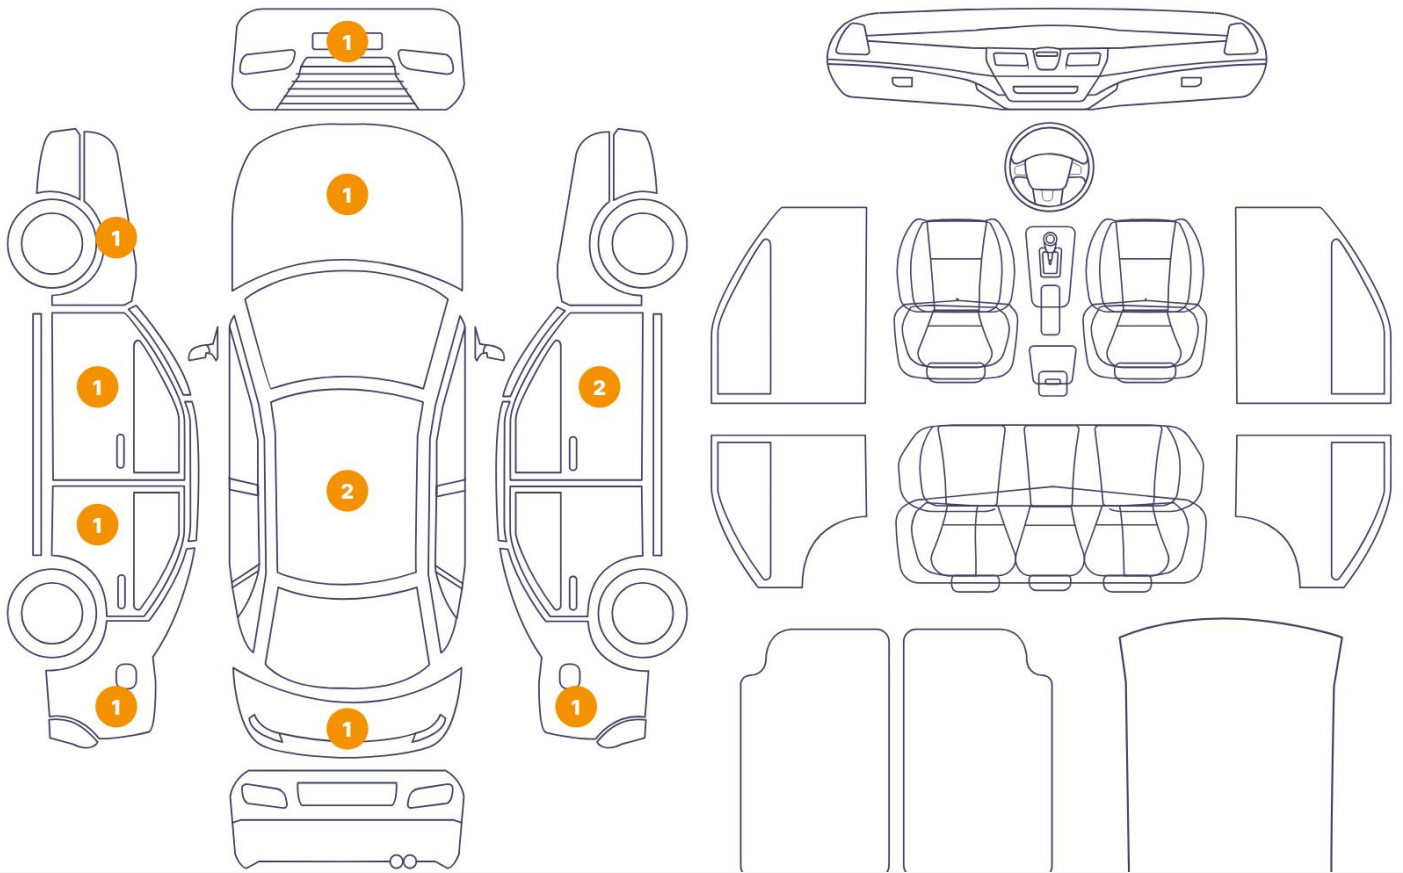
Component		Damage	Comments
1	Bumper / Front	Bodywork / Breakage / Hole	
2	Fender / Back Right	Bodywork / Assembly	
3	Hood	Bodywork / Dent / Hail Area	
4	Mirror / Front Right		
5	Roof	Bodywork / Dent / Hail Area	
6	Door / Front Right	Bodywork / Dent / Dent	
7	Rear Window / Back	Glass Break	
8	Fender / Back Left	Bodywork / Dent / Hail Area	
9	Door / Back Left	Bodywork / Dent / Hail Area	
10	Cant Rail / Left	Bodywork / Dent / Hail Area	
11	Door / Front Left	Bodywork / Dent / Hail Area	
12	Fender / Front Left	Bodywork / Dent / Hail Area

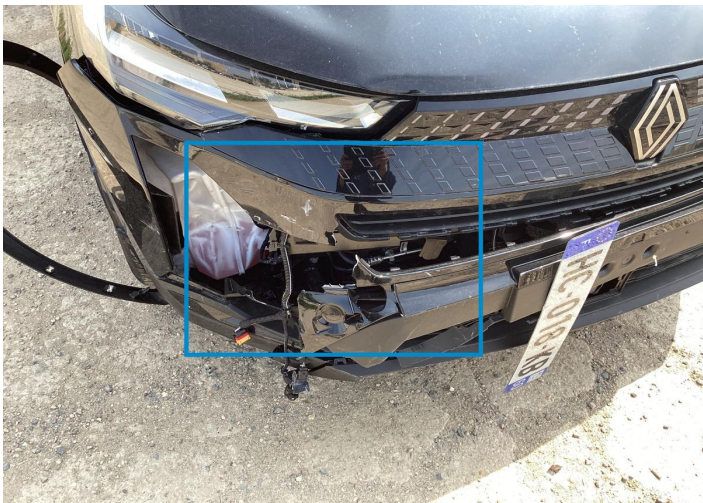
1. Bumper / Front
Bodywork / Breakage / Hole -

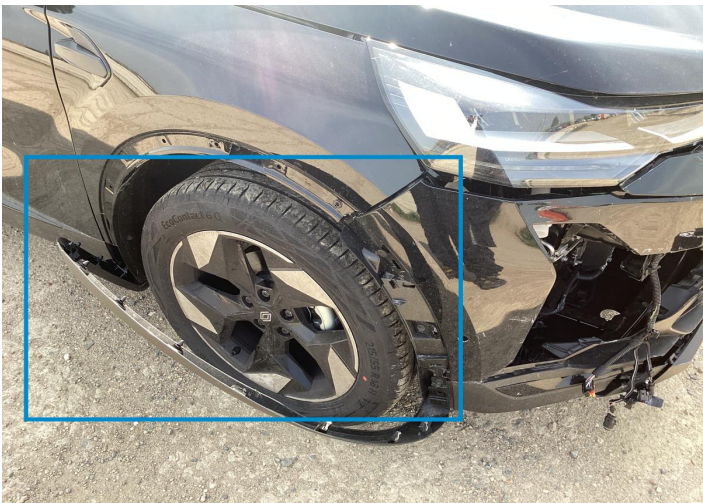
2. Fender / Back Right
Bodywork / Assembly -

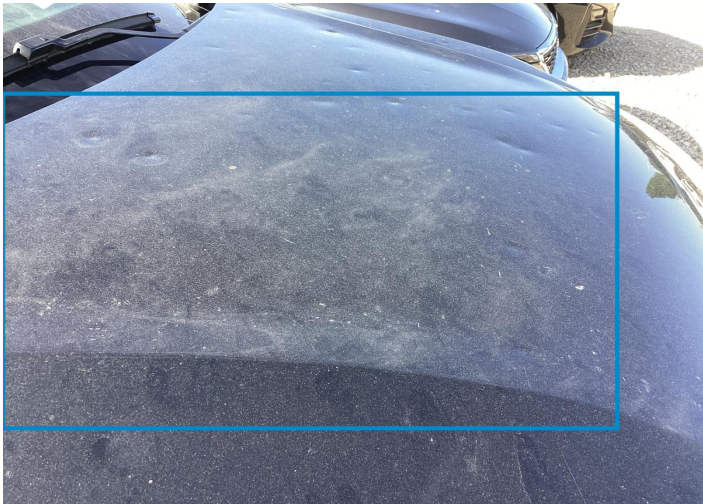
3. Hood
Bodywork / Dent / Hail Area -

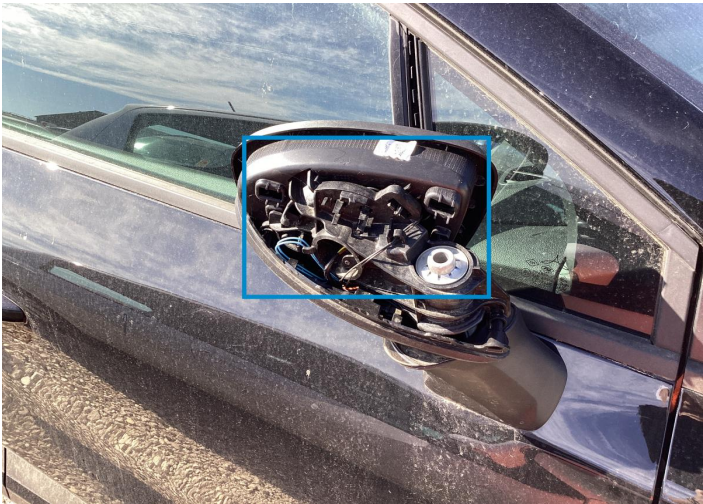
4. Mirror / Front Right
-

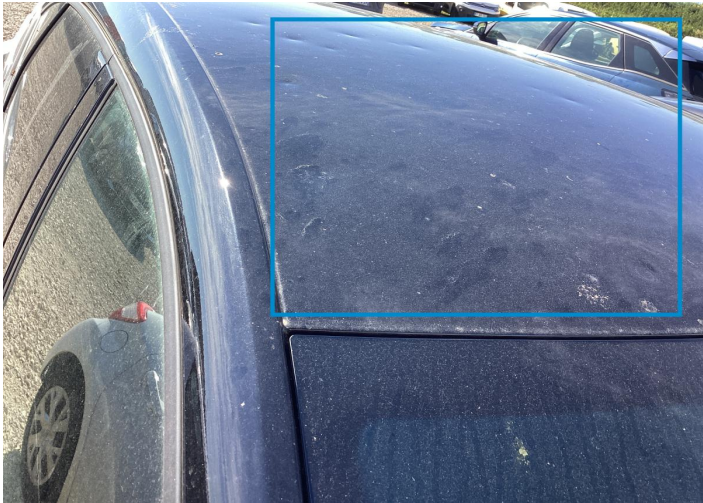
5. Roof
Bodywork / Dent / Hail Area -

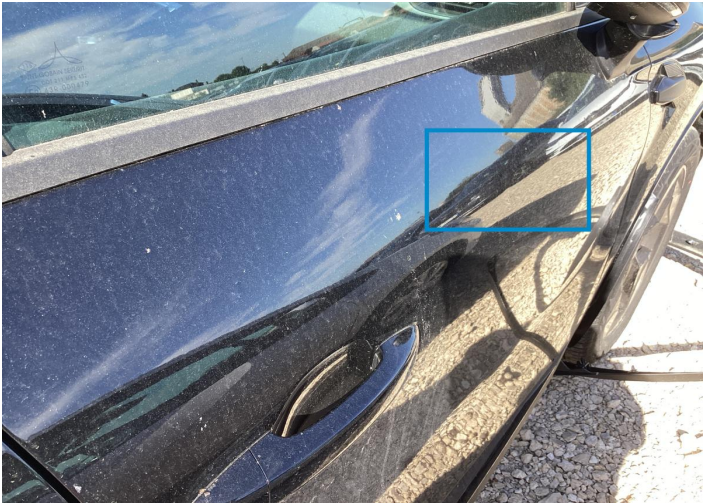
6. Door / Front Right
Bodywork / Dent / Dent -

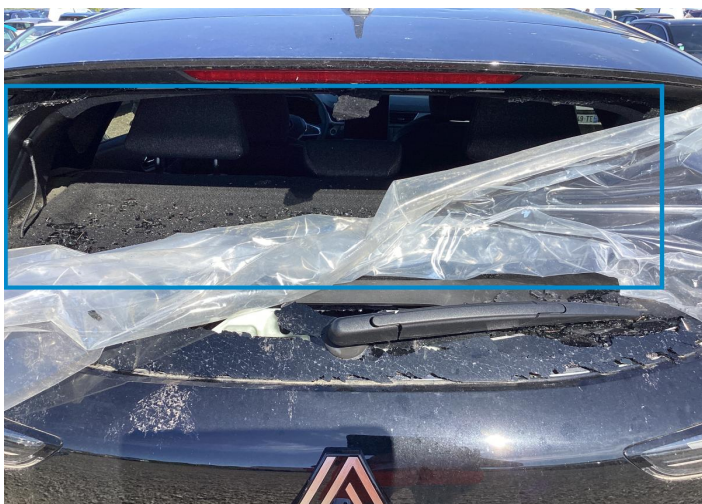
7. Rear Window / Back
Glass Break -

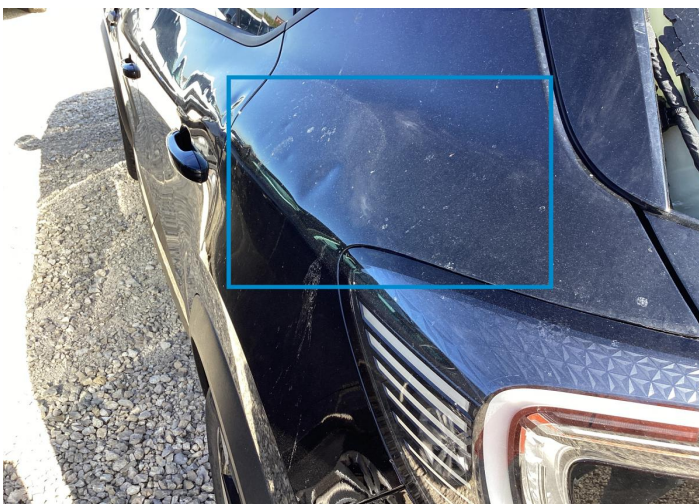
8. Fender / Back Left
Bodywork / Dent / Hail Area -

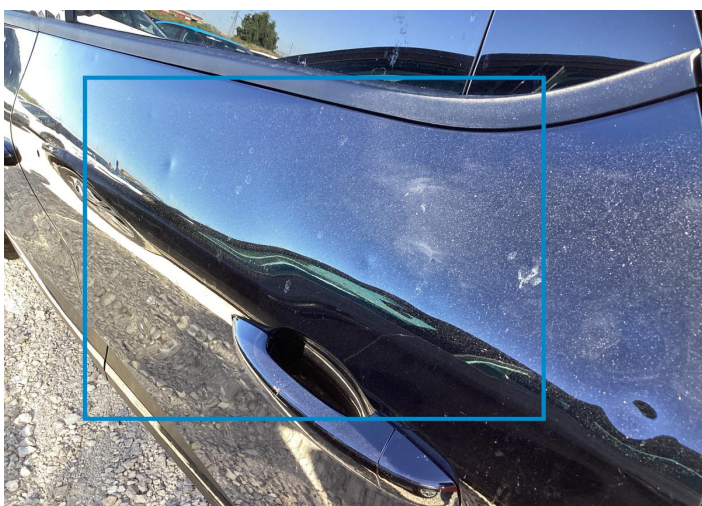
9. Door / Back Left
Bodywork / Dent / Hail Area -

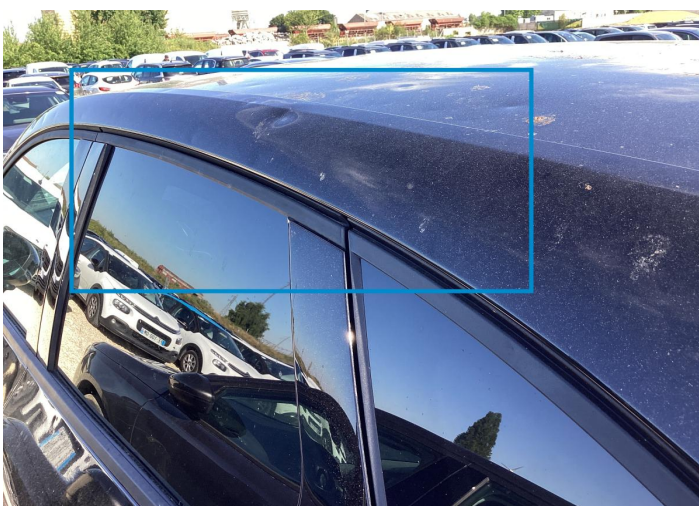
10. Cant Rail / Left
Bodywork / Dent / Hail Area -

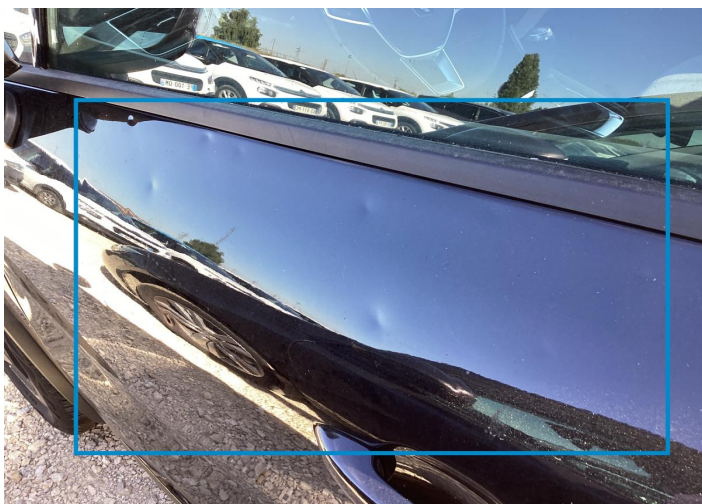
11. Door / Front Left
Bodywork / Dent / Hail Area -

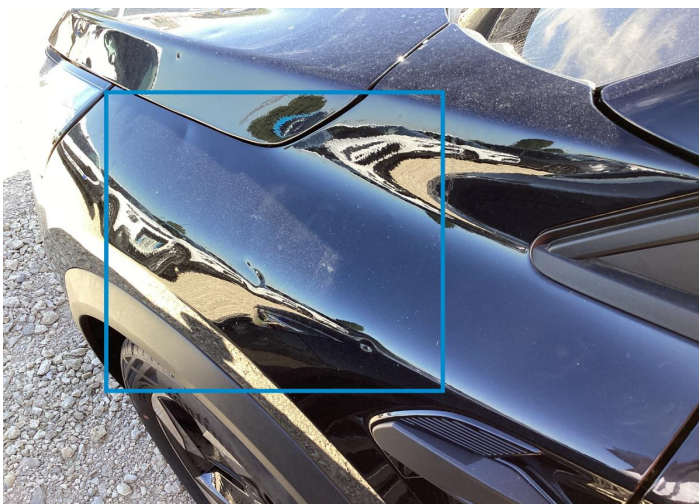
12. Fender / Front Left
Bodywork / Dent / Hail Area -
