RENAULT ARKANA

Arkana mild hybrid 140 EDC GSR2 Evolution

Inspection Report Summary

Customer	BCAuto Encheres	Report Number	P20250826135859
Inspection Date / Place	2025-08-26 / BCA BETHUNE	Cosmetic Grade	4

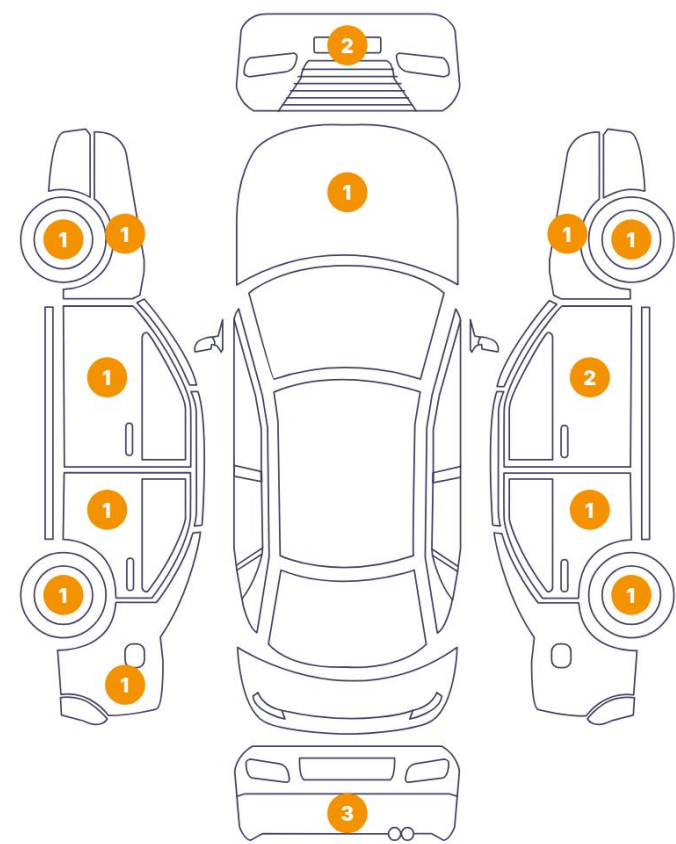
18 Dommages

Component		Damage	Comments
1	Floor Carpet	Interior / Dirty	
2	Floor Carpet	Interior / Dirty	
3	Hood	Bodywork / Dent / Deformation	
4	Bumper / Front	Bodywork / Dent / Deformation	
5	Bumper / Front	Bodywork / Dent / Deformation	
6	Fender / Front Left	Bodywork / Assembly	
7	Rim / Front Left	Out of Bodywork / Scratch	
8	Door / Front Left	Paint / Scratch / Line	
9	Door / Back Left	Paint / Scratch / Line	
10	Rim / Back Left	Out of Bodywork / Scratch	
11	Side Panel / Back Left	Paint / Scratch / Line	
12	Corner Bumper / Back Left	Paint / Scratch / Scuff	
13	Bumper / Back	Paint / Scratch / Scuff

14	Corner Bumper / Back Right	Paint / Scratch / Scuff
15	Rim / Back Right	Out of Bodywork / Scratch
16	Door / Back Right	Paint / Scratch / Line
17	Door / Front Right	Paint / Scratch / Line
18	Mirror / Front Right	Paint / Scratch / Scuff
19	Fender / Front Right	Bodywork / Dent / Deformation
20	Rim / Front Right	Out of Bodywork / Breakage

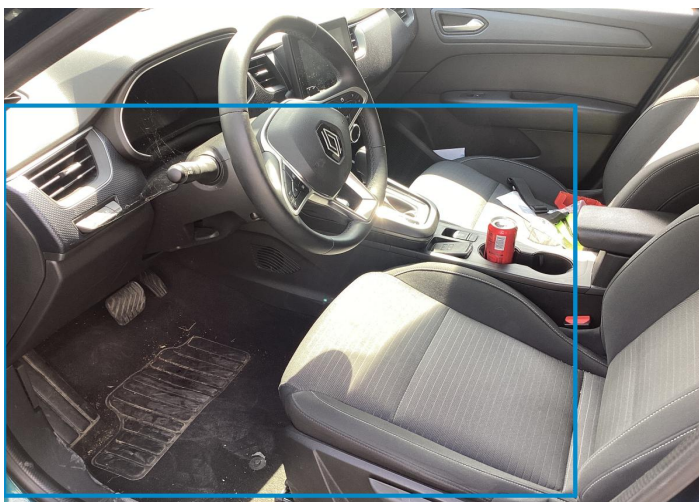
1. Floor Carpet
Interior / Dirty -

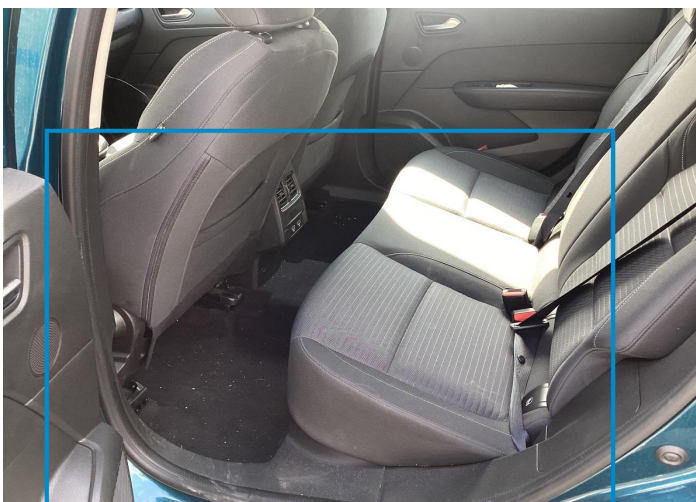
2. Floor Carpet
Interior / Dirty -

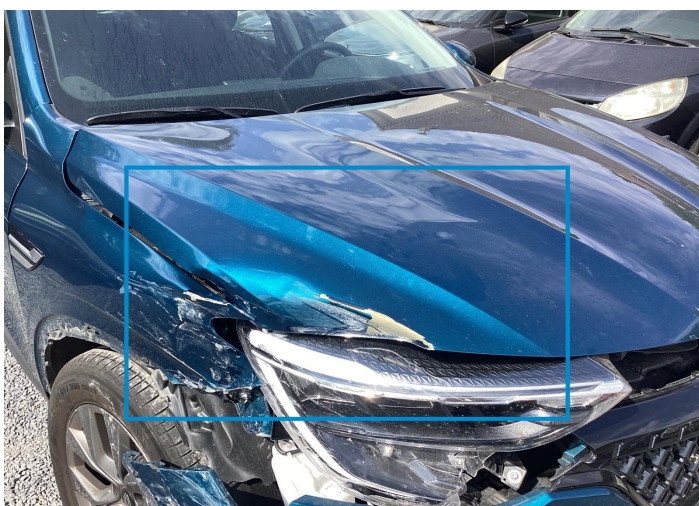
3. Hood
Bodywork / Dent / Deformation -

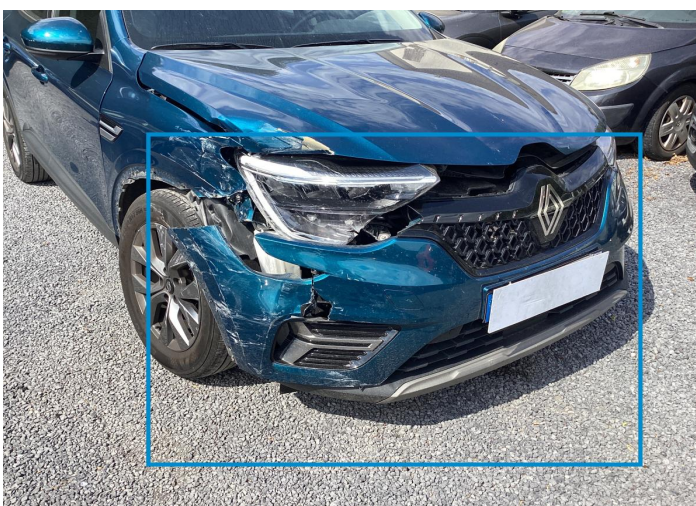
4. Bumper / Front
Bodywork / Dent / Deformation -

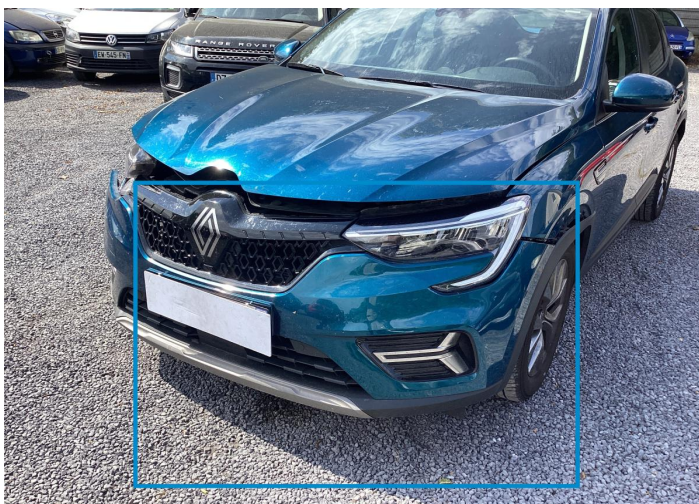
5. Bumper / Front
Bodywork / Dent / Deformation -

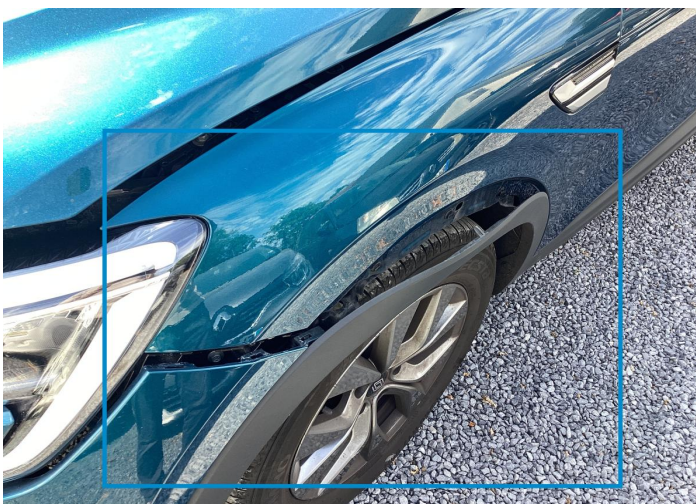
6. Fender / Front Left
Bodywork / Assembly -

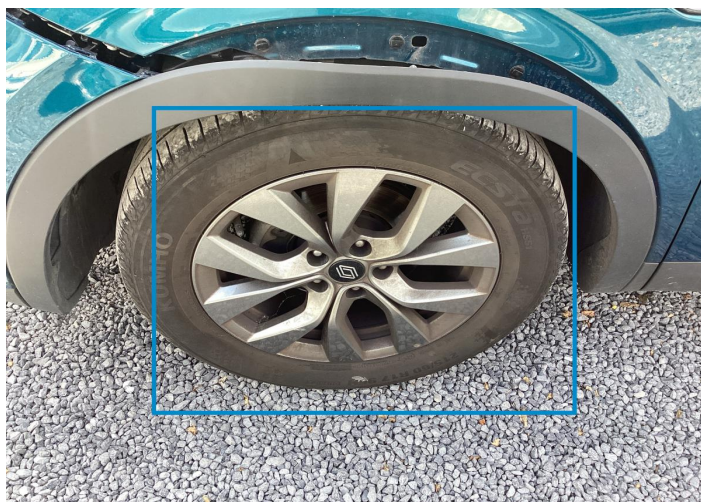
7. Rim / Front Left
Out of Bodywork / Scratch -

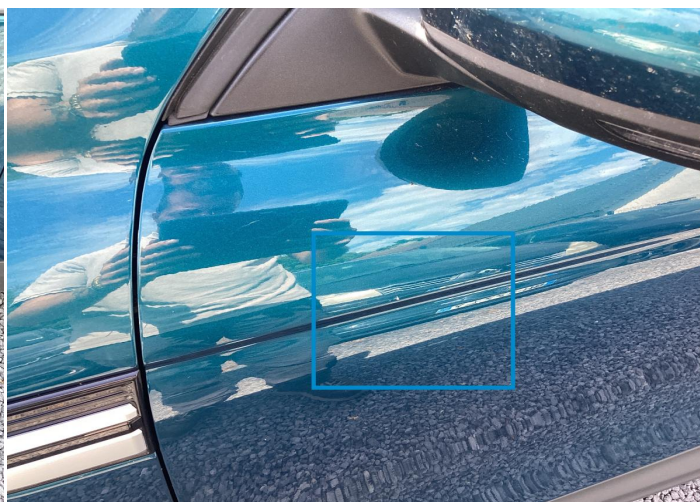
8. Door / Front Left
Paint / Scratch / Line -

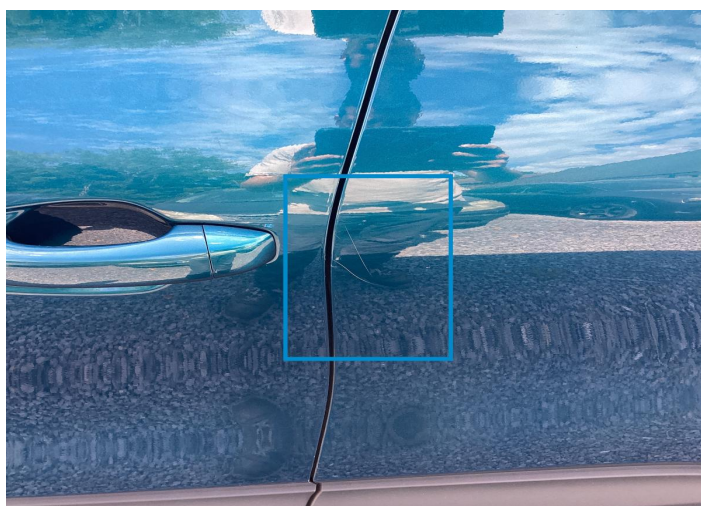
9. Door / Back Left
Paint / Scratch / Line -

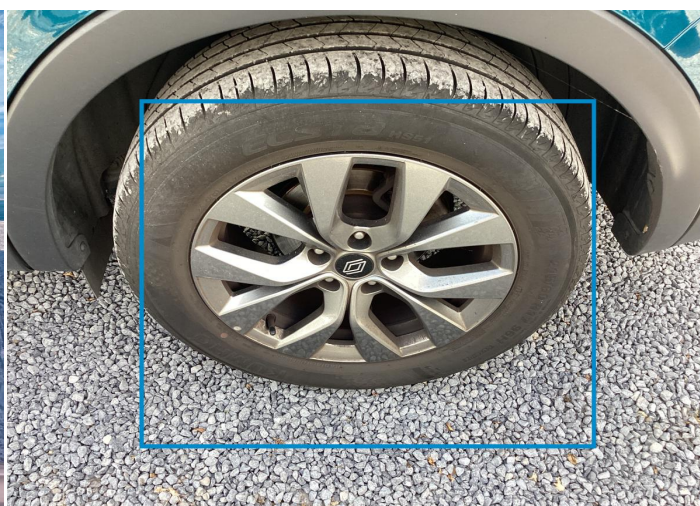
10. Rim / Back Left
Out of Bodywork / Scratch -

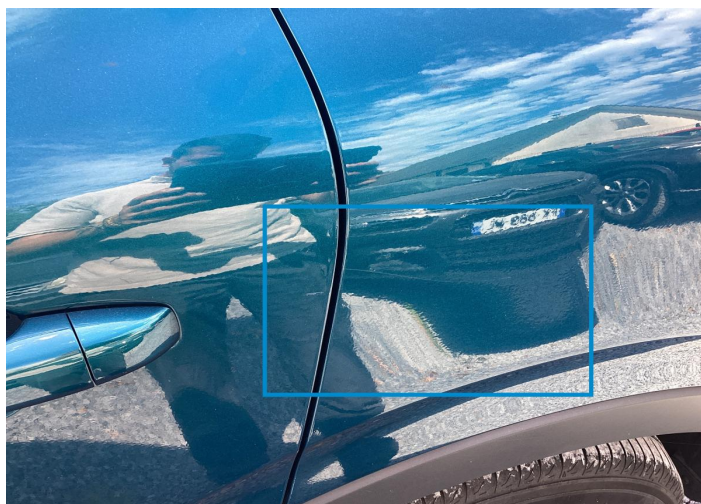
11. Side Panel / Back Left
Paint / Scratch / Line -

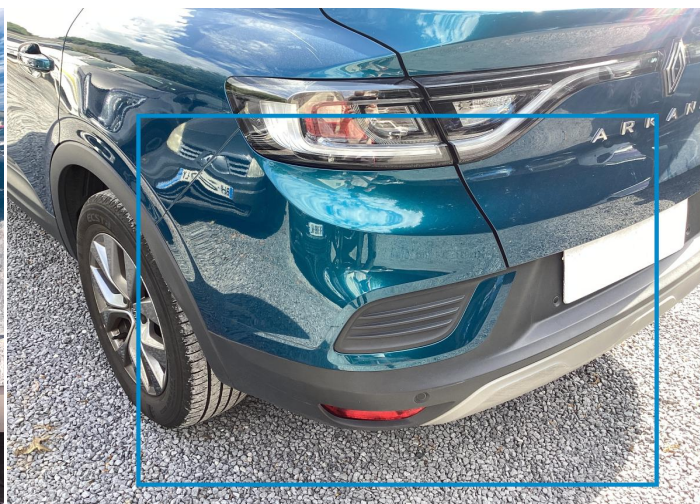
12. Corner Bumper / Back Left
Paint / Scratch / Scuff -

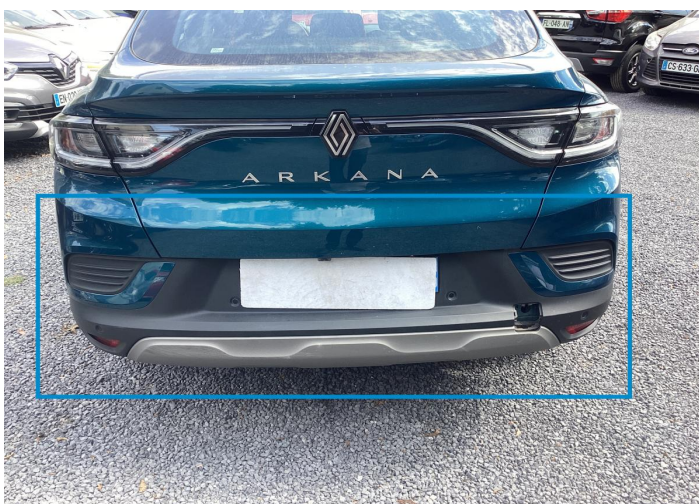
13. Bumper / Back
Paint / Scratch / Scuff -

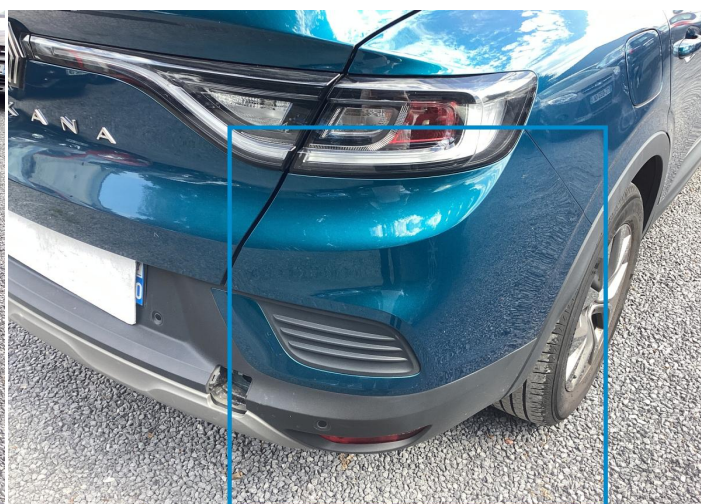
14. Corner Bumper / Back Right
Paint / Scratch / Scuff -

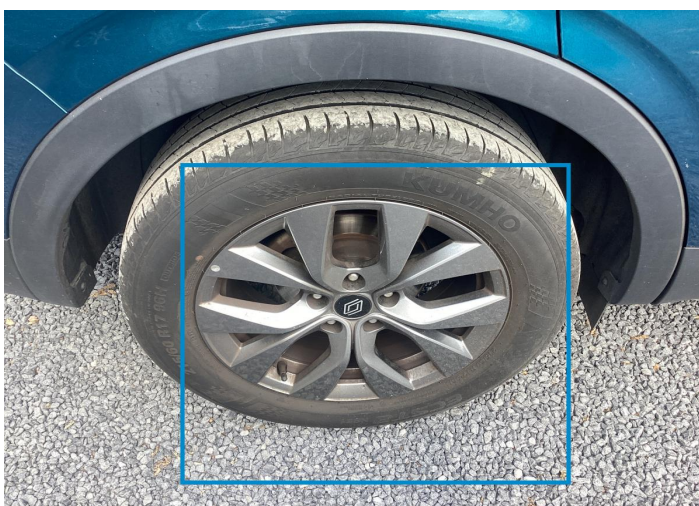
15. Rim / Back Right
Out of Bodywork / Scratch -

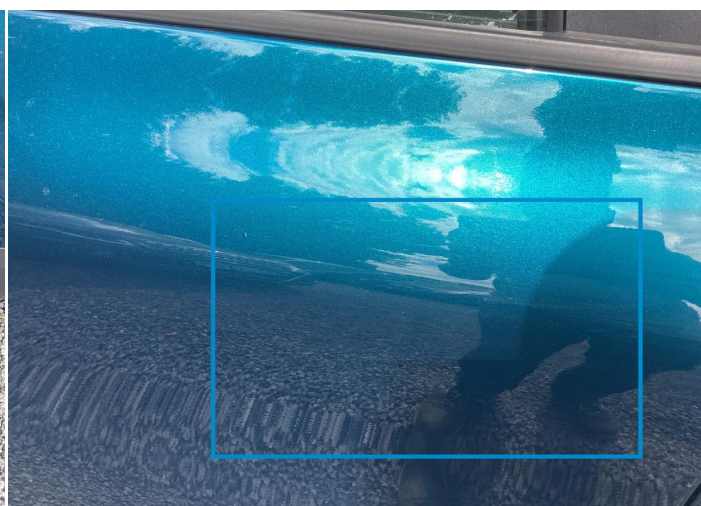
16. Door / Back Right
Paint / Scratch / Line -

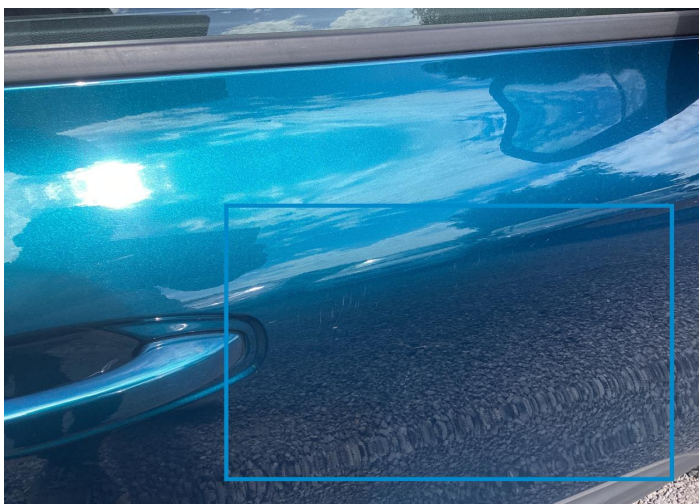
17. Door / Front Right
Paint / Scratch / Line -

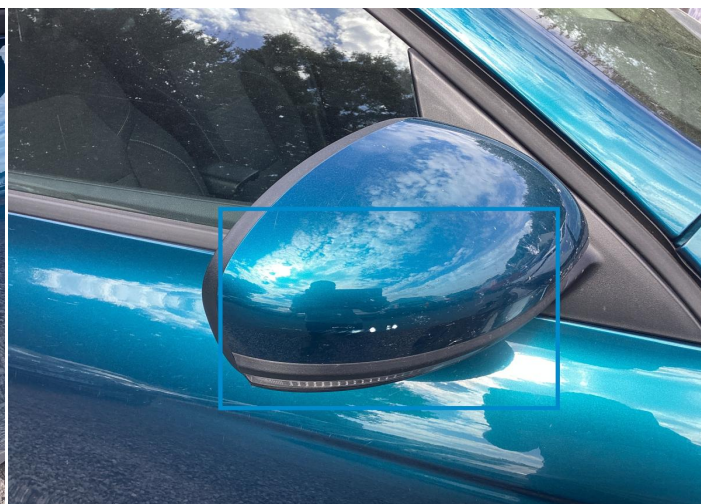
18. Mirror / Front Right
Paint / Scratch / Scuff -

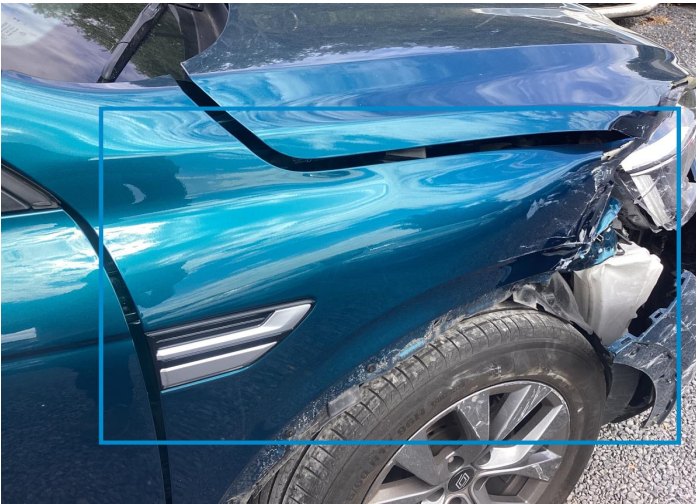
19. Fender / Front Right
Bodywork / Dent / Deformation -

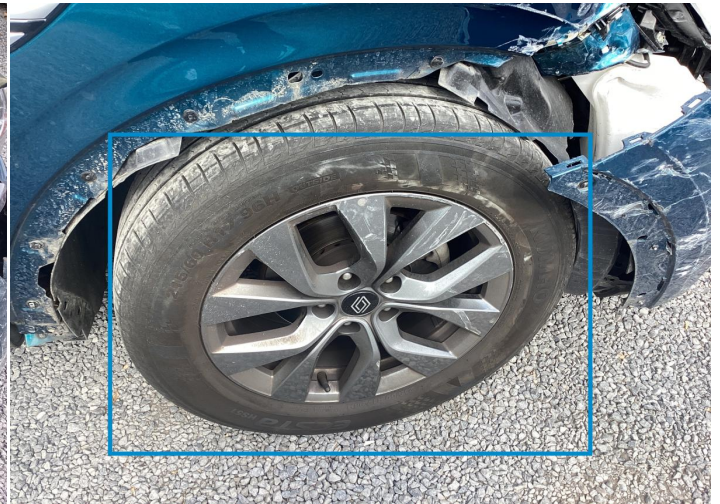
20. Rim / Front Right
Out of Bodywork / Breakage -
