RENAULT ARKANA

Arkana TCe 140 EDC - 23 Techno

VIN NO VF1RJL009UC489586
Registration Number GX863EP

Inspection Report Summary

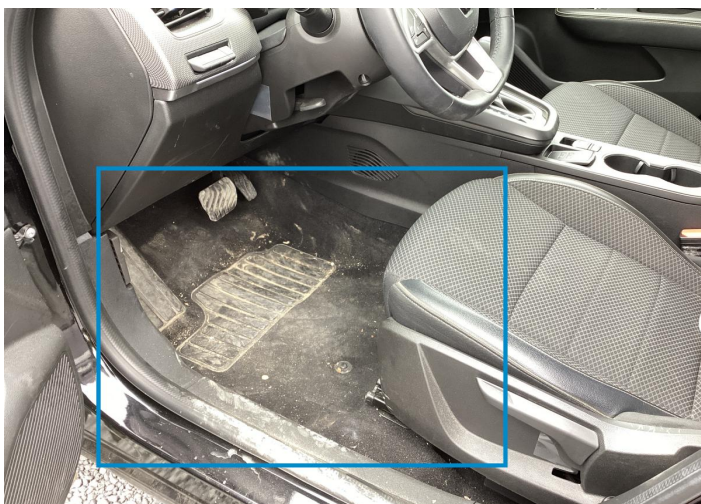
1. Floor Carpet
Interior / Dirty -

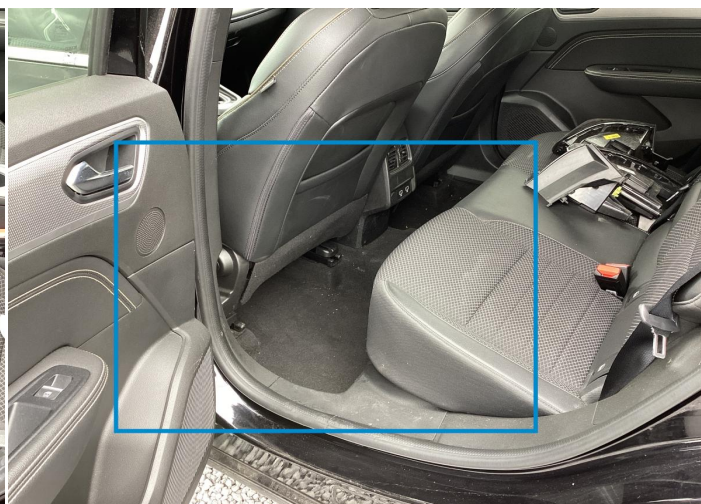
2. Floor Carpet
Interior / Dirty -

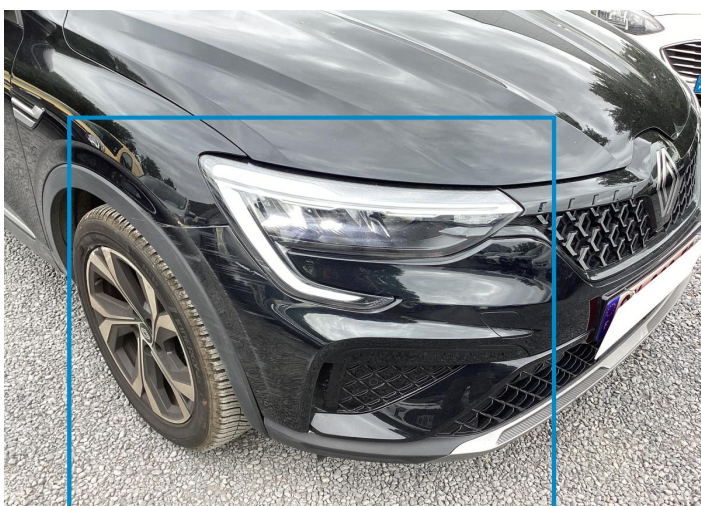
3. Corner Bumper / Front Right
Paint / Scratch / Scuff -

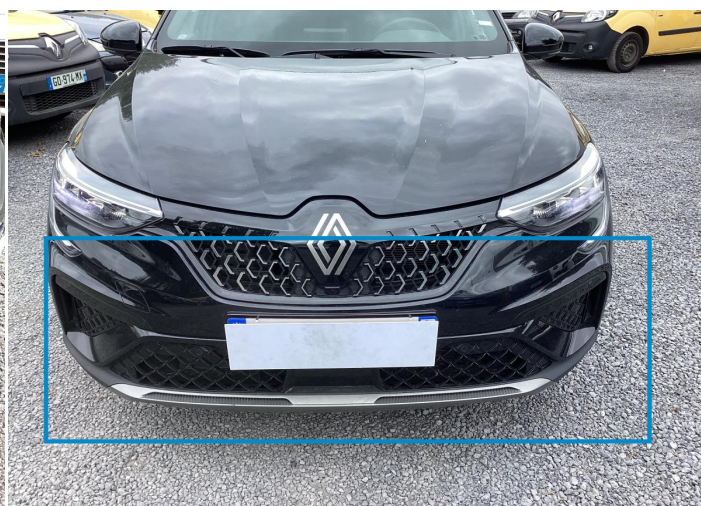
4. Bumper / Front
Paint / Scratch / Scuff -

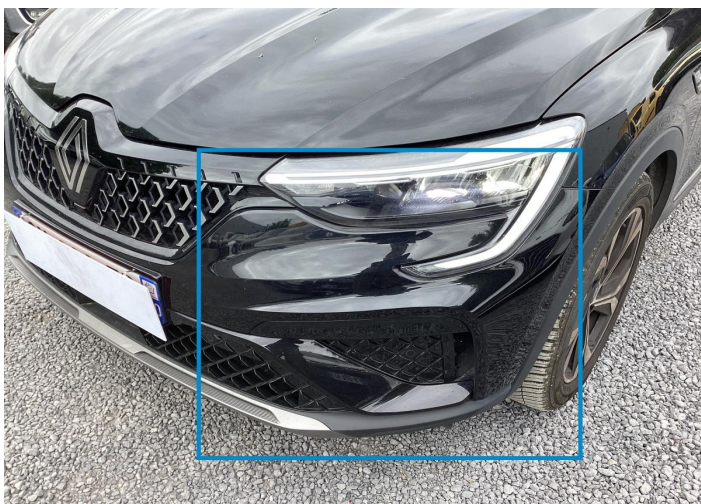
5. Corner Bumper / Front Left
Paint / Scratch / Scuff -

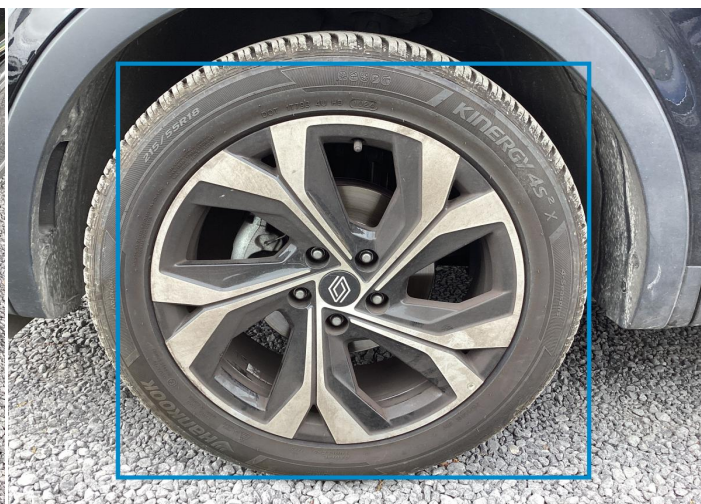
6. Rim / Front Left
Out of Bodywork / Scratch -

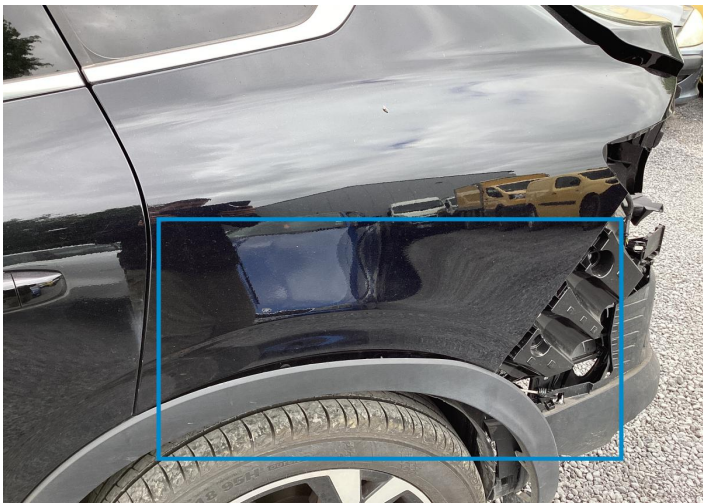
7. Side Panel / Back Left
Bodywork / Assembly -

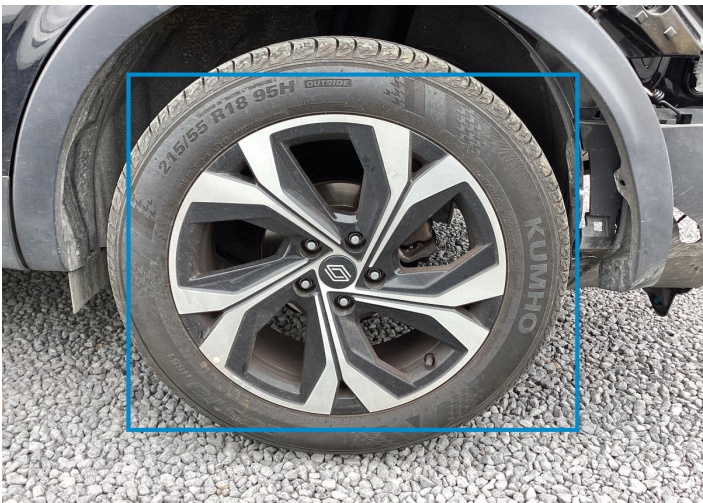
8. Rim / Back Left
Out of Bodywork / Scratch -

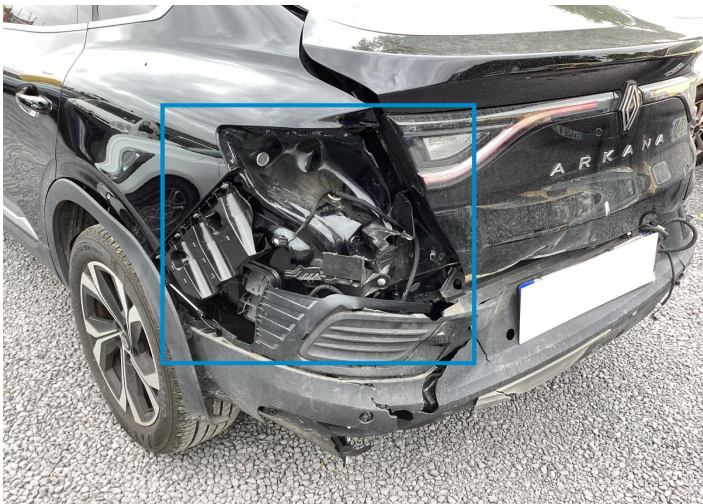
9. Corner Bumper / Back Left
Missing Part -

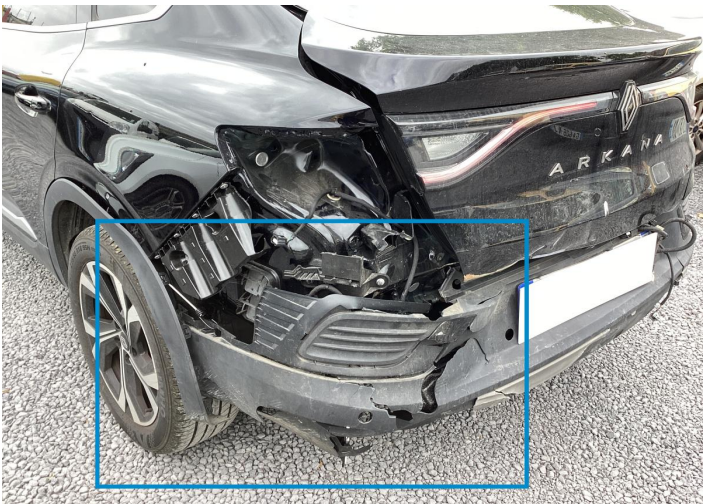
10. Corner Bumper / Back Left
Bodywork / Dent / Deformation -

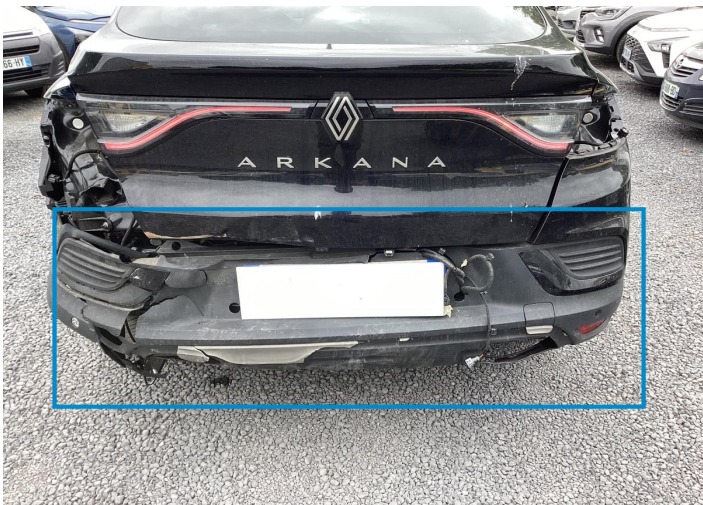
11. Bumper / Back
Bodywork / Dent / Deformation -

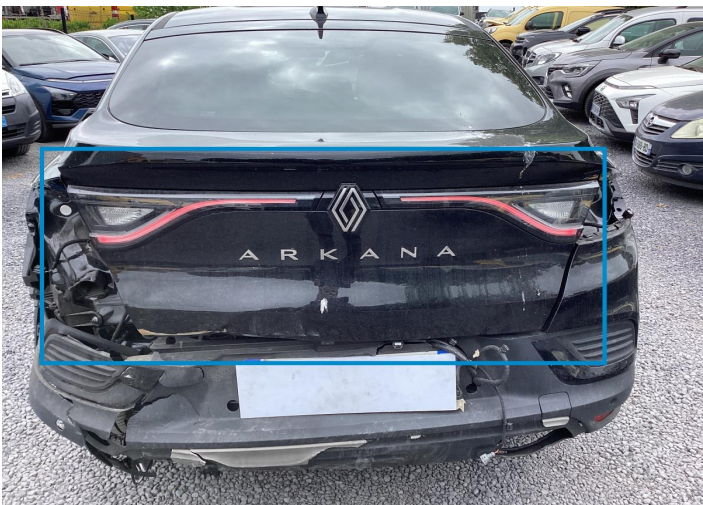
12. Tailgate
Bodywork / Dent / Deformation -

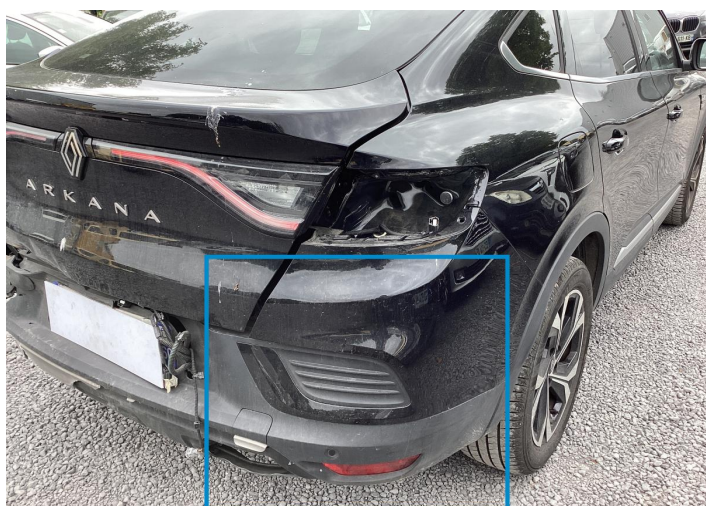
13. Corner Bumper / Back Right
Bodywork / Dent / Deformation -

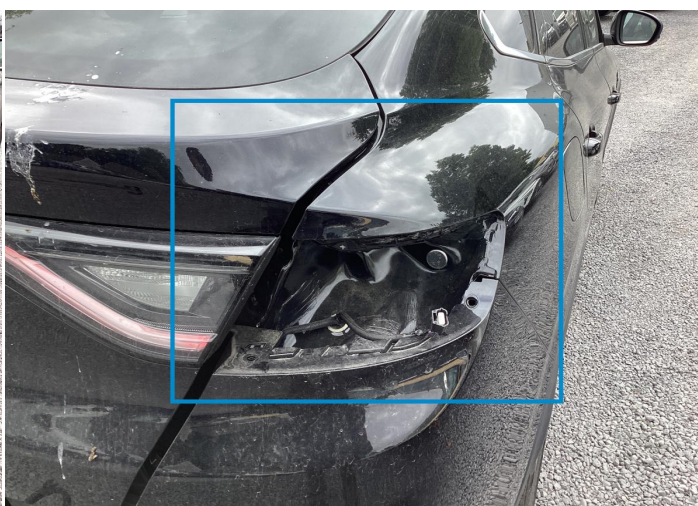
14. Back Light / Right
Missing Part -

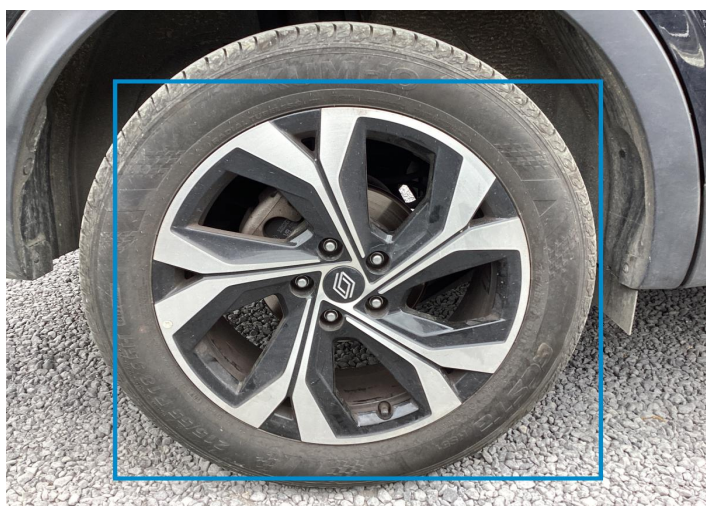
15. Rim / Back Right
Out of Bodywork / Scratch -

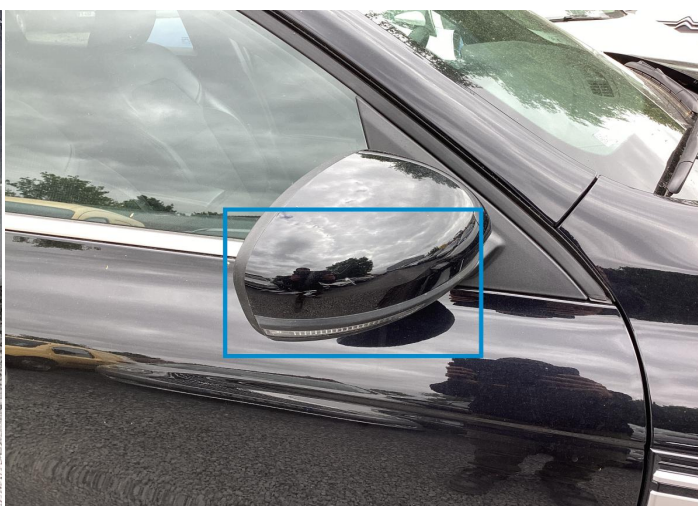
16. Mirror / Front Right
Paint / Scratch / Scuff -

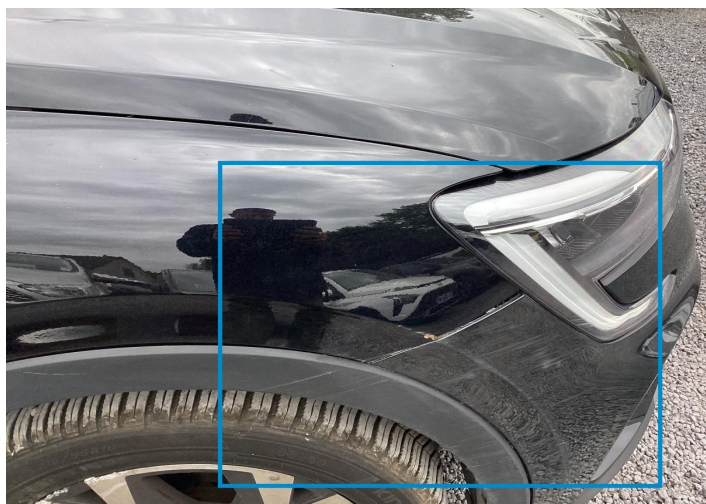
17. Fender / Front Right
Paint / Scratch / Scuff -

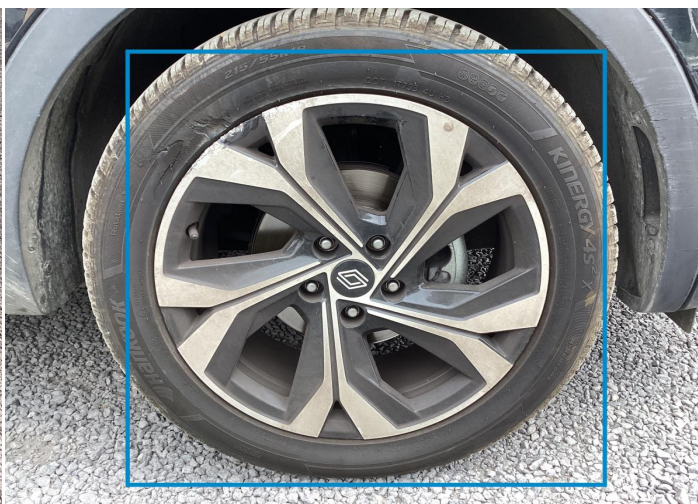
18. Rim / Front Right
Out of Bodywork / Scratch -
