Expertise

Protocol number: 41767397
Order number / reference: 25177772
Inspection date: 30 Sept 2025

Manufacturer: Renault

Model: Koleos TCe 160 EDC GPF INITIALE PARIS

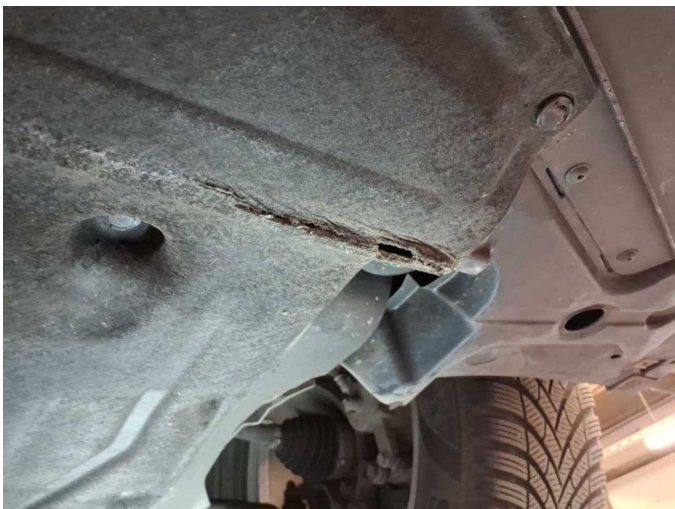
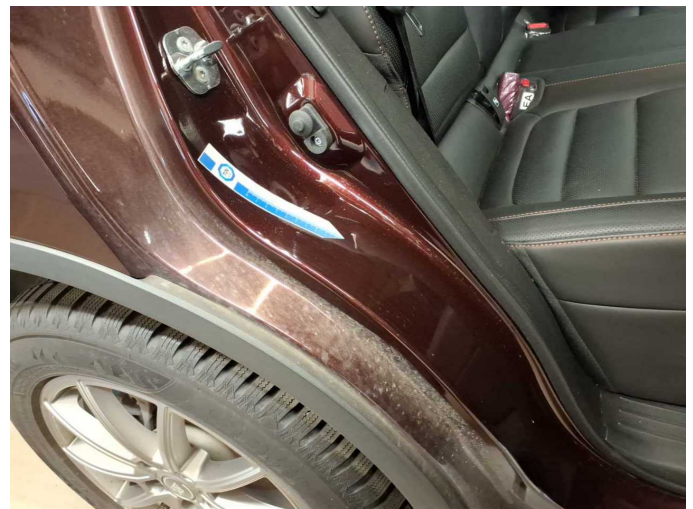
No.	Component group	Description
1	Engine	Engine cowling - lower - Holes - Replace
2	Side panel - rear right side	Sill - Dent / paintcoat damage - Smart repair
3	Seat - front	Seat - left side (Spiel in der Sitzschiene) - Loose - Perform diagnosis
4	Side panel - rear right side	Side panel - Scratch(es) - Paint
5	Front bumper	Front bumper - Scratch(es) - Paint
6	Door - rear left side	Door - Scratch(es) - Paint
7	Door - rear right side	Door - Scratch(es) - Paint
8	Door - front left side	Door - Scratch(es) - Paint
9	2nd wheel set	2nd wheel set (Sommerradsatz 19 Zoll fehlt) - Differs from the original configuration - Repair and paint

Damage 1: Engine: Engine cowl - lower - Holes - Replace

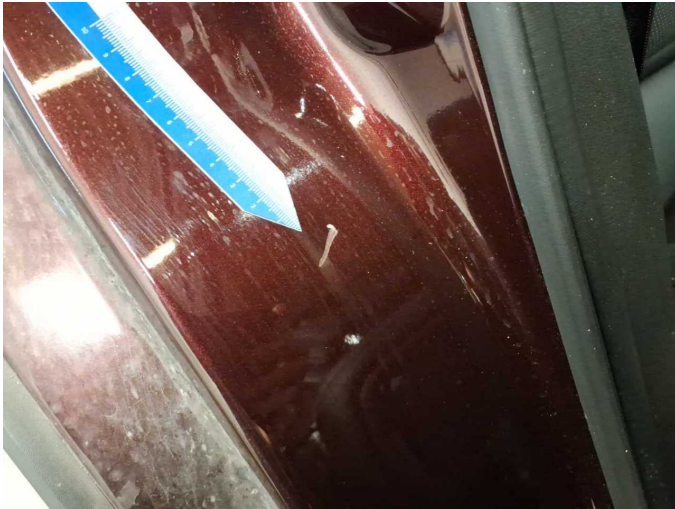
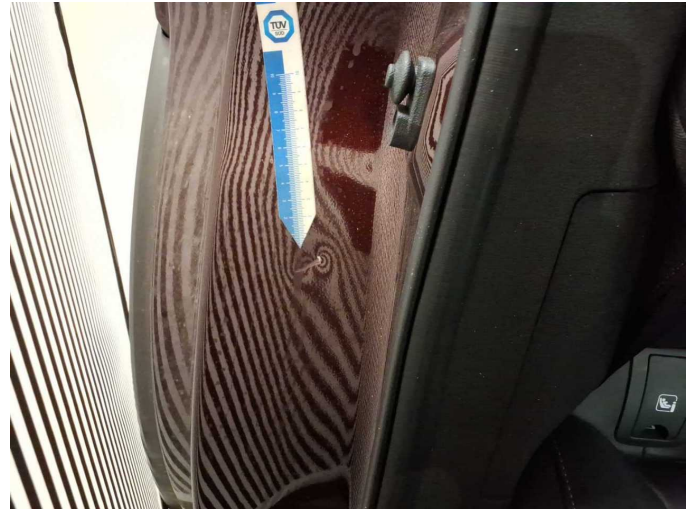
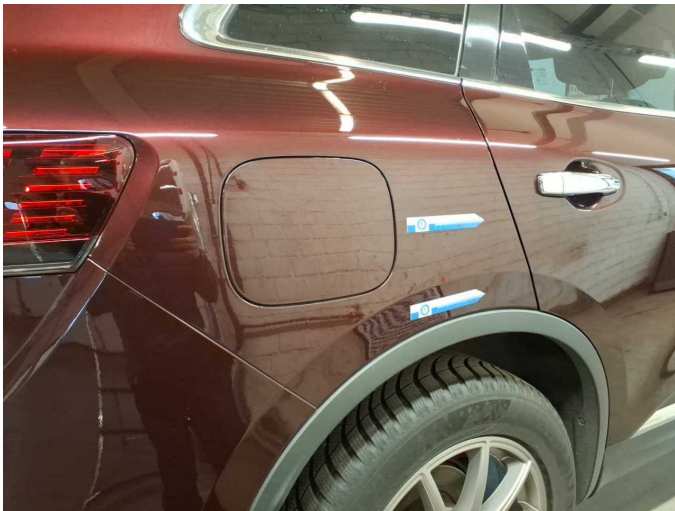
Damage 2: Side panel - rear right side: Sill - Dent / paintcoat damage - Smart repair

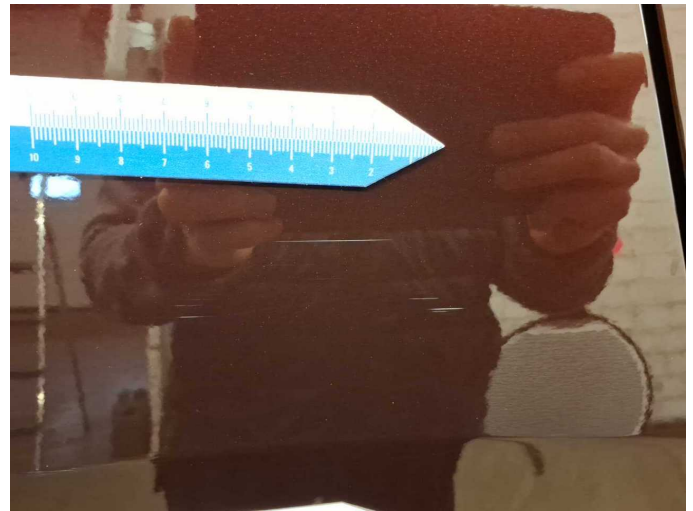
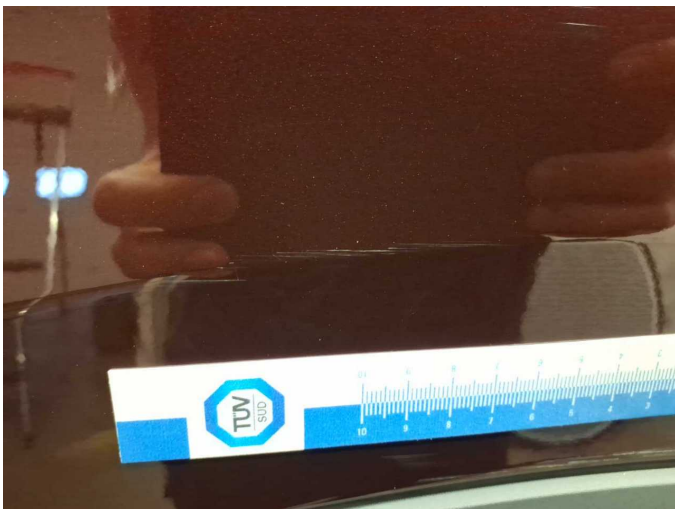
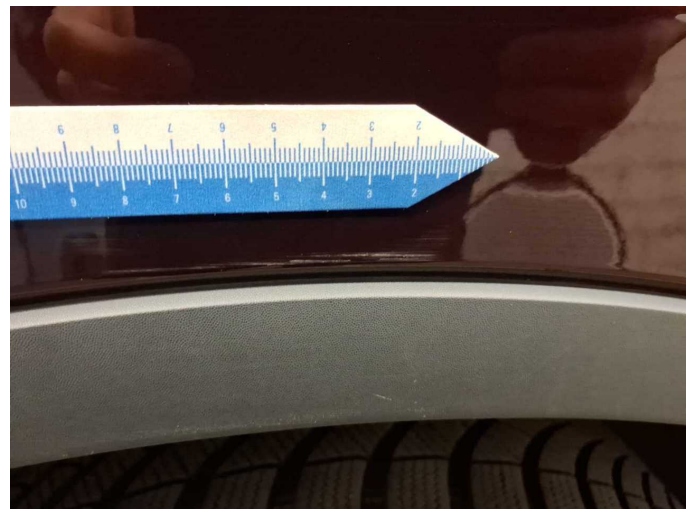
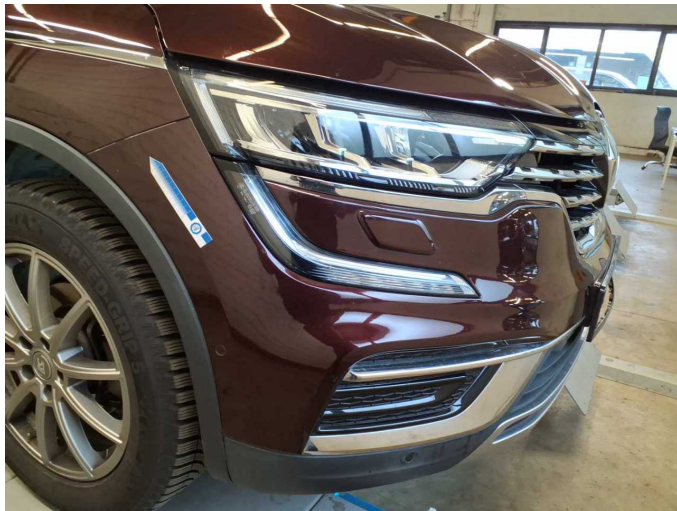
Damage 4: Side panel - rear right side: Side panel - Scratch(es) - Paint

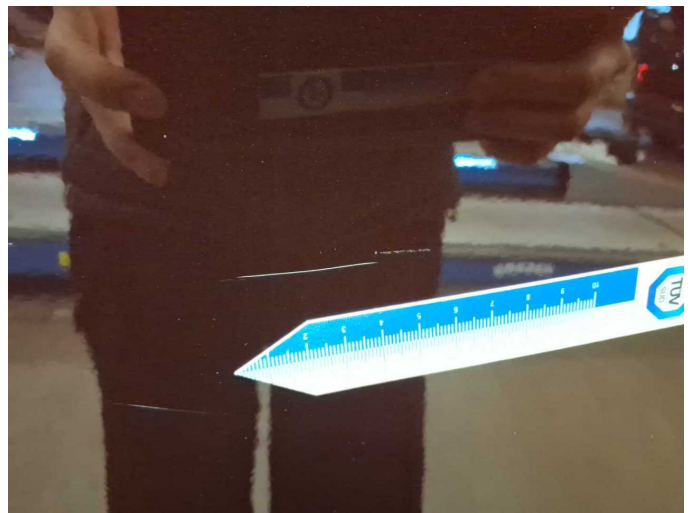
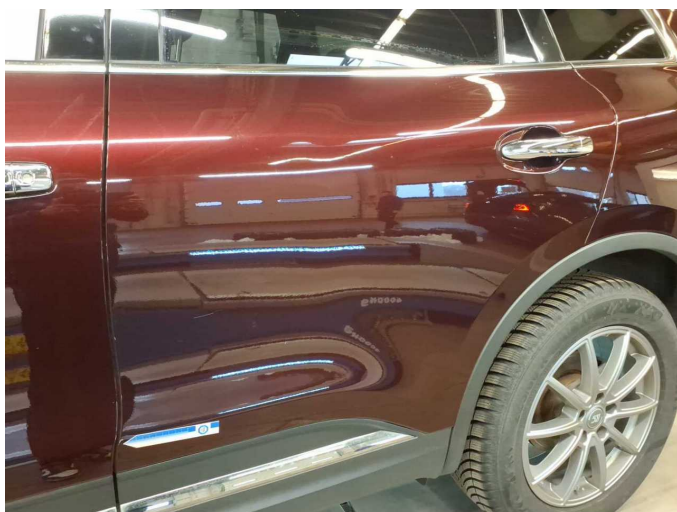
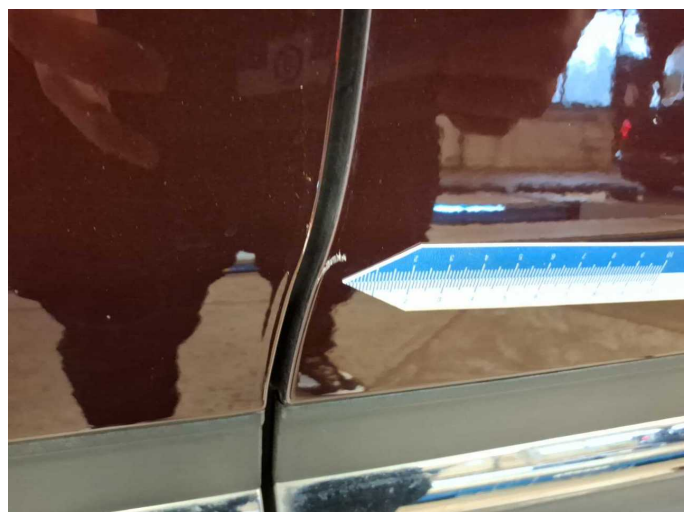
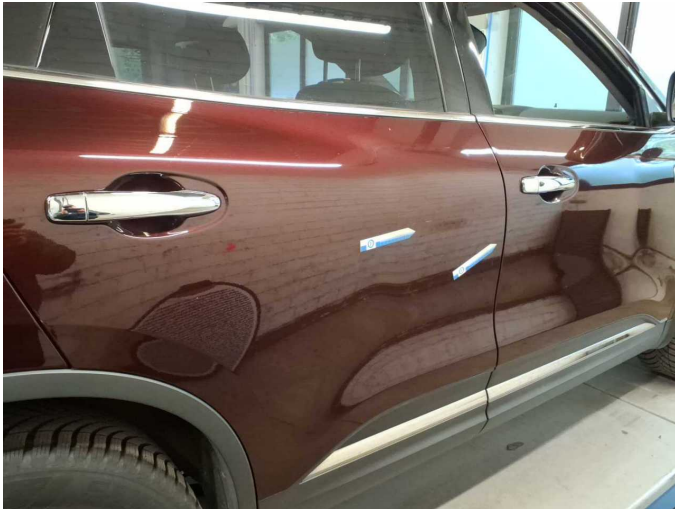
Damage 6: Door - rear left side: Door - Scratch(es) - Paint

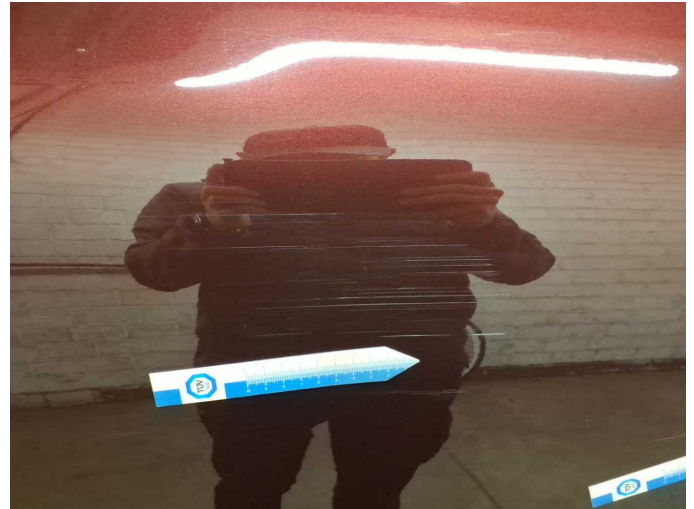
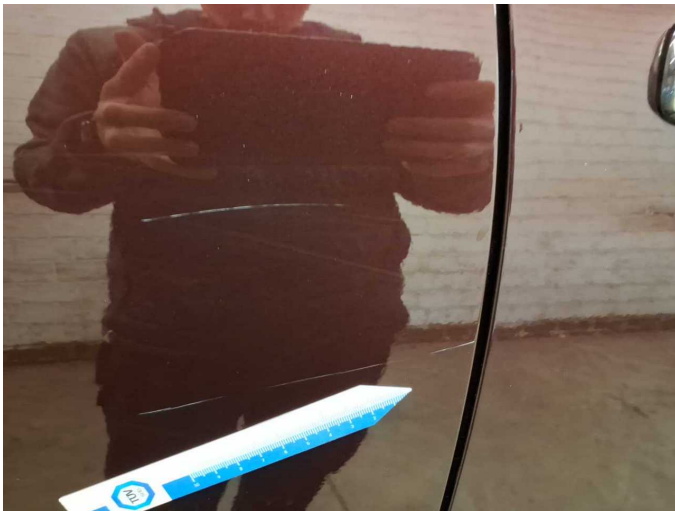
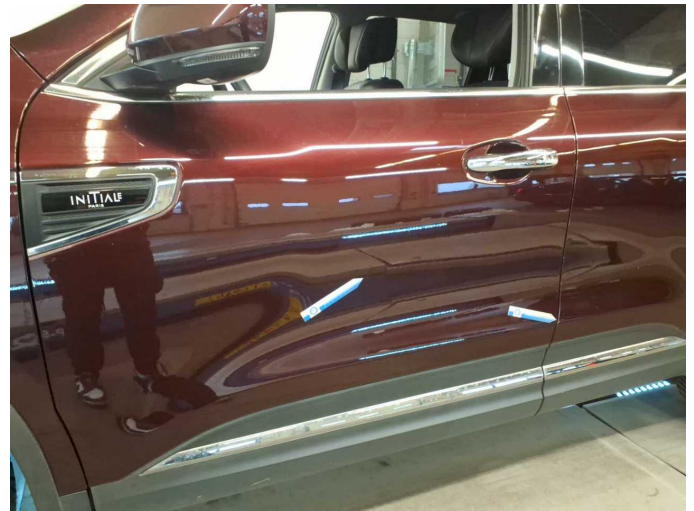
Damage 7: Door - rear right side: Door - Scratch(es) - Paint

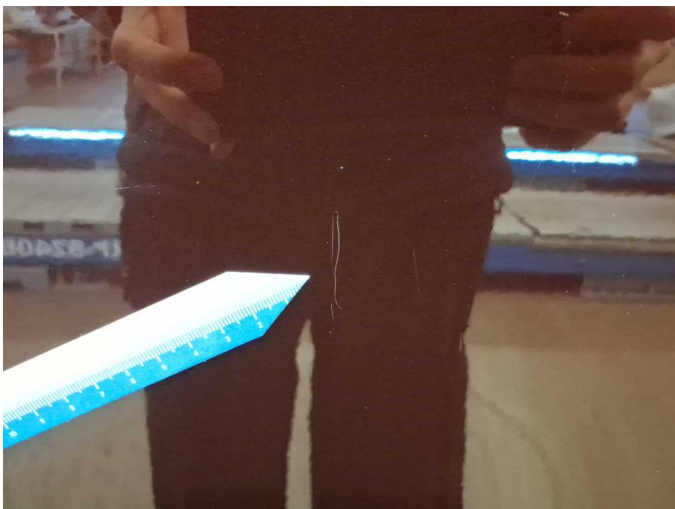
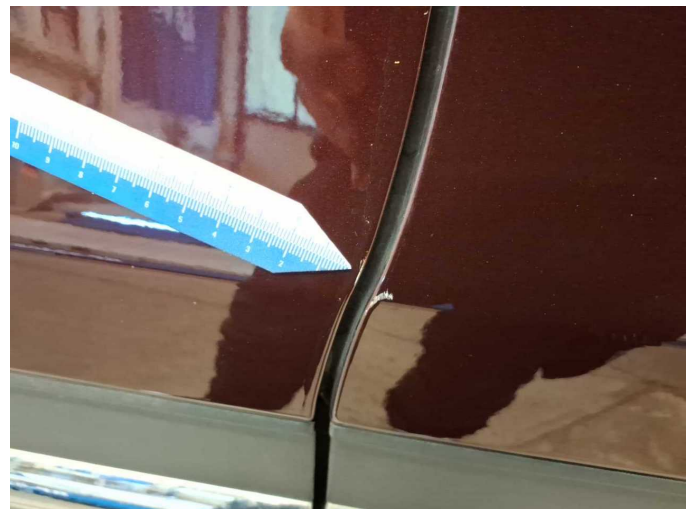
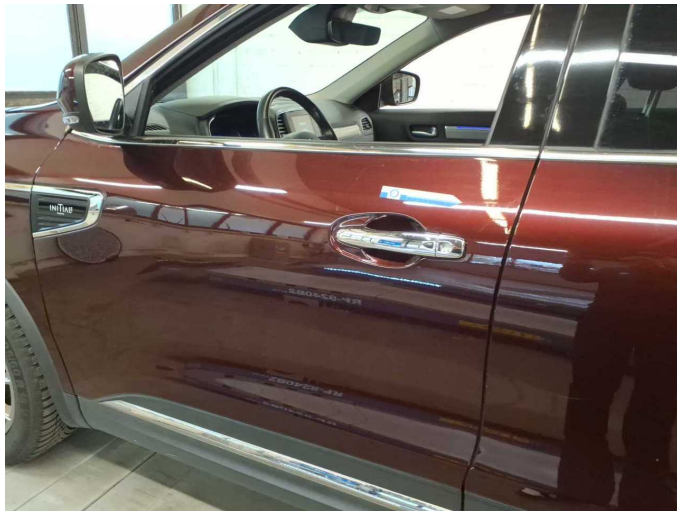
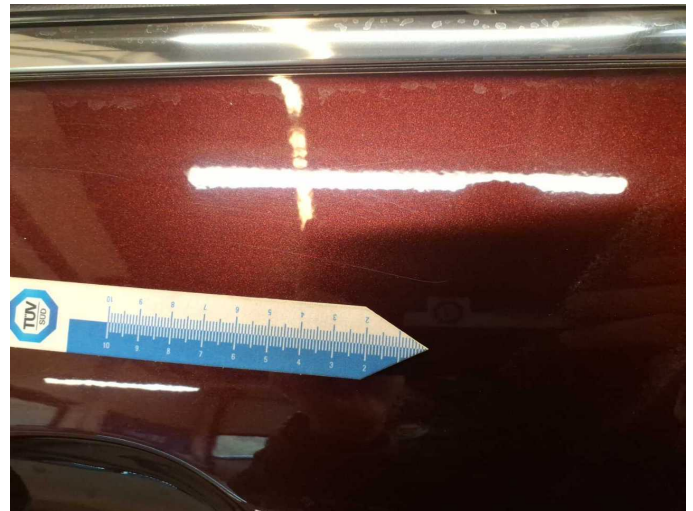
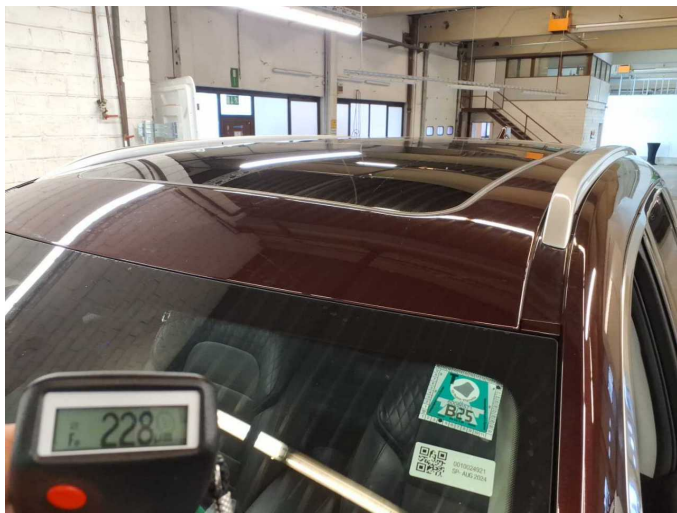
Damage 8: Door - front left side: Door - Scratch(es) - Paint

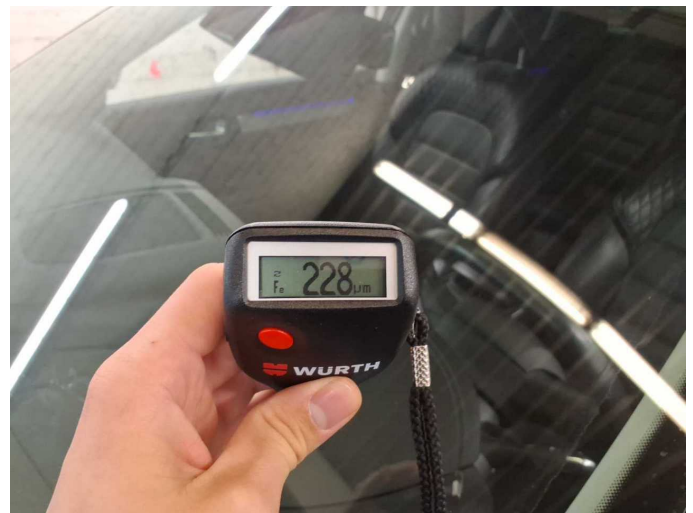
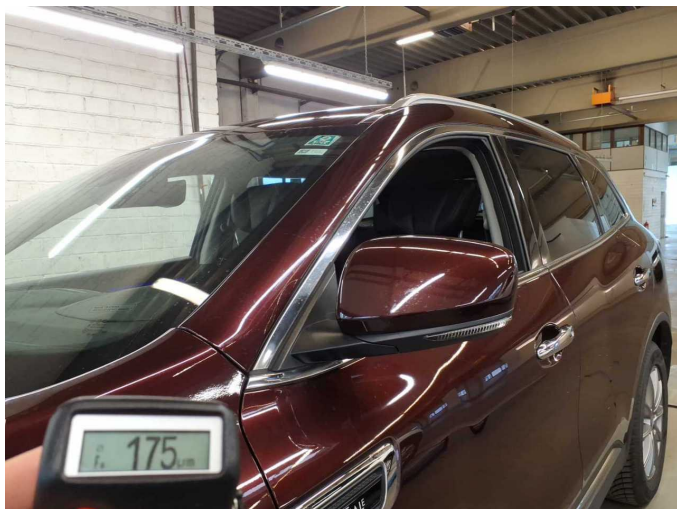
Repainting 1: Roof

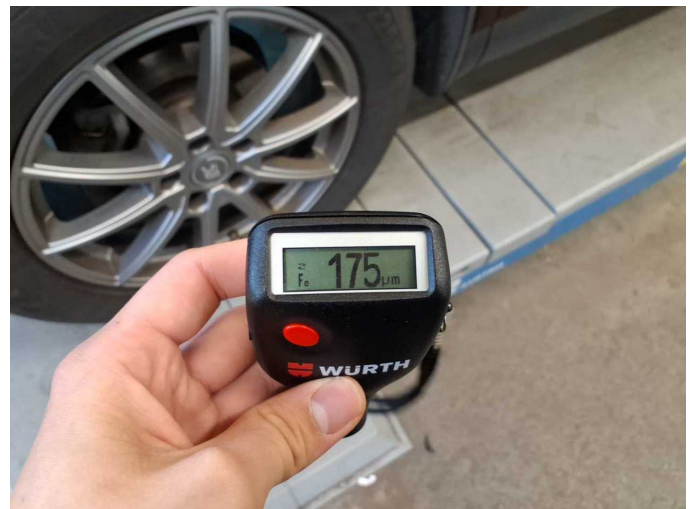
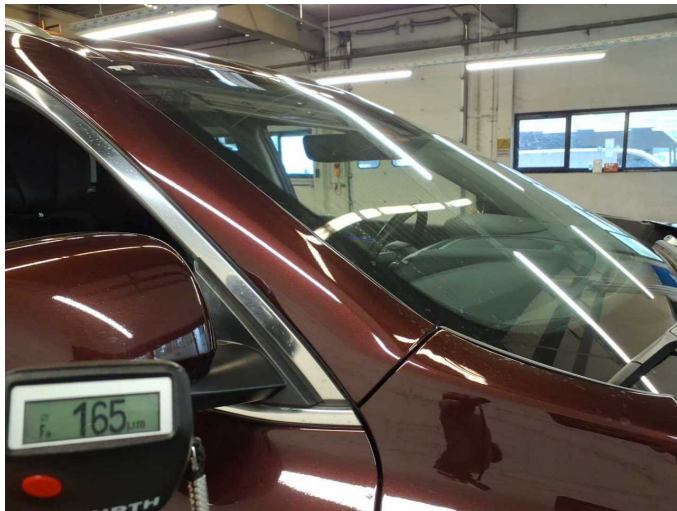
Repainting 2: Roof rail - left side

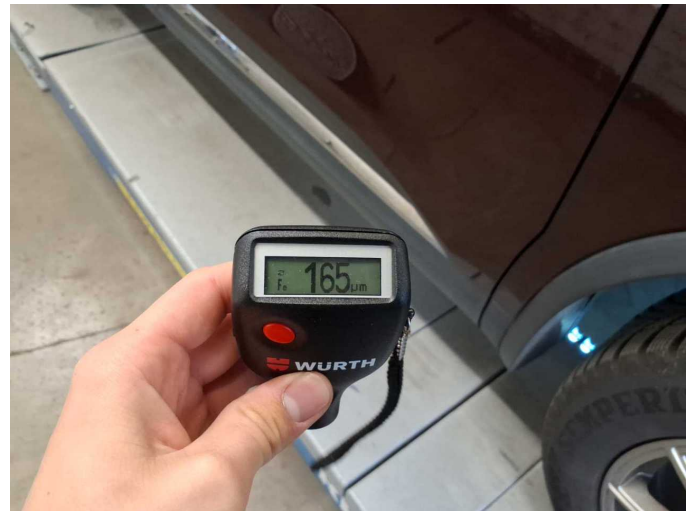
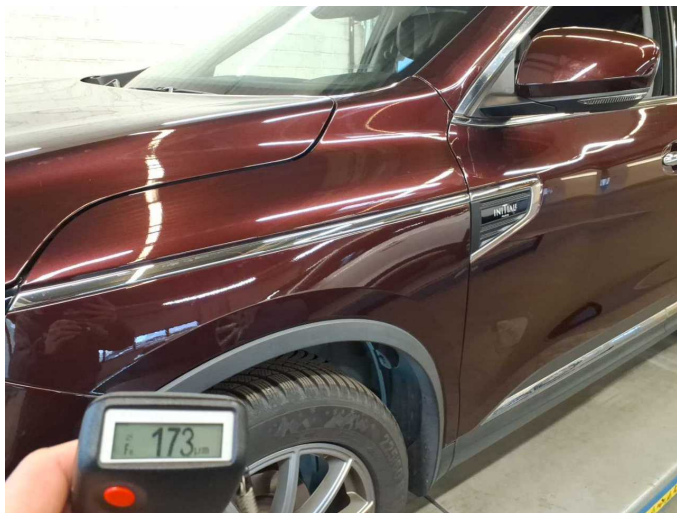
Repainting 3: Roof rail - right side

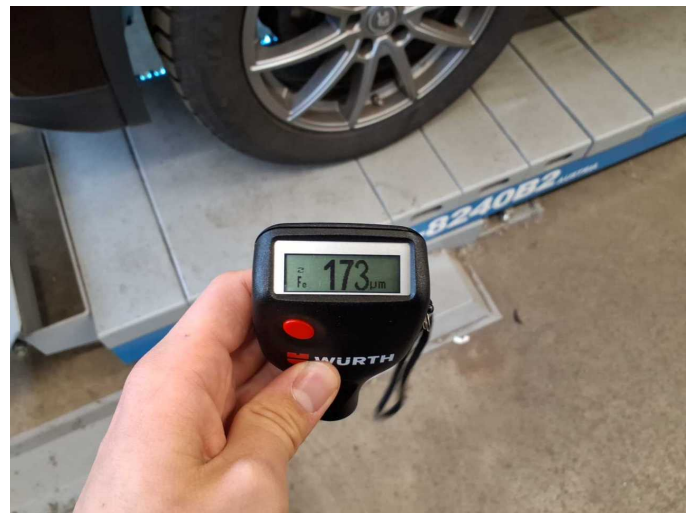
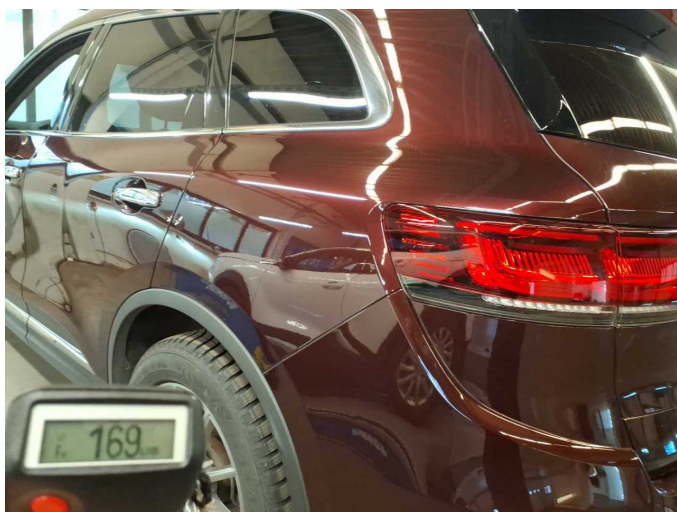
Repainting 4: Mudguard - left side

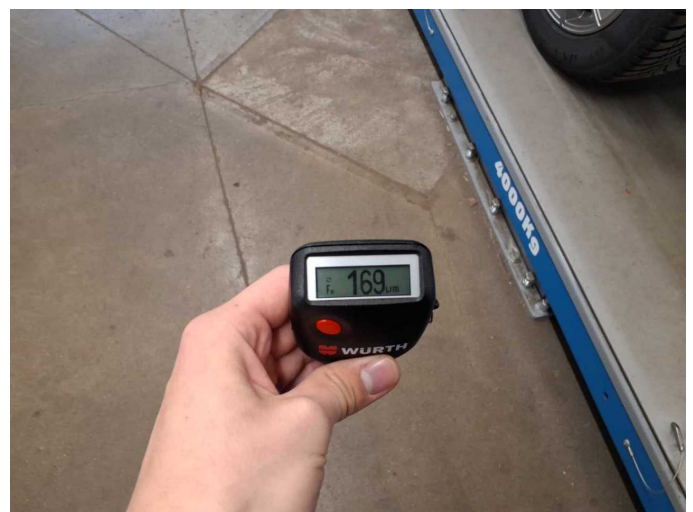
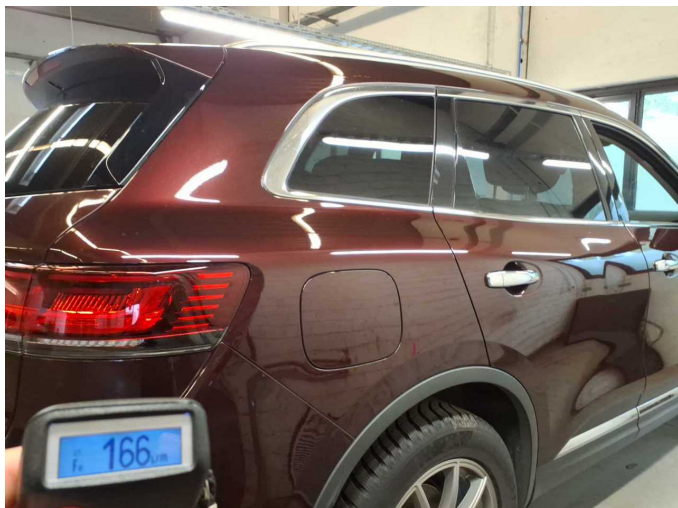
Repainting 5: Side panel - rear left side

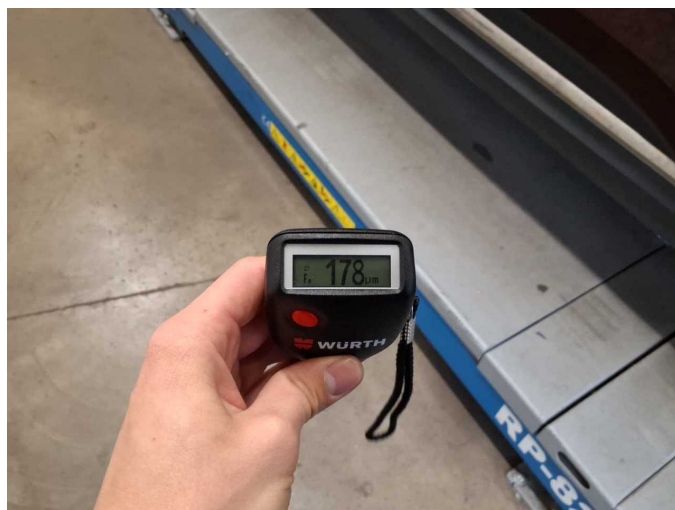
Door - front right side

178 µm

Repainting 7: Door - front right side
