Expertise

Protocol number: 41601312
Order No. / Reference: 25101426
Inspection date: 17 Sept 2025

Manufacturer: Renault	Model: Kangoo Rapid Blue dCi 95 Extra
VIN: VF1WF000465656933

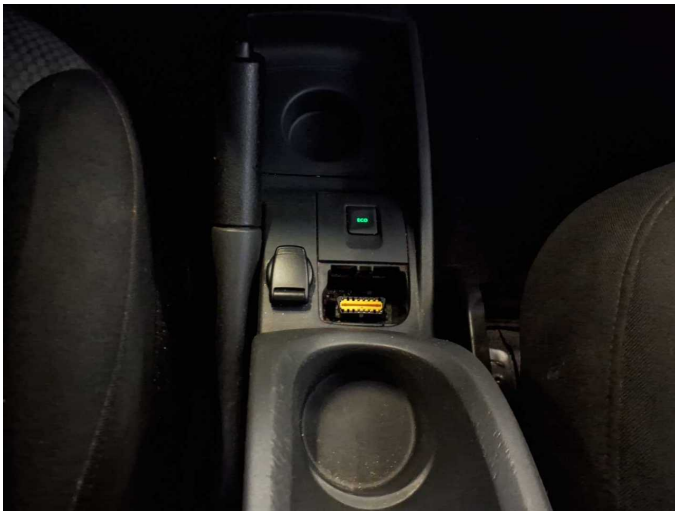
Damage 1: Instrument panel: Centre console - front (OBD Abdeckung) - Missing - Replace

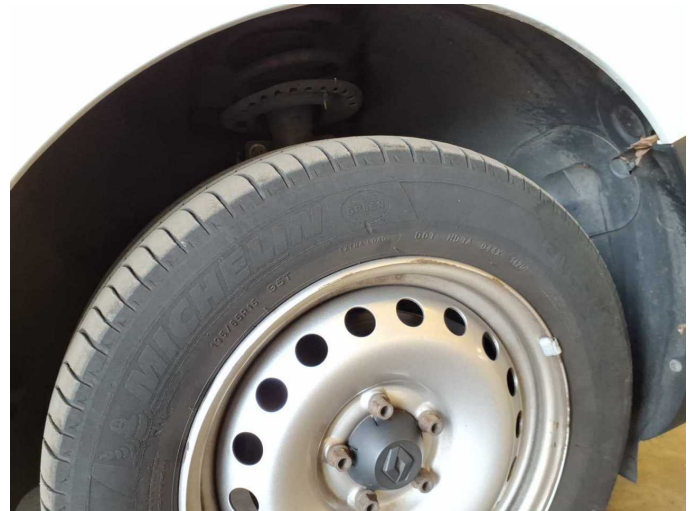
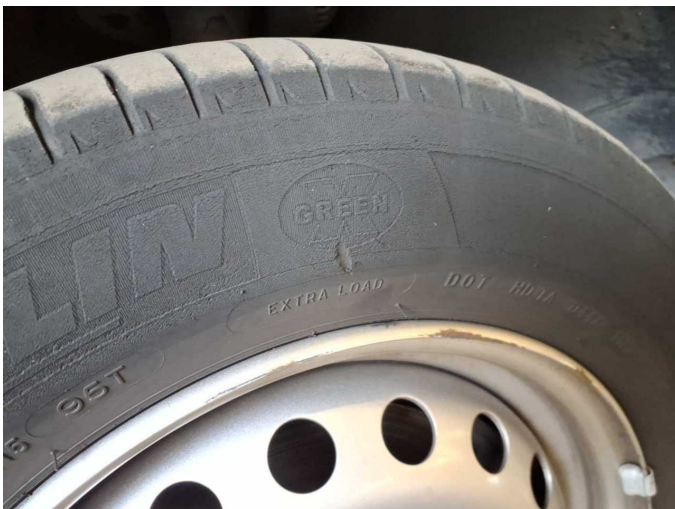
Damage 2: Wheel / tyres: Tyre - front right side (nicht fahrbereit) - Damaged - Replace

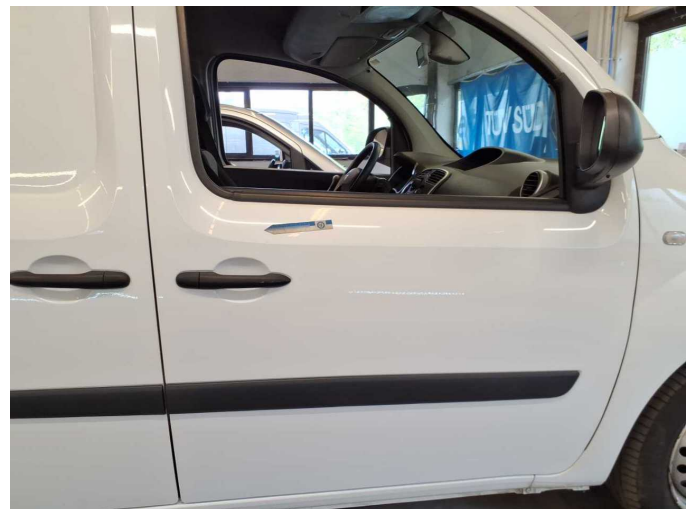
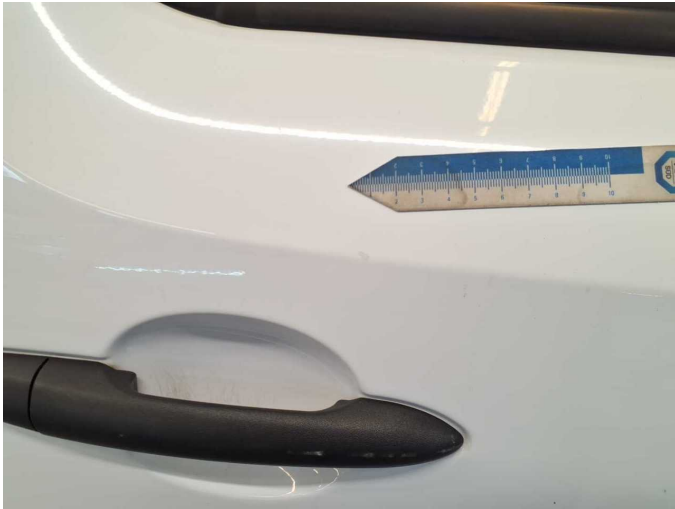
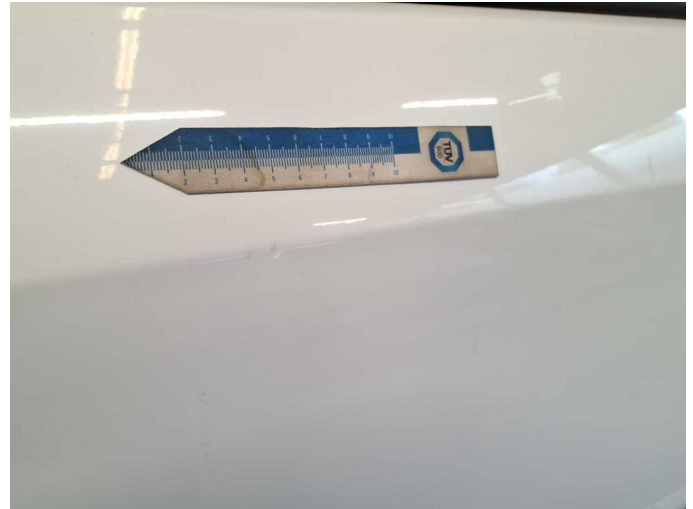
Damage 3: Door - front right side: Door - Scratch(es) - Smart repair

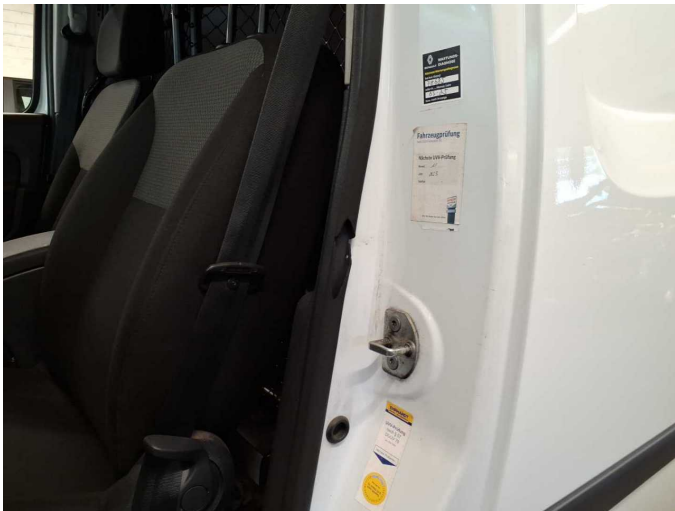
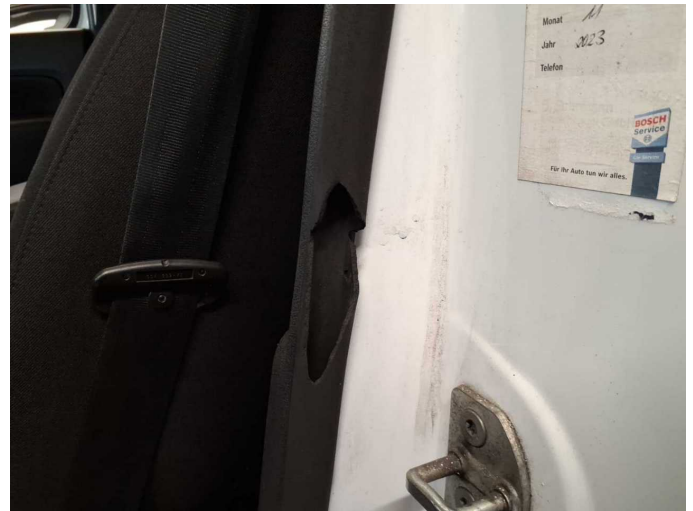
Damage 4: Door - front left side: Door seal - Broken / torn - Replace

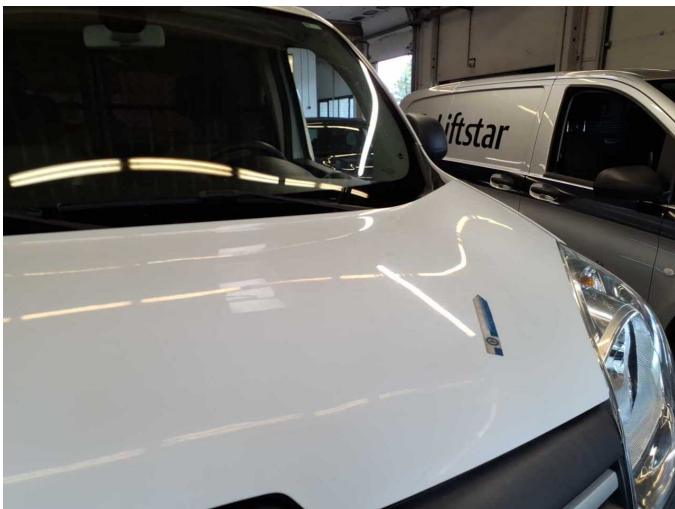
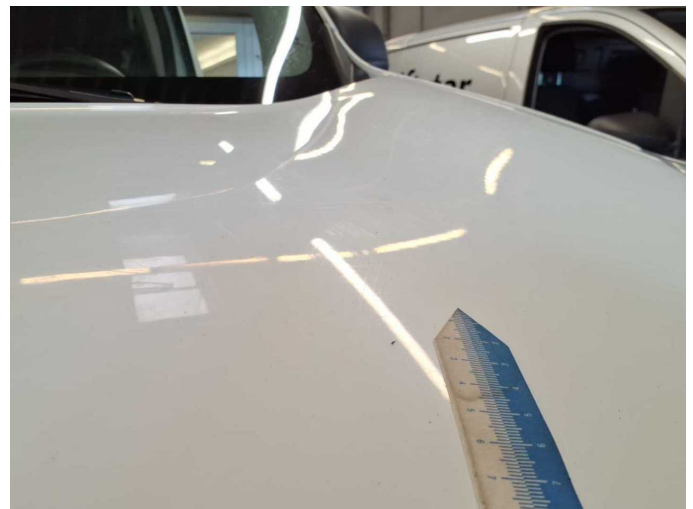
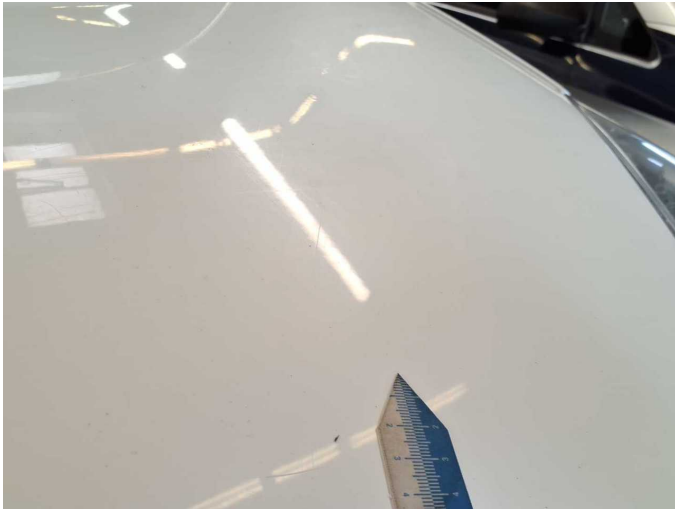
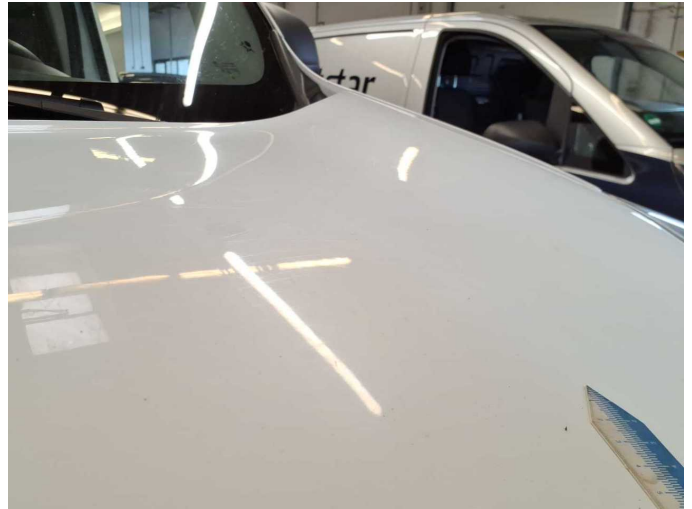
Damage 5: Bonnet: Bonnet - Scratch(es) - Paint

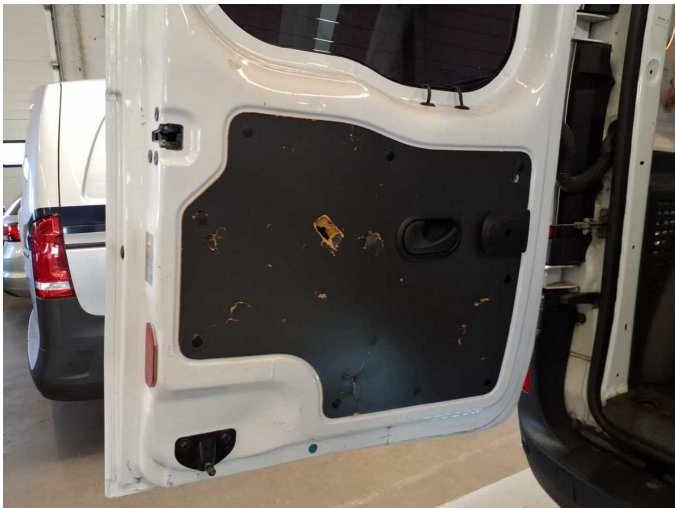
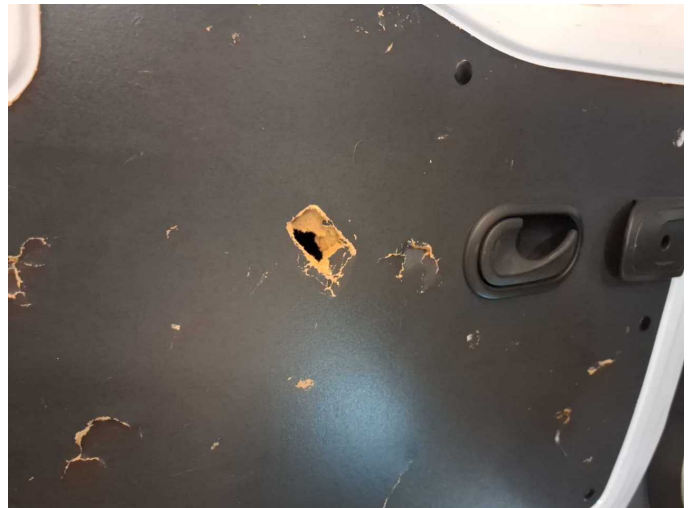
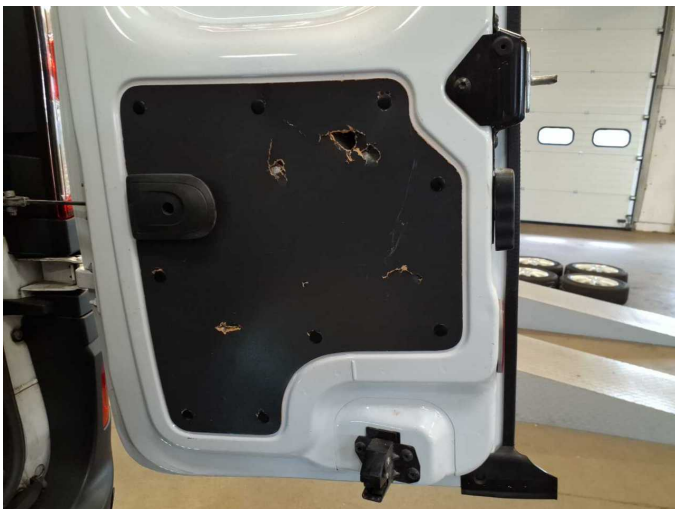
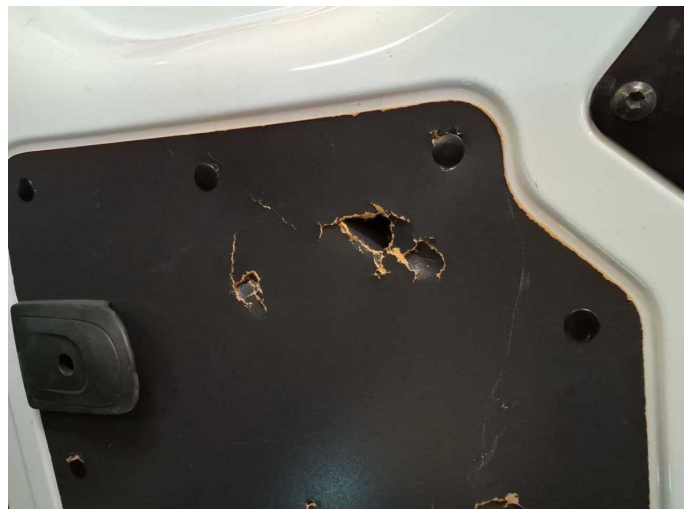
Damage 6: Trim / covers: Boot lid - interior trim (L+ R) - Broken / torn - Replace

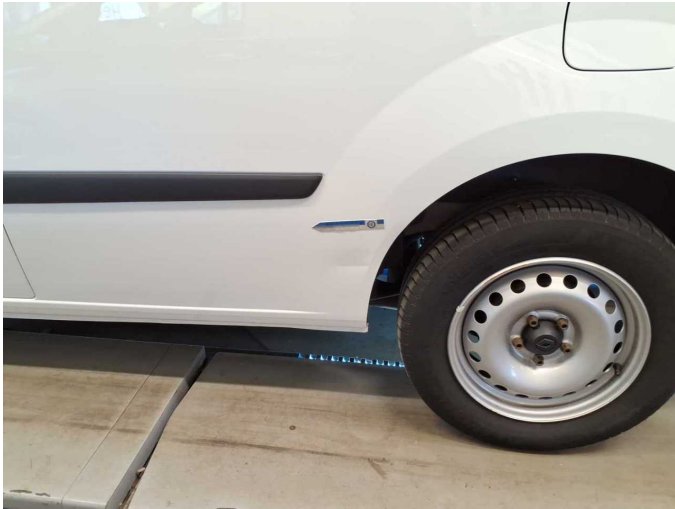
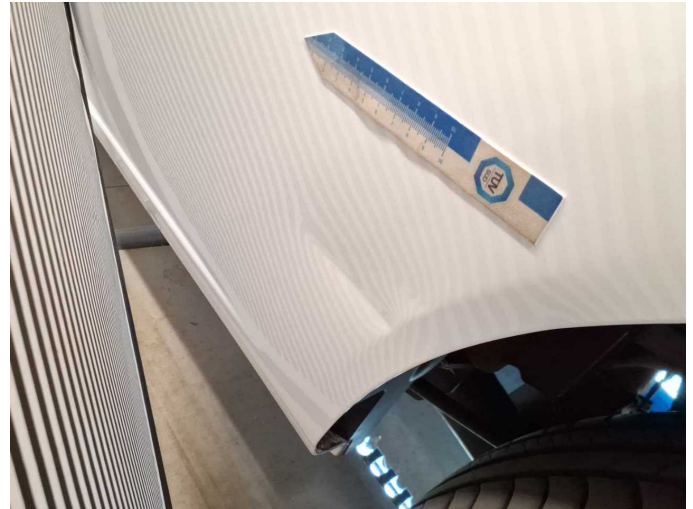
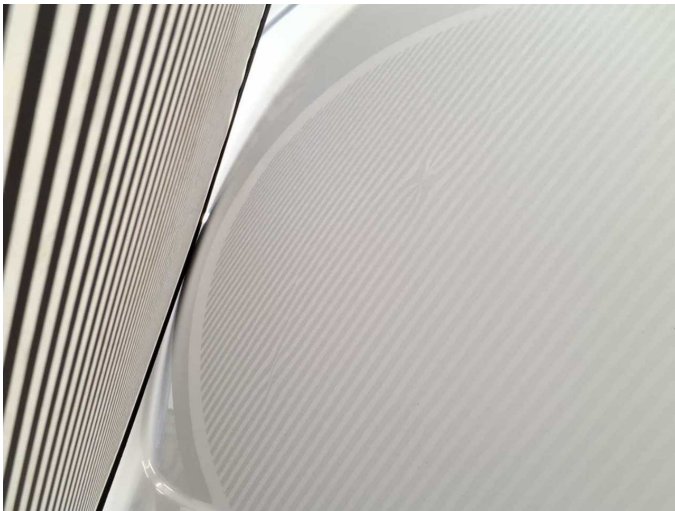
Damage 7: Side panel - rear left side: Side panel - Deformed - Repair and paint

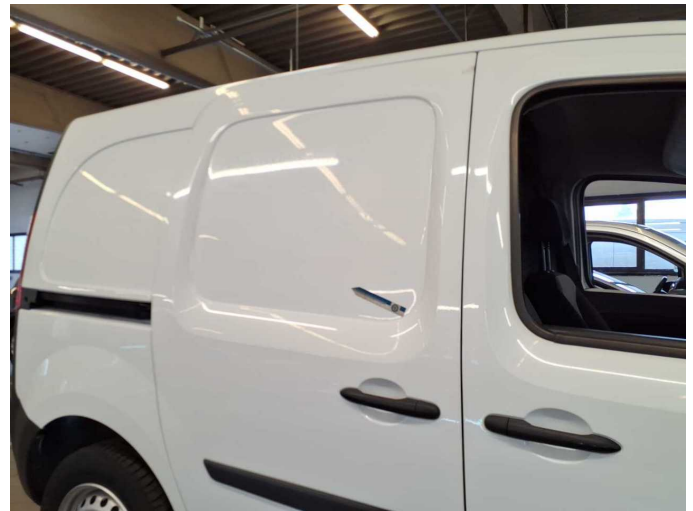
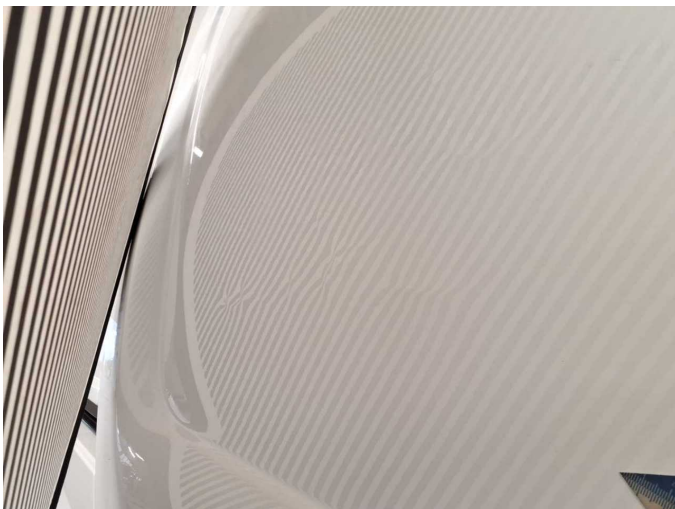
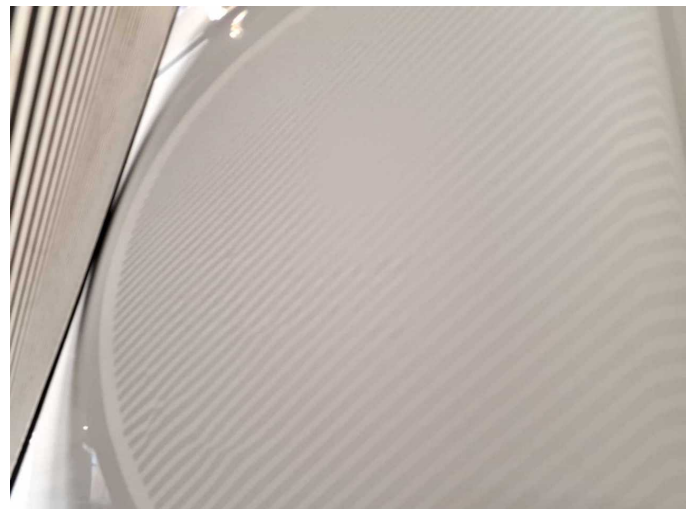
Damage 8: Side panel - rear right side: Side panel - Deformed - Repair and paint

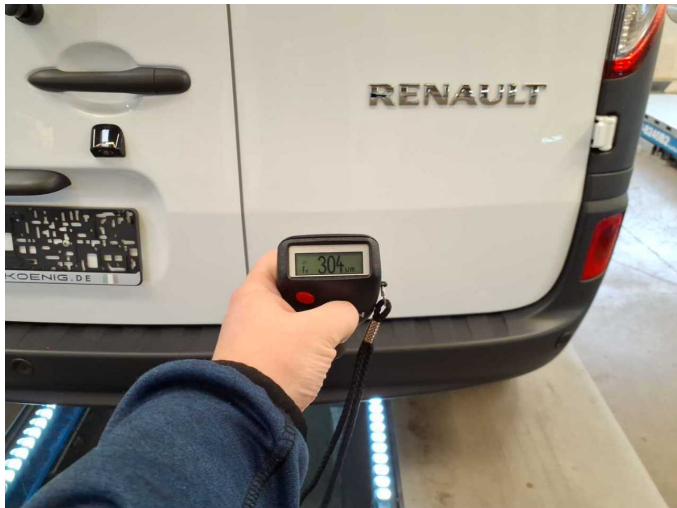
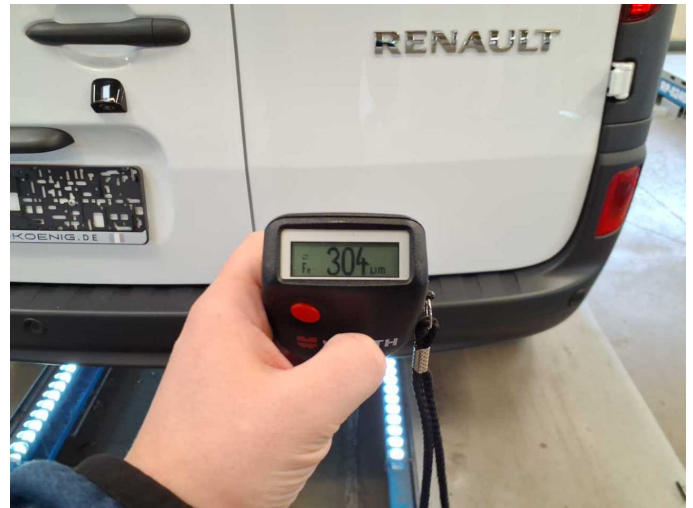
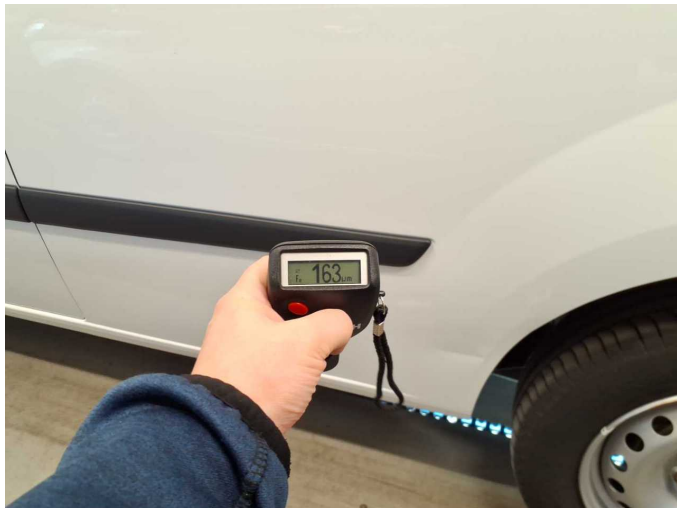
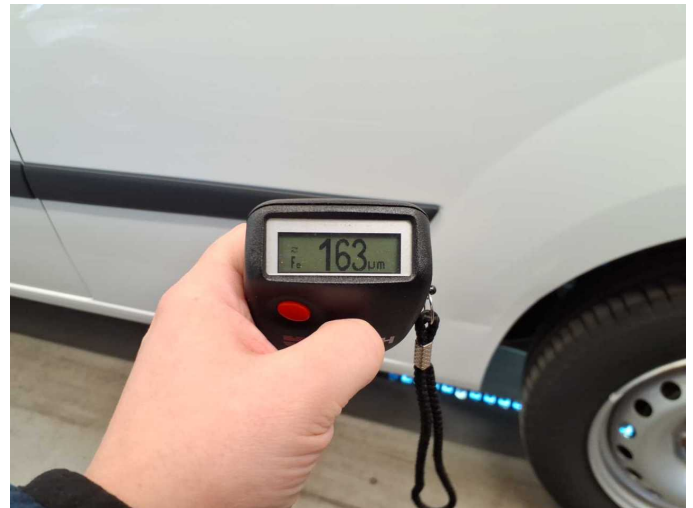
No.	Repainting
1	Boot lid / rear door, Side panel - rear left side, Professionally carried out, Invoice of repair done Non-existent

Boot lid / rear door	304 µm	Side panel - rear left side	163 µm
----------------------	--------	-----------------------------	--------

Repainting 1: Boot lid / rear door, Side panel - rear left side
