PEUGEOT 5008

5008 1.6 HDi 115ch FAP BVM6 Style 5pl

VIN NO VF30E9HD8FS038978

Inspection Report Summary

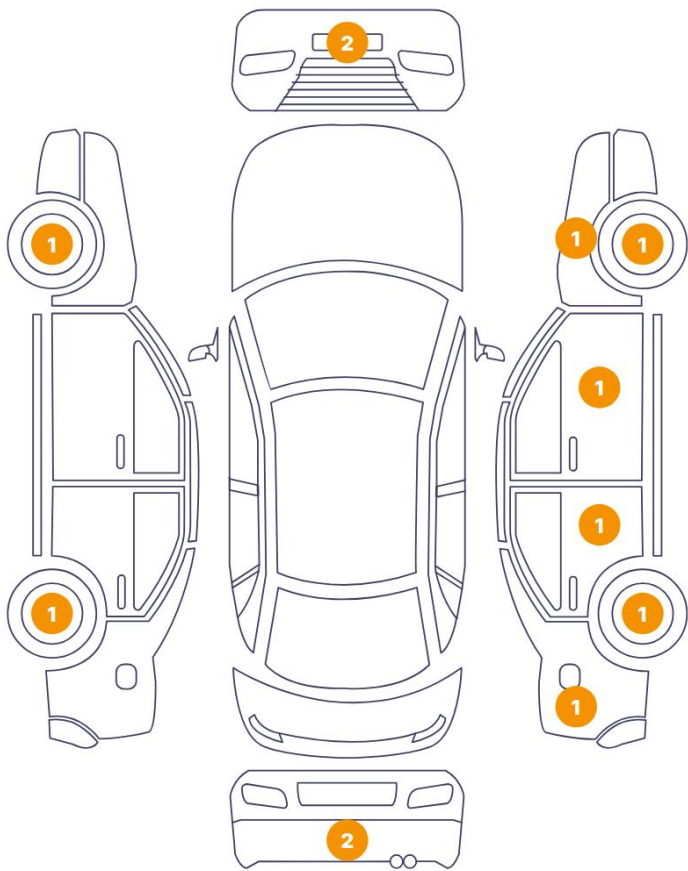
12 Dommages

Component		Damage	Comments
1	Floor Carpet	Interior / Holed	
2	Door / Back Right	Paint / Scratch / Line	
3	Floor Carpet	Interior / Dirty	
4	Door / Front Right	Paint / Scratch / Scuff	
5	Side Panel / Back Right	Paint / Scratch / Scuff	
6	Bumper / Front	Paint / Scratch / Scuff	
7	Bumper / Back	Paint / Scratch / Scuff	
8	Bumper / Front	Paint / Scratch / Scuff	
9	Rim / Front Left	Out of Bodywork / Scratch	
10	Bumper / Back	Paint / Scratch / Scuff	
11	Rim / Back Right	Out of Bodywork / Scratch	
12	Fender / Front Right	Paint / Scratch / Line

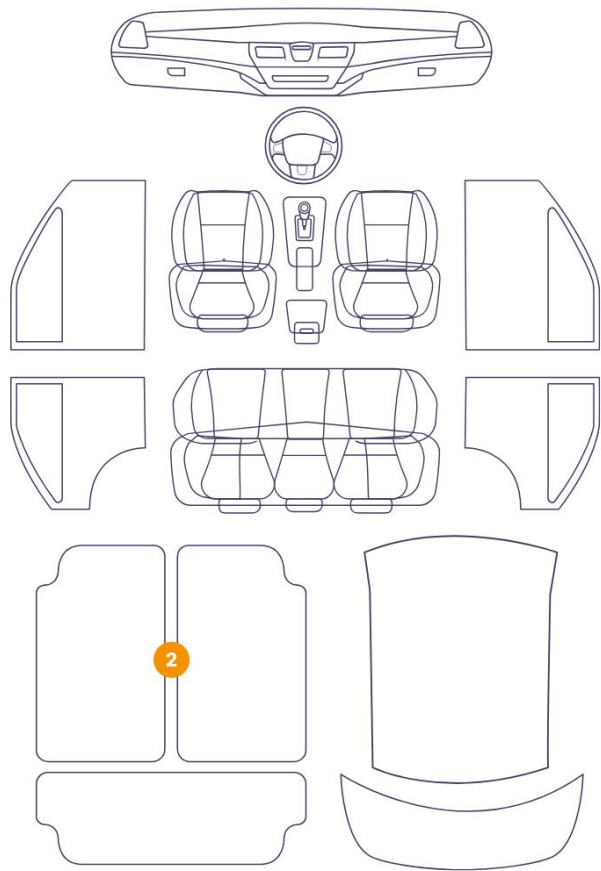
2 Dommages

13	Rim / Back Left	Out of Bodywork / Scratch	
14	Rim / Front Right	Out of Bodywork / Scratch	À plat

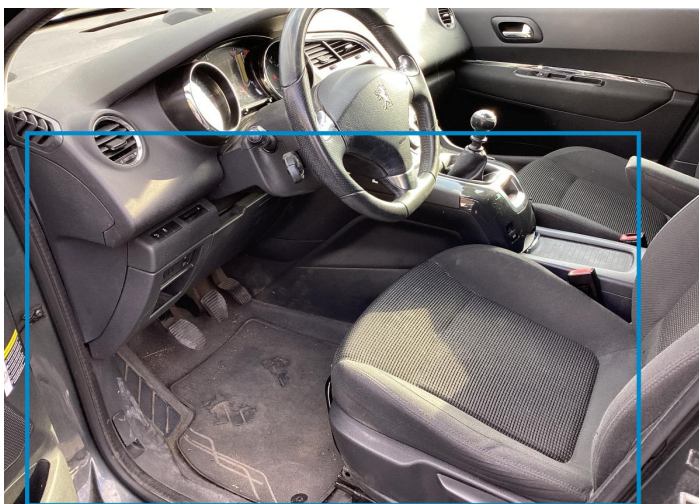
1. Floor Carpet
Interior / Holed -

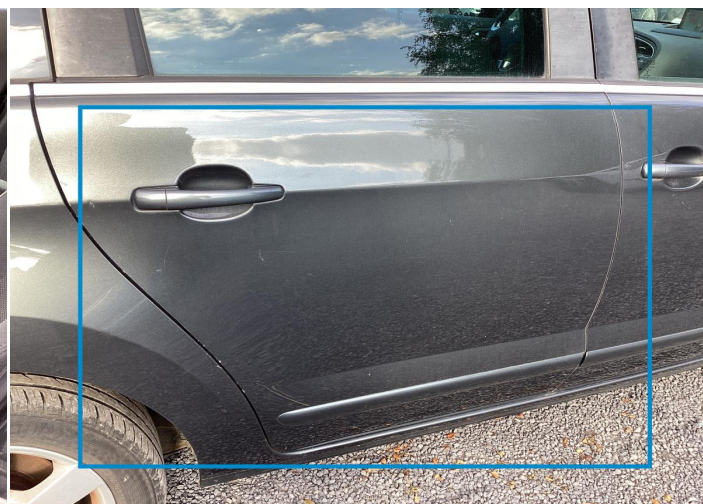
2. Door / Back Right
Paint / Scratch / Line -

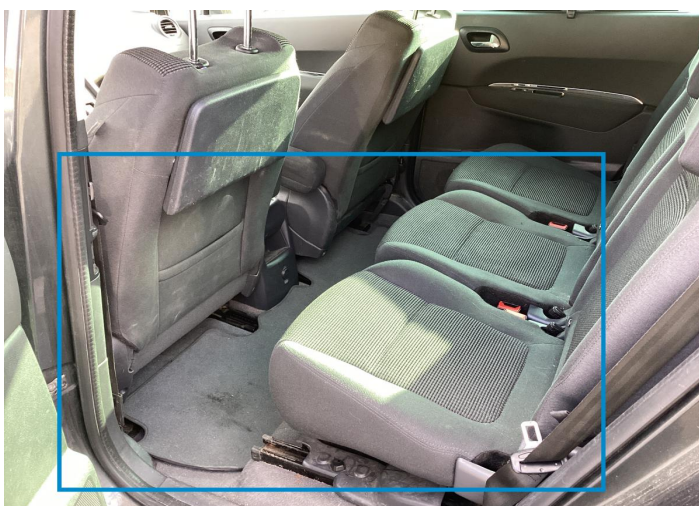
3. Floor Carpet
Interior / Dirty -

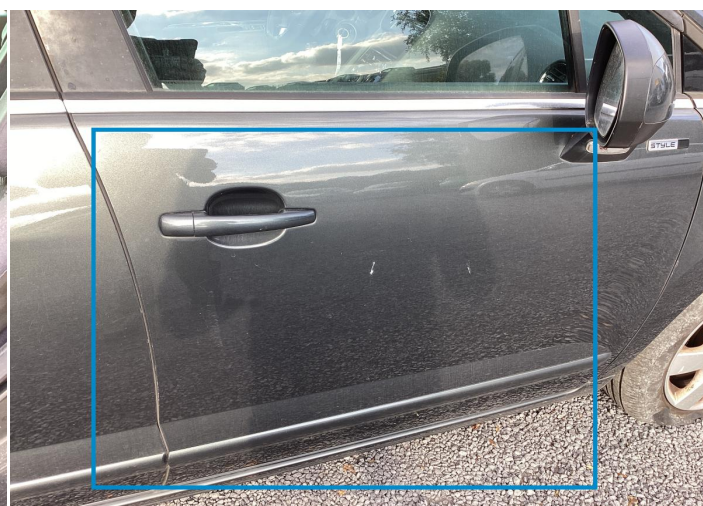
4. Door / Front Right
Paint / Scratch / Scuff -

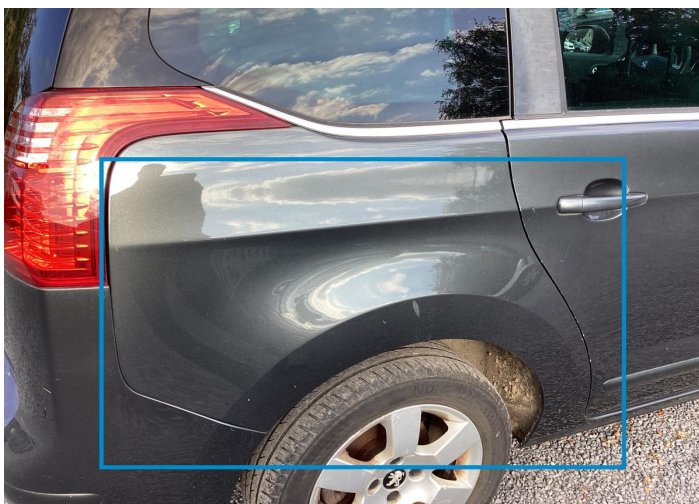
5. Side Panel / Back Right
Paint / Scratch / Scuff -

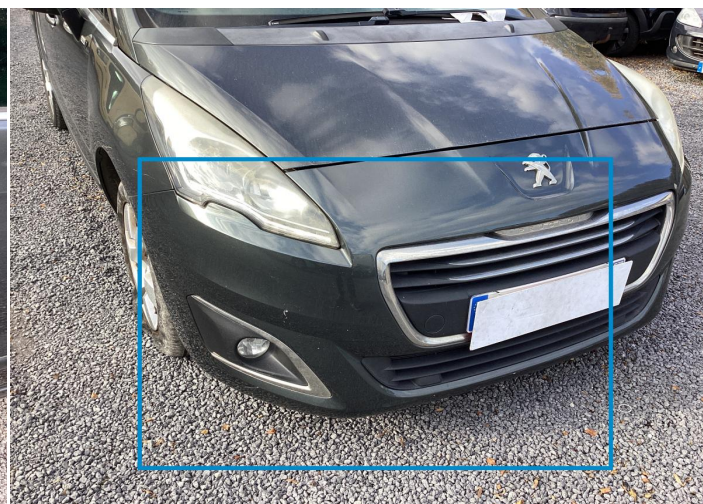
6. Bumper / Front
Paint / Scratch / Scuff -

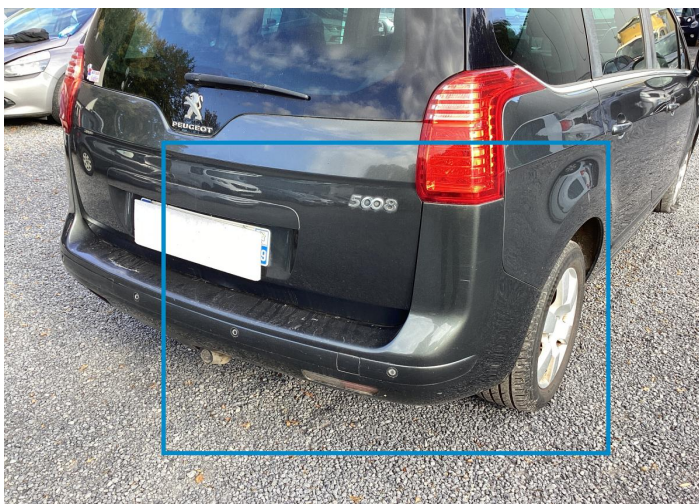
7. Bumper / Back
Paint / Scratch / Scuff -

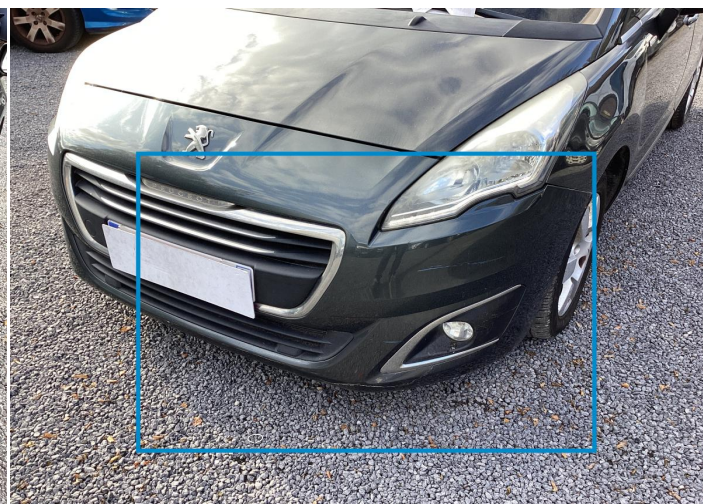
8. Bumper / Front
Paint / Scratch / Scuff -

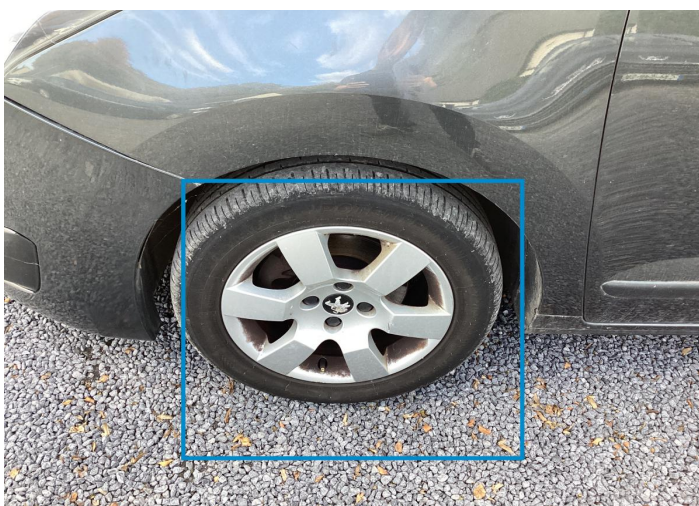
9. Rim / Front Left
Out of Bodywork / Scratch -

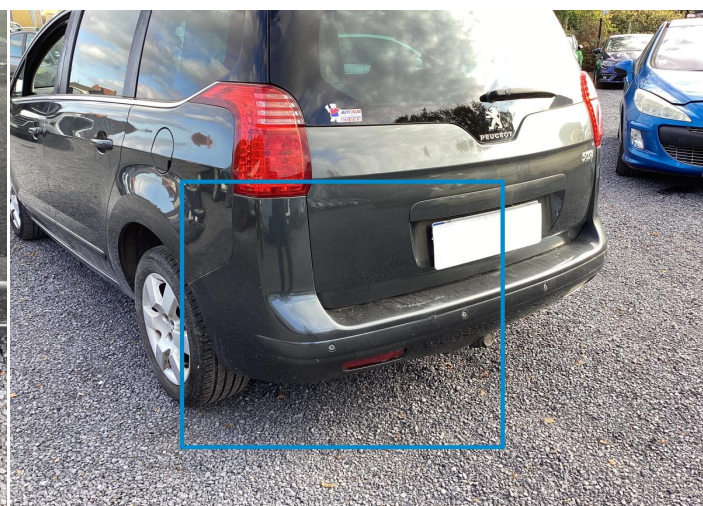
10. Bumper / Back
Paint / Scratch / Scuff -

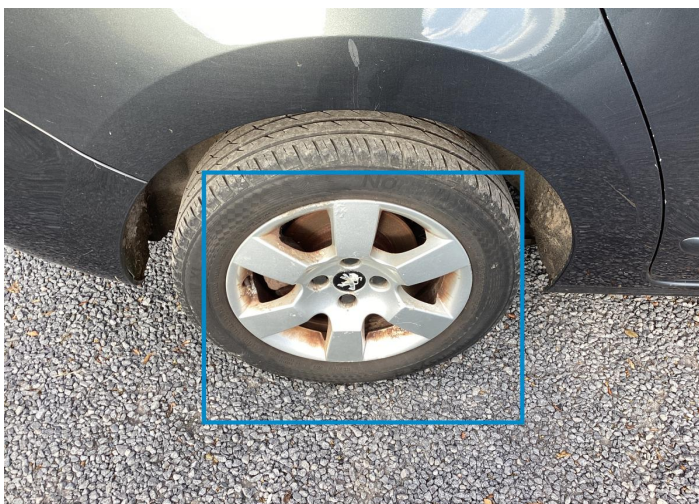
11. Rim / Back Right
Out of Bodywork / Scratch -

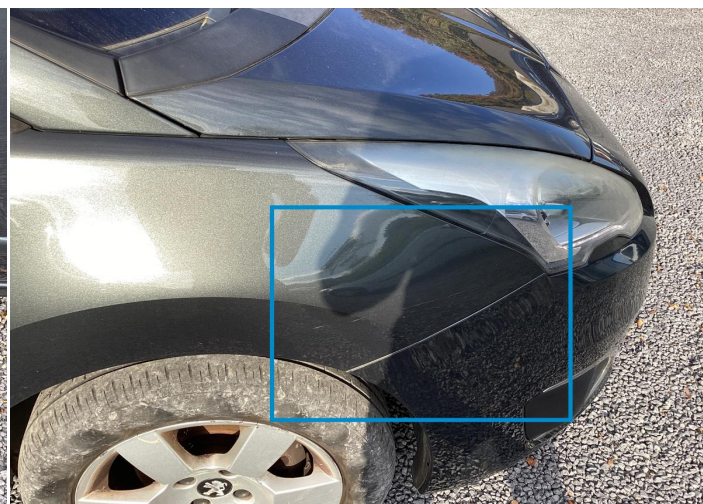
12. Fender / Front Right
Paint / Scratch / Line -

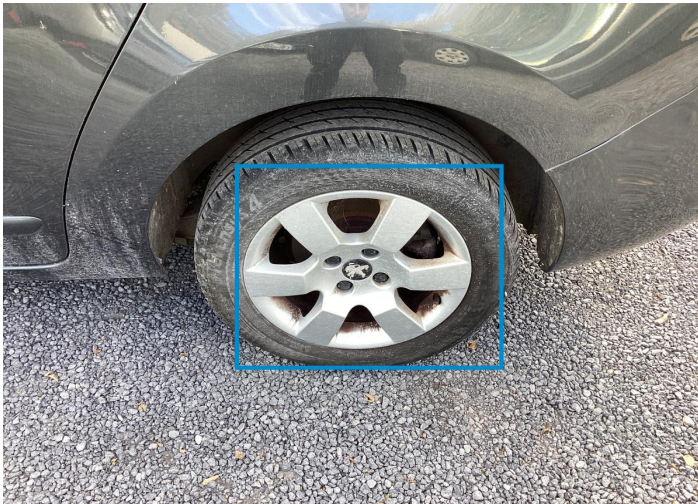
13. Rim / Back Left
Out of Bodywork / Scratch -

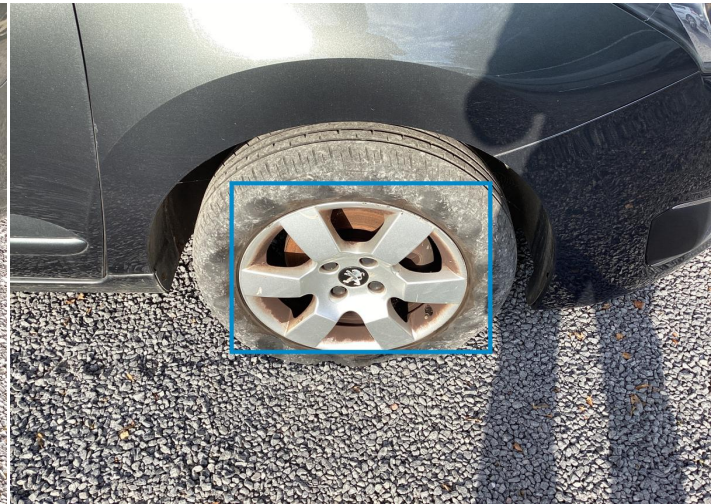
14. Rim / Front Right
Out of Bodywork / Scratch -
À plat
