PEUGEOT 308

308 1.6 HDi 90ch BLUE LION Confort

VIN NO VF34C9HXC55137764
Registration Number 1233YF02

Inspection Report Summary

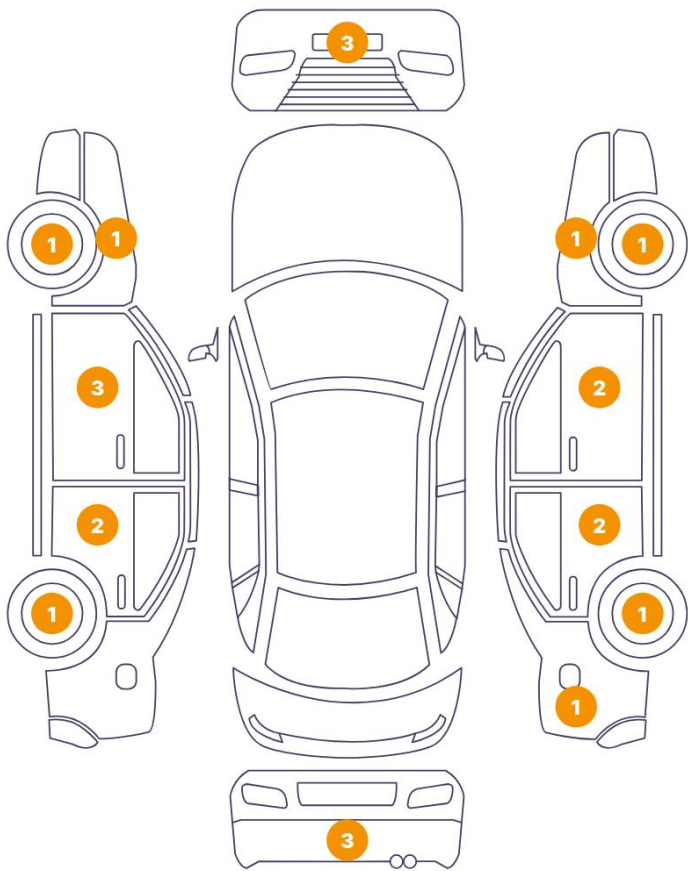
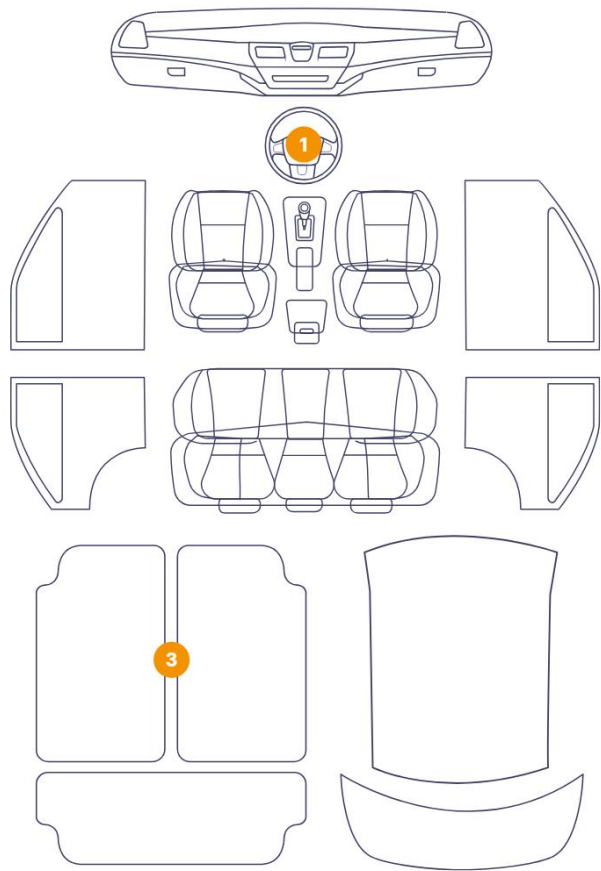
22 Dommages

4 Dommages

Component		Damage	Comments
1	Floor Carpet	Interior / Dirty	
2	Side Panel / Back Right	Paint / Scratch / Scuff	
3	Floor Carpet	Interior / Dirty	
4	Corner Bumper / Front Left	Paint / Scratch / Scuff	
5	Corner Bumper / Back Right	Paint / Scratch / Scuff	
6	Bumper / Back	Paint / Scratch / Scuff	
7	Steering Wheel / Front	Interior / Worn - out	
8	Corner Bumper / Back Left	Paint / Scratch / Scuff	
9	Bumper / Front	Paint / Scratch / Scuff	
10	Rim / Front Left	Out of Bodywork / Scratch	
11	Door / Front Left	Paint / Scratch / Line	
12	Corner Bumper / Front Right	Paint / Scratch / Scuff

13	Rim / Front Right	Out of Bodywork / Scratch
14	Door / Back Left	Paint / Scratch / Line
15	Rim / Back Right	Out of Bodywork / Scratch
16	Rim / Back Left	Out of Bodywork / Scratch
17	Mirror / Front Right	Paint / Scratch / Scuff
18	Mirror / Front Left	Bodywork / Breakage
19	Door / Back Right	Paint / Scratch / Line
20	Door / Front Right	Paint / Scratch / Line
21	Fender / Front Left	Paint / Scratch / Line
22	Door / Front Left	Paint / Scratch / Line
23	Fender / Front Right	Paint / Scratch / Scuff
24	Door / Back Left	Paint / Scratch / Line
25	Floor Carpet	Interior / Holed
26	Door / Back Right	Bodywork / Dent / Dent

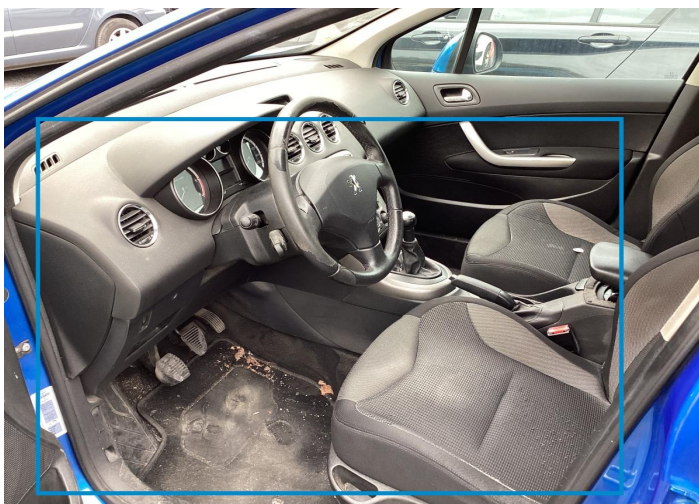
1. Floor Carpet
Interior / Dirty -

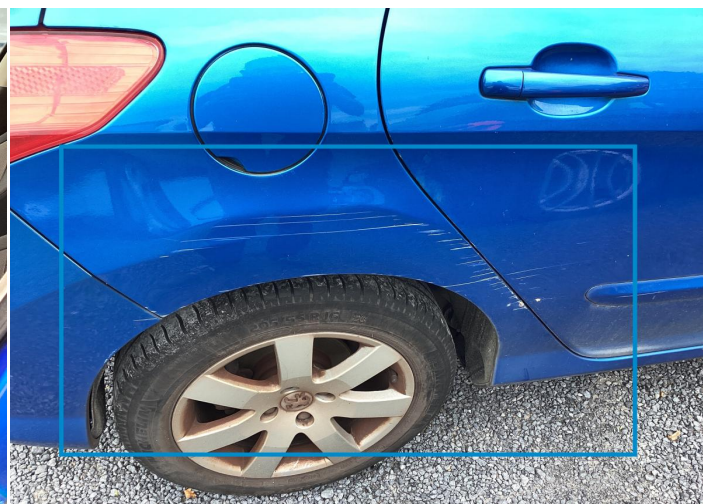
2. Side Panel / Back Right
Paint / Scratch / Scuff -

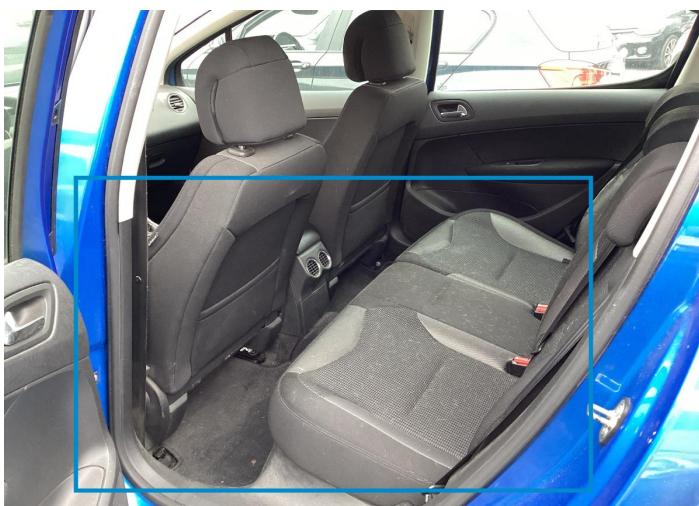
3. Floor Carpet
Interior / Dirty -

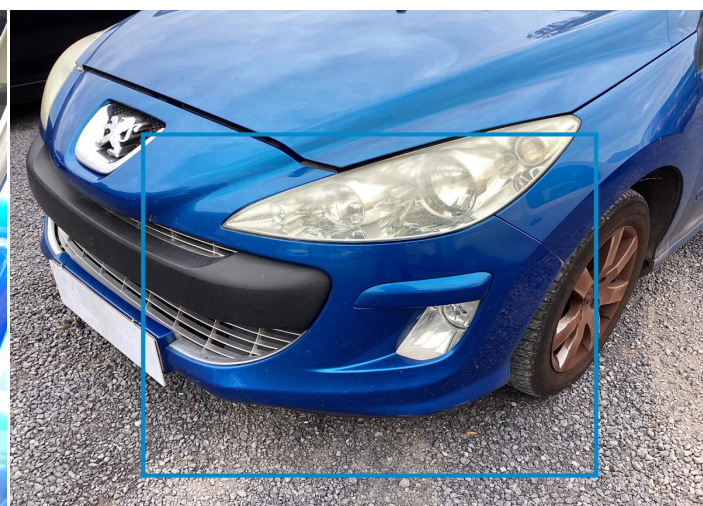
4. Corner Bumper / Front Left
Paint / Scratch / Scuff -

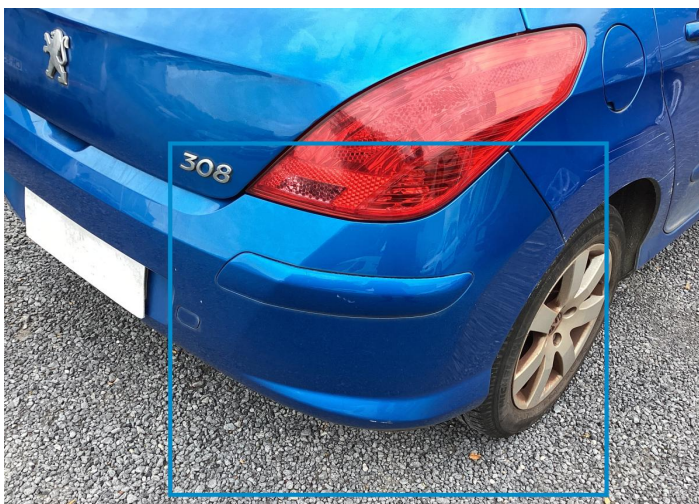
5. Corner Bumper / Back Right
Paint / Scratch / Scuff -

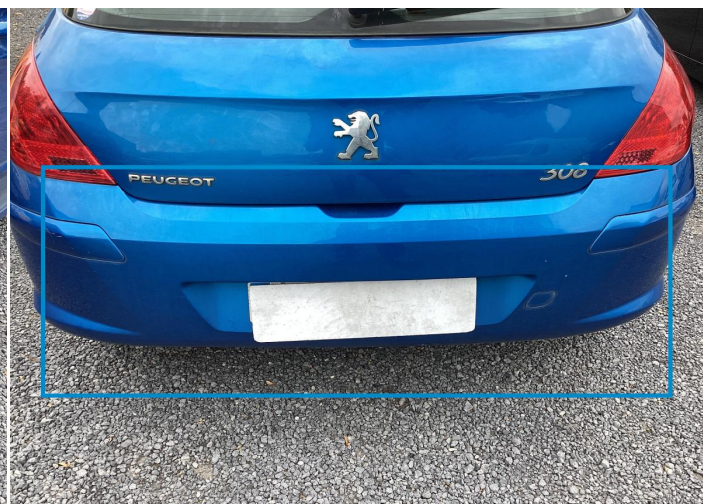
6. Bumper / Back
Paint / Scratch / Scuff -

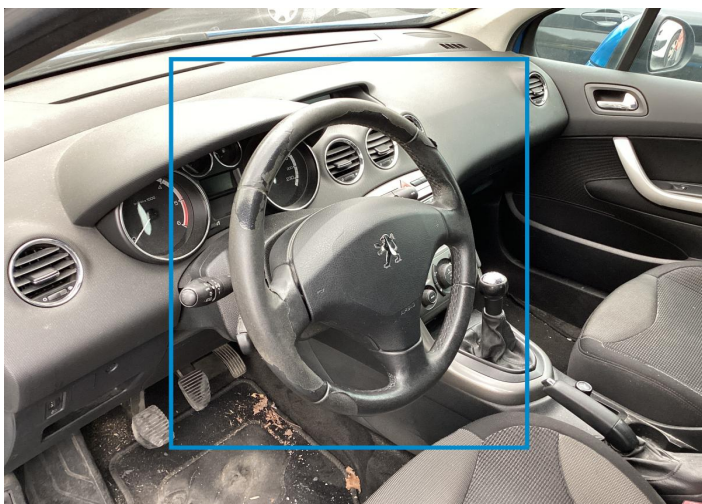
7. Steering Wheel / Front Interior / Worn - out -

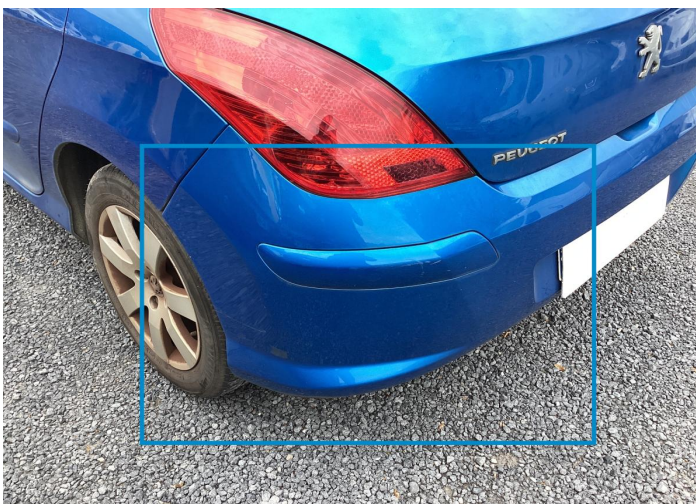
8. Corner Bumper / Back Left Paint / Scratch / Scuff -

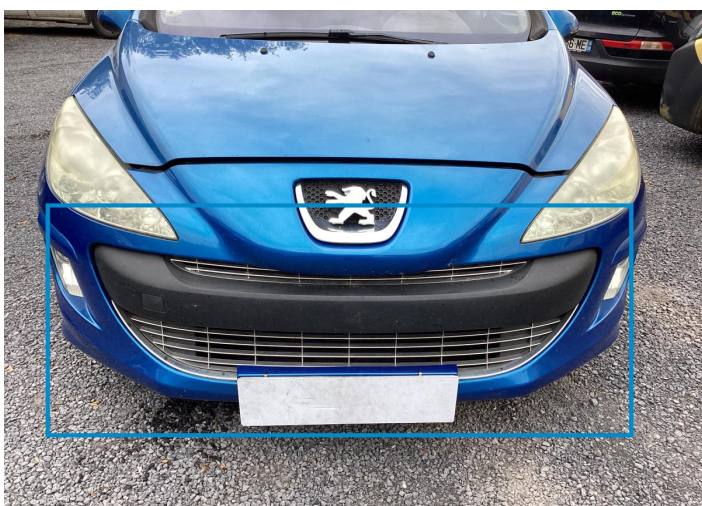
9. Bumper / Front Paint / Scratch / Scuff -

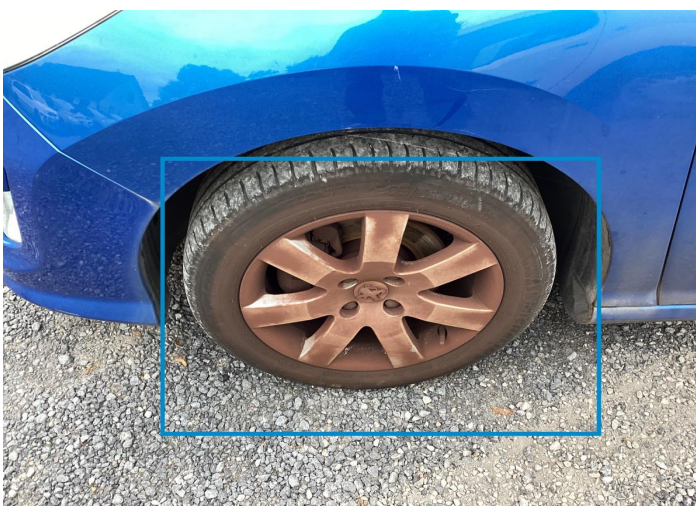
10. Rim / Front Left Out of Bodywork / Scratch -

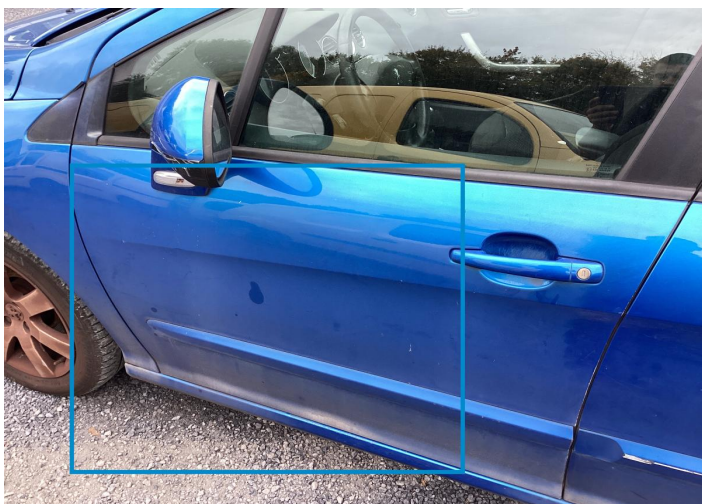
11. Door / Front Left Paint / Scratch / Line -

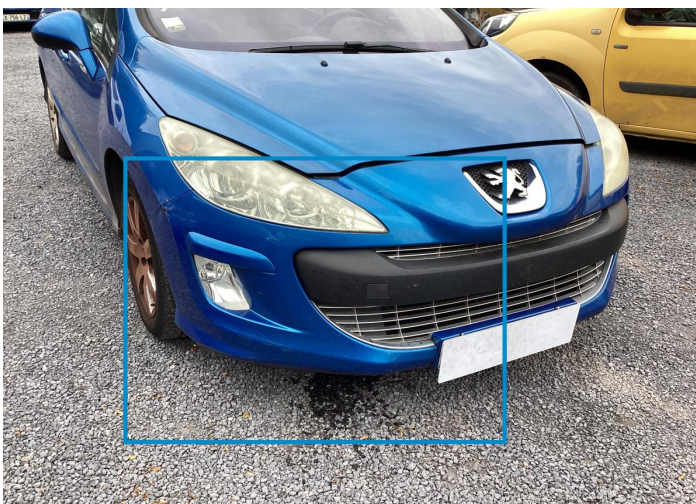
12. Corner Bumper / Front Right Paint / Scratch / Scuff -

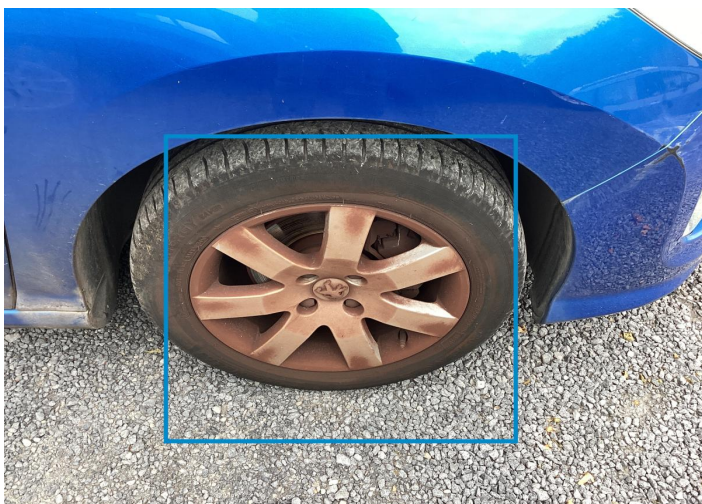
13. Rim / Front Right
Out of Bodywork / Scratch -

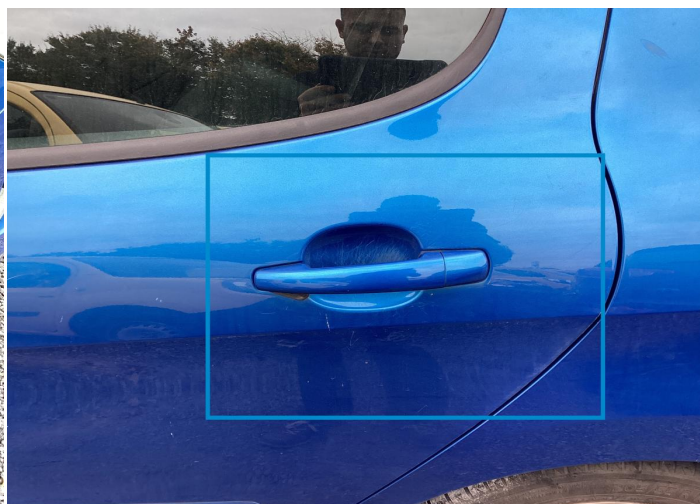
14. Door / Back Left
Paint / Scratch / Line -

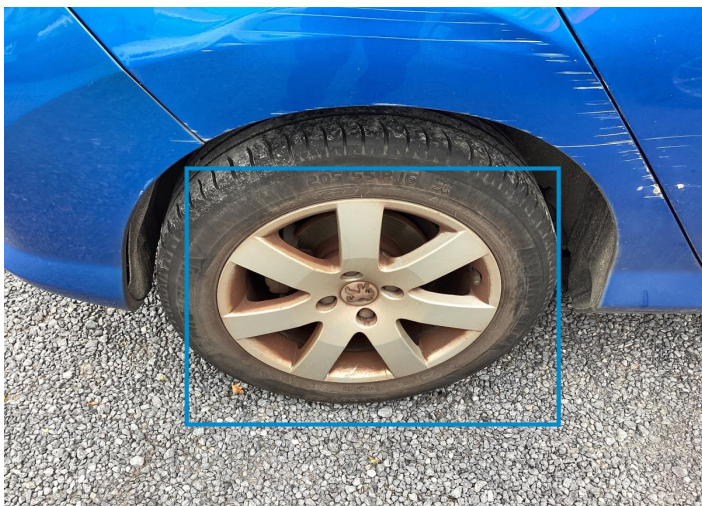
15. Rim / Back Right
Out of Bodywork / Scratch -

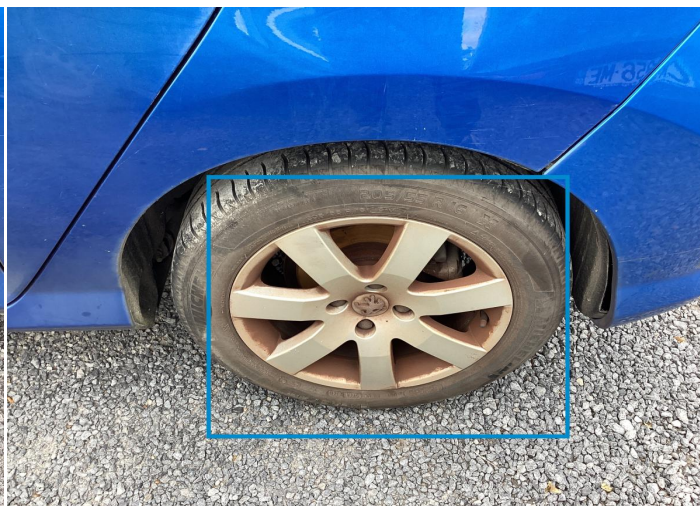
16. Rim / Back Left
Out of Bodywork / Scratch -

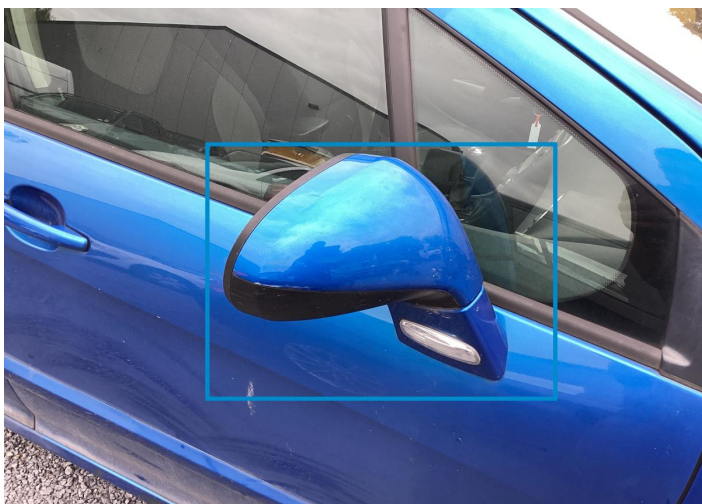
17. Mirror / Front Right
Paint / Scratch / Scuff -

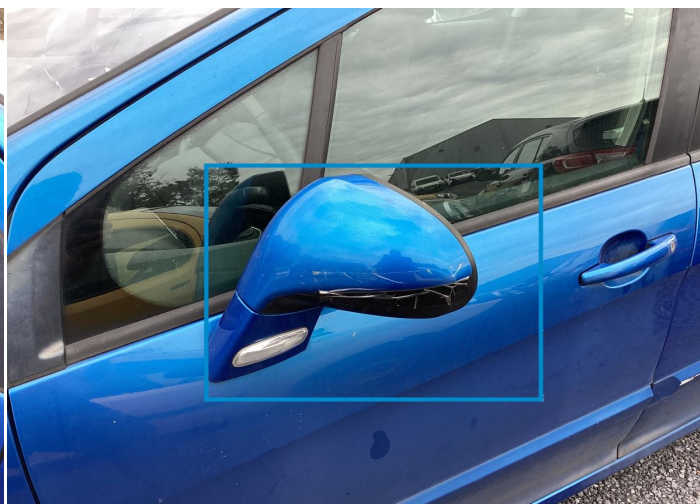
18. Mirror / Front Left
Bodywork / Breakage -

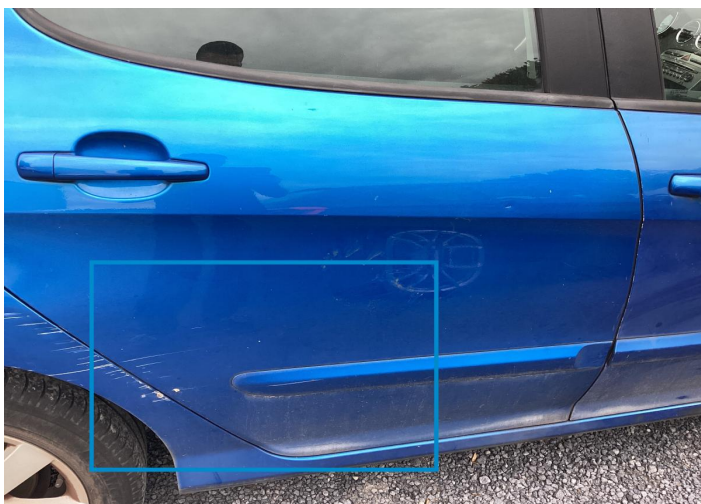
19. Door / Back Right
Paint / Scratch / Line -

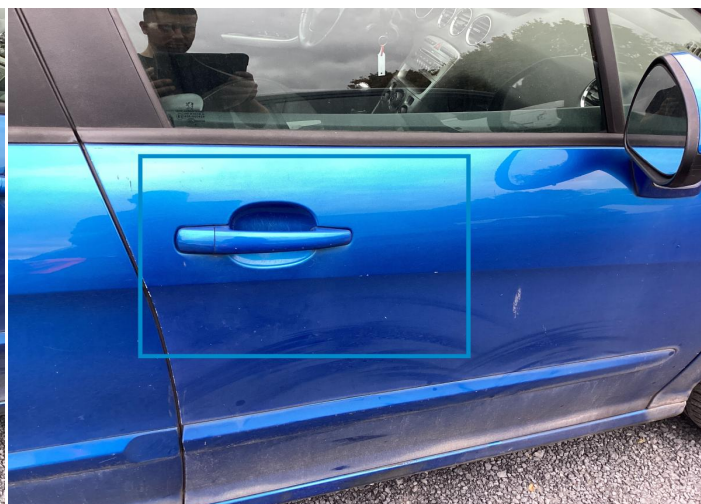
20. Door / Front Right
Paint / Scratch / Line -

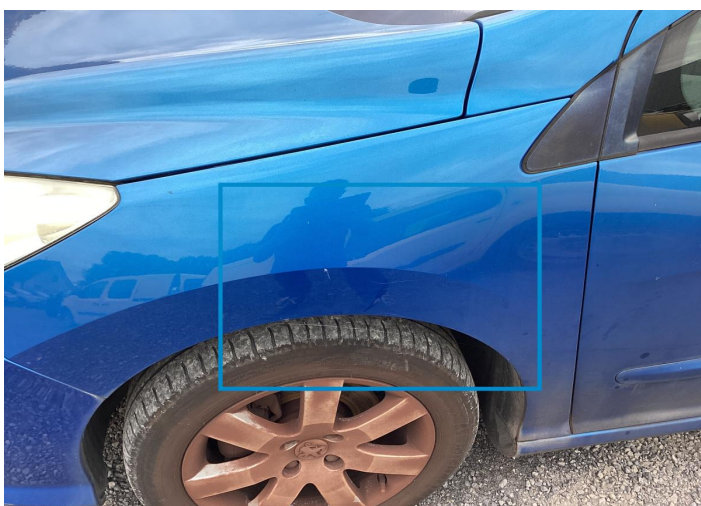
21. Fender / Front Left
Paint / Scratch / Line -

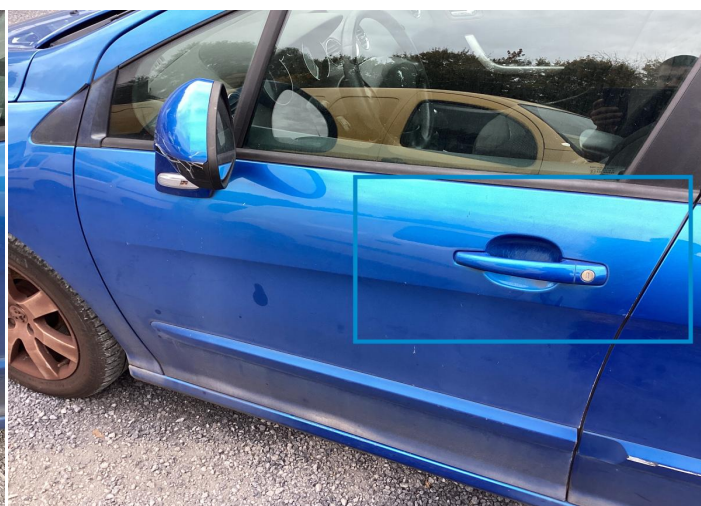
22. Door / Front Left
Paint / Scratch / Line -

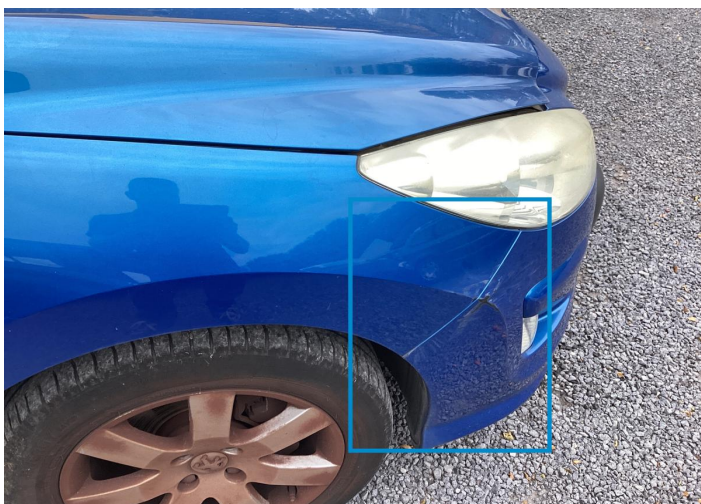
23. Fender / Front Right
Paint / Scratch / Scuff -

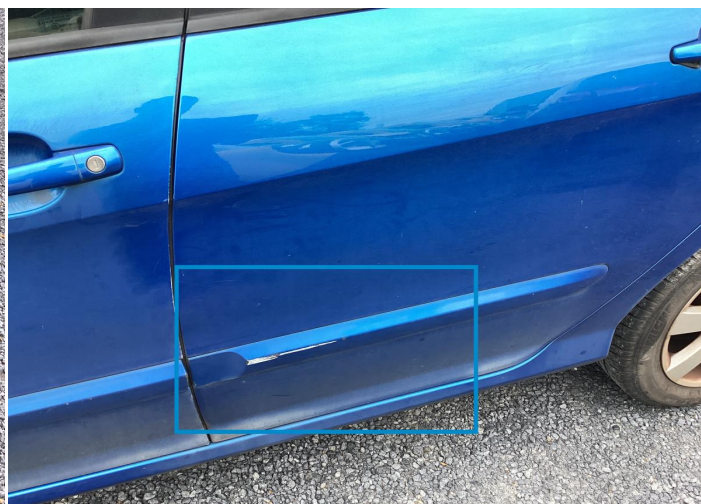
24. Door / Back Left
Paint / Scratch / Line -

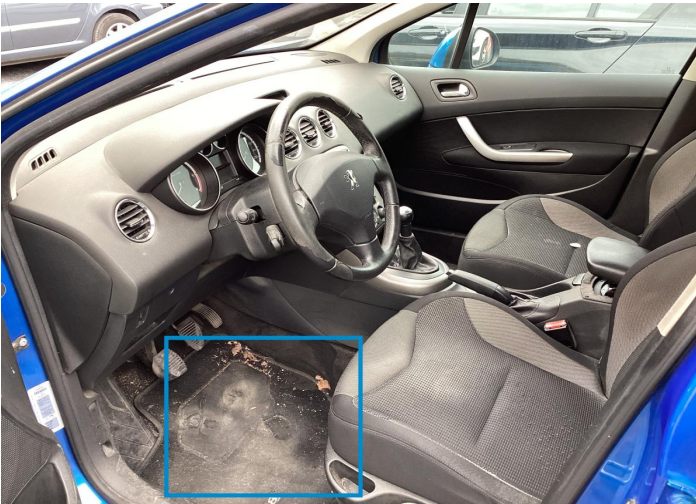
25. Floor Carpet
Interior / Holed -

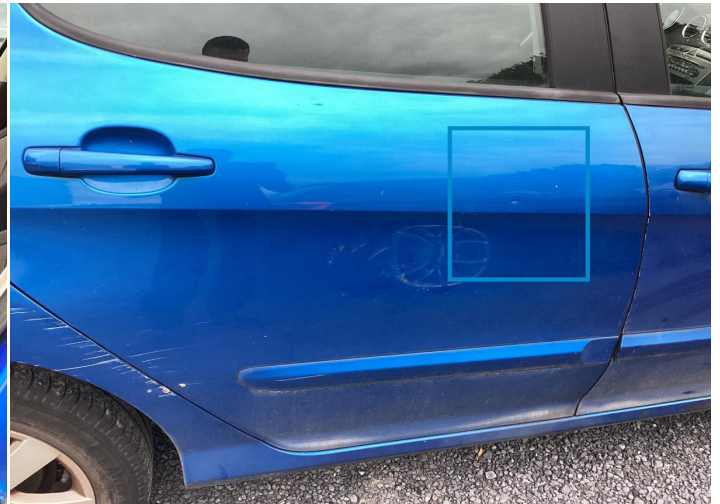
26. Door / Back Right
Bodywork / Dent / Dent -
