PEUGEOT 407 COUPE

407 Coupé 2.7 HDi 24v FAP Sport Pack A

VIN NO VF36JUHZJ21334949
Registration Number CM540SM

Customer	BCA Auto Encheres	Report Number	P20250701163139
Inspection Date / Place	2025-07-01 / BCA BETHUNE	Cosmetic Grade	4

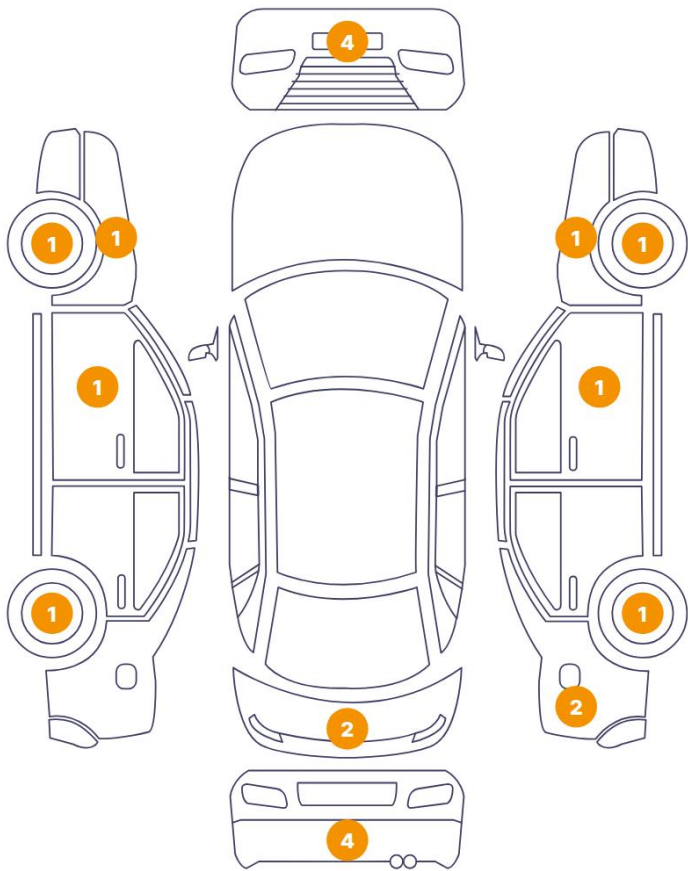
20 Dommages

Component		Damage	Comments
1	Floor Carpet	Interior / Dirty	
2	Backrest Cover / Front Left	Interior / Holed	
3	Roof Upholstery	Interior / Loose	
4	Corner Bumper / Front Right	Paint / Scratch / Scuff	
5	Bumper / Front	Paint / Scratch / Scuff	
6	Corner Bumper / Front Left	Paint / Scratch / Scuff	
7	Blade/spoiler / Front	Bodywork / Breakage	
8	Fender / Front Left	Paint / Scratch / Line	
9	Rim / Front Left	Out of Bodywork / Scratch	
10	Door / Front Left	Paint / Scratch / Line	
11	Rim / Back Left	Out of Bodywork / Scratch	
12	Corner Bumper / Back Left	Paint / Scratch / Scuff	
13	Bumper / Back	Paint / Scratch / Scuff

14	Tailgate	Paint / Chipping
15	Tailgate	Paint / Scratch / Line
16	Corner Bumper / Back Right	Paint / Scratch / Scuff
17	Corner Bumper / Back Right	Bodywork / Breakage
18	Side Panel / Back Right	Paint / Scratch / Line
19	Rim / Back Right	Out of Bodywork / Scratch
20	Side Panel / Back Right	Paint / Scratch / Line
21	Mirror / Front Right	Paint / Scratch / Scuff
22	Fender / Front Right	Paint / Scratch / Line
23	Rim / Front Right	Out of Bodywork / Scratch

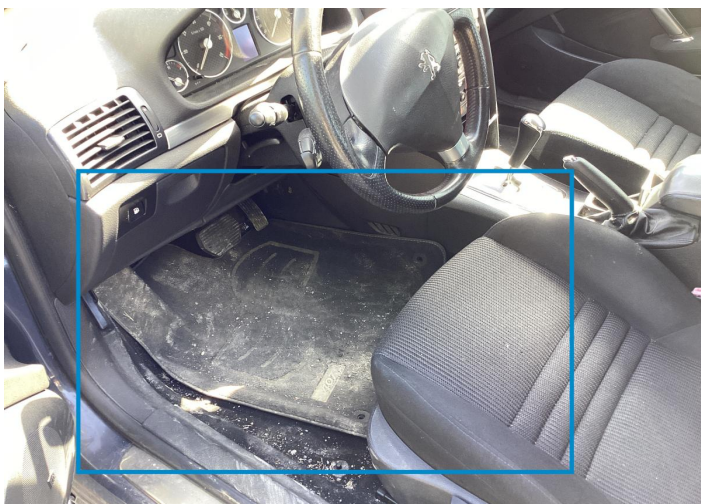
1. Floor Carpet
Interior / Dirty -

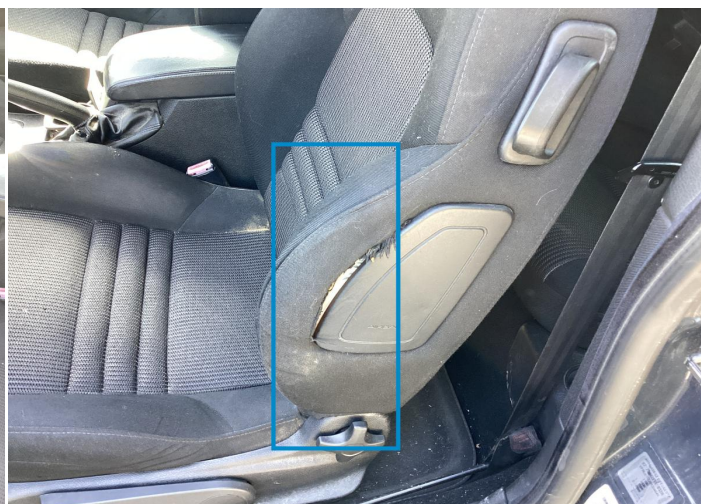
2. Backrest Cover / Front Left
Interior / Holed -

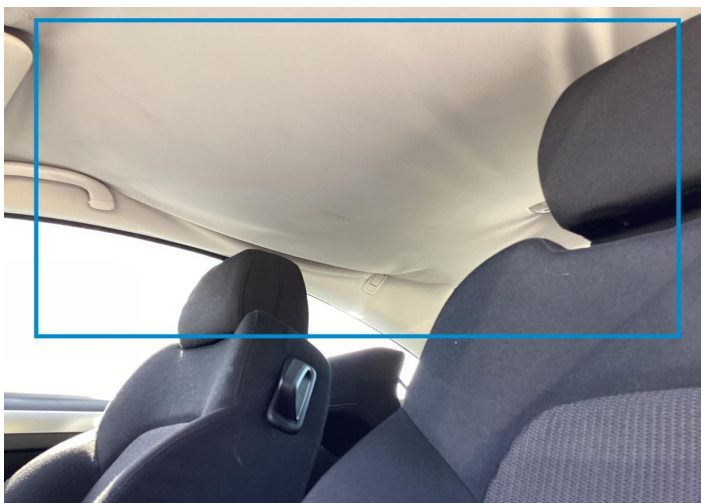
3. Roof Upholstery
Interior / Loose -

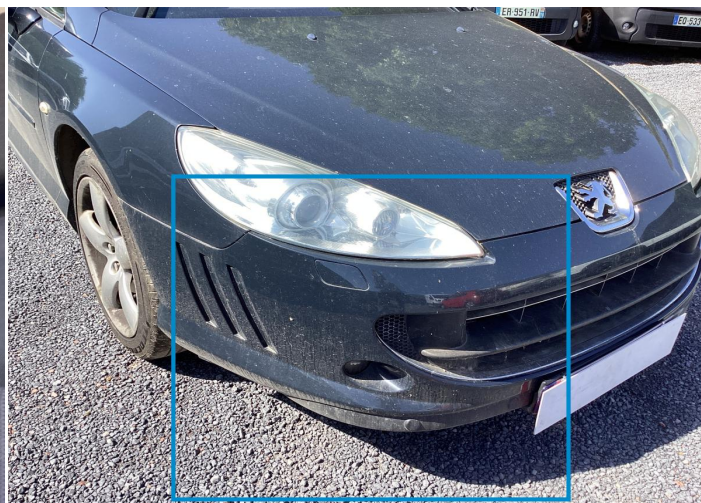
4. Corner Bumper / Front Right
Paint / Scratch / Scuff -

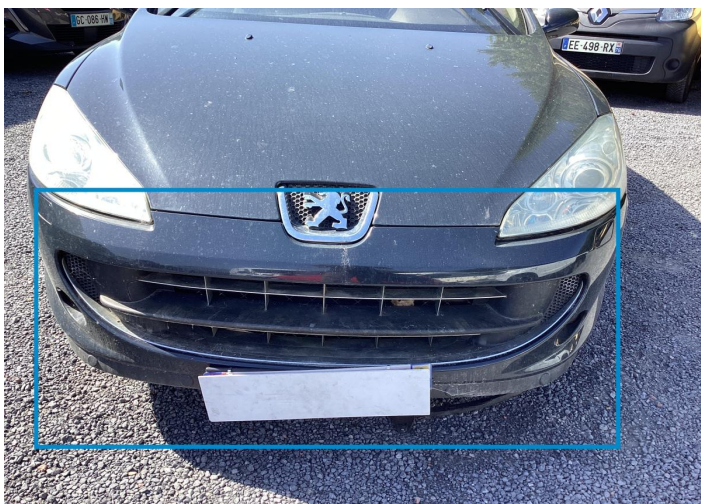
5. Bumper / Front
Paint / Scratch / Scuff -

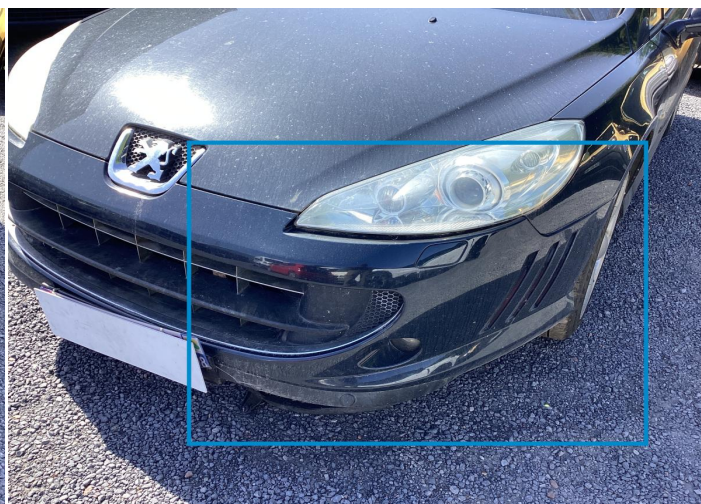
6. Corner Bumper / Front Left
Paint / Scratch / Scuff -

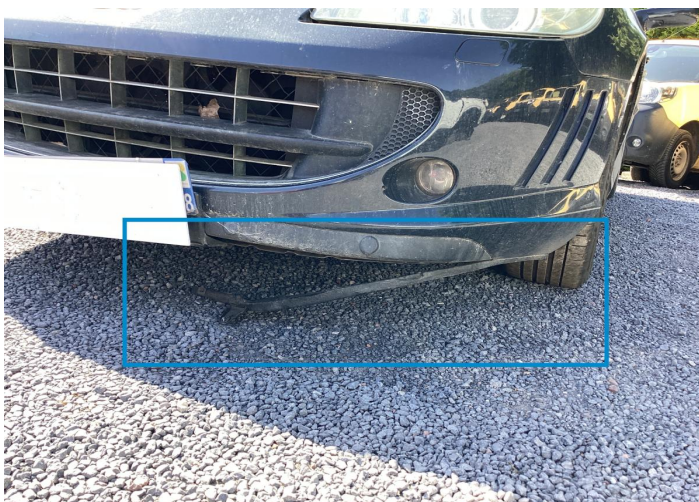
7. Blade/spoiler / Front
Bodywork / Breakage -

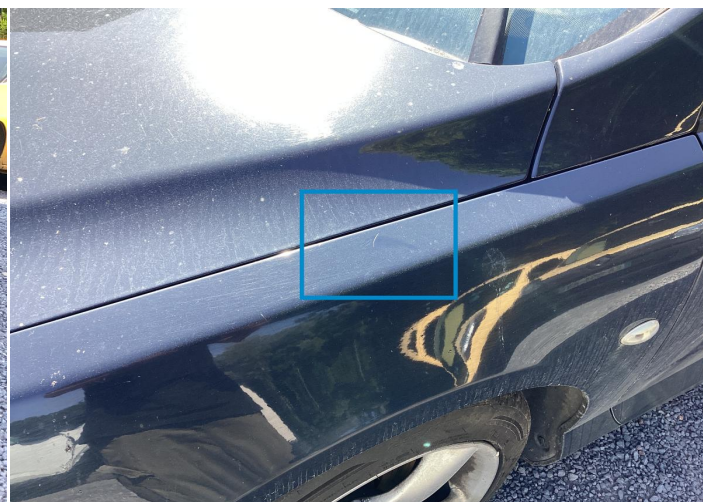
8. Fender / Front Left
Paint / Scratch / Line -

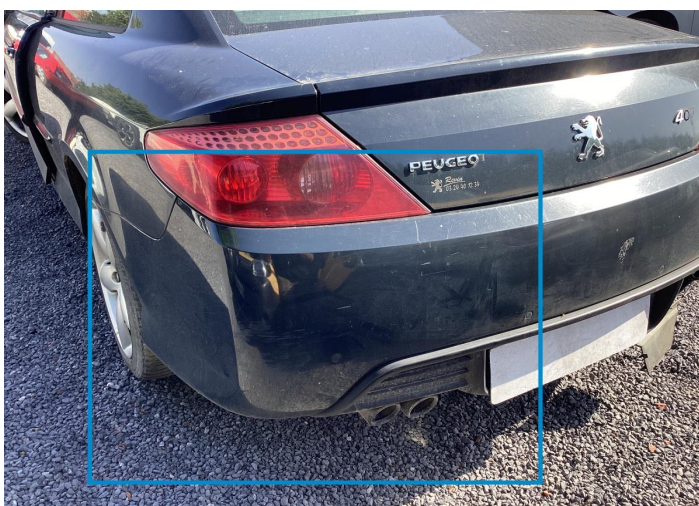
12. Corner Bumper / Back Left
Paint / Scratch / Scuff -

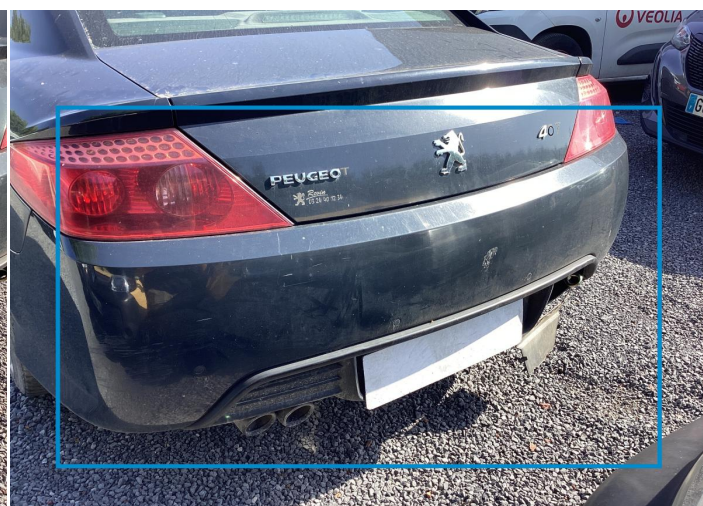
13. Bumper / Back
Paint / Scratch / Scuff -

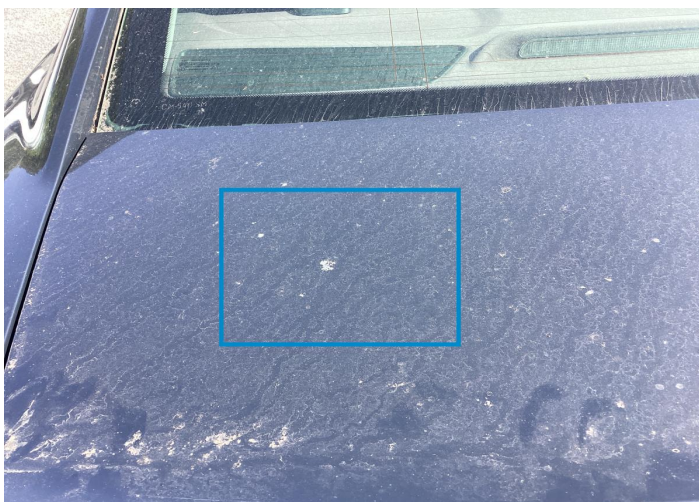
14. Tailgate
Paint / Chipping -

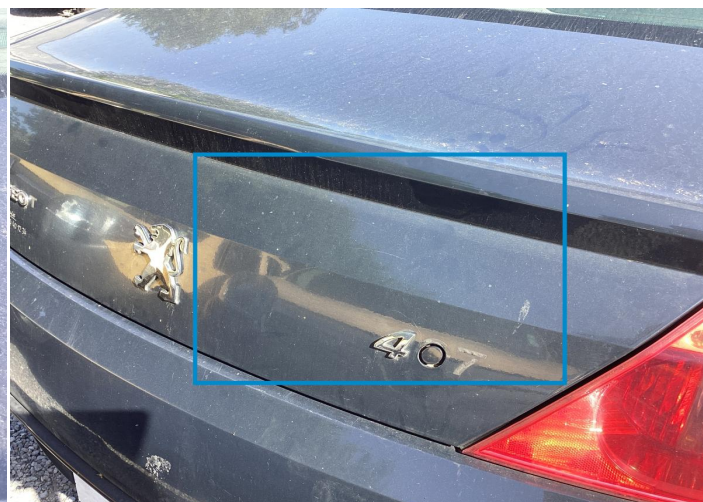
15. Tailgate
Paint / Scratch / Line -

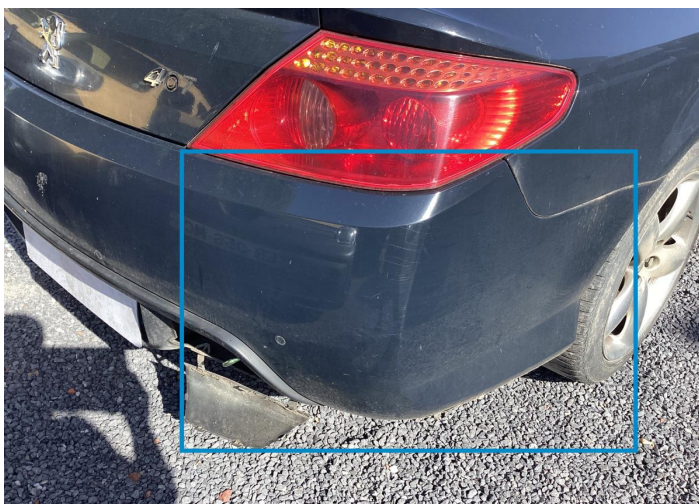
16. Corner Bumper / Back Right
Paint / Scratch / Scuff -

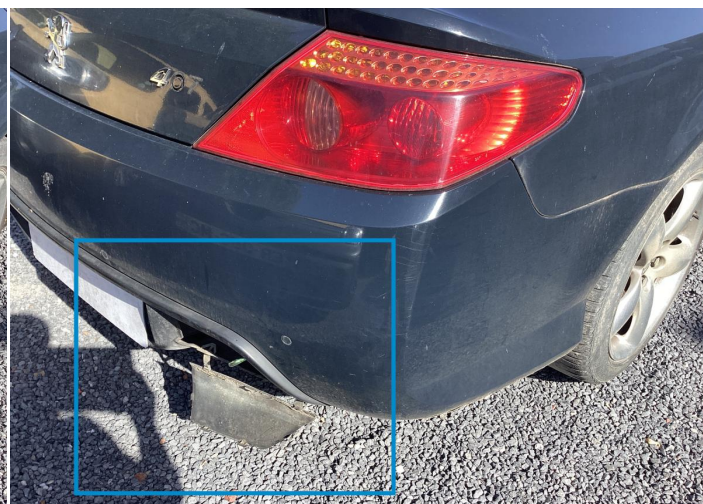
17. Corner Bumper / Back Right
Bodywork / Breakage -

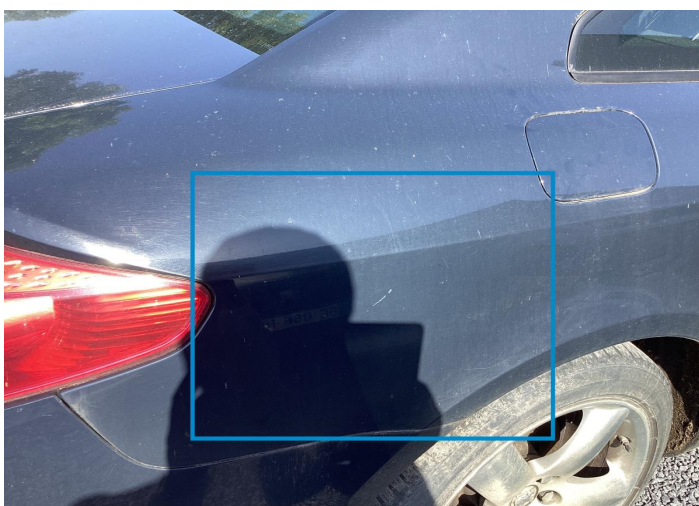
18. Side Panel / Back Right
Paint / Scratch / Line -

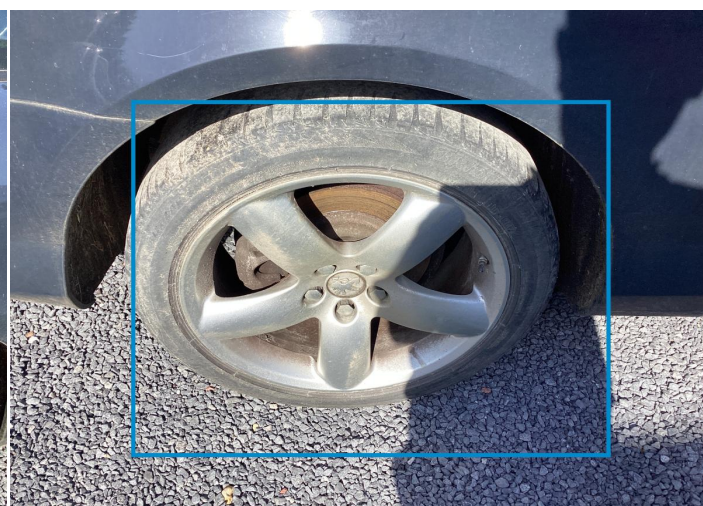
19. Rim / Back Right
Out of Bodywork / Scratch -

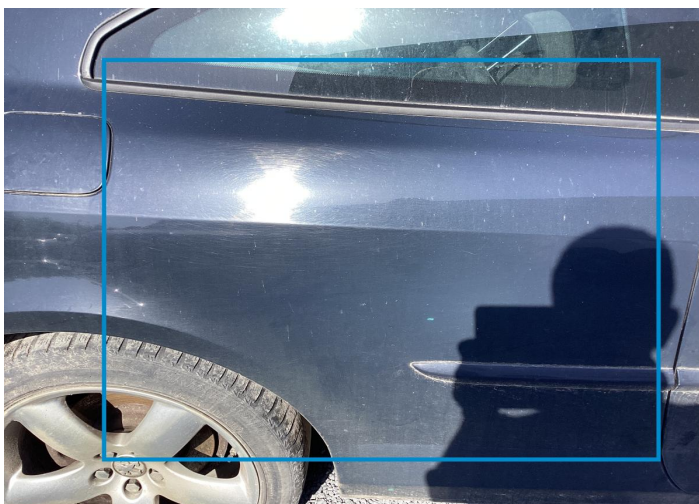
20. Side Panel / Back Right
Paint / Scratch / Line -

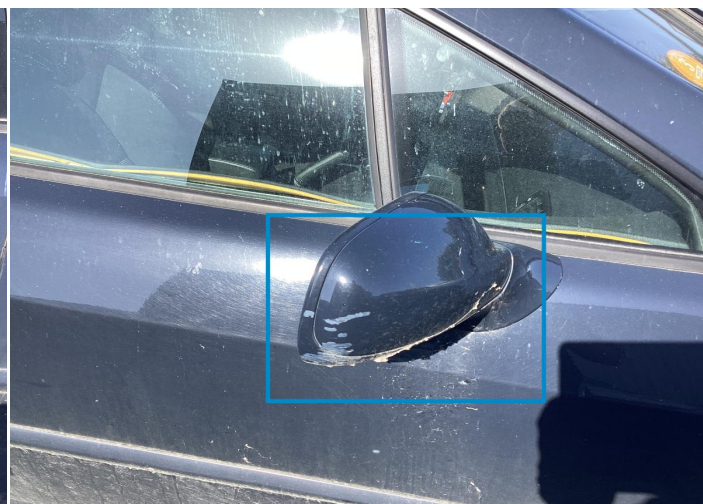
21. Mirror / Front Right
Paint / Scratch / Scuff -

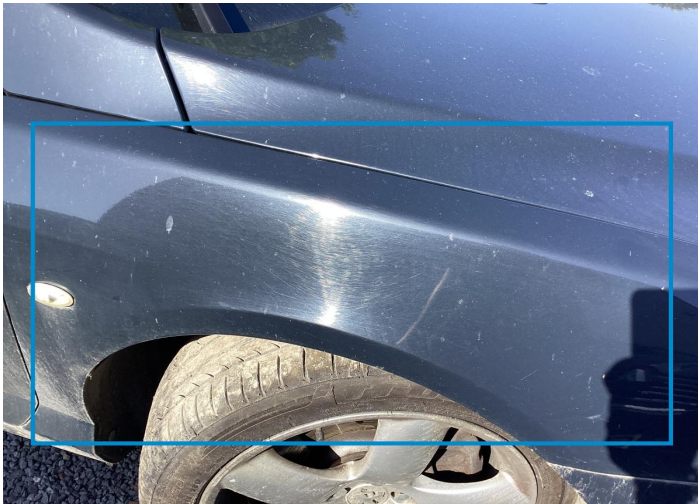
22. Fender / Front Right
Paint / Scratch / Line -

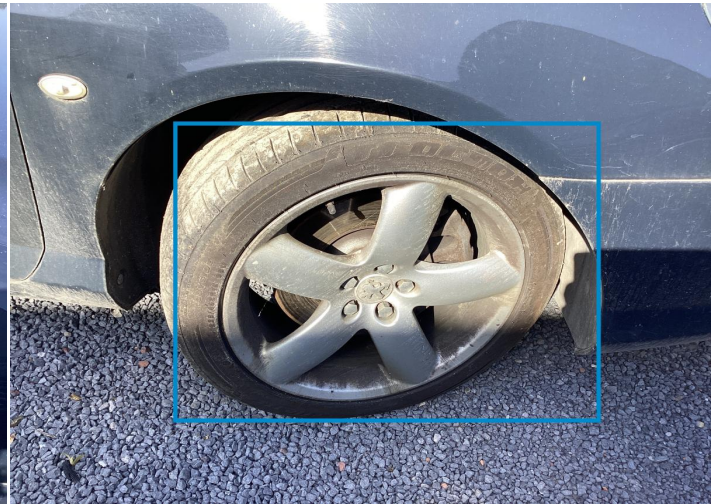
23. Rim / Front Right
Out of Bodywork / Scratch -
