## status report

#### Peugeot 308 Allure

| Vehicle identification number | <b>VF3LBBHZ3GS266997</b> | mileage read: | <b>200013 km</b> |

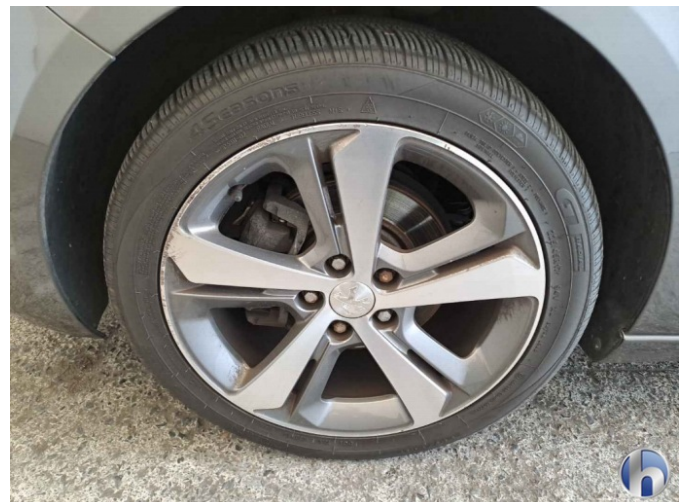
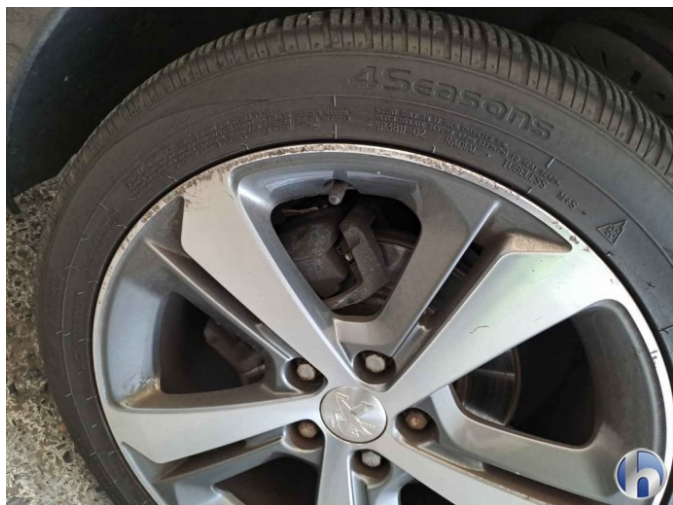
| component | Damage | Rep kind |
|---|---|---|
| 1. Rim front - left | Scratch(es) | Replace |

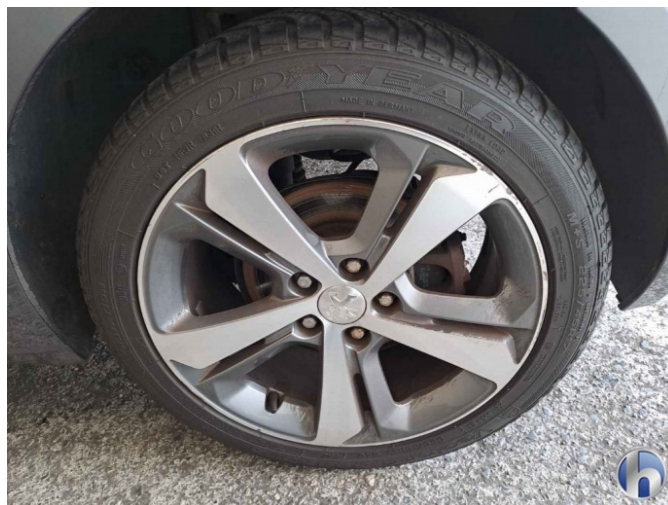
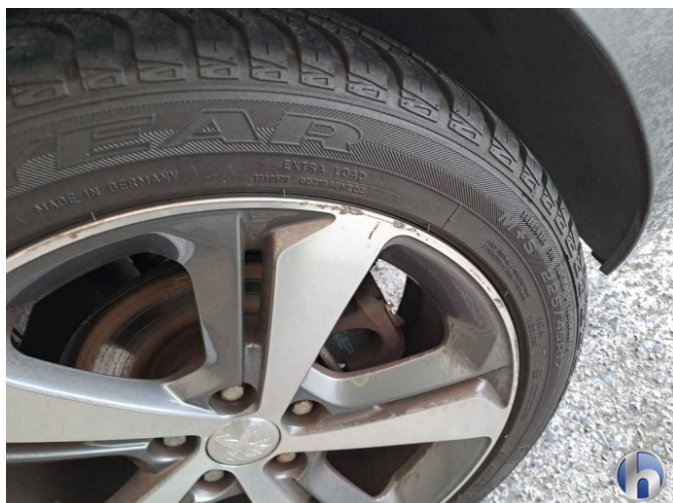
| component | Damage | Rep kind |
|---|---|---|
| 2. Rim rear - left | Scratch(es) | Replace |

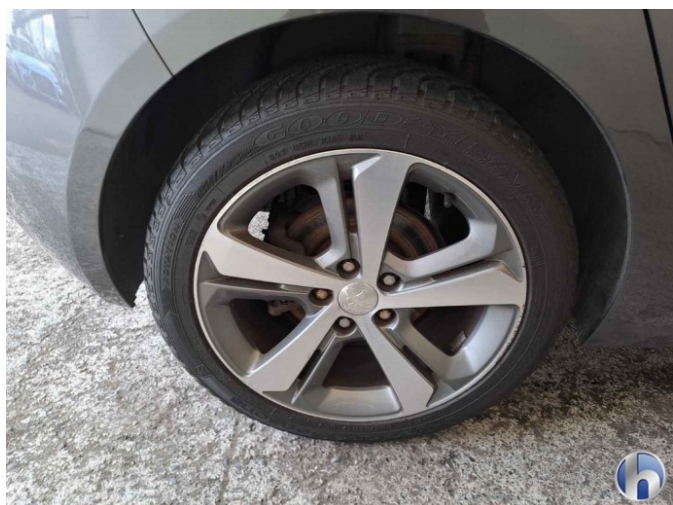
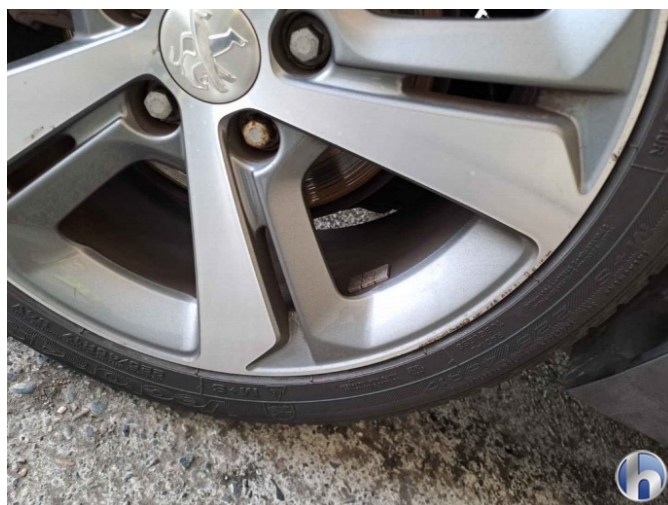
| component | Damage | Rep kind |
|---|---|---|
| 3. Rim rear - right | Scratch(es) | Replace |

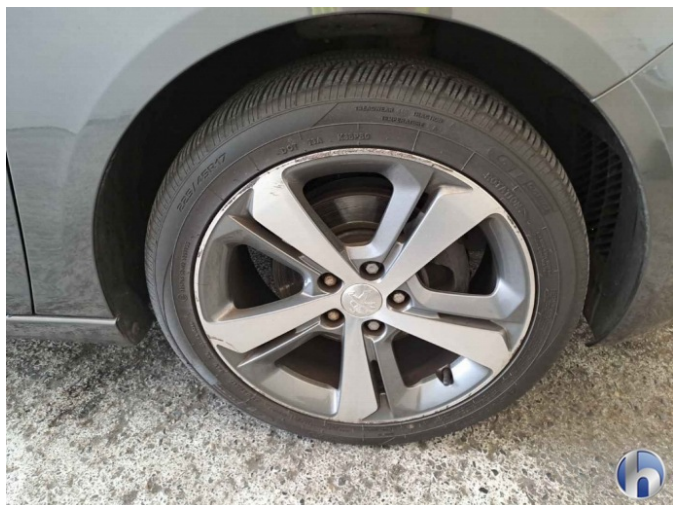
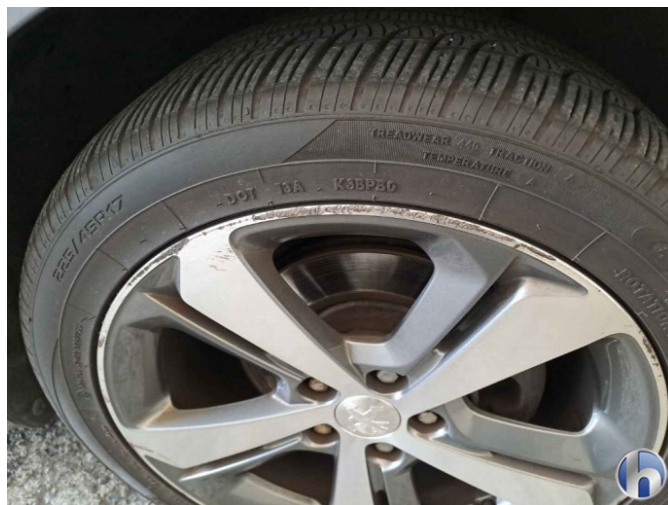
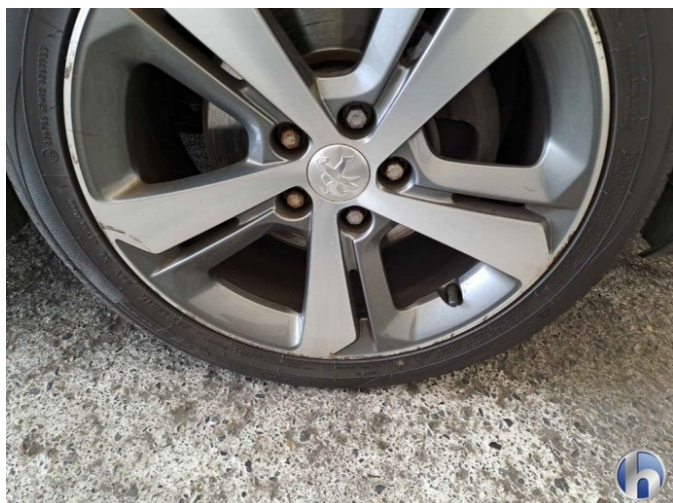
| component | Damage | Rep kind |
|---|---|---|
| 4. Rim front - right | Scratch(es) | Replace |

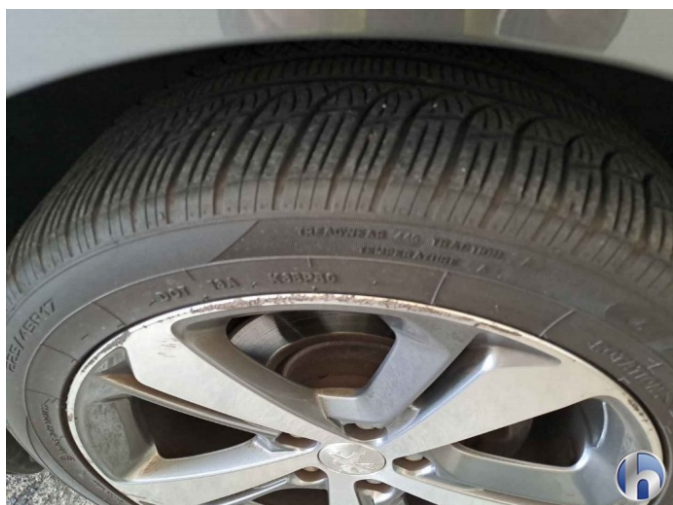
| component | Damage | Rep kind |
|---|---|---|
| 5. tire front - right | Worn | Replace |

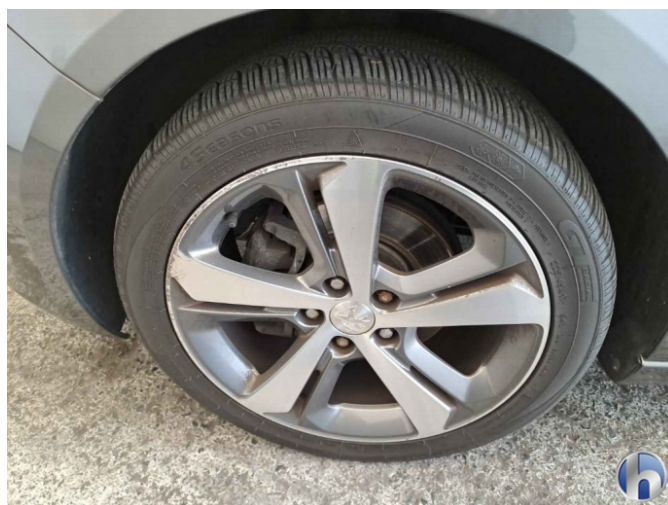
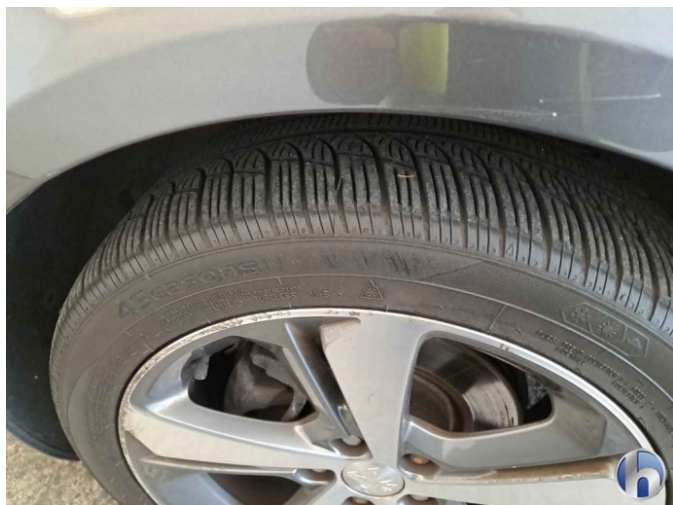
| component | Damage | Rep kind |
|---|---|---|
| 6. tire front - left | Worn | Replace |

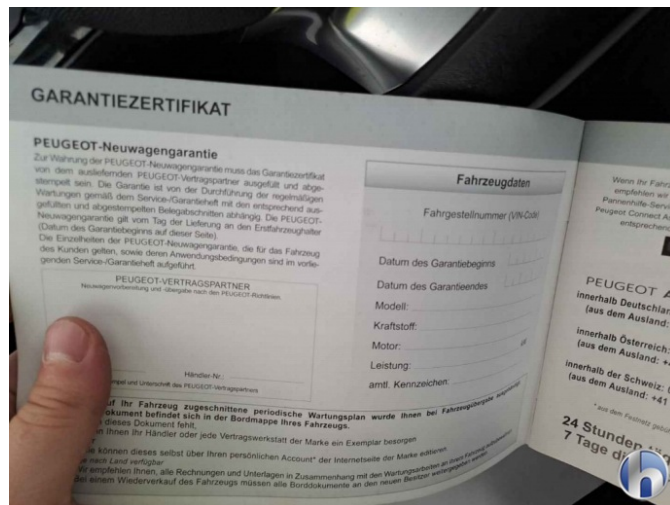
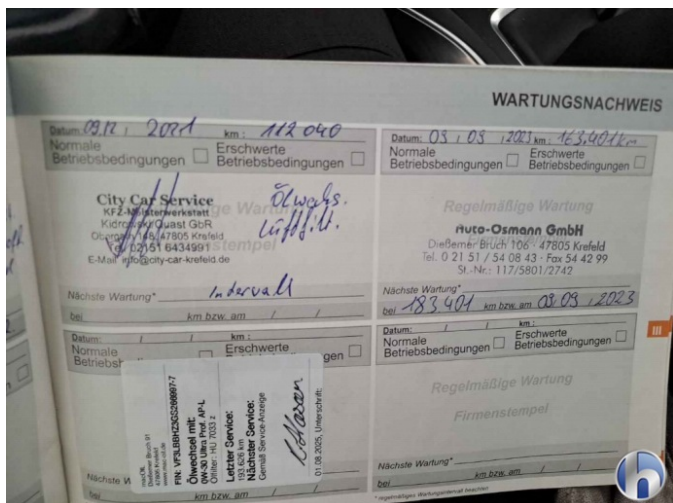
| component | Damage | Rep kind |
|---|---|---|
| 9. proof of maintenance | Not okay | Replace |

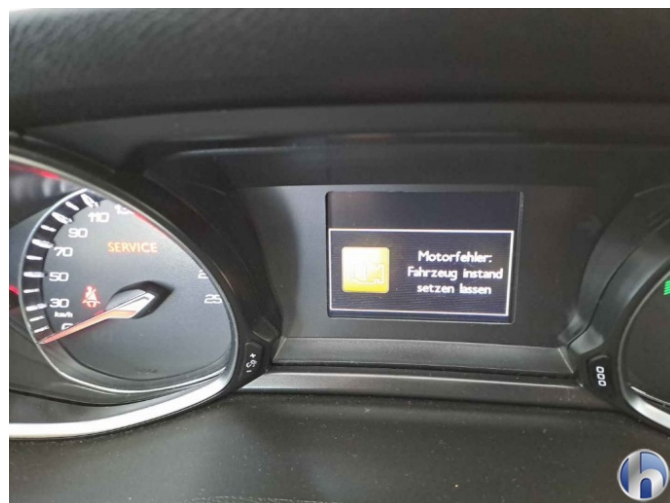
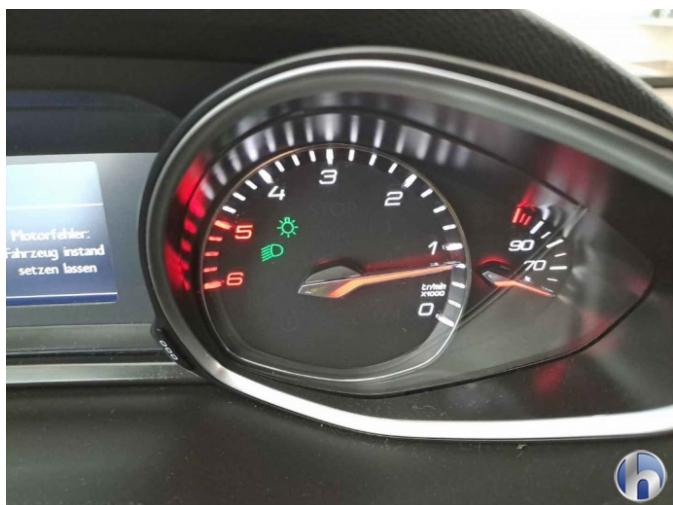
| component | Damage | Rep kind |
|---|---|---|
| 10. Malfunction Indicator Lamp | Error message | Carry out a fault diagnosis |

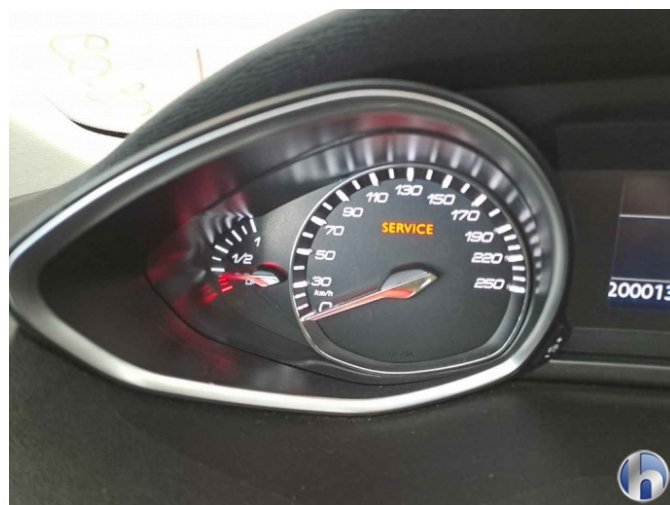
| component | Damage | Rep kind |
|---|---|---|
| 11. warning light | Error message | Carry out a fault diagnosis |

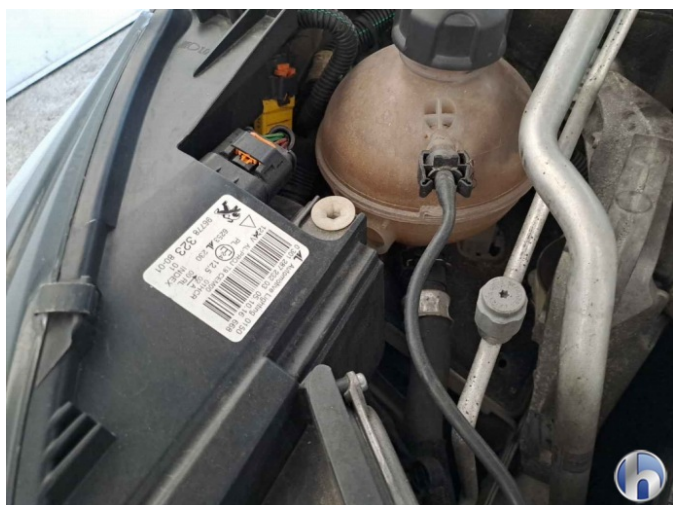
| component | Damage | Rep kind |
|---|---|---|
| 12. Kühlmittel | Not okay | Fill Up |

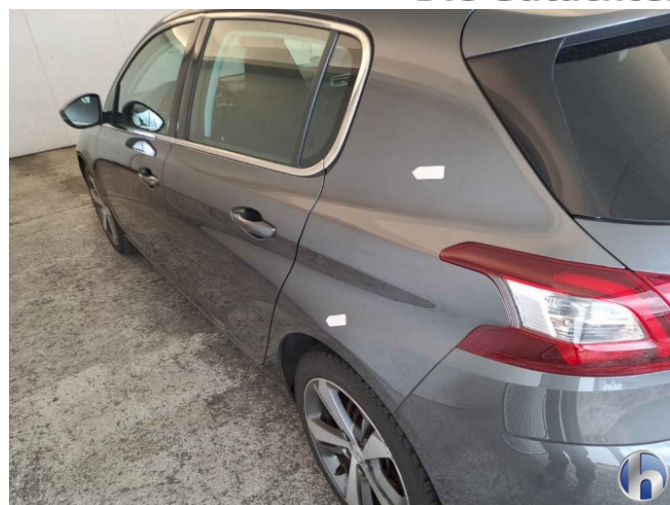
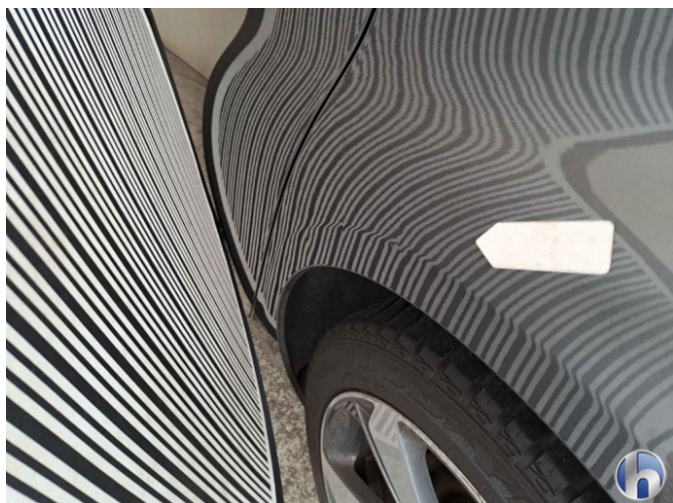
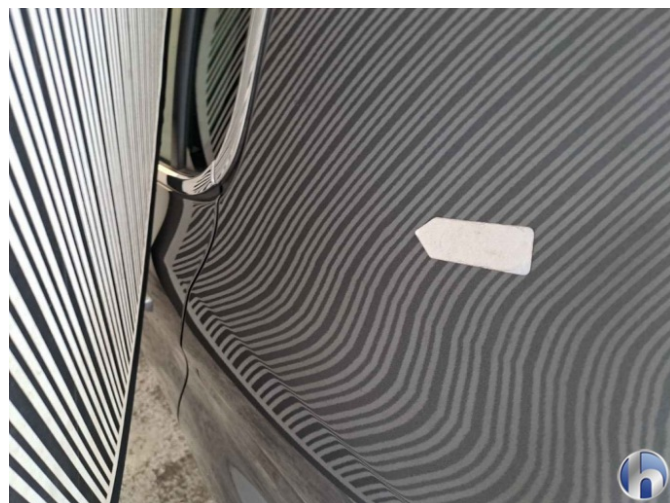
| component | Damage | Rep kind |
|---|---|---|
| 13. Sidewall - Rear - Left | Damaged | Refurbish and paint |

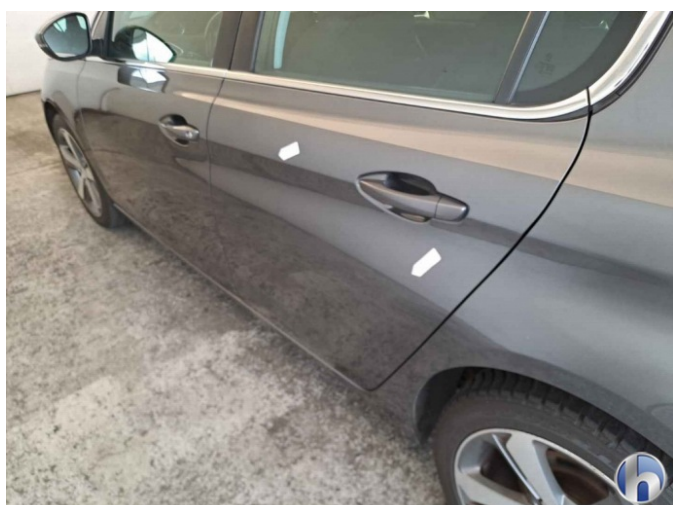
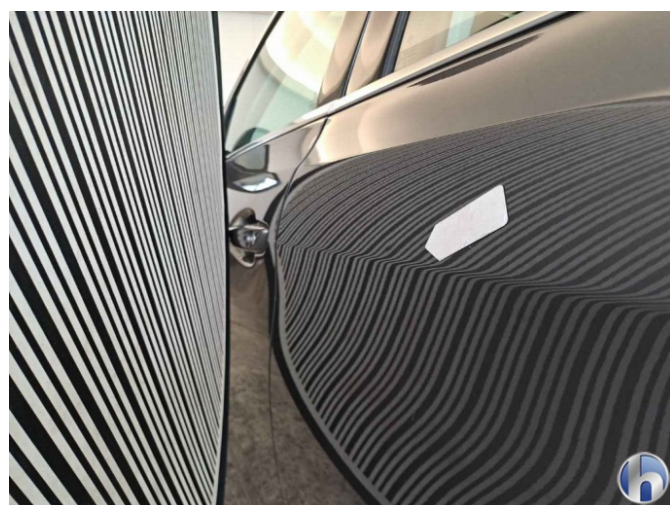
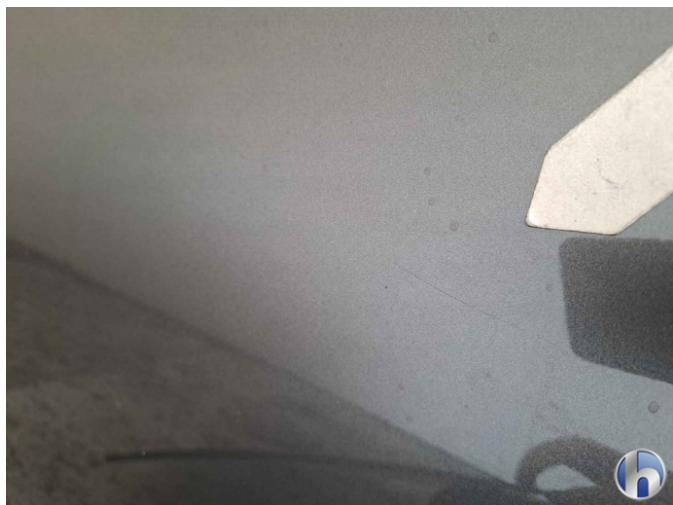
| component | Damage | Rep kind |
|---|---|---|
| 14. Rear door - left | Damaged | Refurbish and paint |

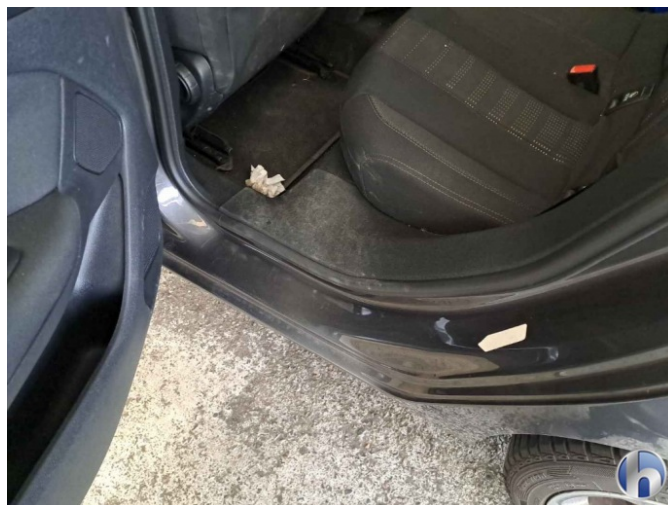
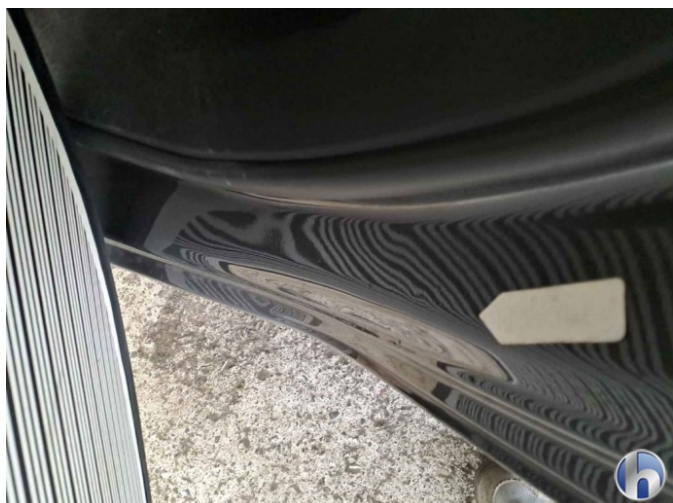
| component | Damage | Rep kind |
|---|---|---|
| 15. Türeinstieg Hinten - Links | Deformed | Refurbish and paint |

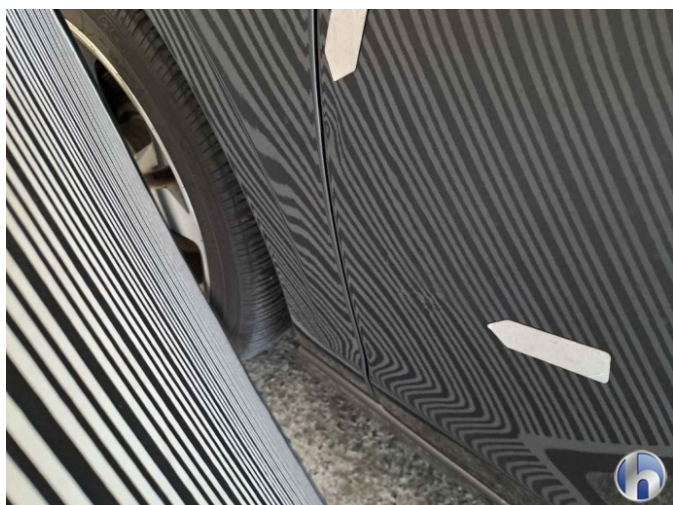
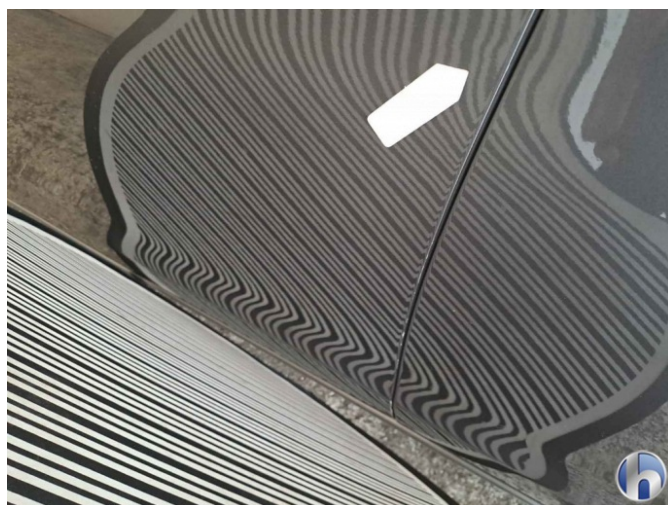
| component | Damage | Rep kind |
|---|---|---|
| 16. Front door - left | Damaged | Refurbish and paint |

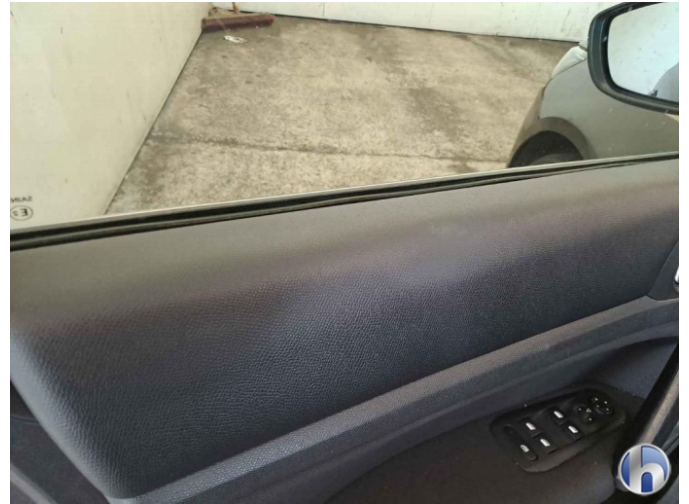
| component | Damage | Rep kind |
|---|---|---|
| 17. Front door trim - left | Damaged | Replace |

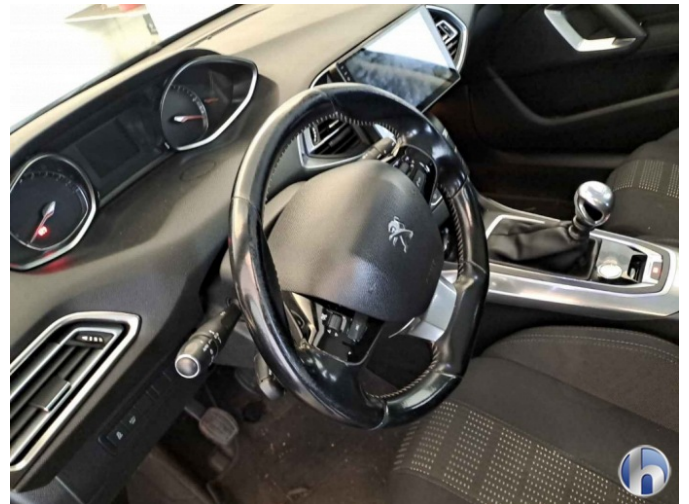
| component | Damage | Rep kind |
|---|---|---|
| 19. Steering wheel (leather) | Scrape | Replace |

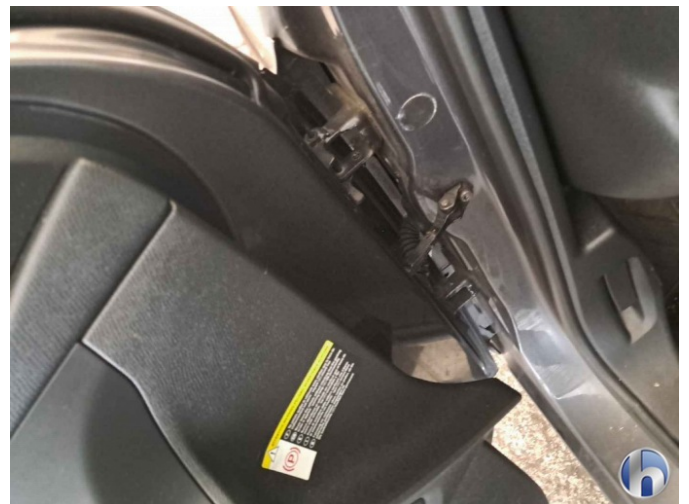
| component | Damage | Rep kind |
|---|---|---|
| 20. Türfangband Vorne links | Abnormal noises | Carry out a fault diagnosis |

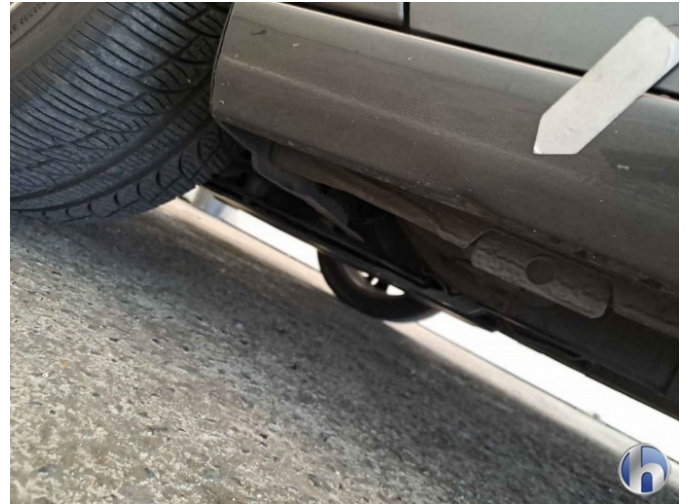
| component | Damage | Rep kind |
|---|---|---|
| 22. side skirt - left | Damaged | Refurbish and paint |

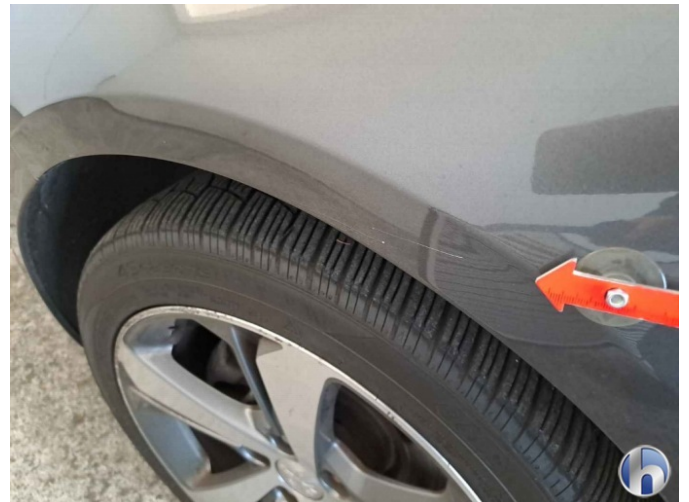
| component | Damage | Rep kind |
|---|---|---|
| 23. Front fender - left | Damaged | Replace |

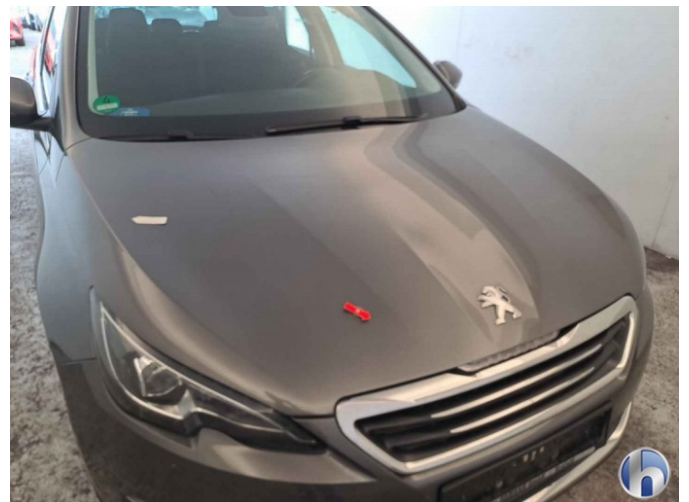
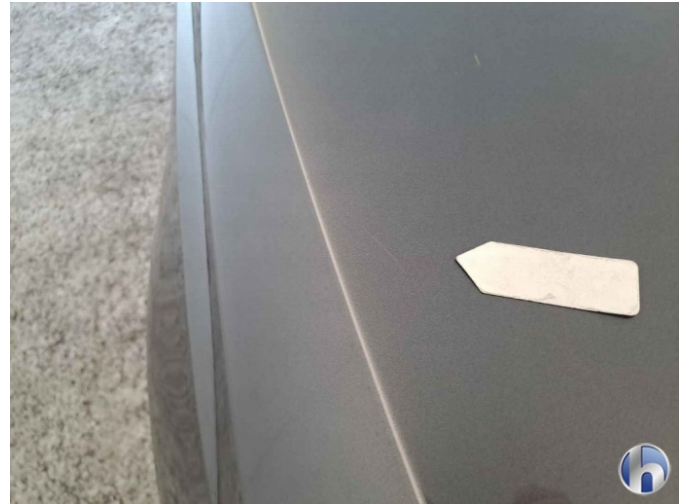
| component | Damage | Rep kind |
|---|---|---|
| 24. hood | Damaged | Refurbish and paint |

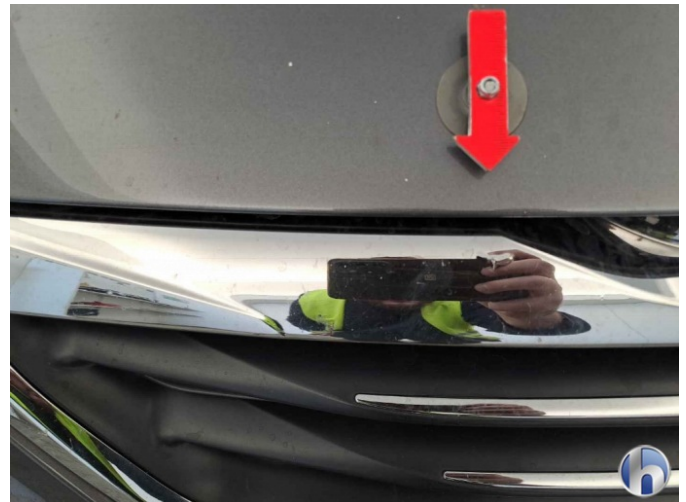
| component | Damage | Rep kind |
|---|---|---|
| 25. Front grille top | Damaged | Replace |

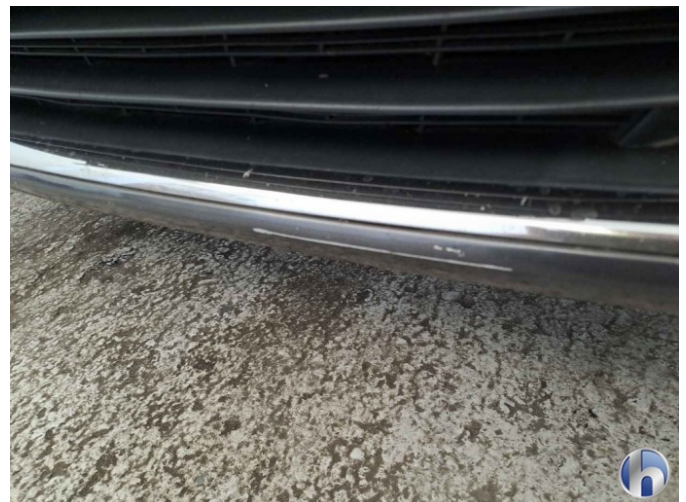
| component | Damage | Rep kind |
|---|---|---|
| 26. Front bumper | Scrape | Refurbish and paint |

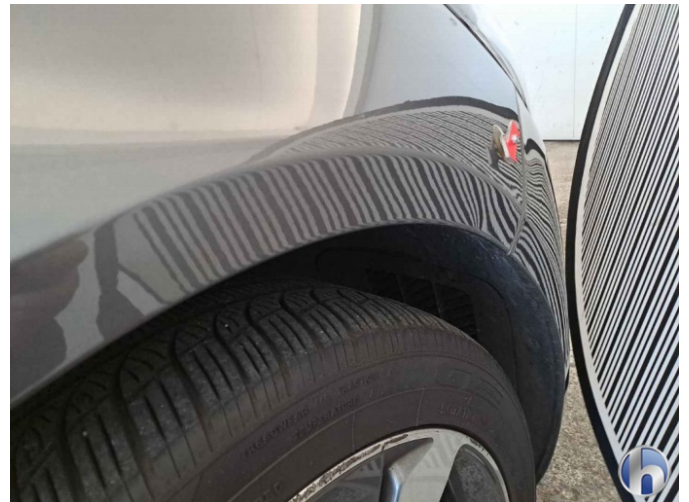
| component | Damage | Rep kind |
|---|---|---|
| 32. Front fender - right | Deformed | Refurbish and paint |

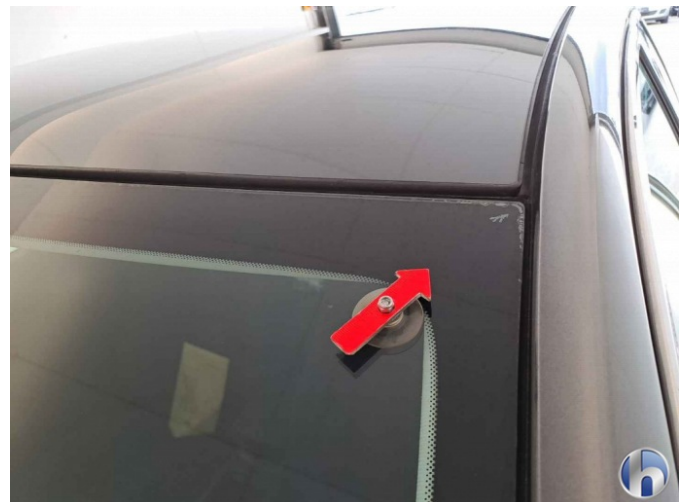
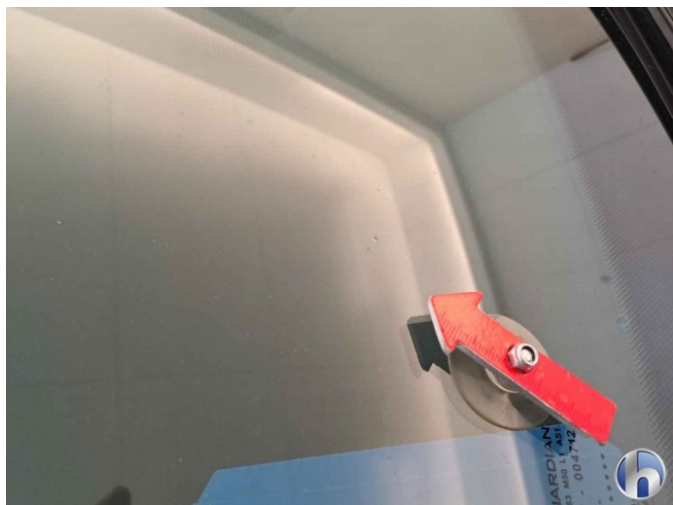
| component | Damage | Rep kind |
|---|---|---|
| 33. Windshield | Damaged | Replace |

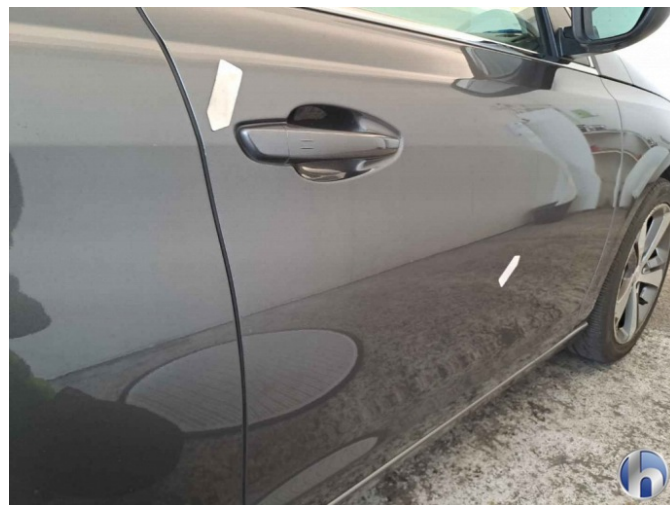
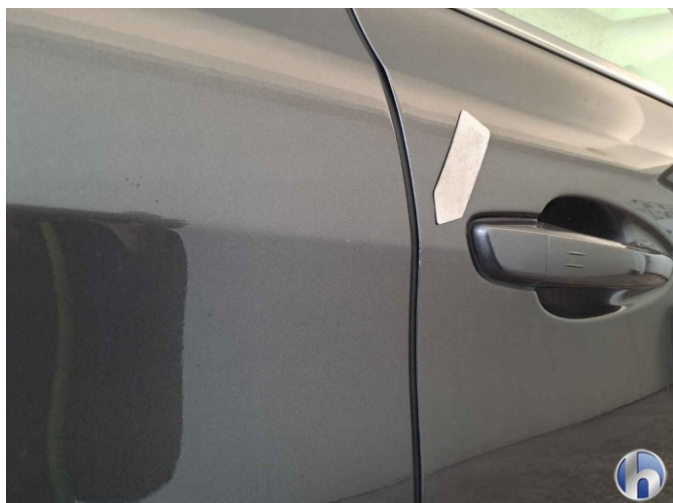
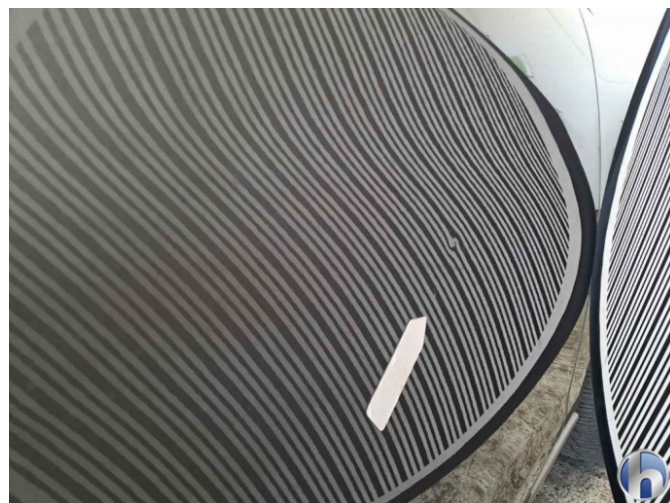
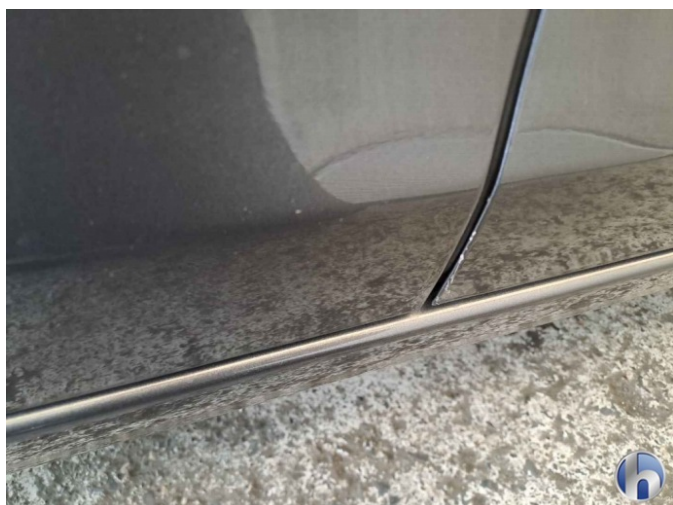
| component | Damage | Rep kind |
|---|---|---|
| 34. Front door - right | Damaged | Refurbish and paint |

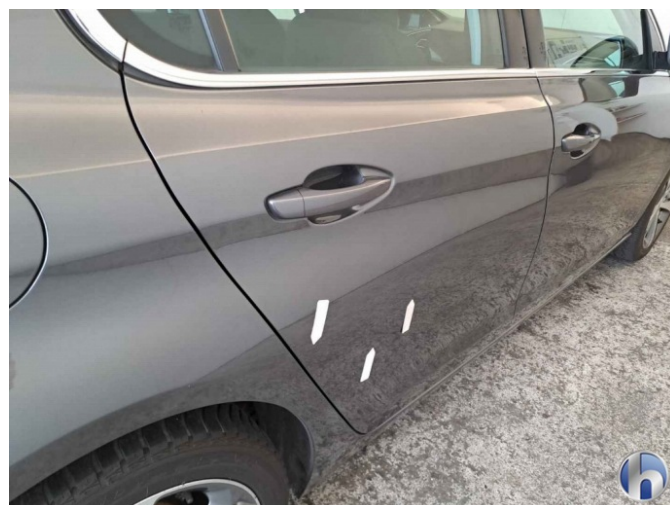
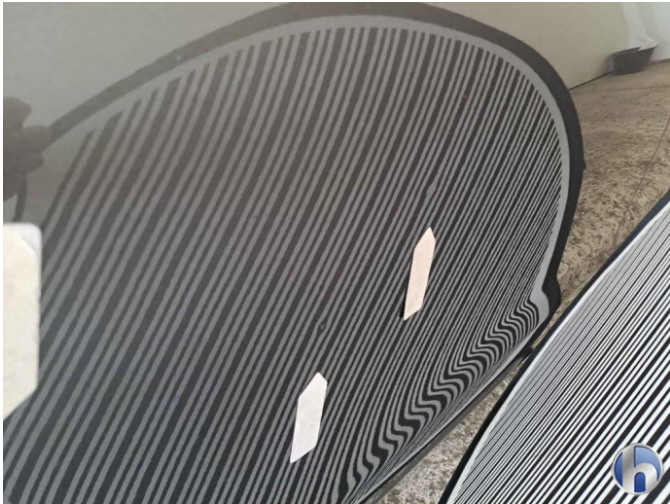
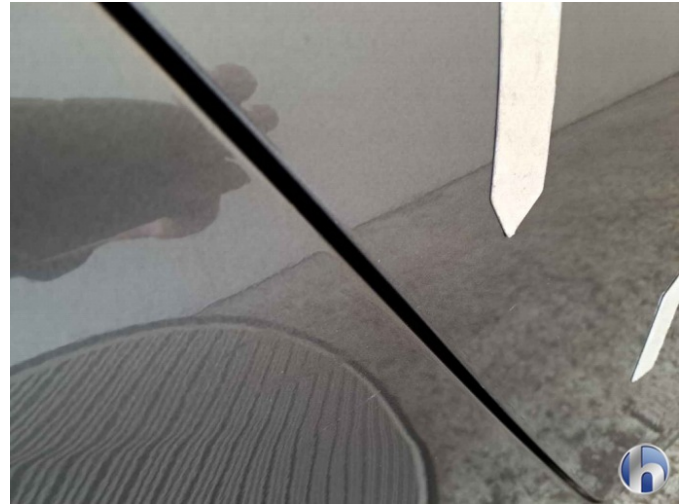
| component | Damage | Rep kind |
|---|---|---|
| 35. Door Rear - right | Damaged | Refurbish and paint |

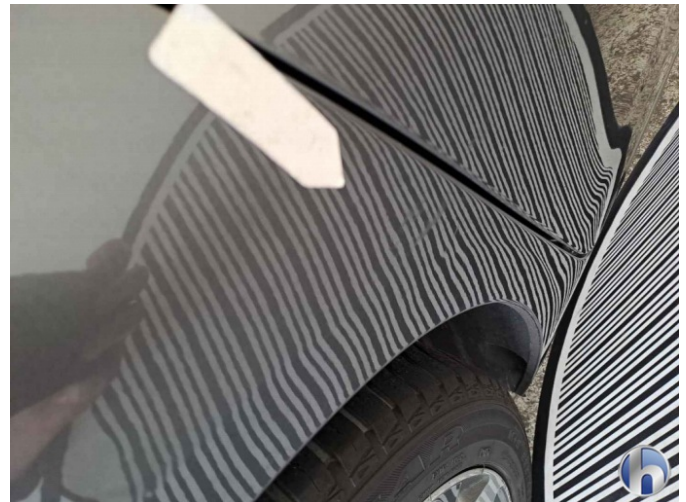
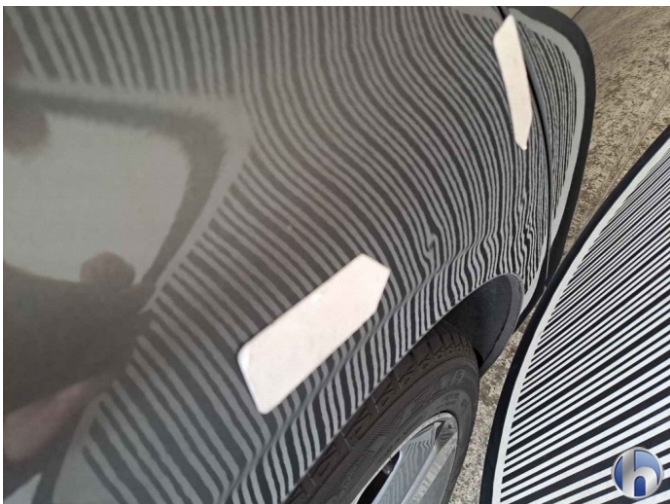
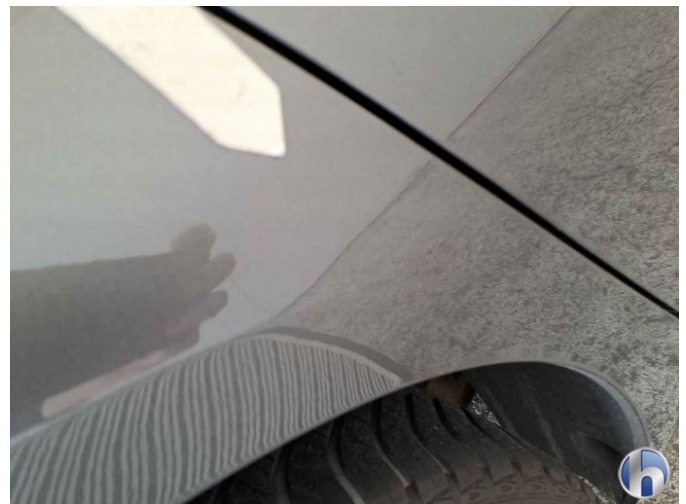
| component | Damage | Rep kind |
|---|---|---|
| 36. Sidewall - Rear - right | Damaged | Refurbish and paint |

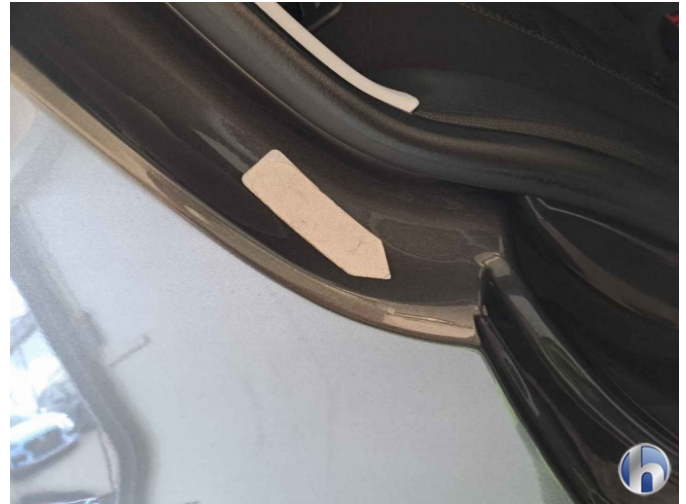
| component | Damage | Rep kind |
|---|---|---|
| 37. Türeinstieg Hinten - Rechts | Scratch(es) | Paint |
