## status report

#### Peugeot 308 SW Style

| Vehicle identification number | <b>VF3LRHNSTKS240512</b> | mileage read: | <b>86875 km</b> |
| First Registration / construction year: | <b>10.07.2019 / 2019</b> | Visit Date / place of birth: | <b>25.09.2025 Riedstadt-Goddelau</b> |

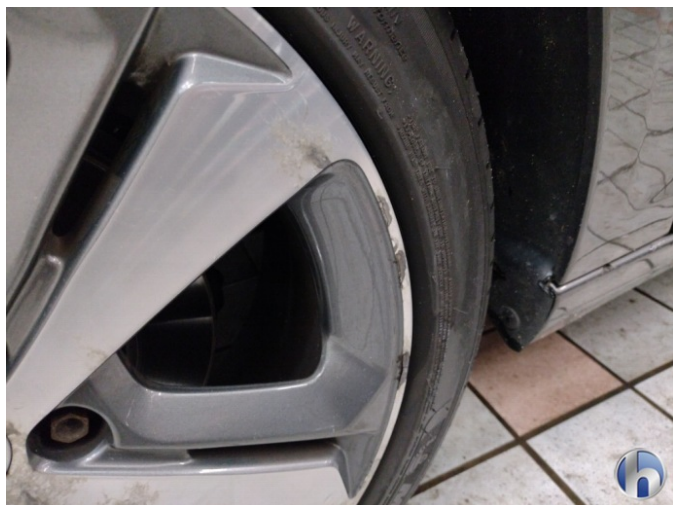
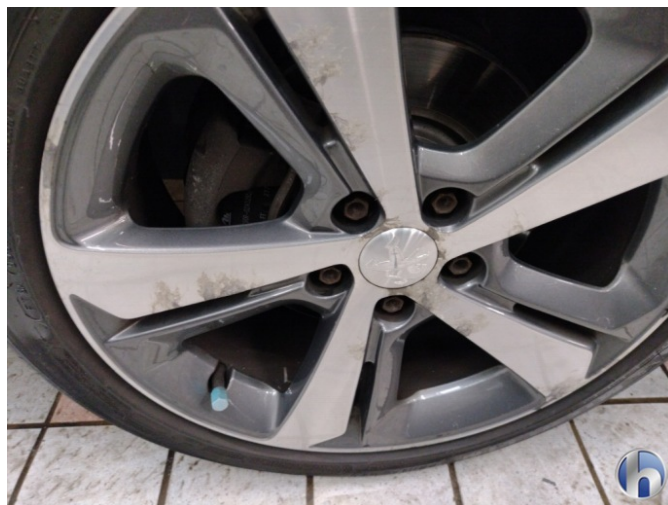
| component | Damage | Rep kind |
|---|---|---|
| 2. Rim front - left | Damaged | Replace |

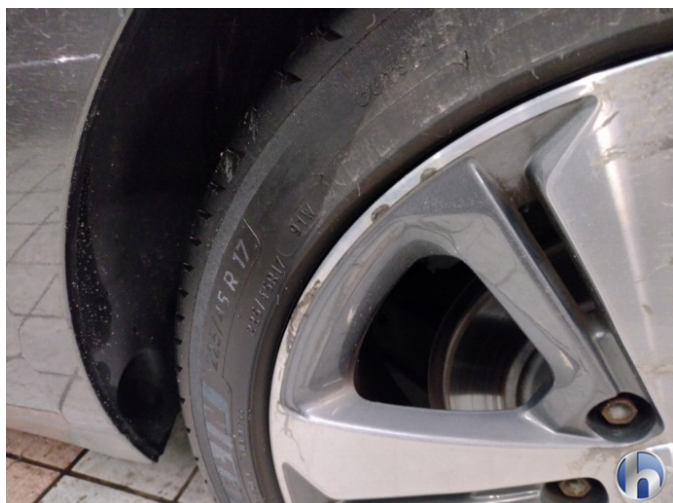
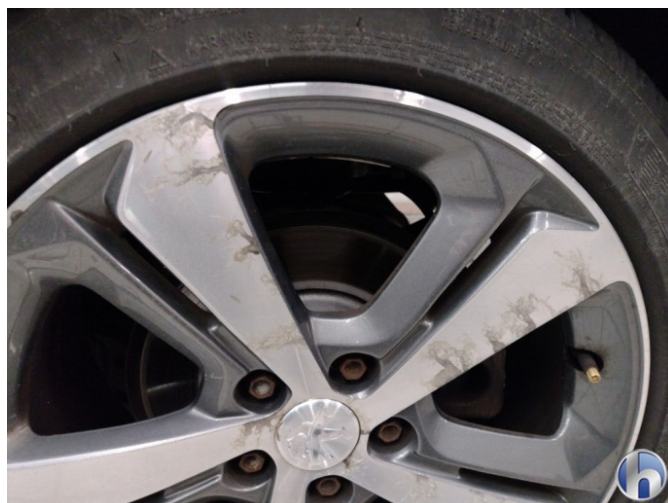
| component | Damage | Rep kind |
|---|---|---|
| 3. Rim rear - left | Damaged | Replace |

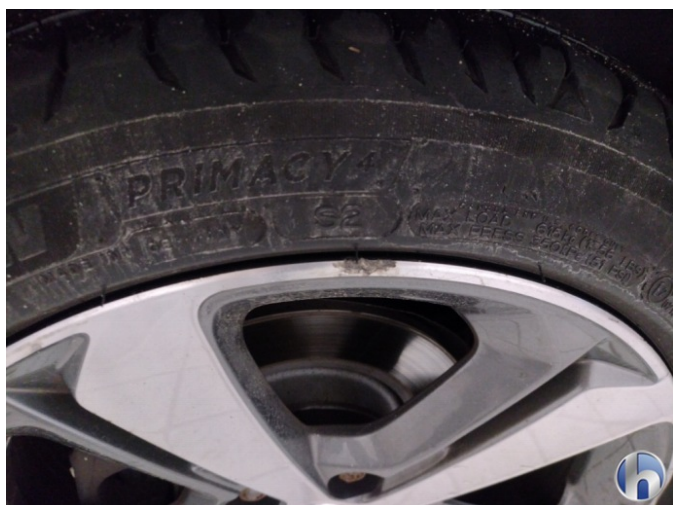
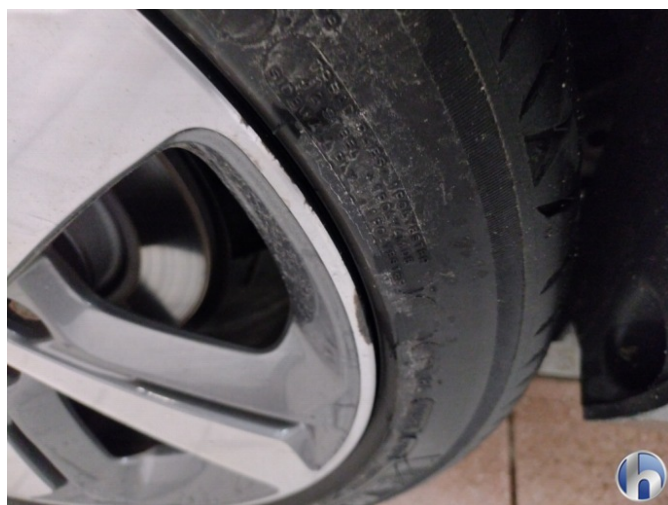
| component | Damage | Rep kind |
|---|---|---|
| 4. Rim rear - right | Damaged | Replace |

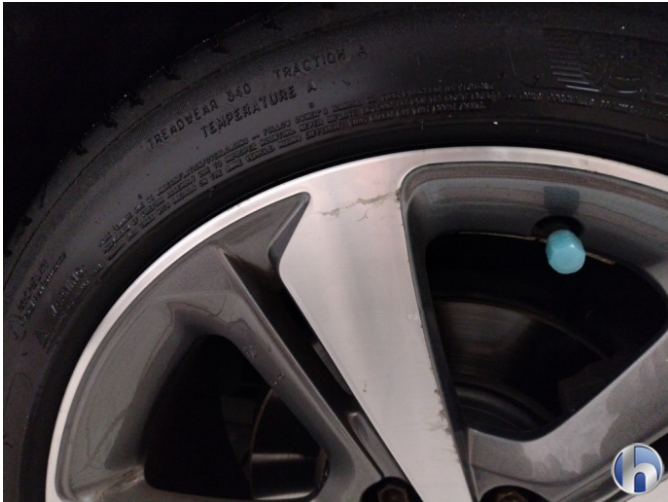
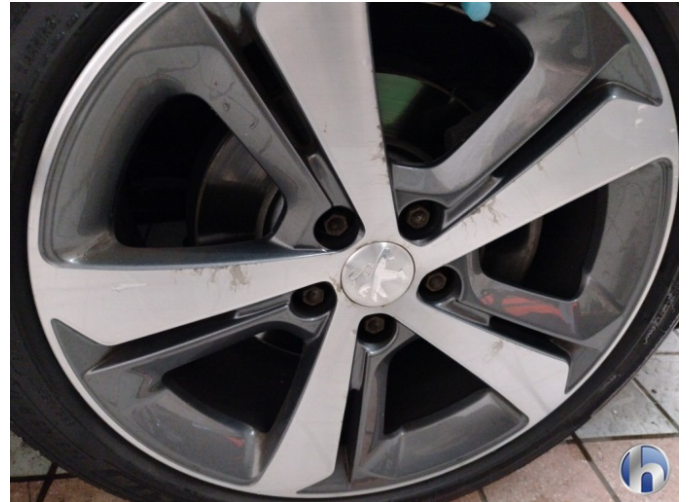
| component | Damage | Rep kind |
|---|---|---|
| 5. Rim front - right | Damaged | Replace |

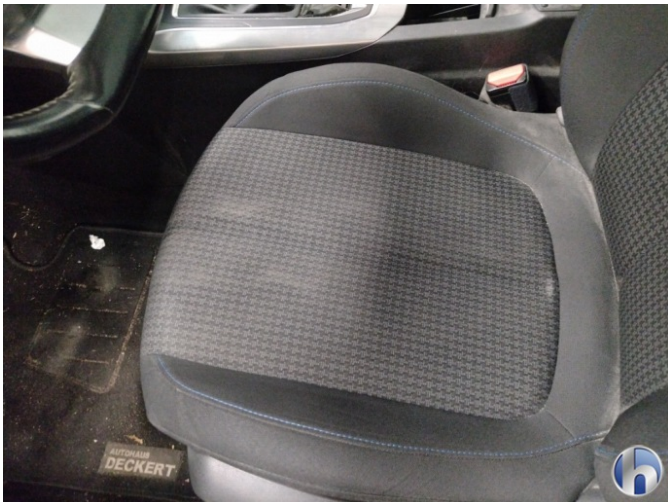
| component | Damage | Rep kind |
|---|---|---|
| 6. | Dirty | |

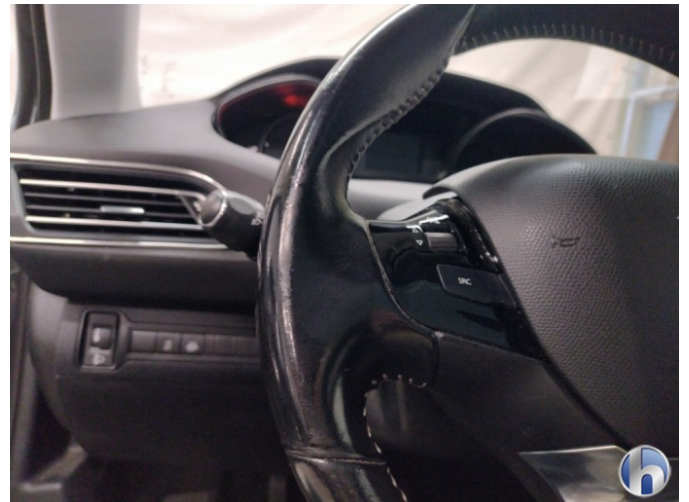
| component | Damage | Rep kind |
|---|---|---|
| 7. steering wheel | Damaged | Smart repair |

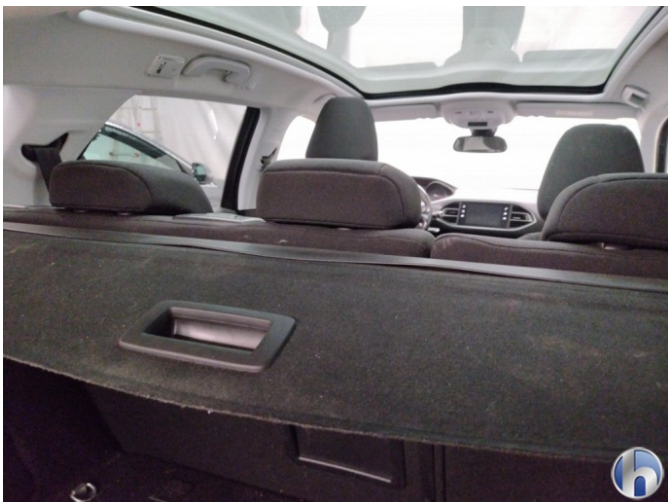
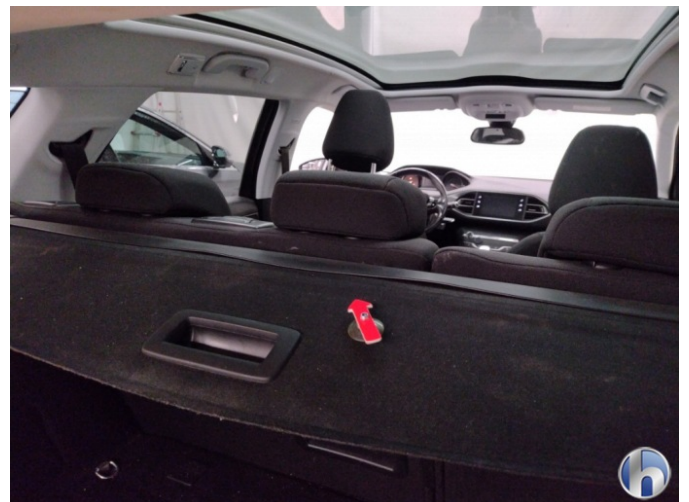
| component | Damage | Rep kind |
|---|---|---|
| 9. Cargo cover | Damaged | Smart repair |

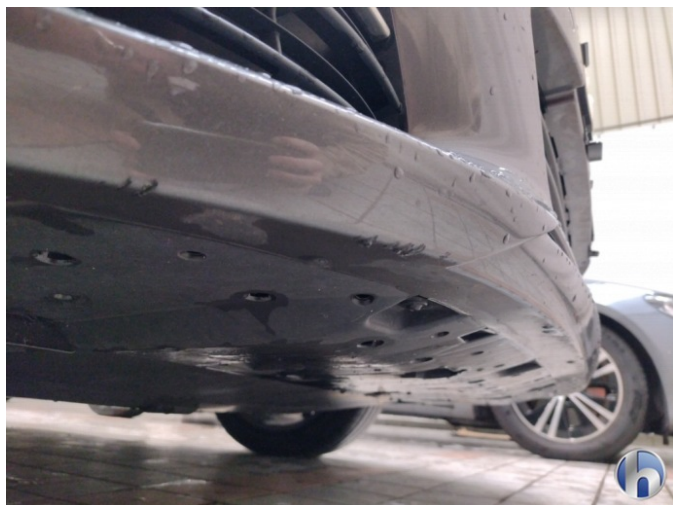
| component | Damage | Rep kind |
|---|---|---|
| 10. Front bumper | Scrape | Paint |

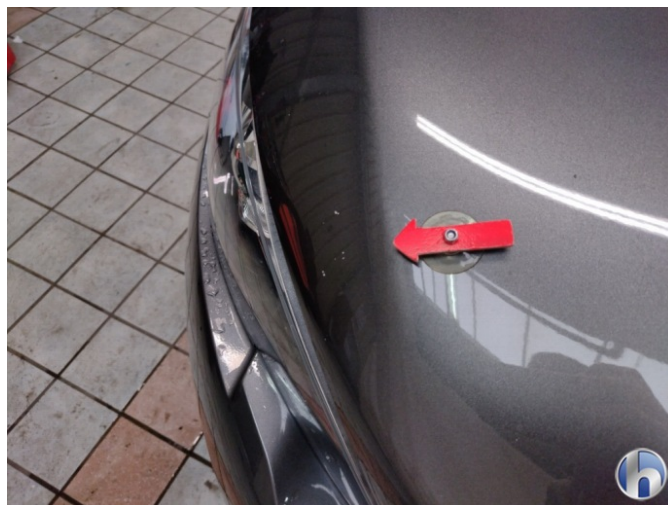
| component | Damage | Rep kind |
|---|---|---|
| 11. hood | Wear and tear | acceptable |

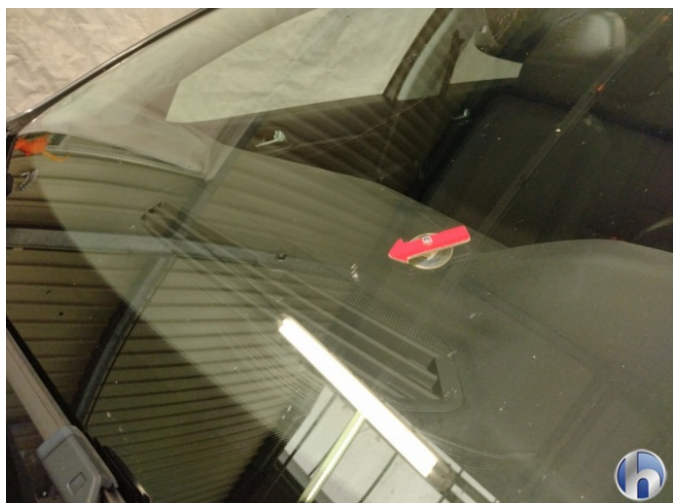
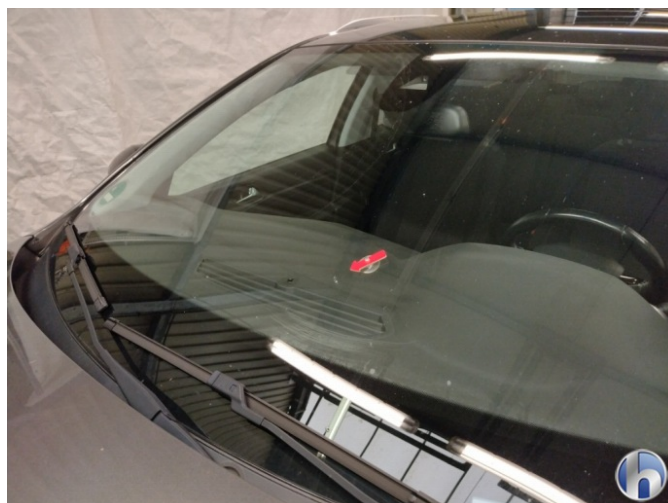
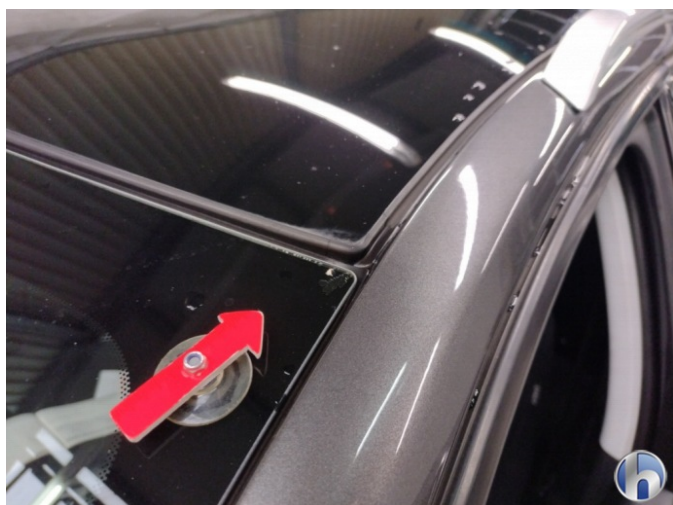
| component | Damage | Rep kind |
|---|---|---|
| 12. Windshield | Wear and tear | acceptable |

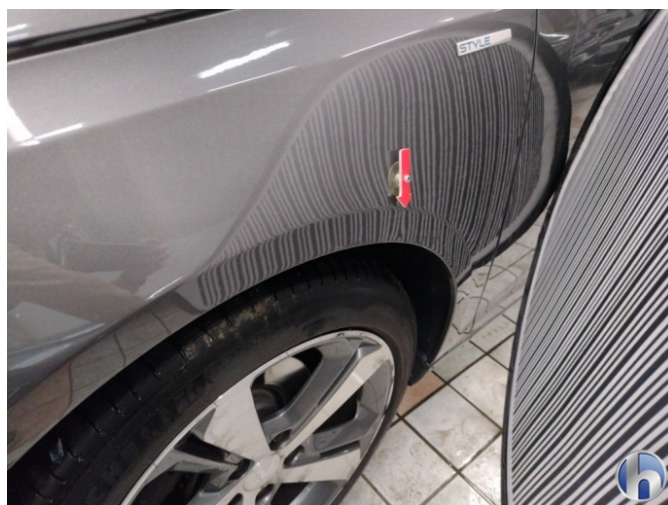
| component | Damage | Rep kind |
|---|---|---|
| 13. Front fender - left | Deformed | Refurbish and paint |

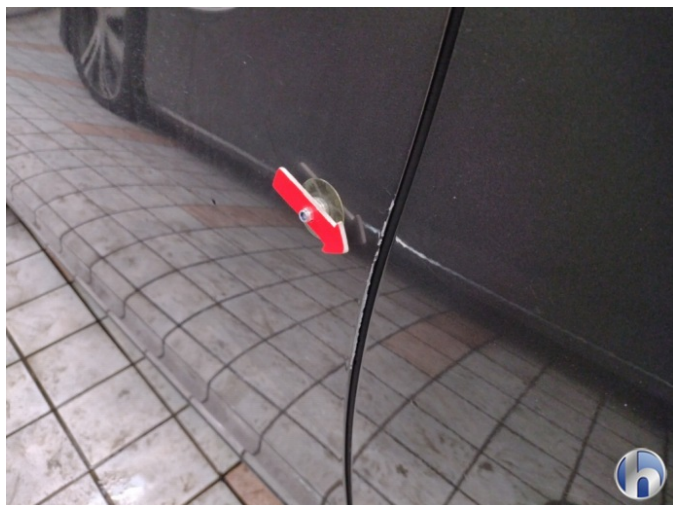
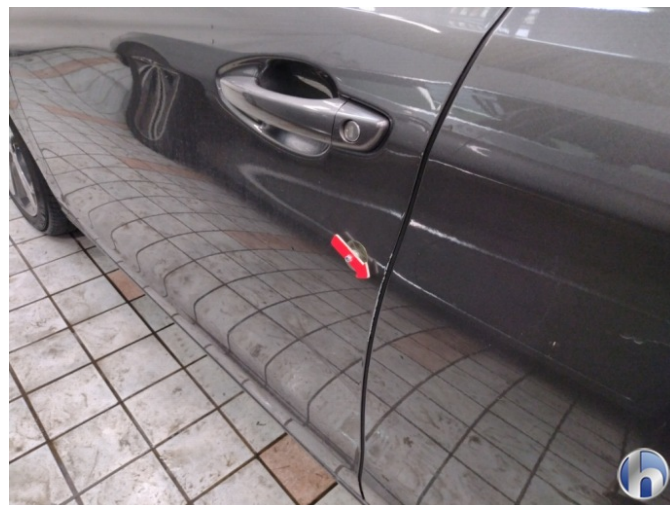
| component | Damage | Rep kind |
|---|---|---|
| 14. Front door - left | Scratch(es) | Paint |

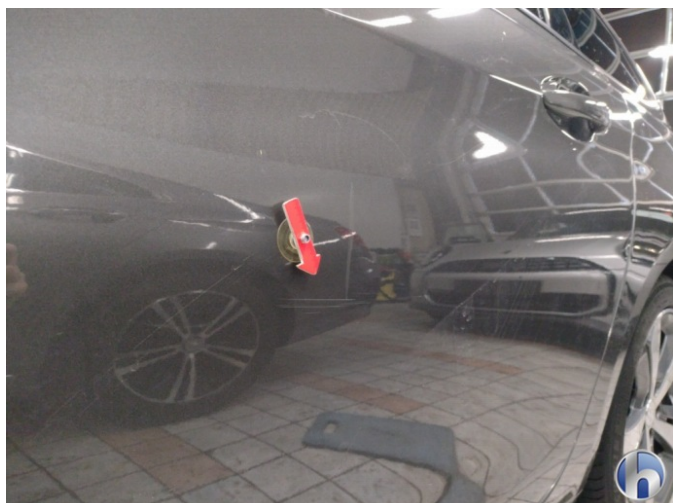
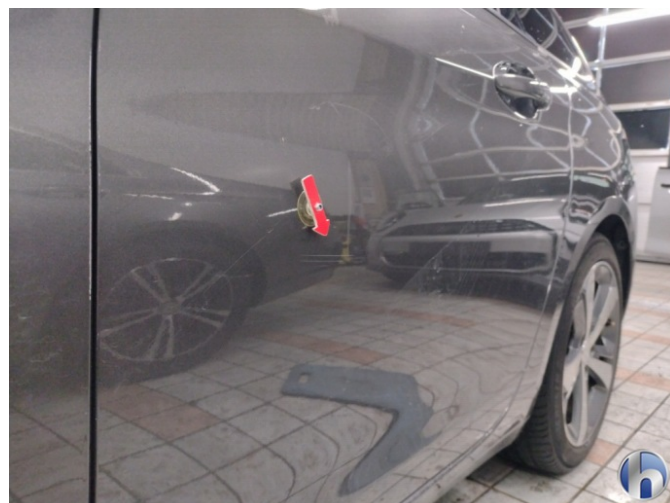
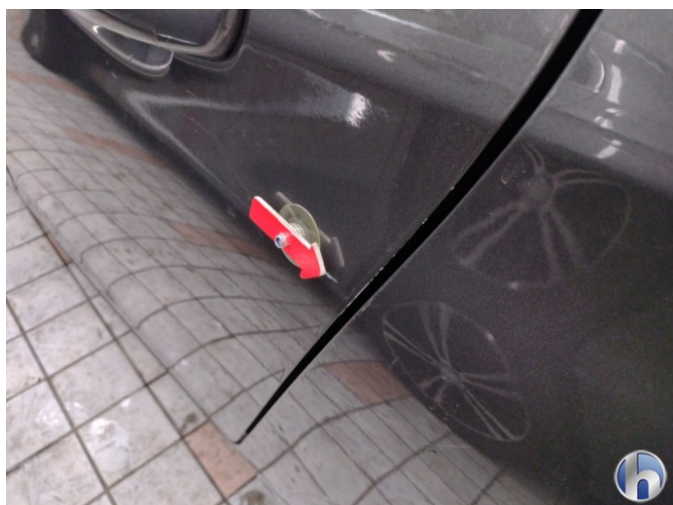
| component | Damage | Rep kind |
|---|---|---|
| 15. Rear door - left | Scratch(es) | Paint |

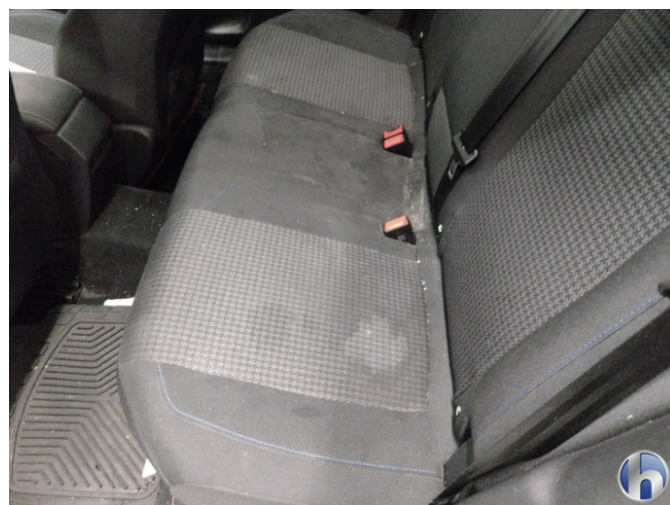
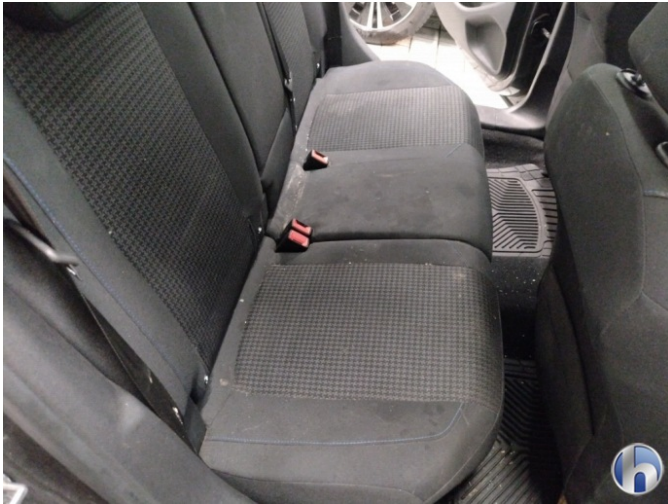
| component | Damage | Rep kind |
|---|---|---|
| 16. Sitzreihe Hinten | Dirty | |

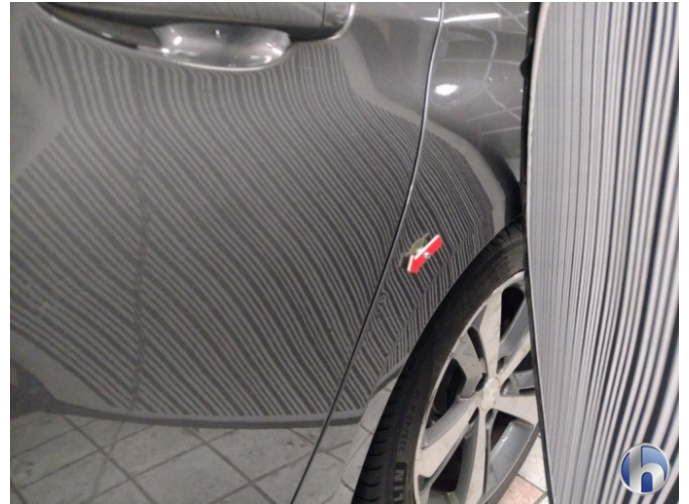
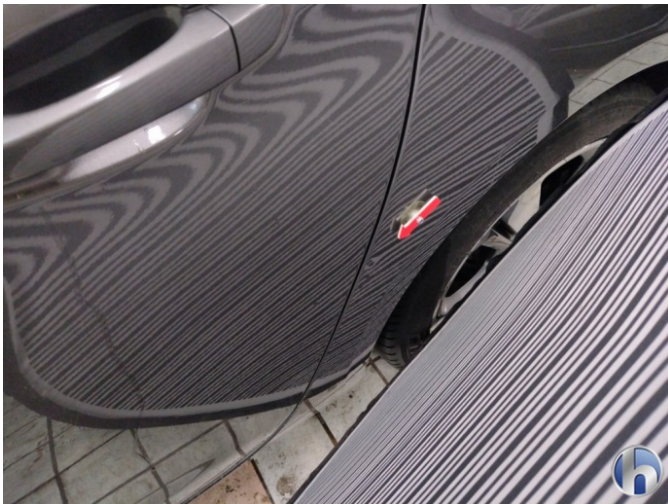
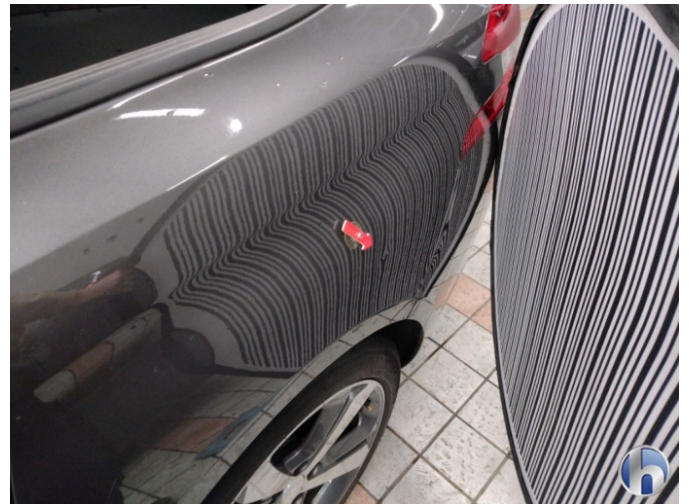
| component | Damage | Rep kind |
|---|---|---|
| 17. Sidewall - Rear - Left | Deformed | Refurbish and paint |

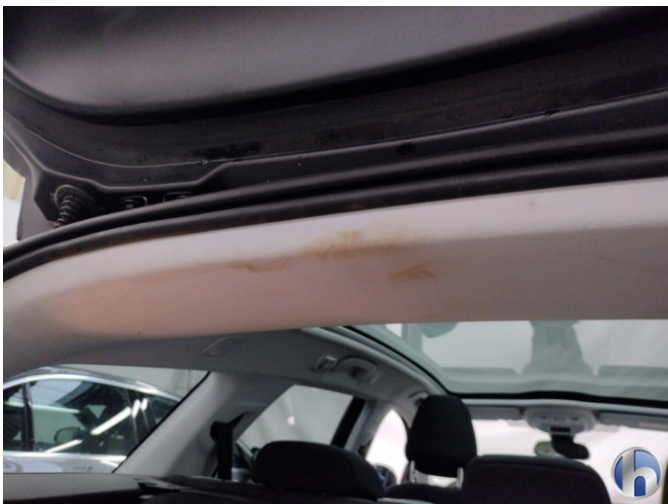
| component | Damage | Rep kind |
|---|---|---|
| 18. headlining | Dirty | |

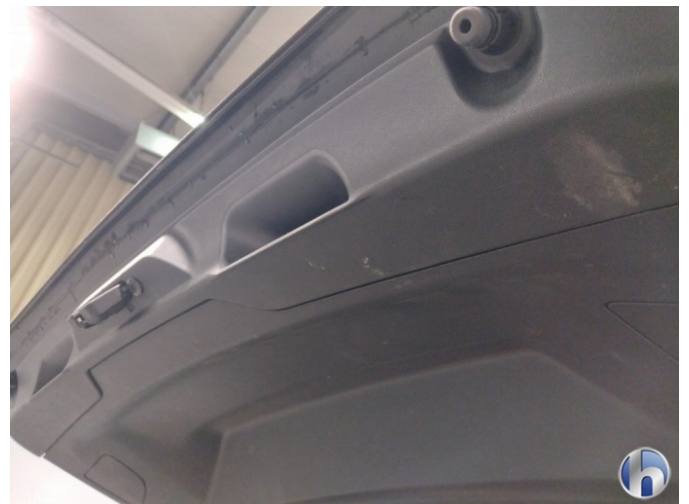
| component | Damage | Rep kind |
|---|---|---|
| 19. tailgate trim | Wear and tear | acceptable |

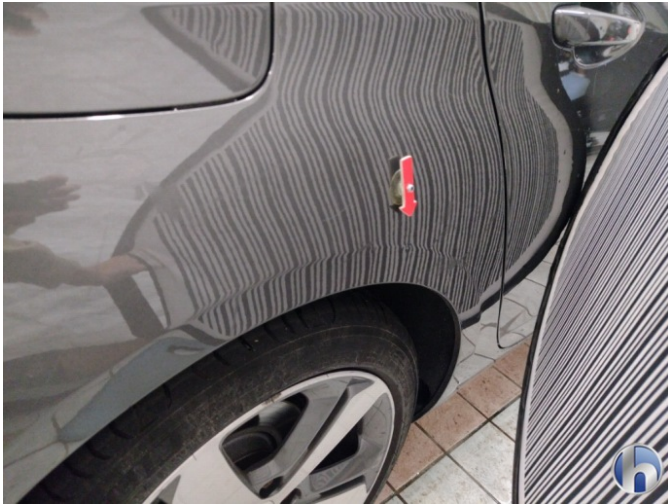
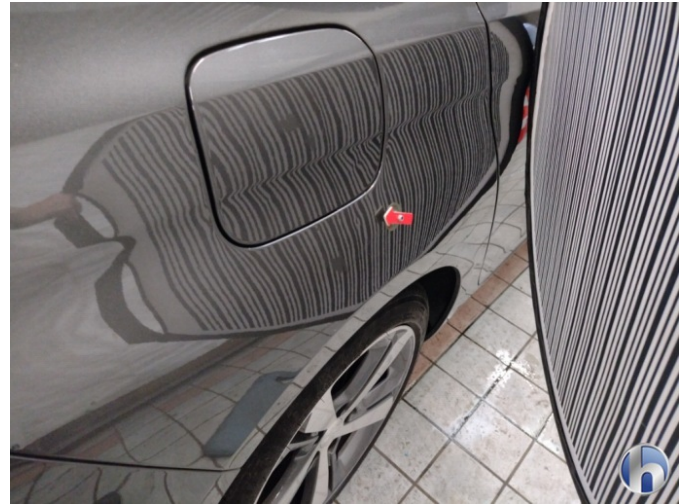
| component | Damage | Rep kind |
|---|---|---|
| 20. Sidewall - Rear - right | Deformed | Refurbish and paint |

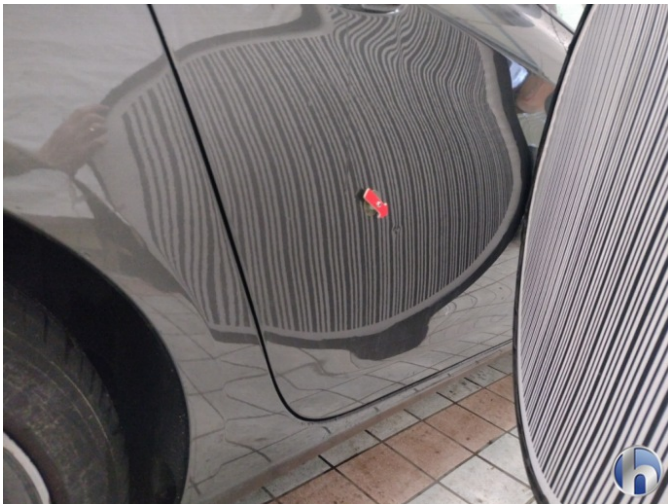
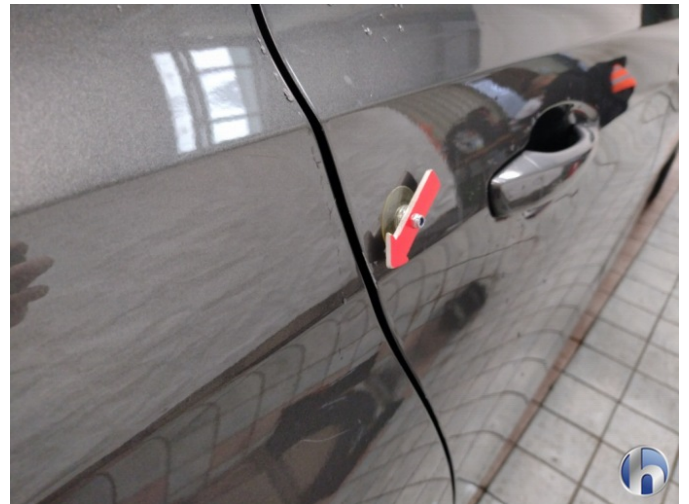
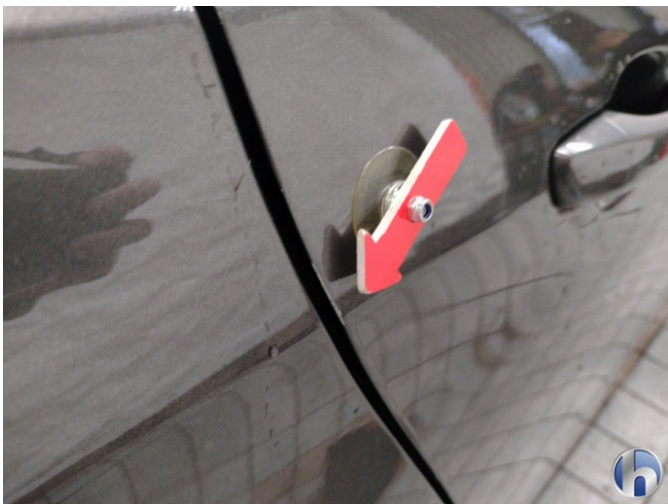
| component | Damage | Rep kind |
|---|---|---|
| 21. Door Rear - right | Damaged | Refurbish and paint |

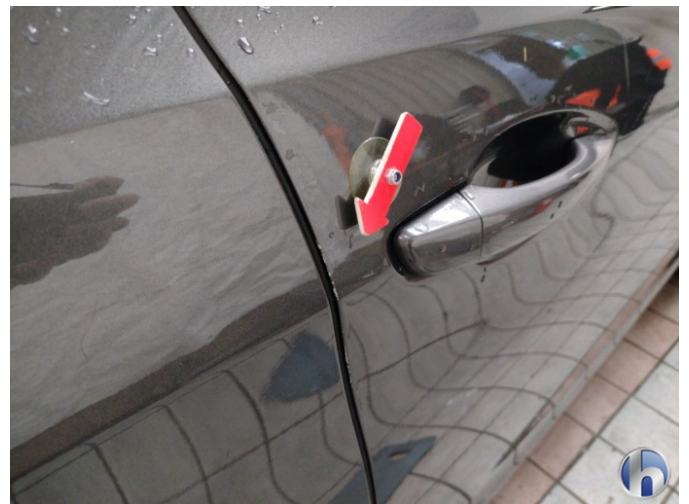
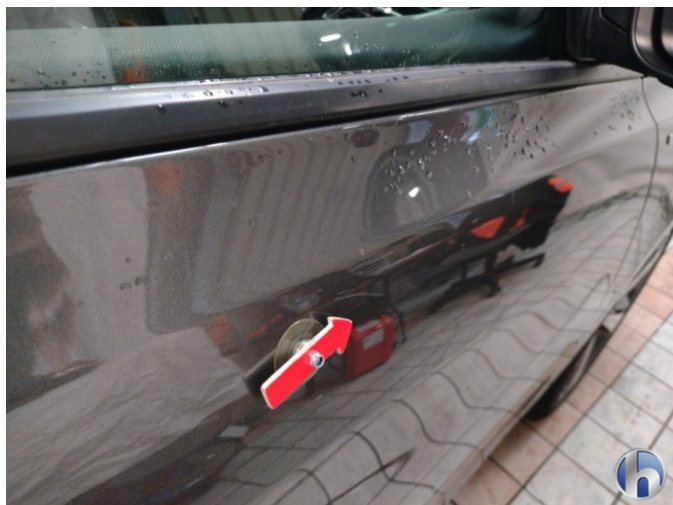
| component | Damage | Rep kind |
|---|---|---|
| 22. Front door - right | Scratch(es) | Paint |

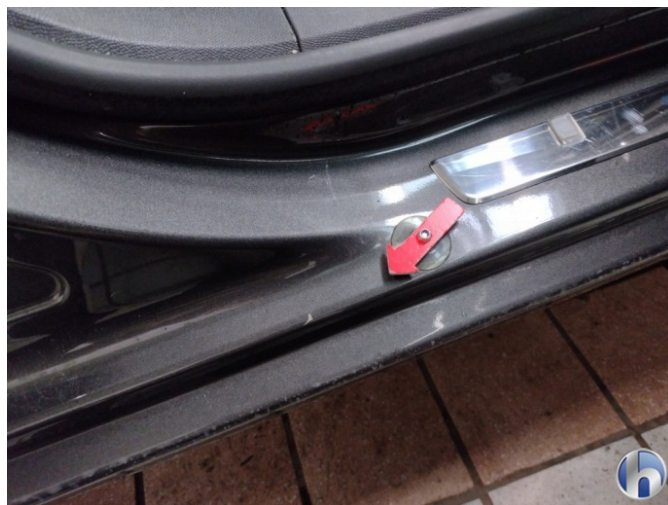
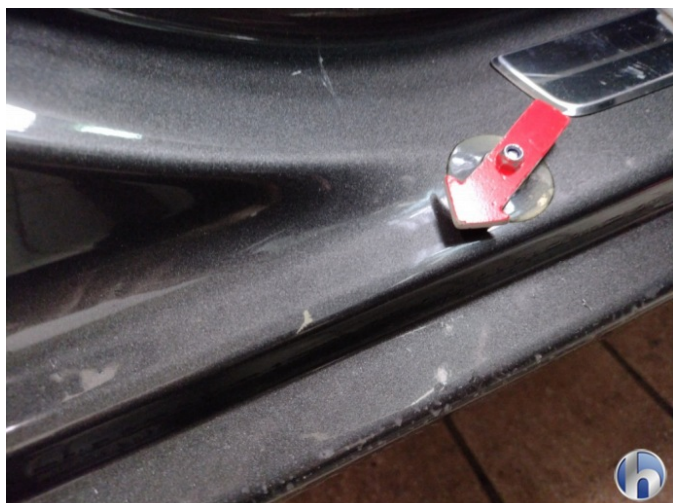
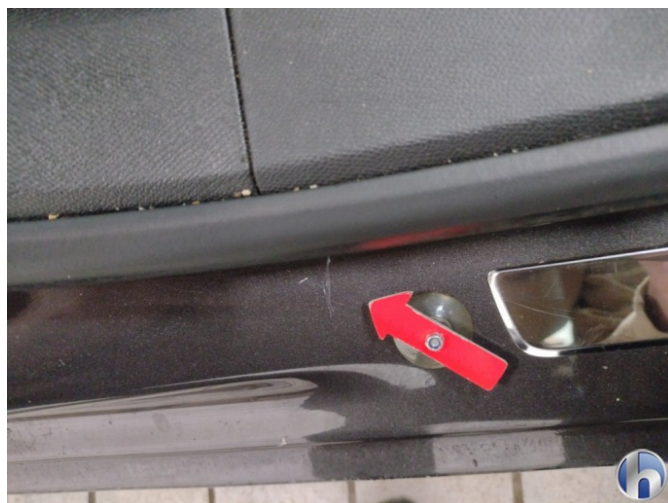
| component | Damage | Rep kind |
|---|---|---|
| 23. Türeinstieg Vorne - Rechts | Scratch(es) | Paint |
