## status report

**customer:** Bank 11, Neuss  
**contract number:** 1069224030  
**reference:**

#### Peugeot 5008 Crossway

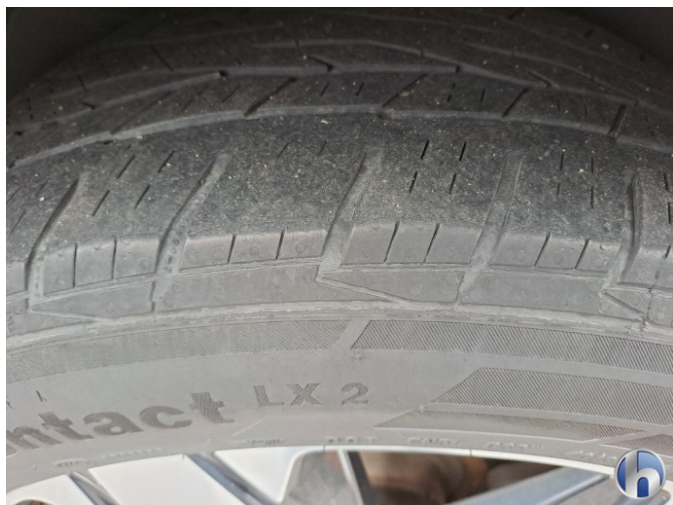
1. tire rear - left

| | component | Damage | Rep kind |
|---|---|---|---|
| 1. | tire rear - left | Worn | Replace |

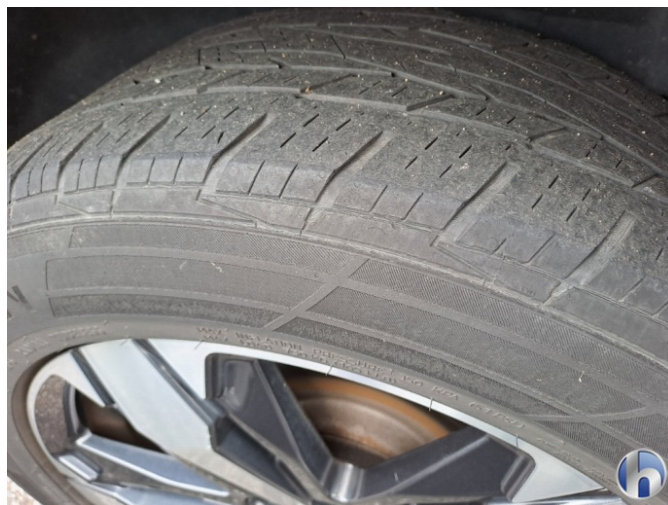
2. tire rear - right

| | component | Damage | Rep kind |
|---|---|---|---|
| 2. | tire rear - right | Worn | Replace |

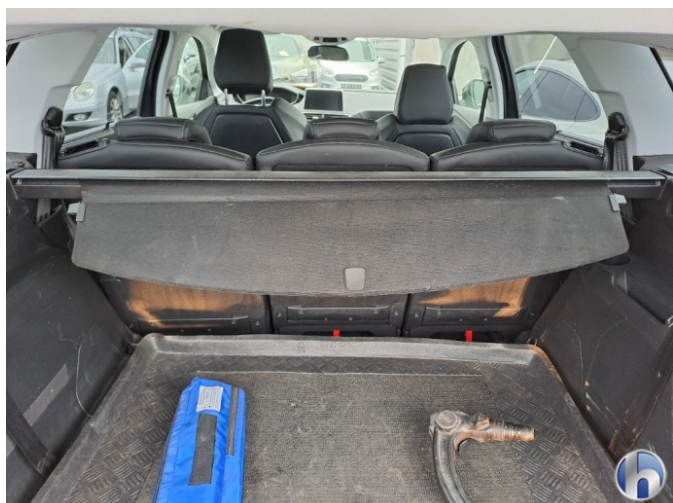
3. Cargo cover

| | component | Damage | Rep kind |
|---|---|---|---|
| 3. | Cargo cover | Damaged | Replace |

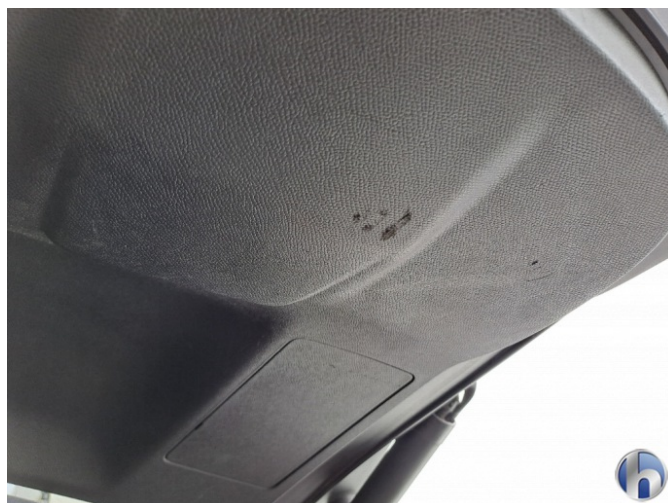
4. tailgate trim

| | component | Damage | Rep kind |
|---|---|---|---|
| 4. | tailgate trim | Scrape | Replace |

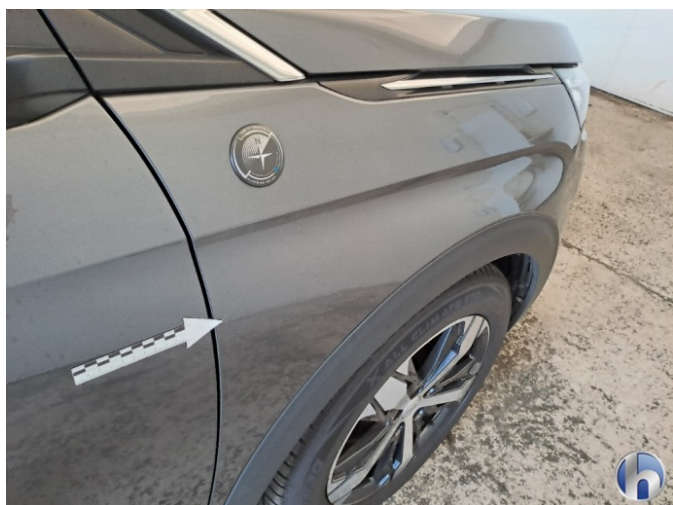
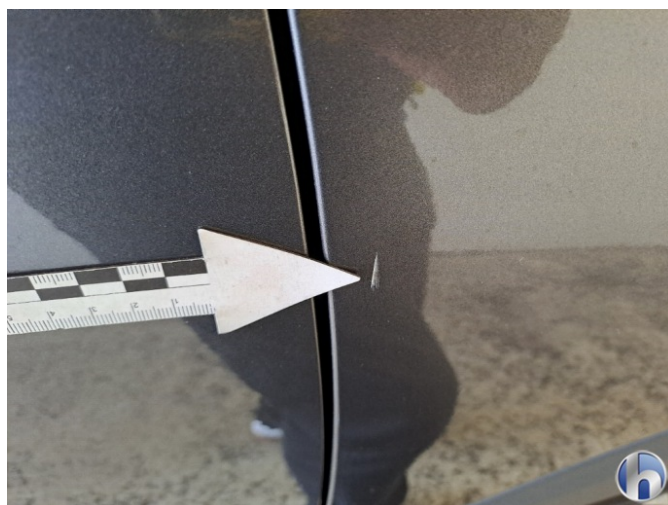
5. Front fender - right

| | component | Damage | Rep kind |
|---|---|---|---|
| 5. | Front fender - right | Scratch(es) | Smart repair |

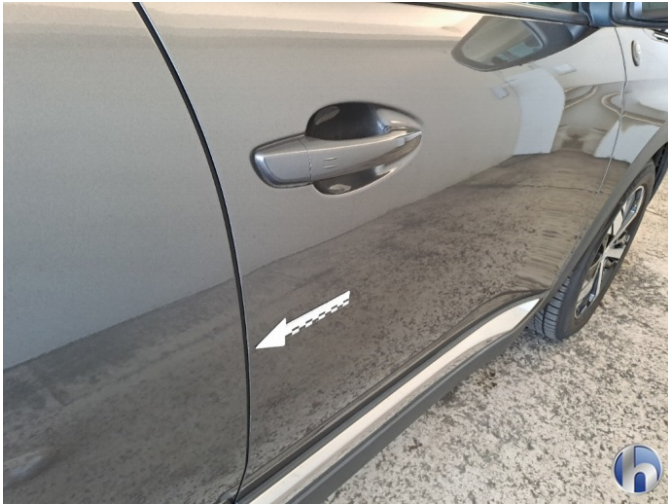
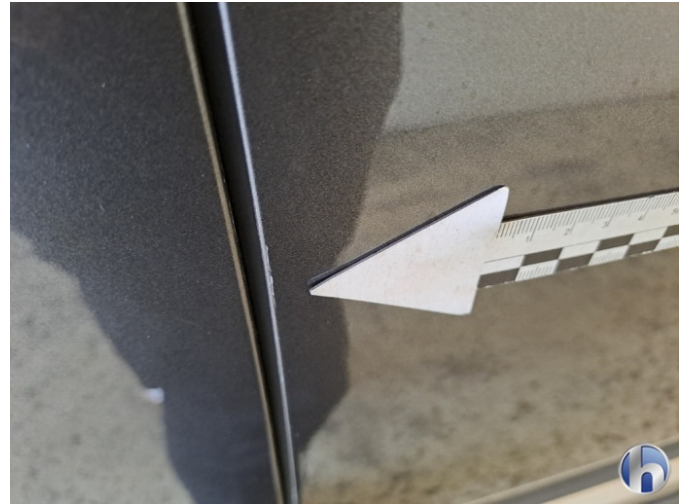
6. Front door - right

| | component | Damage | Rep kind |
|---|---|---|---|
| 6. | Front door - right | Wear and tear | acceptable |

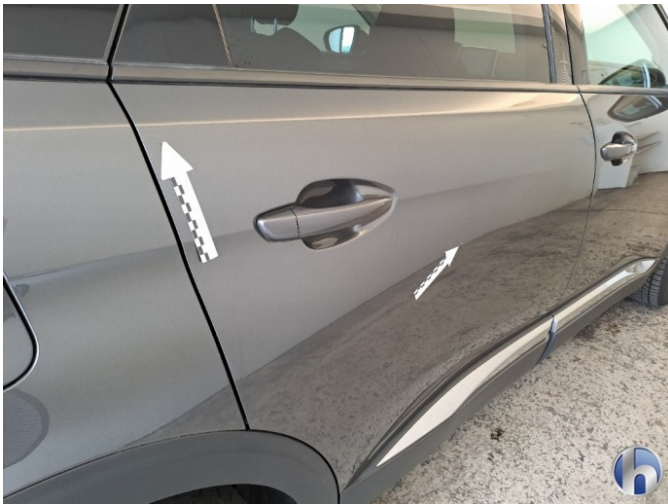
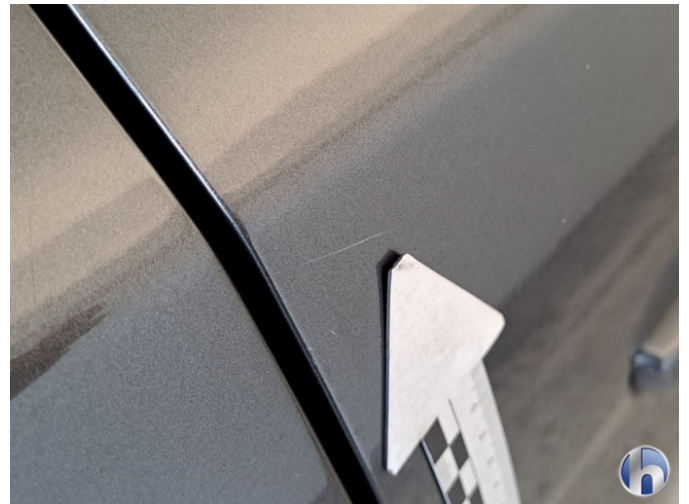
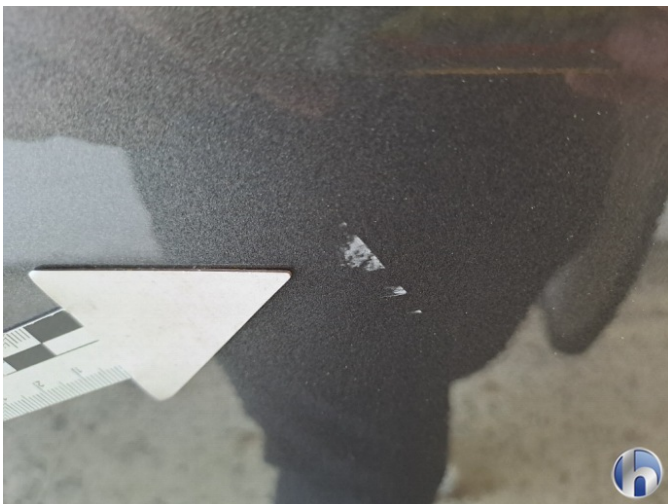
7. Door Rear - right

| | component | Damage | Rep kind |
|---|---|---|---|
| 7. | Door Rear - right | Scratch(es) | Smart repair |

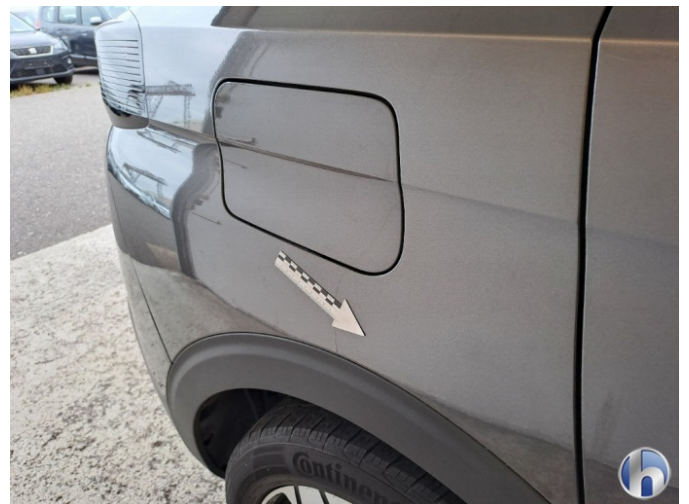
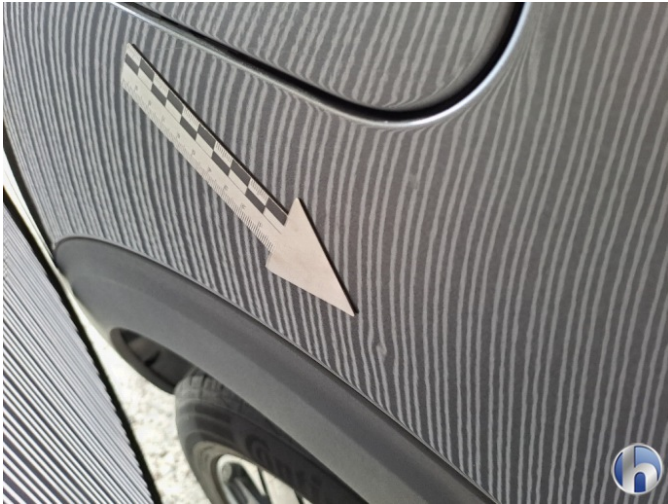
8. Sidewall - Rear - right

| | component | Damage | Rep kind |
|---|---|---|---|
| 8. | Sidewall - Rear - right | Delle | Smart repair |

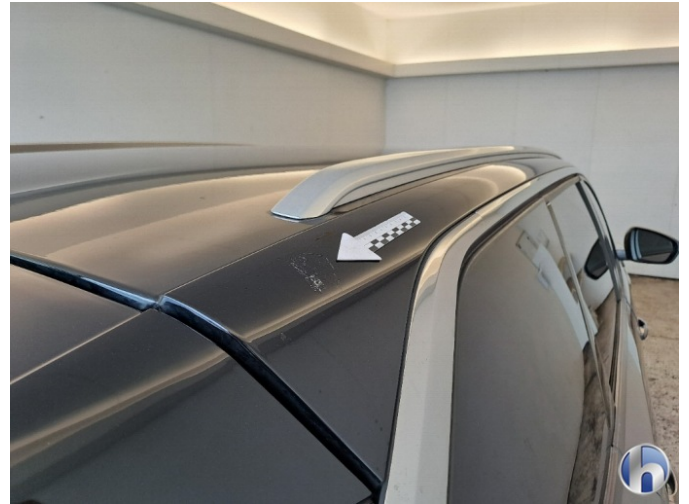
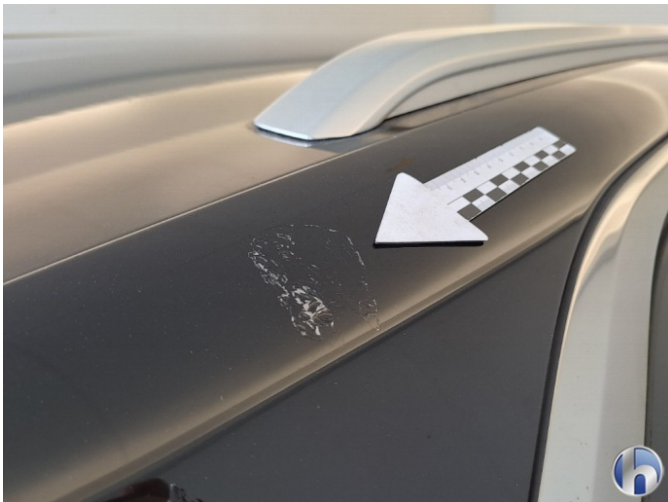
9. Roof frame - right

| | component | Damage | Rep kind |
|---|---|---|---|
| 9. | Roof frame - right | | Paint |

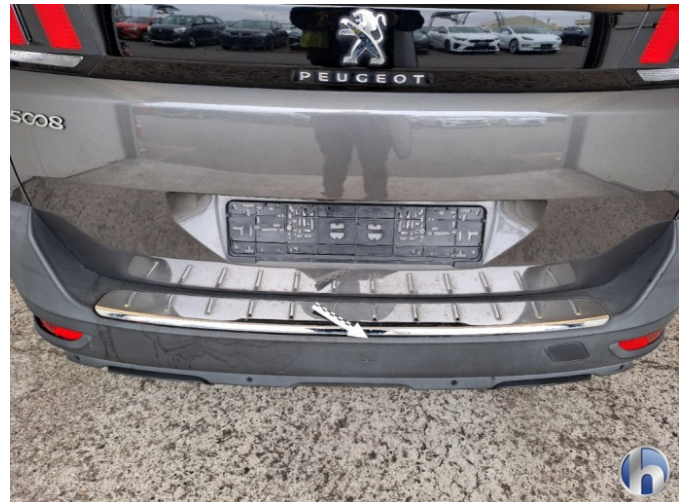
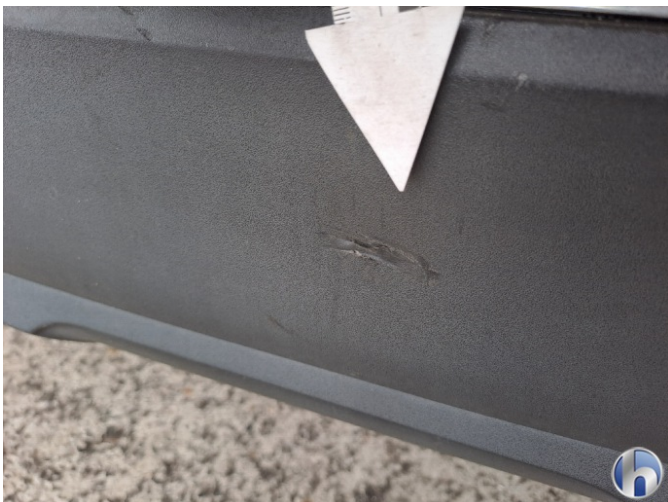
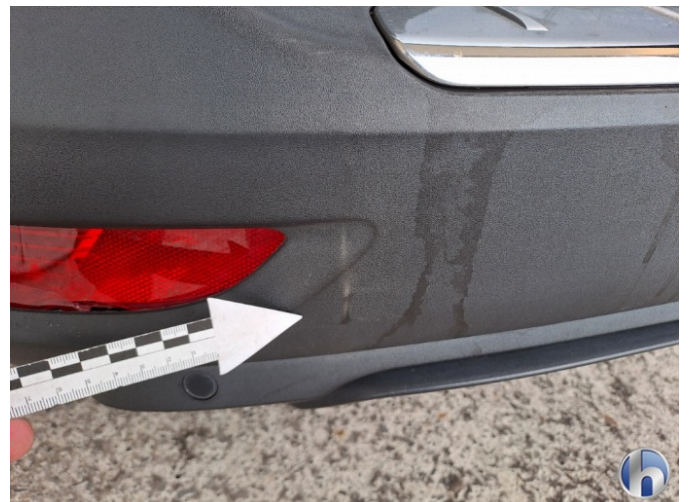
10. Rear bumper

| | component | Damage | Rep kind |
|---|---|---|---|
| 10. | Rear bumper | Damaged | Replace |

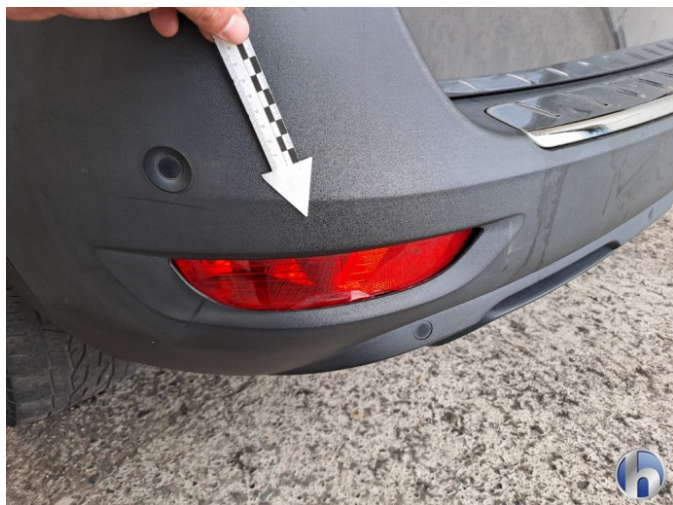
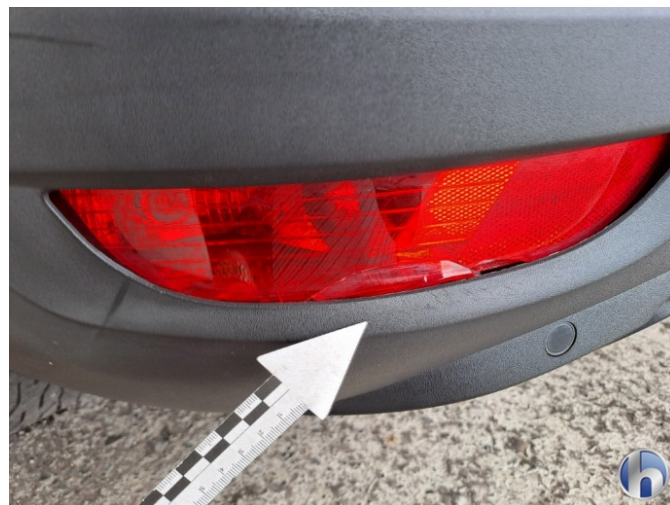
11. Taillight left

| | component | Damage | Rep kind |
|---|---|---|---|
| 11. | Taillight left | Damaged | Replace |

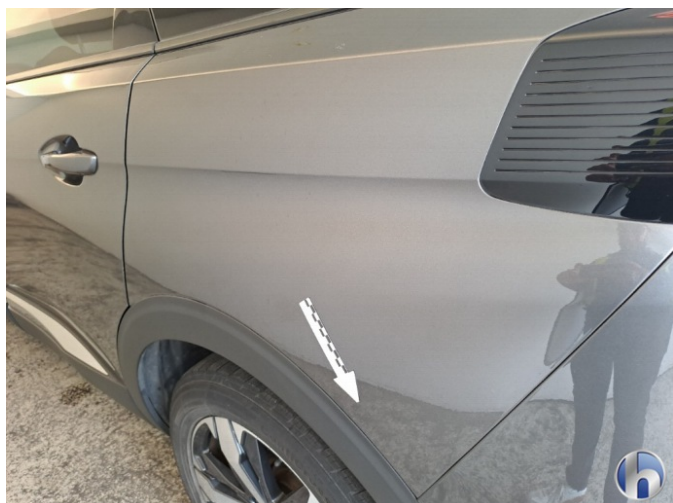
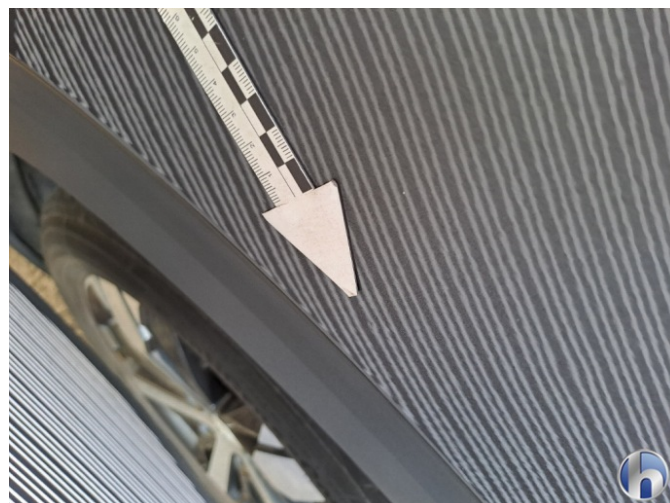
12. Sidewall - Rear - Left

| | component | Damage | Rep kind |
|---|---|---|---|
| 12. | Sidewall - Rear - Left | Delle | Smart repair |

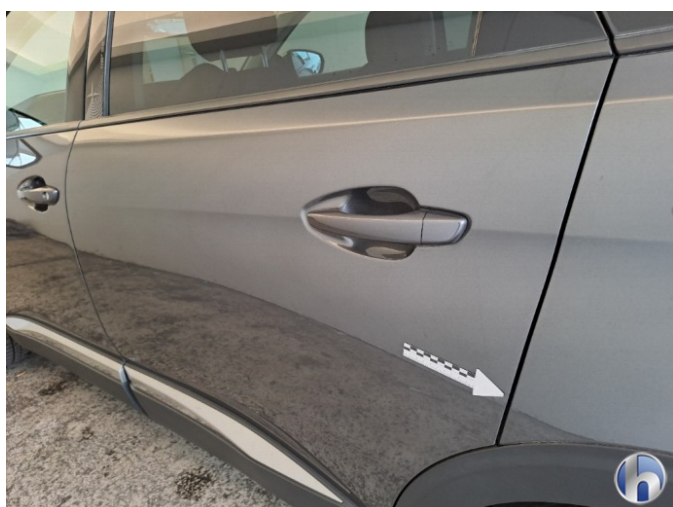
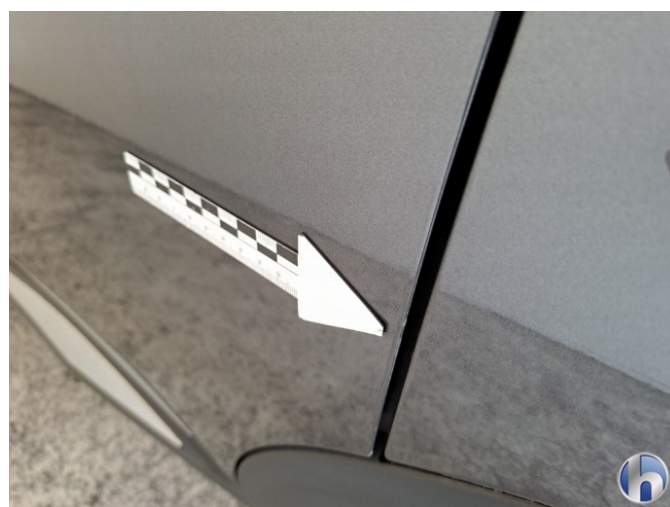
13. Rear door - left

| | component | Damage | Rep kind |
|---|---|---|---|
| 13. | Rear door - left | Wear and tear | acceptable |

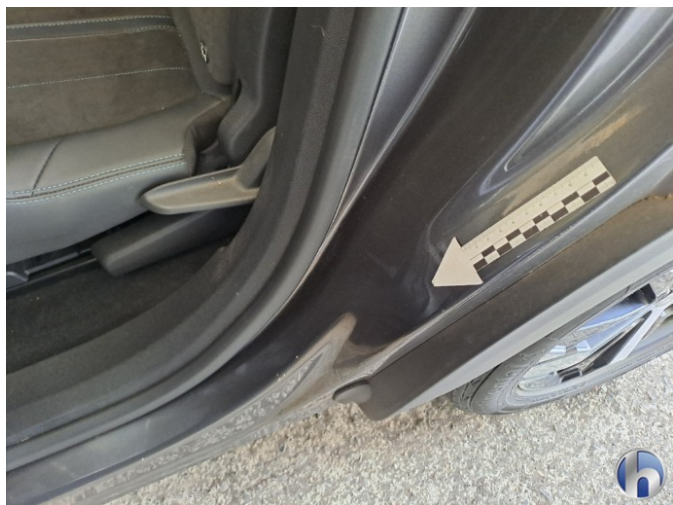
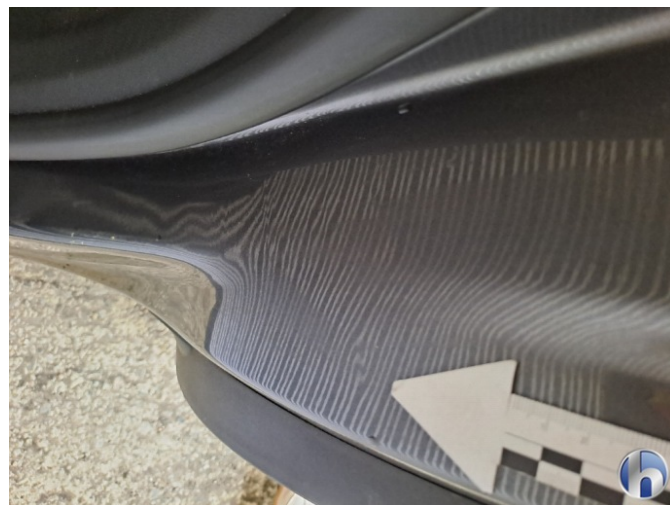
14. Türeinstieg Hinten - Links

| | component | Damage | Rep kind |
|---|---|---|---|
| 14. | Türeinstieg Hinten - Links | Delle | Refurbish and paint |

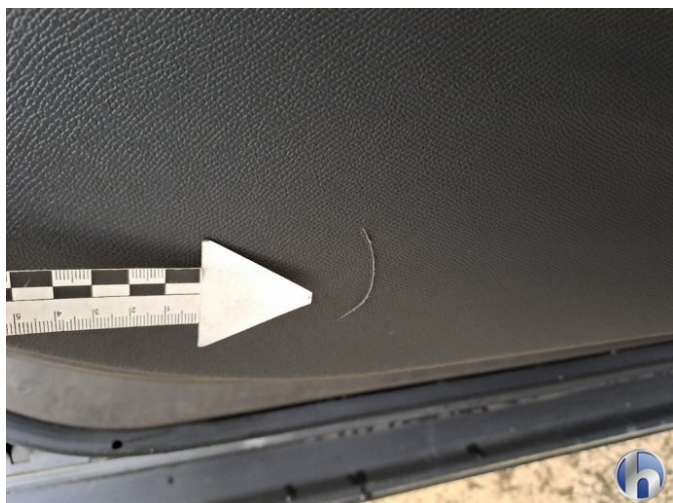
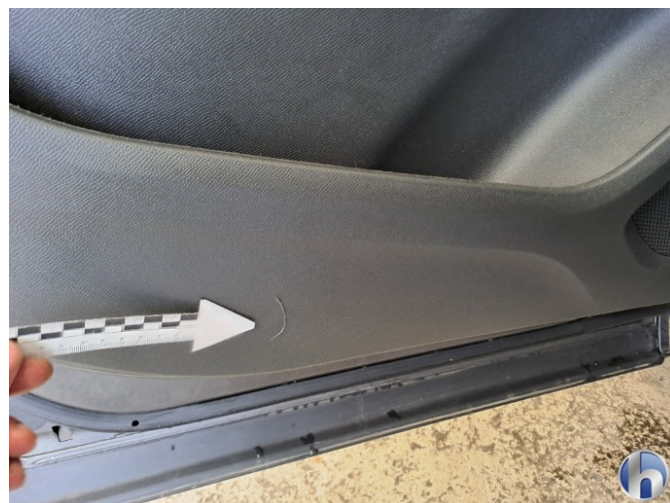
15. Rear door trim - left

| | component | Damage | Rep kind |
|---|---|---|---|
| 15. | Rear door trim - left | Scratch(es) | Replace |

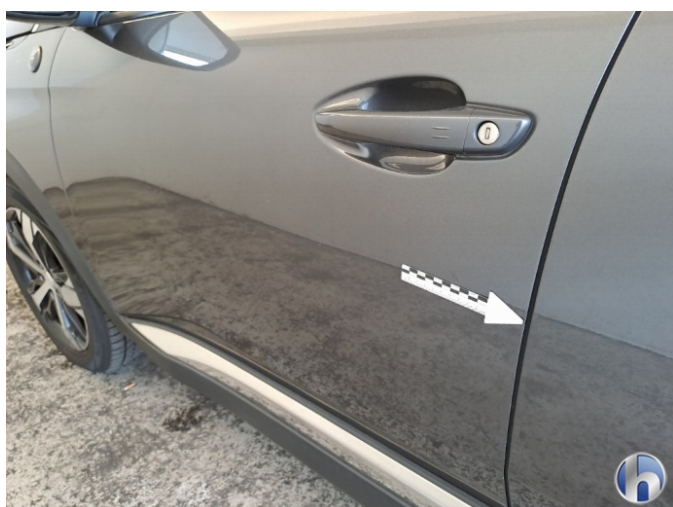
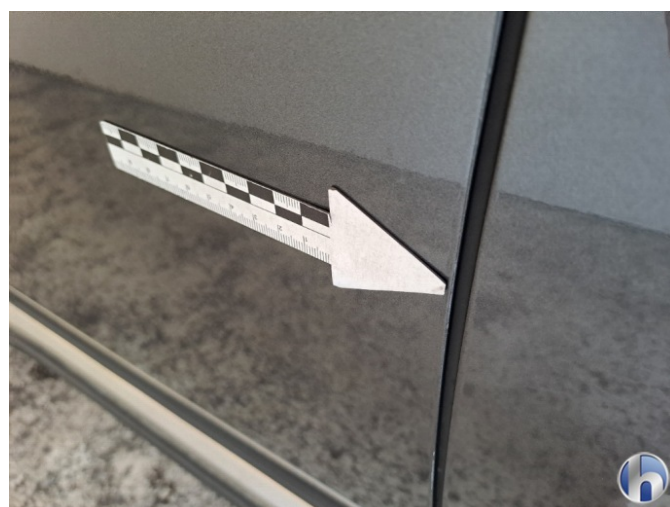
16. Front door - left

| | component | Damage | Rep kind |
|---|---|---|---|
| 16. | Front door - left | Scratch(es) | Smart repair |

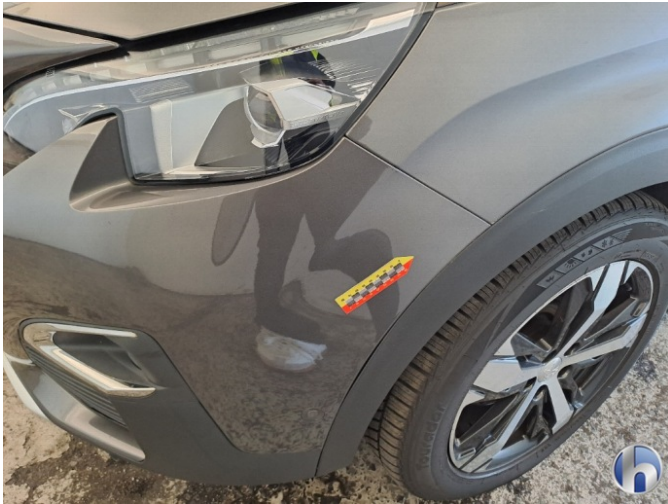
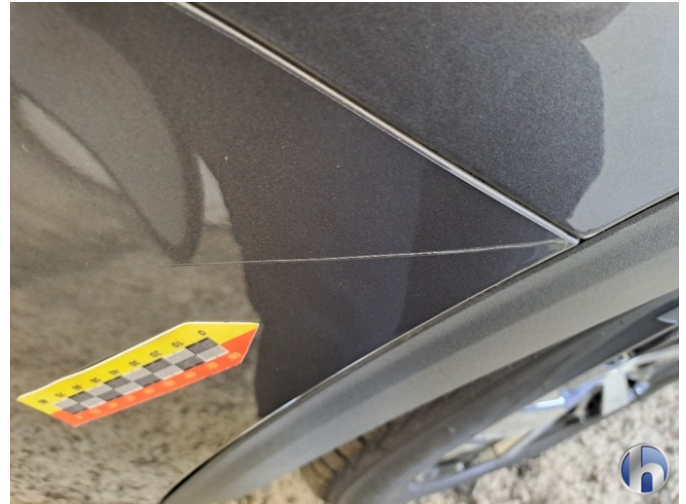
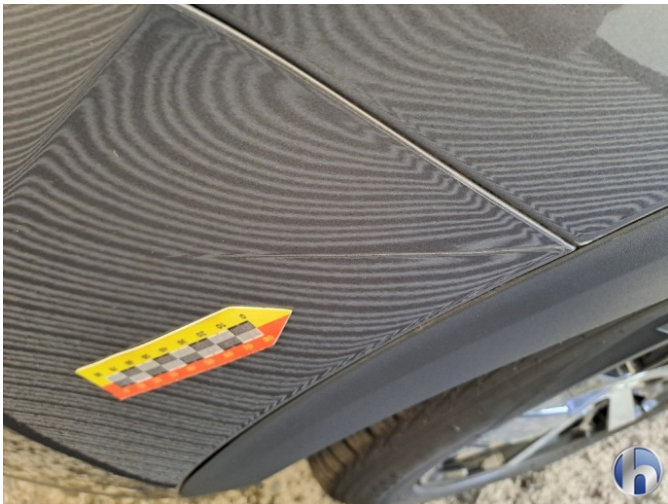
17. Front bumper

| | component | Damage | Rep kind |
|---|---|---|---|
| 17. | Front bumper | Damaged | Replace |

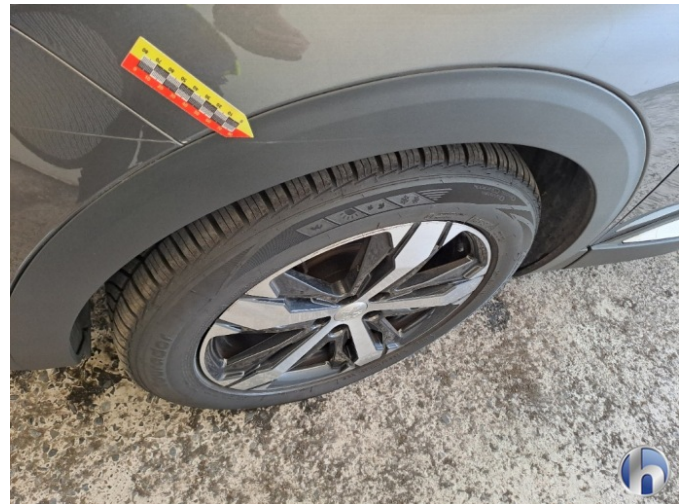
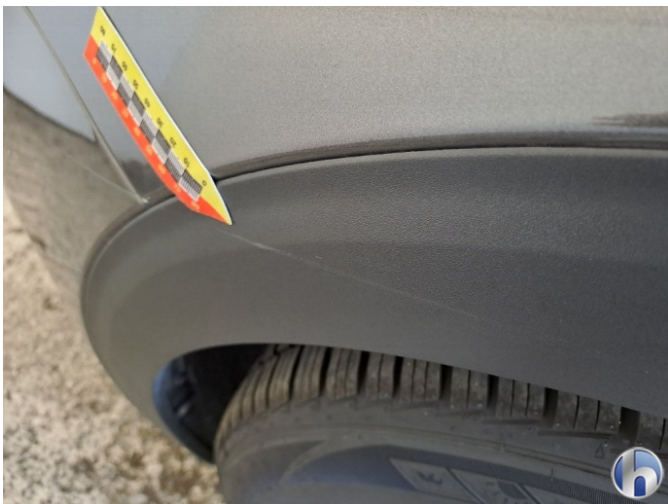
| | component | Damage | Rep kind |
|---|---|---|---|
| 18. | | Scratch(es) | Replace |

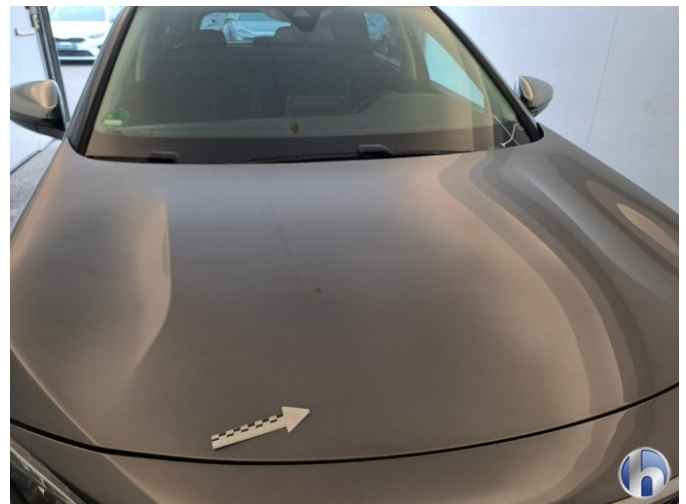
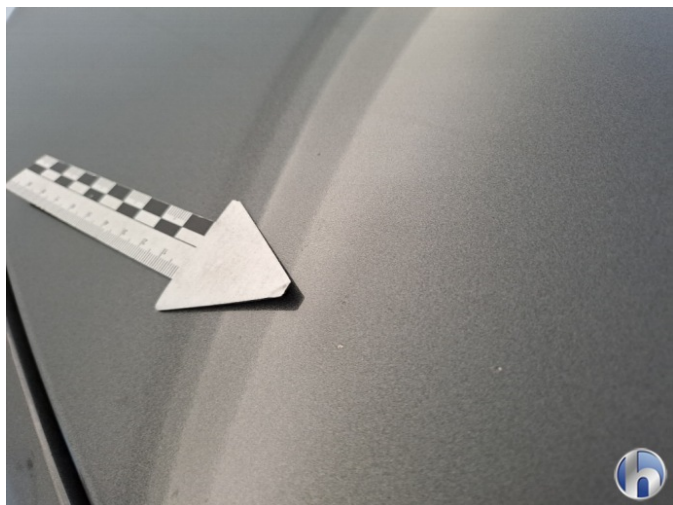
19. hood

| | component | Damage | Rep kind |
|---|---|---|---|
| 19. | hood | Chipping from stones | Smart repair |

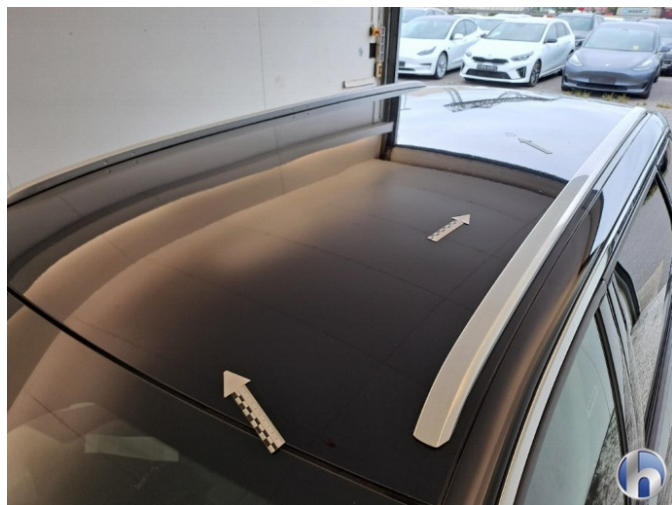
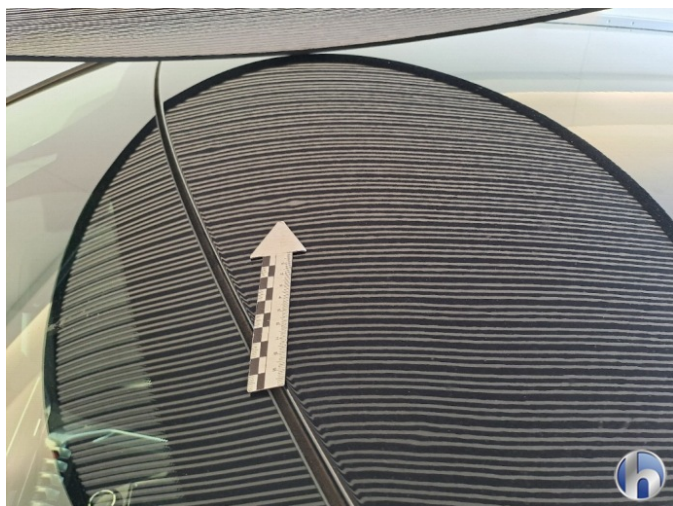
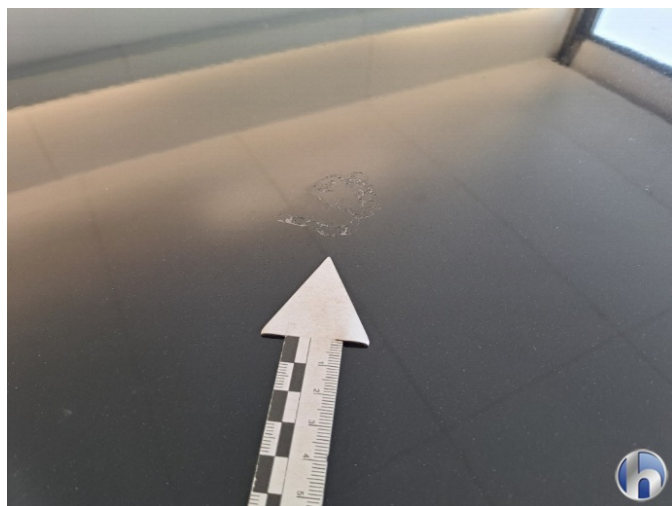
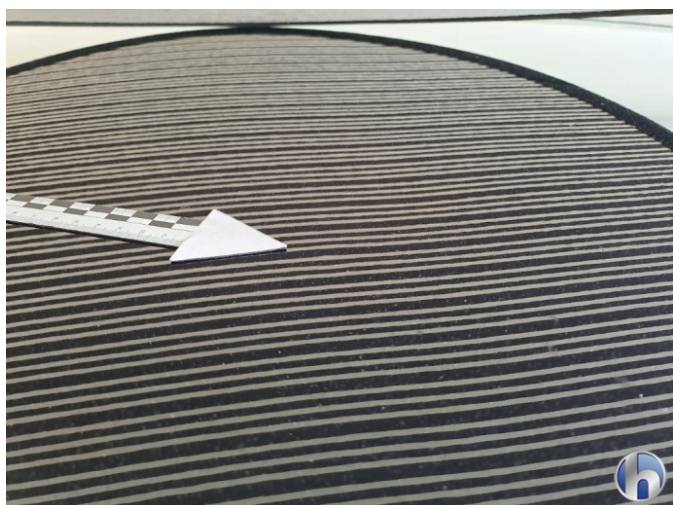
20. roof

| | component | Damage | Rep kind |
|---|---|---|---|
| 20. | roof | Dented | Refurbish and paint |
