PEUGEOT 3008 3008 THP 165 EAT6 Stop & Start

VIN NO VF3M45GZWHS278570 Registration Number ZWHS278570

Inspection Report Summary

Customer	BCA Online	Report Number	P20250331081644
Inspection Date / Place	2025-03-31 / HARTMANN Compound-Professionals GmbH Dorfmark	Cosmetic Grade	4

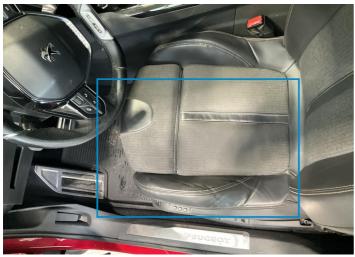
1. Seat Cushion / Front Left Interior / Worn - out -

2. Panel Filling / Front Left Interior / Worn - out -

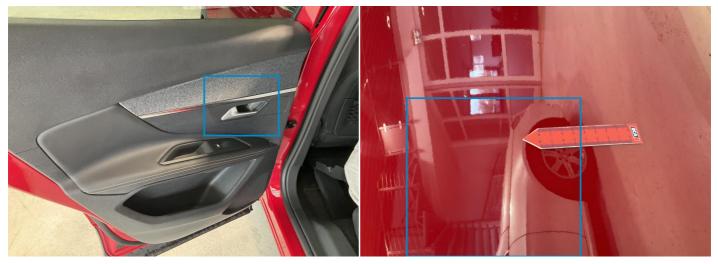
3. Panel Filling / Back Left Interior / Scraped -

4. Door / Back Right Paint / Scratch / Line -

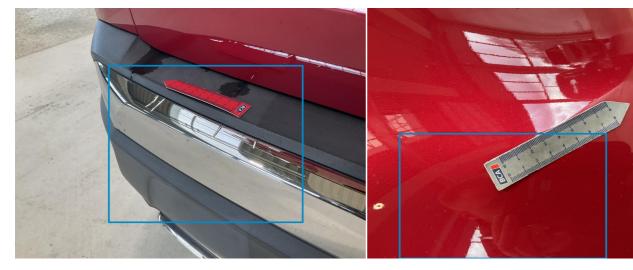
5. Bumper / Back Paint / Scratch / Scuff -

6. Corner Bumper / Back Left Paint / Scratch / Line -

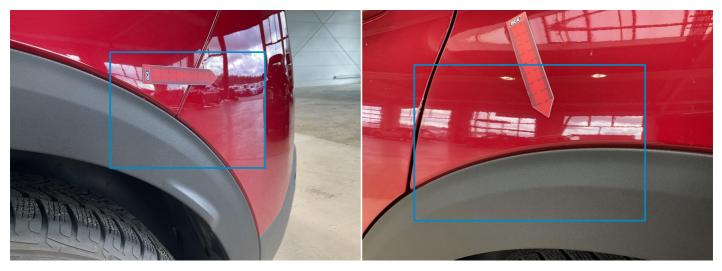
7. Side Panel / Back Left Paint / Scratch / Scuff -

8. Side Panel / Back Left Paint / Scratch / Scuff -

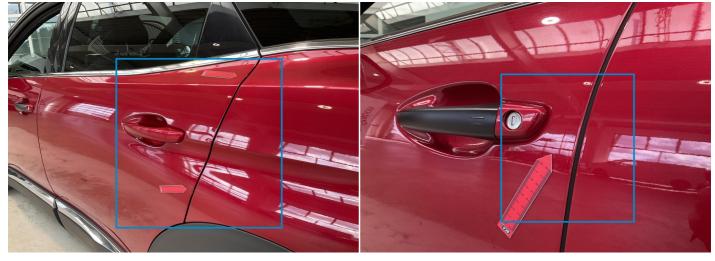
9. Door / Back Left Paint / Scratch / Scuff -

10. Door / Front Left Paint / Scratch / Scuff -

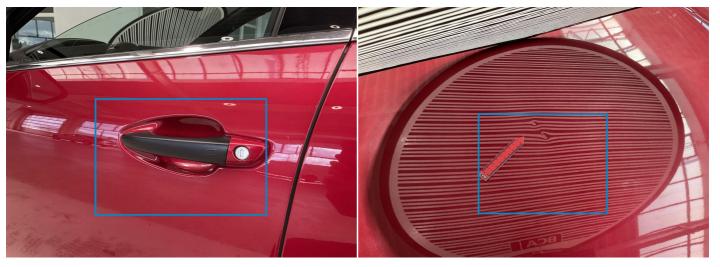
11. Door Handle / Front Left Paint / Poor Previous Repair -

12. Hood Bodywork / Dent / Dent -

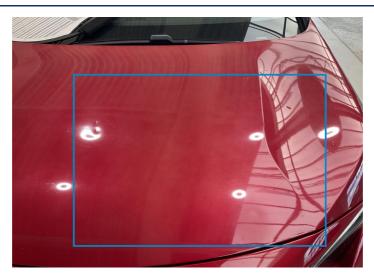
13. Hood Paint / Poor Previous Repair -
