Expertise

Protocol number: 41196490
Order No. / Reference: 25058284
Inspection date: 20 Aug 2025

Manufacturer: Peugeot

Model: 5008 BlueHDi 130 Allure Pack

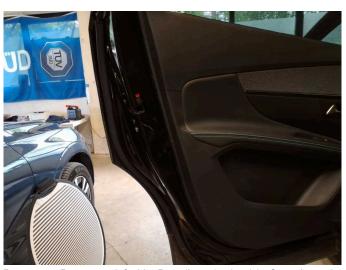
Damage 3: Side panel - rear right side: Sill - Scratch(es) - Smart repair

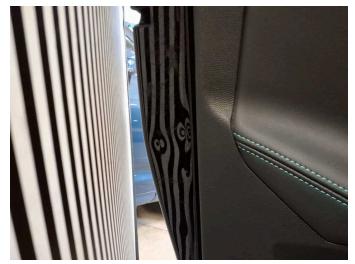
Damage 4: Door - rear left side: Door (Innen) - dent(s) - Smooth repair work
