Expertise

Protocol number: 39729520 Order No. / Reference: 24733642 Inspection date: 14 May 2025

Manufacturer: Peugeot

Model: 5008 BlueHDi 130 EAT8 Allure incl Business-Paket

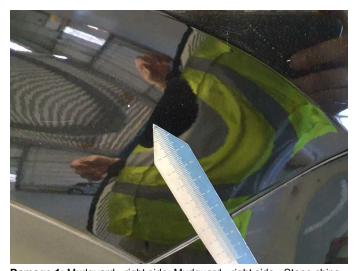
Damage 1: Mudguard - right side: Mudguard - right side - Stone chips - Smart repair

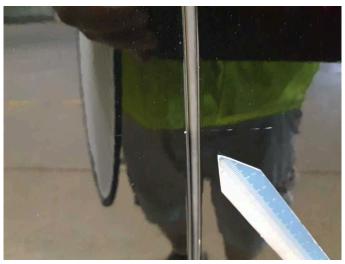
Damage 1: Mudguard - right side: Mudguard - right side - Stone chips - Smart repair

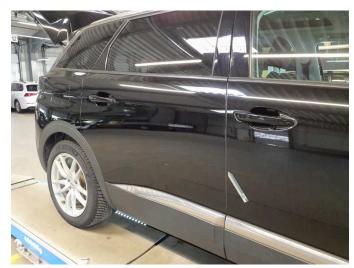
Damage 2: Door - rear right side: Door - Scratch(es) - Smart repair

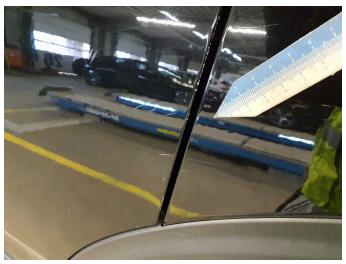
Damage 4: Side panel - rear right side: Side panel - Scratch(es) - Paint

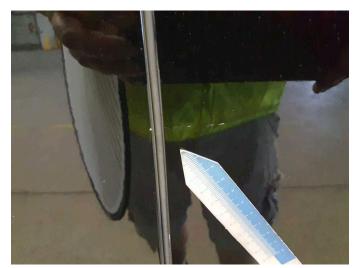
Damage 6: Door - front right side: Door - Scratch(es) - Paint

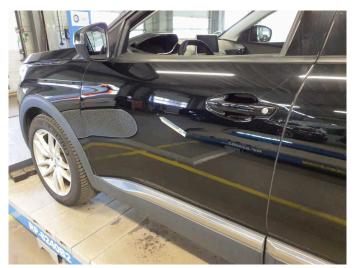
Damage 6: Door - front right side: Door - Scratch(es) - Paint

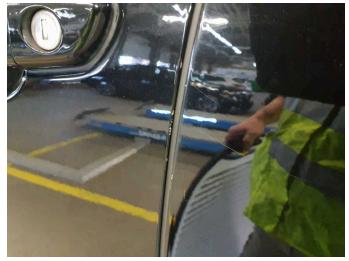
Damage 7: Door - front left side: Door - Dent / paintcoat damage - Repair and paint

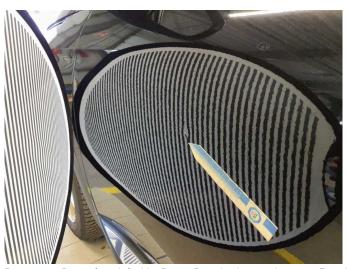
Damage 7: Door - front left side: Door - Dent / paintcoat damage - Repair and paint

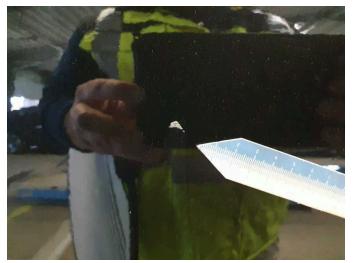
Damage 7: Door - front left side: Door - Dent / paintcoat damage - Repair and paint

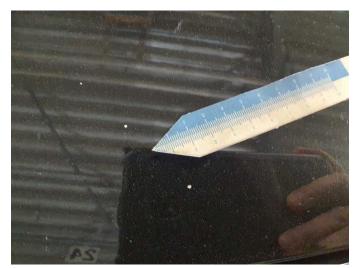
Damage 8: Bonnet: Bonnet - Stone chips - Paint
