PEUGEOT 107

107 70 2-Tronic

Inspection Report Summary

Customer	BCA Online	Report Number	P20250925085001
Inspection Date / Place	2025-09-25 / BCA Berlin	Cosmetic Grade	5

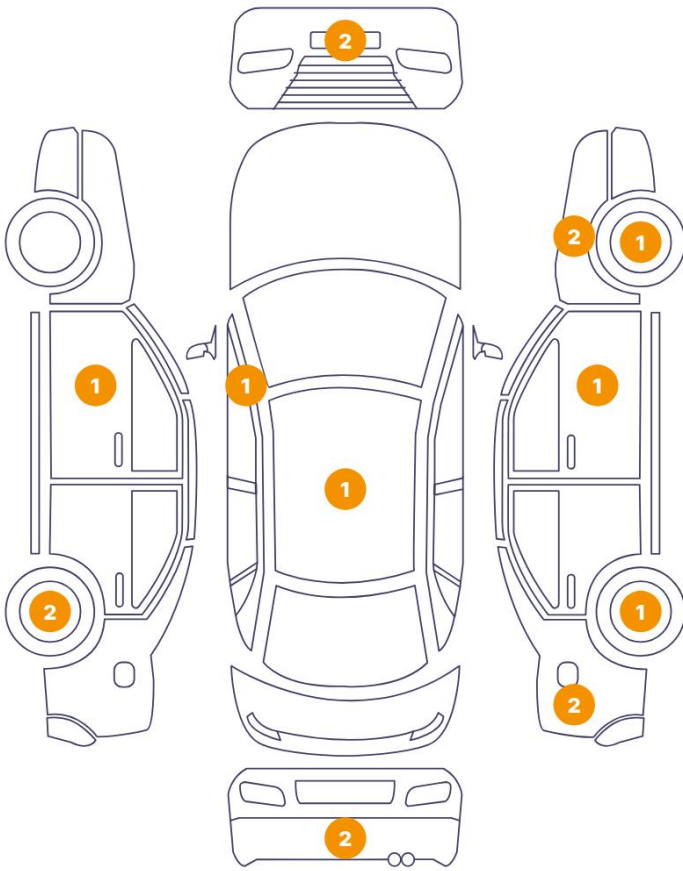
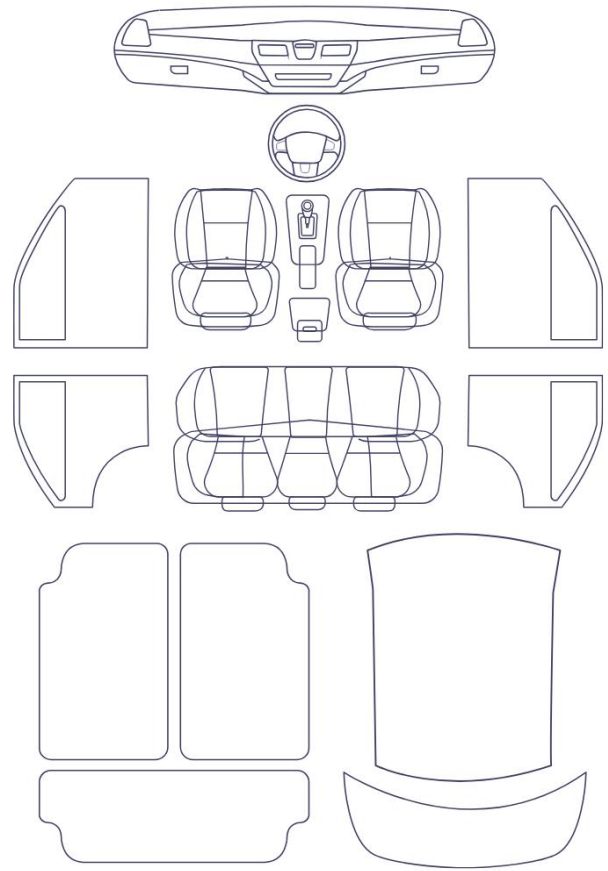
Component	Damage	Comments
1 Bumper / Back	Bodywork / Dent / Deformation	
2 Rim / Back Left	Out of Bodywork / Scratch	
3 Rim / Back Left	Out of Bodywork / Scratch	
4 Door / Front Left	Paint / Scratch / Scuff	
5 Deflector / Front Left	Paint / Scratch / Scuff	
6 Bumper / Front	Bodywork / Dent / Deformation	
7 Bumper / Front	Paint / Scratch / Scuff	
8 Fender / Front Right	Bodywork / Dent / Dent	
9 Fender / Front Right	Paint / Corrosion	
10 Rim / Front Right	Out of Bodywork / Scratch	
11 Door / Front Right	Paint / Scratch / Scuff	
12 Side Panel / Back Right	Bodywork / Dent / Dent

13	Side Panel / Back Right	Paint / Corrosion
14	Rim / Back Right	Out of Bodywork / Scratch
15	Bumper / Back	Bodywork / Dent / Deformation
16	Roof	Paint / Scratch / Scuff

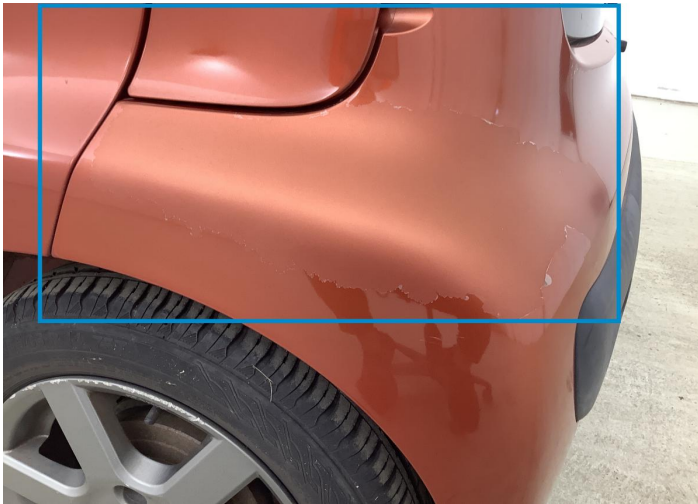
1. Bumper / Back
Bodywork / Dent / Deformation -

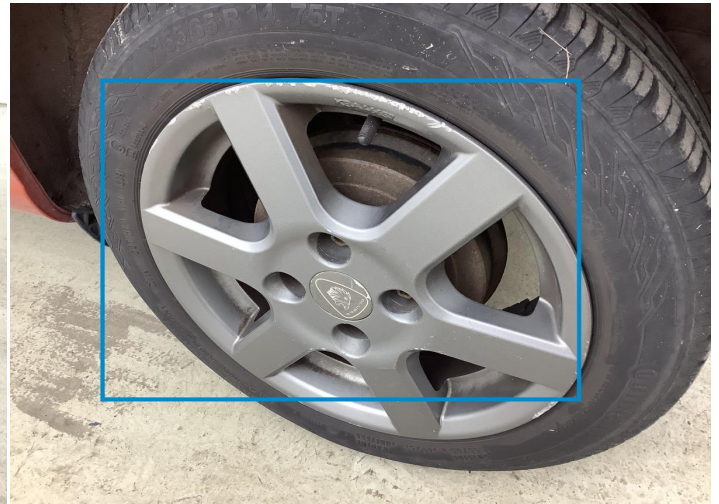
2. Rim / Back Left
Out of Bodywork / Scratch -

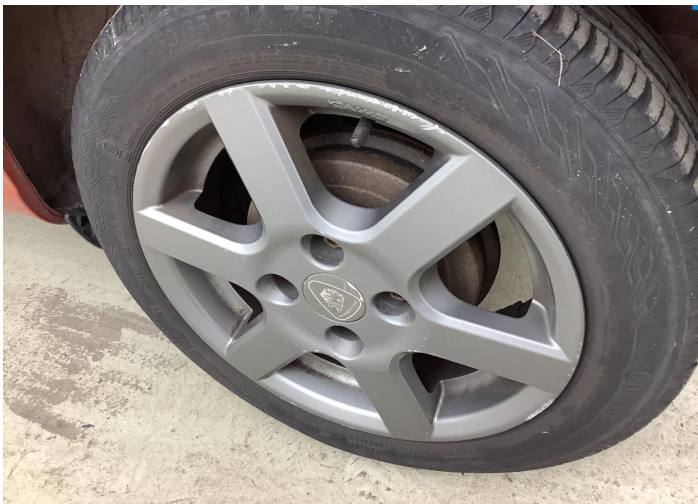
3. Rim / Back Left
Out of Bodywork / Scratch -

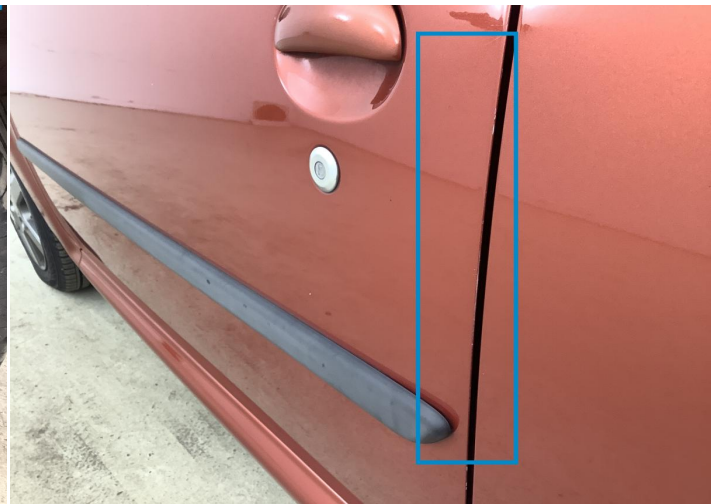
4. Door / Front Left
Paint / Scratch / Scuff -

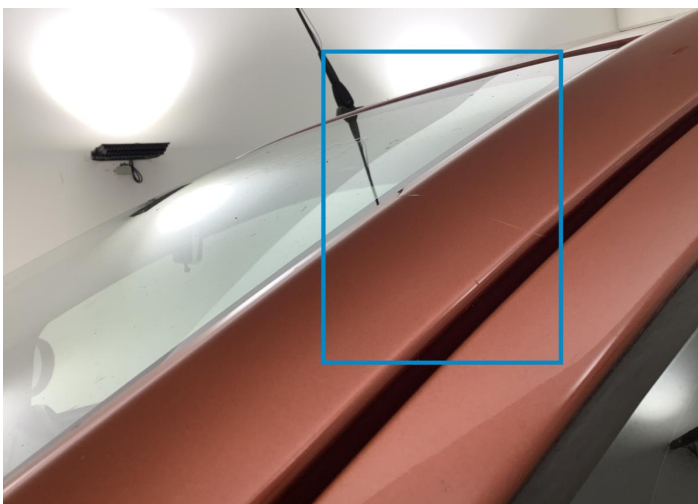
5. Deflector / Front Left
Paint / Scratch / Scuff -

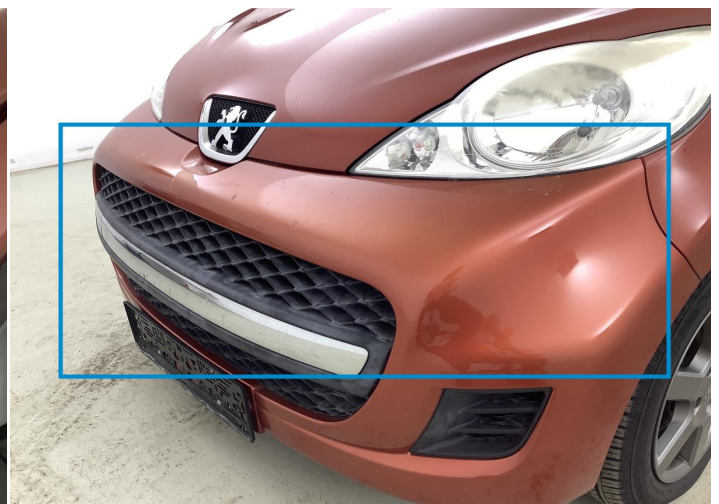
6. Bumper / Front
Bodywork / Dent / Deformation -

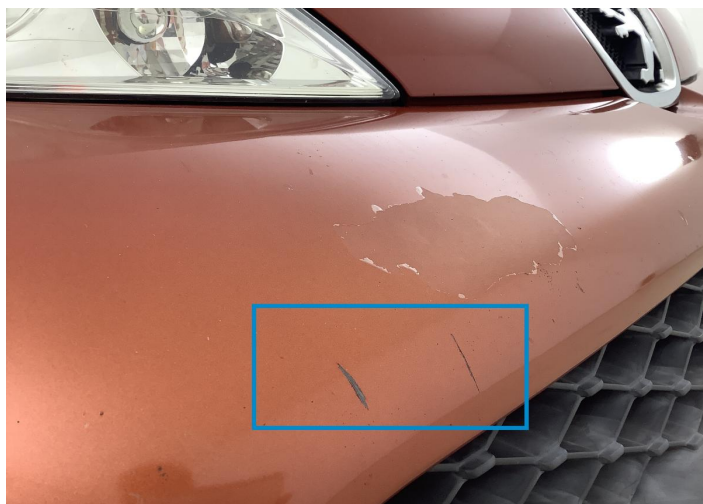
7. Bumper / Front
Paint / Scratch / Scuff -

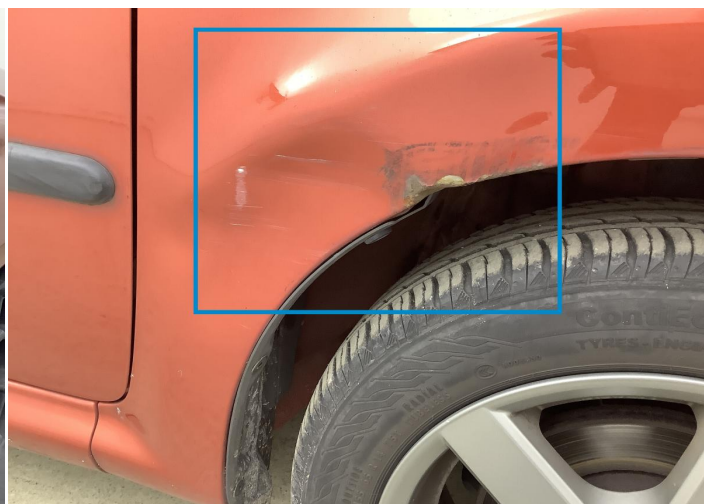
8. Fender / Front Right
Bodywork / Dent / Dent -

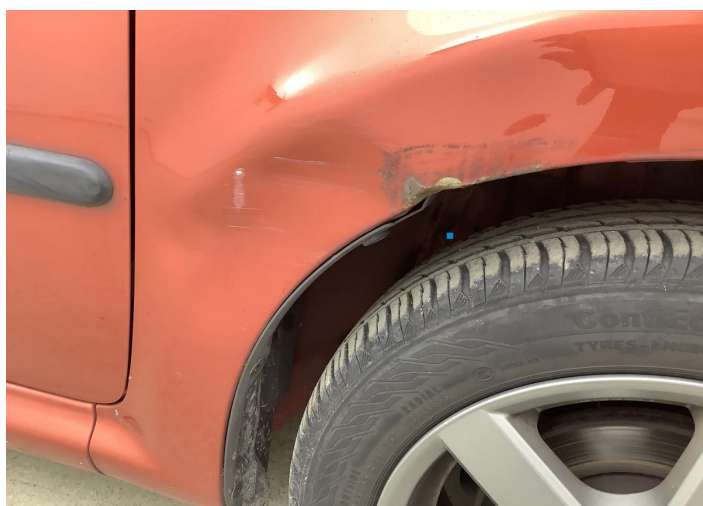
9. Fender / Front Right
Paint / Corrosion -

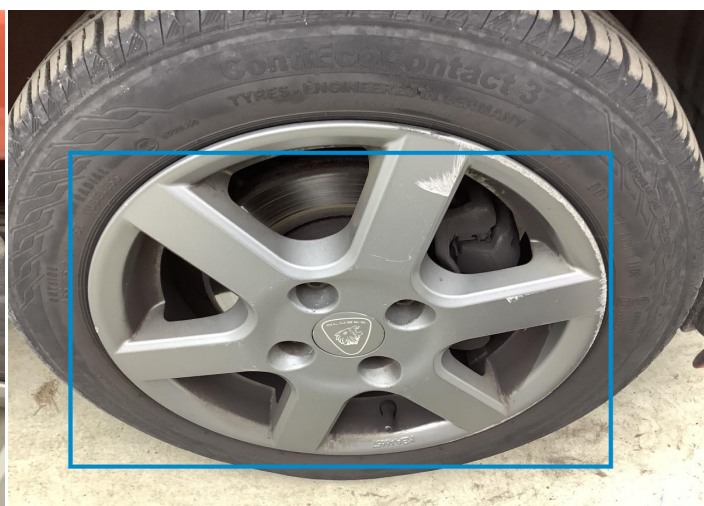
10. Rim / Front Right
Out of Bodywork / Scratch -

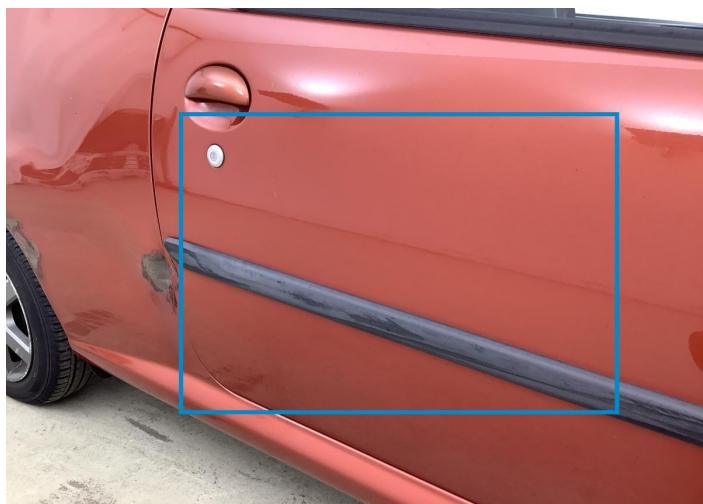
11. Door / Front Right
Paint / Scratch / Scuff -

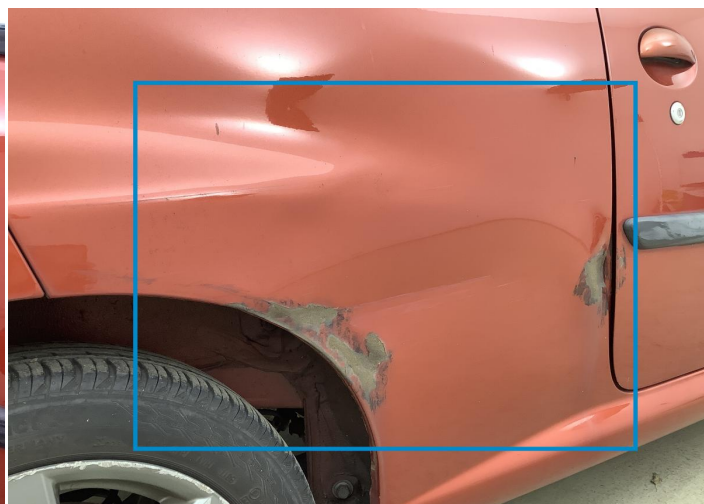
12. Side Panel / Back Right
Bodywork / Dent / Dent -

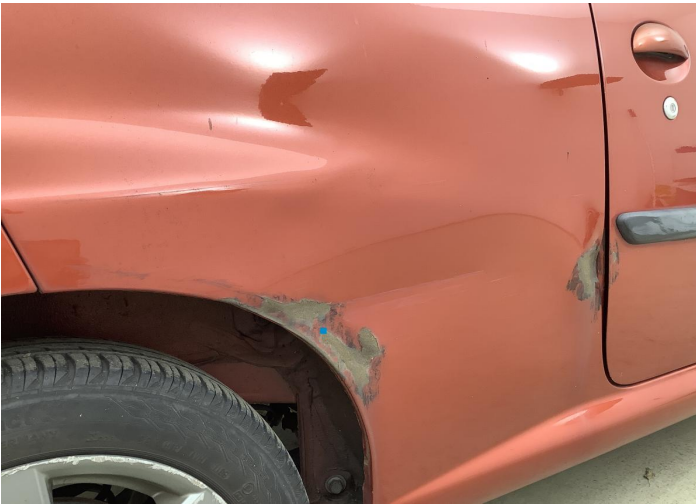
13. Side Panel / Back Right
Paint / Corrosion -

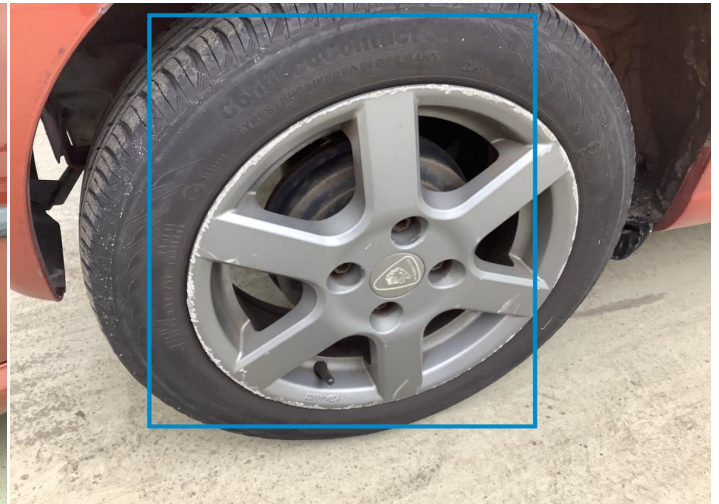
14. Rim / Back Right
Out of Bodywork / Scratch -

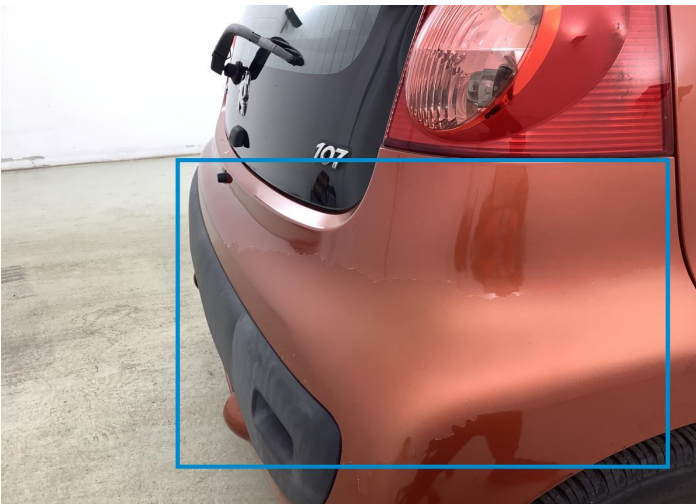
15. Bumper / Back
Bodywork / Dent / Deformation -

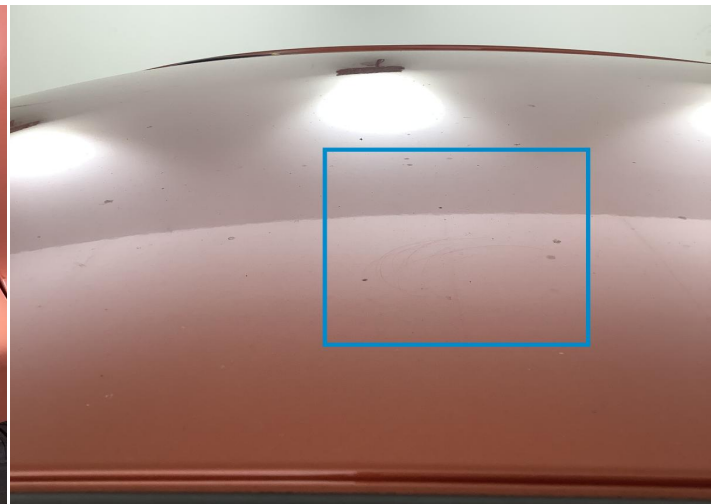
16. Roof
Paint / Scratch / Scuff -
