## status report

| vehicle data | | | |
|---|---|---|---|
| <b>Peugeot Expert Kombi L2</b> | | | |
| Vehicle identification number | <b>VF3VAYHVKJZ116434</b> | mileage read: | <b>210591 km</b> |
| First Registration / construction year: | <b>10.04.2019 / 2018</b> | Visit Date / place of birth: | <b>07.03.2025 Neuss</b> |

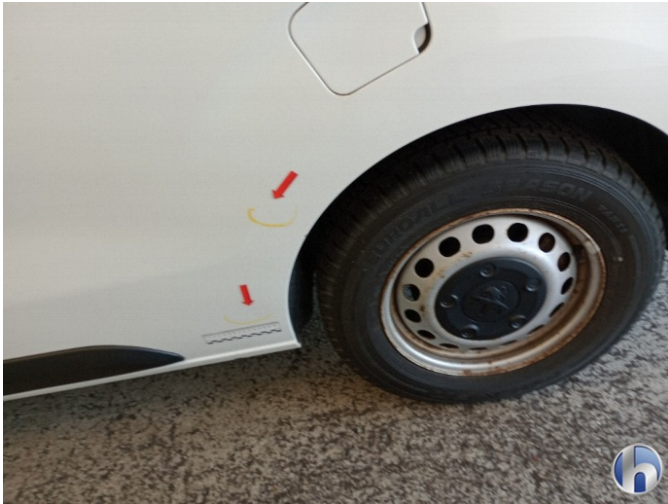
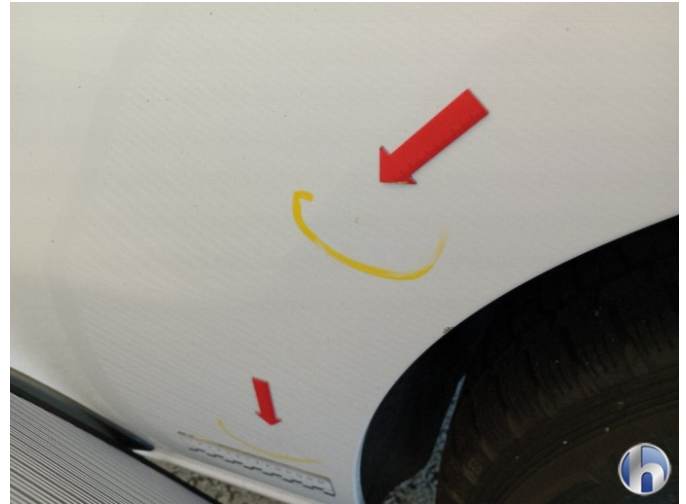
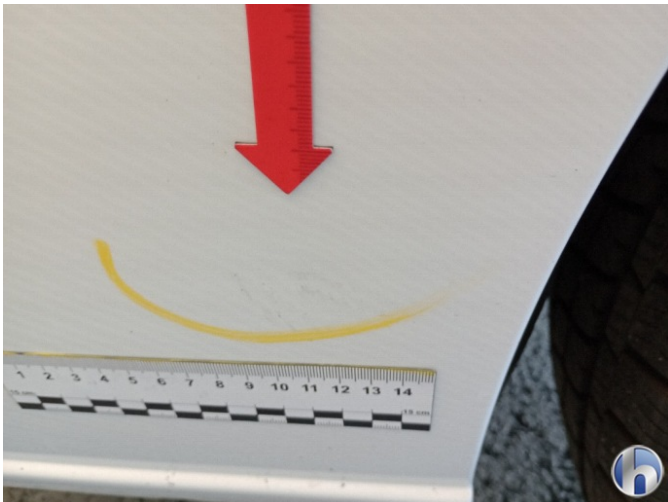
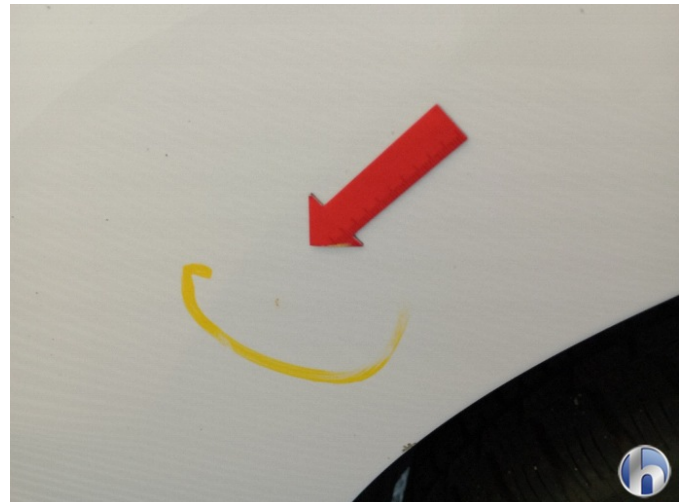
| component | Damage | Rep kind |
|---|---|---|
| 1. Sidewall - Rear - Left | | Smart repair |

1. Sidewall - Rear - Left

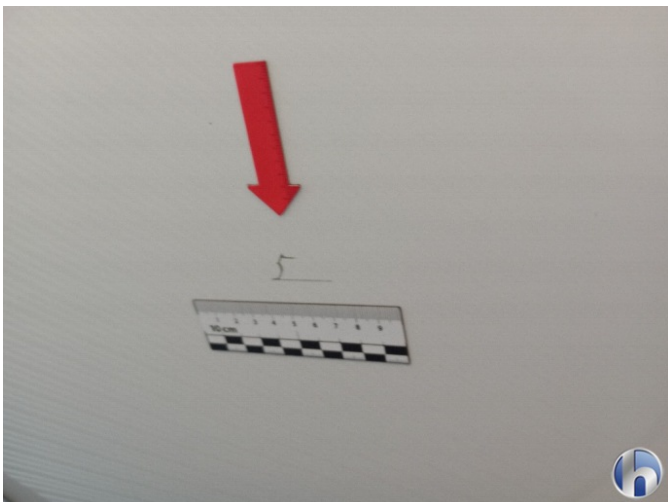
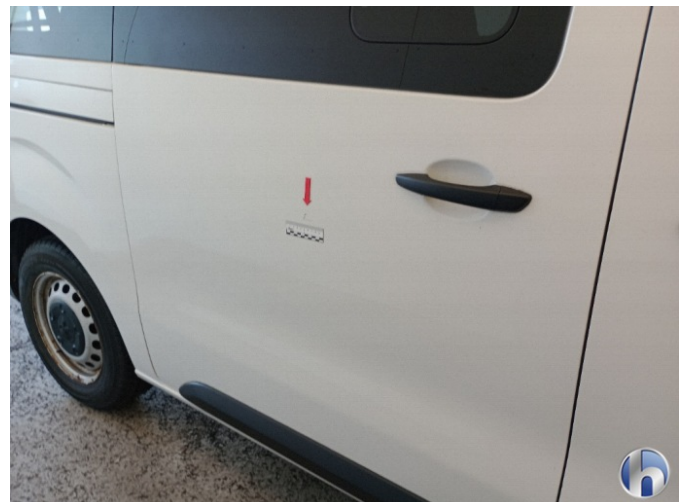
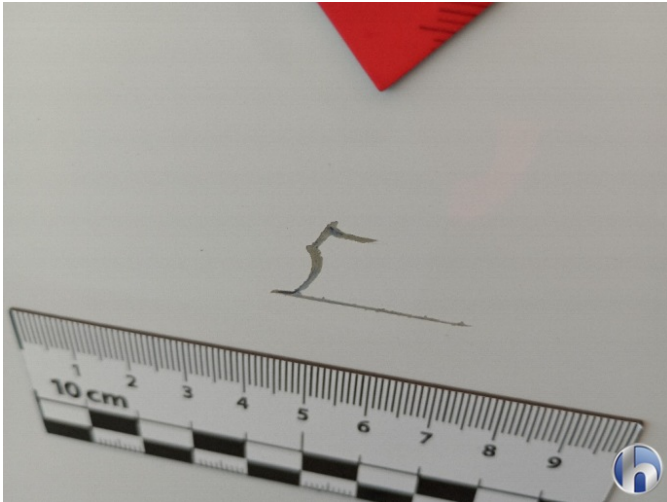
| component | Damage | Rep kind |
|---|---|---|
| 2. Sliding door - right | Scrape | Refurbish and paint |

2. Sliding door - right

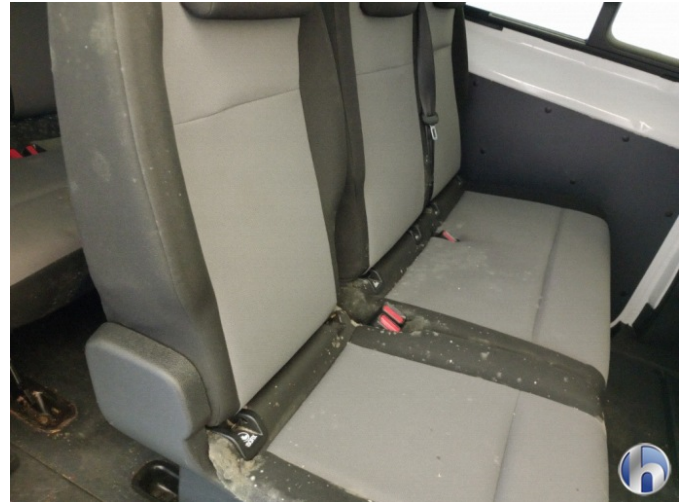
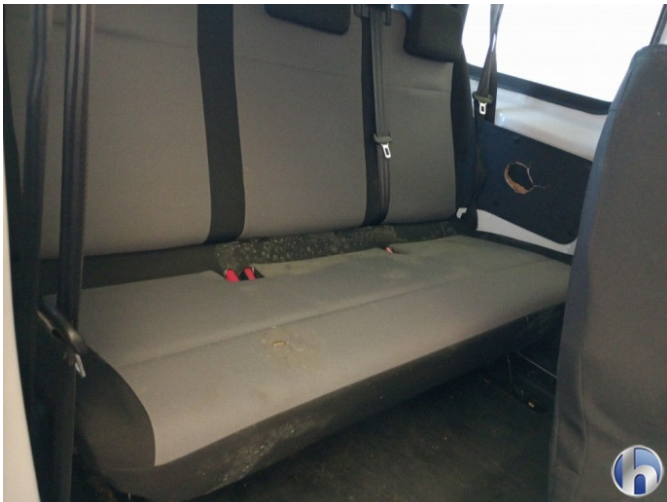
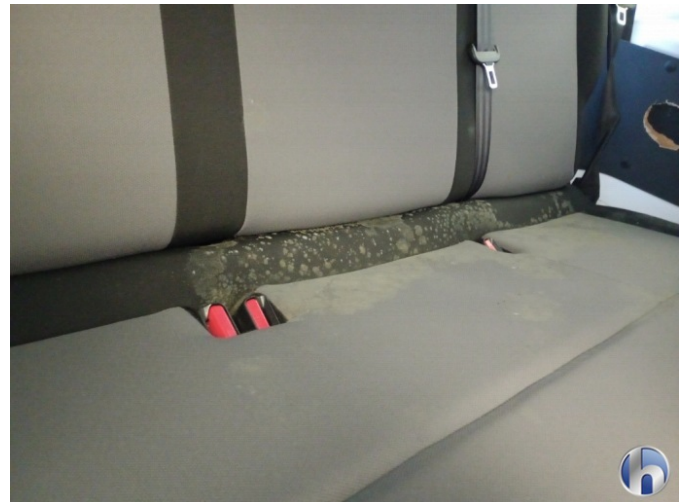
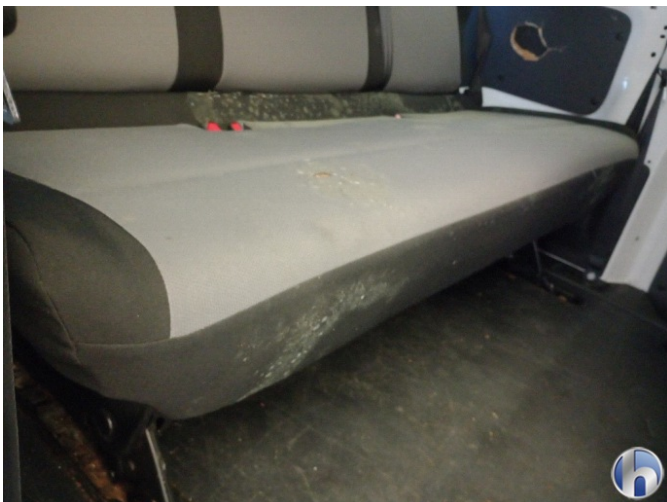
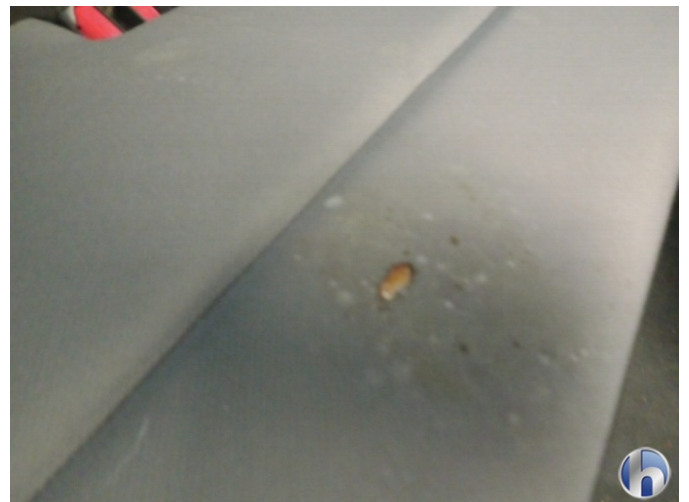
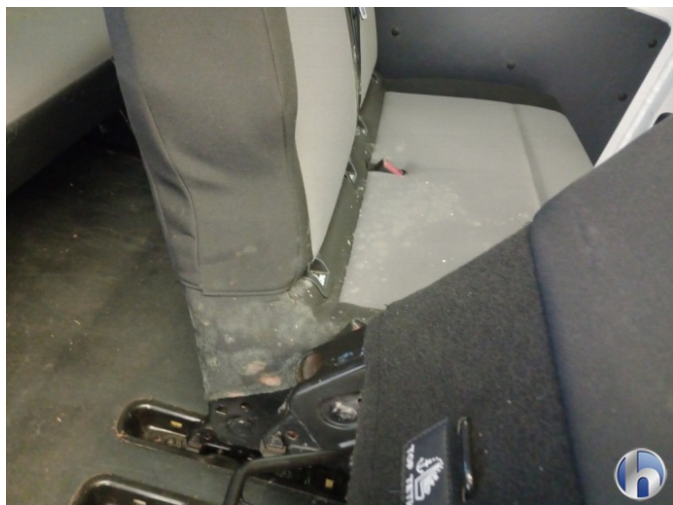
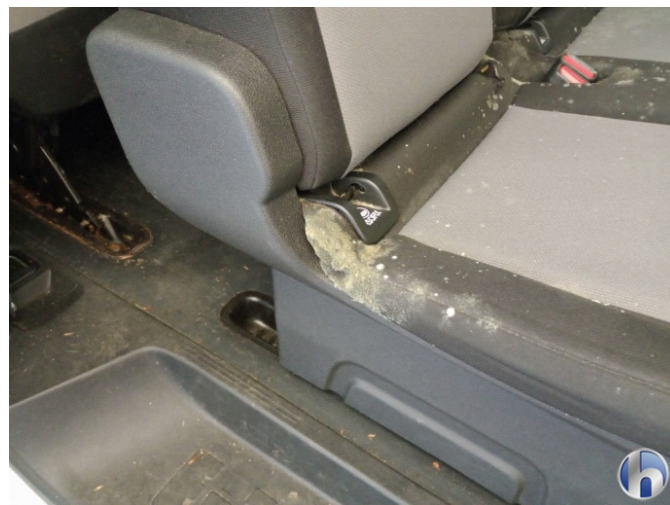
| component | Damage | Rep kind |
|---|---|---|
| 3. Polster Fahrgastraum | Formation of mould | |

3. Polster Fahrgastraum
