PEUGEOT BOXER (30)

BOXER CC 435 L4 BLUEHDI 130 S&S PRO SR

VIN NO VF3YD2MAU12H02574
Registration Number FC850LC

Customer	BCAauto Encheres	Report Number	P20251014091745
Inspection Date / Place	2025-10-14 / BCA MONTMARTIN	Cosmetic Grade	9

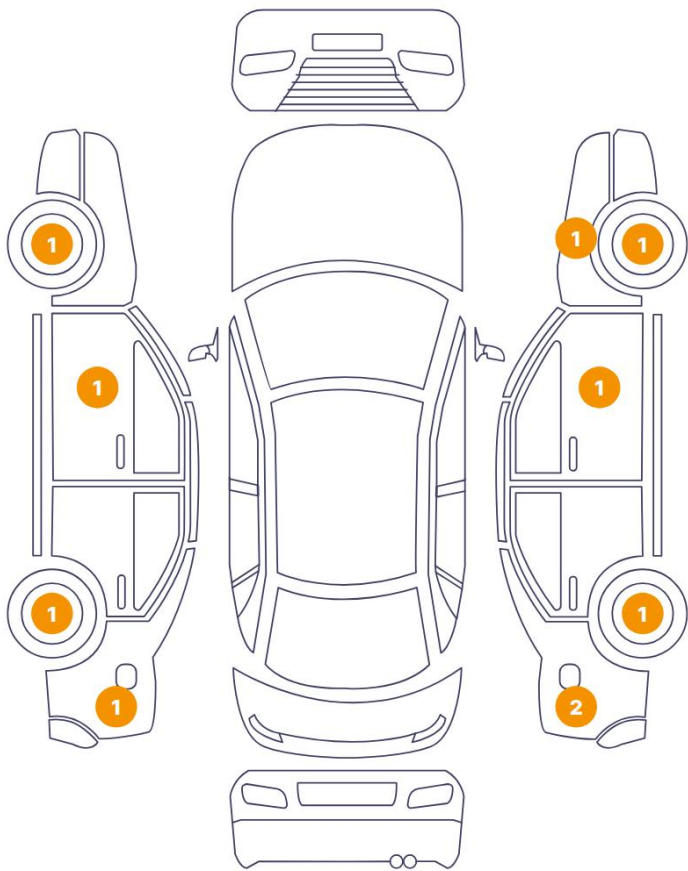
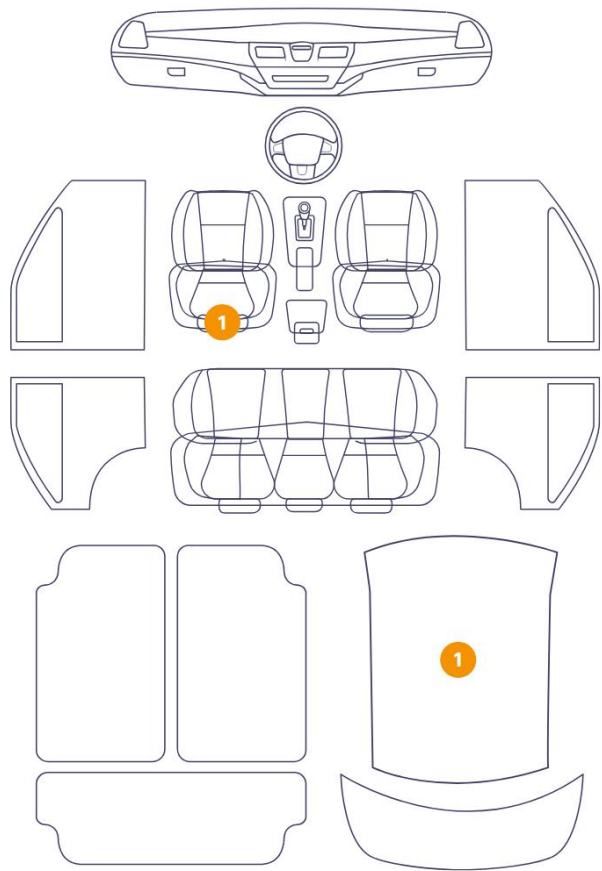
Component		Damage	Comments
1	Roof Upholstery	Interior / Stained	
2	Rim / Back Left	Out of Bodywork / Scratch	
3	Rim / Back Right	Out of Bodywork / Scratch	
4	Rim / Front Left	Out of Bodywork / Scratch	
5	Seat Cushion / Front Left	Interior / Stained	
6	Rim / Front Right	Out of Bodywork / Scratch	
7	Mirror / Front Right	Bodywork / Breakage / Hole	
8	Side Panel / Back Left	Bodywork / Breakage	
9	Side Panel / Back Right	Bodywork / Dent / Deformation	
10	Mirror / Front Left	Bodywork / Breakage	
11	Fender / Front Right	Bodywork / Dent / Deformation	
12	Side Panel / Back Right	Bodywork / Breakage

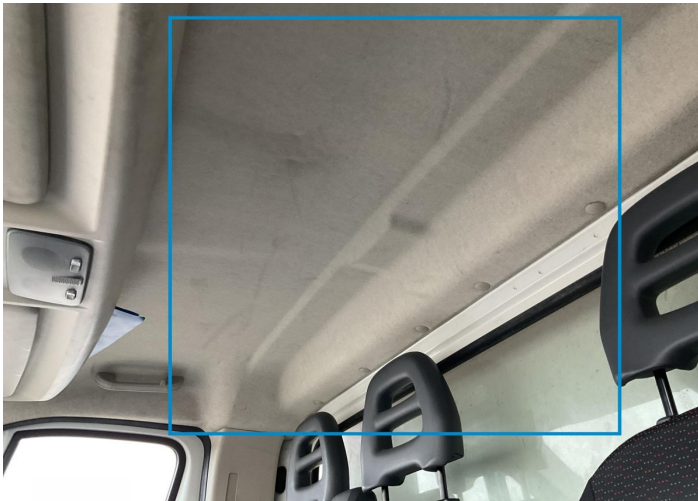
1. Roof Upholstery
Interior / Stained -

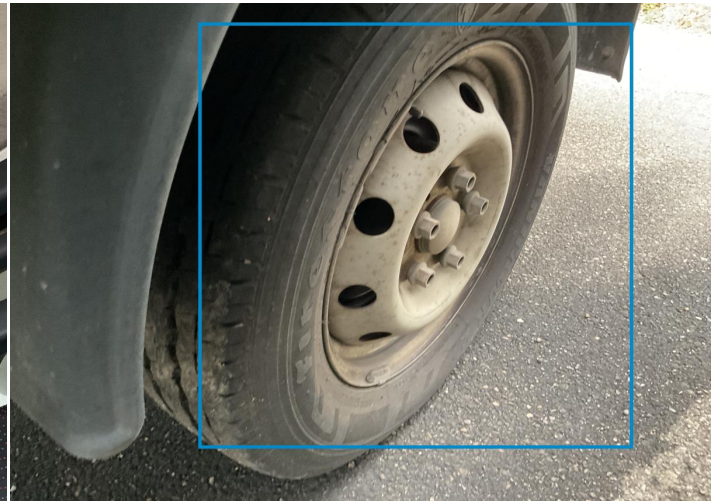
2. Rim / Back Left
Out of Bodywork / Scratch -

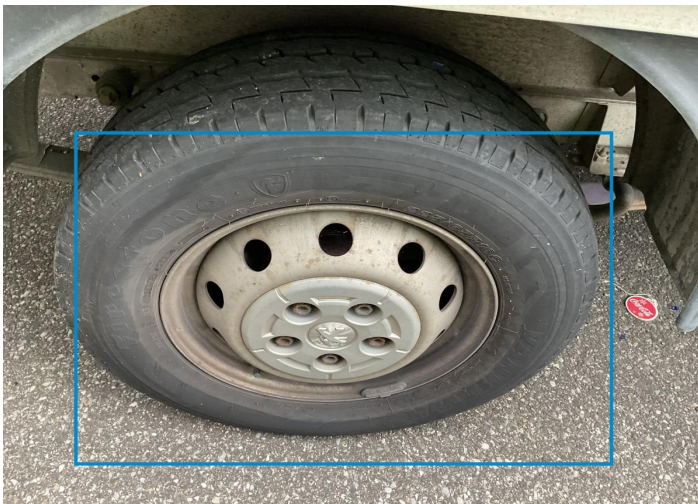
3. Rim / Back Right
Out of Bodywork / Scratch -

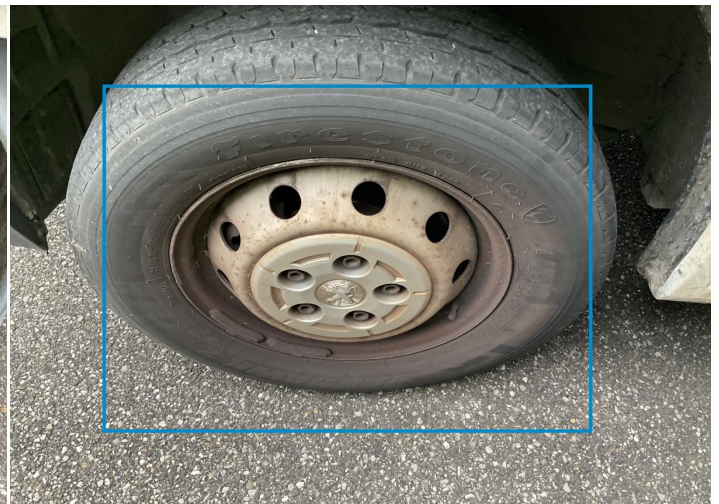
4. Rim / Front Left
Out of Bodywork / Scratch -

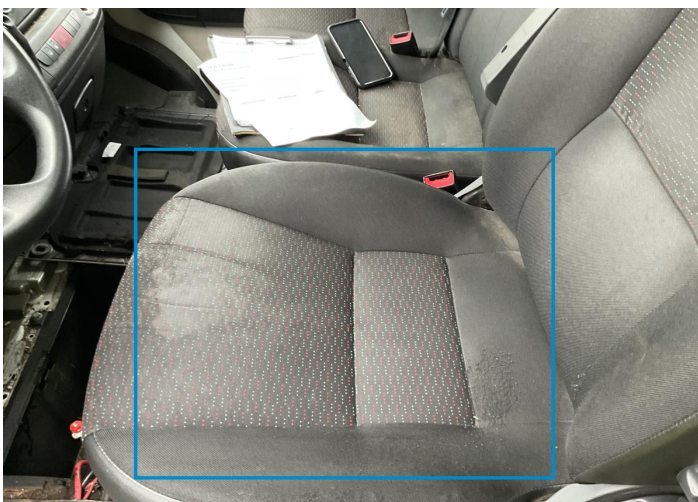
5. Seat Cushion / Front Left
Interior / Stained -

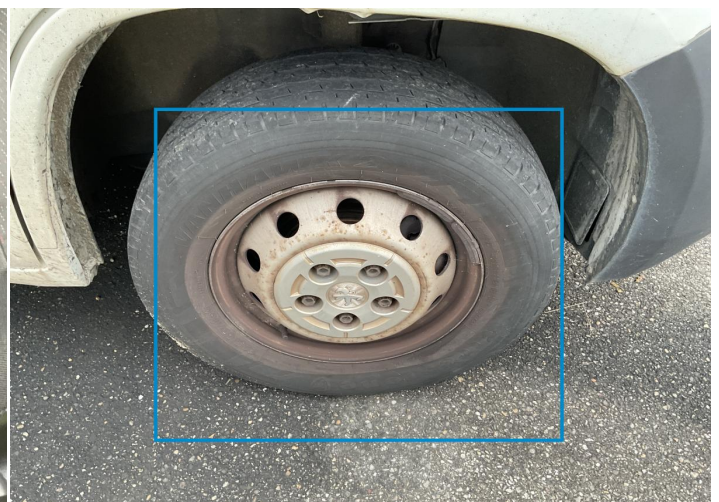
6. Rim / Front Right
Out of Bodywork / Scratch -

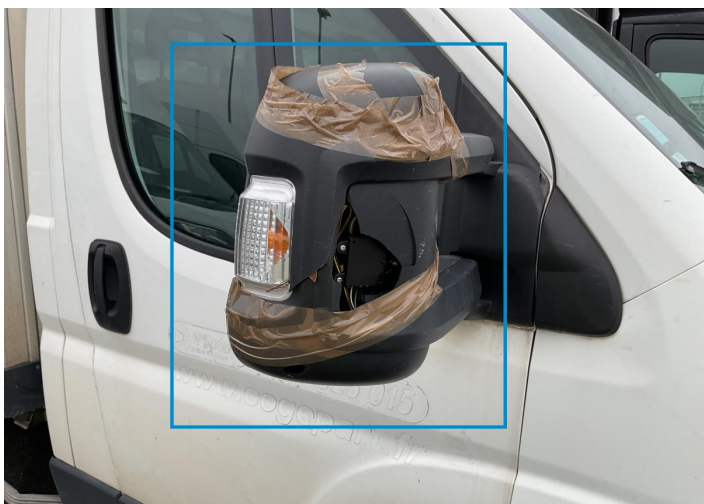
7. Mirror / Front Right
Bodywork / Breakage / Hole -

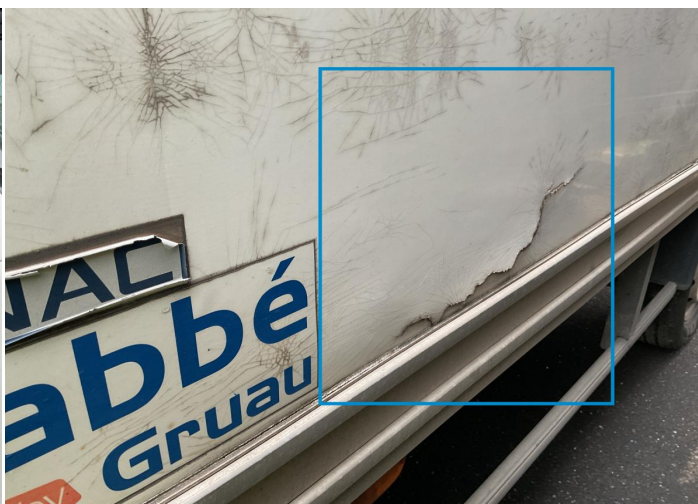
8. Side Panel / Back Left
Bodywork / Breakage -

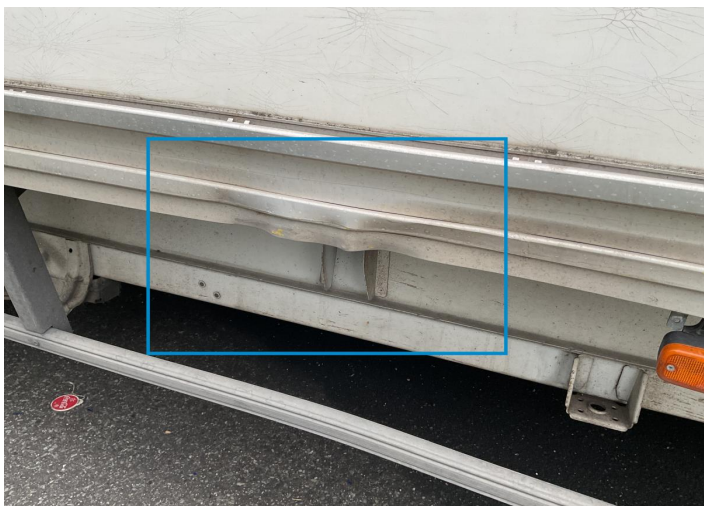
9. Side Panel / Back Right
Bodywork / Dent / Deformation -

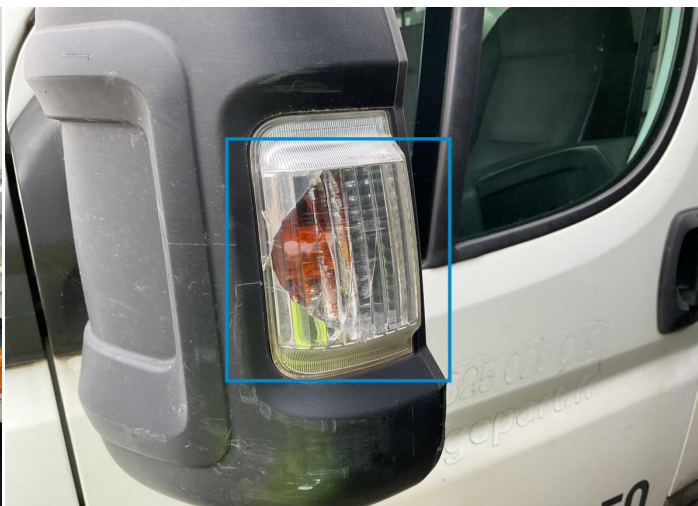
10. Mirror / Front Left
Bodywork / Breakage -

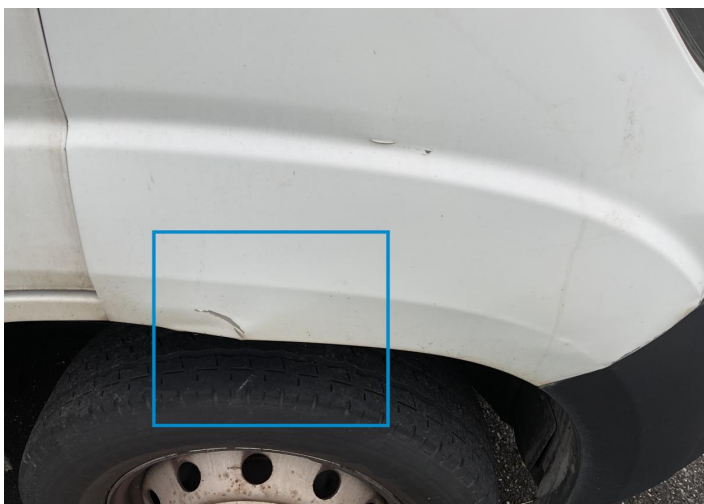
11. Fender / Front Right
Bodywork / Dent / Deformation -

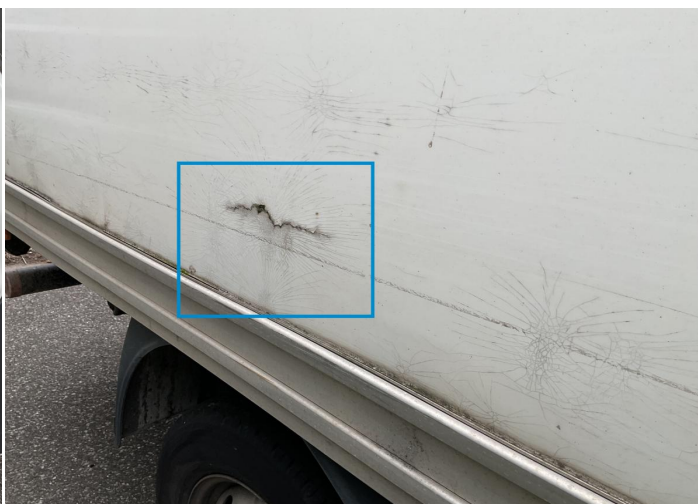
12. Side Panel / Back Right
Bodywork / Breakage -
