# CITROEN C4 Cactus 2014 Diesel

## C4 Cactus 1.6 e-hdi Shine 92cv etg6

VIN NO VF70B9HPGEE546069

### Inspection Report Summary

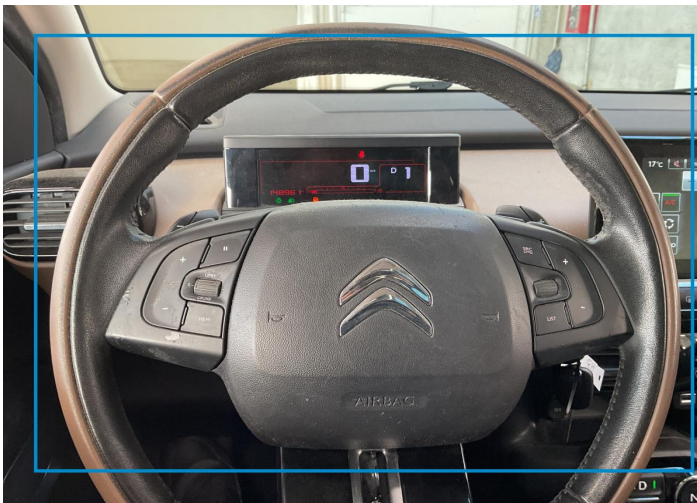
| Component | | Damage | Comments |
|---|---|---|---|
| 1 | Steering Wheel / Front | Interior / Worn - out | |

1. Steering Wheel / Front Interior / Worn - out -

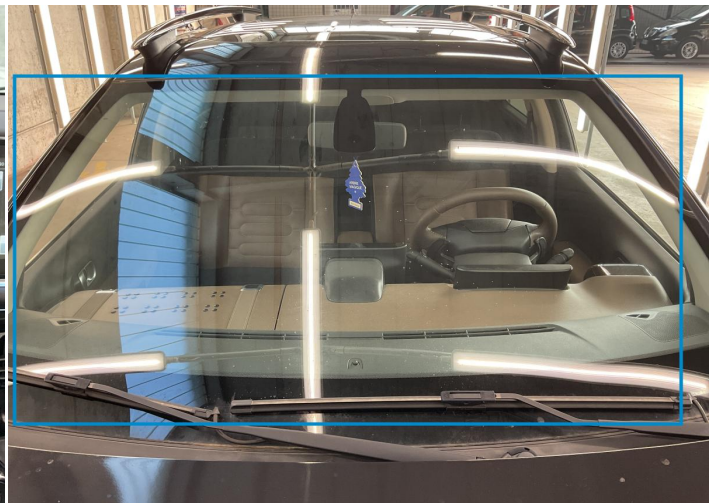
| Component | | Damage | Comments |
|---|---|---|---|
| 2 | Windshield / Front | Glass Break / Impact | |

2. Windshield / Front Glass Break / Impact -

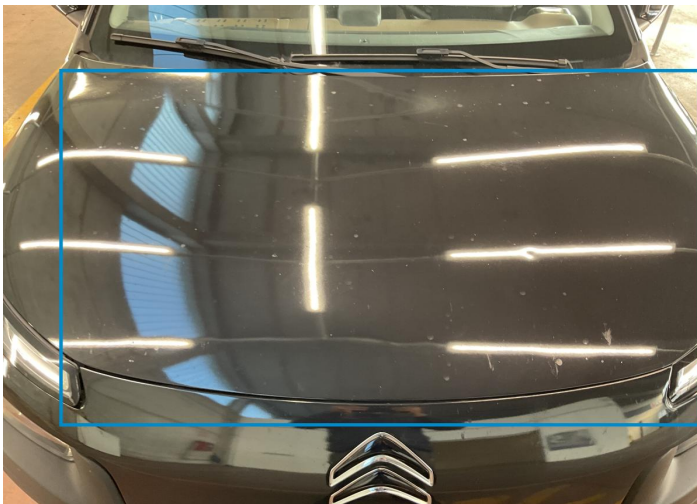
| Component | | Damage | Comments |
|---|---|---|---|
| 3 | Hood | Bodywork / Dent / Hail Area | |

3. Hood Bodywork / Dent / Hail Area -

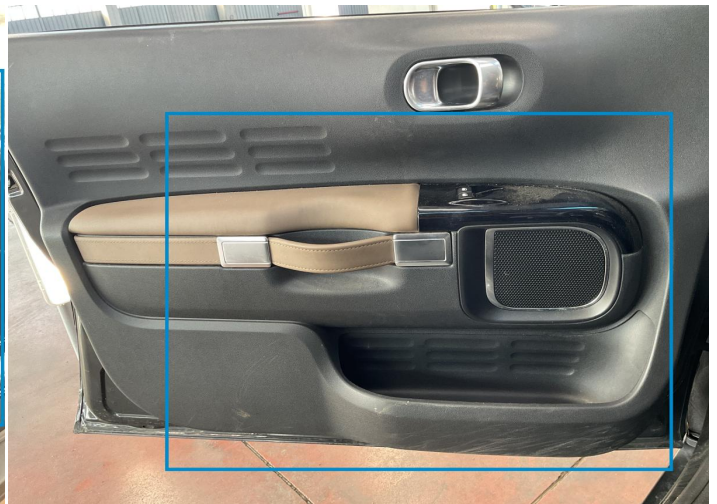
| Component | | Damage | Comments |
|---|---|---|---|
| 4 | Panel Filling / Front Left | Interior / Scratched | |

4. Panel Filling / Front Left Interior / Scratched -

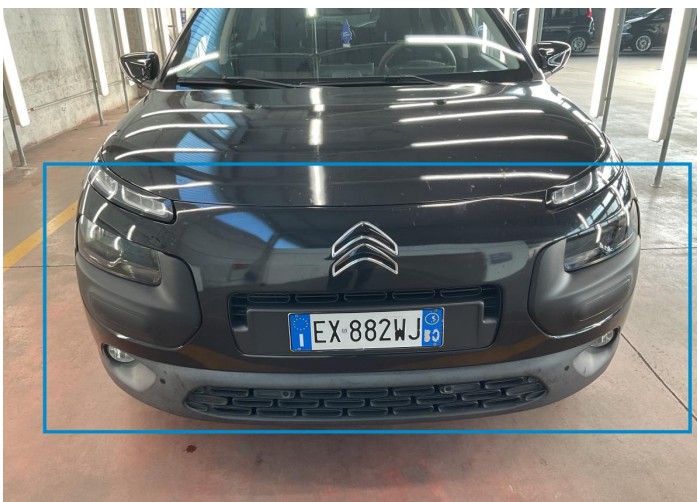
| Component | | Damage | Comments |
|---|---|---|---|
| 5 | Bumper / Front | Paint / Chipping | |

5. Bumper / Front Paint / Chipping -

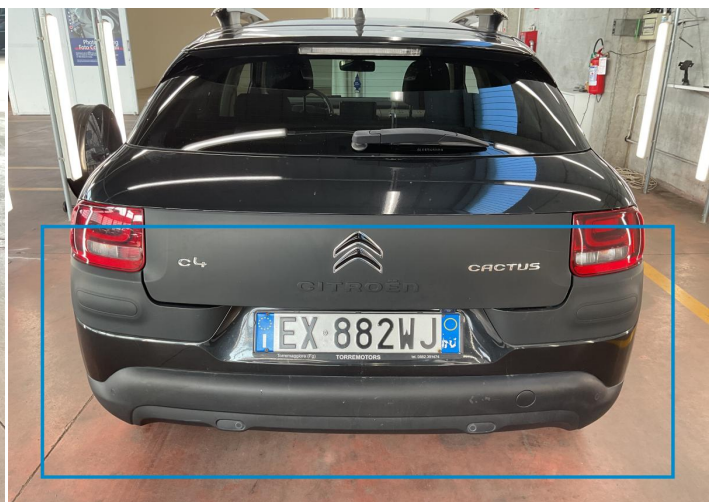
| Component | | Damage | Comments |
|---|---|---|---|
| 6 | Bumper / Back | Paint / Scratch / Line | |

6. Bumper / Back Paint / Scratch / Line -

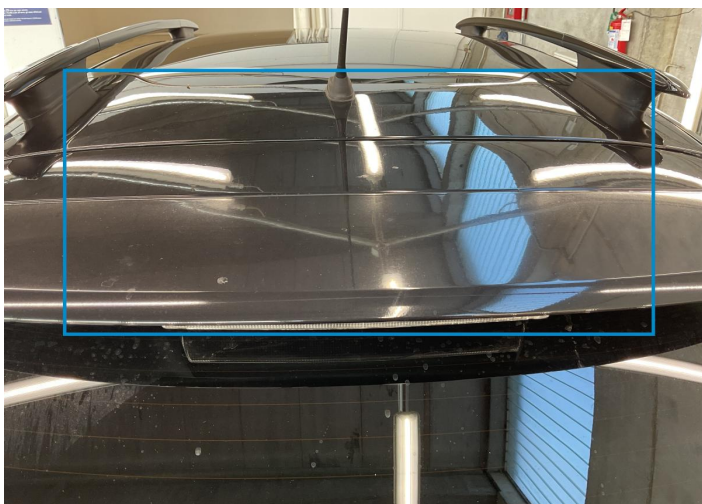
| Component | | Damage | Comments |
|---|---|---|---|
| 7 | Roof | Bodywork / Dent / Hail Area | |

7. Roof  
Bodywork / Dent / Hail Area -

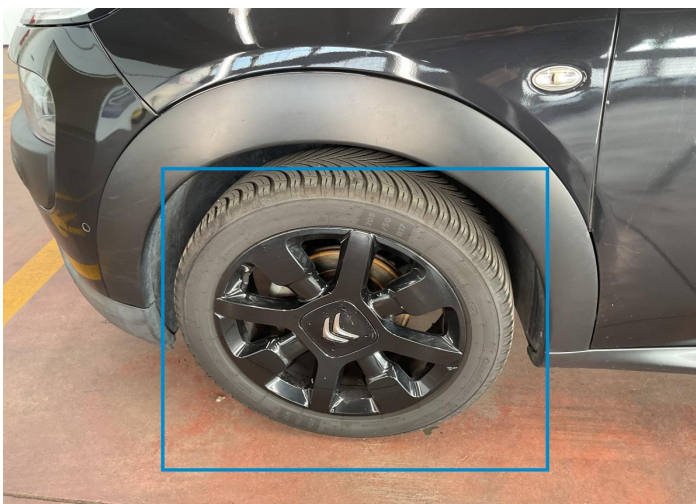
| Component | | Damage | Comments |
|---|---|---|---|
| 8 | Rim / Front Left | Out of Bodywork / Scratch | |

8. Rim / Front Left  
Out of Bodywork / Scratch -

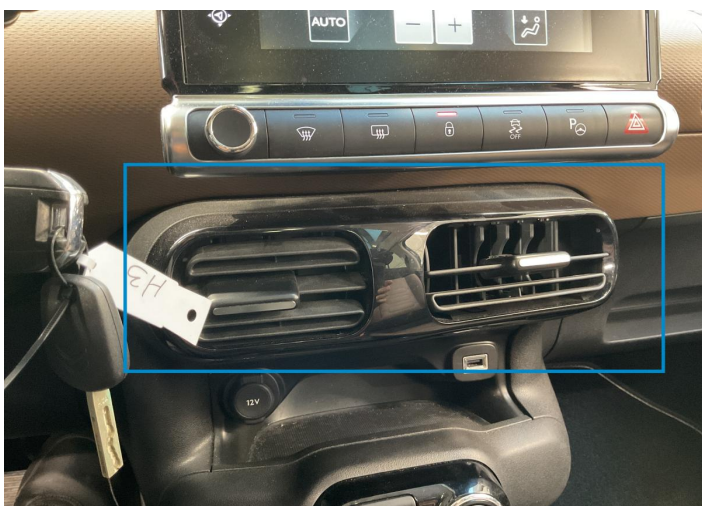
| Component | | Damage | Comments |
|---|---|---|---|
| 9 | Aeration Grid / Front Center | Interior / Broken | |

9. Aeration Grid / Front Center  
Interior / Broken -

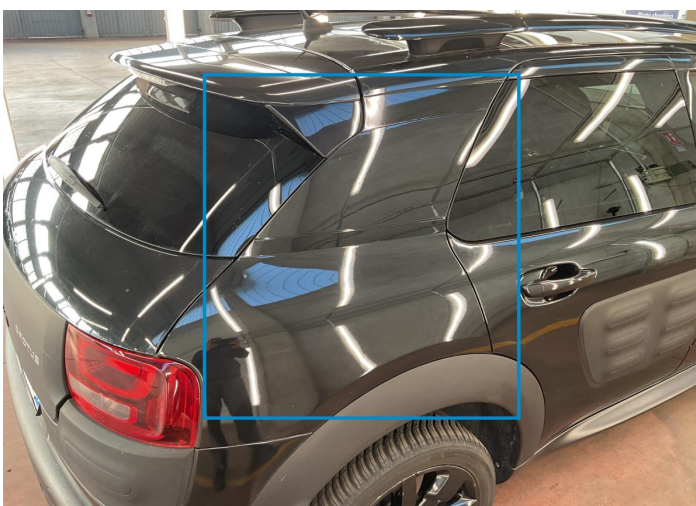
| Component | | Damage | Comments |
|---|---|---|---|
| 10 | Fender / Back Right | Bodywork / Poor Previous Repair | |

10. Fender / Back Right  
Bodywork / Poor Previous Repair -

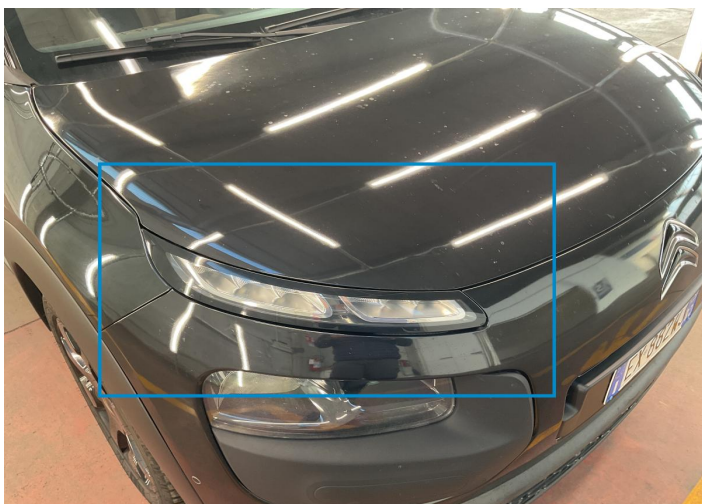
| Component | | Damage | Comments |
|---|---|---|---|
| 11 | Front Light / Front Right | Bodywork / Breakage | |

11. Front Light / Front Right  
Bodywork / Breakage -

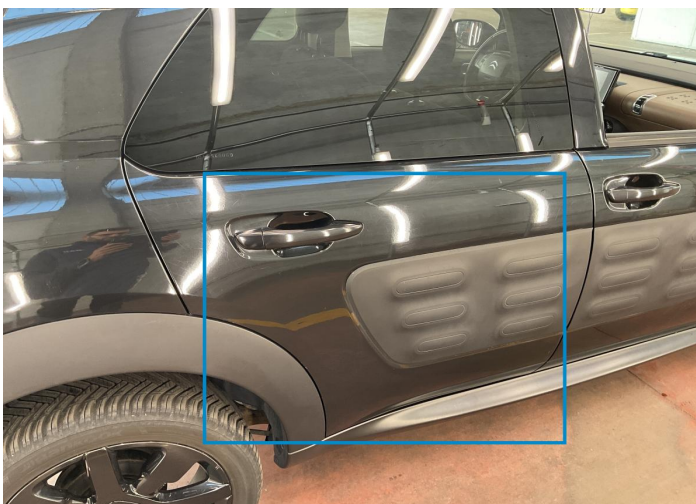
| Component | | Damage | Comments |
|---|---|---|---|
| 12 | Door / Back Right | Paint / Scratch / Line | |

12. Door / Back Right  
Paint / Scratch / Line -

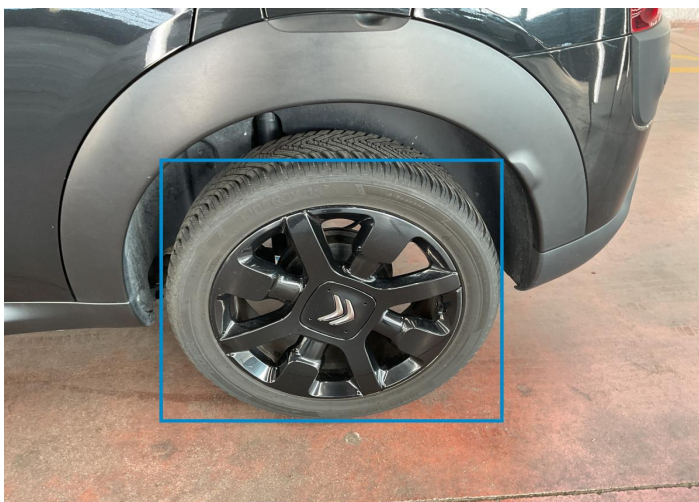
| 13 | Rim / Back Left | Out of Bodywork / Scratch |

13. Rim / Back Left  
Out of Bodywork / Scratch -

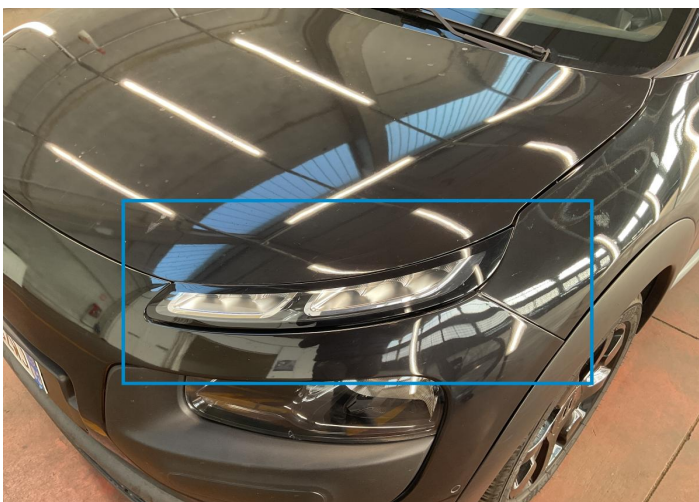
| 14 | Front Light / Front Left | Bodywork / Breakage |

14. Front Light / Front Left  
Bodywork / Breakage -

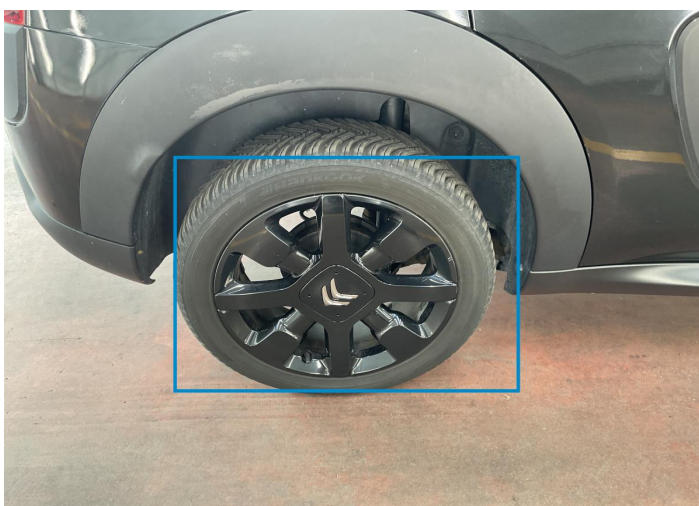
| 15 | Rim / Back Right | Out of Bodywork / Scratch |

15. Rim / Back Right  
Out of Bodywork / Scratch -

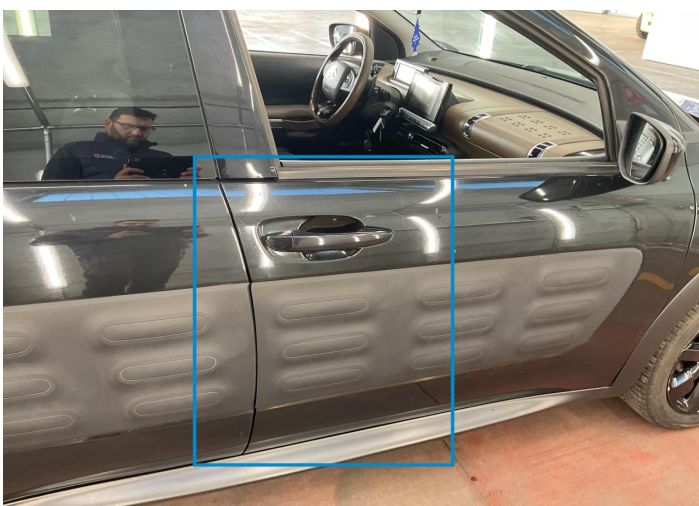
| 16 | Door / Front Right | Paint / Scratch / Line |

16. Door / Front Right  
Paint / Scratch / Line -

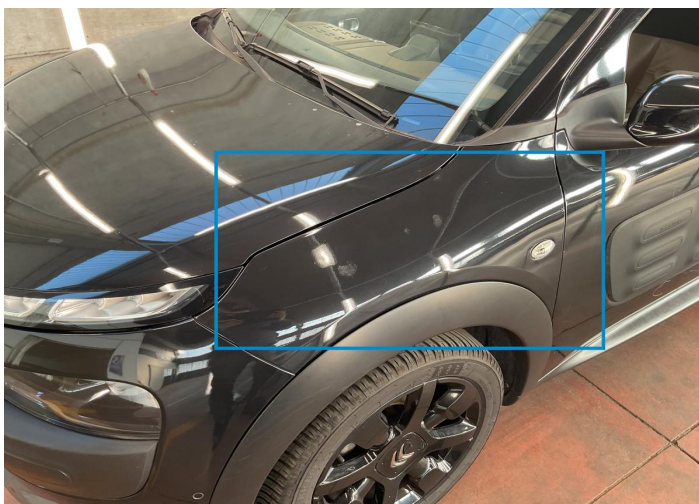
| 17 | Fender / Front Left | Bodywork / Dent / Hail Area |

17. Fender / Front Left  
Bodywork / Dent / Hail Area -

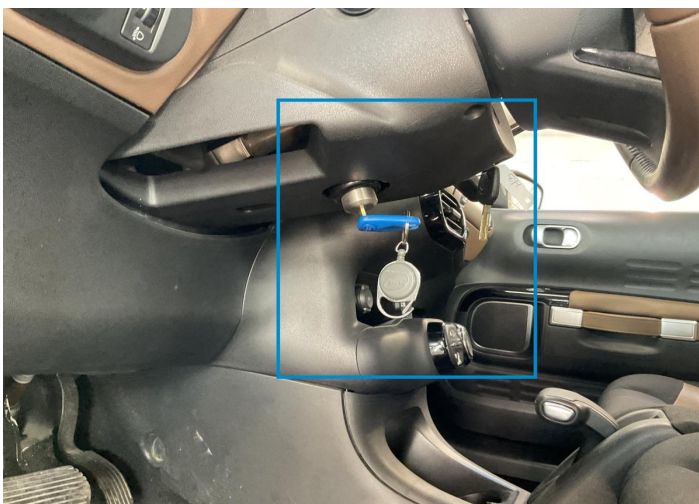
| 18 | Dashboard / Front | Interior / Non - compliant |

18. Dashboard / Front  
Interior / Non - compliant -

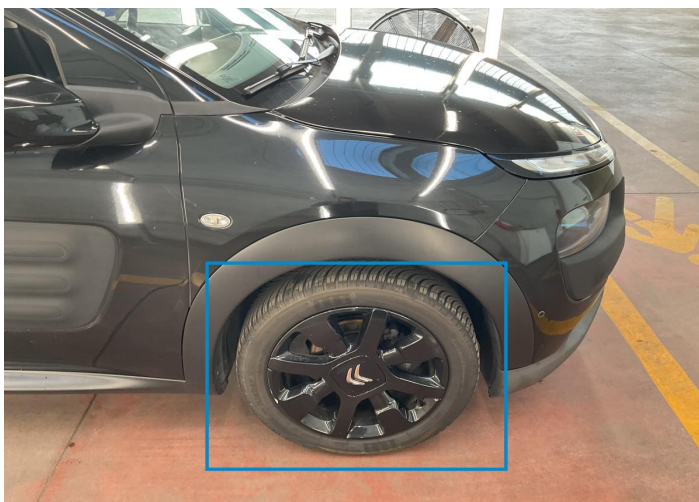
| 19 | Rim / Front Right | Out of Bodywork / Scratch |

19. Rim / Front Right  
Out of Bodywork / Scratch -

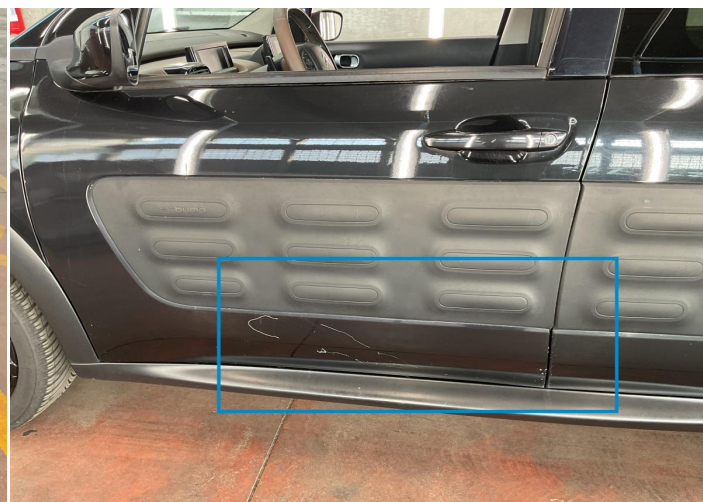
| 20 | Door / Front Left | Paint / Scratch / Line |

20. Door / Front Left  
Paint / Scratch / Line -

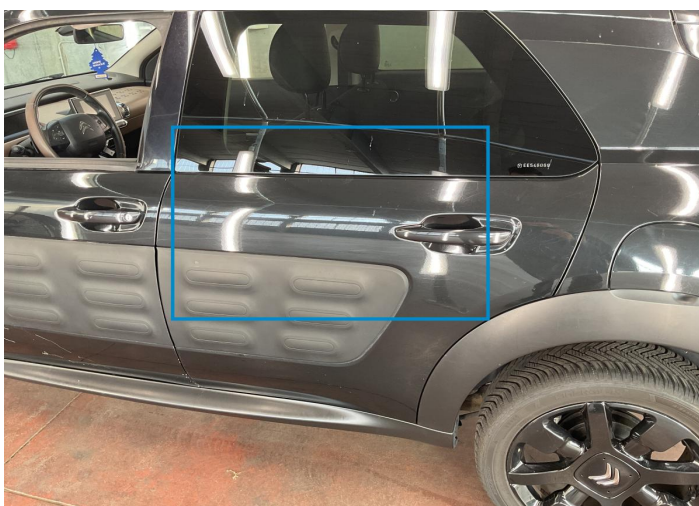
| 21 | Door / Back Left | Bodywork / Poor Previous Repair |

21. Door / Back Left  
Bodywork / Poor Previous Repair -

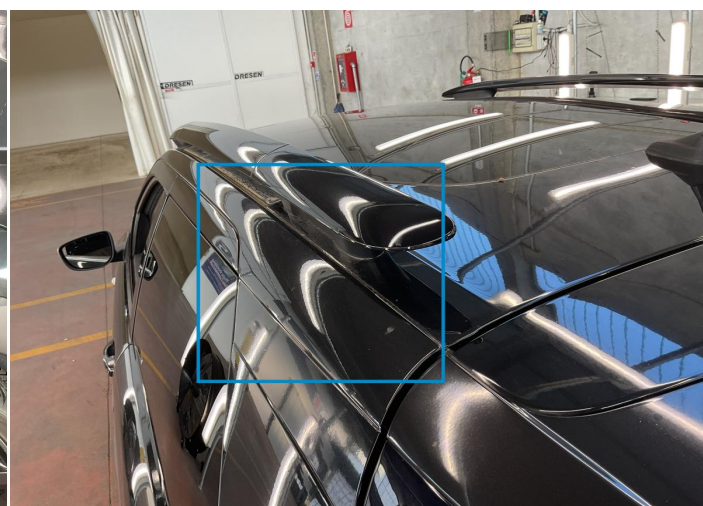
| 22 | Pillar / Front Left | Bodywork / Dent / Hail Area |

22. Pillar / Front Left  
Bodywork / Dent / Hail Area -

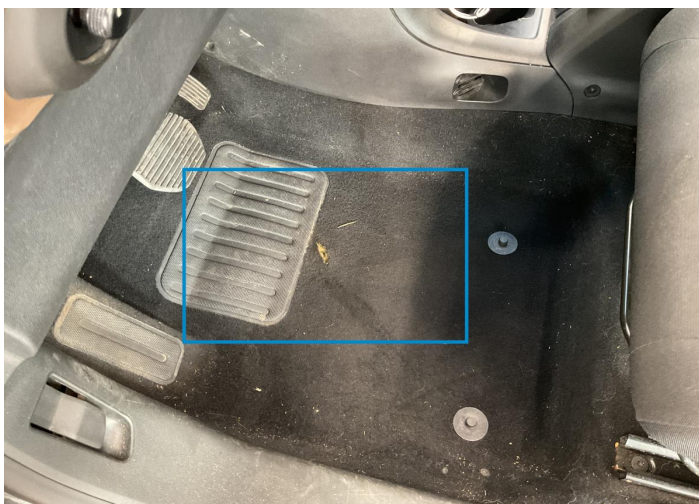
| 23 | Floor Carpet | Interior / Ripped |

23. Floor Carpet  
Interior / Ripped -

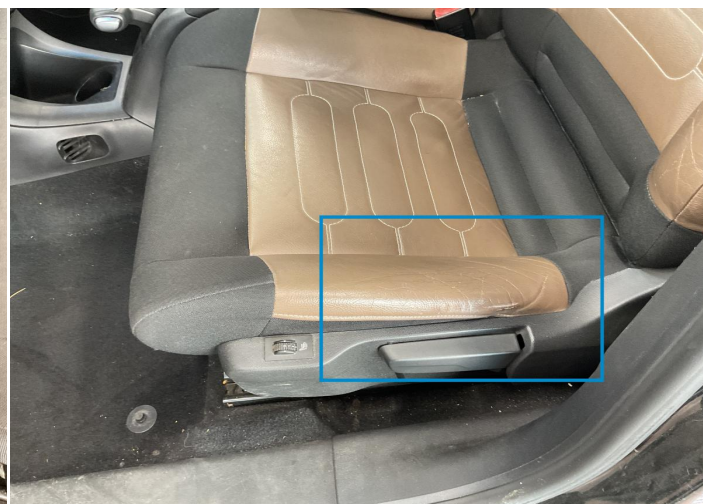
| 24 | Seat / Front Left | Interior / Ripped |

24. Seat / Front Left  
Interior / Ripped -

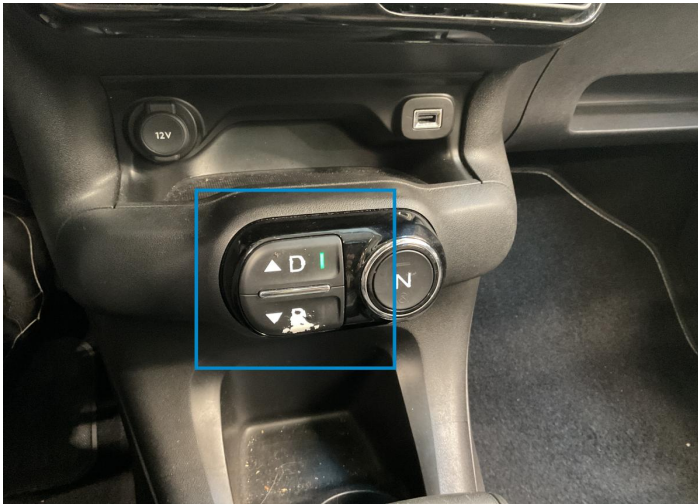
| 25 | Center Console | Interior / Worn - out |

25. Center Console  
Interior / Worn - out -

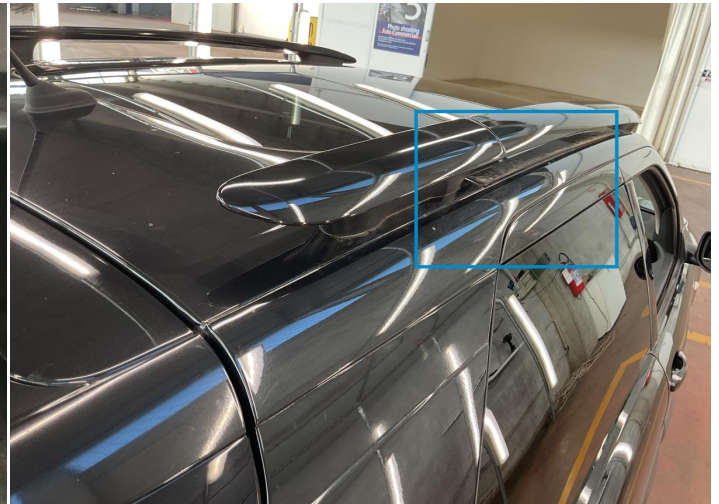
| 26 | Pillar / Front Right | Bodywork / Dent / Hail Area |

26. Pillar / Front Right  
Bodywork / Dent / Hail Area -
