CITROEN C4 CACTUS

C4 Cactus PureTech 110 S&S BVM6 Shine

Inspection Report Summary

Customer	BCAuto Encheres	Report Number	P20250731140512
Inspection Date / Place	2025-07-31 / BCA BETHUNE	Cosmetic Grade	1

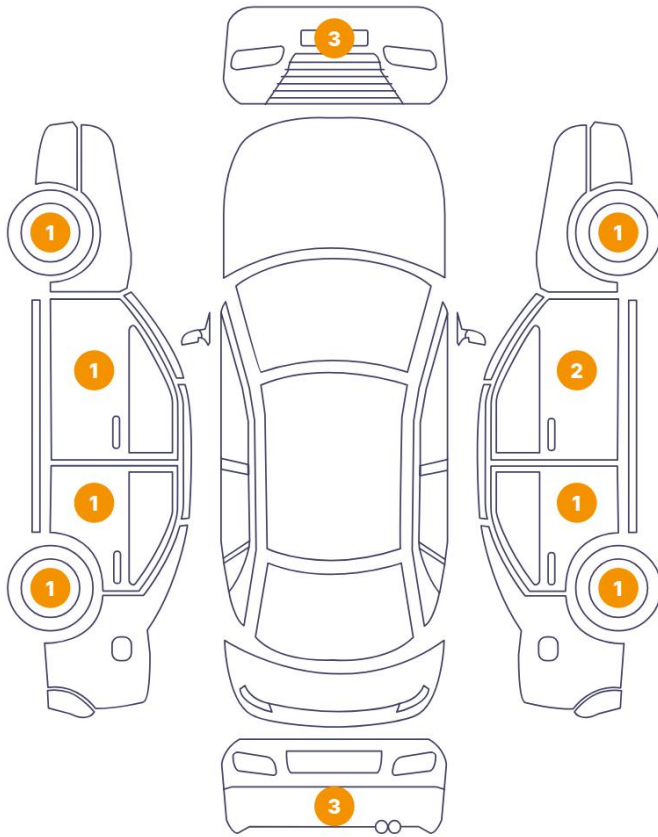
15 Dommages

Component	Damage	Comments
1 Floor Carpet	Interior / Dirty	
2 Floor Carpet	Interior / Dirty	
3 Corner Bumper / Front Right	Paint / Scratch / Scuff	
4 Bumper / Front	Paint / Scratch / Scuff	
5 Corner Bumper / Front Left	Paint / Scratch / Scuff	
6 Rim / Front Left	Out of Bodywork / Scratch	
7 Door / Front Left	Paint / Scratch / Line	
8 Door / Back Left	Paint / Scratch / Line	
9 Rim / Back Left	Out of Bodywork / Scratch	
10 Corner Bumper / Back Left	Paint / Scratch / Scuff	
11 Bumper / Back	Paint / Scratch / Scuff	
12 Corner Bumper / Back Right	Paint / Scratch / Scuff	
13 Rim / Back Right	Out of Bodywork / Scratch

14	Door / Back Right	Paint / Scratch / Line
15	Door / Front Right	Paint / Scratch / Line
16	Door / Front Right	Paint / Scratch / Line
17	Rim / Front Right	Out of Bodywork / Scratch

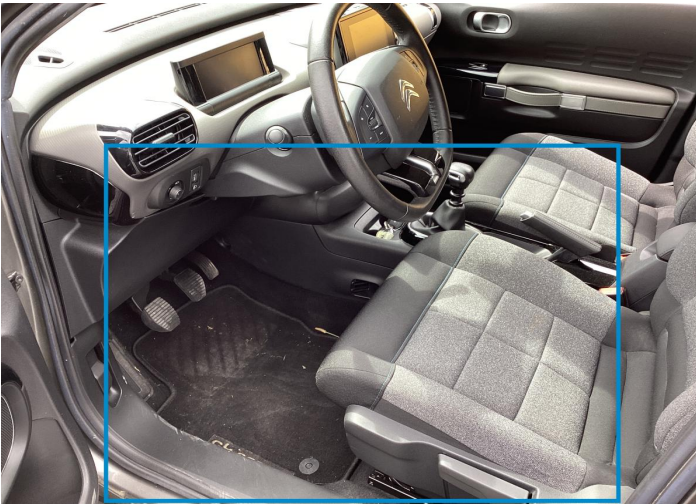
1. Floor Carpet
Interior / Dirty -

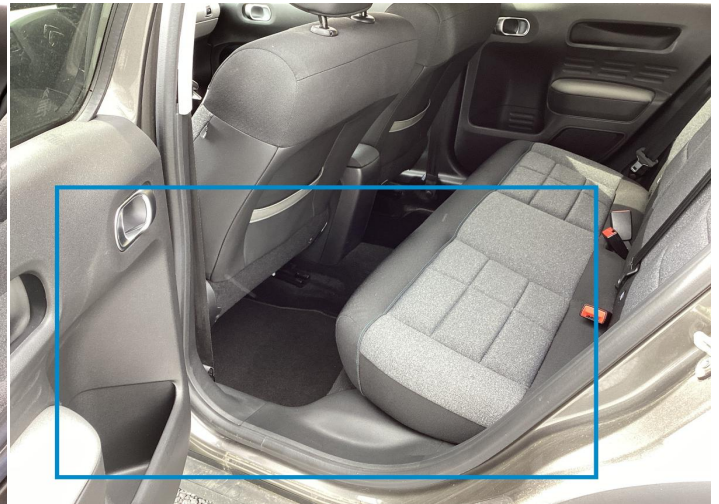
2. Floor Carpet
Interior / Dirty -

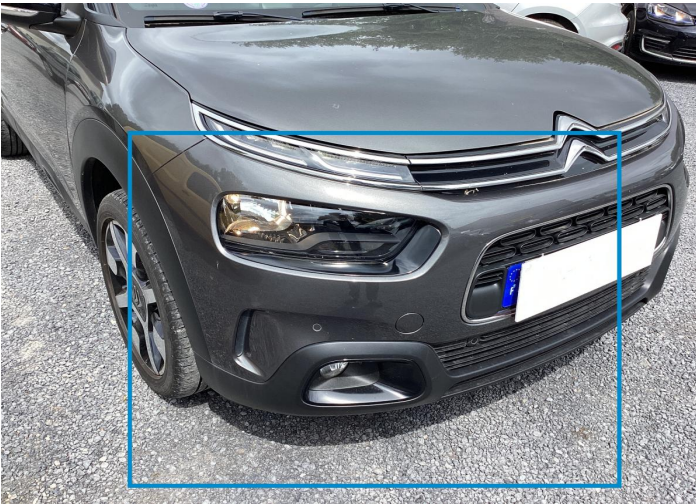
3. Corner Bumper / Front Right
Paint / Scratch / Scuff -

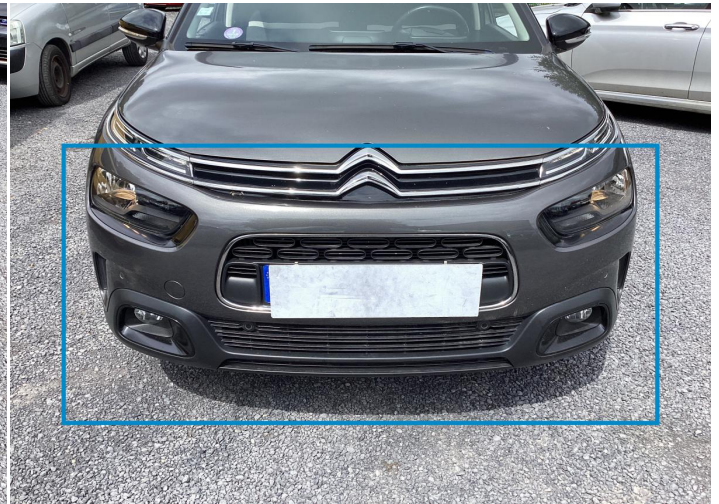
4. Bumper / Front
Paint / Scratch / Scuff -

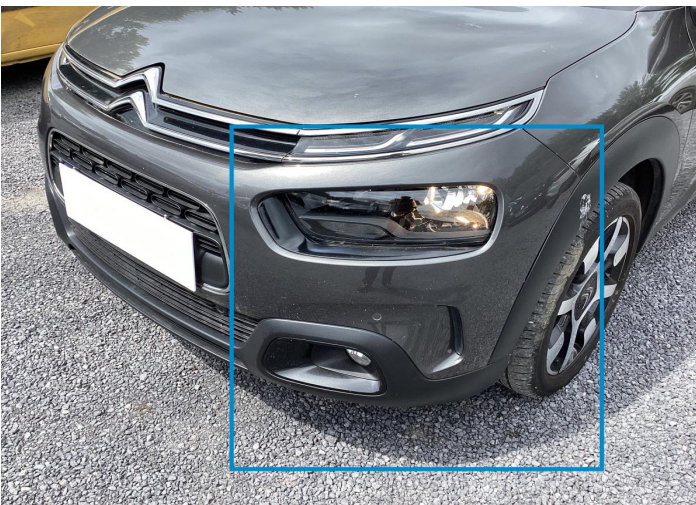
5. Corner Bumper / Front Left
Paint / Scratch / Scuff -

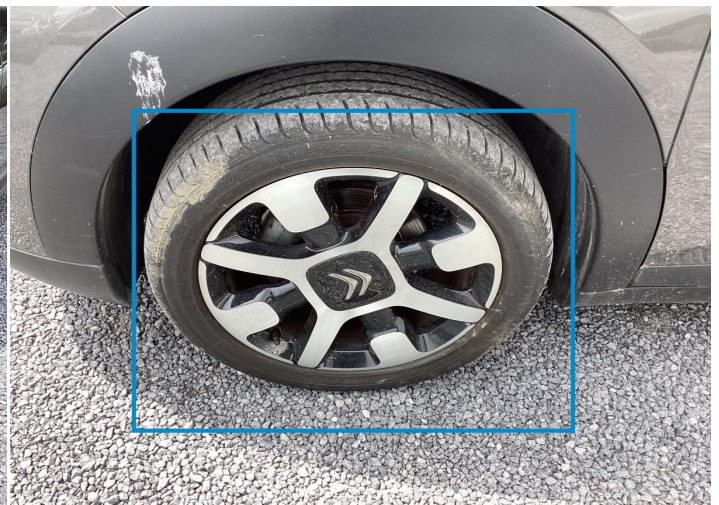
6. Rim / Front Left
Out of Bodywork / Scratch -

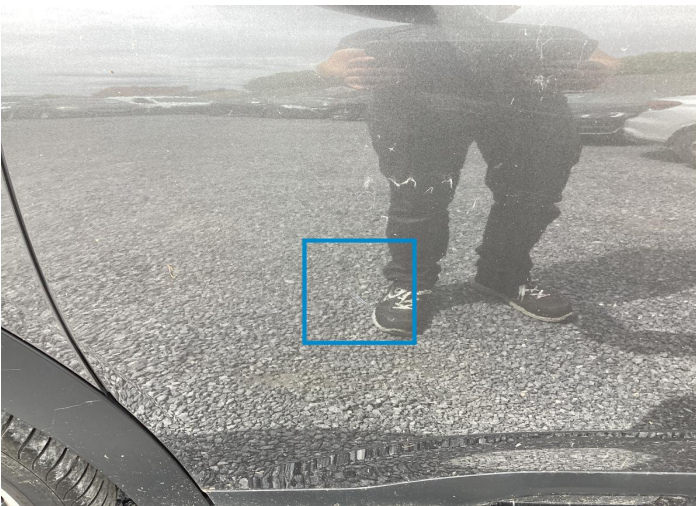
7. Door / Front Left
Paint / Scratch / Line -

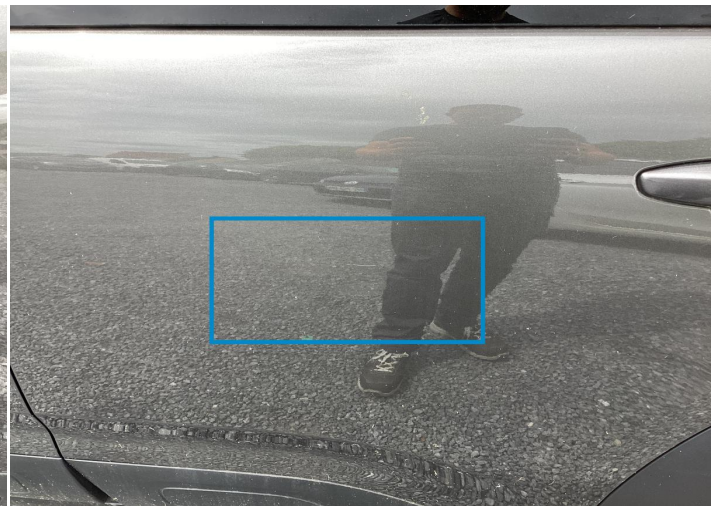
8. Door / Back Left
Paint / Scratch / Line -

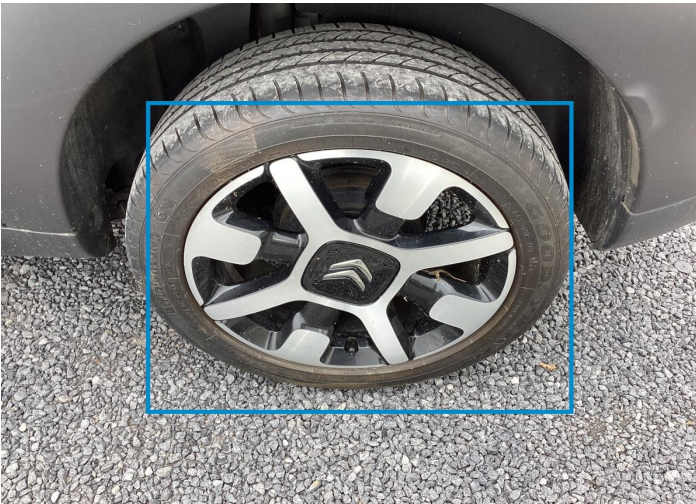
9. Rim / Back Left
Out of Bodywork / Scratch -

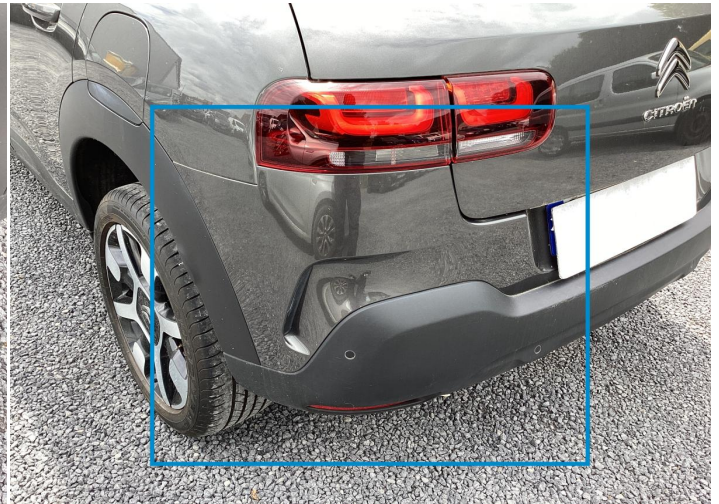
10. Corner Bumper / Back Left
Paint / Scratch / Scuff -

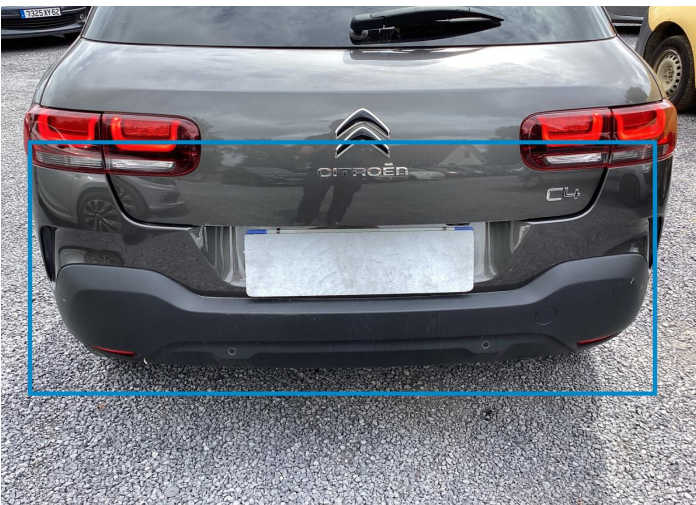
11. Bumper / Back
Paint / Scratch / Scuff -

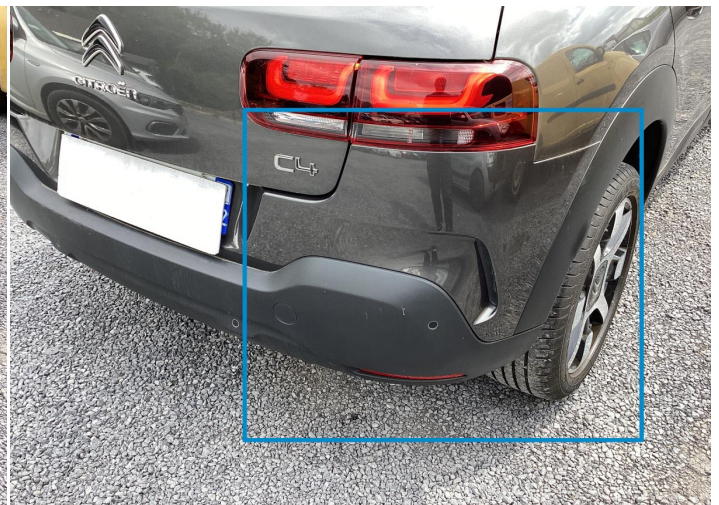
12. Corner Bumper / Back Right
Paint / Scratch / Scuff -

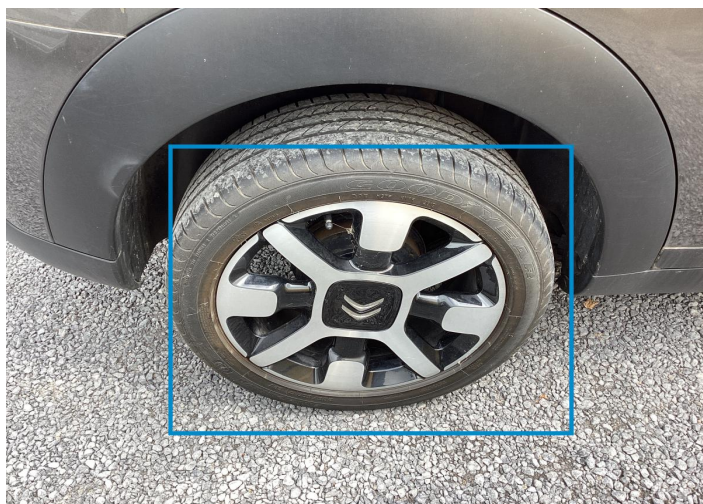
13. Rim / Back Right
Out of Bodywork / Scratch -

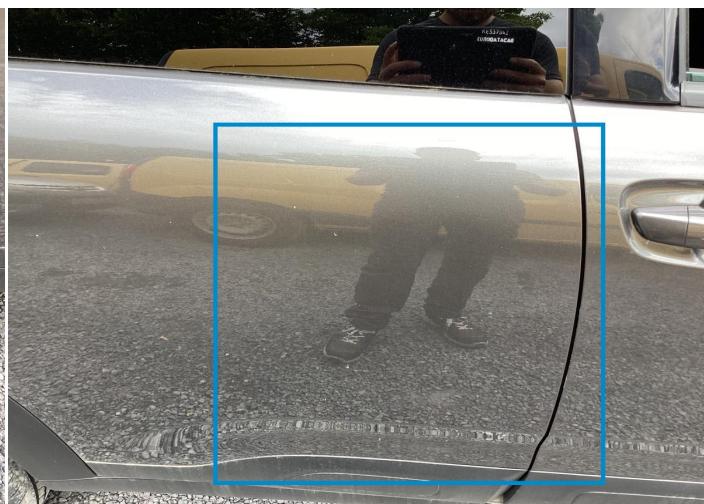
14. Door / Back Right
Paint / Scratch / Line -

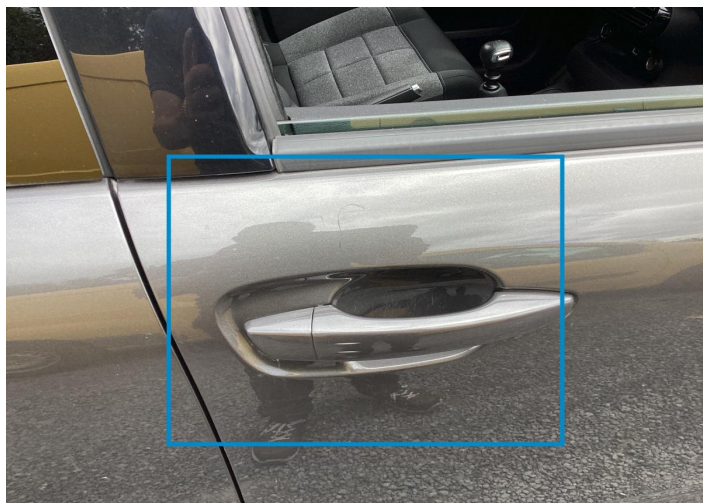
15. Door / Front Right
Paint / Scratch / Line -

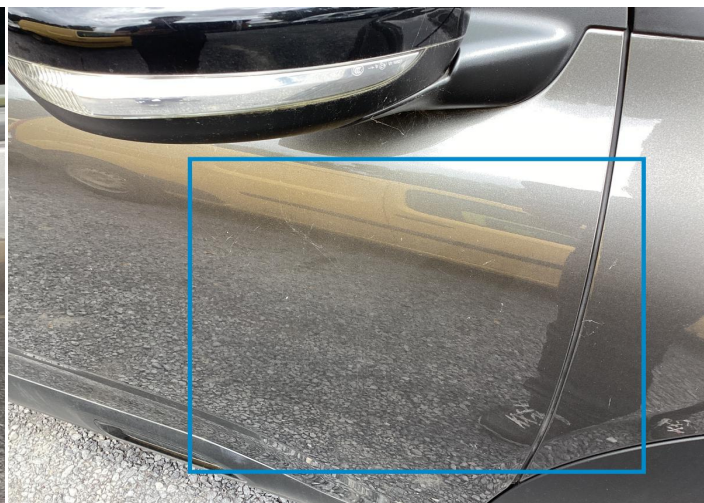
16. Door / Front Right
Paint / Scratch / Line -

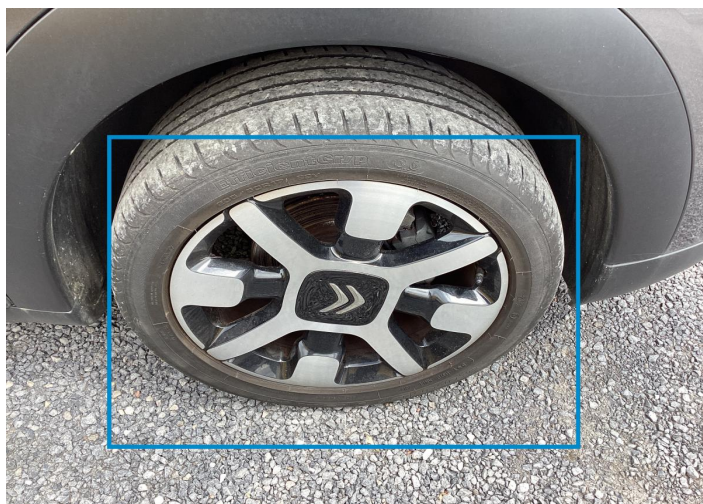
17. Rim / Front Right
Out of Bodywork / Scratch -
