Expertise

Protocol number: 41219025
Order No. / Reference: 25116213
Inspection date: 25 Aug 2025

Manufacturer: Citroën

Model: Grand C4 Spacetourer BlueHDi 160 Stop&Start EAT8 SHINE

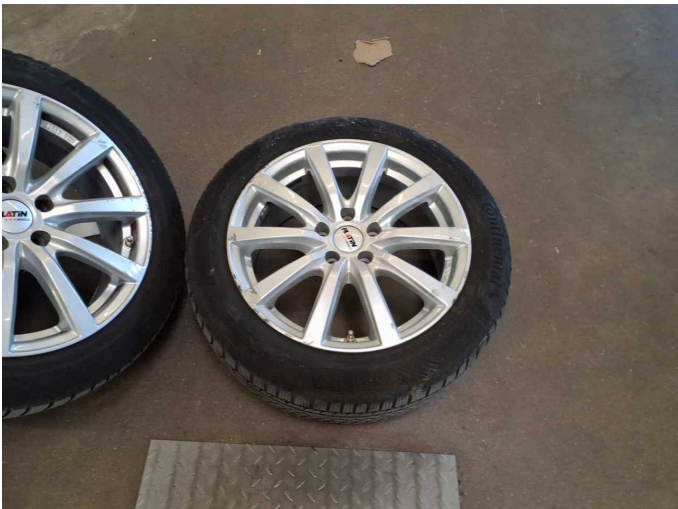
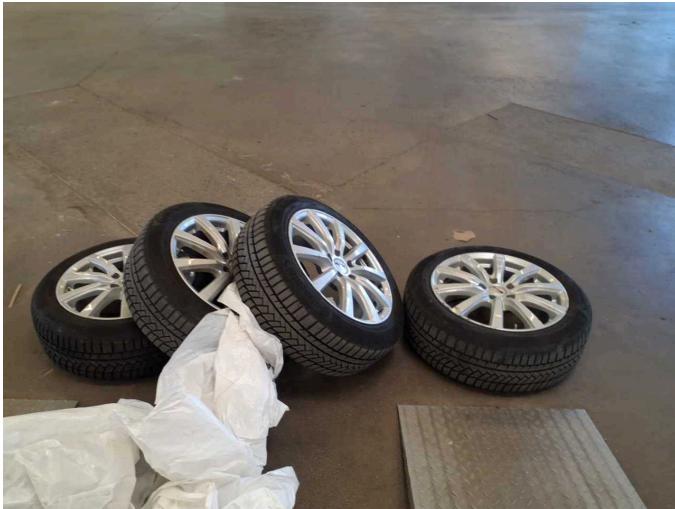
No.	Component group	Description
1	Body	Body (Waschstraßenkratzer) - Scratch(es) - No deduction
2	2nd wheel set	2 alloy rims - Scratched - No deduction

Der beiliegende Radsatz gehört nicht zur Ausstattung.

Figure 18: Additional tyres

Figure 19: Additional tyres

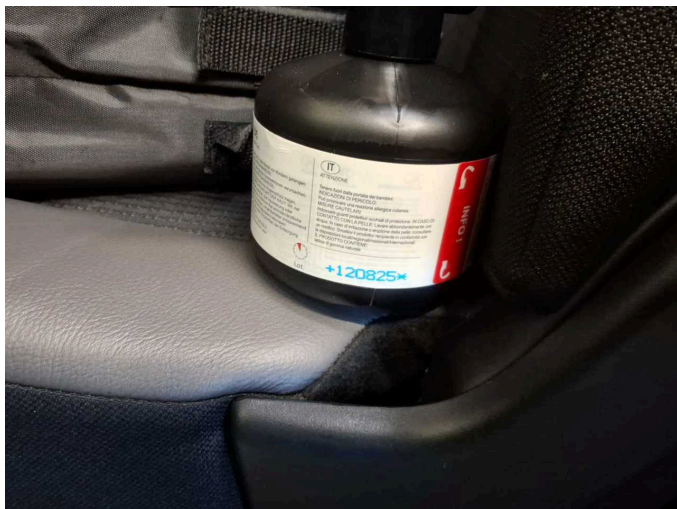
No.	Component group	Description
1	Equipment	Tirefit filler - Expired - Replace
2	Roof	Roof rail - right side - dent(s) - Smooth repair work
3	Door - front right side	Door - Scratch(es) - Paint

Damage 1: Equipment: Tirefit filler - Expired - Replace

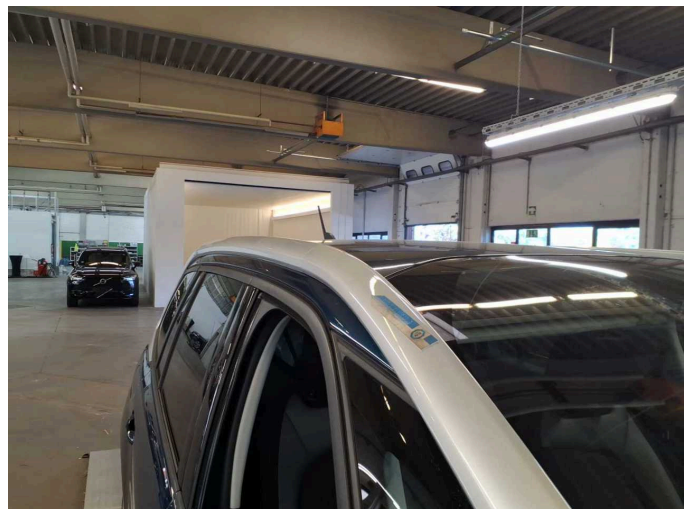
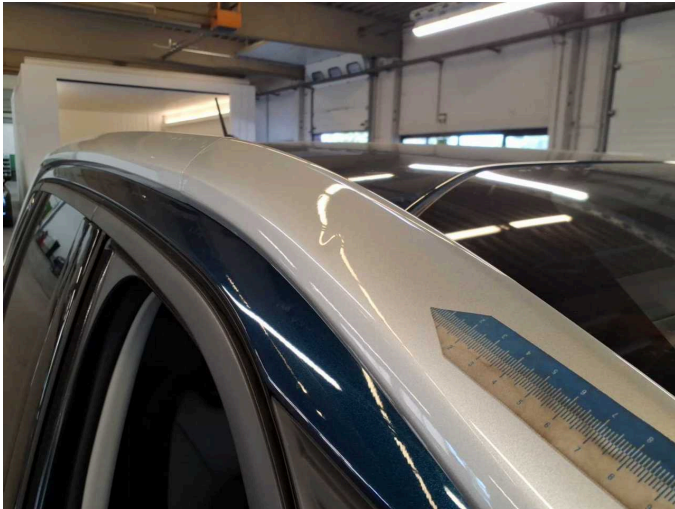
Damage 2: Roof: Roof rail - right side - dent(s) - Smooth repair work

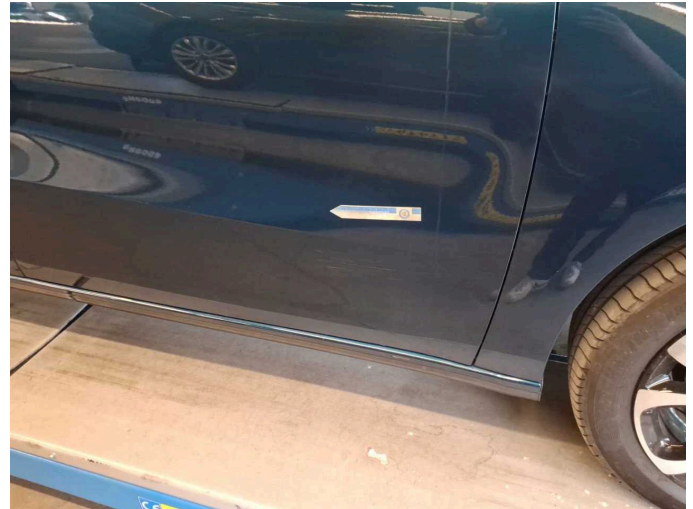
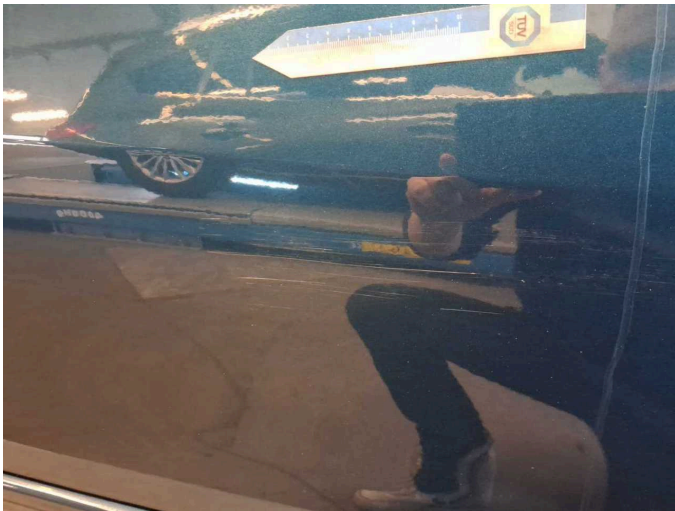
Damage 3: Door - front right side: Door - Scratch(es) - Paint

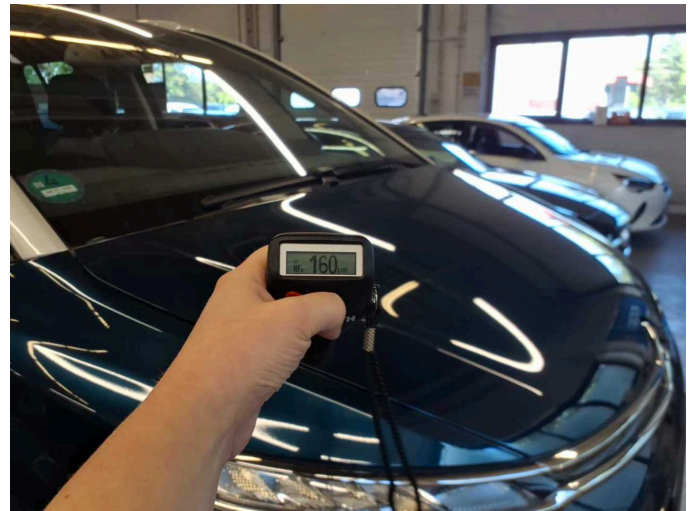
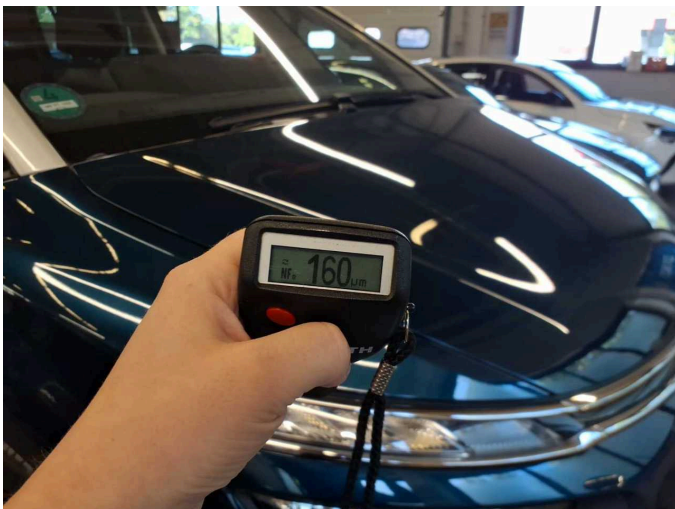
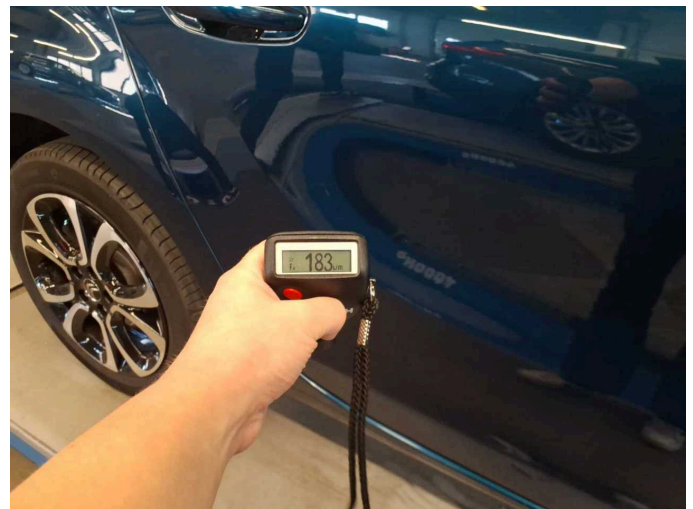
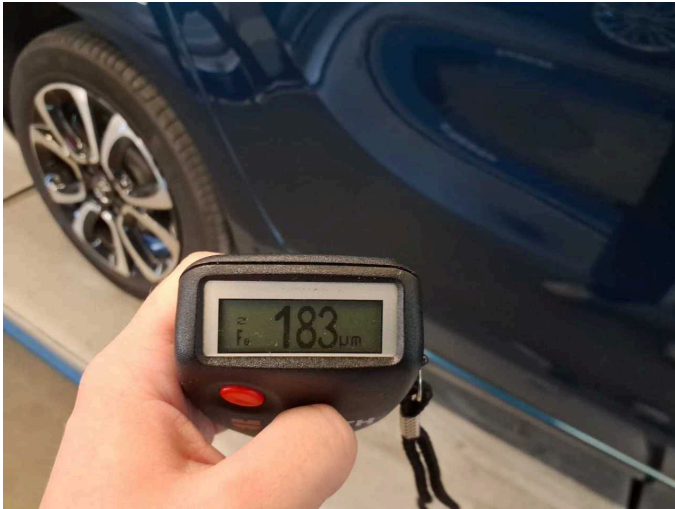
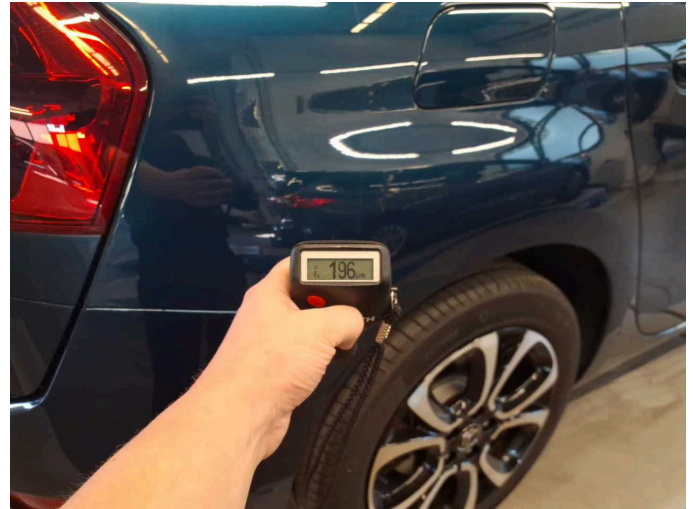
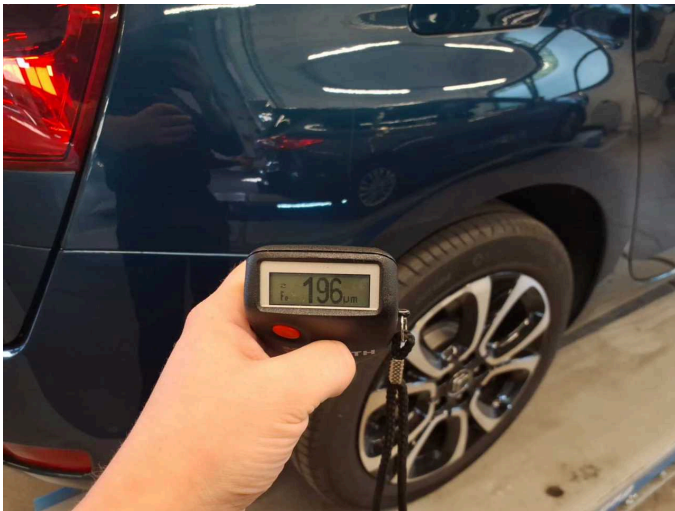
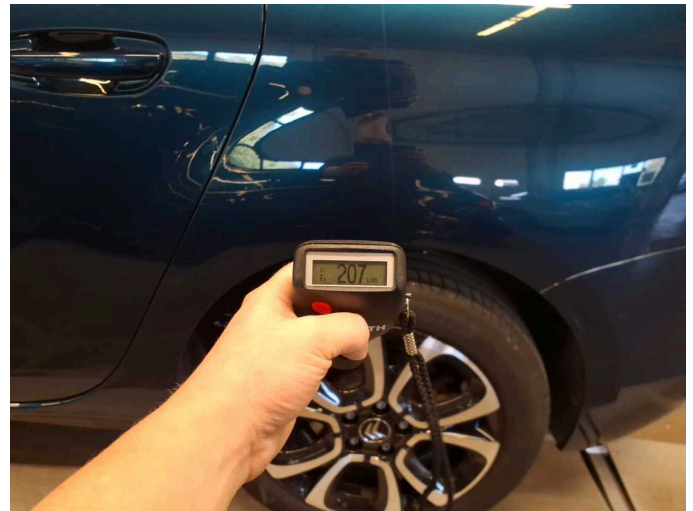
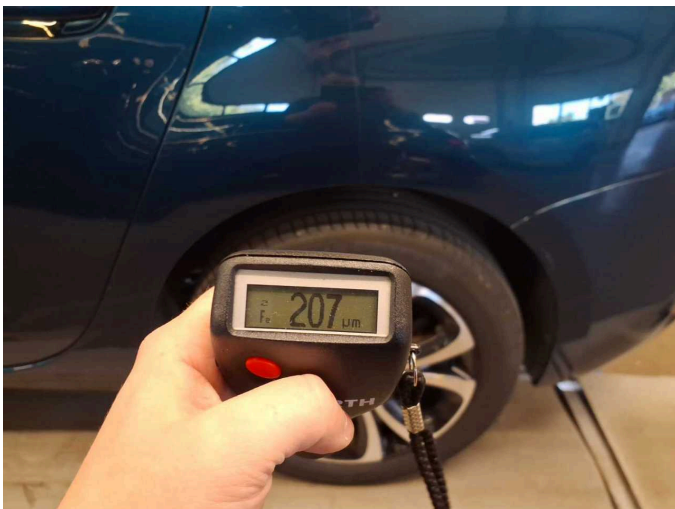
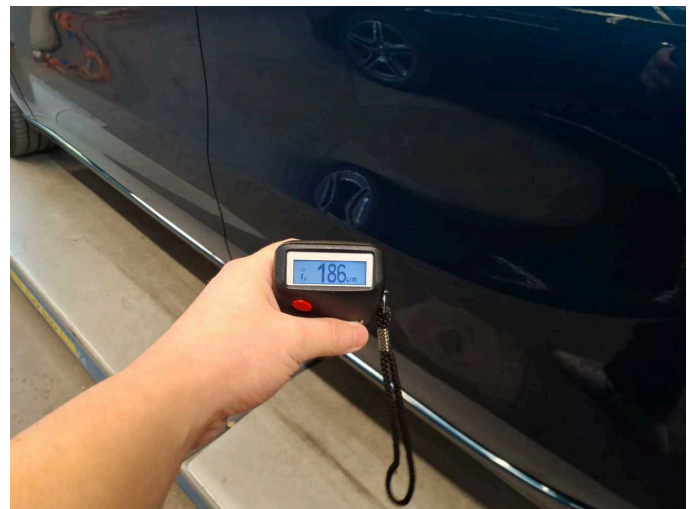
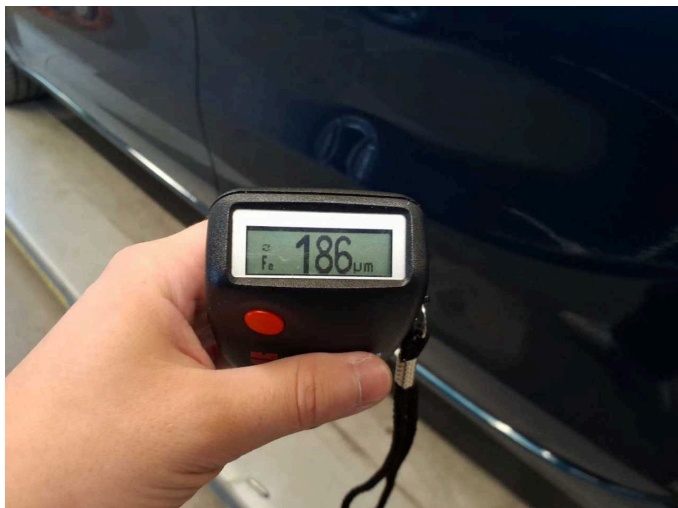
No.	Repainting
1	Bonnet, Side panel - rear left side, Side panel - rear right side, Door - rear left side, Door - rear right side, Professionally carried out, Invoice of repair done Non-existent

Bonnet	160 µm	Side panel - rear left side	207 µm
Side panel - rear right side	196 µm	Door - rear left side	186 µm
Door - rear right side	183 µm

Repainting 1: Bonnet, Side panel - rear left side, Side panel - rear right side, Door - rear left side, Door - rear right side
