## status report

#### Citroën C4 Picasso/Spacetourer Shine

| Vehicle identification number | <b>VF73DBHZTHJ820271</b> | mileage read: | <b>165140 km</b> |

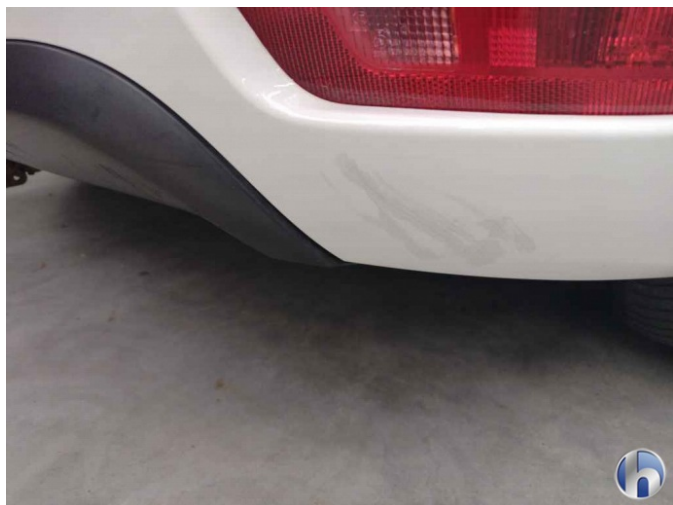
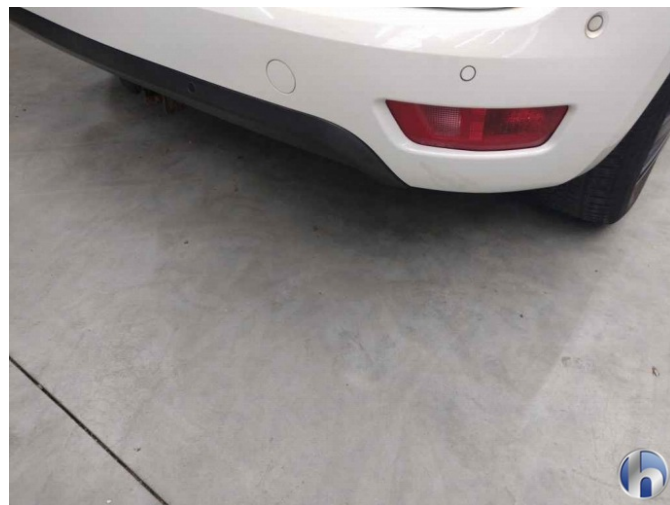
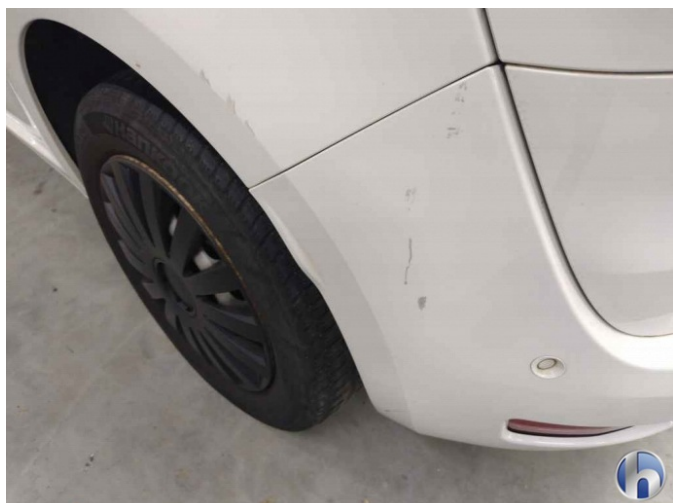
3. Rear bumper

| | <b>component</b> | <b>Damage</b> | <b>Rep kind</b> |
|---|---|---|---|
| 3. | Rear bumper | Scratch(es) | Paint |

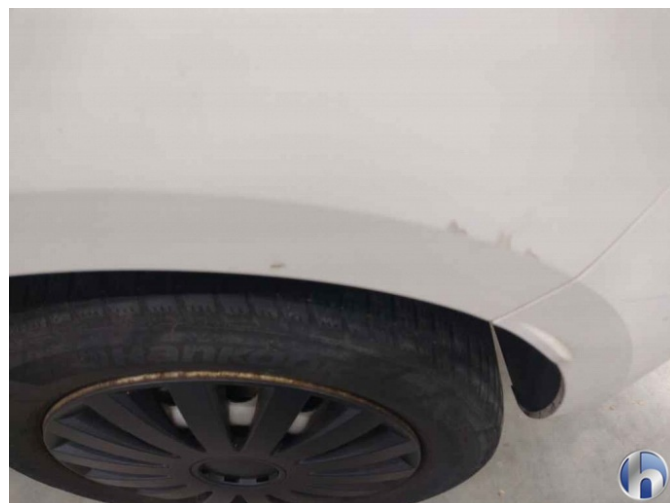
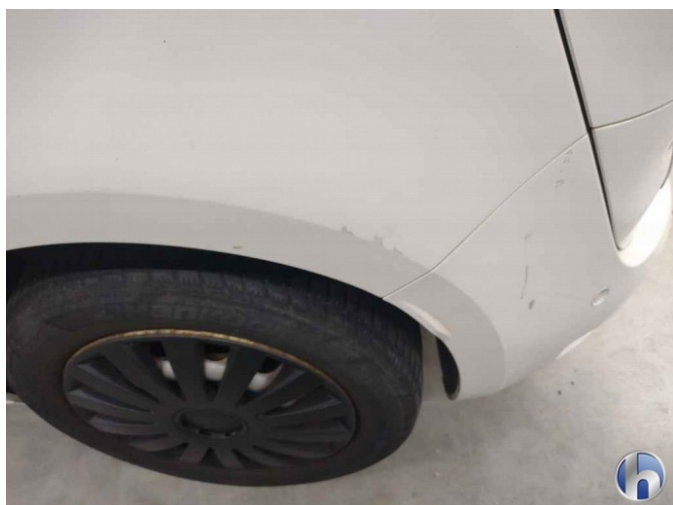
4. Sidewall - Rear - Left

| | <b>component</b> | <b>Damage</b> | <b>Rep kind</b> |
|---|---|---|---|
| 4. | Sidewall - Rear - Left | Surface scratch(es) | |

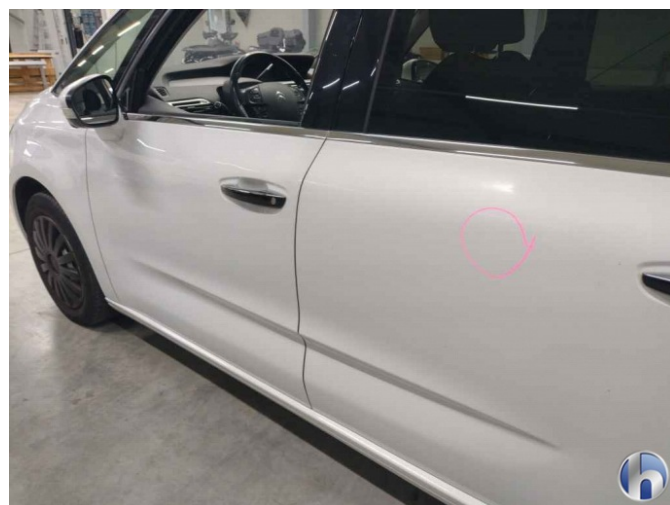
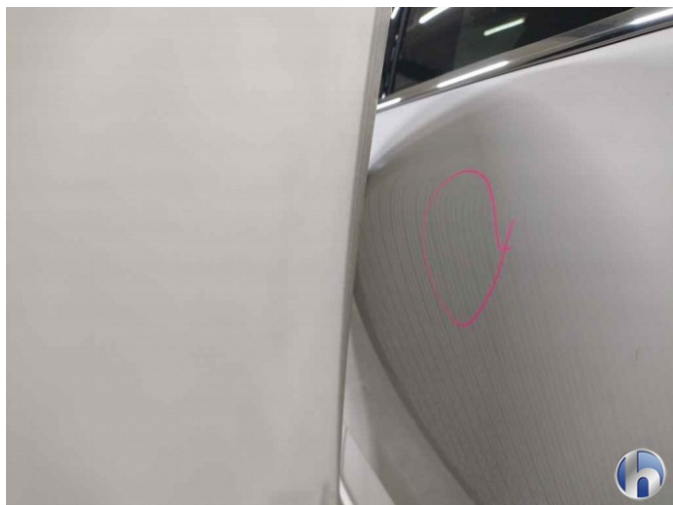
5. Rear door - left

| | <b>component</b> | <b>Damage</b> | <b>Rep kind</b> |
|---|---|---|---|
| 5. | Rear door - left | | Smart repair |

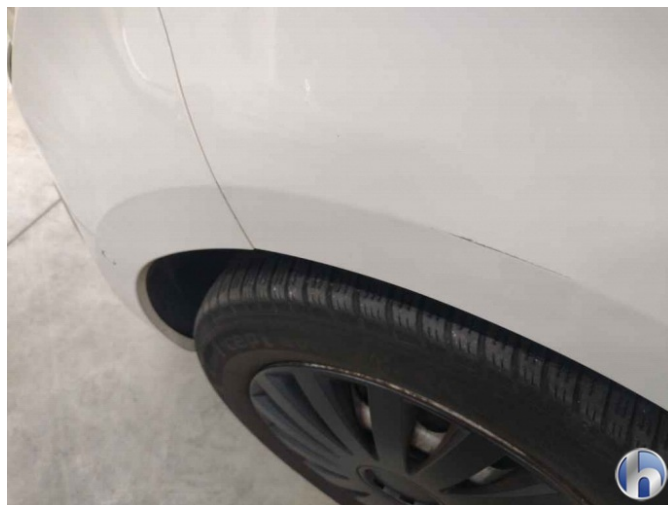
6. Front fender - left

| | <b>component</b> | <b>Damage</b> | <b>Rep kind</b> |
|---|---|---|---|
| 6. | Front fender - left | Surface scratch(es) | |
