## status report

**customer:** BCA Autoauktionen GmbH

#### Citroën Berlingo Kasten Business L2

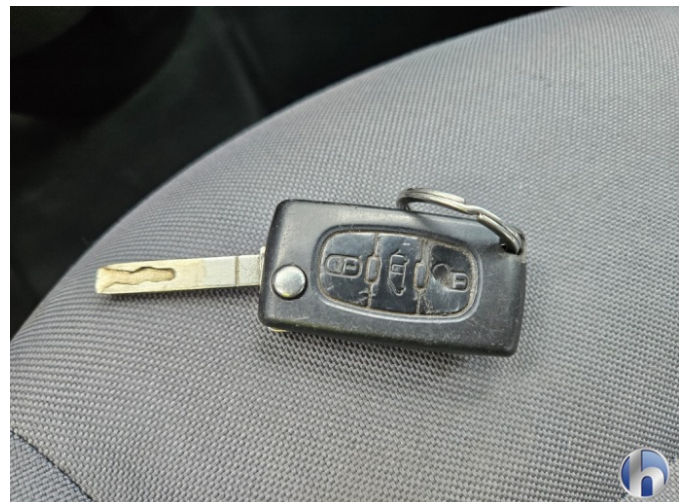
| component | Damage | Rep kind |
|---|---|---|
| 1. Key with remote control | No functionality | Replace |

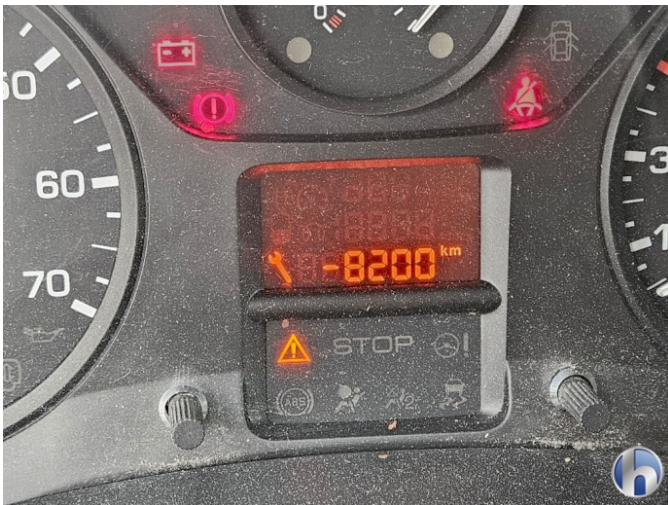
| component | Damage | Rep kind |
|---|---|---|
| 4. maintenance | Due | Replace |

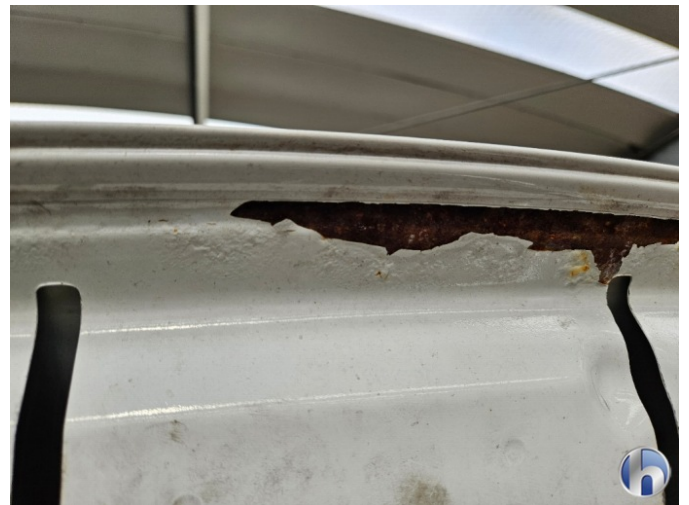
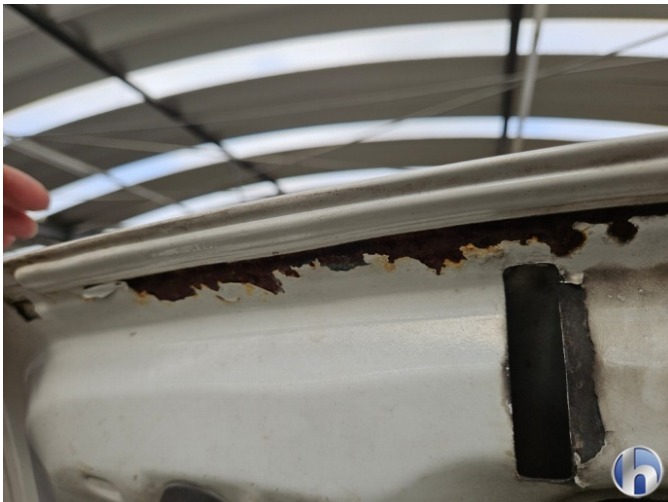
| component | Damage | Rep kind |
|---|---|---|
| 5. hood | Rust | Paint |

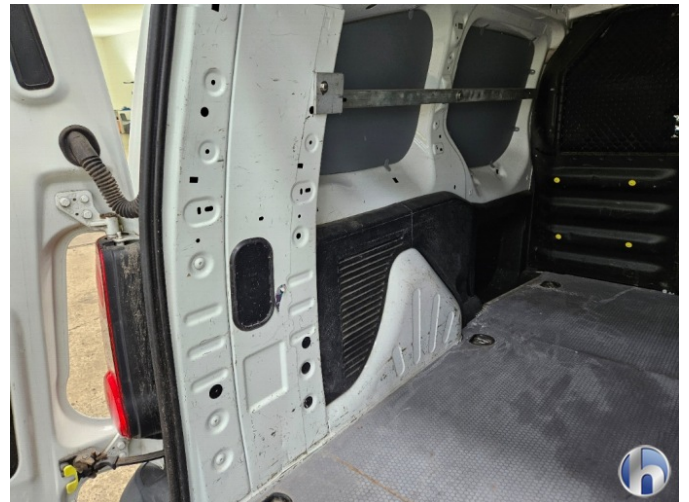
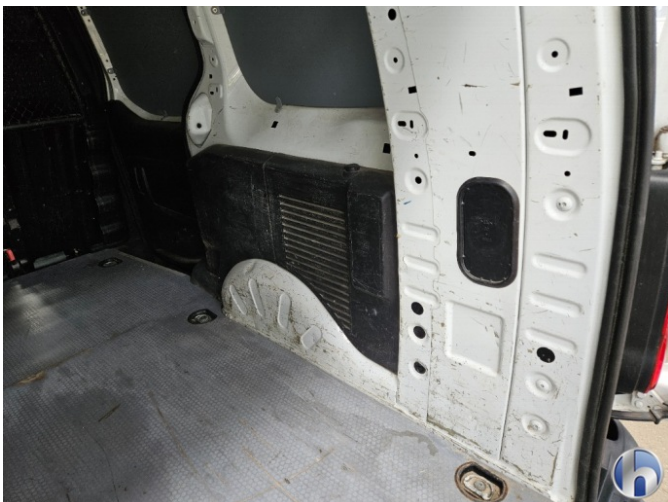
| component | Damage | Rep kind |
|---|---|---|
| 6. Laderaum | Wear and tear | acceptable |

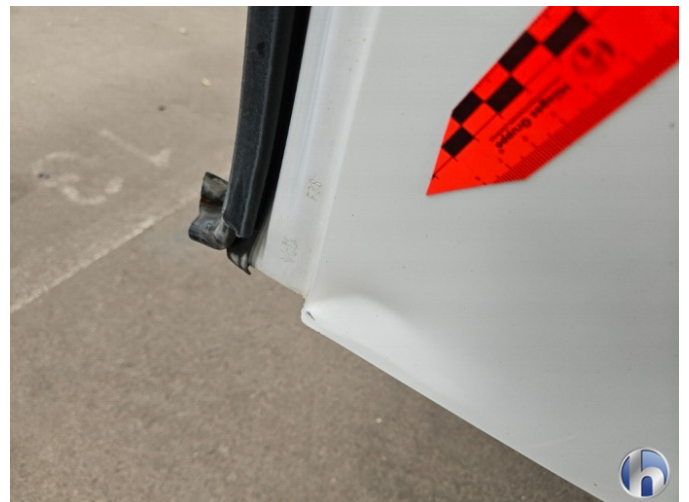
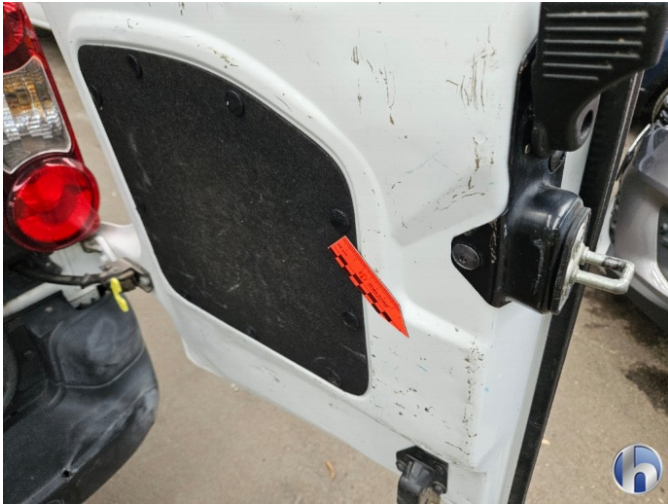
| component | Damage | Rep kind |
|---|---|---|
| 7. Tailgate right | Damaged | Refurbish and paint |

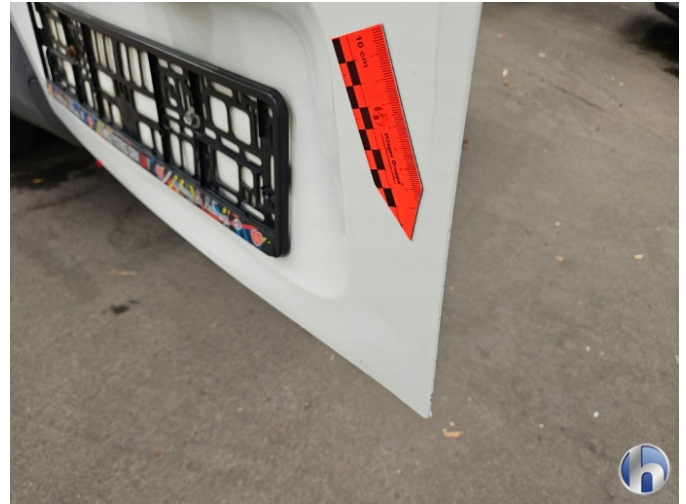
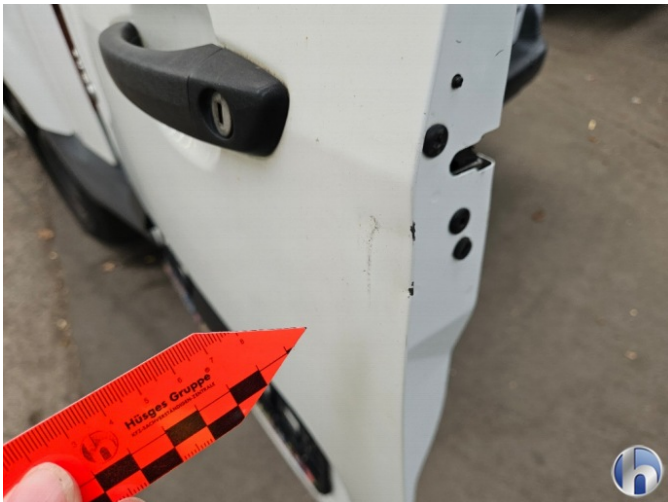
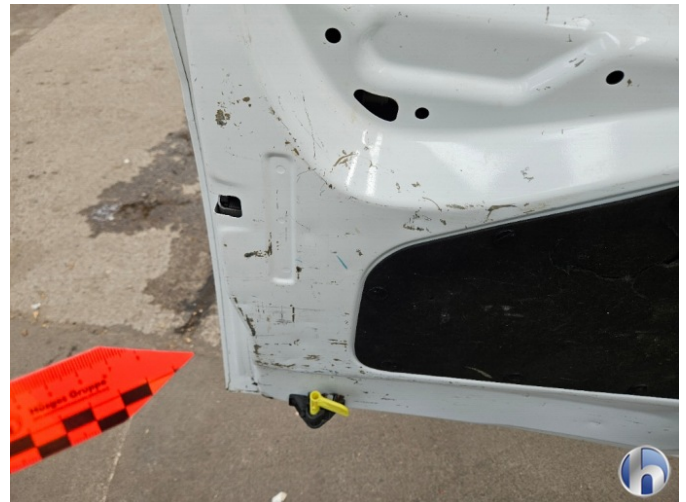
| component | Damage | Rep kind |
|---|---|---|
| 8. Tailgate left | Damaged | Refurbish and paint |

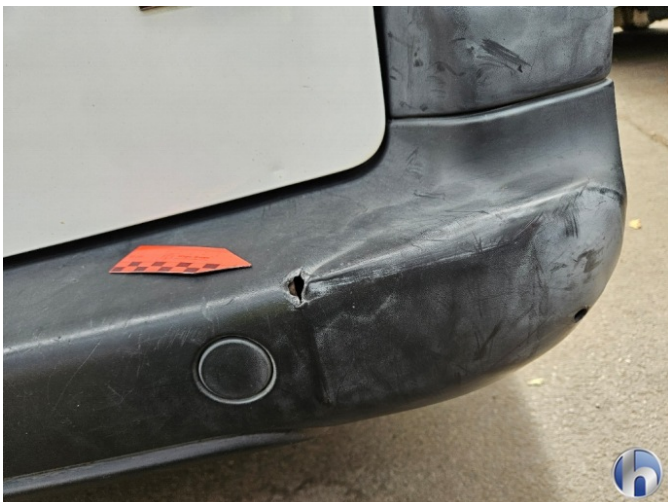
| component | Damage | Rep kind |
|---|---|---|
| 9. Rear bumper | Damaged | Replace |

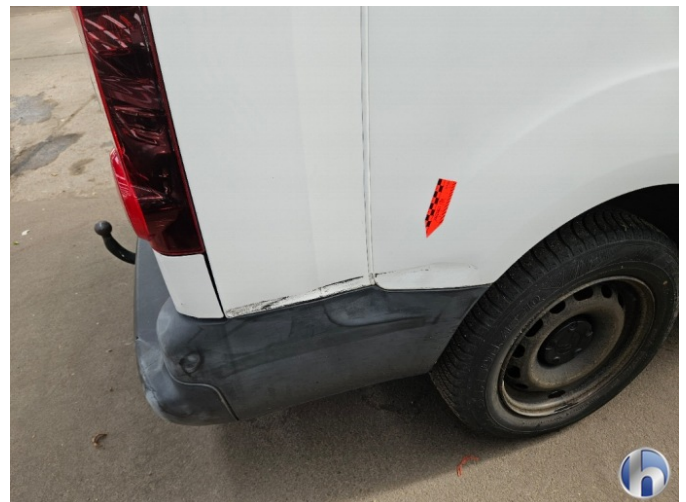
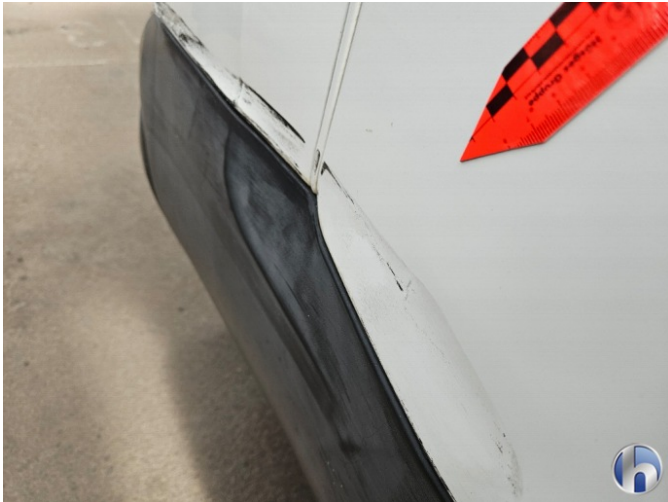
| component | Damage | Rep kind |
|---|---|---|
| 10. Sidewall - Rear - right | Damaged | Refurbish and paint |

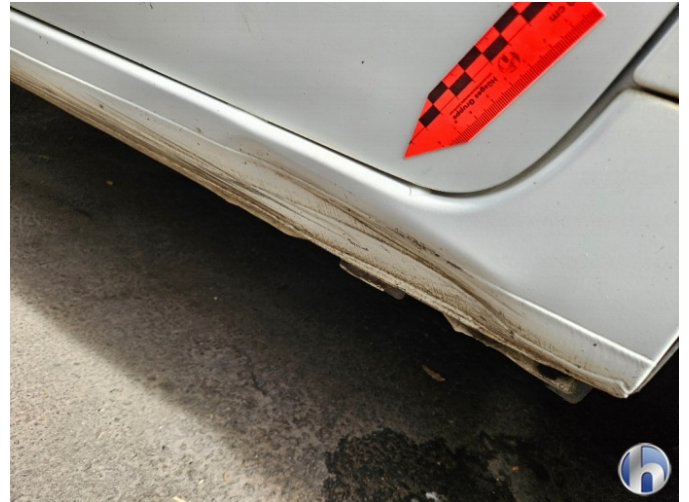
| component | Damage | Rep kind |
|---|---|---|
| 11. side skirt - right | Deformed | Refurbish and paint |

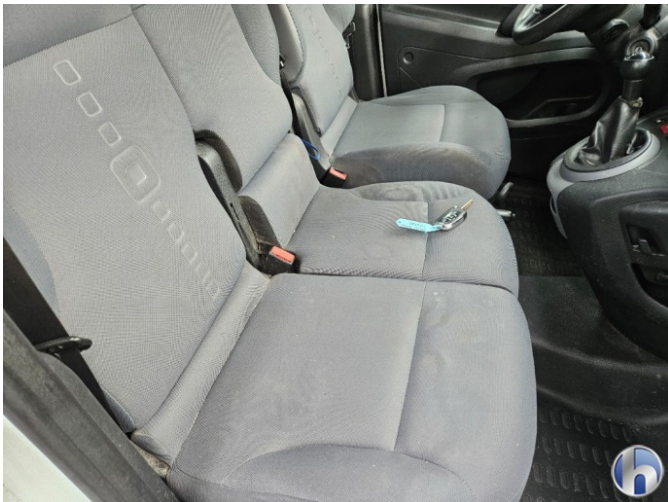
| component | Damage | Rep kind |
|---|---|---|
| 12. | Dirty | |

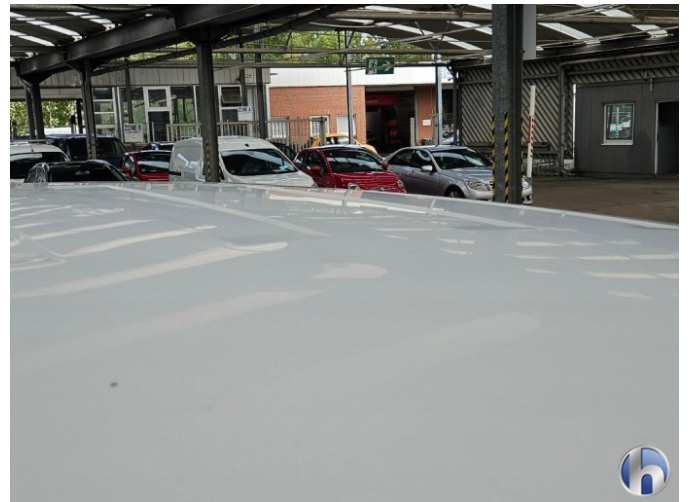
| component | Damage | Rep kind |
|---|---|---|
| 13. roof | Wear and tear | acceptable |

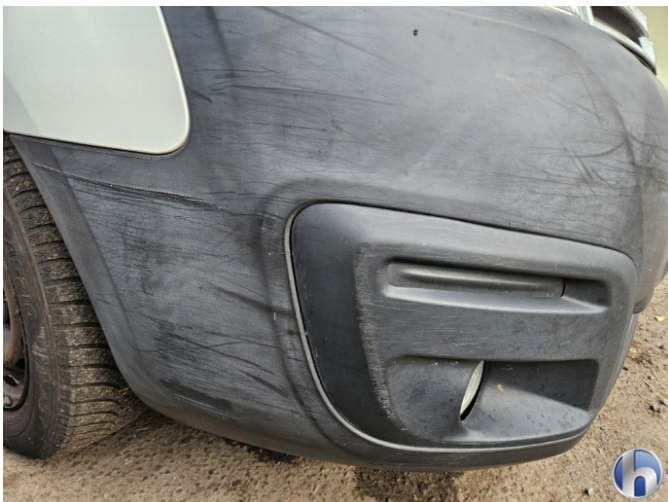
| component | Damage | Rep kind |
|---|---|---|
| 14. Front bumper | Wear and tear | acceptable |

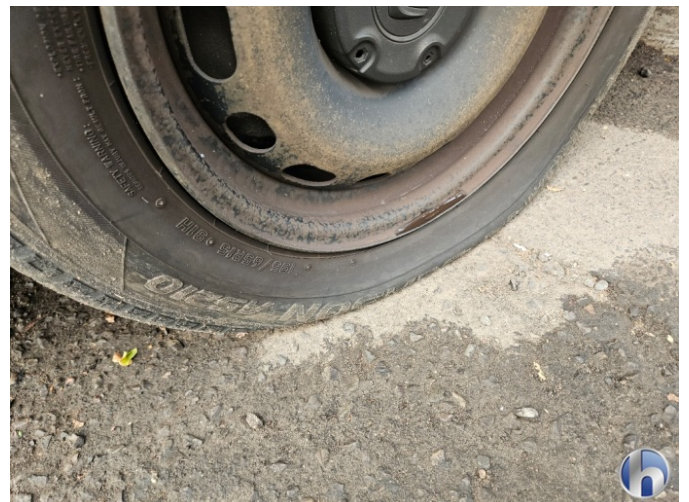
| General examination | |
|---|---|
| <b>Note Road Safe:</b> | Reifen beschädigt |

| component | Damage | Rep kind |
|---|---|---|
| 15. tire front - left | Damaged | Replace |

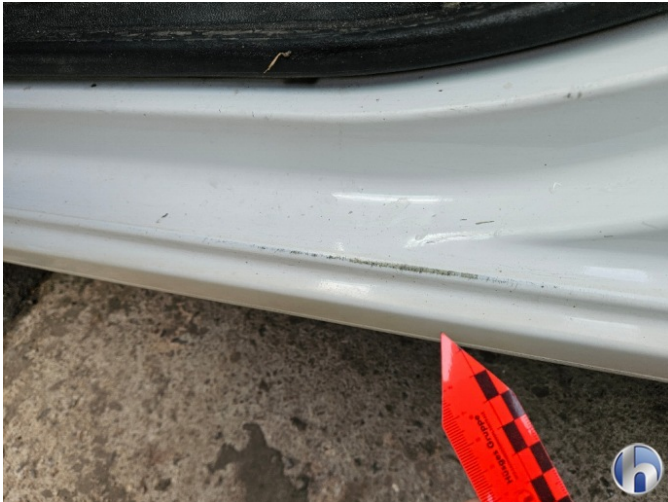
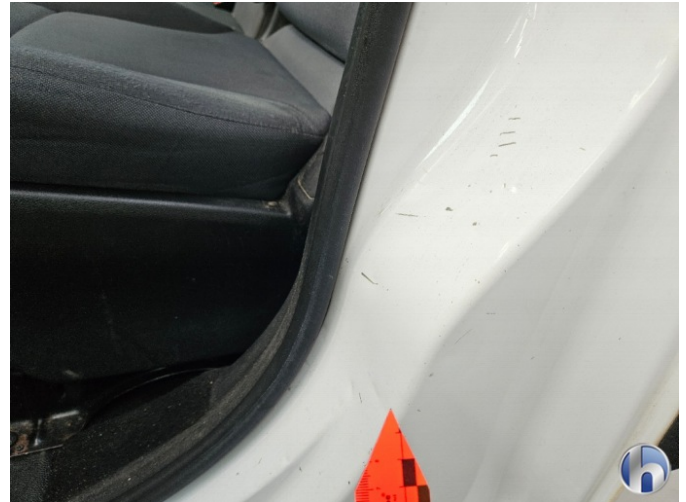
| component | Damage | Rep kind |
|---|---|---|
| 16. Türeinstieg Vorne - Links | Scrape | Paint |

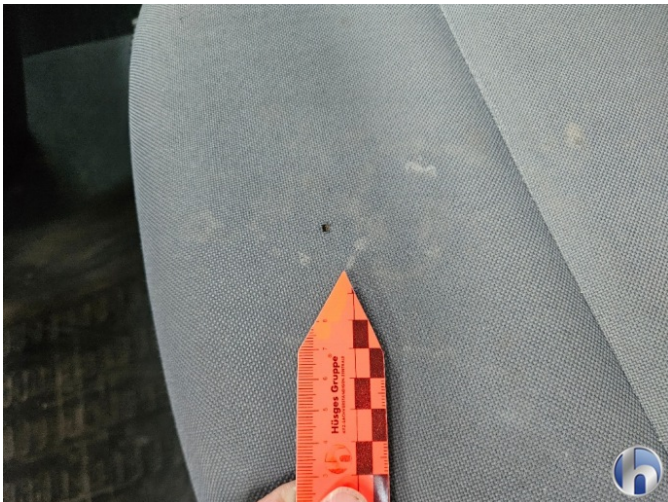
| component | Damage | Rep kind |
|---|---|---|
| 17. | Burn hole | Smart repair |

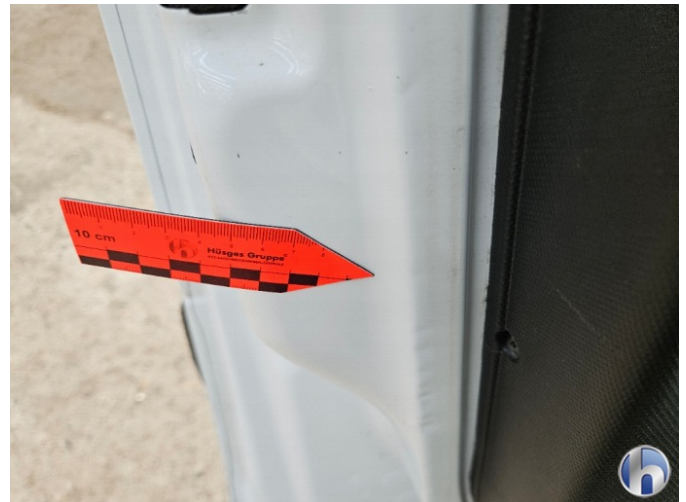
| component | Damage | Rep kind |
|---|---|---|
| 18. Front door - left | Wear and tear | acceptable |

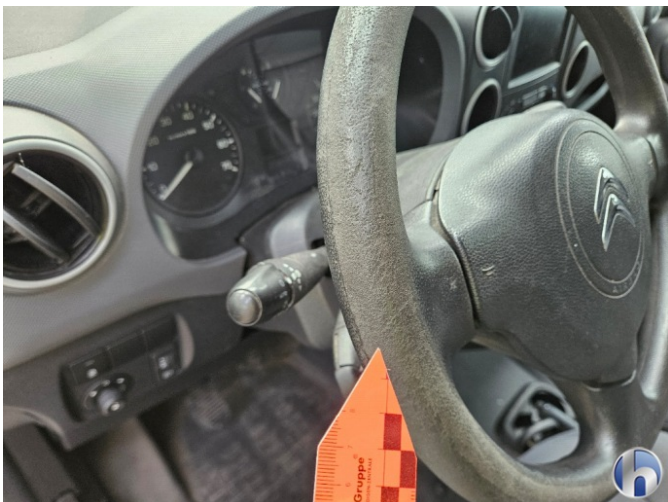
| component | Damage | Rep kind |
|---|---|---|
| 19. steering wheel | Wear and tear | acceptable |

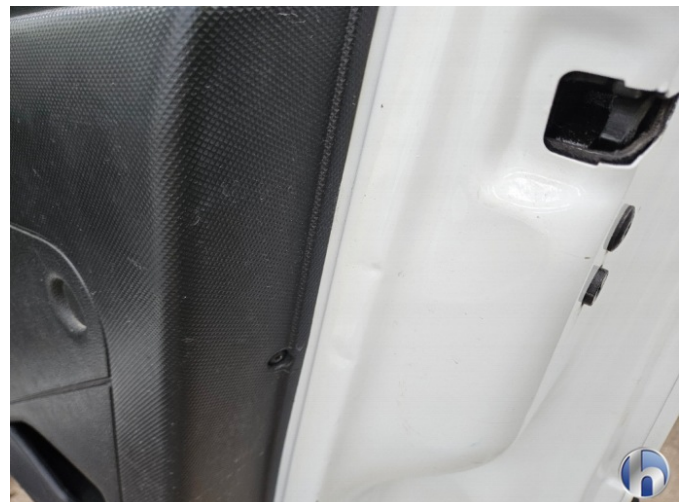
| component | Damage | Rep kind |
|---|---|---|
| 20. Front door - right | Wear and tear | acceptable |

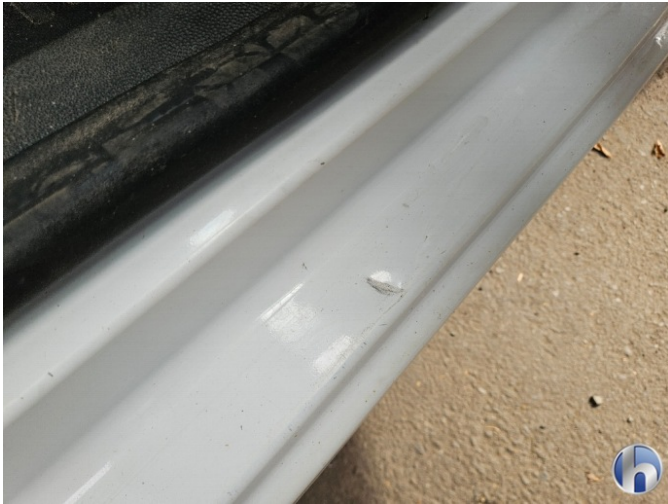
| component | Damage | Rep kind |
|---|---|---|
| 21. Türeinstieg Vorne - Rechts | Wear and tear | acceptable |
