## status report

#### Citroën Berlingo Kombi Selection

| Vehicle identification number | <b>VF77JBHY6FJ800076</b> | mileage read: | <b>121684 km</b> |

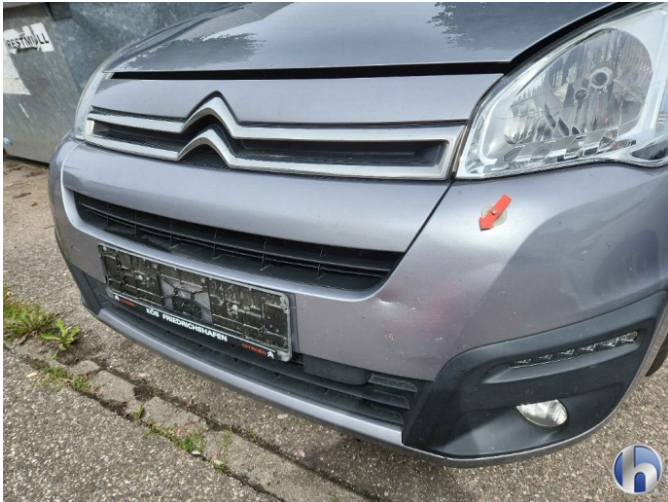
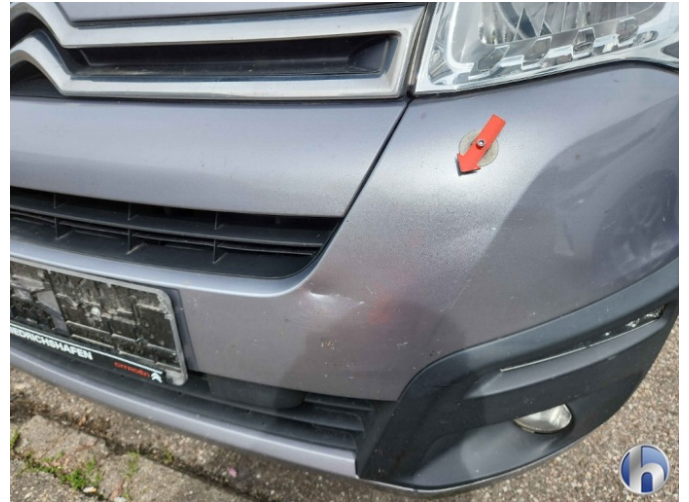
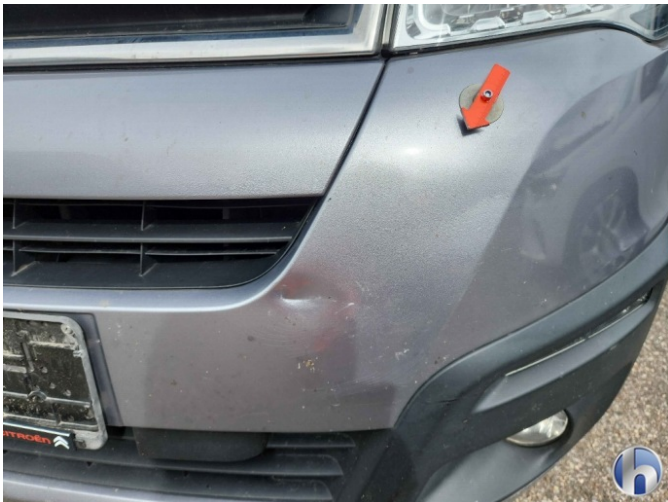
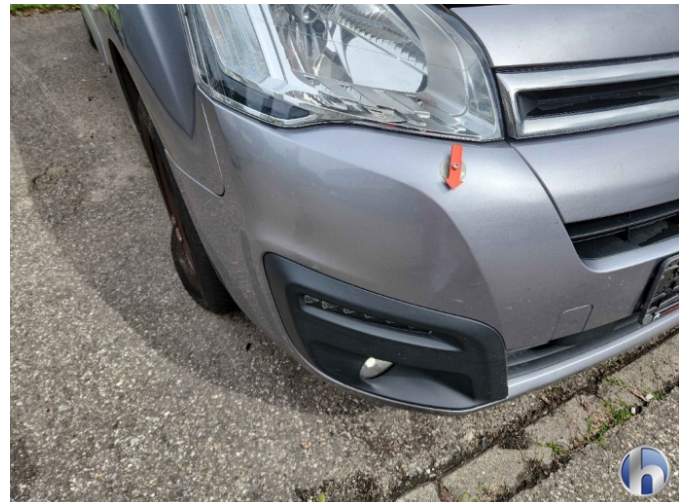
| | <b>component</b> | <b>Damage</b> | <b>Rep kind</b> |
|---|---|---|---|
| 1. | Front bumper | Damaged | Replace |

1. Front bumper

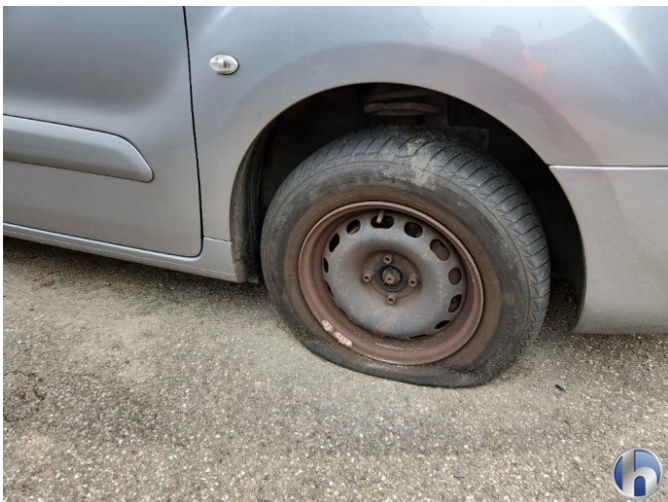
| | <b>component</b> | <b>Damage</b> | <b>Rep kind</b> |
|---|---|---|---|
| 2. | tire front - right | Damaged | Replace |

2. tire front - right

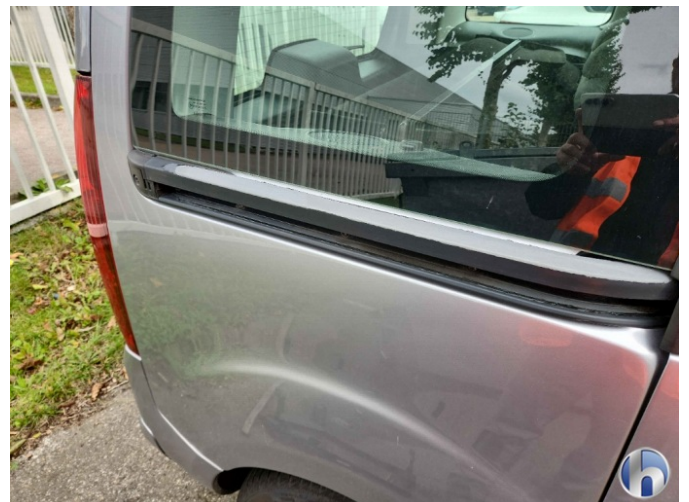
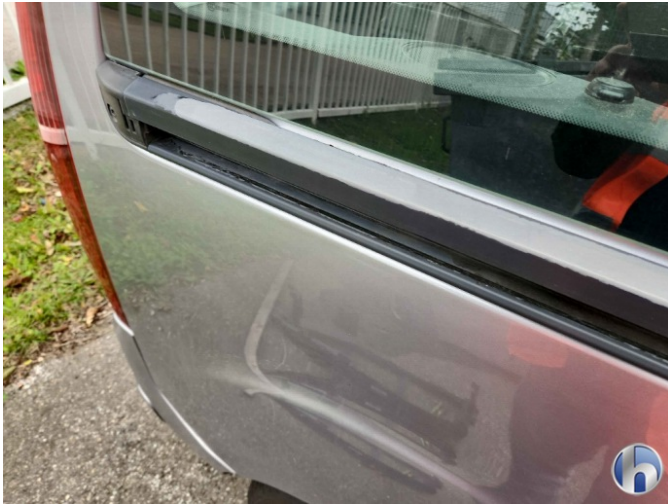
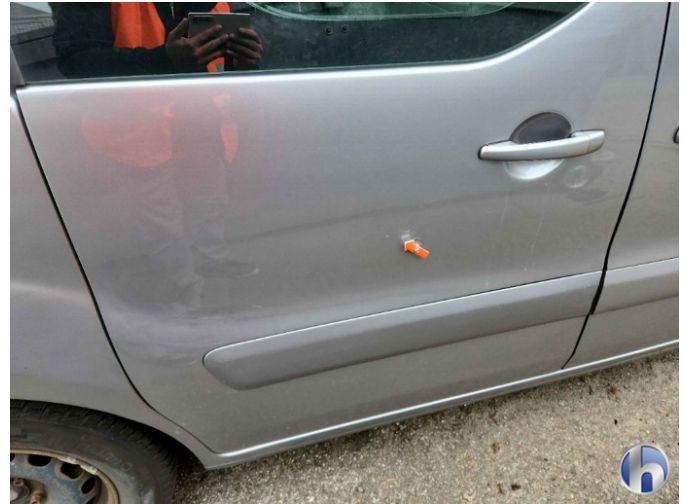
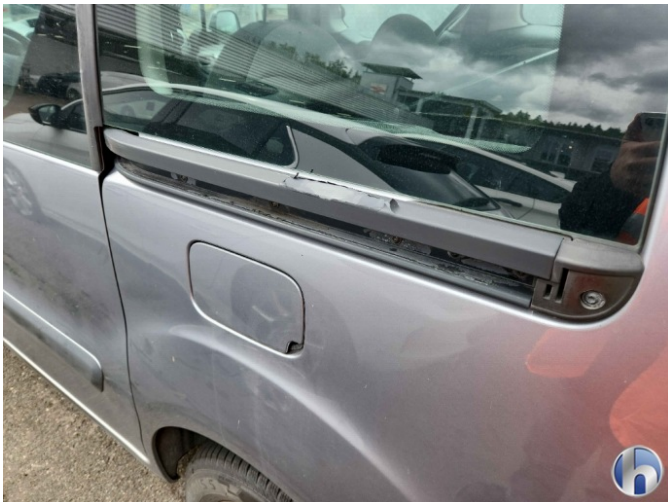
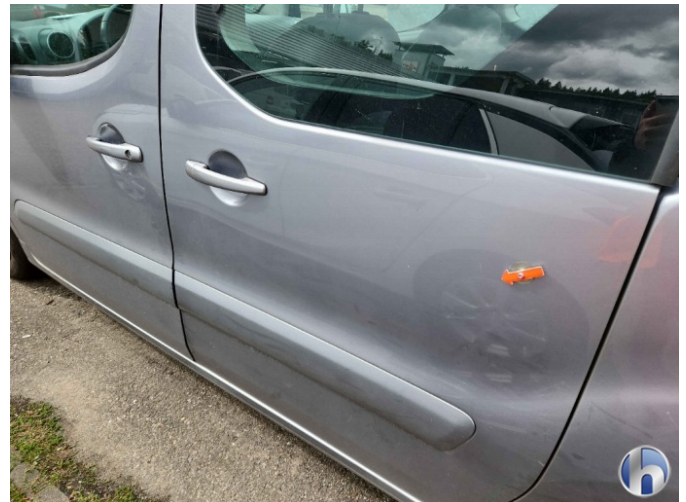
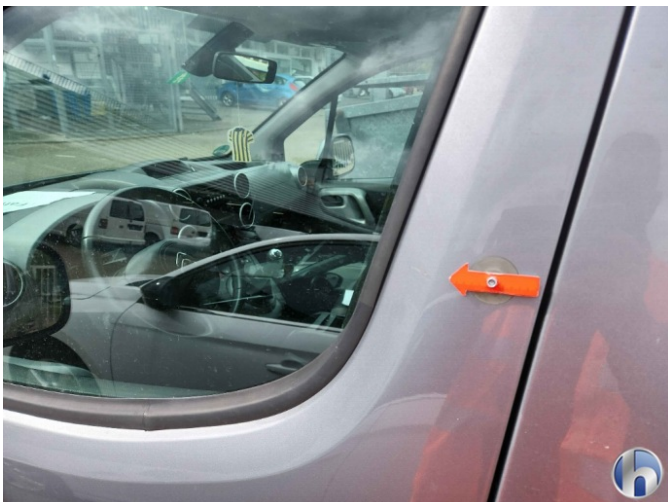
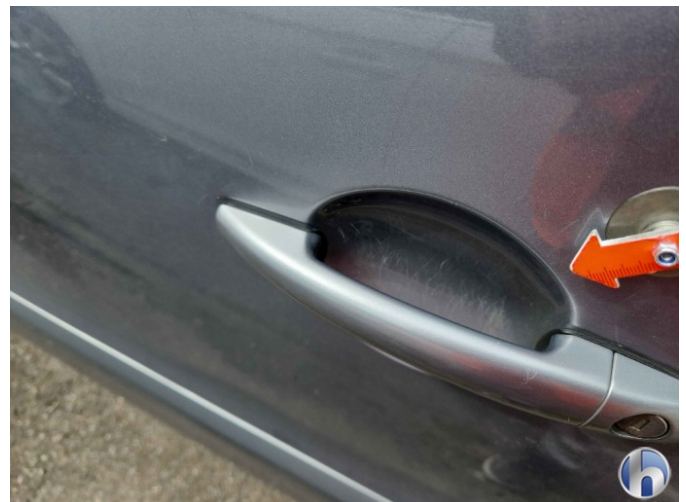
| | <b>component</b> | <b>Damage</b> | <b>Rep kind</b> |
|---|---|---|---|
| 3. | Fahrzeug Aussen Gebrauch Spuren<br>(Kratzer,dellen) | Damaged | |

3. Fahrzeug Aussen Gebrauch Spuren (Kratzer,dellen)

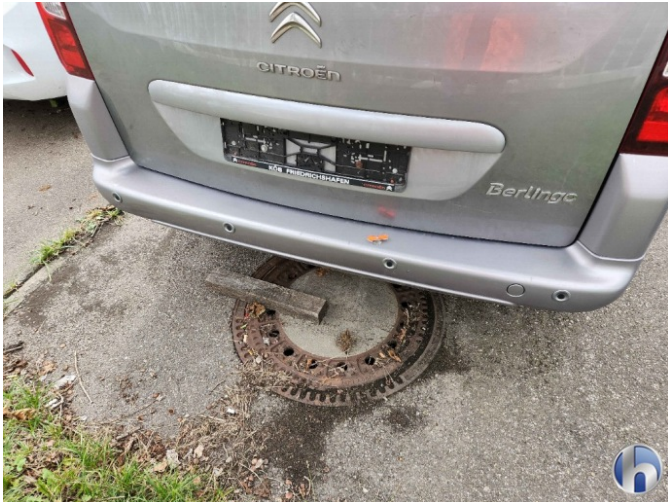
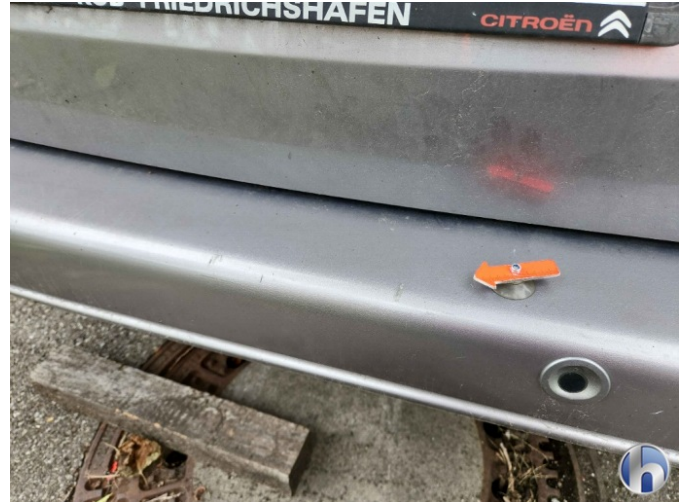
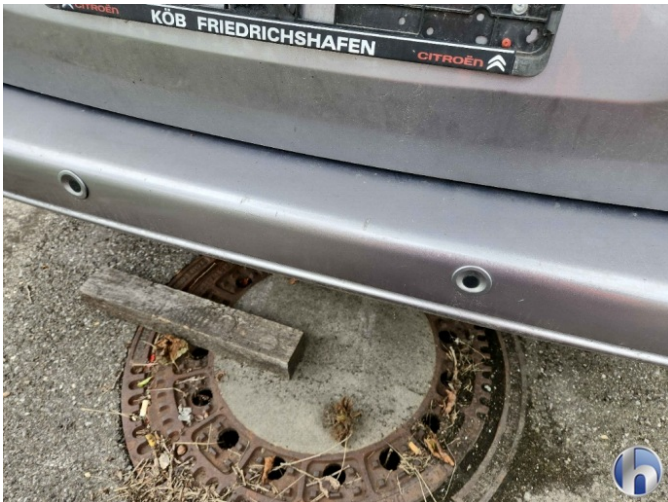
| | <b>component</b> | <b>Damage</b> | <b>Rep kind</b> |
|---|---|---|---|
| 4. | Rear bumper | Damaged | Replace |

4. Rear bumper

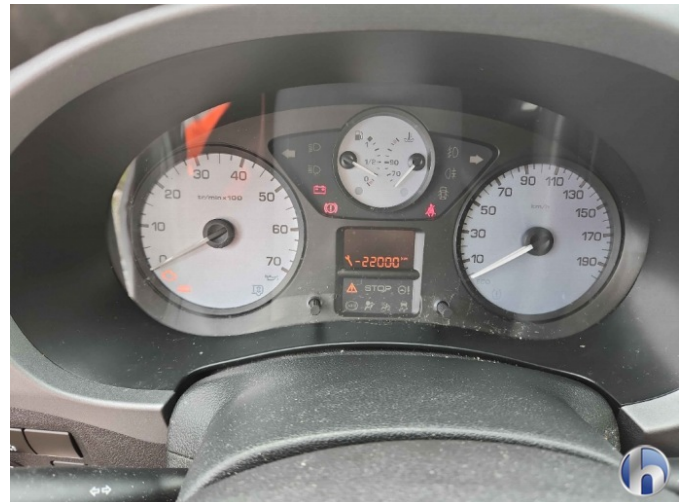
| | <b>component</b> | <b>Damage</b> | <b>Rep kind</b> |
|---|---|---|---|
| 5. | Service | Due | Replace |

5. Service

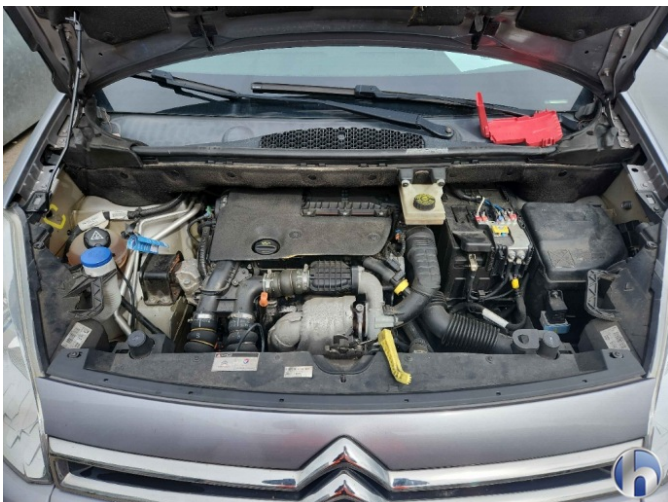
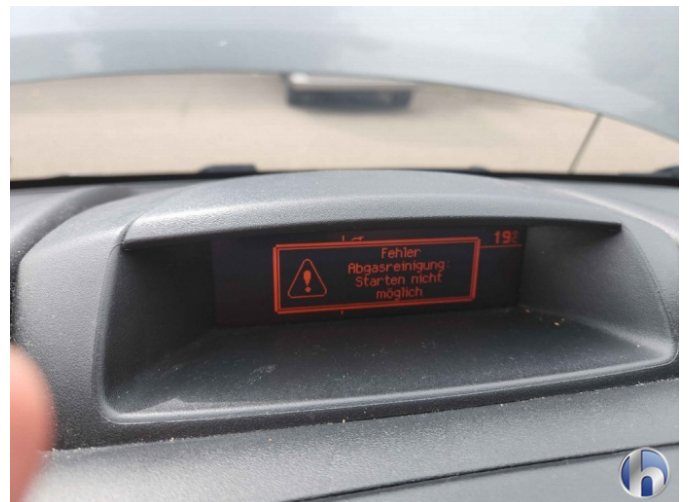
| Performed testing technology | |
|---|---|
| <b>engine running:</b> | A field test of the engine could not be performed<br>*Motorhaube Startet nicht |

| | <b>component</b> | <b>Damage</b> | <b>Rep kind</b> |
|---|---|---|---|
| 6. | motor | No functionality | Carry out a fault diagnosis |

6. motor

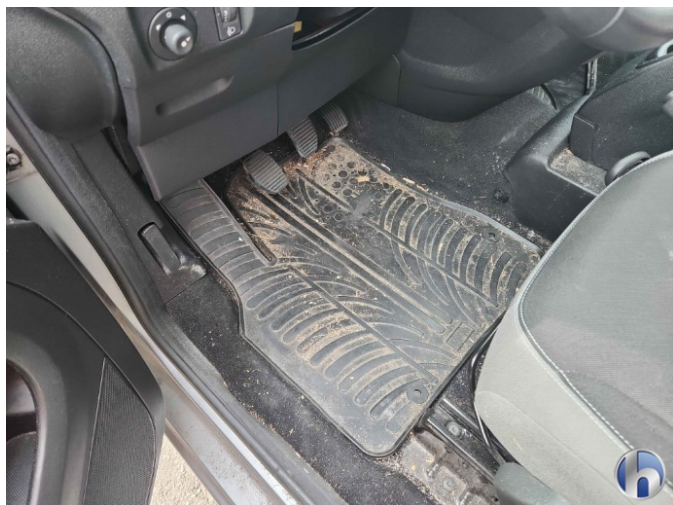
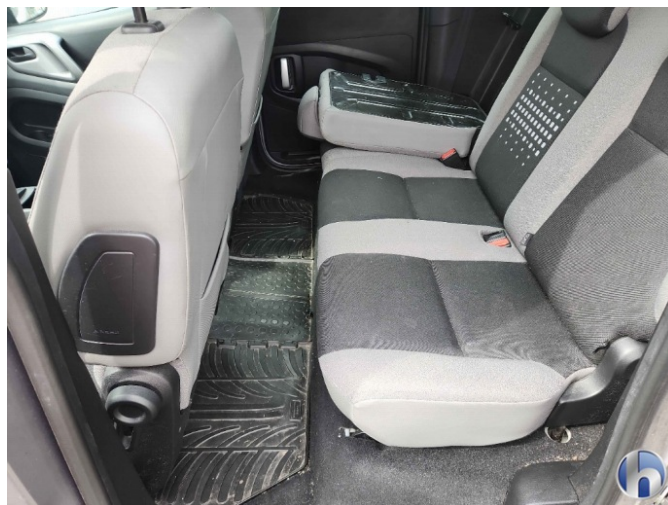
| | <b>component</b> | <b>Damage</b> | <b>Rep kind</b> |
|---|---|---|---|
| 7. | | Dirty (strong) | |

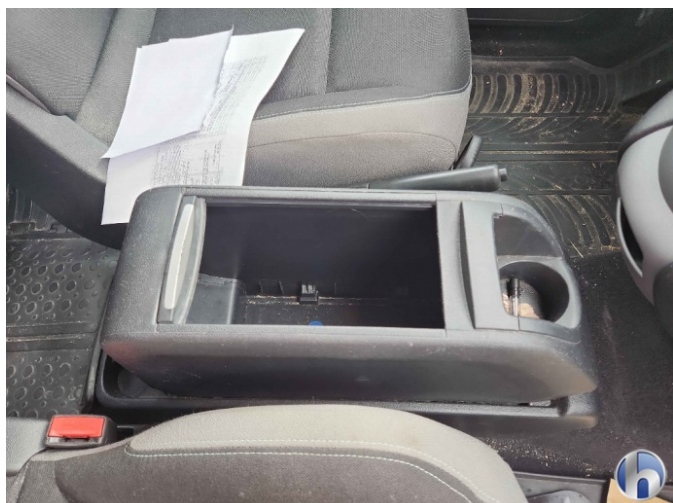
| | <b>component</b> | <b>Damage</b> | <b>Rep kind</b> |
|---|---|---|---|
| 8. | center console - flap | Damaged | Replace |

8. center console - flap

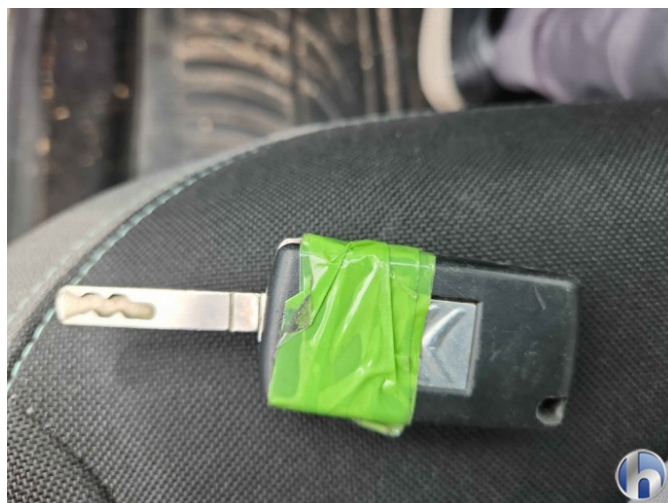
| | <b>component</b> | <b>Damage</b> | <b>Rep kind</b> |
|---|---|---|---|
| 9. | key | Damaged | Replace |

9. key
