## status report

| <b>contract number:</b> | <b>618229170-INSO</b> |

| vehicle data | | | |
|---|---|---|---|
| <b>Citroën Berlingo Kombi Selection</b> | | | |
| Vehicle identification number | <b>VF77JBHY6GJ832162</b> | mileage read: | <b>117178 km</b> |

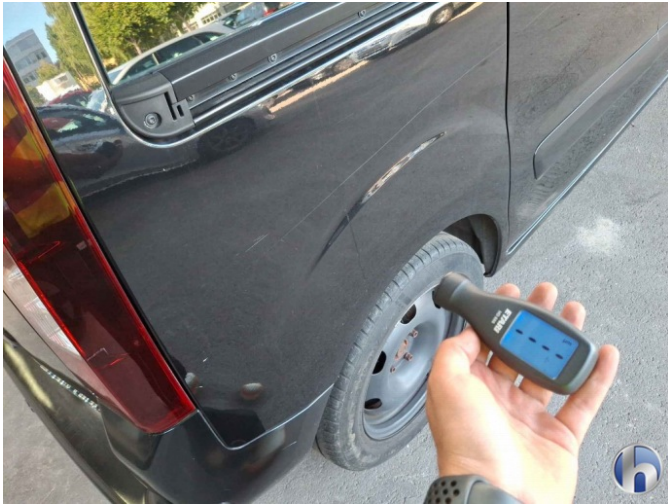
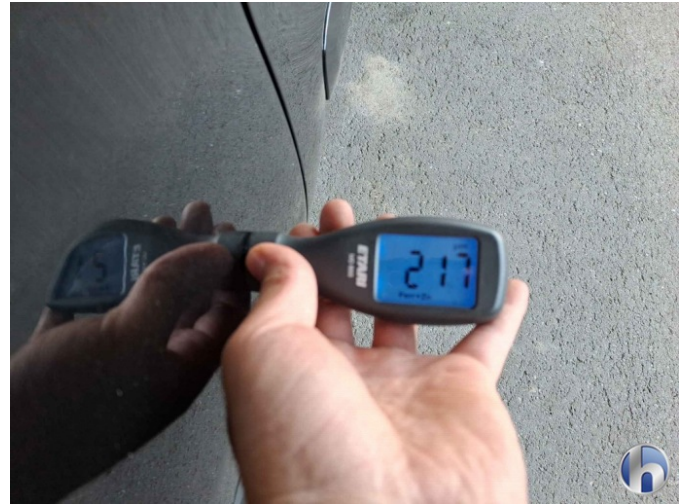
| component | Damage | Rep kind |
|---|---|---|
| 1. Sidewall - Rear - right | Subsequently painted | acceptable |

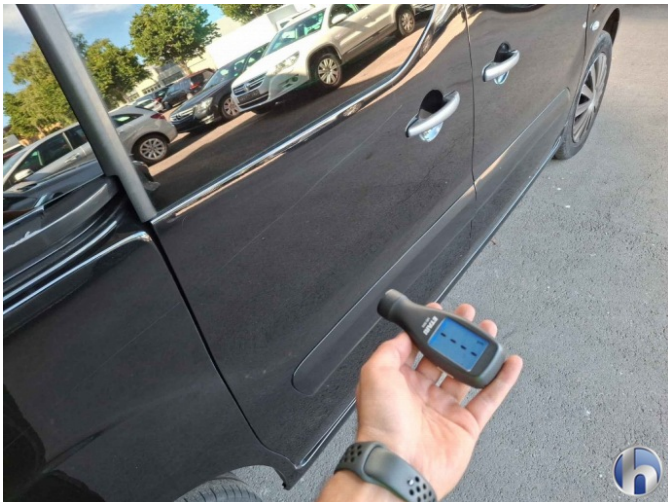
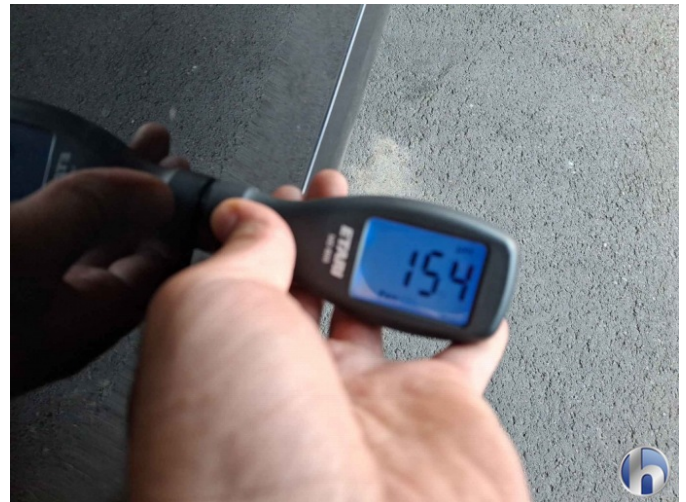
| component | Damage | Rep kind |
|---|---|---|
| 2. Door Rear - right | Subsequently painted | acceptable |

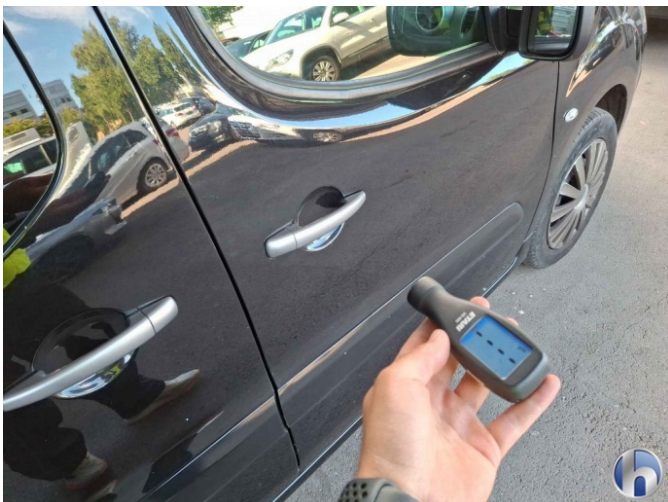
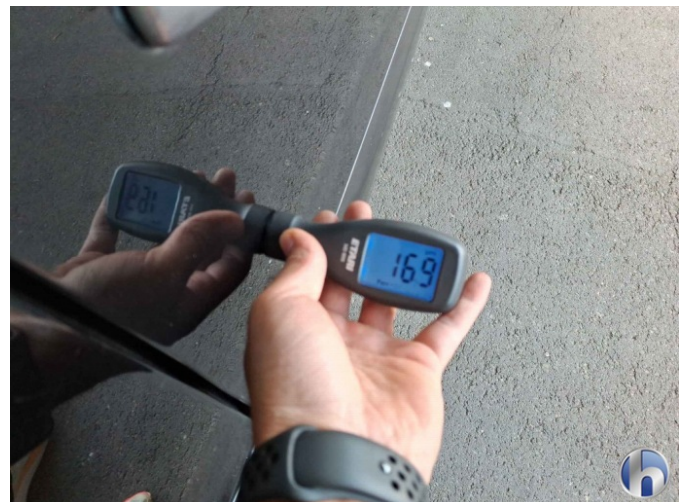
| component | Damage | Rep kind |
|---|---|---|
| 3. Front door - right | Subsequently painted | acceptable |

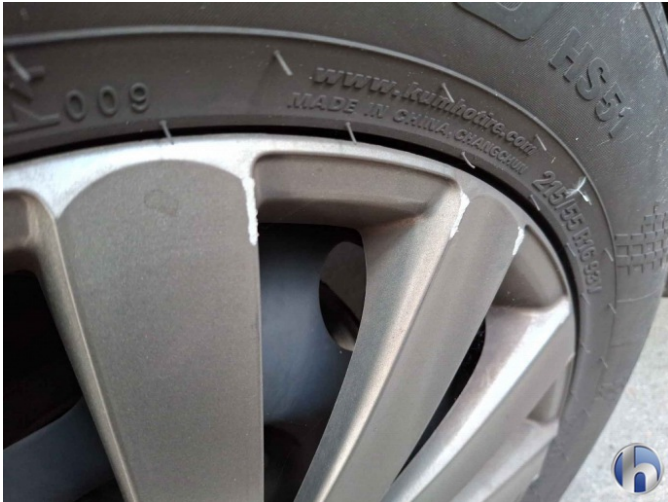
| component | Damage | Rep kind |
|---|---|---|
| 5. Rim front - left | Scratch(es) | Paint |

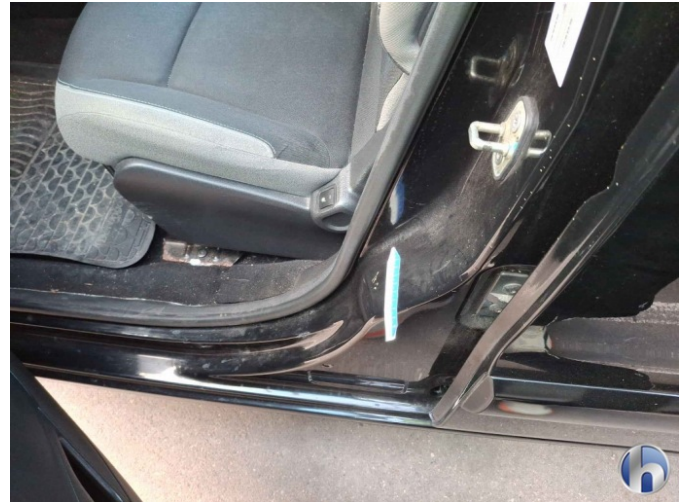
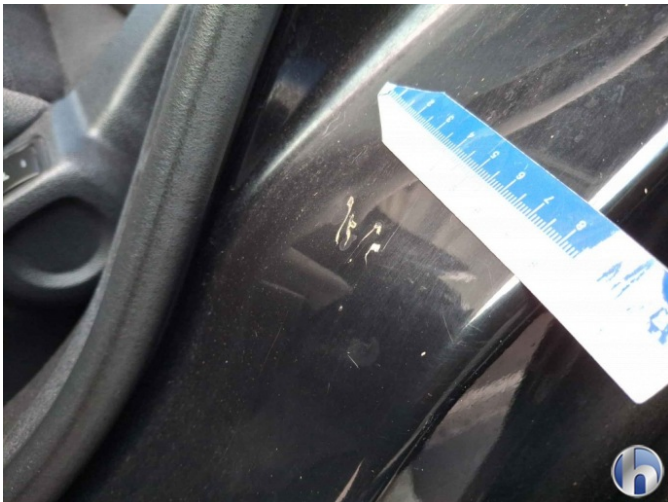
| component | Damage | Rep kind |
|---|---|---|
| 6. Türeinstieg Vorne - Links | Scratch(es) | Paint |

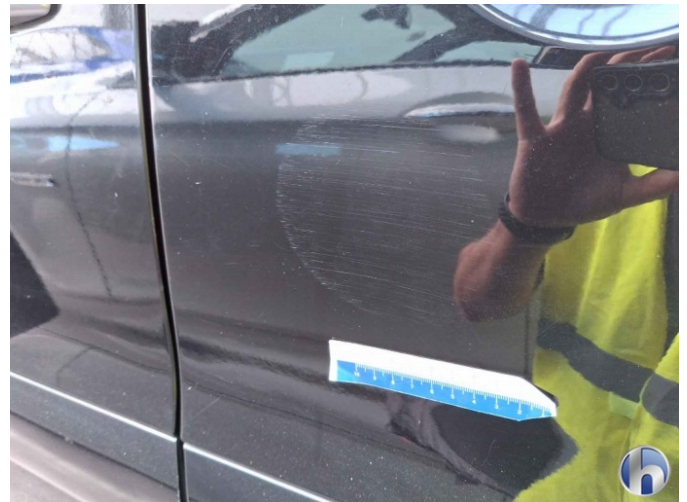
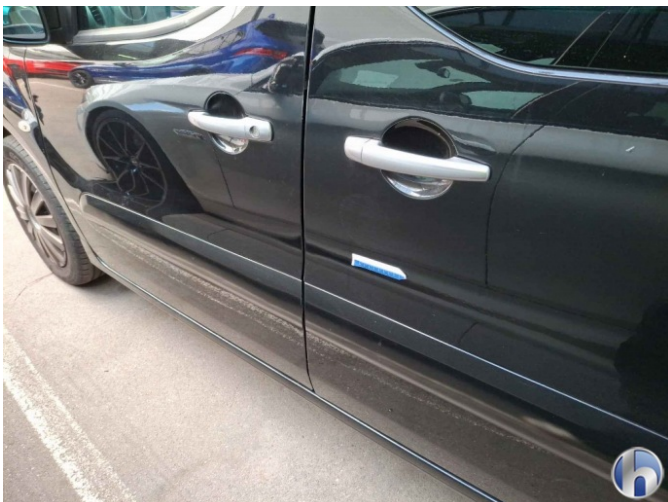
| component | Damage | Rep kind |
|---|---|---|
| 7. Rear door - left | Scrape | Refurbish and paint |

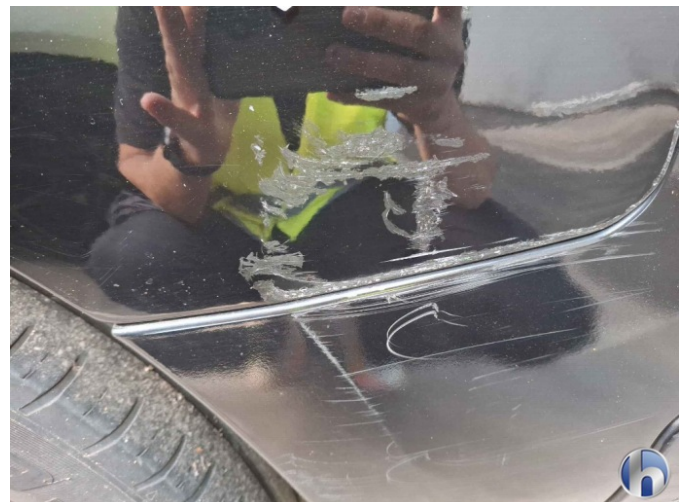
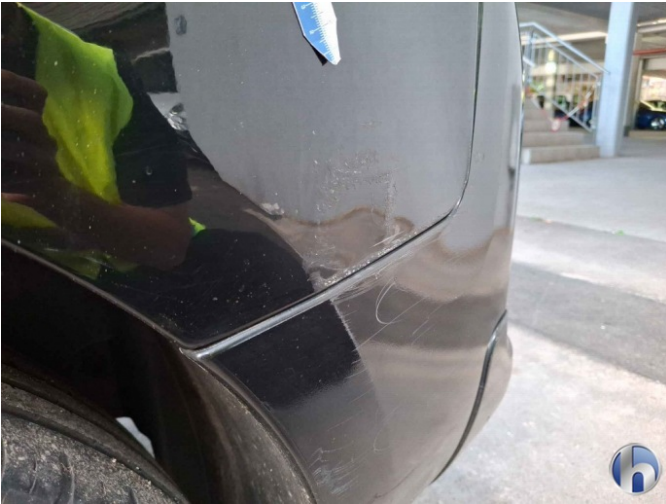
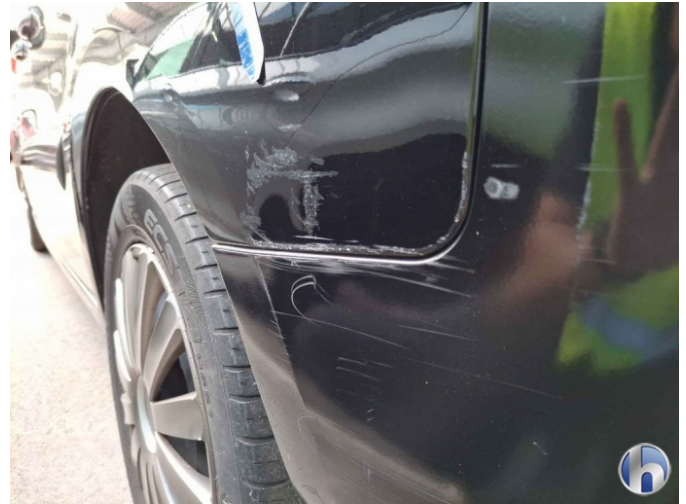
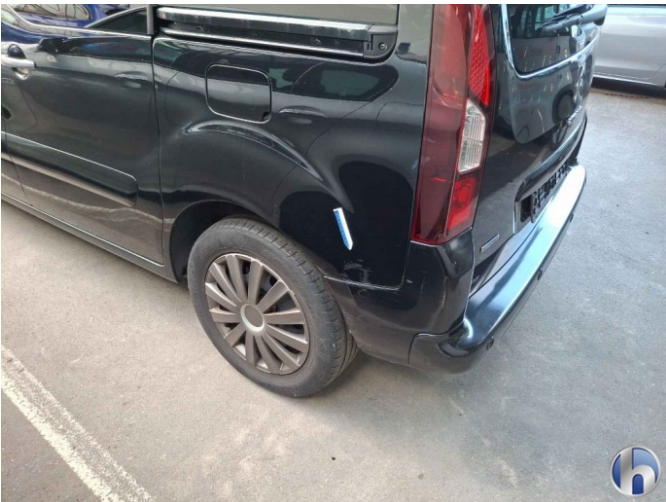
| component | Damage | Rep kind |
|---|---|---|
| 8. Sidewall - Rear - Left | Accident damage | Refurbish and paint |

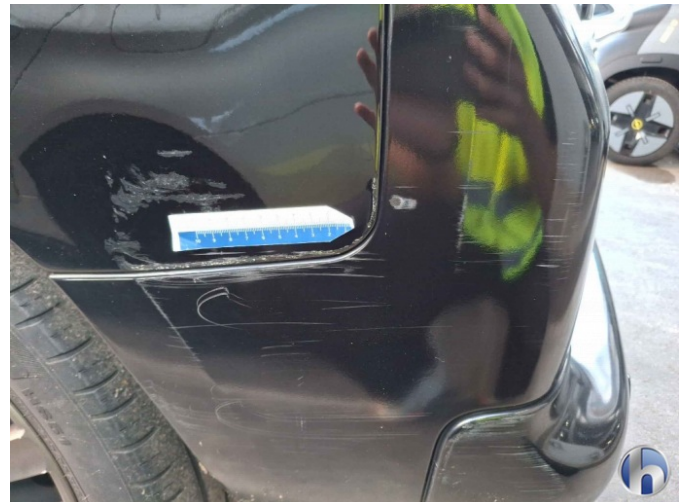
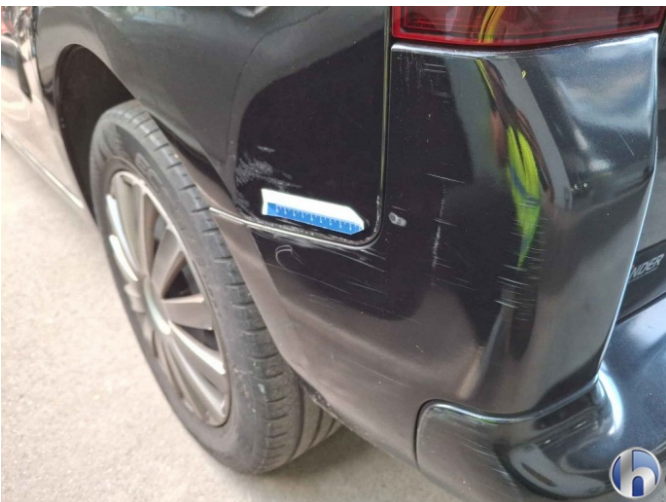
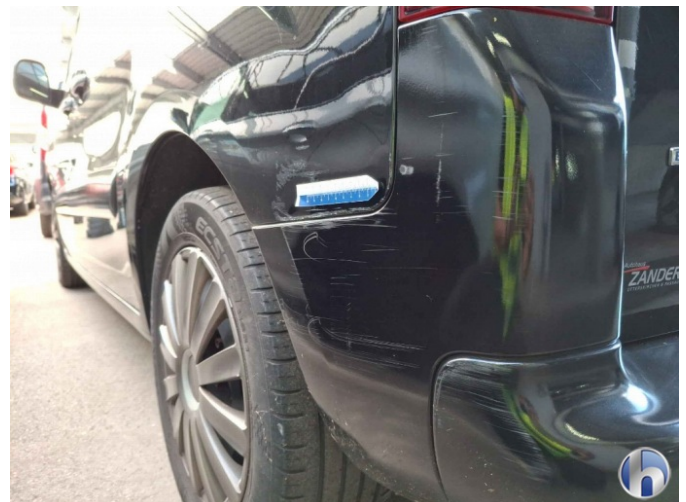
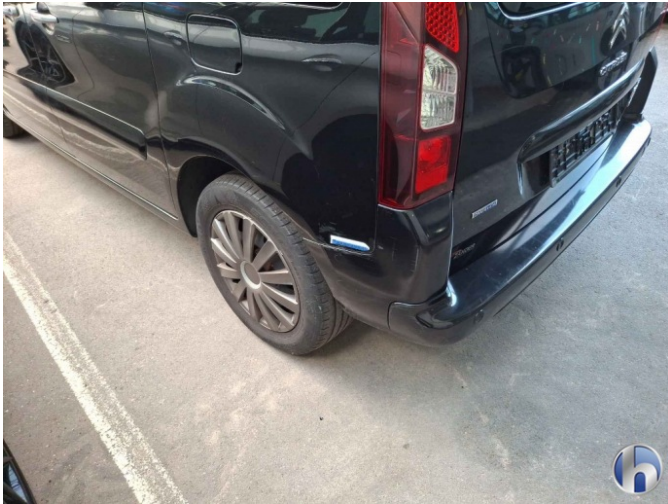
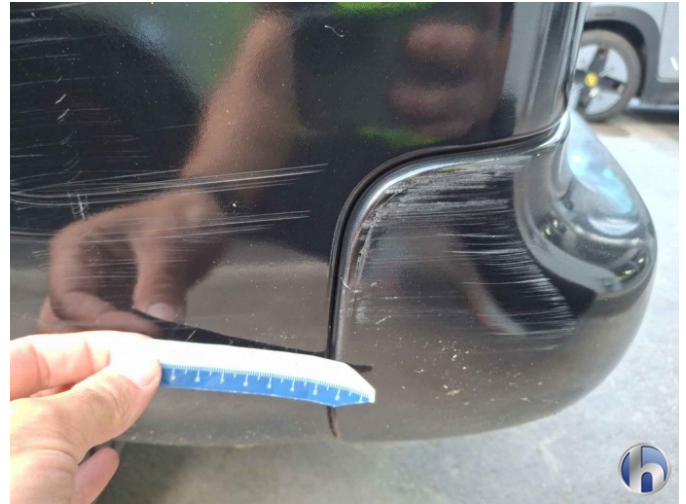
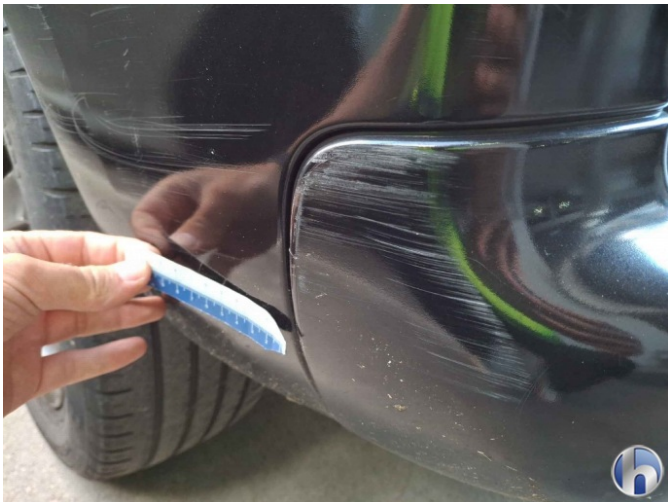
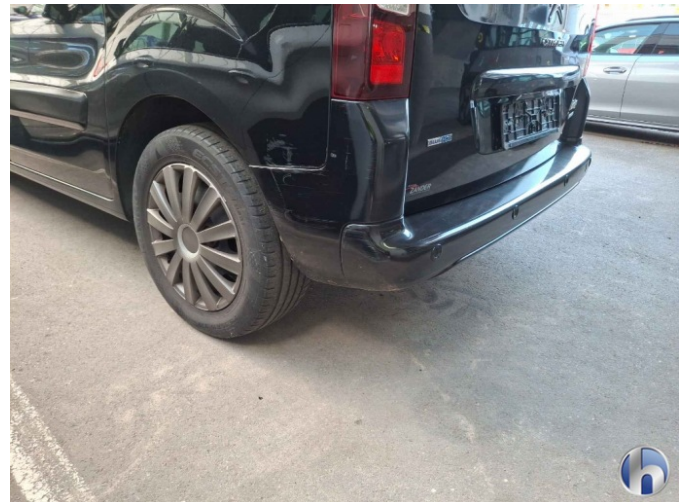
| component | Damage | Rep kind |
|---|---|---|
| 9. Rear bumper | Accident damage | Refurbish and paint |

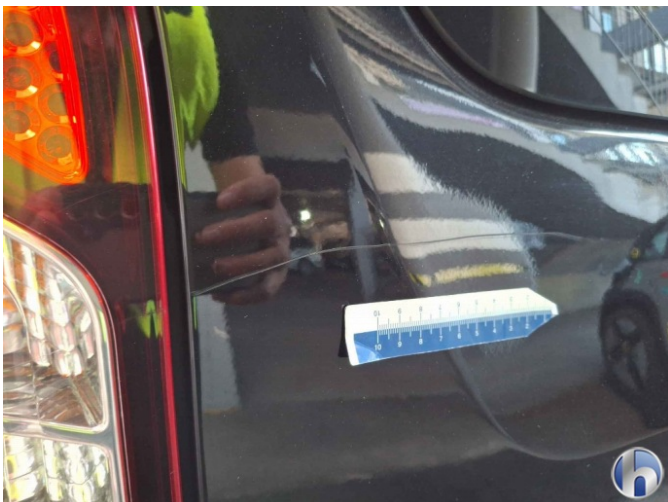
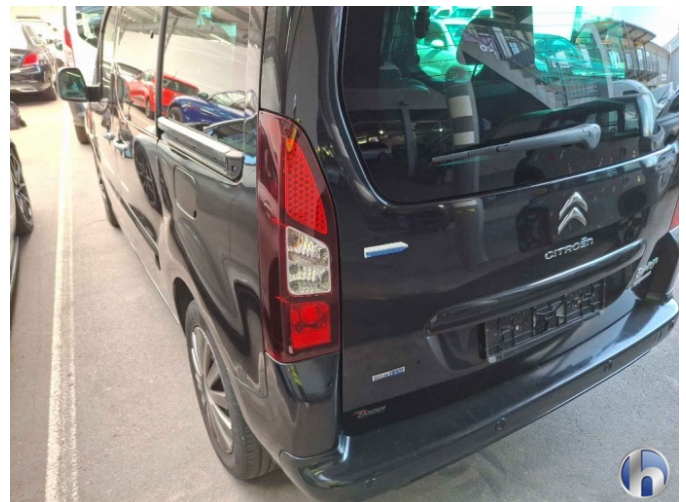
| component | Damage | Rep kind |
|---|---|---|
| 10. tailgate | Scratch(es) | Paint |

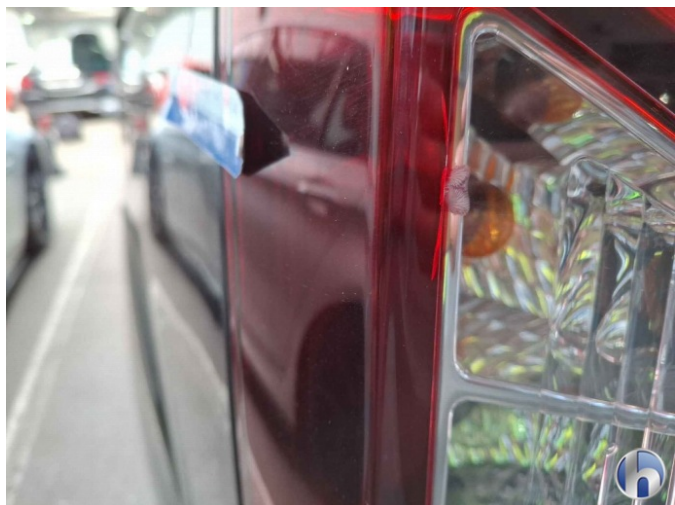
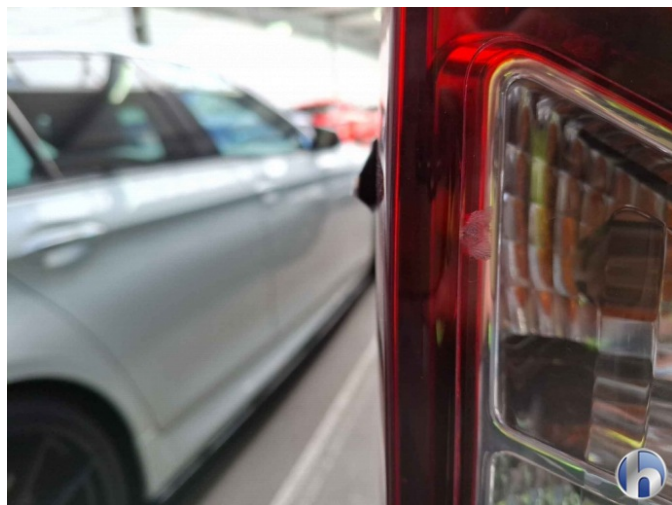
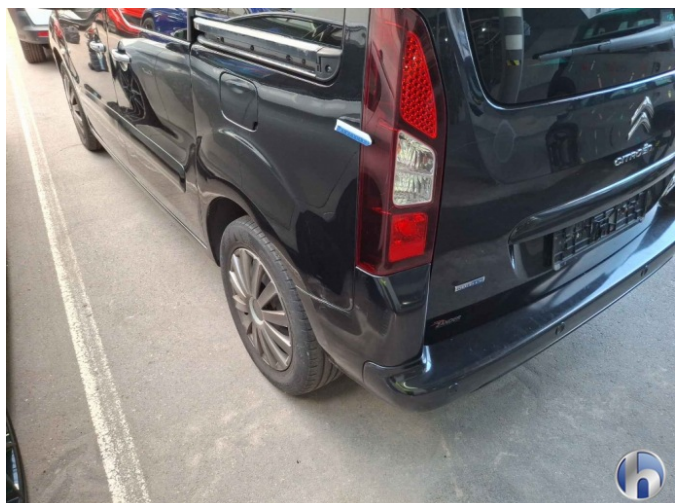
| component | Damage | Rep kind |
|---|---|---|
| 11. Taillight left | Accident damage | Replace |

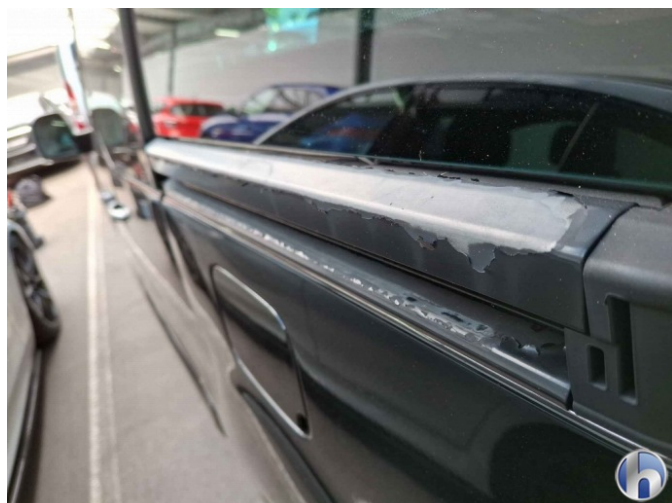
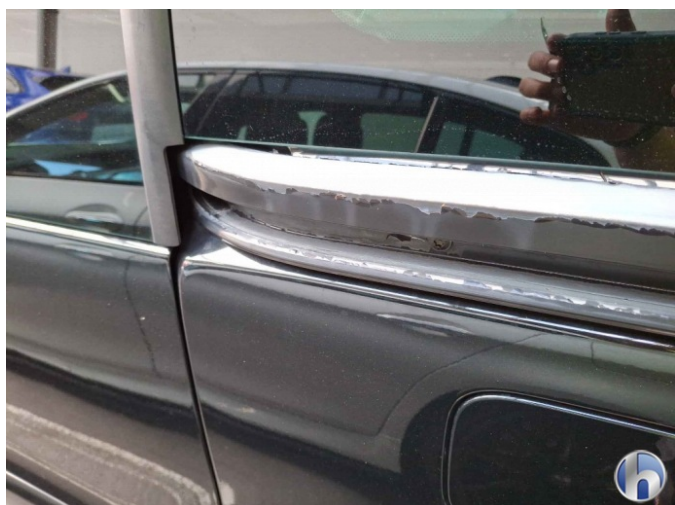
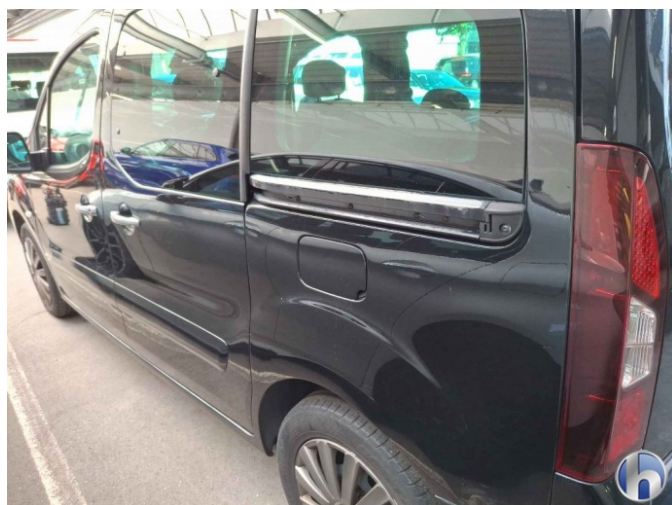
| component | Damage | Rep kind |
|---|---|---|
| 12. Sidewall - Rear - Left | Wear and tear | acceptable |

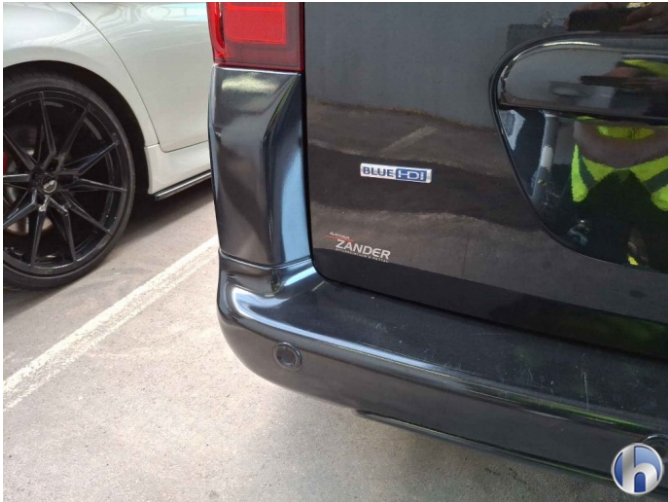
| component | Damage | Rep kind |
|---|---|---|
| 13. tailgate | Sticker | |

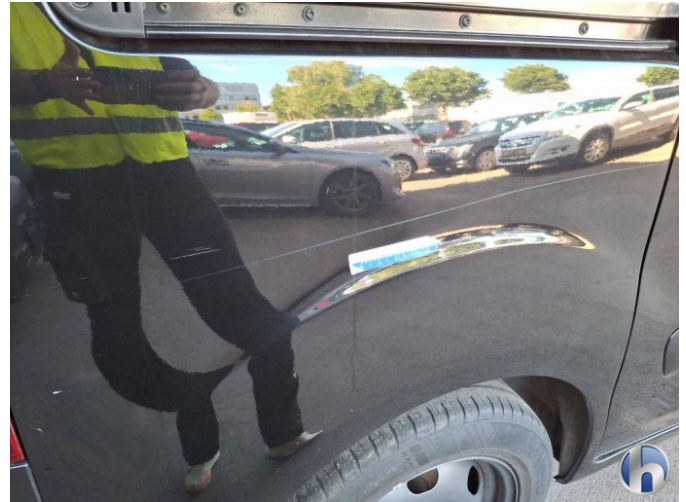
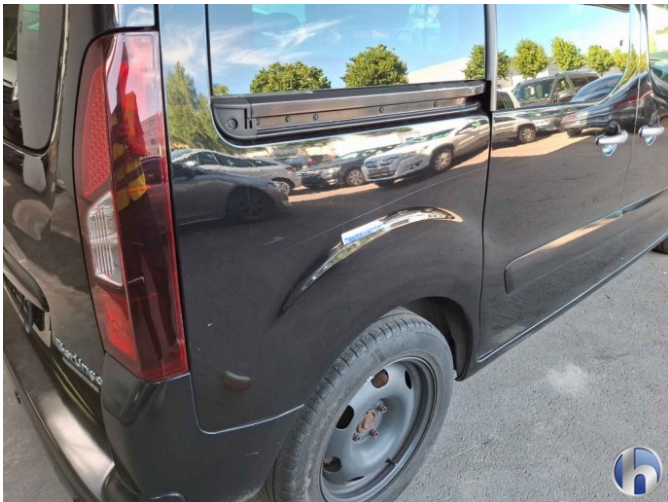
| component | Damage | Rep kind |
|---|---|---|
| 14. Sidewall - Rear - right | Scratch(es) | Paint |

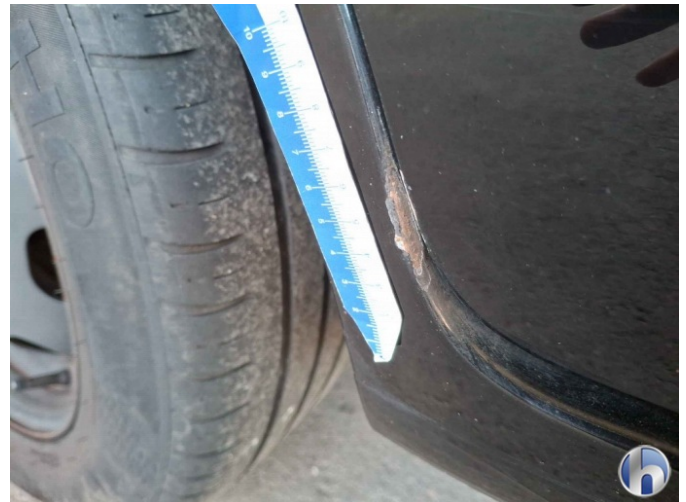
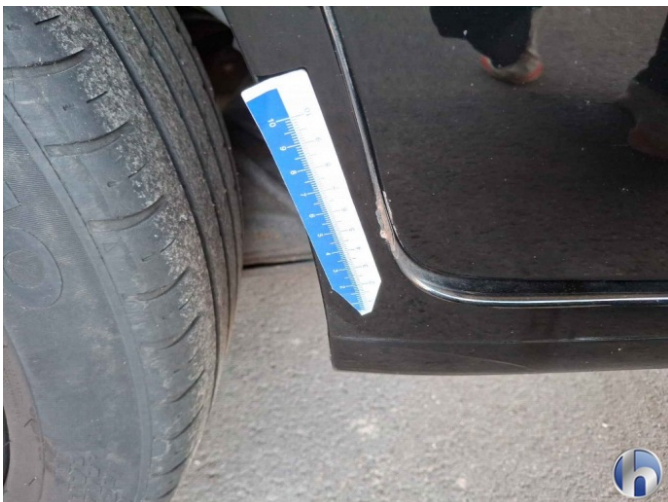
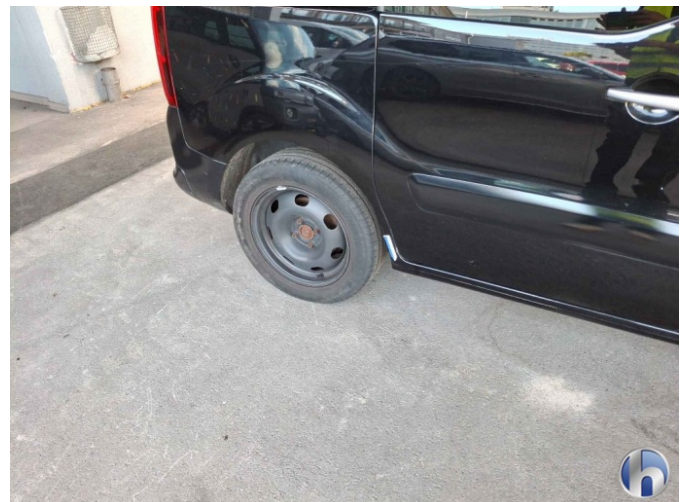
| component | Damage | Rep kind |
|---|---|---|
| 15. side skirt - right | Scrape | Refurbish and paint |

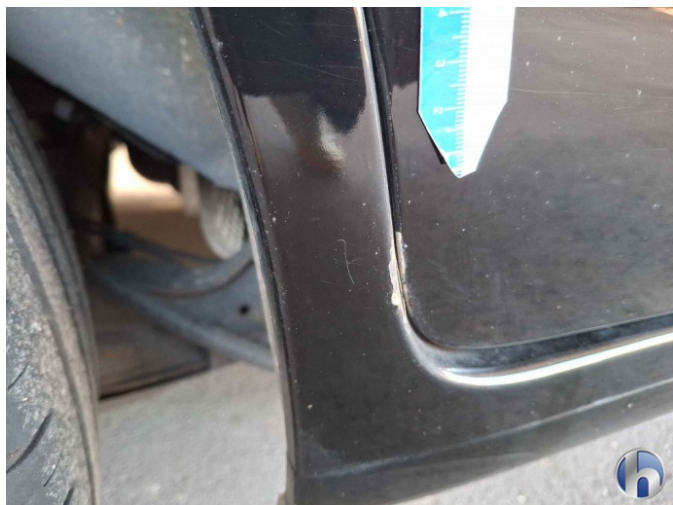
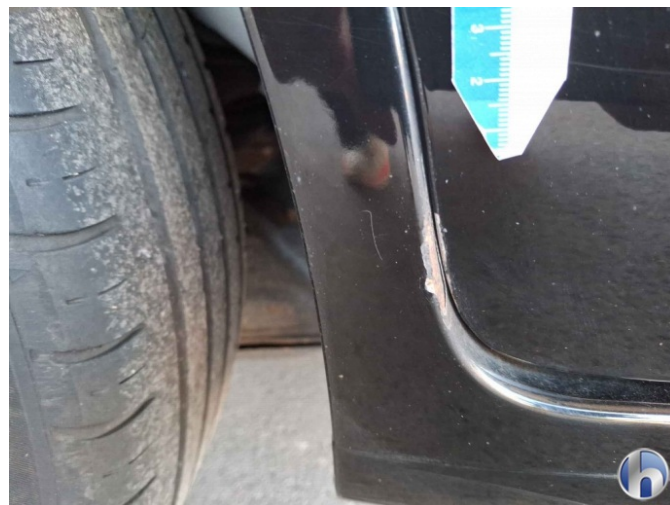
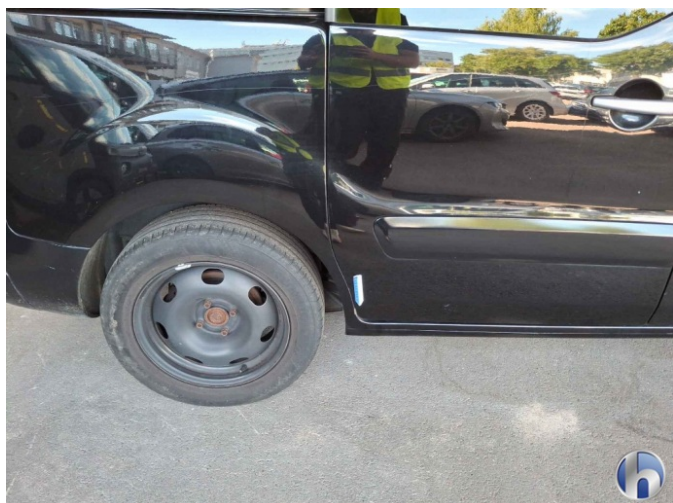
| component | Damage | Rep kind |
|---|---|---|
| 16. Door Rear - right | Scrape | Refurbish and paint |

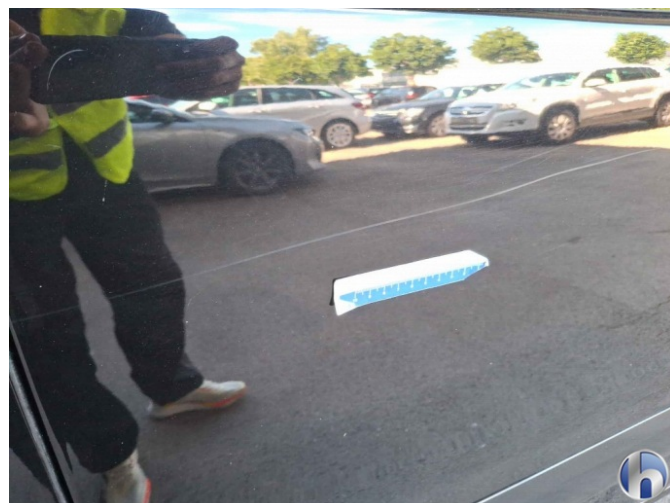
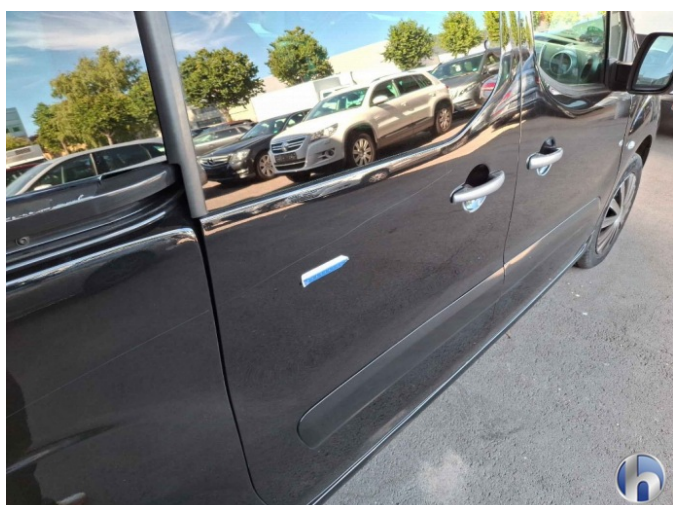
| component | Damage | Rep kind |
|---|---|---|
| 17. Door Rear - right | Scratch(es) | Paint |

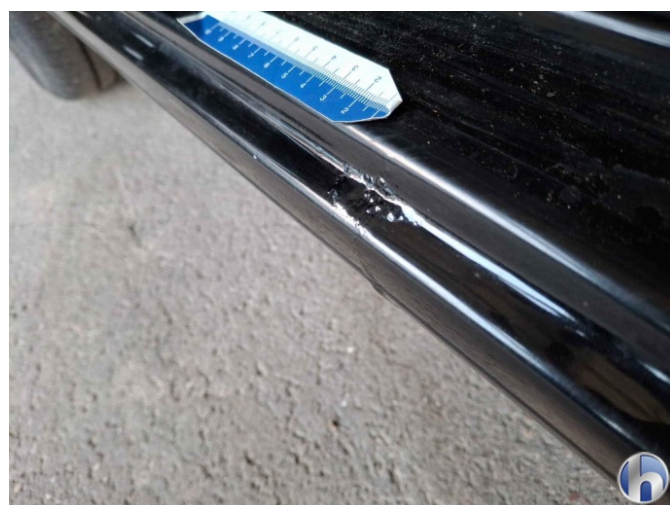
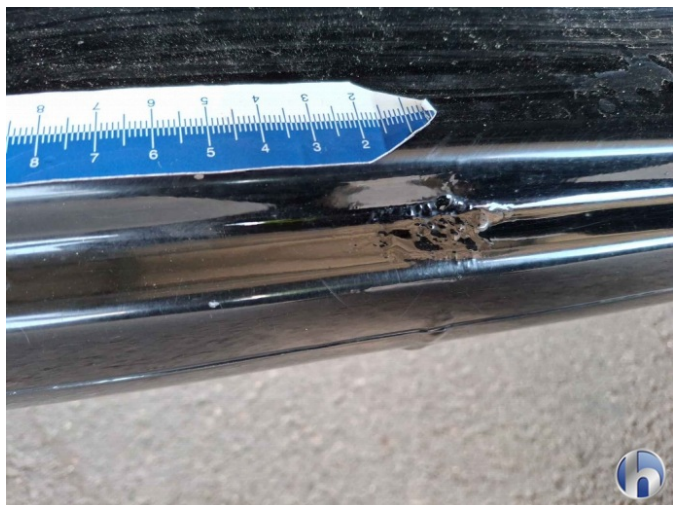
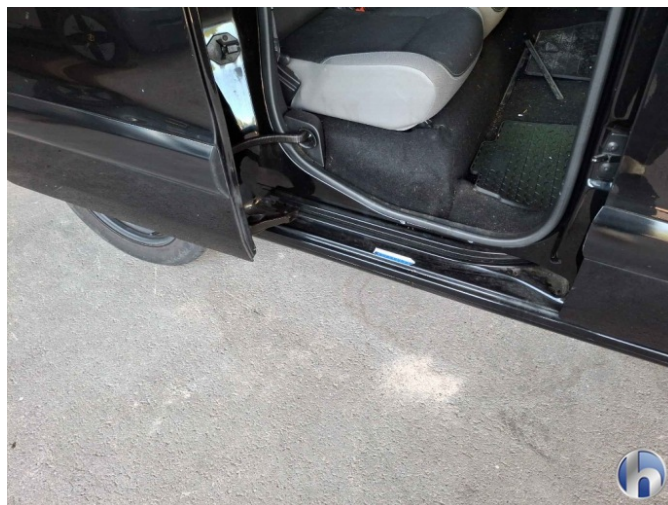
| component | Damage | Rep kind |
|---|---|---|
| 18. side skirt - right | Subsequently painted | acceptable |

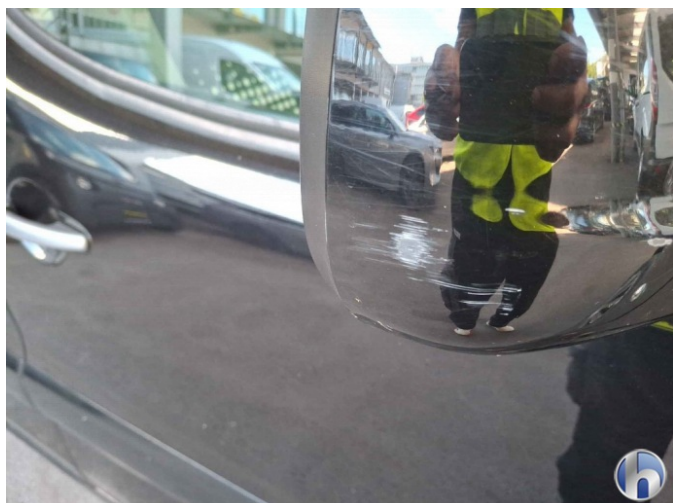
| component | Damage | Rep kind |
|---|---|---|
| 19. Outside mirror - right | Scratch(es) | Paint |

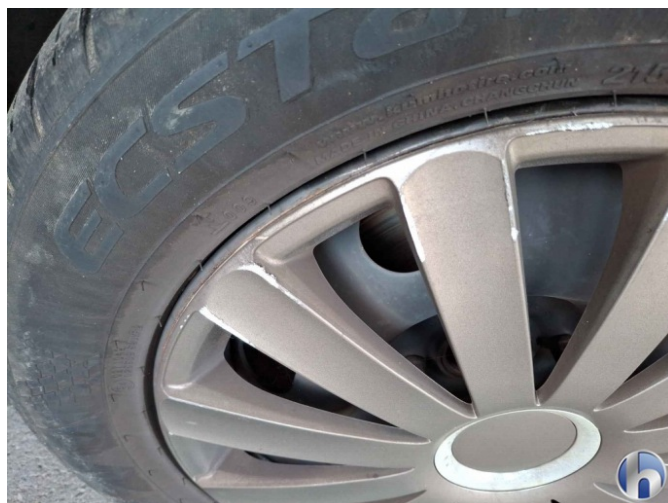
| component | Damage | Rep kind |
|---|---|---|
| 20. Rim rear - left | Scratch(es) | Paint |
