# CITROEN C4

## C4 HDi 92

VIN NO VF7LC9HXC74617149  
Registration Number AK152JK

| Customer | BCAuto Encheres | Report Number | P20250612032317 |

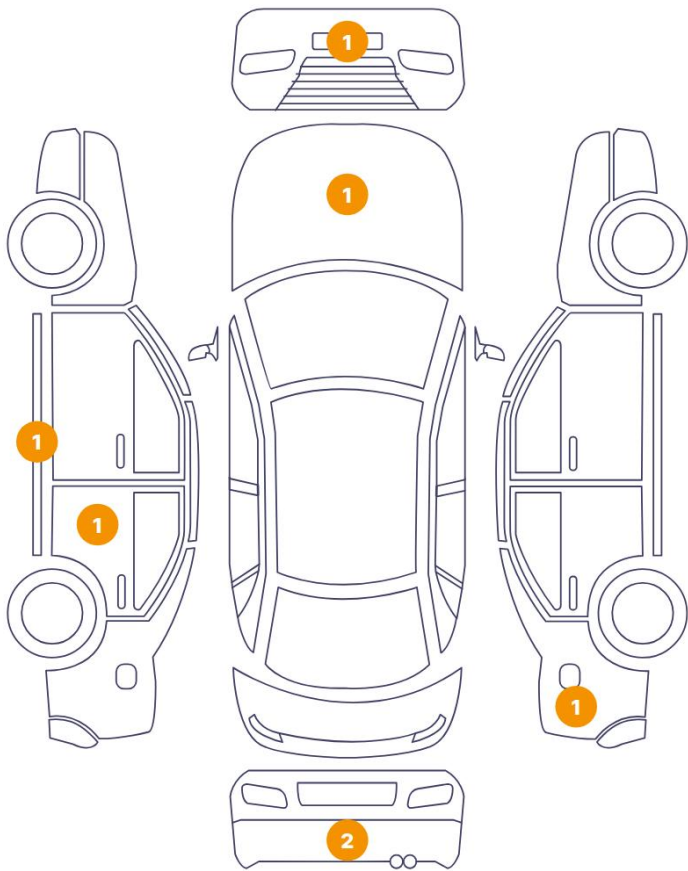
7 Dommages

| Component | | Damage | Comments |
|---|---|---|---|
| 1 | Door / Back Left | Bodywork / Dent / Dent | |
| 2 | Rocker Panel / Center Left | Bodywork / Dent / Deformation | |
| 3 | Corner Bumper / Front Left | Bodywork / Breakage / Crack | |
| 4 | Hood | Bodywork / Assembly | |
| 5 | Fender / Back Right | Bodywork / Dent / Dent | |
| 6 | Corner Bumper / Back Right | Paint / Chipping | |
| 7 | Corner Bumper / Back Right | Paint / Scratch / Line | |

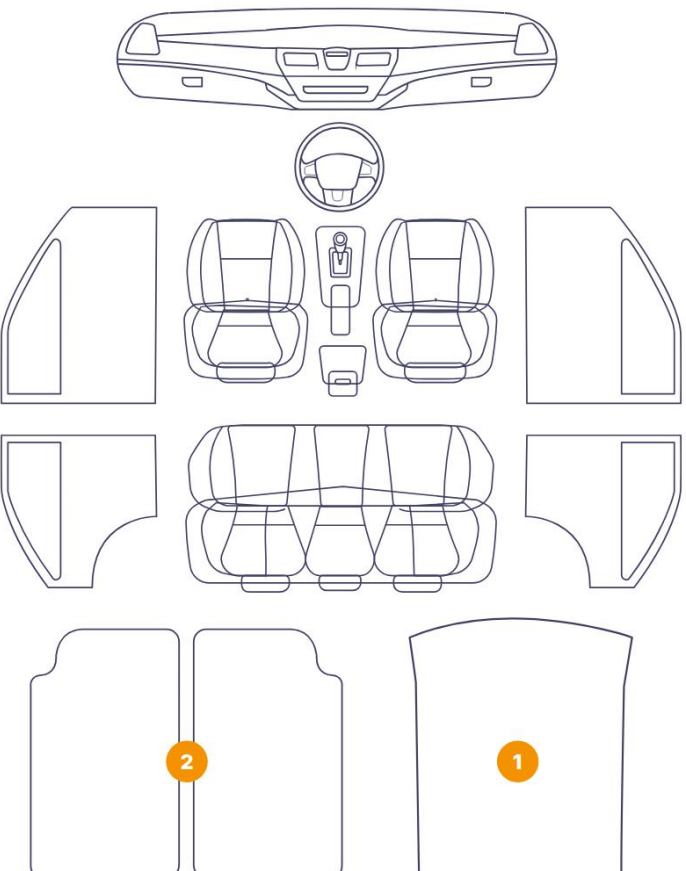
3 Dommages

| Component | | Damage | Comments |
|---|---|---|---|
| 8 | Roof Upholstery | Interior / Loose | |
| 9 | Floor Carpet | Interior / Holed | |
| 10 | Floor Carpet | Interior / Dirty | |

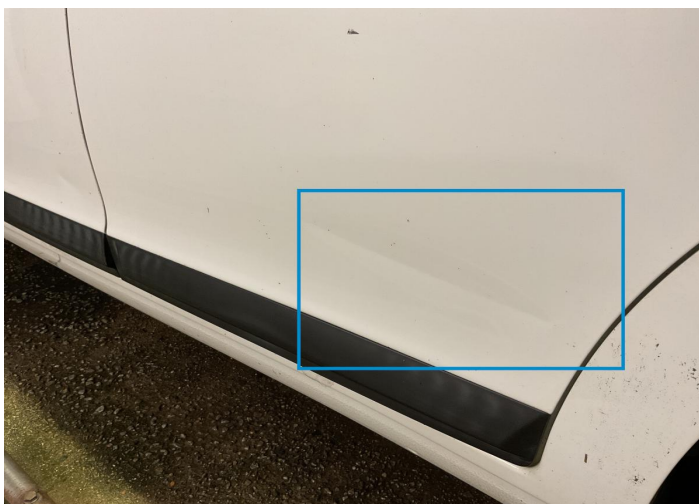
1. Door / Back Left  
Bodywork / Dent / Dent -

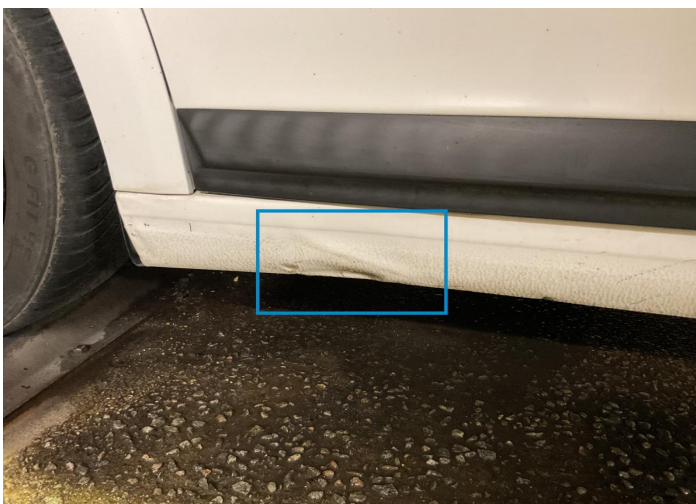
2. Rocker Panel / Center Left  
Bodywork / Dent / Deformation -

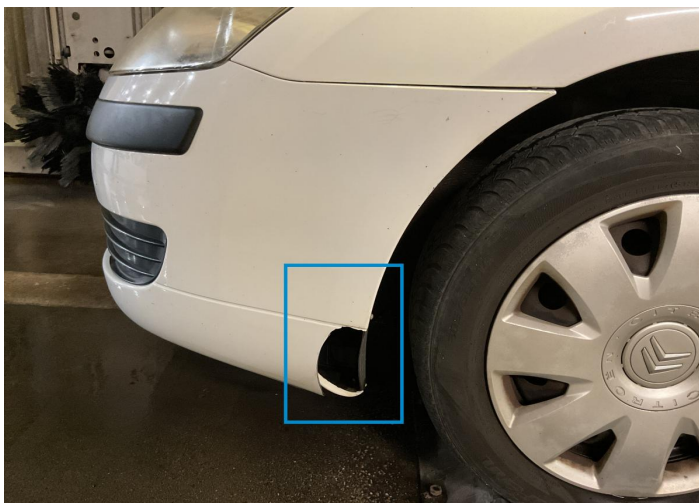
3. Corner Bumper / Front Left  
Bodywork / Breakage / Crack -

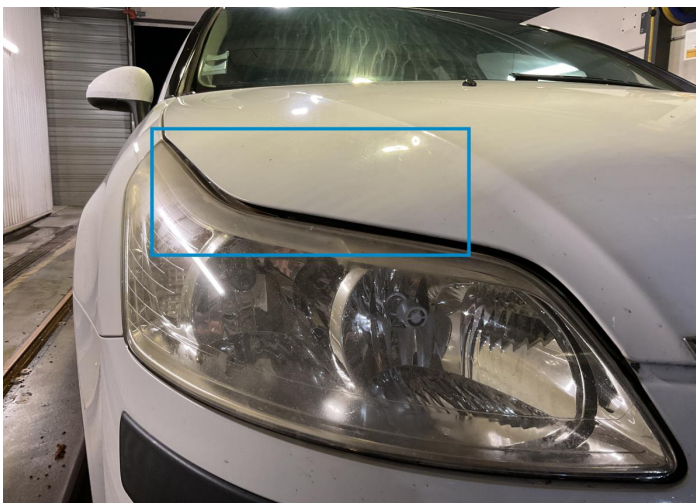
4. Hood  
Bodywork / Assembly -

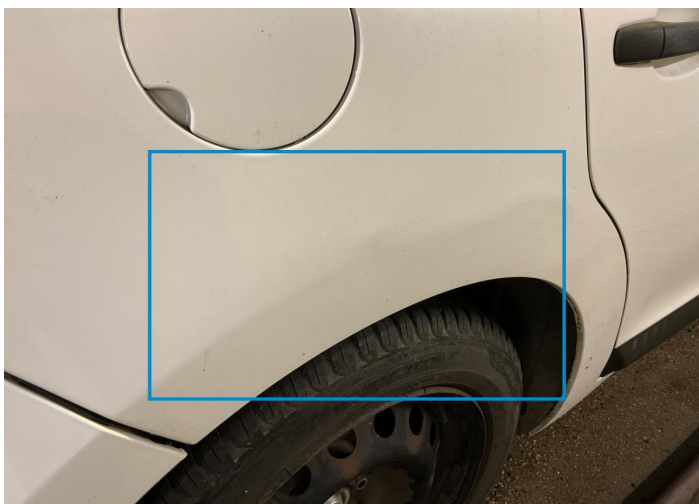
5. Fender / Back Right  
Bodywork / Dent / Dent -

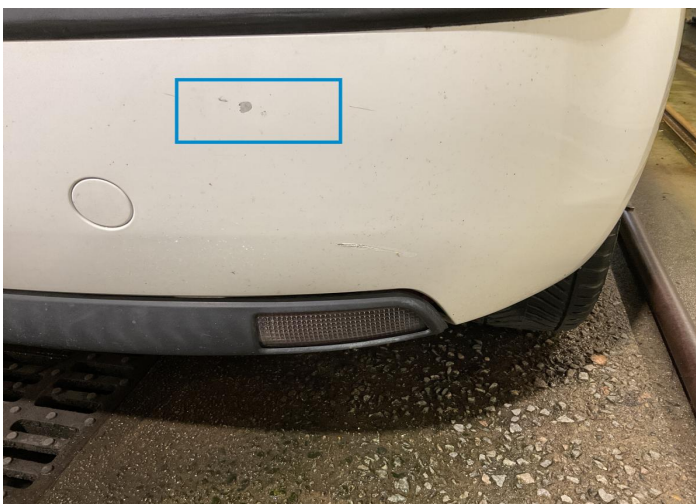
6. Corner Bumper / Back Right  
Paint / Chipping -

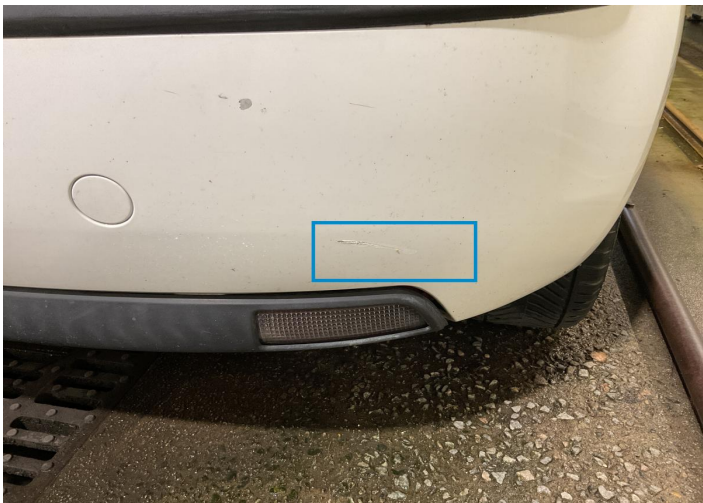
7. Corner Bumper / Back Right  
Paint / Scratch / Line -

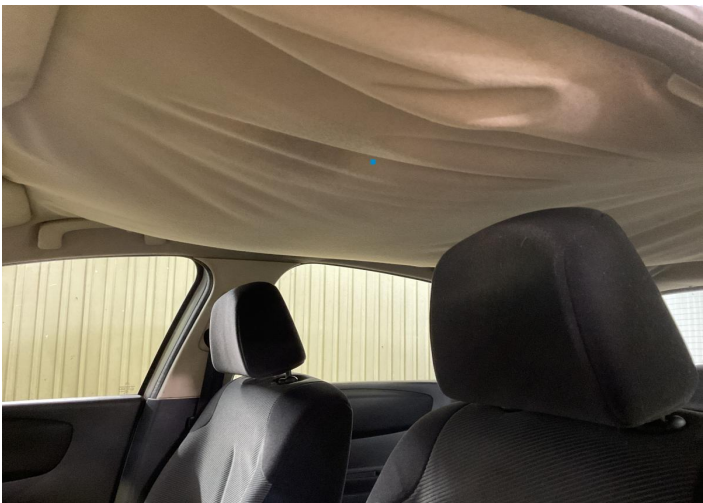
8. Roof Upholstery  
Interior / Loose -

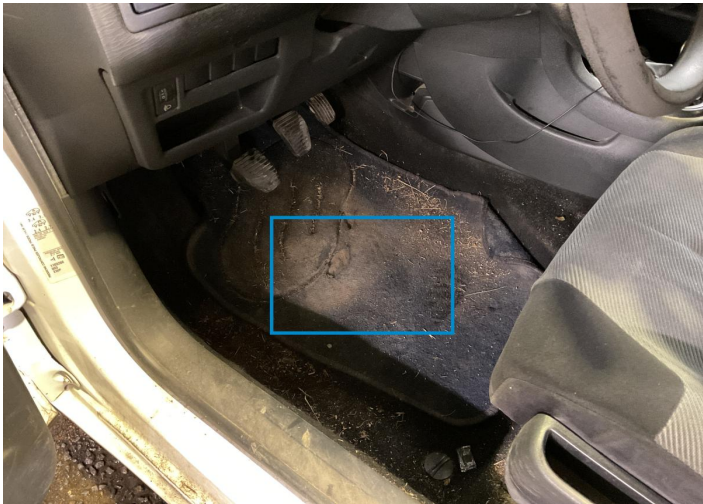
9. Floor Carpet  
Interior / Holed -

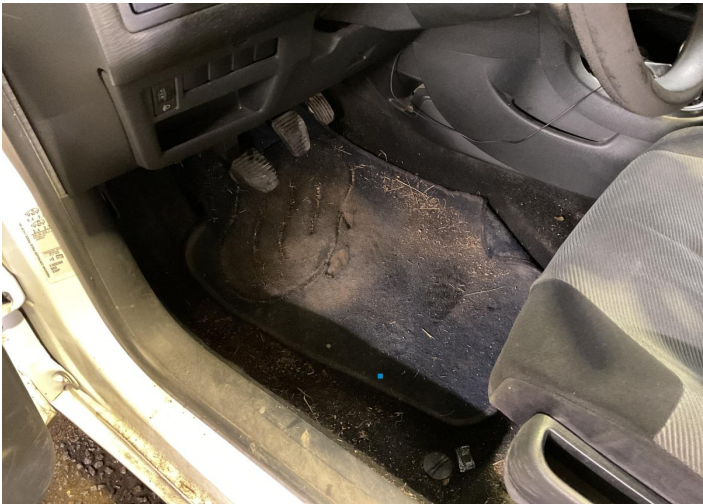
10. Floor Carpet  
Interior / Dirty -
