Hüsge Gruppe®  
Die Gutachter

## status report

#### Citroën C1 Selection

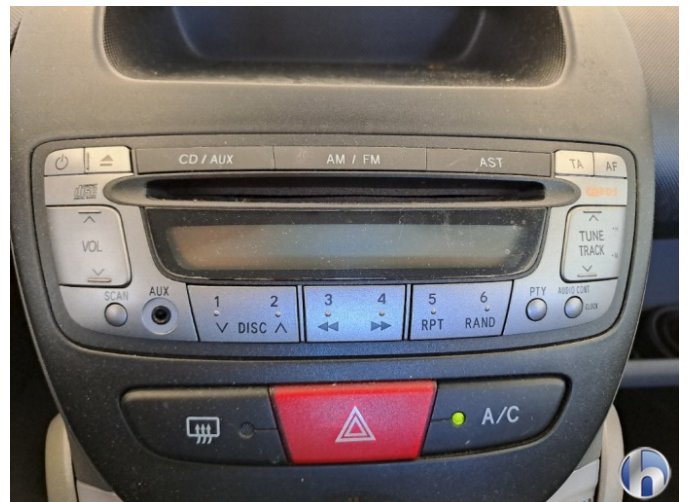
| component | Damage | Rep kind |
|---|---|---|
| 1. | No functionality | Carry out a fault diagnosis |

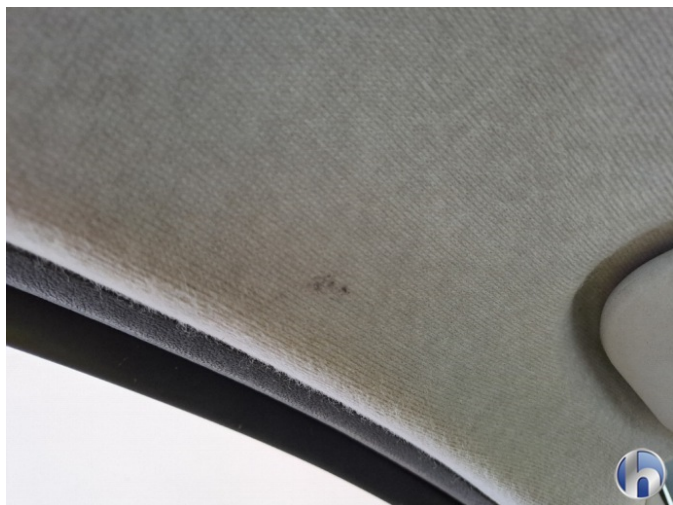
| component | Damage | Rep kind |
|---|---|---|
| 2. headlining | Burn hole | Replace |

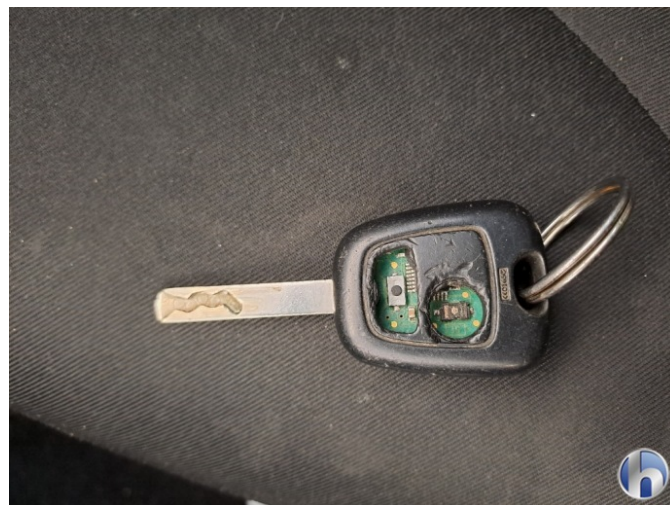
| component | Damage | Rep kind |
|---|---|---|
| 5. Key with remote control | Damaged | Replace |

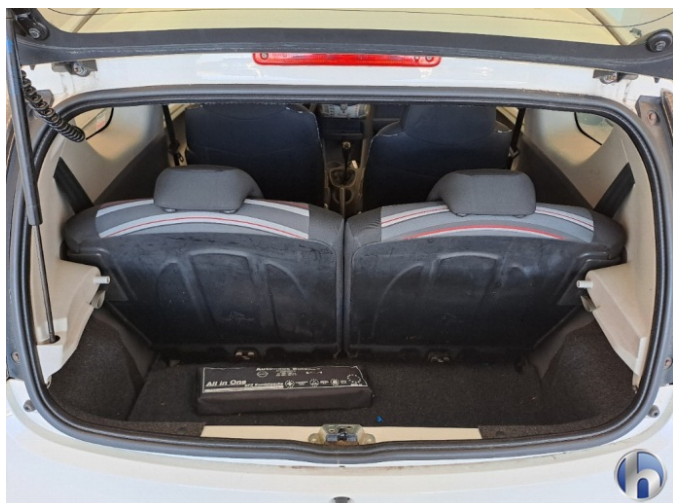
| component | Damage | Rep kind |
|---|---|---|
| 6. Cargo cover | Missing | Replace |

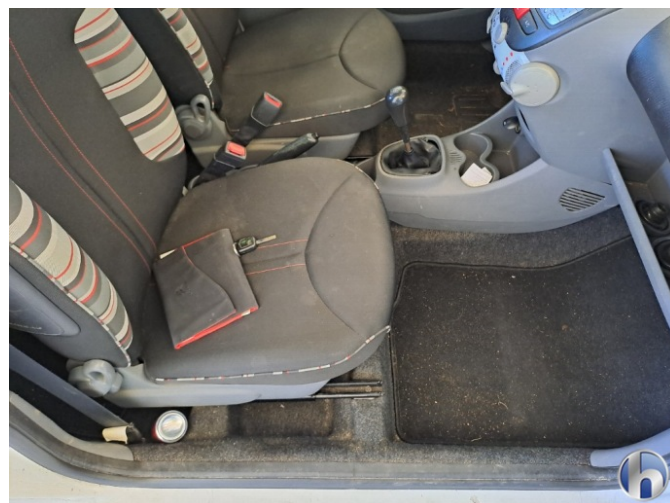
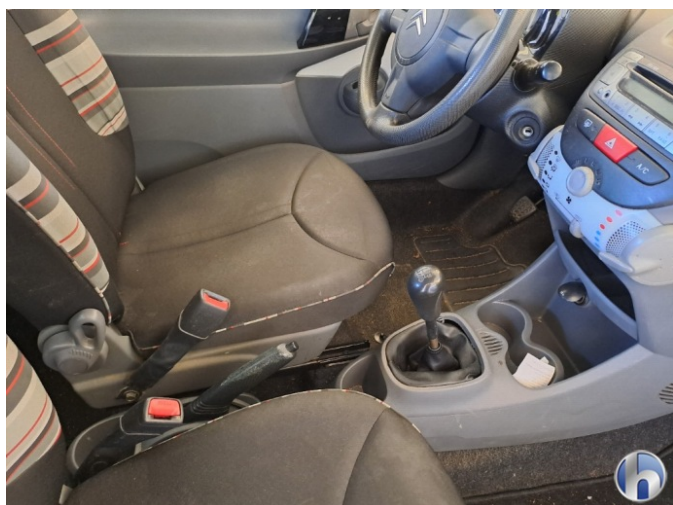
| component | Damage | Rep kind |
|---|---|---|
| 7. | Dirty | |

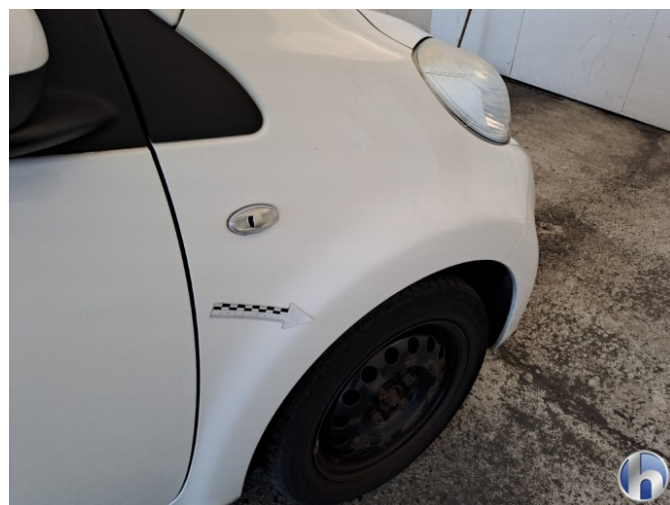
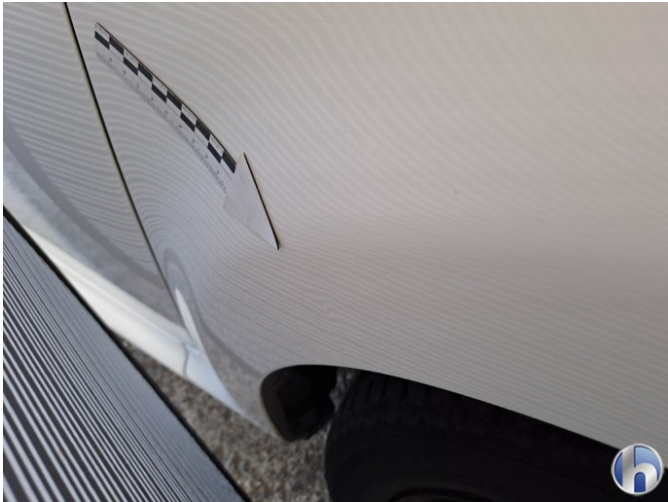
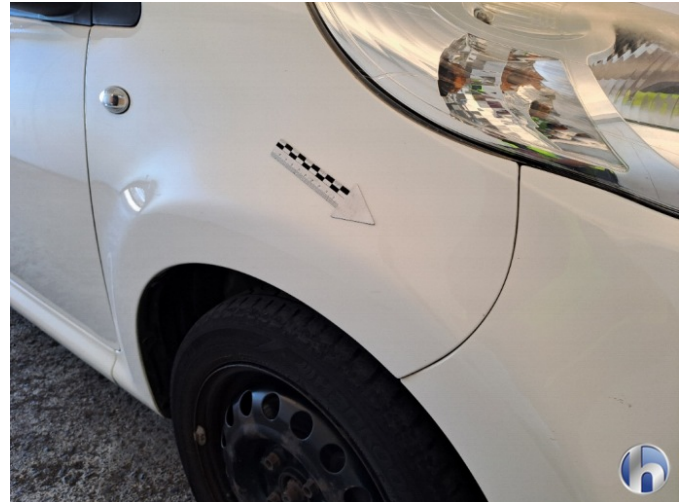
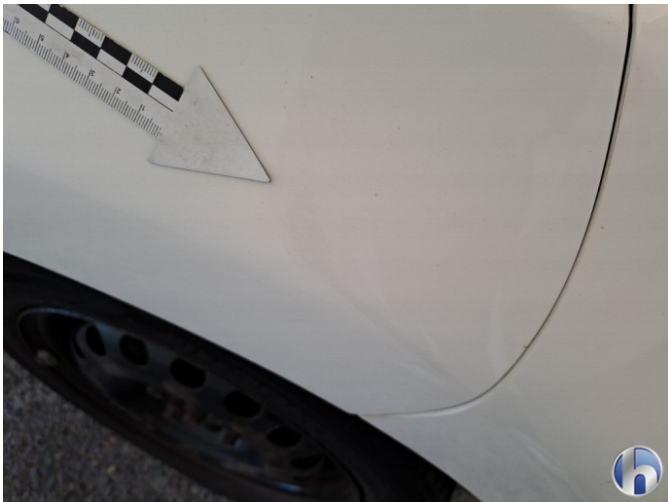
| component | Damage | Rep kind |
|---|---|---|
| 8. Front fender - right | | Refurbish and paint |

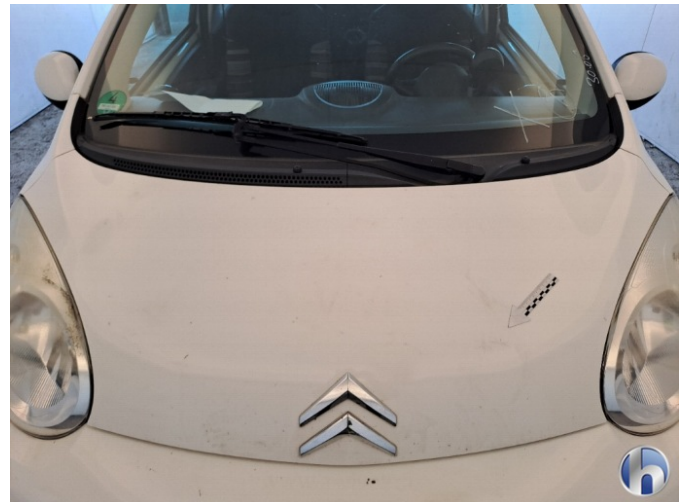
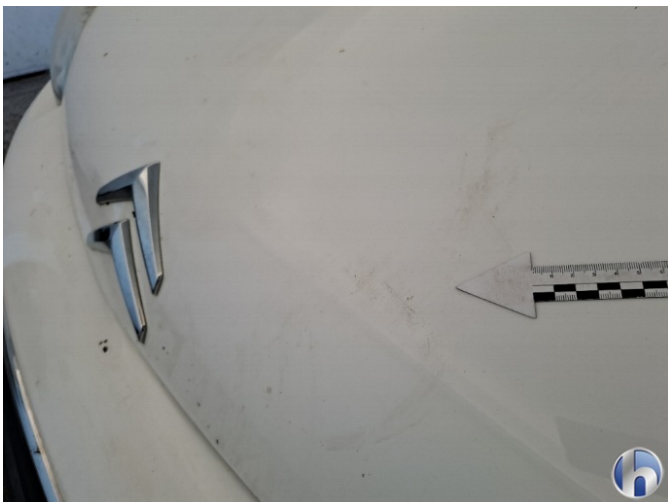
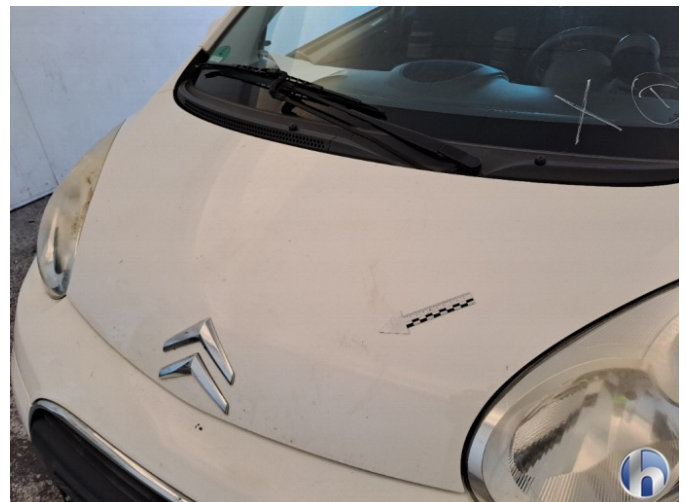
| component | Damage | Rep kind |
|---|---|---|
| 9. hood | | |

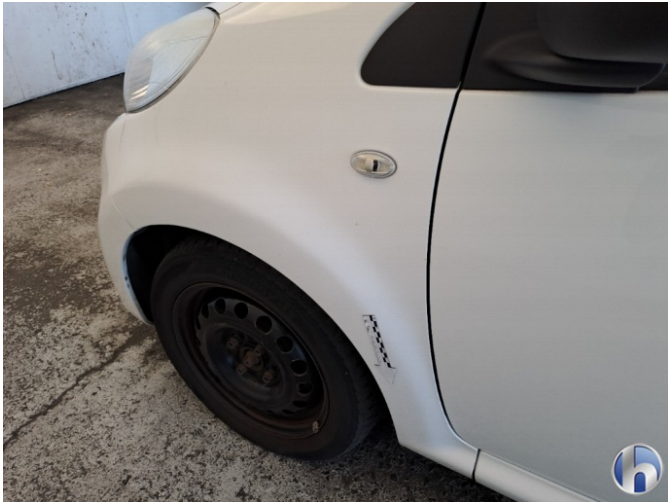
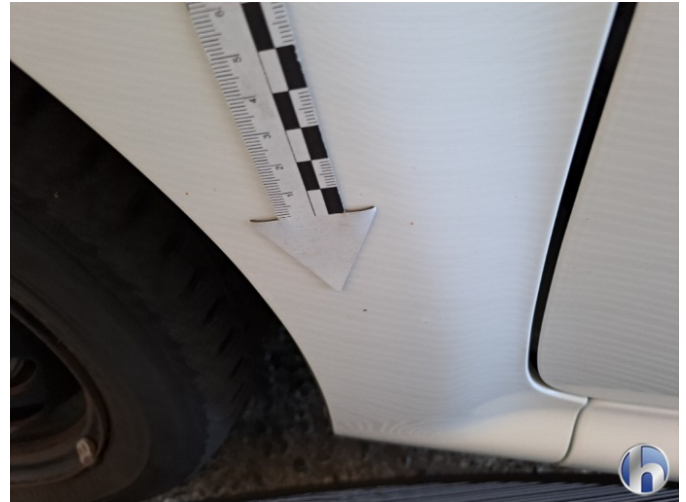
| component | Damage | Rep kind |
|---|---|---|
| 10. Front fender - left | Delle | Smart repair |

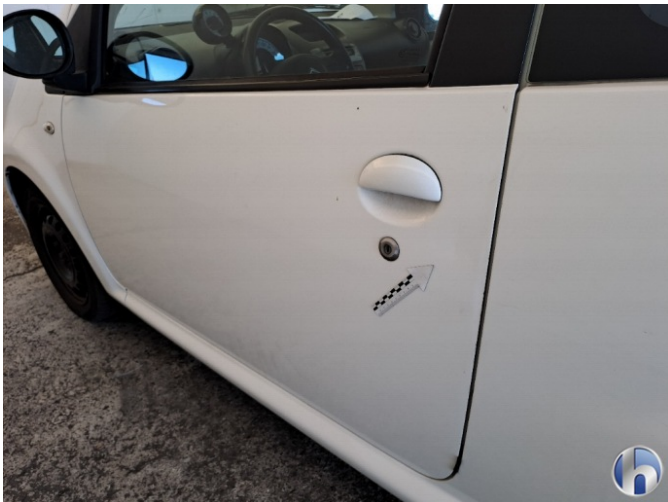
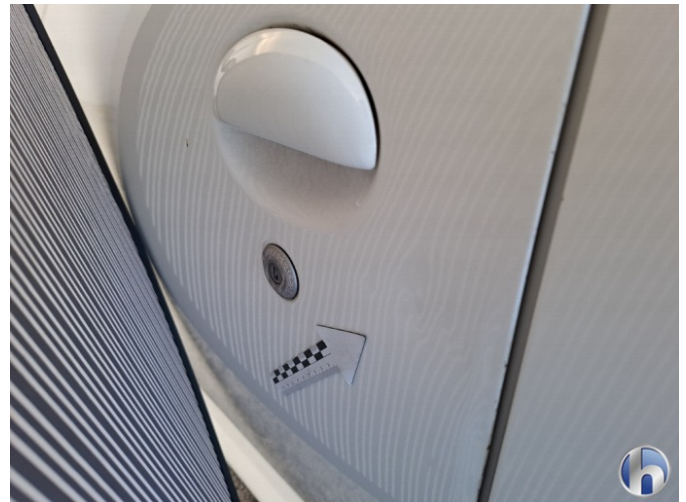
| component | Damage | Rep kind |
|---|---|---|
| 11. Front door - left | Dented | Refurbish and paint |

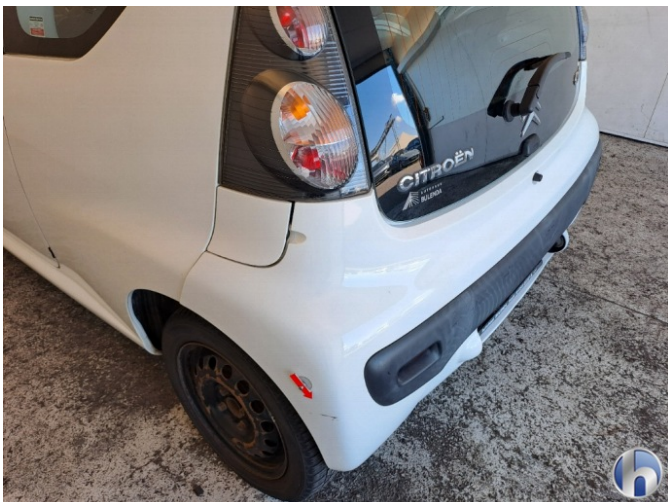
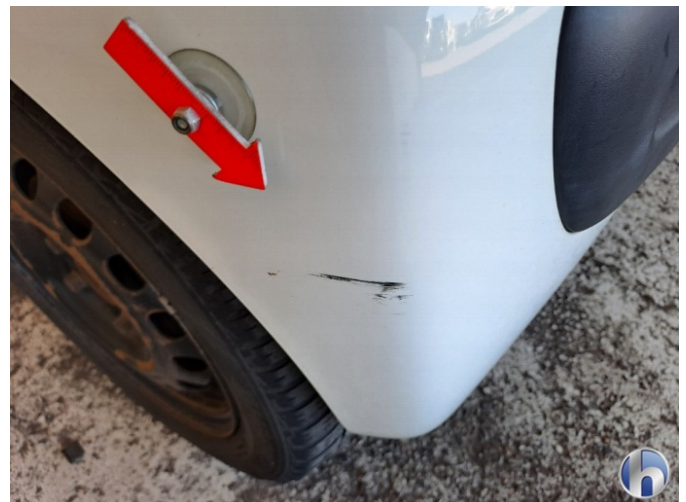
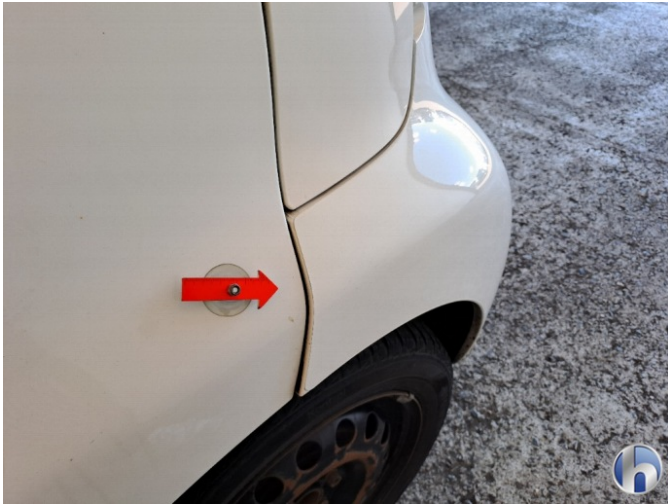
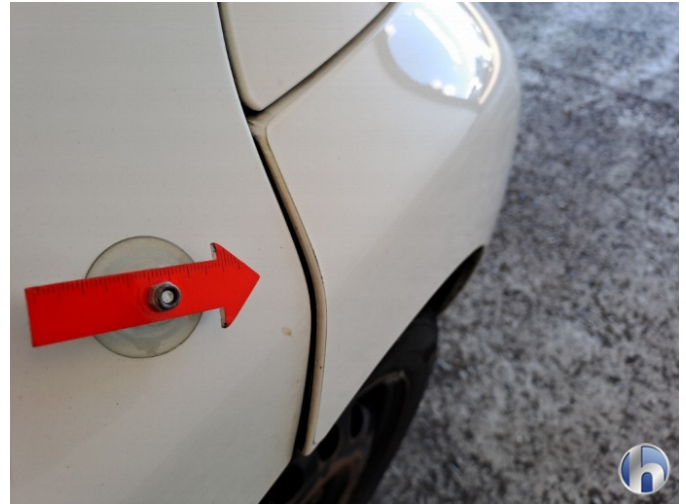
| component | Damage | Rep kind |
|---|---|---|
| 12. Rear bumper | Damaged | Replace |

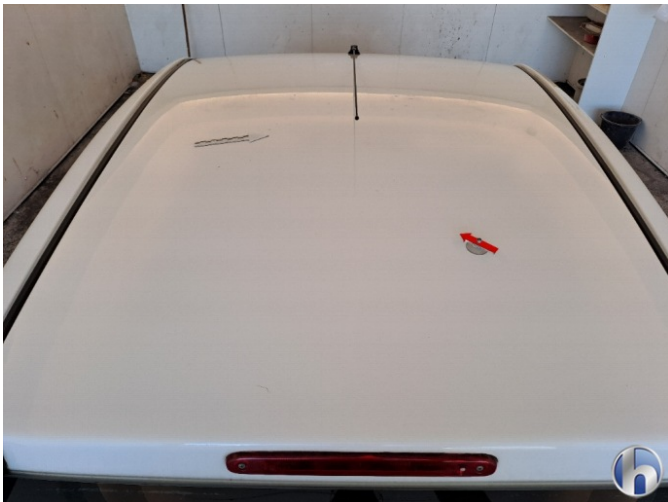
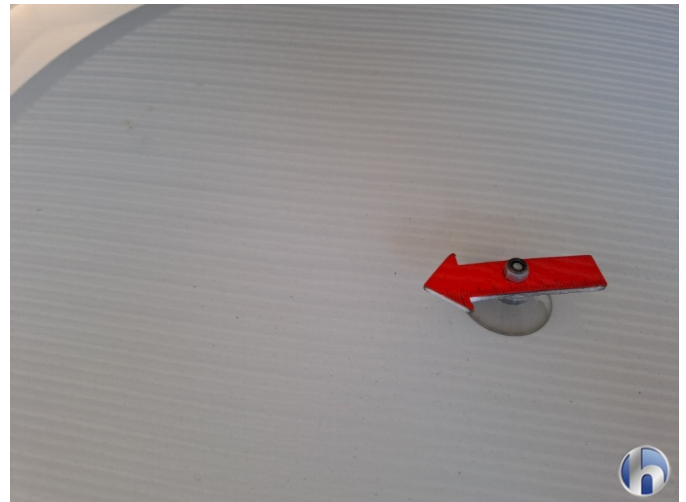
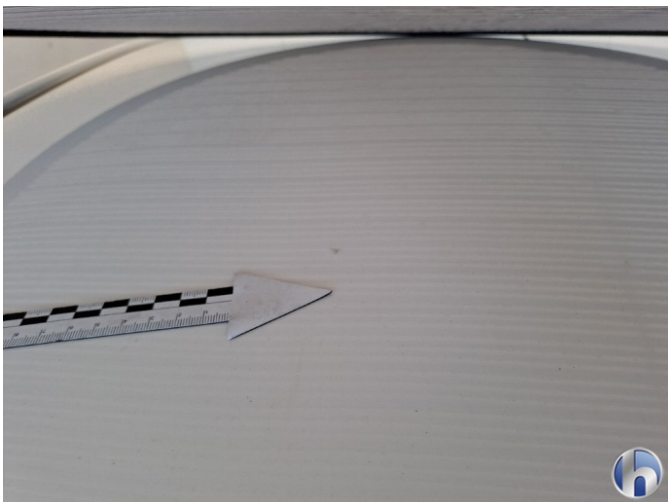
| component | Damage | Rep kind |
|---|---|---|
| 13. roof | | Smart repair |

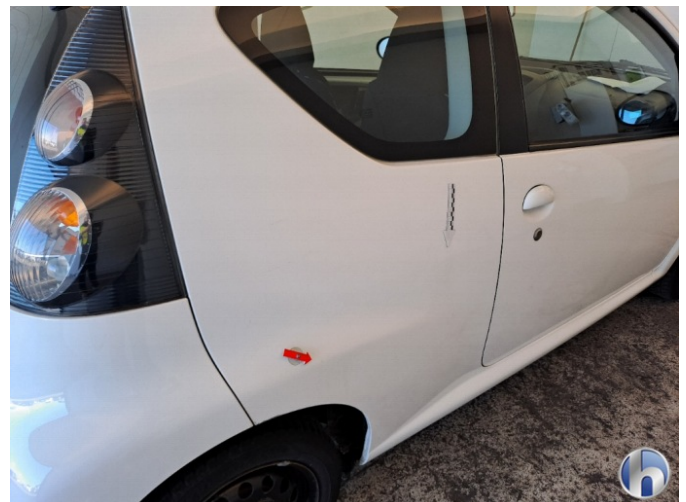
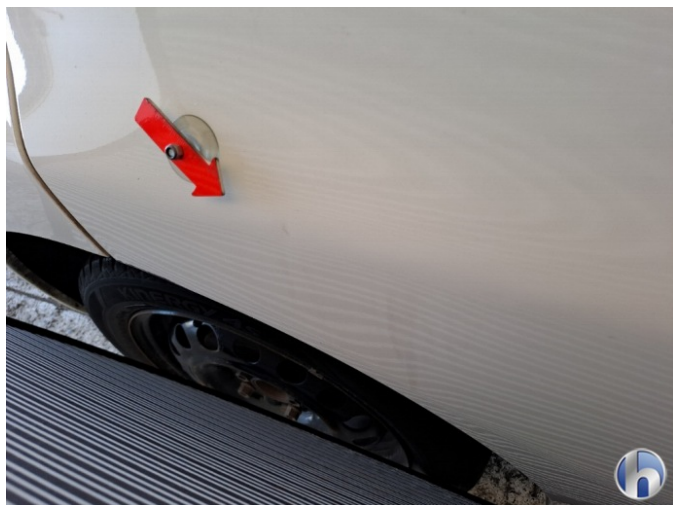
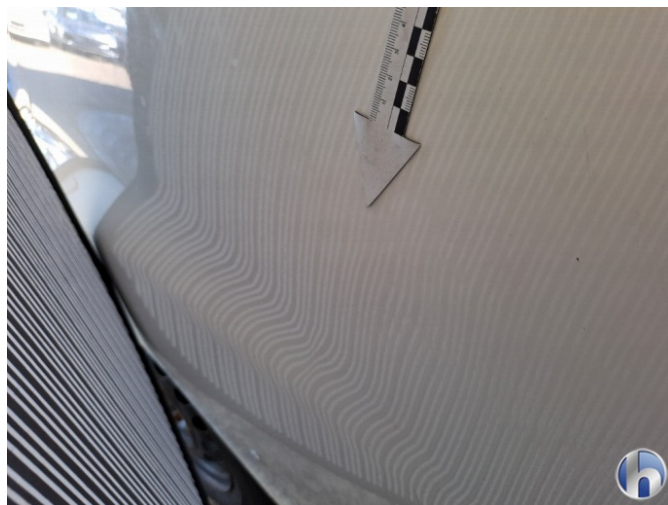
| component | Damage | Rep kind |
|---|---|---|
| 14. Sidewall - Rear - right | Deformed | Refurbish and paint |

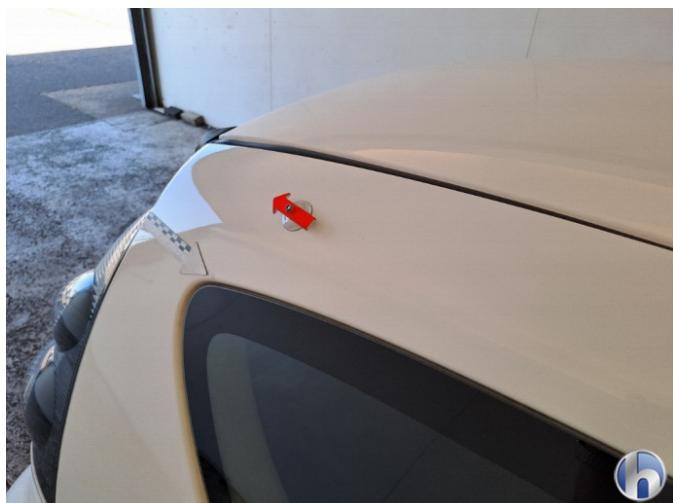
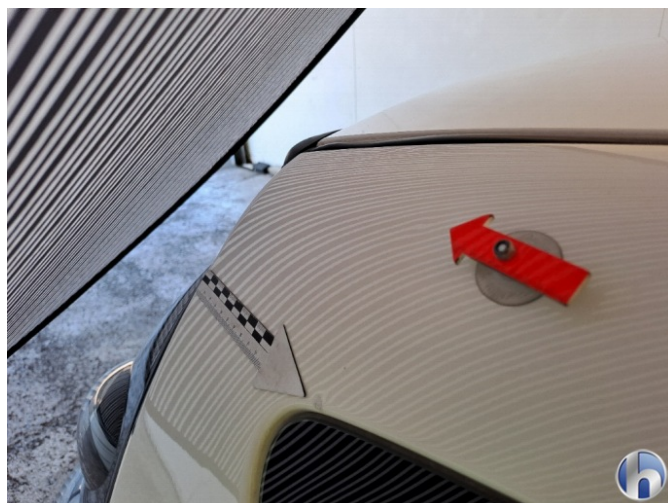
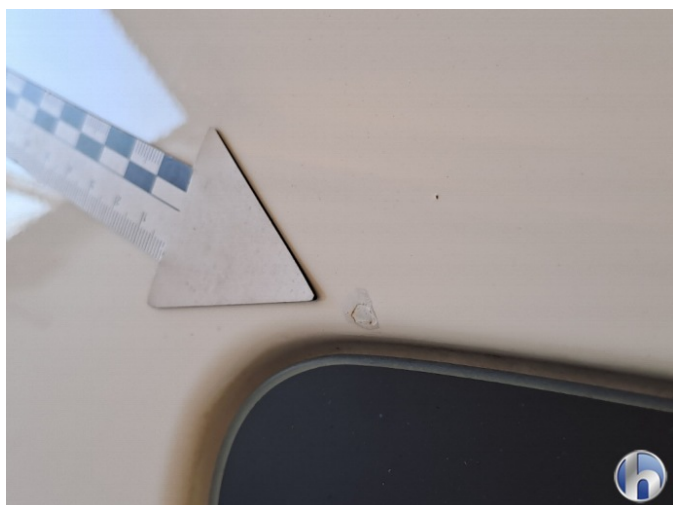
| component | Damage | Rep kind |
|---|---|---|
| 15. Roof frame - right | | Refurbish and paint |

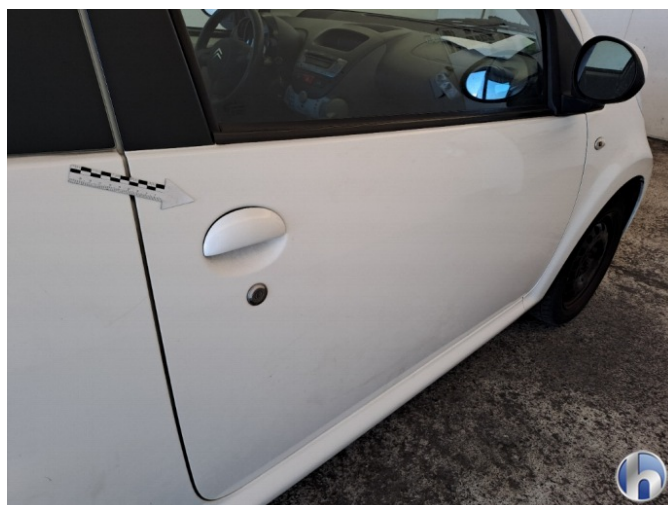
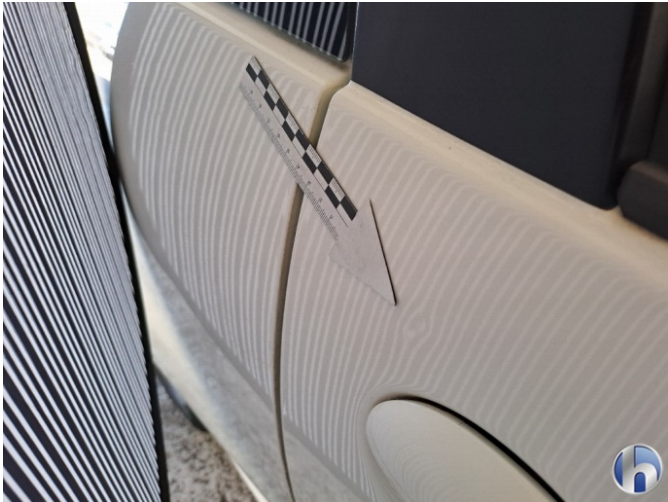
| component | Damage | Rep kind |
|---|---|---|
| 16. Front door - right | Delle | Smart repair |

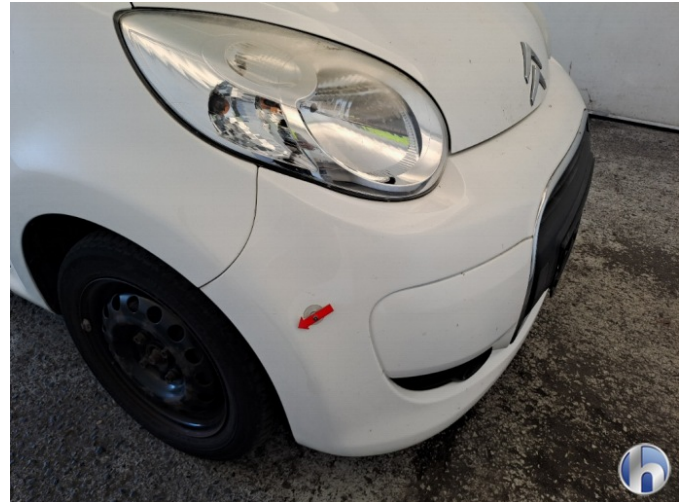
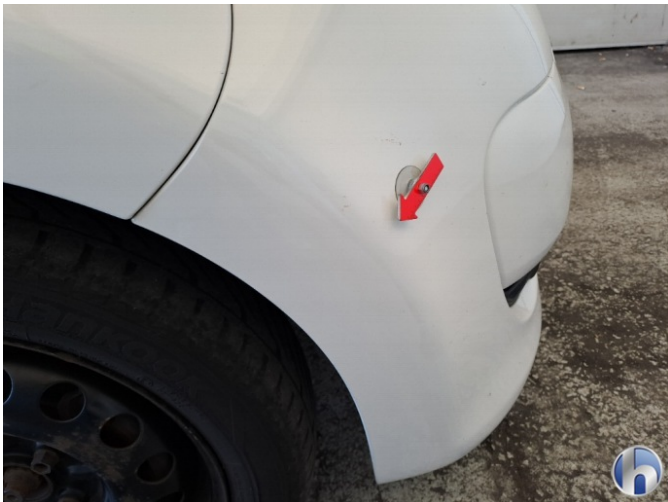
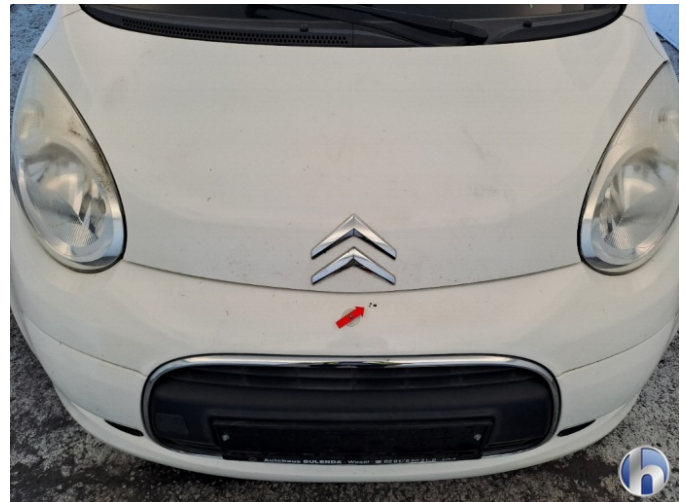
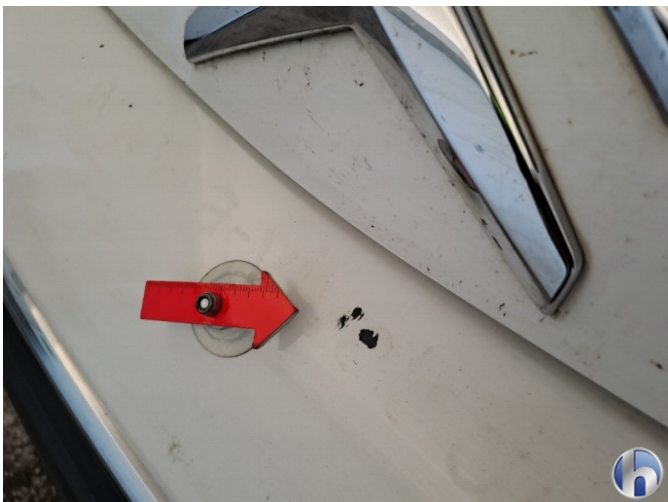
| component | Damage | Rep kind |
|---|---|---|
| 17. Front bumper | Scratch(es) | Refurbish and paint |

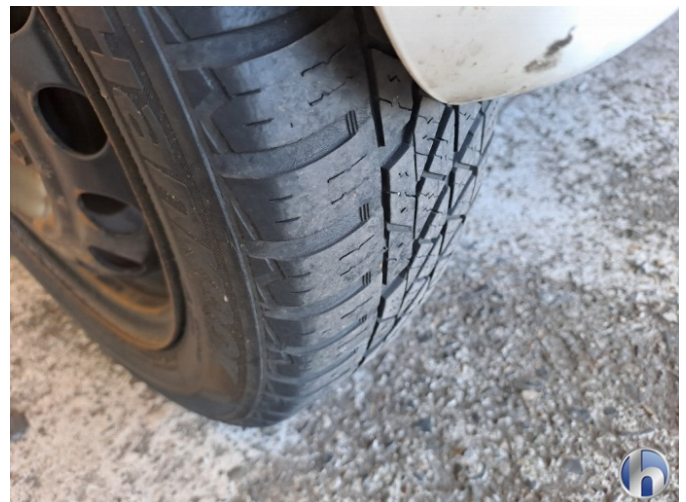
| mounted tires | | |
|---|---|---|
| 2nd axis - Left / states . | <b>Hankook</b> | <b>155/65/R14/75T 1 mm</b> |

| component | Damage | Rep kind |
|---|---|---|
| 18. tire rear - left | Worn | Replace |

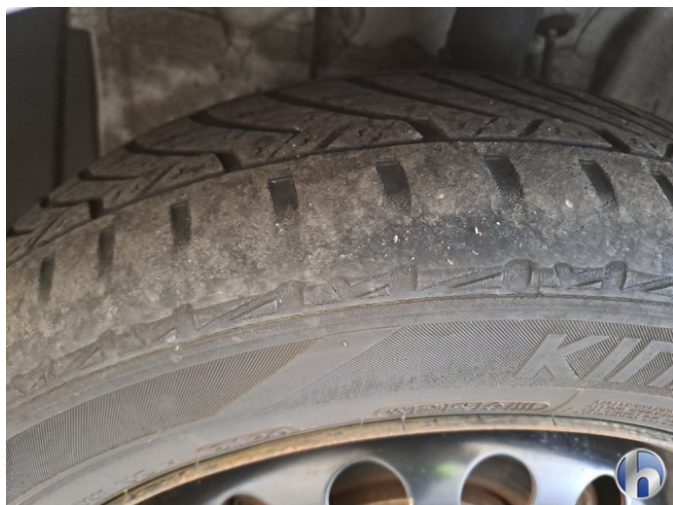
| mounted tires | | |
|---|---|---|
| 1st axis - Left / states . | <b>Hankook</b> | <b>155/65/R14/75T 0 mm</b> |

| component | Damage | Rep kind |
|---|---|---|
| 19. tire front - left | Worn | Replace |

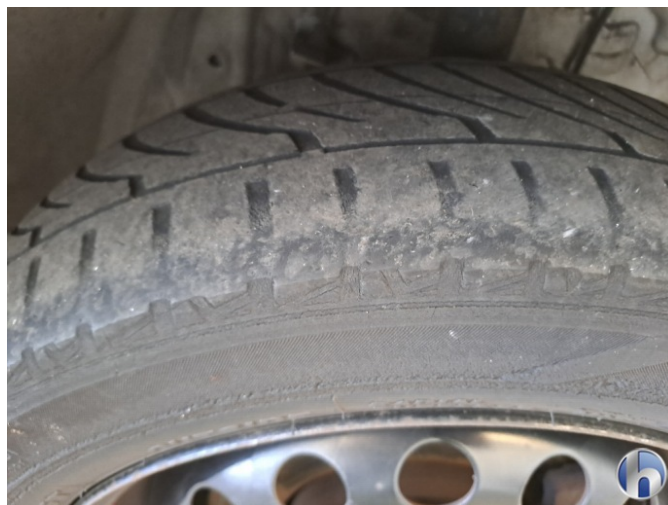
| mounted tires | | |
|---|---|---|
| 1st axis - right / states . | <b>Hankook</b> | <b>155/65/R14/75T 0 mm</b> |

| component | Damage | Rep kind |
|---|---|---|
| 20. tire front - right | Worn | Replace |

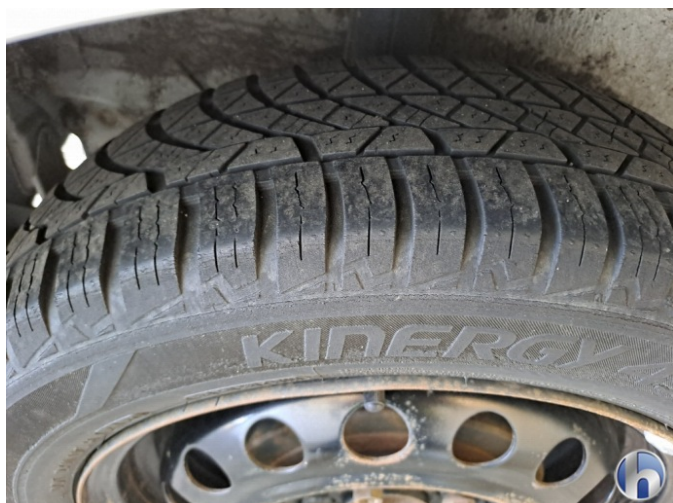
| mounted tires | | |
|---|---|---|
| 2nd axis - right / states . | <b>Hankook</b> | <b>155/65/R14/75T 3 mm</b> |

| component | Damage | Rep kind |
|---|---|---|
| 21. tire rear - right | Worn | Replace |
