CITROEN C1 2012 Benzina  
C1 1.0 Exclusive 3p

VIN NO VF7PMCFB4CR535286  
Registration Number ER403CX

Inspection Report Summary

Customer	BCA Lodi	Report Number	P20250923142607
Inspection Date / Place	2025-09-23 / BCA Lodi	Cosmetic Grade	5

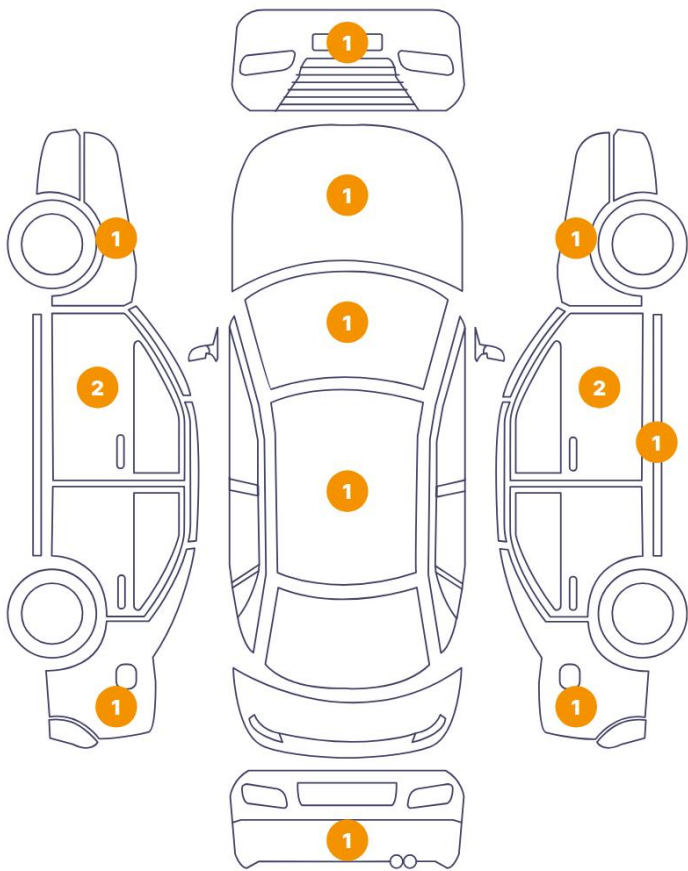
14 Danni

Component		Damage	Comments
1	Floor Carpet	Interior / Ripped	
2	Panel Filling / Front Left	Interior / Scratched	
3	Seat / Front Left	Interior / Ripped	
4	Luggage Space Cover / Back	Interior / Broken	
5	Fender / Front Right	Paint / Poor Previous Repair	
6	Bumper / Front	Bodywork / Dent	
7	Hood	Bodywork / Dent / Hail Area	
8	Windshield / Front	Glass Break / Scratch	
9	Fender / Front Left	Paint / Scratch / Line	
10	Door / Front Left	Bodywork / Dent	
11	Fender / Back Left	Bodywork / Dent / Hail Area	
12	Pillar / Front Left	Bodywork / Dent / Hail Area

13	Bumper / Back	Bodywork / Dent
14	Roof	Bodywork / Dent / Hail Area
15	Pillar / Front Right	Bodywork / Dent / Hail Area
16	Fender / Back Right	Bodywork / Dent
17	Rocker Panel / Center Right	Bodywork / Dent
18	Door / Front Right	Paint / Scratch / Line

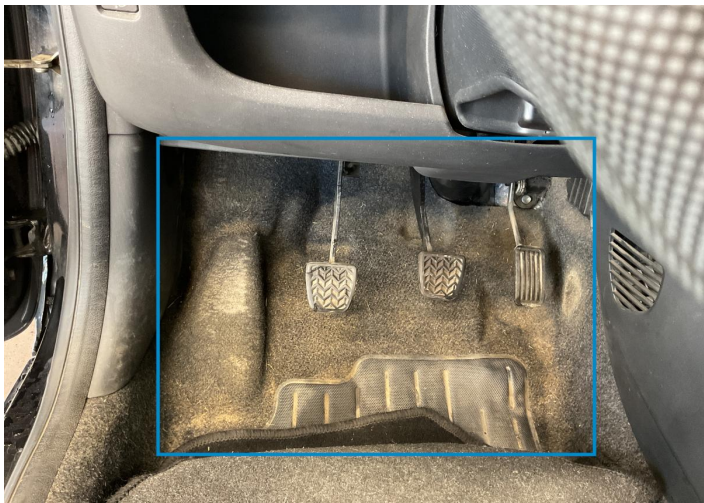
1. Floor Carpet  
Interior / Ripped -

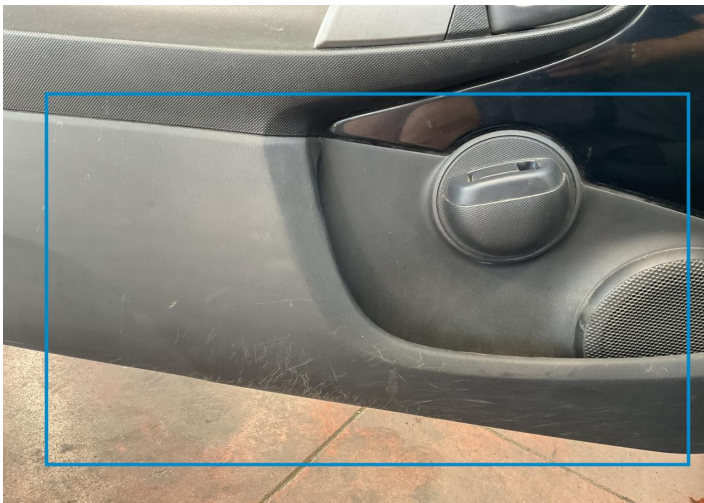
2. Panel Filling / Front Left  
Interior / Scratched -

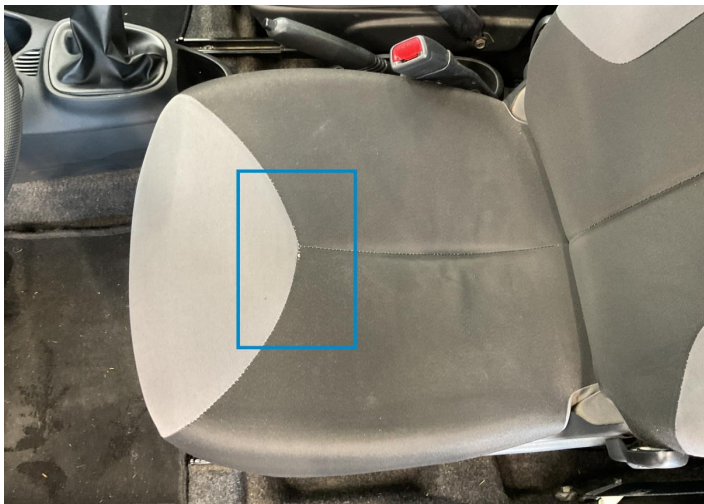
3. Seat / Front Left  
Interior / Ripped -

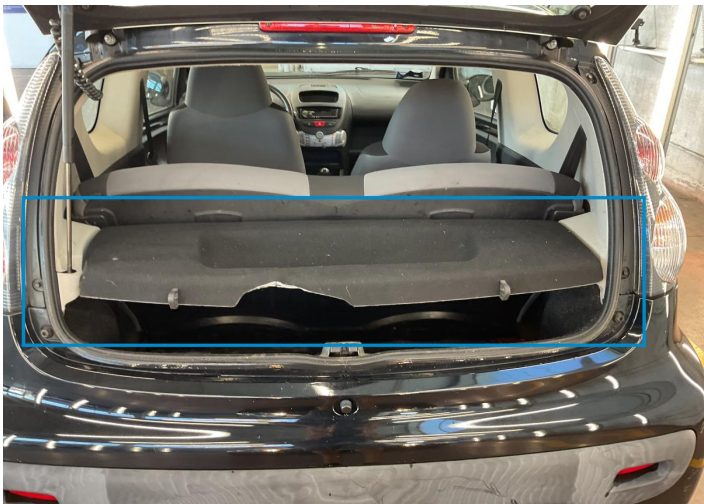
4. Luggage Space Cover / Back  
Interior / Broken -

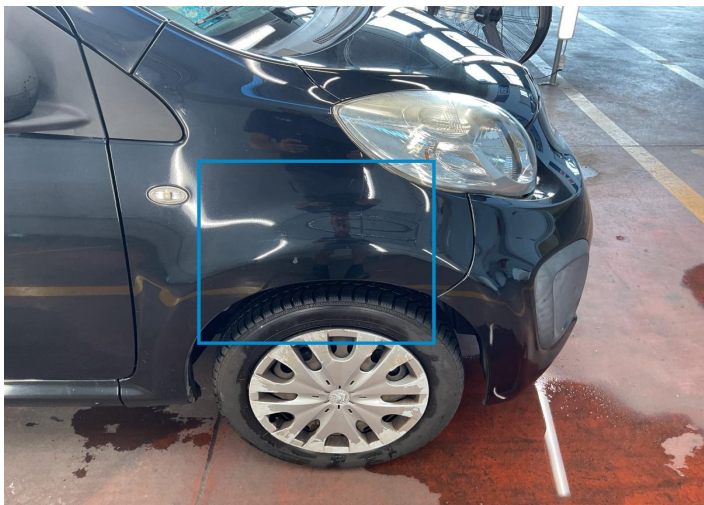
5. Fender / Front Right  
Paint / Poor Previous Repair -

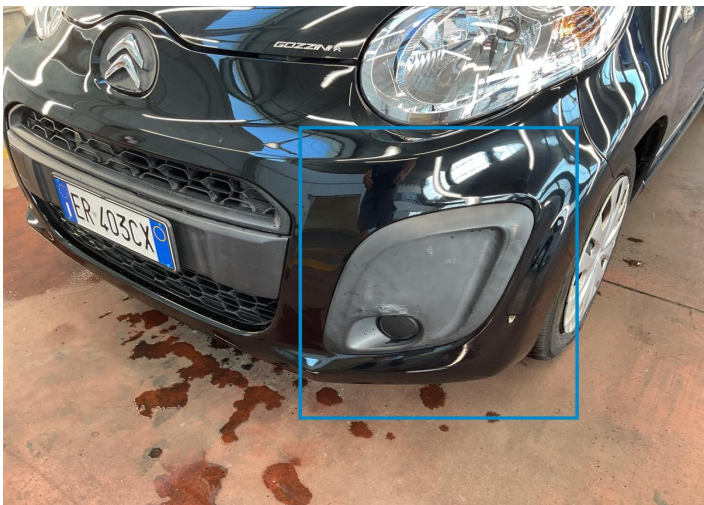
6. Bumper / Front  
Bodywork / Dent -

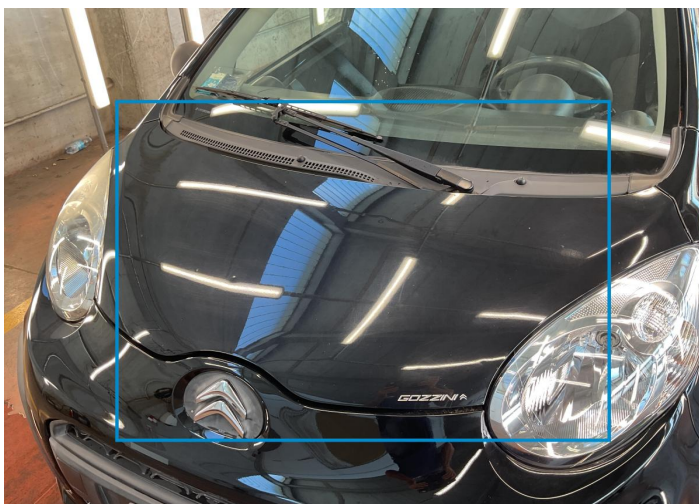
7. Hood  
Bodywork / Dent / Hail Area -

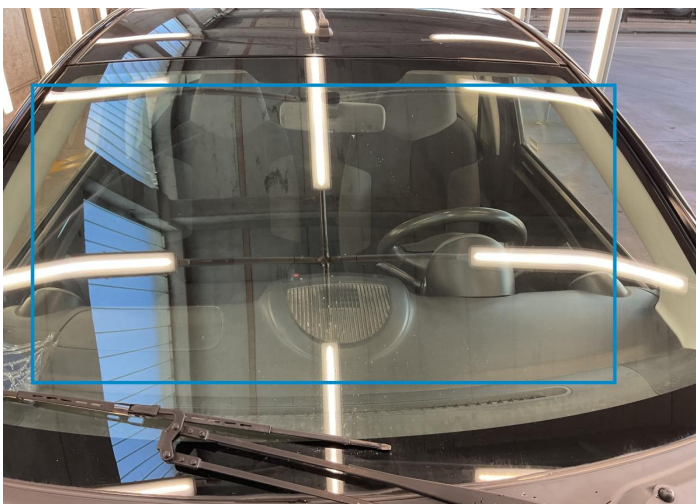
8. Windshield / Front  
Glass Break / Scratch -

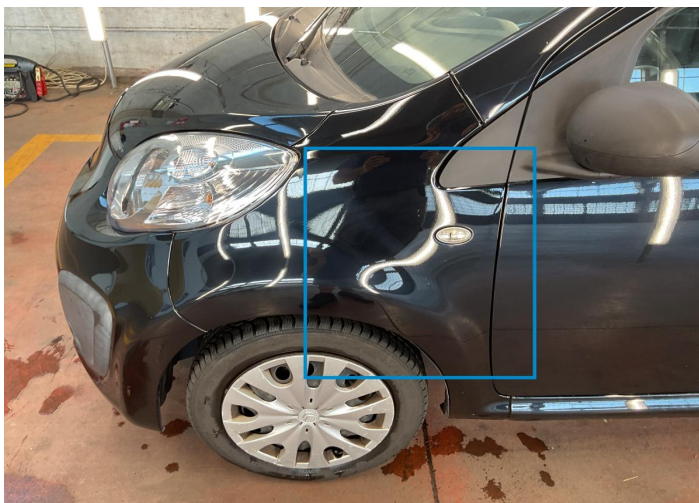
9. Fender / Front Left  
Paint / Scratch / Line -

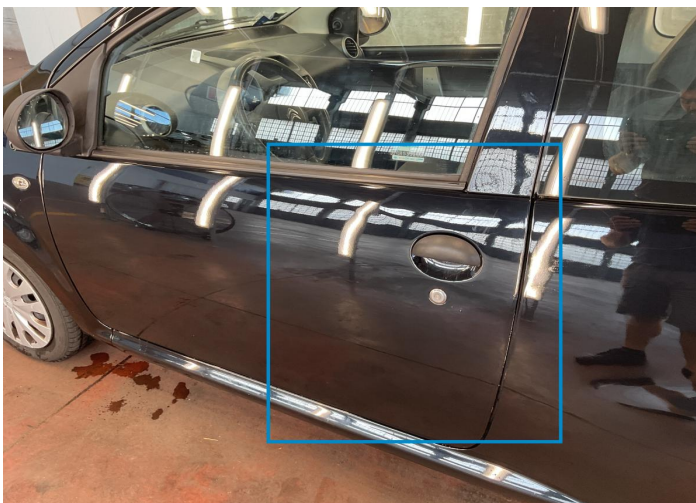
10. Door / Front Left  
Bodywork / Dent -

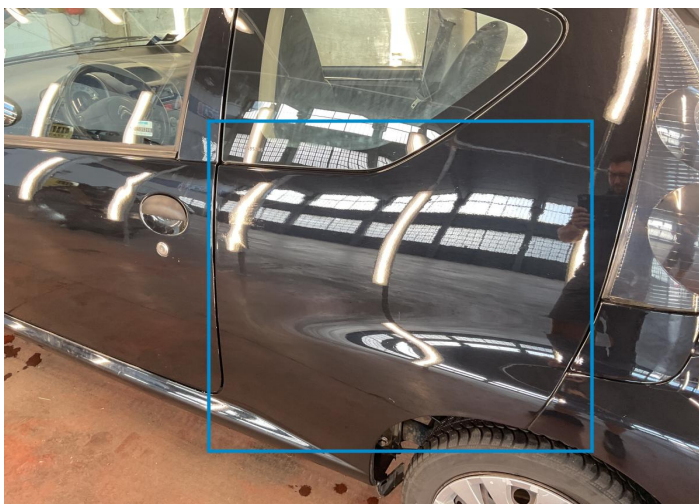
11. Fender / Back Left  
Bodywork / Dent / Hail Area -

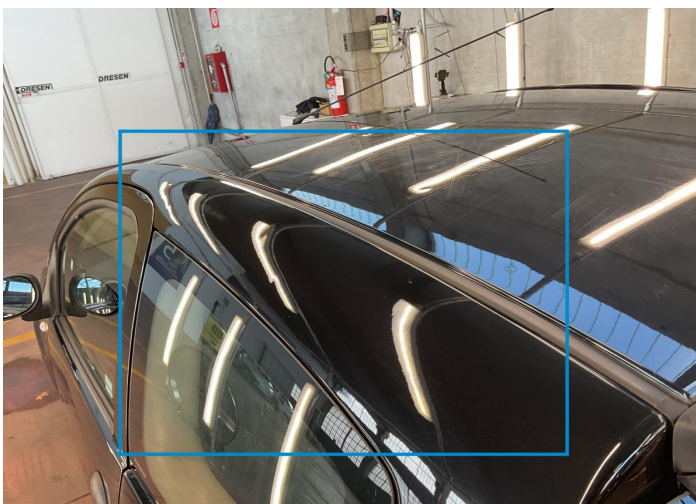
12. Pillar / Front Left  
Bodywork / Dent / Hail Area -

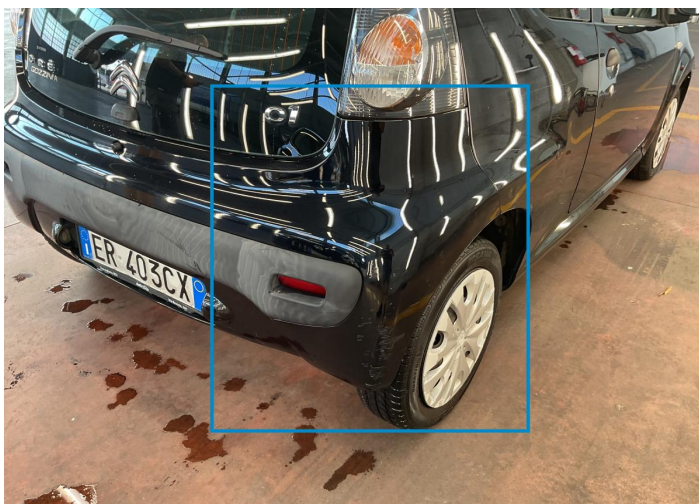
13. Bumper / Back  
Bodywork / Dent -

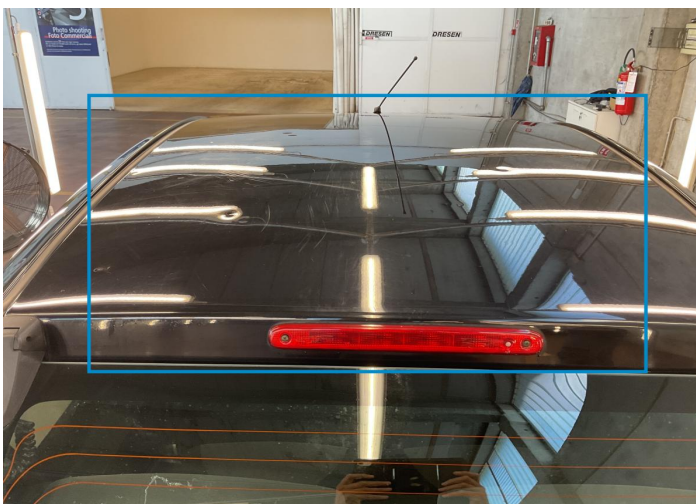
14. Roof  
Bodywork / Dent / Hail Area -

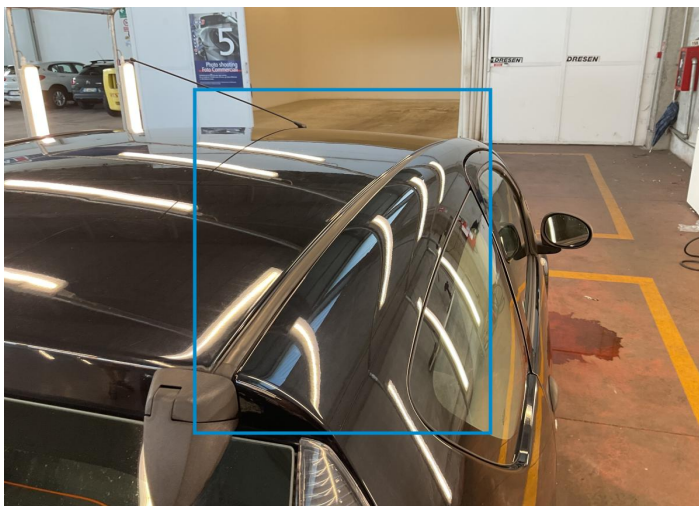
15. Pillar / Front Right  
Bodywork / Dent / Hail Area -

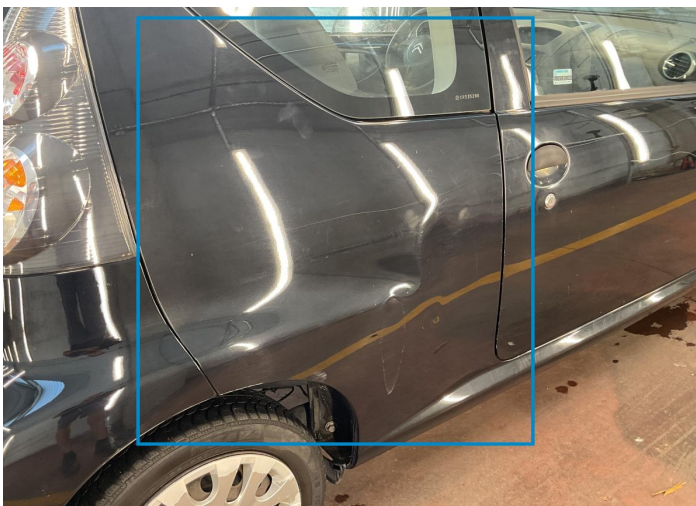
16. Fender / Back Right  
Bodywork / Dent -

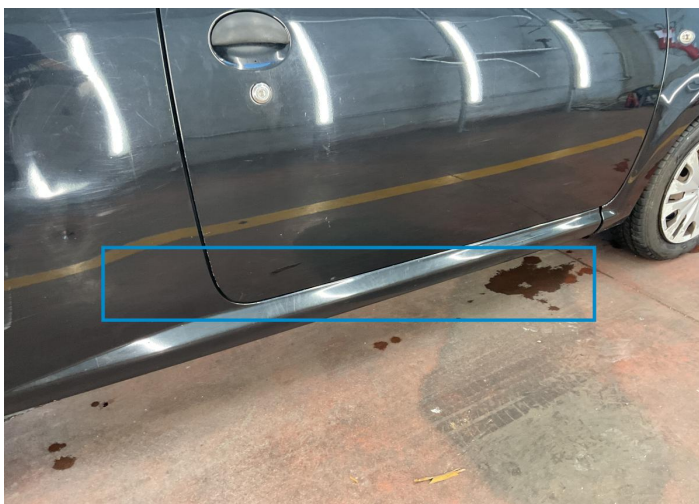
17. Rocker Panel / Center Right  
Bodywork / Dent -

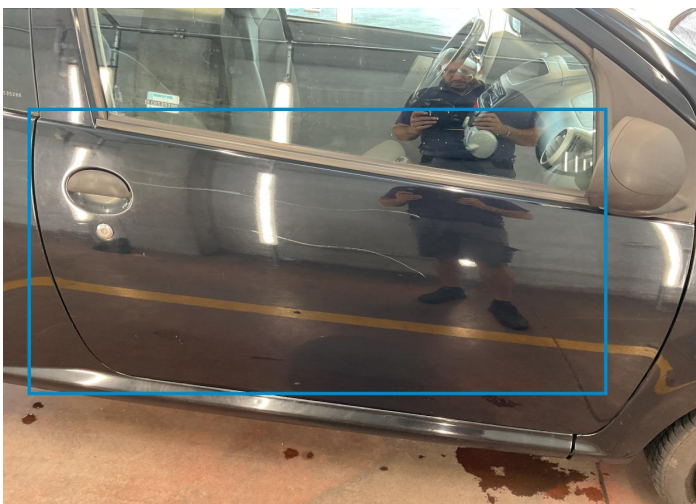
18. Door / Front Right  
Paint / Scratch / Line -
