CITROEN C3 C3 Picasso VTi 95 Collection

VIN NO VF7SH8FP0BT526300 Registration Number BQ767LA

Inspection Report Summary

| Customer | BCAuto Encheres | Report Number | P20250930230120 |

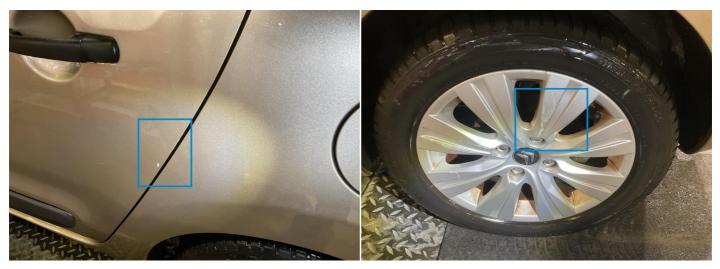
1. Door / Back Left Paint / Chipping -

2. Rim / Back Left Out of Bodywork / Scratch -

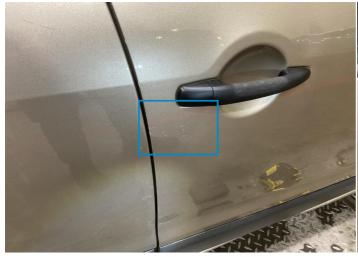
3. Corner Bumper / Back Right Paint / Scratch / Scuff -

4. Fender / Back Right Bodywork / Dent / Dent -

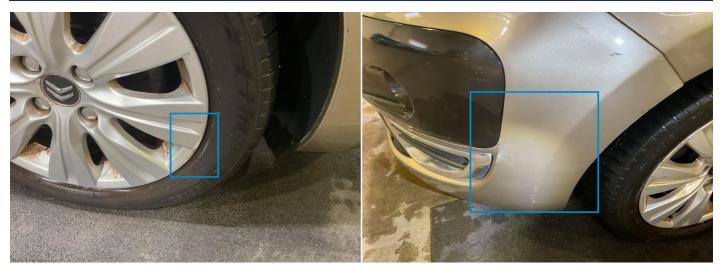
5. Door / Front Right Paint / Scratch / Scuff -

6. Mirror Shell / Front Right Paint / Chipping -

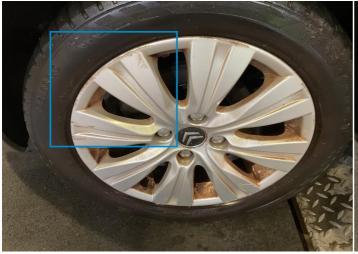
7. Rim / Front Right
Out of Bodywork / Scratch -

8. Corner Bumper / Front Left Paint / Scratch / Scuff -

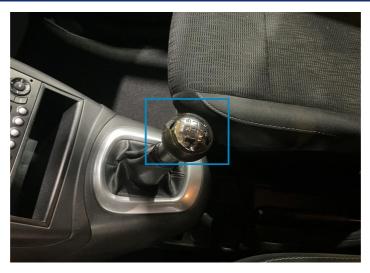
11. Mirror Shell / Front Left Bodywork / Breakage -

12. Rocker Panel / Center Left Bodywork / Dent / Deformation -

13. Gear Knob Interior / Broken -
