CITROEN C3 Picasso Diesel  
C3 Picasso 1.6 e-hdi (airdream) Seduction  
90cv cmp

VIN NO VF7SH9HP4ET525108  
Registration Number FH546DR

Inspection Report Summary

| Customer | BCA Lodi | Report Number | P20251008114006 |

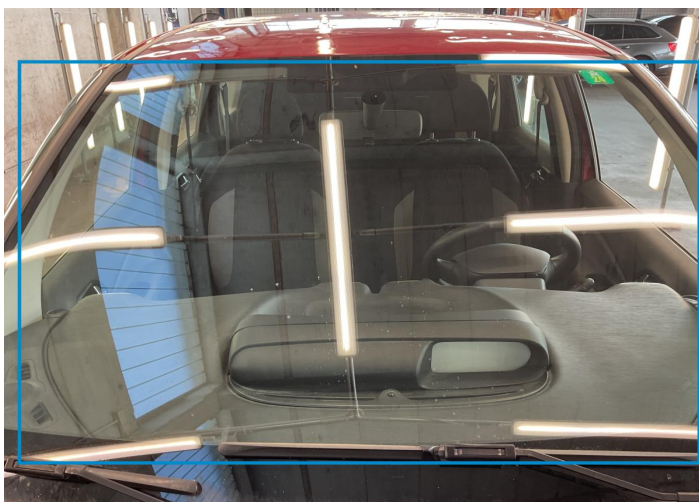
| Component | Damage | Comments |
|---|---|---|
| 1 Windshield / Front | Glass Break / Impact | |

1. Windshield / Front  
Glass Break / Impact -

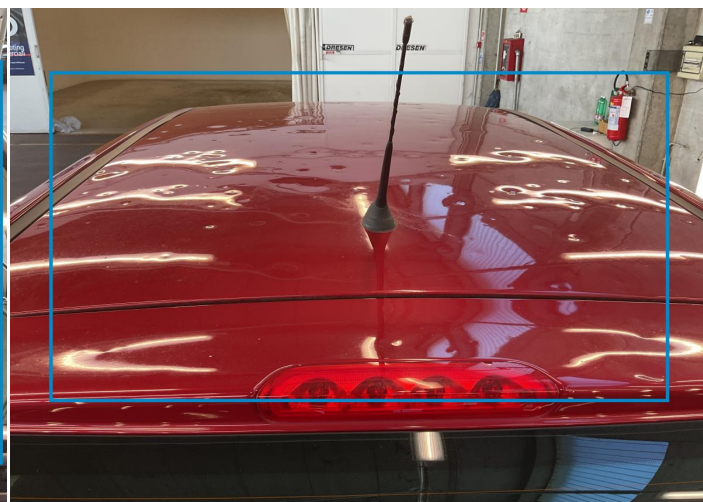
| Component | Damage | Comments |
|---|---|---|
| 2 Roof | Bodywork / Dent / Hail Area | |

2. Roof  
Bodywork / Dent / Hail Area -

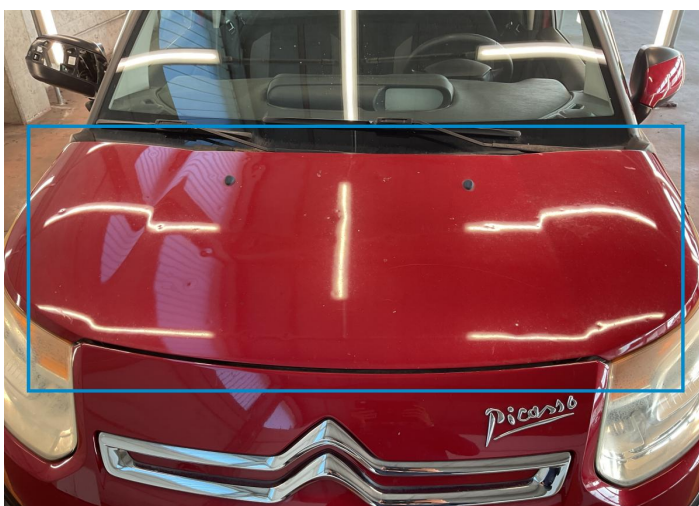
| Component | Damage | Comments |
|---|---|---|
| 3 Hood | Bodywork / Dent / Hail Area | |

3. Hood  
Bodywork / Dent / Hail Area -

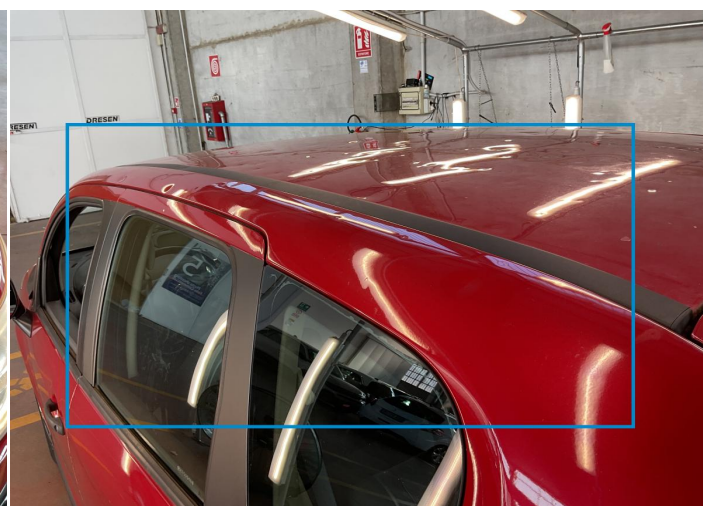
| Component | Damage | Comments |
|---|---|---|
| 4 Pillar / Front Left | Bodywork / Dent / Hail Area | |

4. Pillar / Front Left  
Bodywork / Dent / Hail Area -

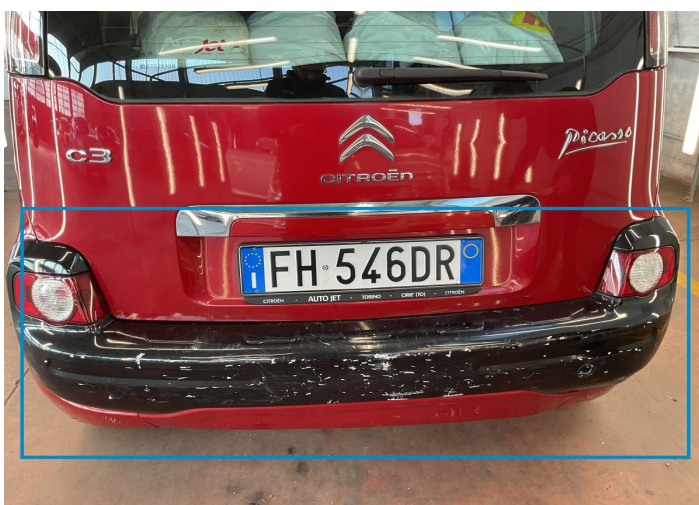
| Component | Damage | Comments |
|---|---|---|
| 5 Bumper / Back | Bodywork / Dent | |

5. Bumper / Back  
Bodywork / Dent -

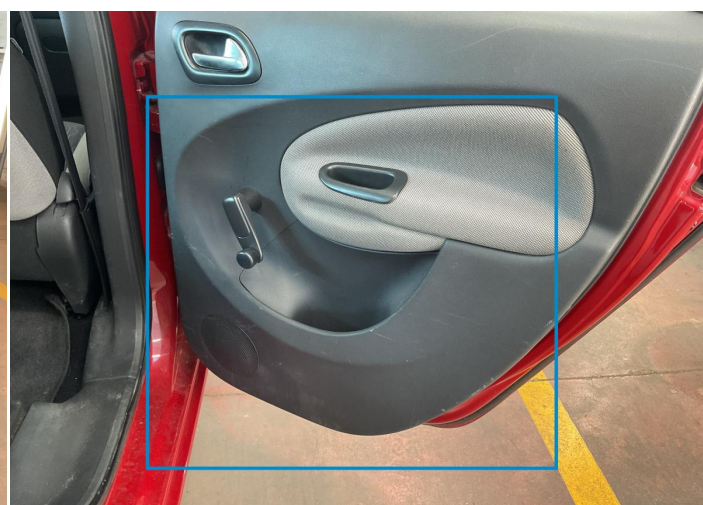
| Component | Damage | Comments |
|---|---|---|
| 6 Panel Filling / Back Right | Interior / Scratched | |

6. Panel Filling / Back Right  
Interior / Scratched -

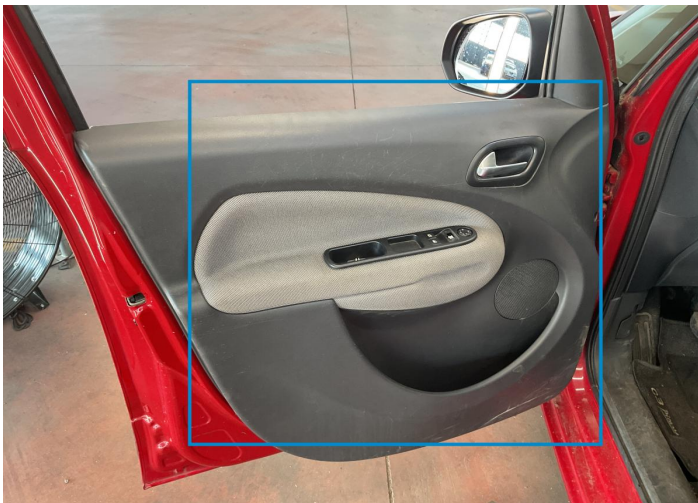
| Component | Damage | Comments |
|---|---|---|
| 7 Panel Filling / Front Left | Interior / Scratched | |

7. Panel Filling / Front Left  
Interior / Scratched -

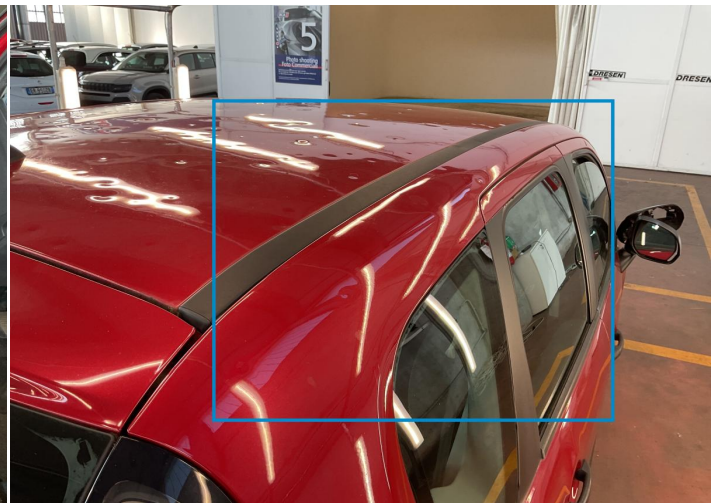
| Component | Damage | Comments |
|---|---|---|
| 8 Pillar / Front Right | Bodywork / Dent / Hail Area | |

8. Pillar / Front Right  
Bodywork / Dent / Hail Area -

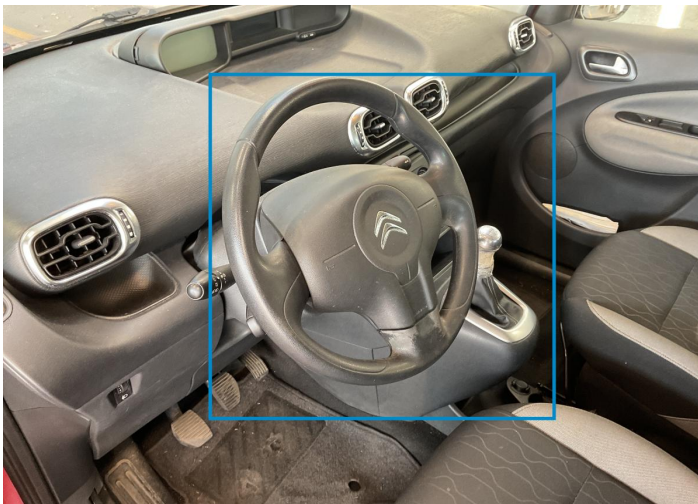
| Component | Damage | Comments |
|---|---|---|
| 9 Steering Wheel / Front | Interior / Worn - out | |

9. Steering Wheel / Front  
Interior / Worn - out -

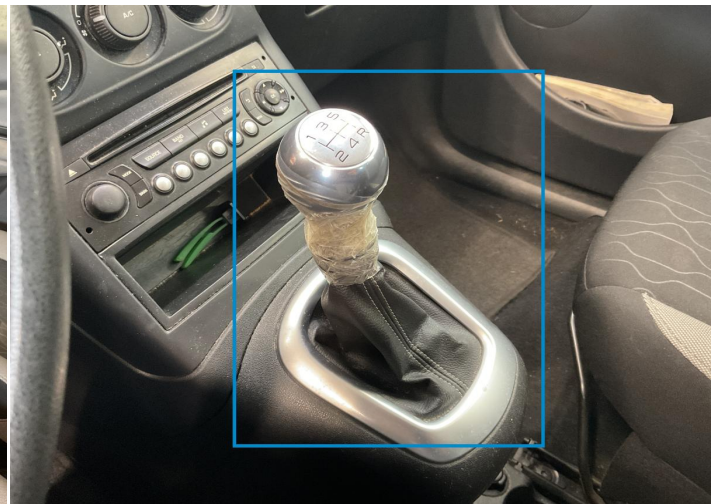
| Component | Damage | Comments |
|---|---|---|
| 10 Center Console | Interior / Broken | |

10. Center Console  
Interior / Broken -

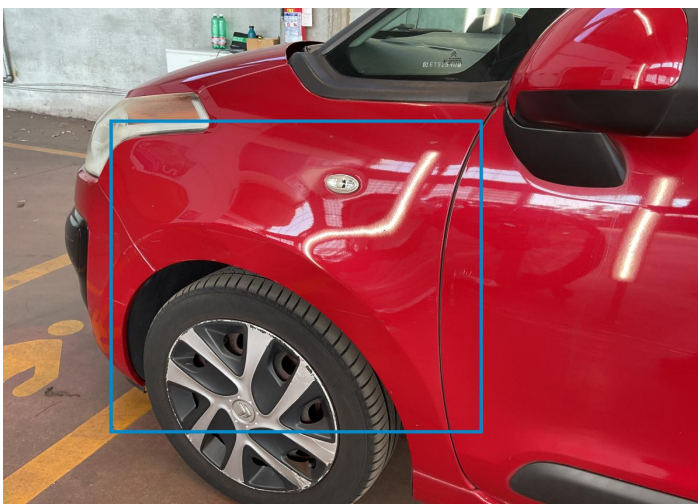
| Component | Damage | Comments |
|---|---|---|
| 11 Fender / Front Left | Bodywork / Dent | |

11. Fender / Front Left  
Bodywork / Dent -

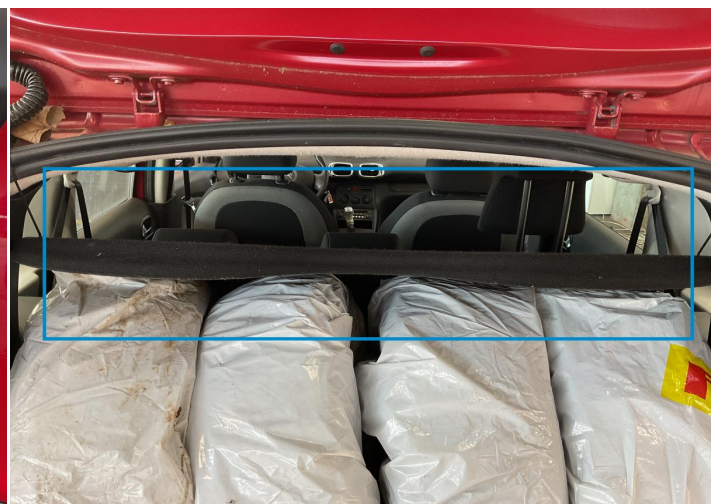
| Component | Damage | Comments |
|---|---|---|
| 12 Luggage Space Cover / Back | Interior / Broken | |

12. Luggage Space Cover / Back  
Interior / Broken -

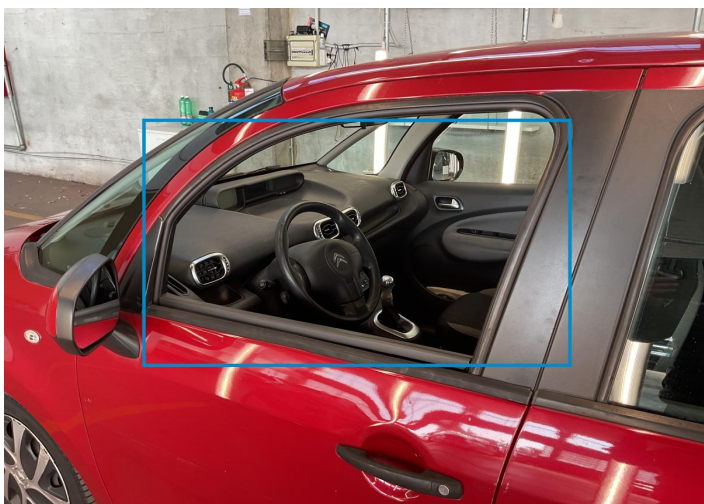
| 13 | Side Window / Front Left | Bodywork / Assembly | Alza cristalli NON FUNZIONANTE |

13. Side Window / Front Left  
Bodywork / Assembly -  
Alza cristalli NON FUNZIONANTE

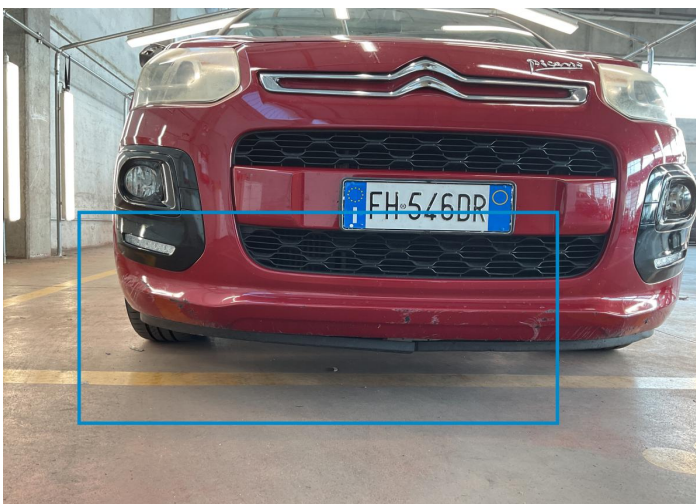
| 14 | Bumper / Front | Bodywork / Breakage | |

14. Bumper / Front  
Bodywork / Breakage -

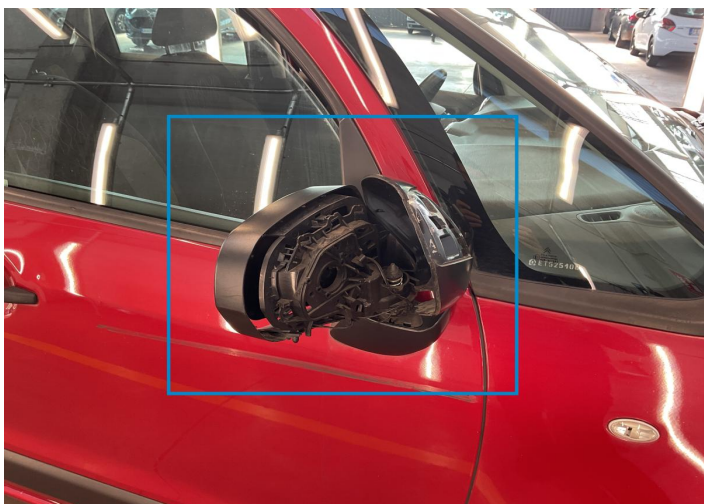
| 15 | Mirror Shell / Front Right | Bodywork / Breakage | |

15. Mirror Shell / Front Right  
Bodywork / Breakage -

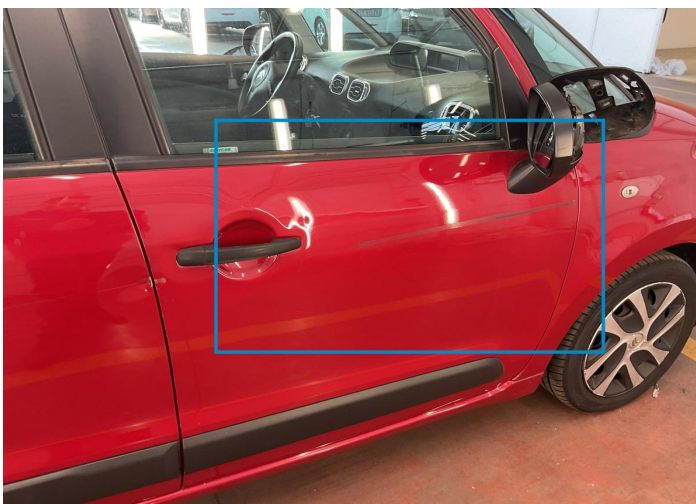
| 16 | Door / Front Right | Bodywork / Dent | |

16. Door / Front Right  
Bodywork / Dent -

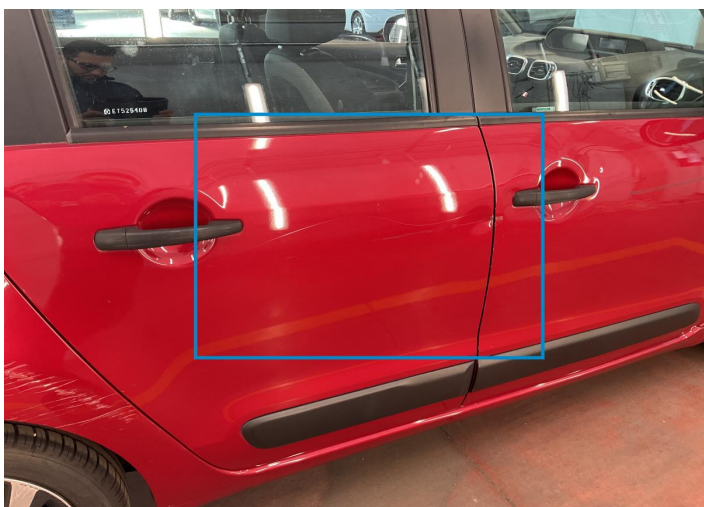
| 17 | Door / Back Right | Bodywork / Dent | |

17. Door / Back Right  
Bodywork / Dent -

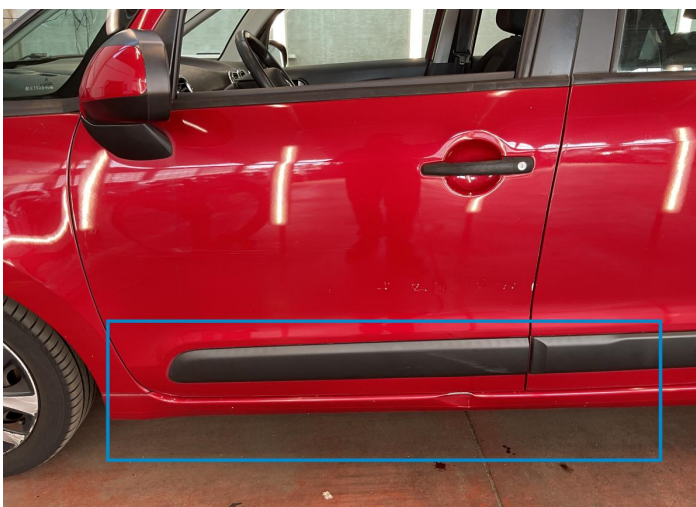
| 18 | Rocker Panel / Center Left | Bodywork / Dent | |

18. Rocker Panel / Center Left  
Bodywork / Dent -

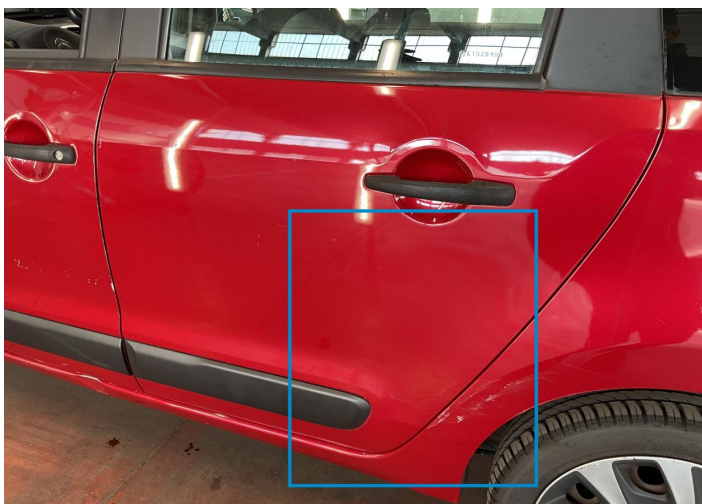
| 19 | Door / Back Left | Paint / Scratch / Line | |

19. Door / Back Left  
Paint / Scratch / Line -

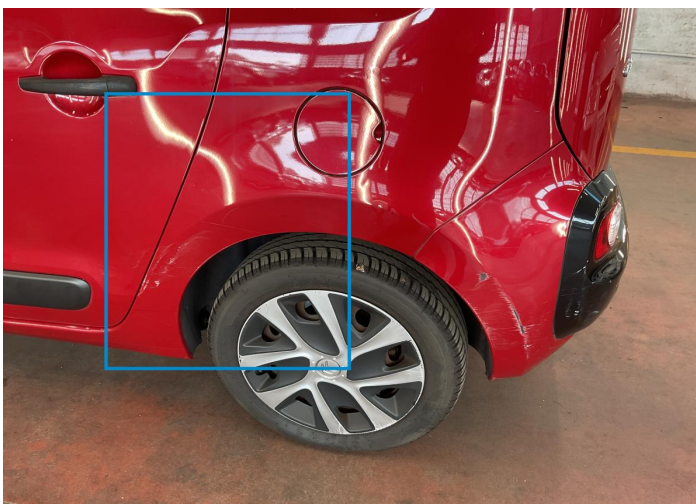
| 20 | Fender / Back Left | Bodywork / Dent | |

20. Fender / Back Left  
Bodywork / Dent -

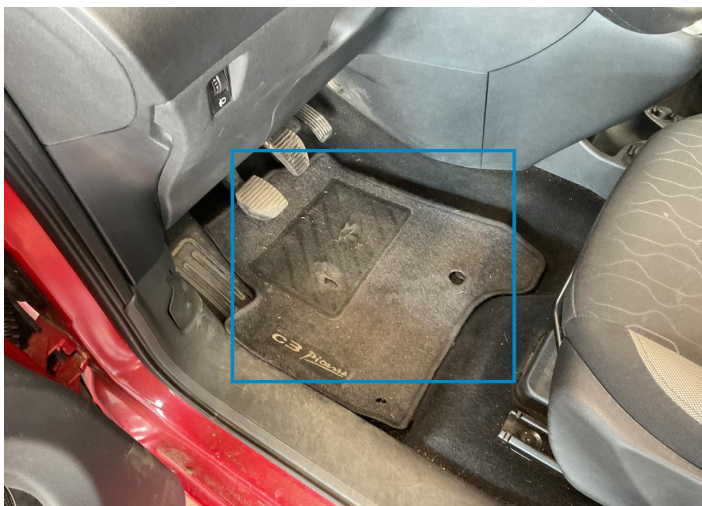
| 21 | Floor Carpet | Interior / Ripped | |

21. Floor Carpet  
Interior / Ripped -

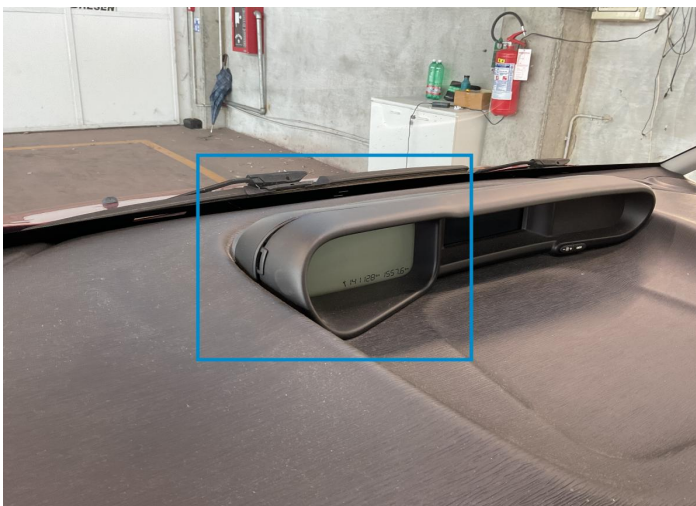
| 22 | Dashboard / Front | Interior / Broken | |

22. Dashboard / Front  
Interior / Broken -

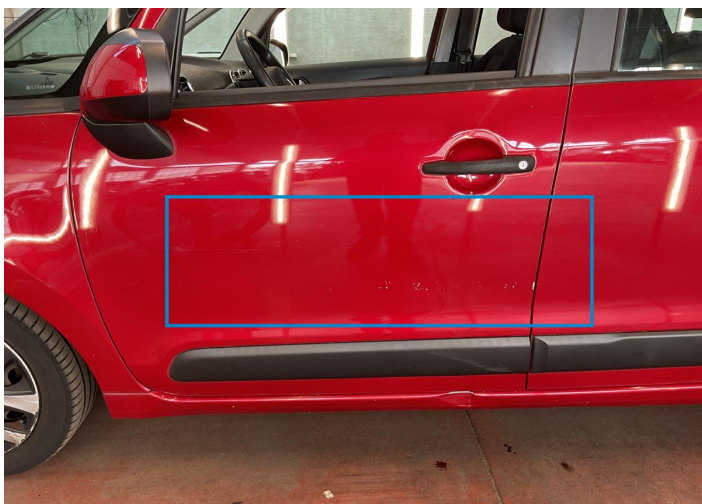
| 23 | Door / Front Left | Bodywork / Dent | |

23. Door / Front Left  
Bodywork / Dent -

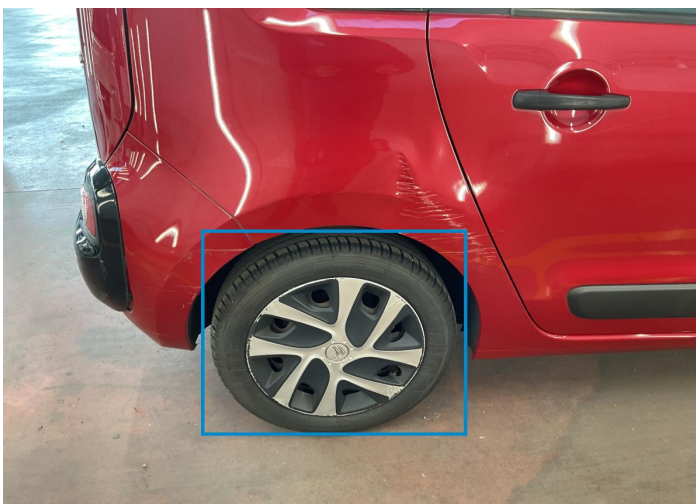
| 24 | Hubcap / Back Right | Out of Bodywork / Scratch | |

24. Hubcap / Back Right  
Out of Bodywork / Scratch -

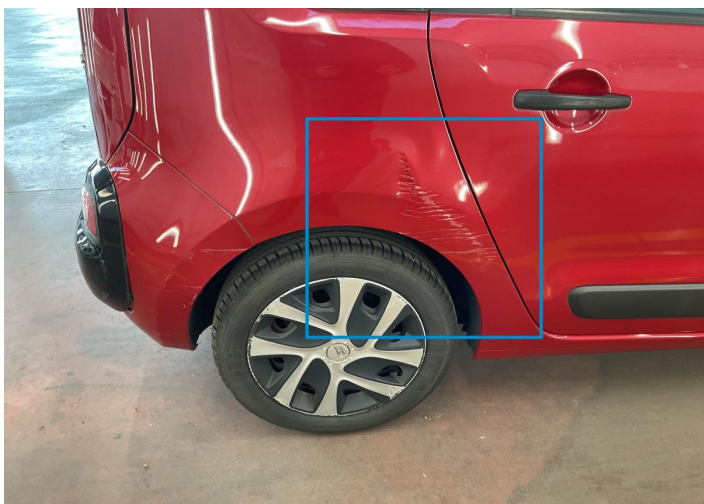
| 25 | Fender / Back Right | Bodywork / Dent | |

25. Fender / Back Right  
Bodywork / Dent -

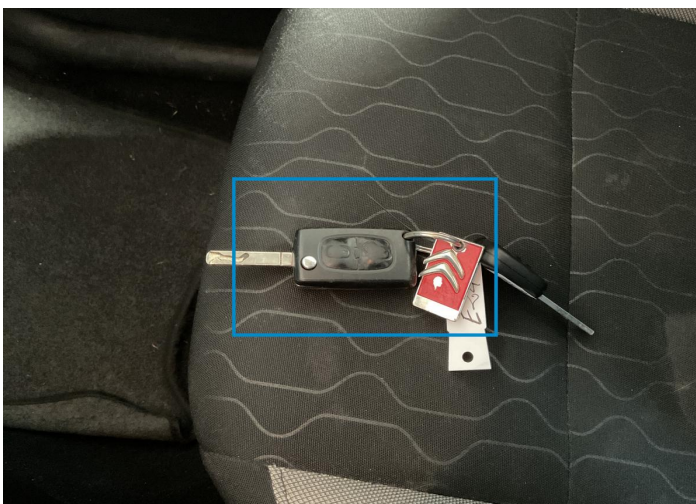
| 26 | Ignition Key | Interior / Broken | |

26. Ignition Key  
Interior / Broken -

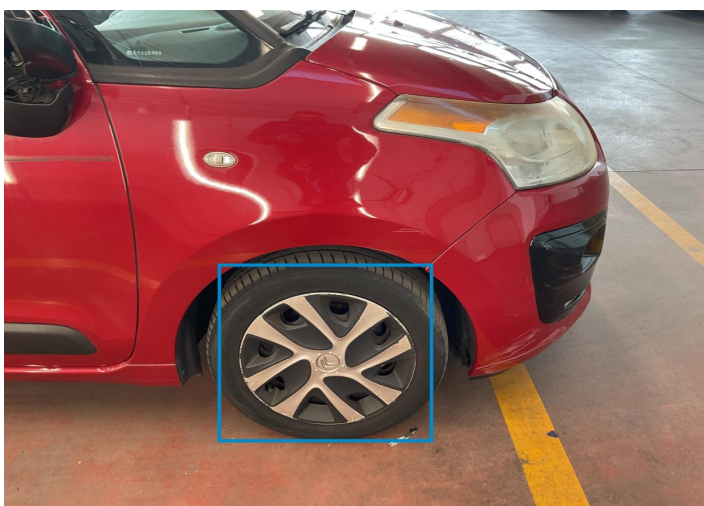
| 27 | Hubcap / Front Right | Out of Bodywork / Scratch | |

27. Hubcap / Front Right  
Out of Bodywork / Scratch -

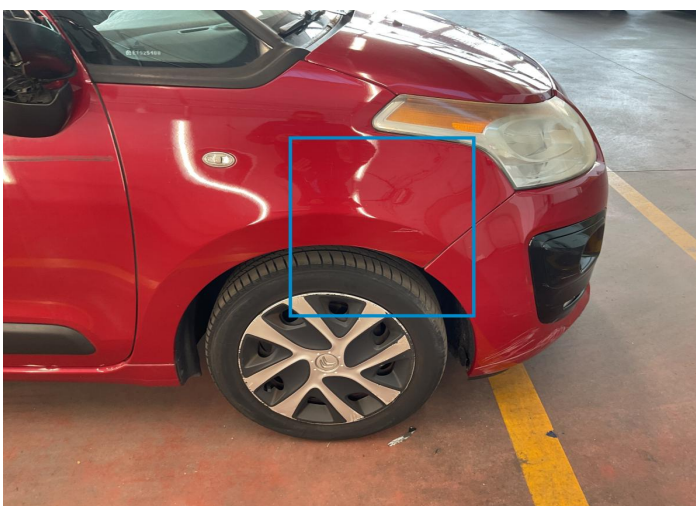
| 28 | Fender / Front Right | Bodywork / Dent | |

28. Fender / Front Right  
Bodywork / Dent -

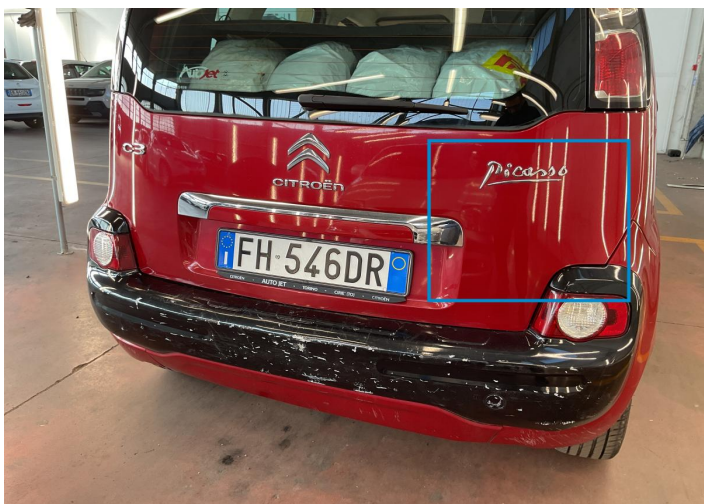
| 29 | Tailgate | Bodywork / Dent / Dent | |

29. Tailgate  
Bodywork / Dent / Dent -

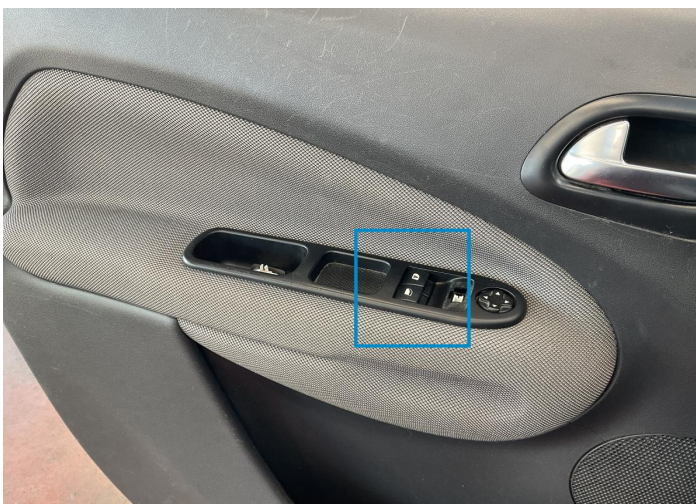
| 30 | Window Switch / Front Left | Interior / Dysfunctional | |

30. Window Switch / Front Left  
Interior / Dysfunctional -

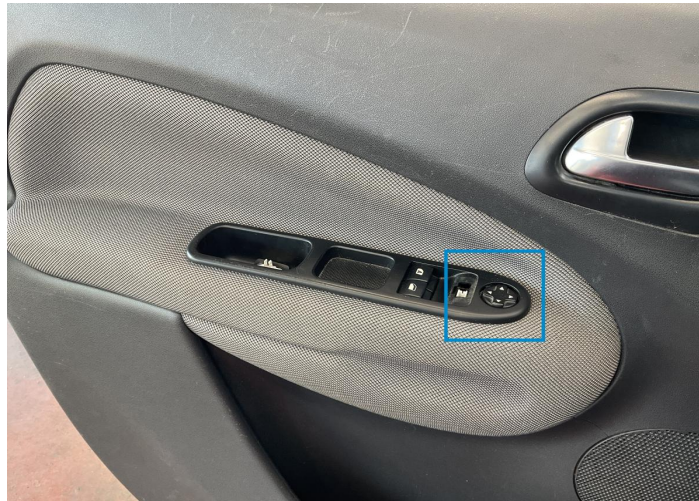
| 31 | Window Switch / Front Left | Interior / Broken | |

31. Window Switch / Front Left  
Interior / Broken -
