# CITROEN C4

## C4 Picasso HDi 150 FAP Millenium BMP6

VIN NO VF7UDRHB8BJ747173  
Registration Number BT366YJ

### Inspection Report Summary

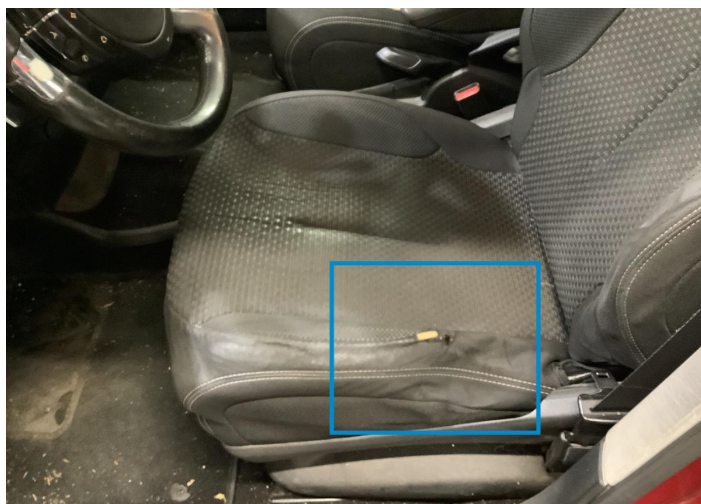
1. Seat / Front Left  
Interior / Holed -

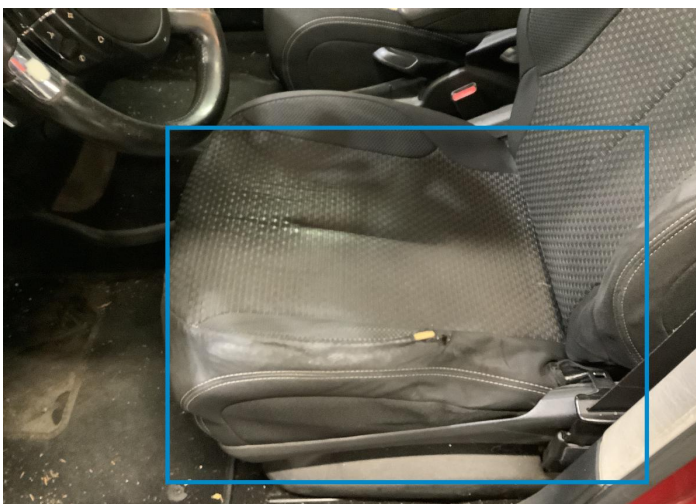
2. Seat / Front Left  
Interior / Dirty -

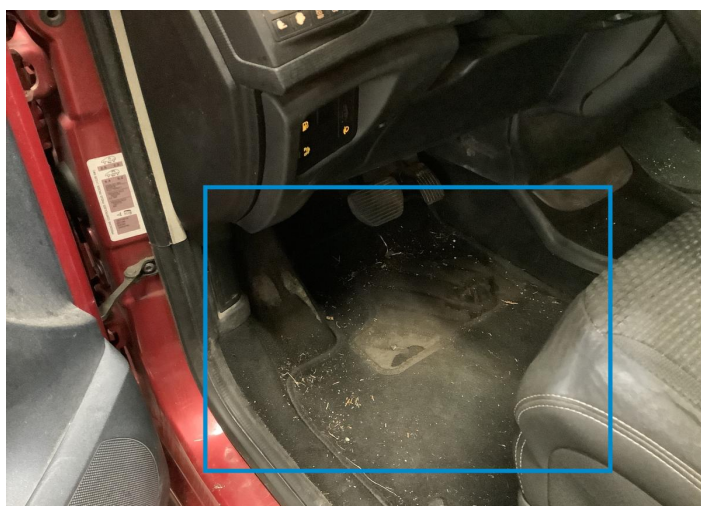
3. Floor Carpet  
Interior / Ripped -

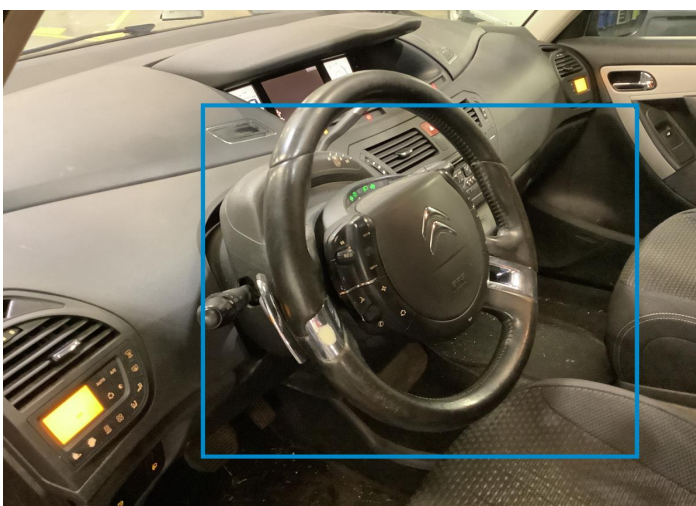
4. Steering Wheel / Front  
Interior / Worn - out -

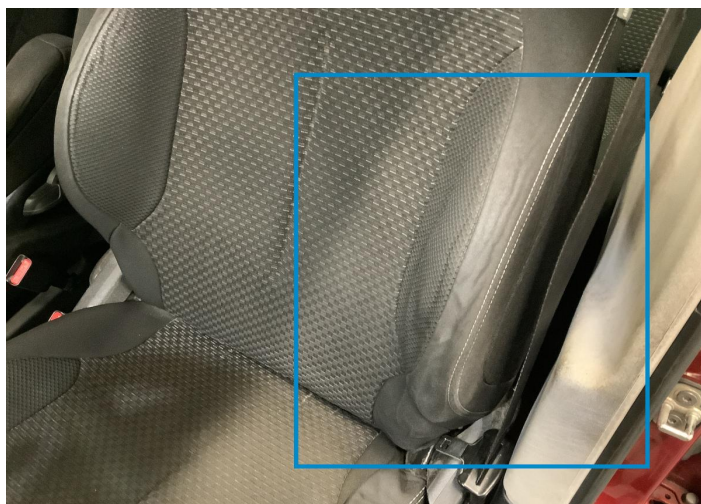
5. Seat / Front Left  
Interior / Broken -

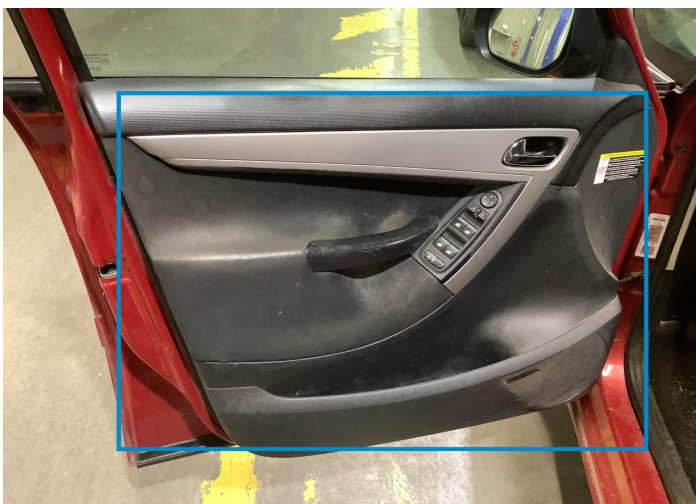
6. Panel Filling / Front Left  
Interior / Dirty -

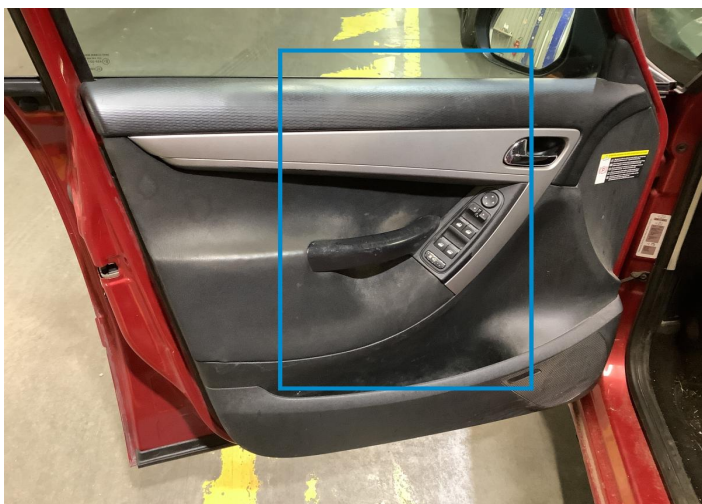
7. Panel Filling / Front Left  
Interior / Scraped -

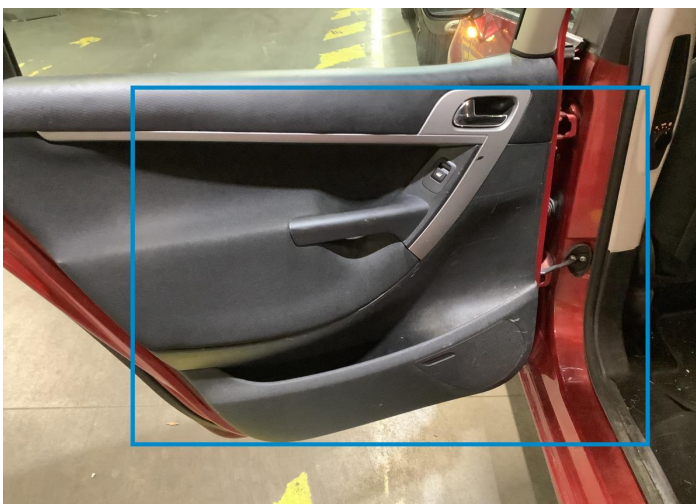
8. Panel Filling / Back Left  
Interior / Scraped -

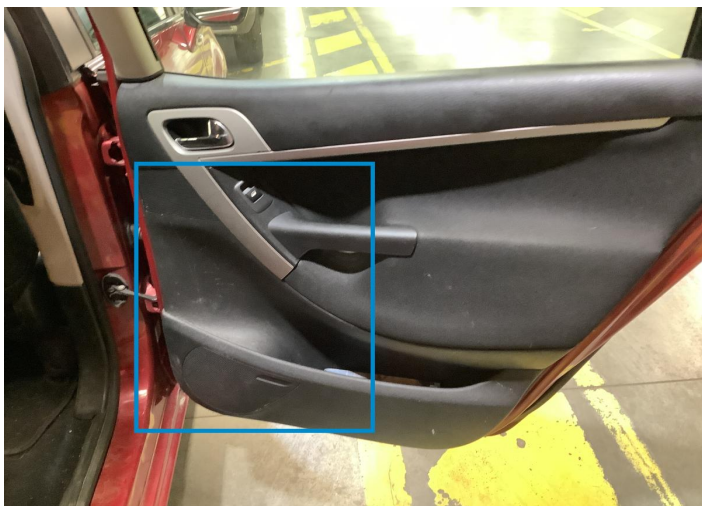
9. Panel Filling / Back Right  
Interior / Scraped -

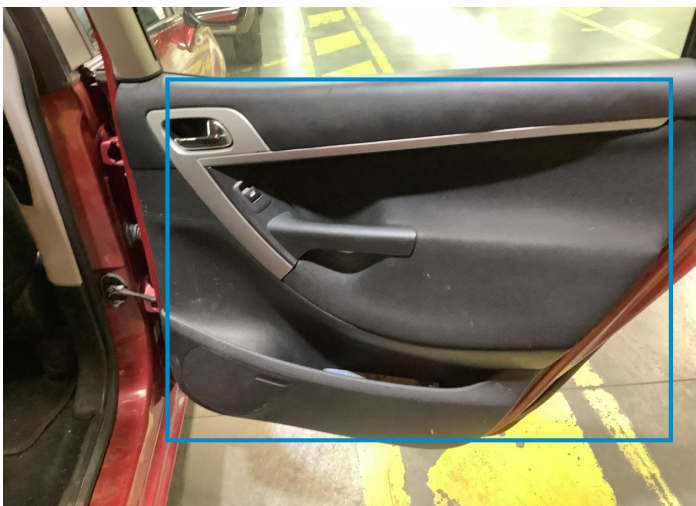
10. Panel Filling / Back Right  
Interior / Stained -

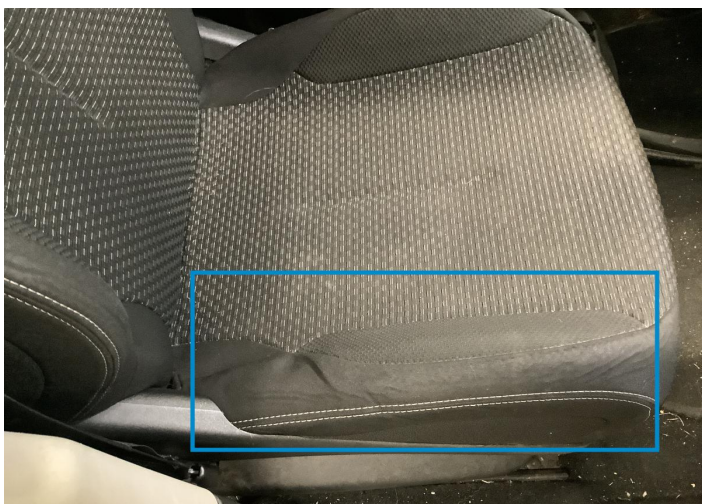
11. Seat / Front Right  
Interior / Broken -

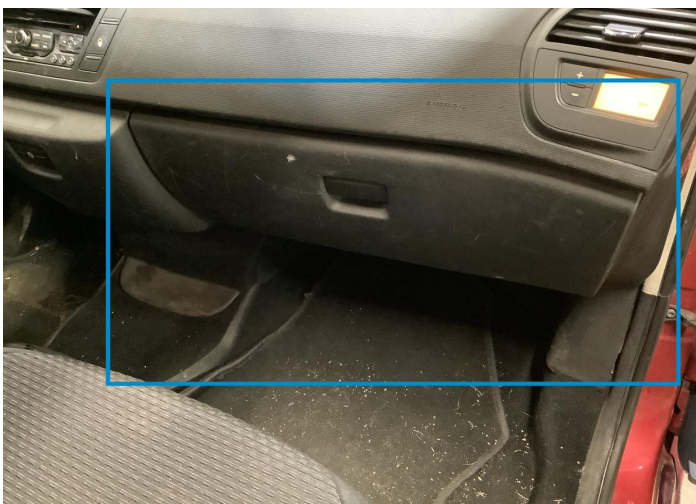
12. Glovebox  
Interior / Scraped -

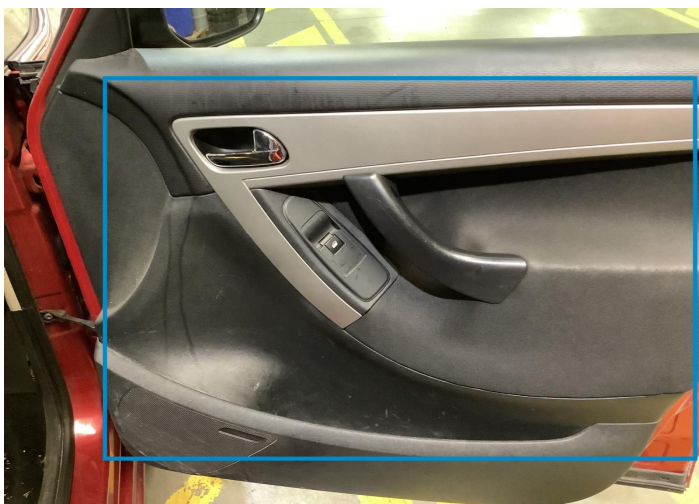
13. Panel Filling / Front Right Interior / Scraped -

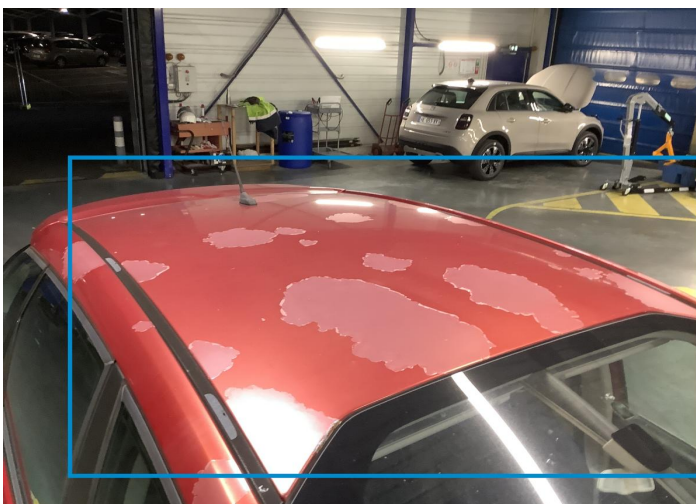
14. Roof Paint / Poor Previous Repair -

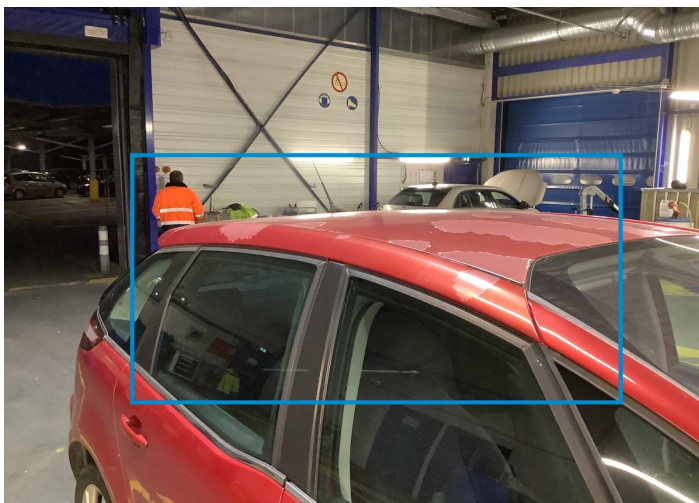
15. Cant Rail / Right Paint / Poor Previous Repair -

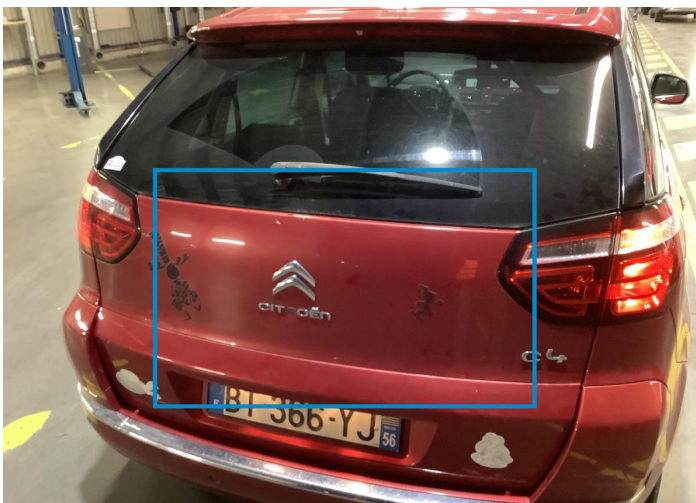
16. Tailgate Paint / Poor Previous Repair -

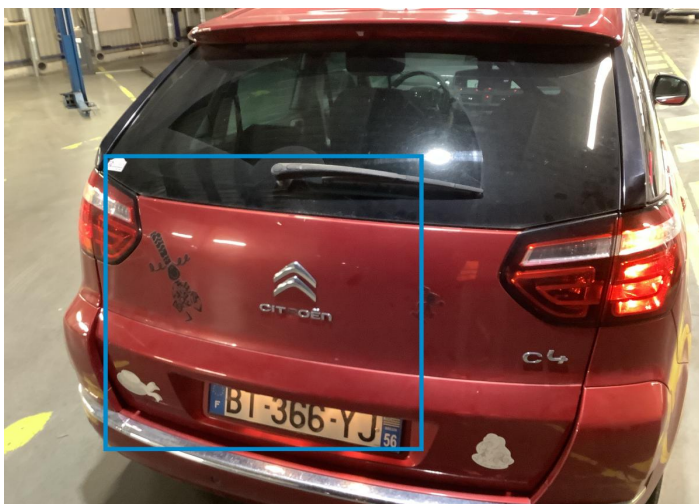
17. Tailgate Bodywork / Dent / Dent -

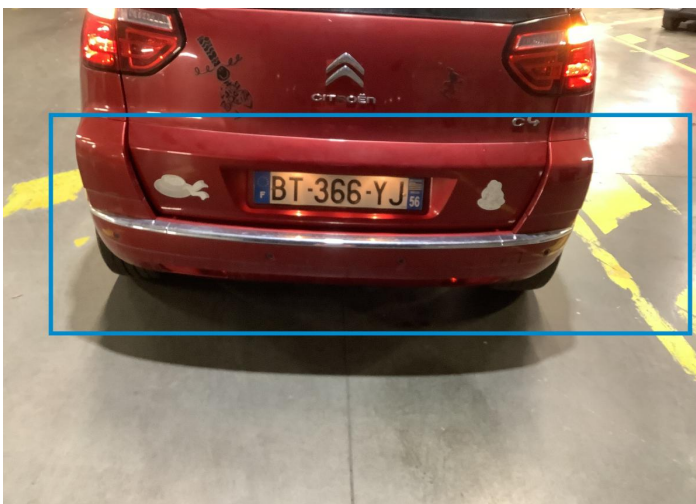
18. Bumper / Back Paint / Scratch / Line -

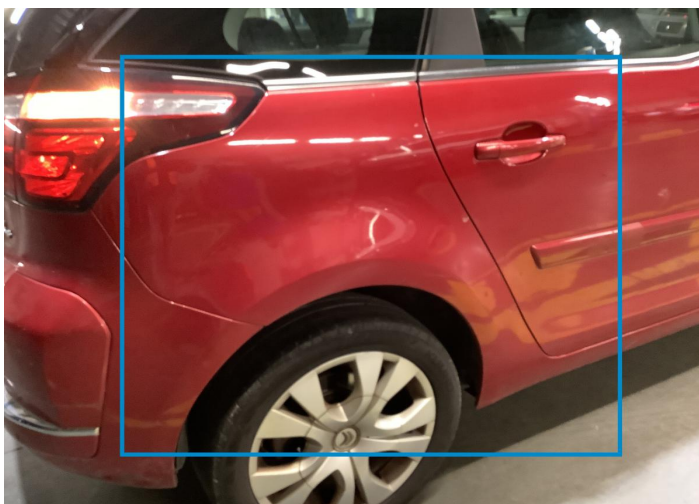
19. Fender / Back Right  
Bodywork / Dent / Deformation -

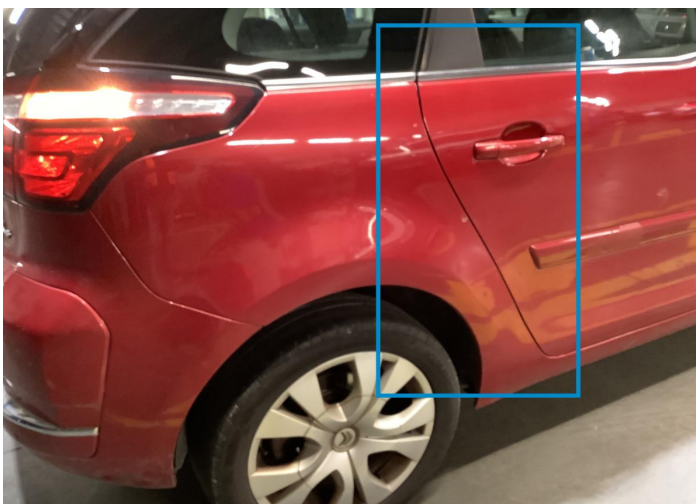
20. Fender / Back Right  
Paint / Poor Previous Repair -

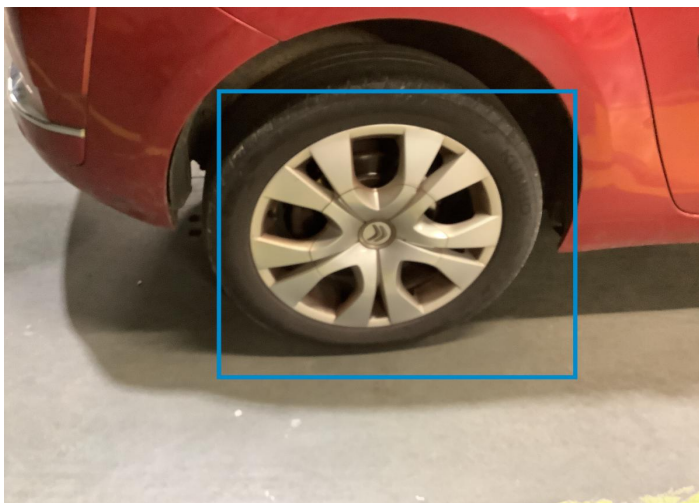
21. Rim Brake pads  
Out of Bodywork / Scratch -

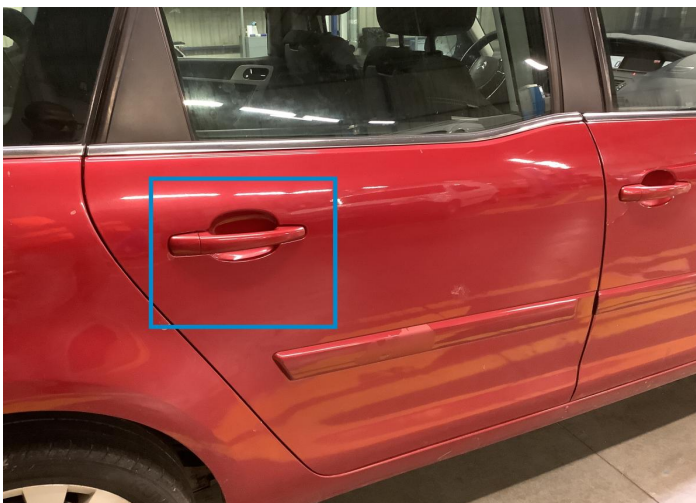
22. Door / Back Right  
Paint / Poor Previous Repair -

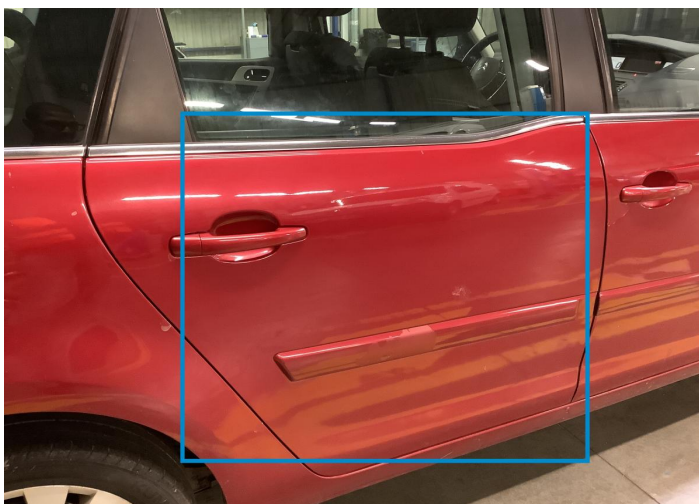
23. Door / Back Right  
Bodywork / Dent / Dent -

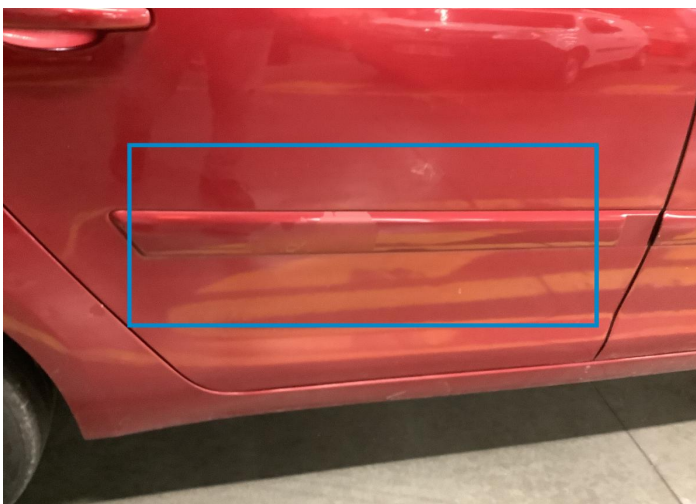
24. Door Side Molding / Back Right  
Paint / Poor Previous Repair -

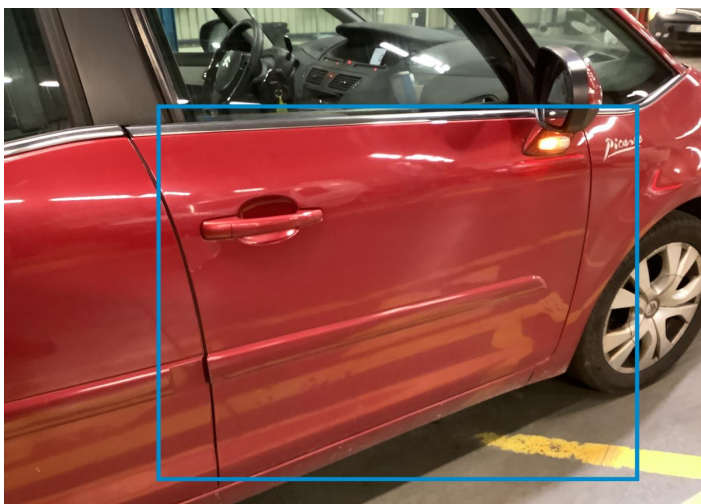
25. Door / Front Right  
Paint / Poor Previous Repair -

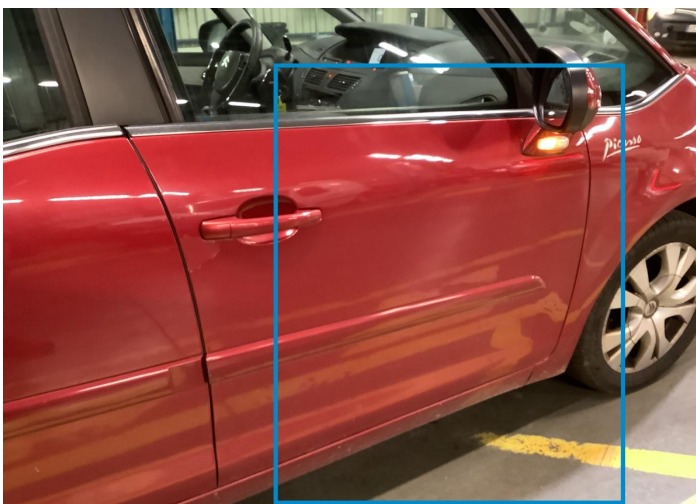
26. Door / Front Right  
Bodywork / Dent / Dent -

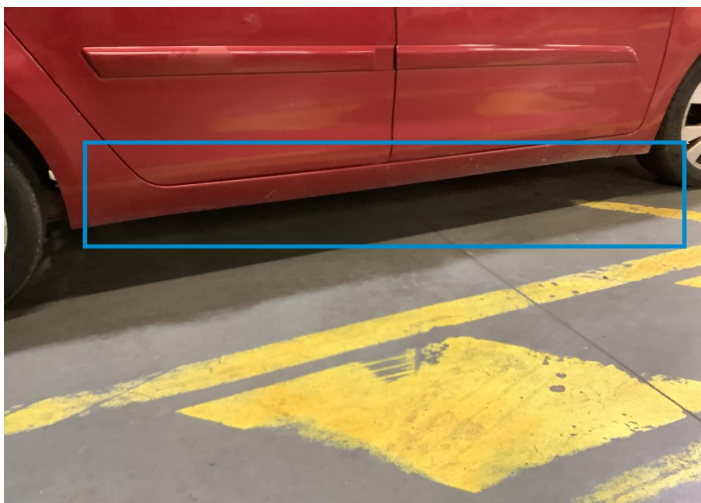
27. Rocker Panel / Center Right  
Paint / Poor Previous Repair -

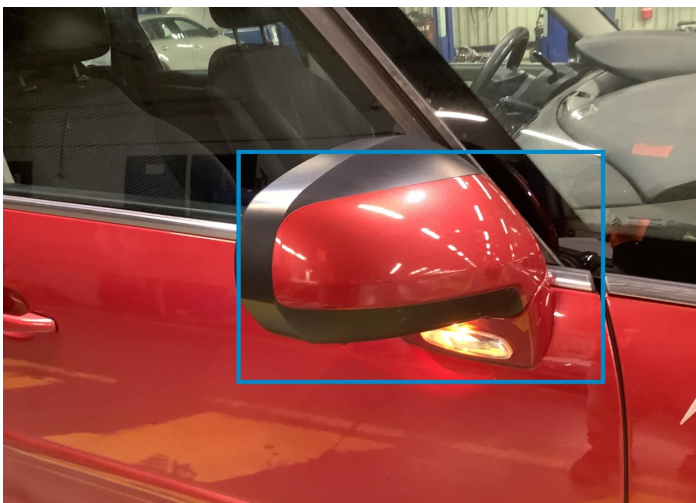
28. Mirror Shell / Front Right  
Paint / Scratch / Line -

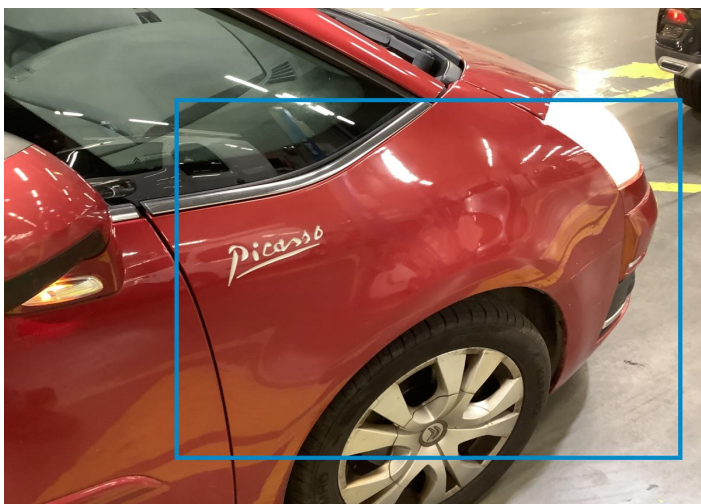
29. Fender / Front Right  
Paint / Scratch / Line -

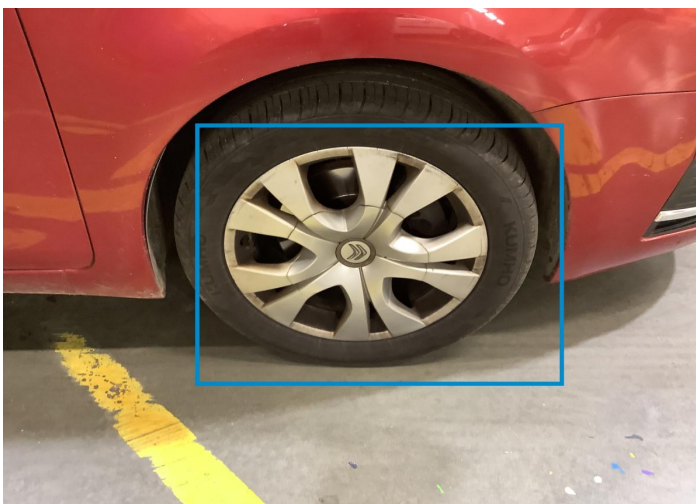
30. Rim  
Out of Bodywork / Scratch -

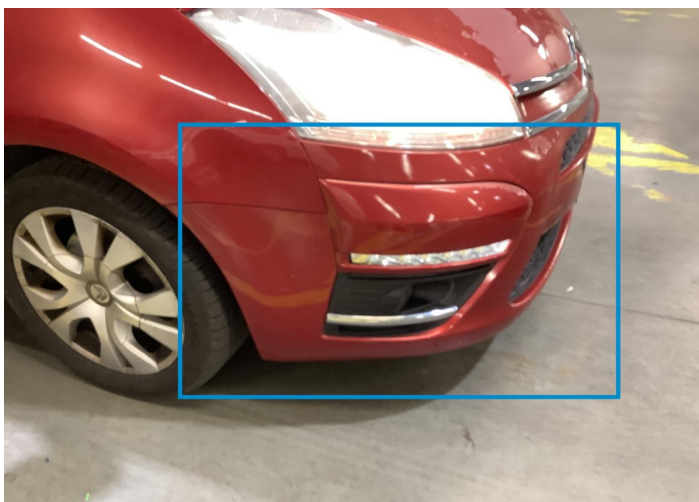
31. Corner Bumper / Front Right  
Paint / Poor Previous Repair -

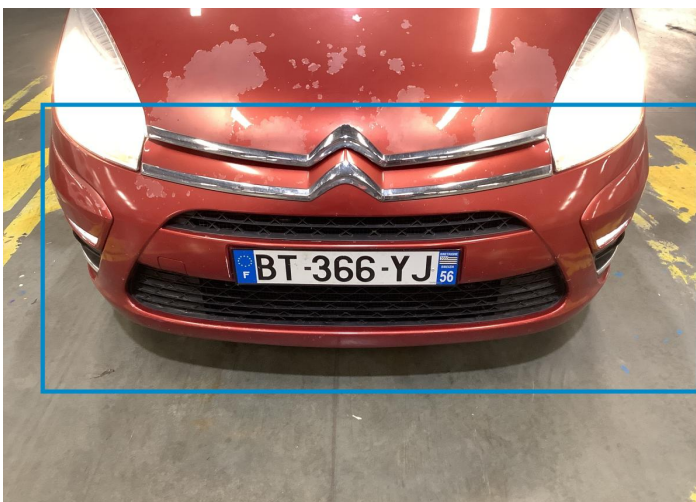
32. Bumper / Front  
Paint / Poor Previous Repair -

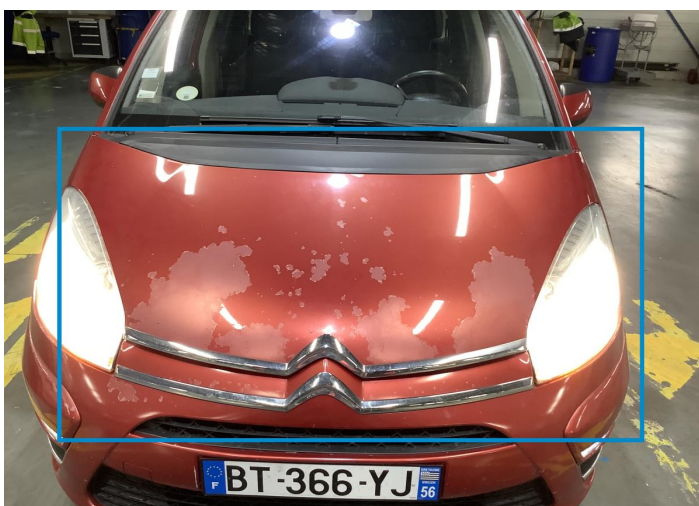
33. Hood  
Paint / Poor Previous Repair -

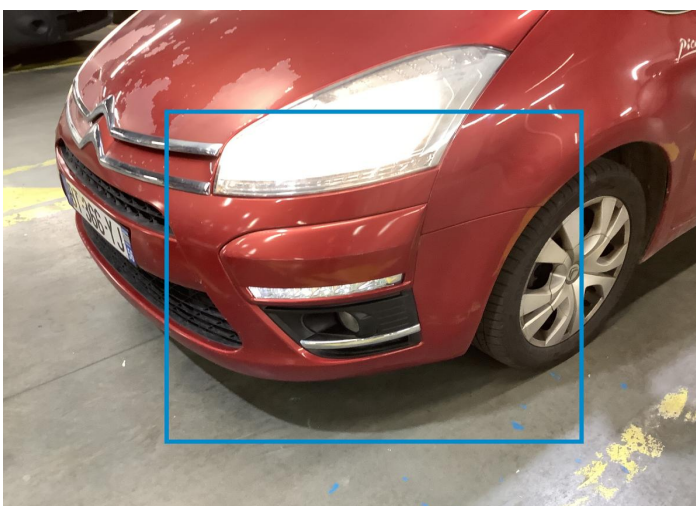
34. Corner Bumper / Front Left  
Paint / Poor Previous Repair -

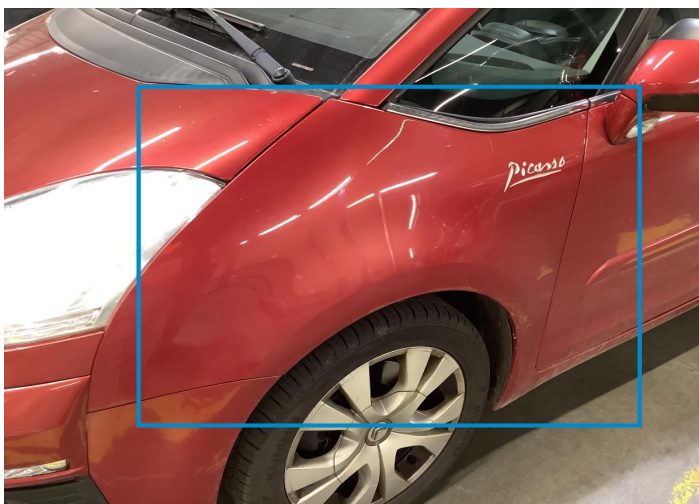
35. Fender / Front Left  
Paint / Scratch / Line -

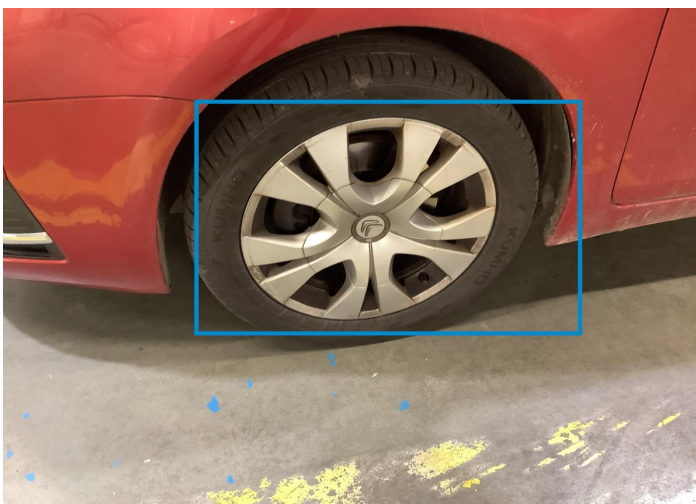
36. Rim  
Out of Bodywork / Scratch -

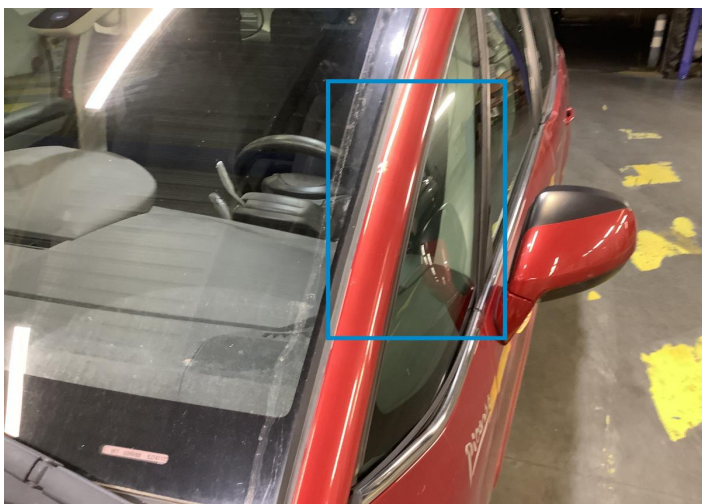
37. Pillar / Front Left  
Paint / Poor Previous Repair -

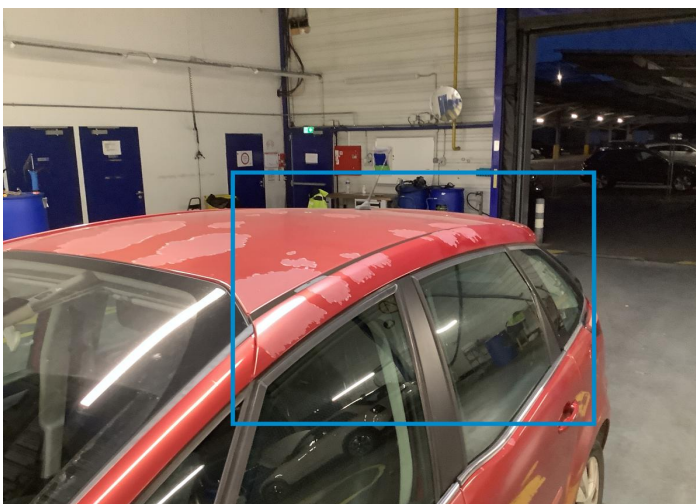
38. Cant Rail / Left  
Paint / Poor Previous Repair -

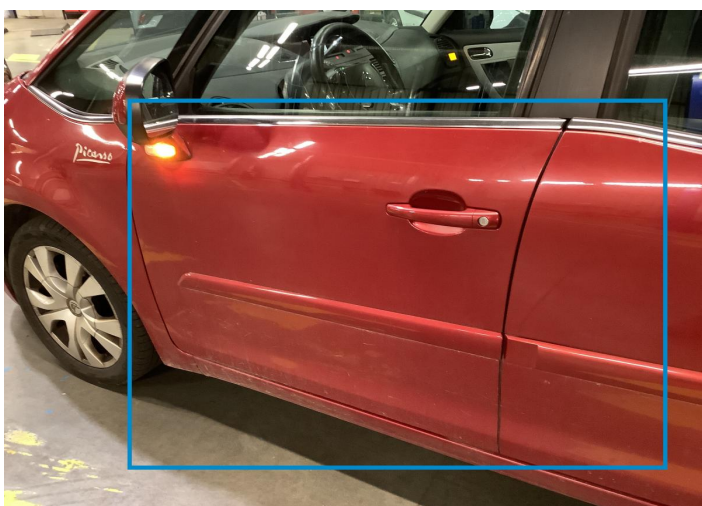
39. Door / Front Left  
Paint / Scratch / Line -

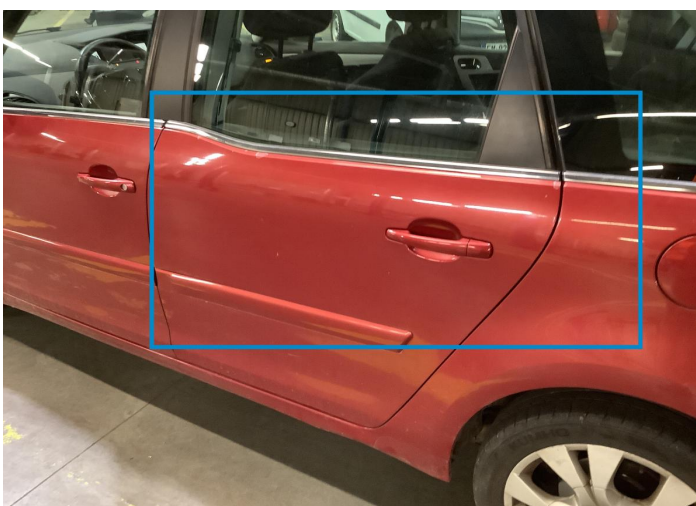
40. Door / Back Left  
Paint / Poor Previous Repair -

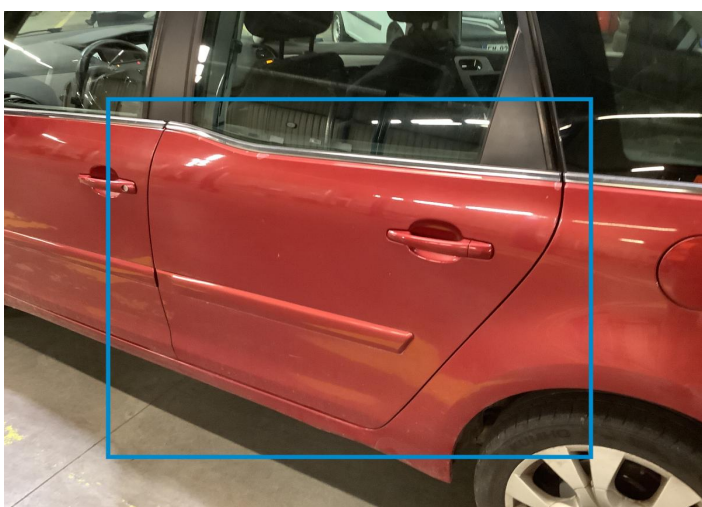
41. Door / Back Left  
Bodywork / Dent / Deformation -

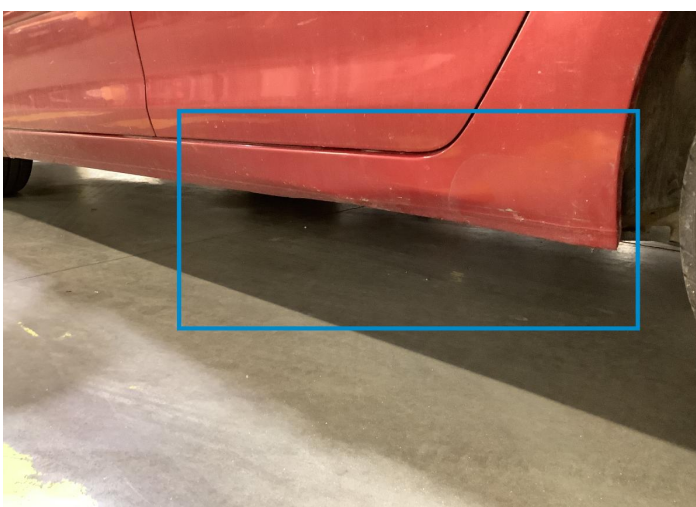
42. Rocker Panel / Center Left  
Bodywork / Dent / Deformation -

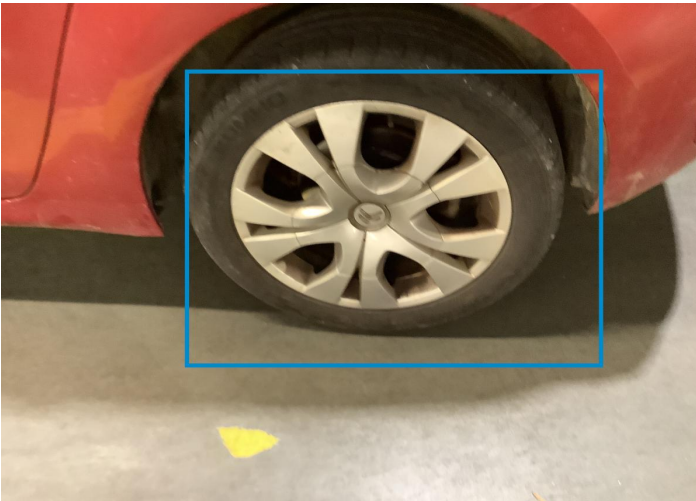
43. Rim  
Out of Bodywork / Scratch -

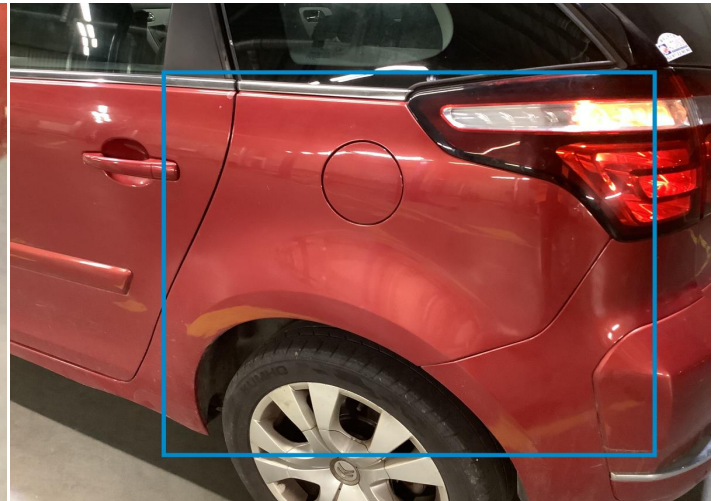
44. Fender / Back Left  
Paint / Scratch / Line -

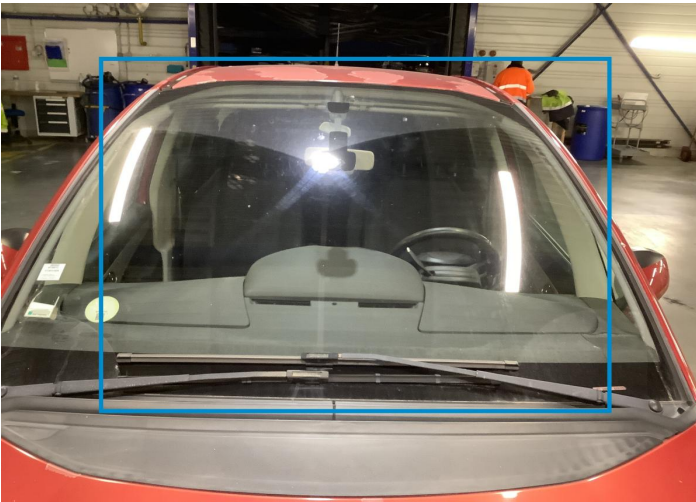
45. Windshield / Front  
Glass Break / Impact -
