## status report

**customer:** Bank 11, Neuss  
**contract number:** 585175030  
**reference:**

#### Citroën Spacetourer Shine XL

| Vehicle identification number | <b>VF7VEAHHWJZ065628</b> | mileage read: | <b>197281 km</b> |

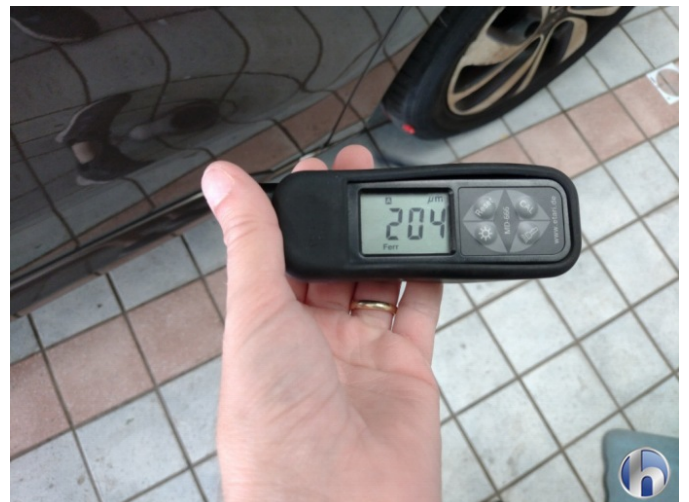
| component | Damage | Rep kind |
|---|---|---|
| 1. Front door - right | Subsequently painted | acceptable |

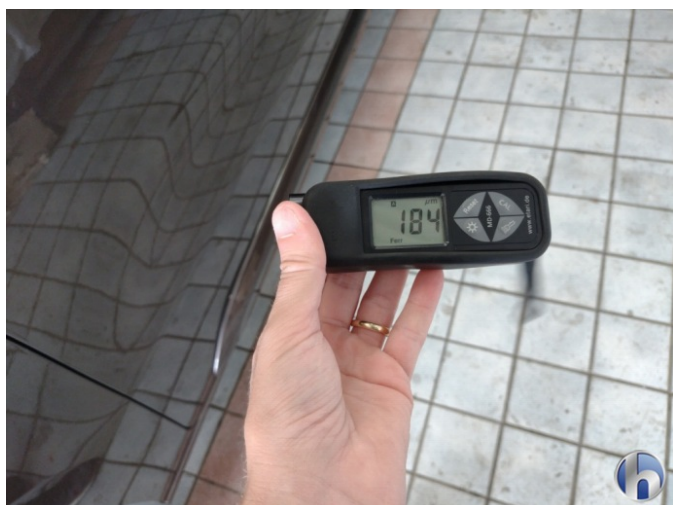
| component | Damage | Rep kind |
|---|---|---|
| 2. Door Rear - right | Subsequently painted | acceptable |

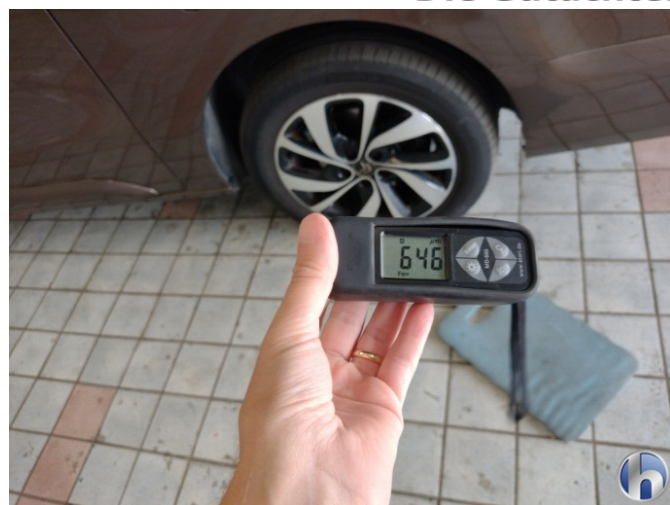
| component | Damage | Rep kind |
|---|---|---|
| 3. Sidewall - Rear - Left | Subsequently painted | acceptable |

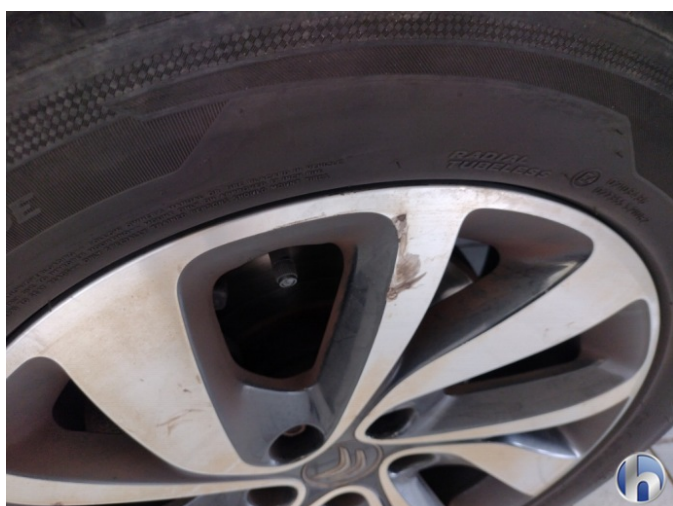
| component | Damage | Rep kind |
|---|---|---|
| 4. Rim front - left | Damaged | Replace |

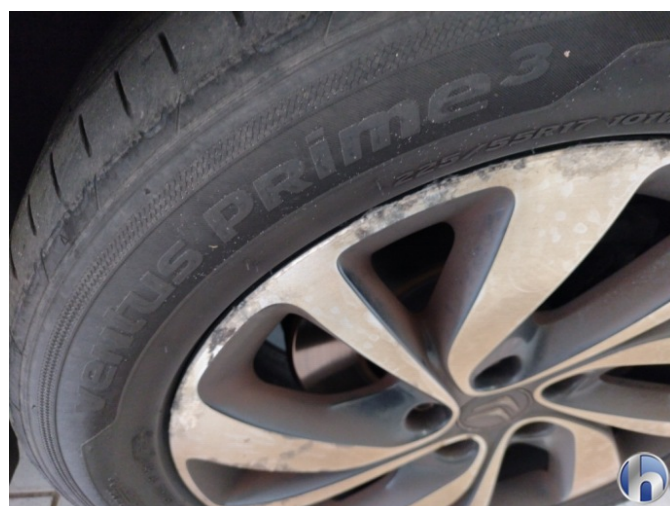
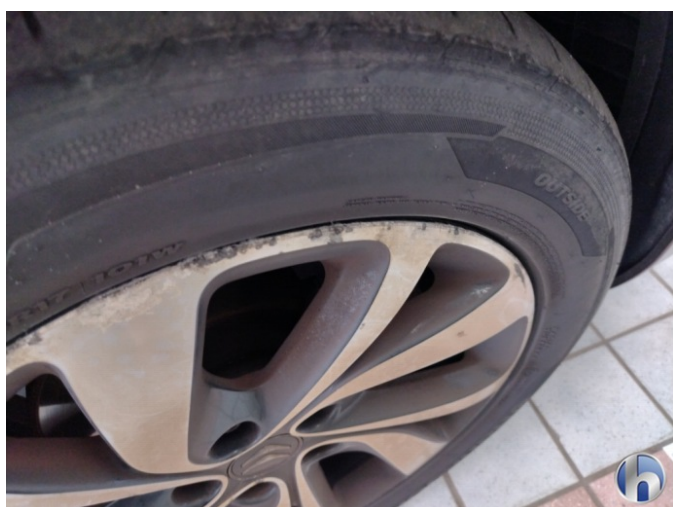
| component | Damage | Rep kind |
|---|---|---|
| 5. Rim front - right | Damaged | Replace |

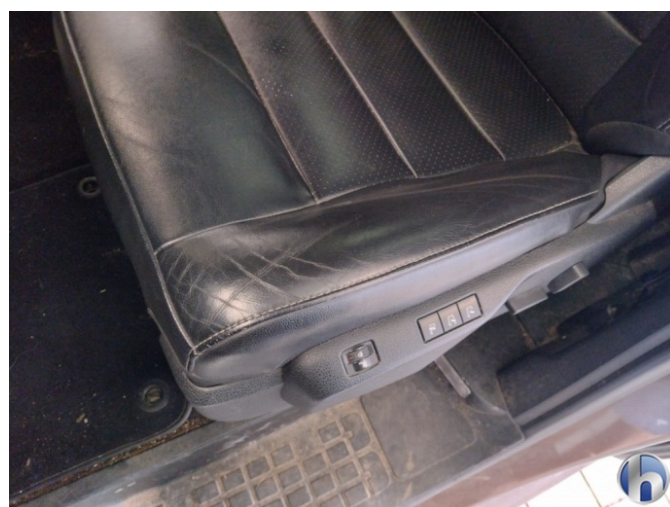
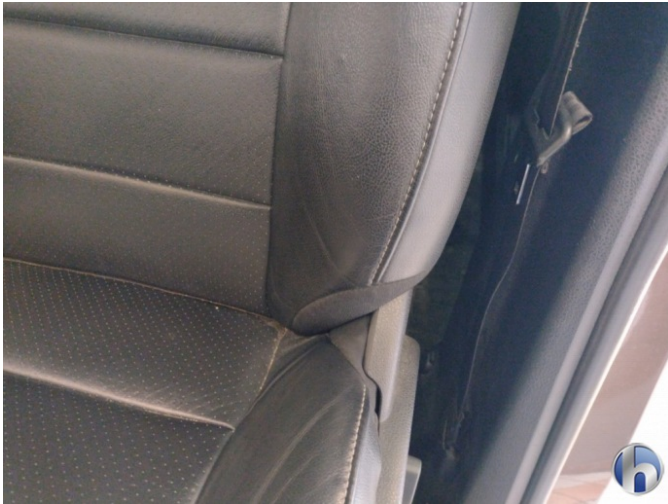
| component | Damage | Rep kind |
|---|---|---|
| 6. Sitz Vorne Links | Damaged | Smart repair |

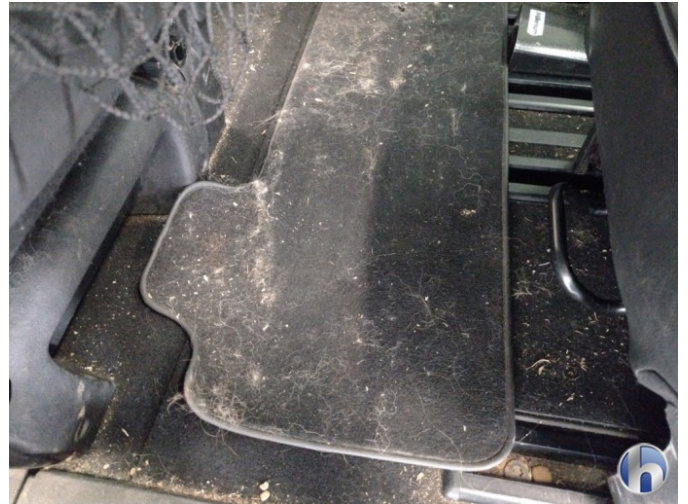
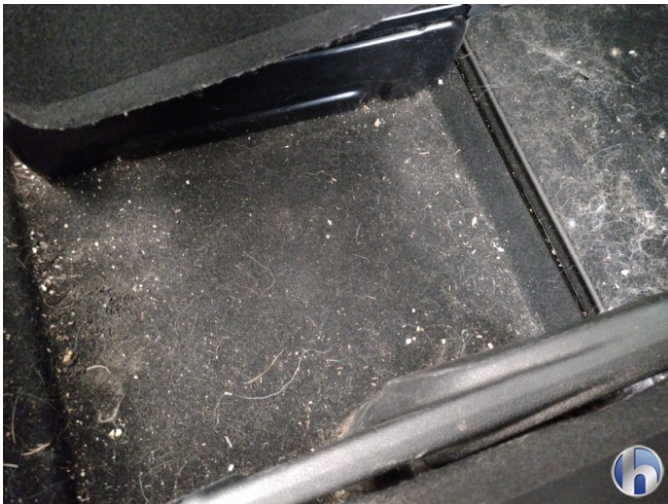
| component | Damage | Rep kind |
|---|---|---|
| 7. flooring | Dirty (animal hair) | |

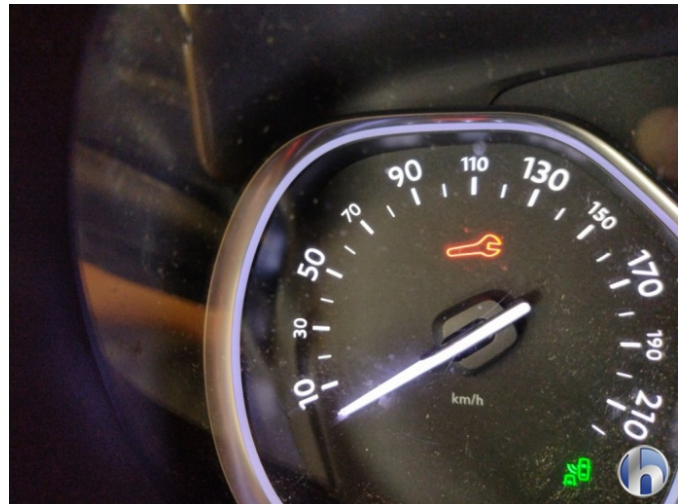
| component | Damage | Rep kind |
|---|---|---|
| 10. maintenance | Due | Replace |

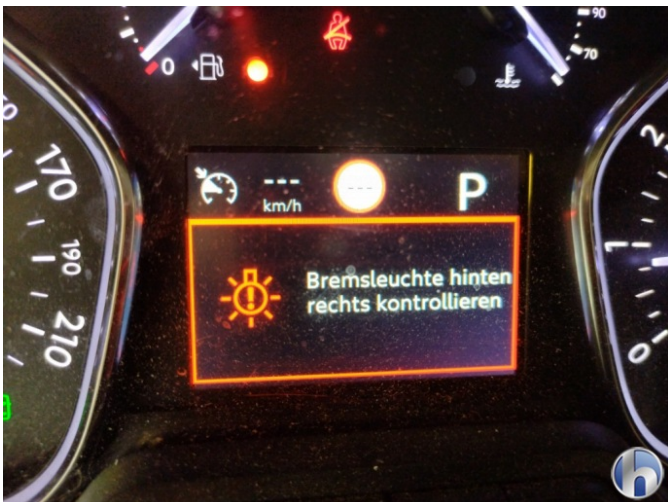
| component | Damage | Rep kind |
|---|---|---|
| 11. Bremslicht | Error message | Carry out a fault diagnosis |

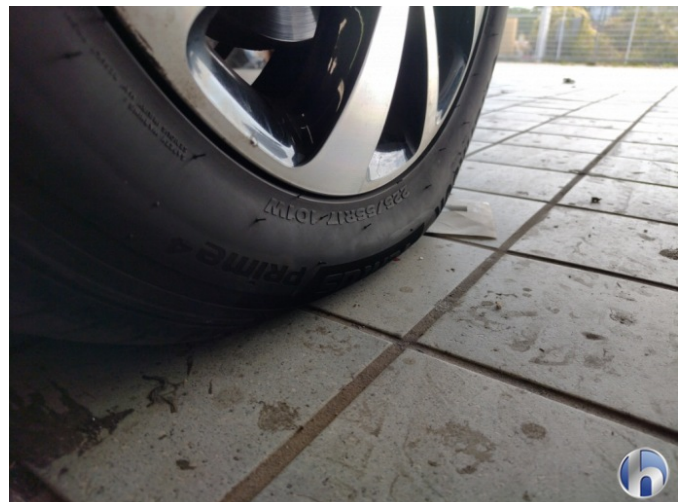
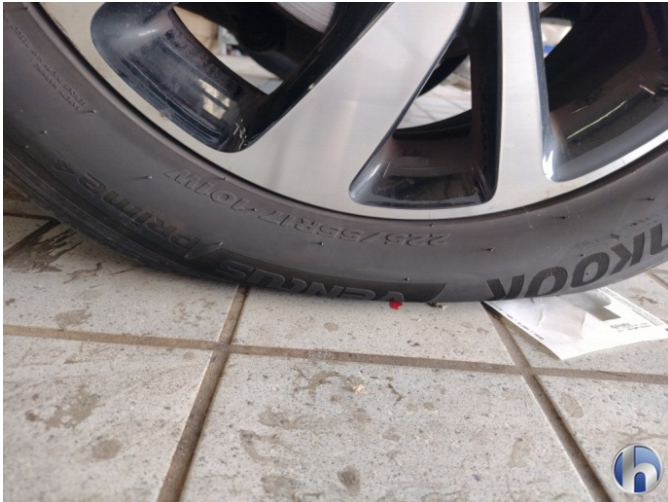
| <b>Note Road Safe:</b> | Reifen HL Undicht |

| component | Damage | Rep kind |
|---|---|---|
| 12. tire rear - left | Leaky | Replace |

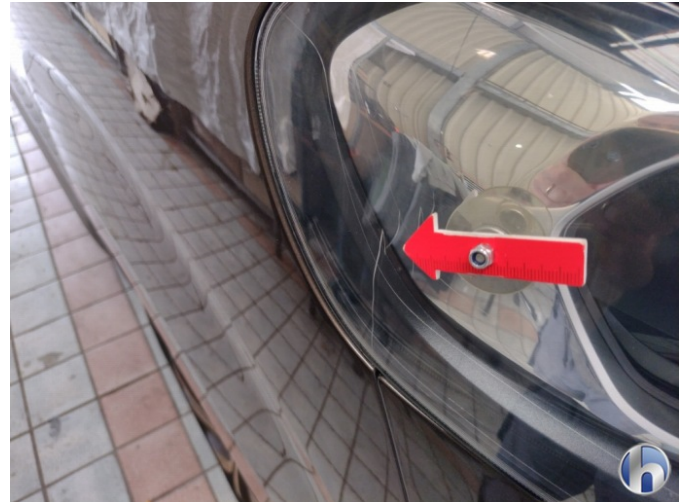
| component | Damage | Rep kind |
|---|---|---|
| 13. Halogen headlights - right | Scratch(es) | Replace |

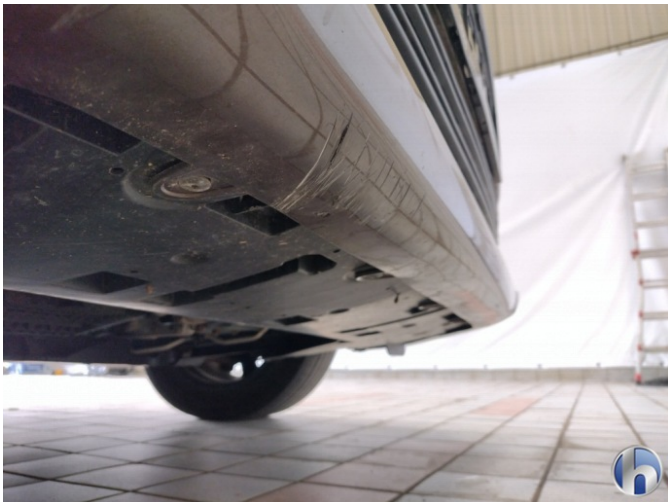
| component | Damage | Rep kind |
|---|---|---|
| 14. Front bumper | Scrape | Paint |

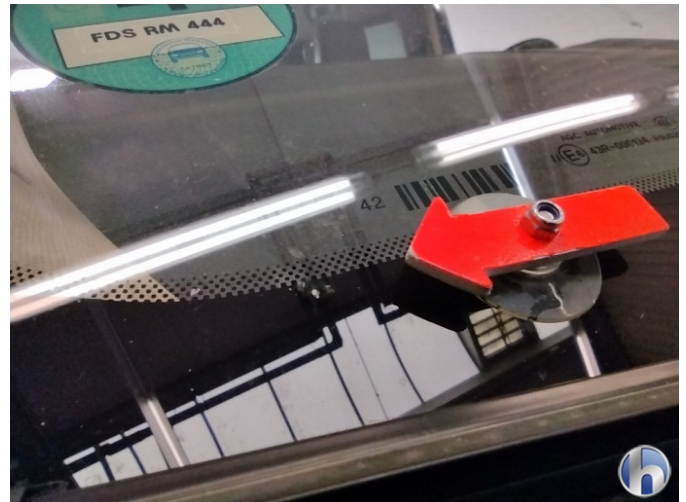
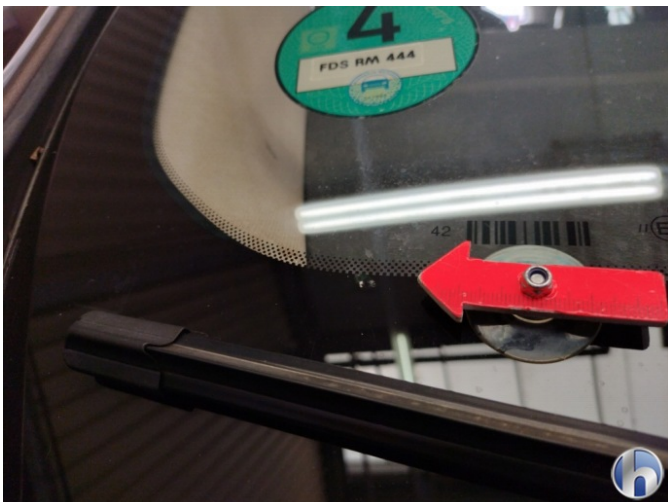
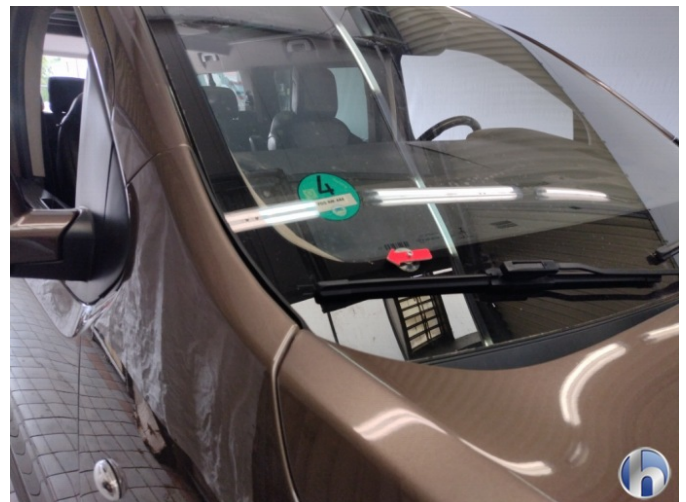
| component | Damage | Rep kind |
|---|---|---|
| 15. Windshield | Damaged | Replace |

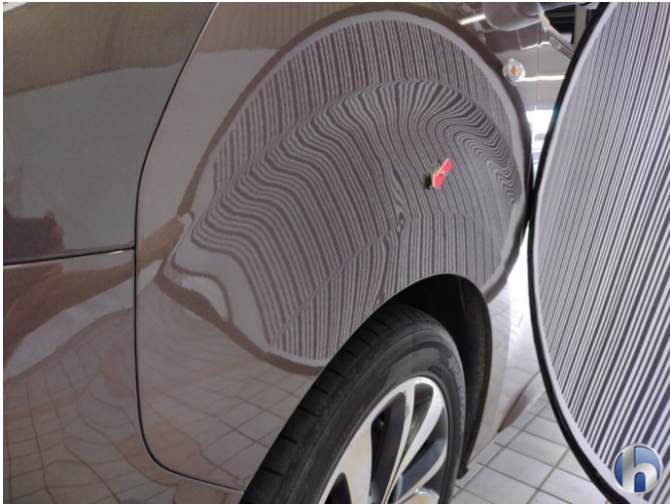
| component | Damage | Rep kind |
|---|---|---|
| 16. Front fender - left | Deformed | Refurbish and paint |

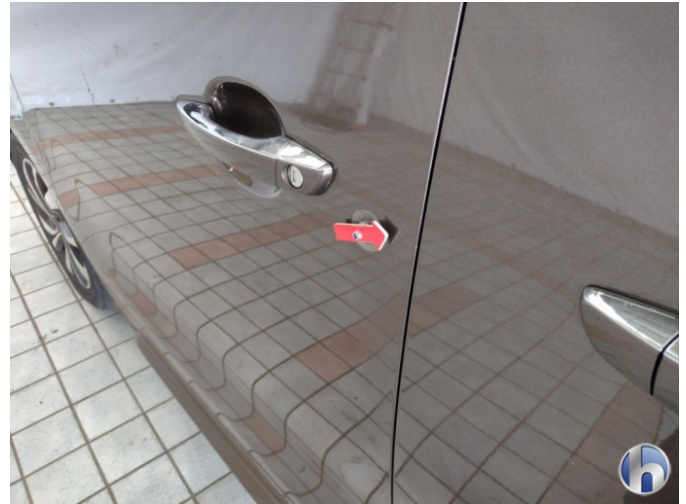
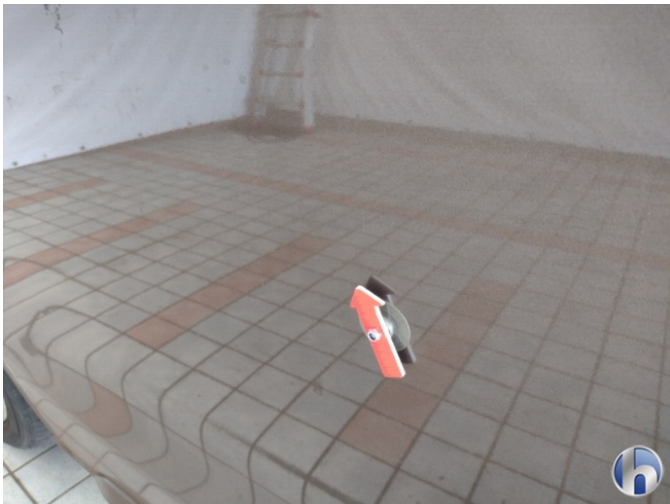
| component | Damage | Rep kind |
|---|---|---|
| 17. Front door - left | Wear and tear | acceptable |

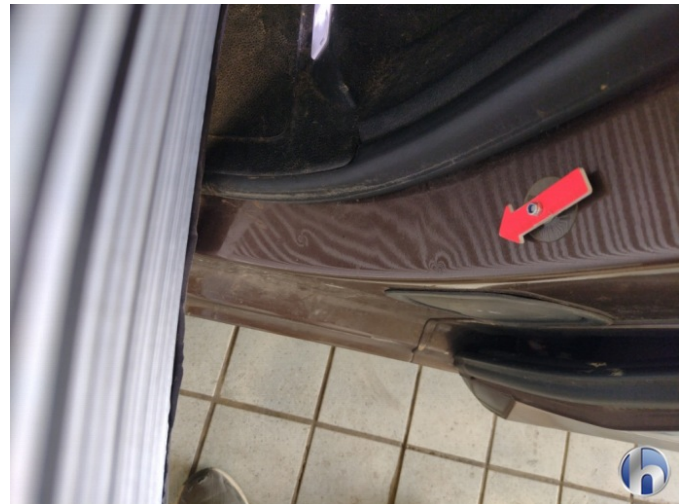
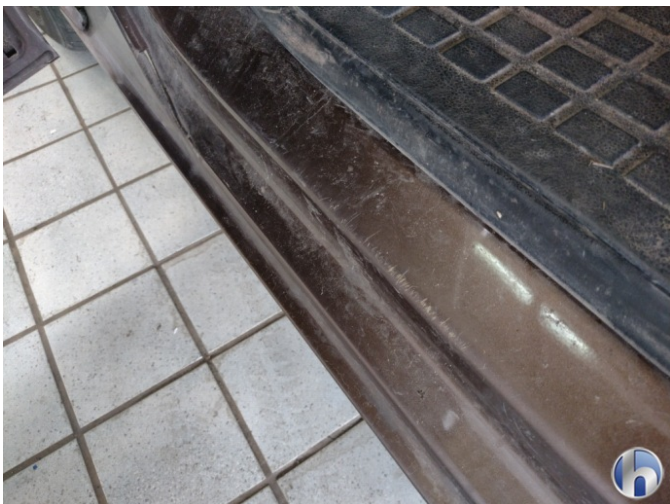
| component | Damage | Rep kind |
|---|---|---|
| 18. Türeinstieg Vorne - Links | Deformed | Refurbish and paint |

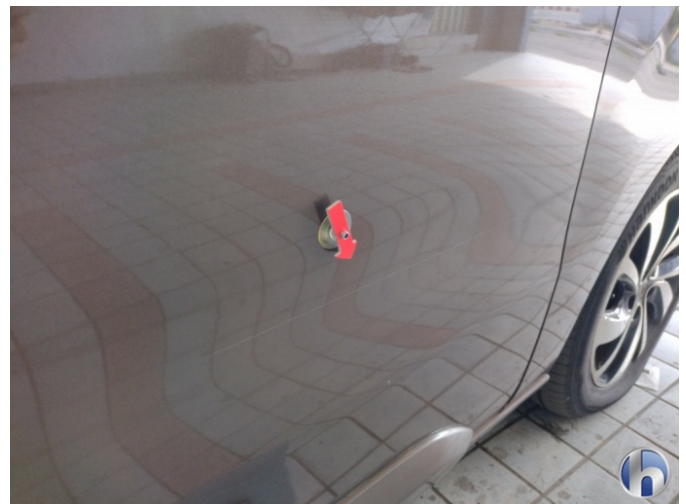
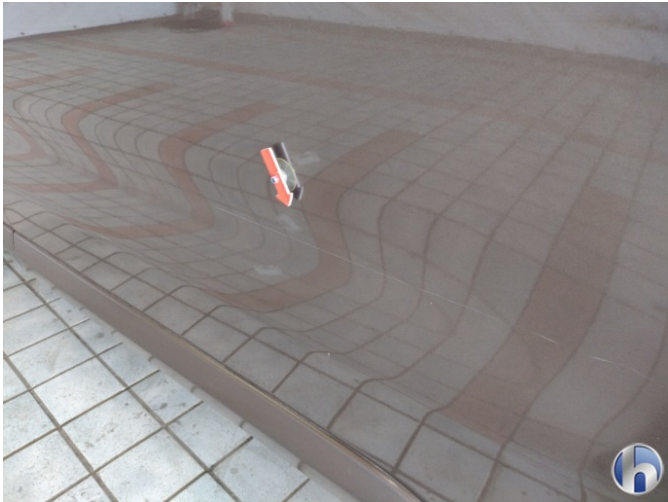
| component | Damage | Rep kind |
|---|---|---|
| 19. Rear door - left | Scratch(es) | Paint |

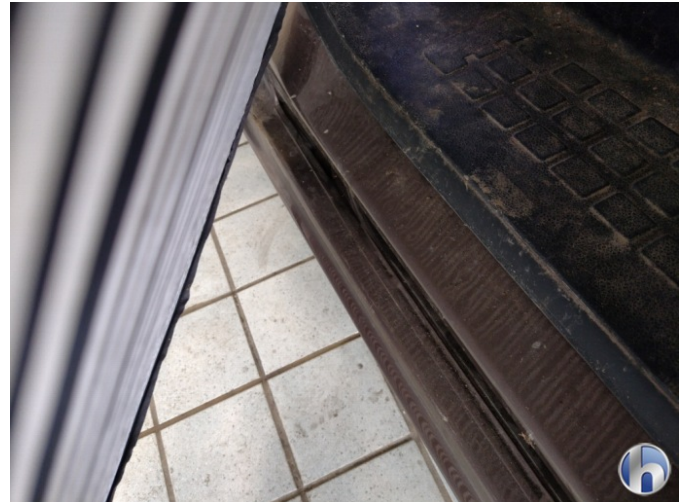
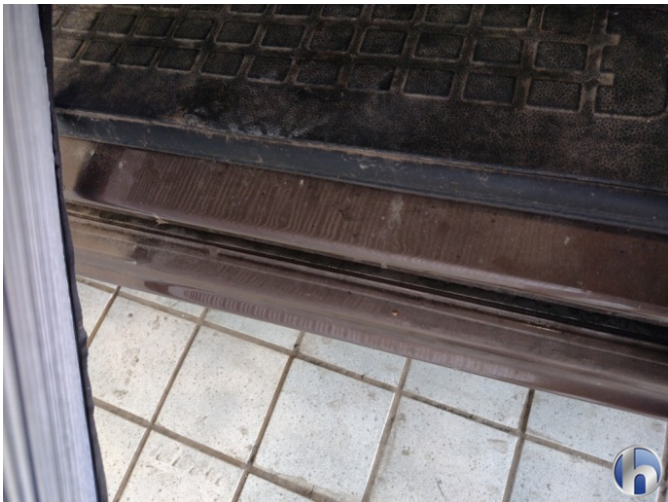
| component | Damage | Rep kind |
|---|---|---|
| 20. Türeinstieg Hinten - Links | Deformed | Refurbish and paint |

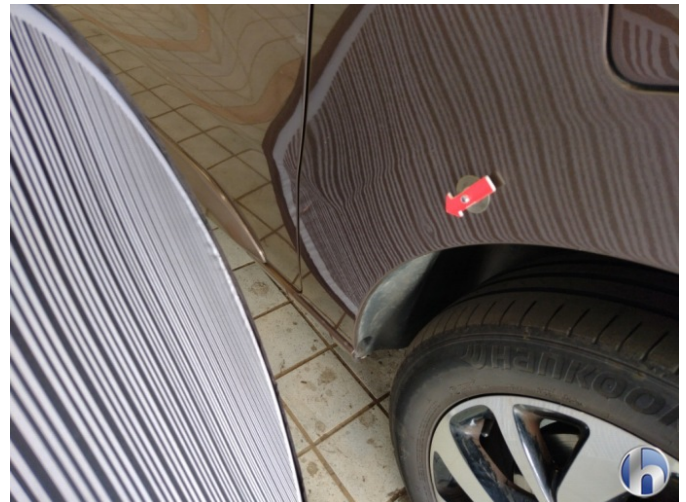
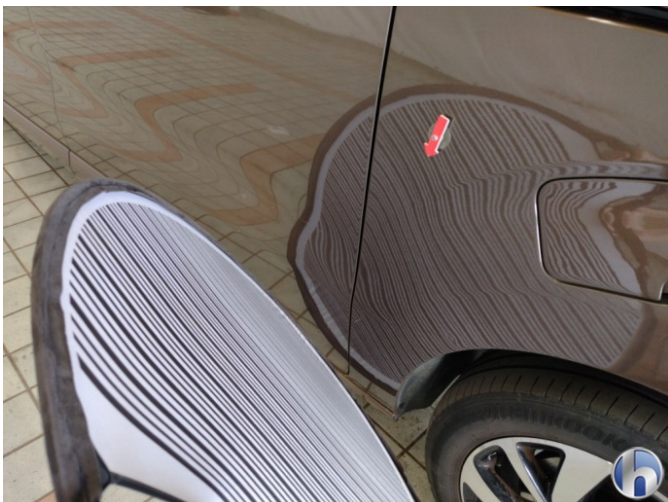
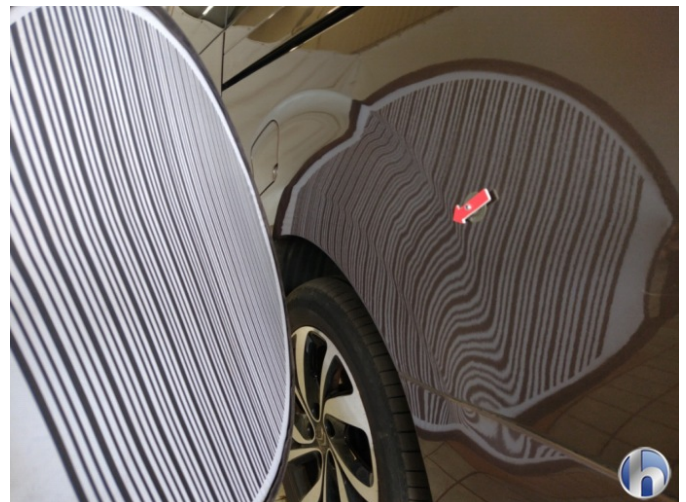
| component | Damage | Rep kind |
|---|---|---|
| 21. Sidewall - Rear - Left | Execution defect | Refurbish and paint |

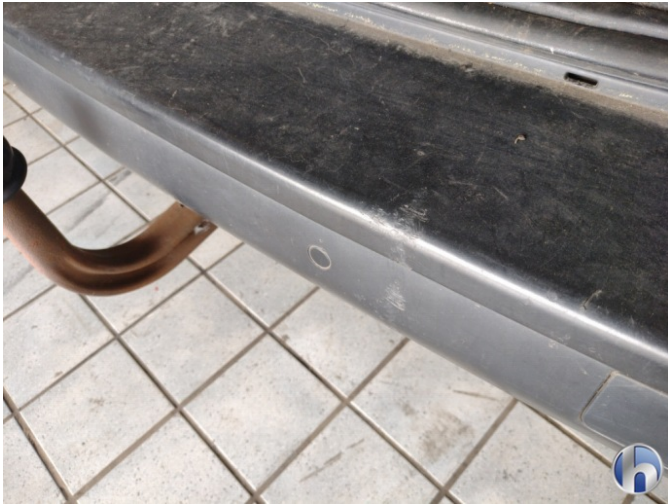
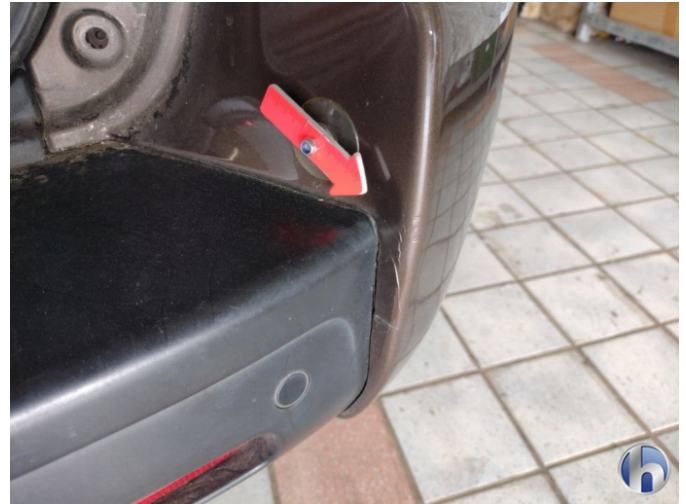
| component | Damage | Rep kind |
|---|---|---|
| 22. Rear bumper | Damaged | Replace |

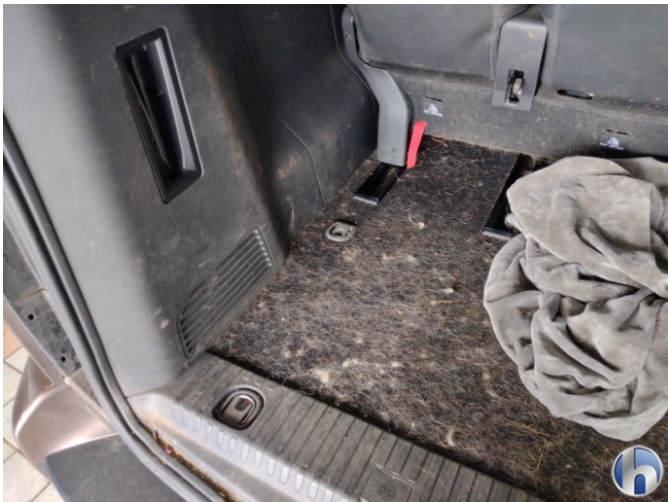
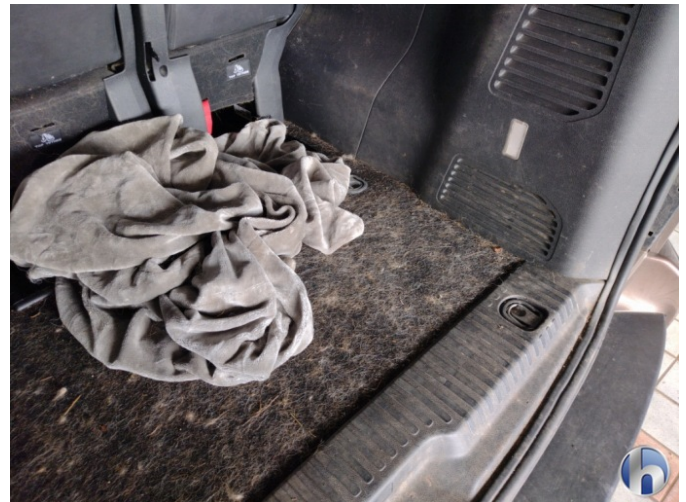
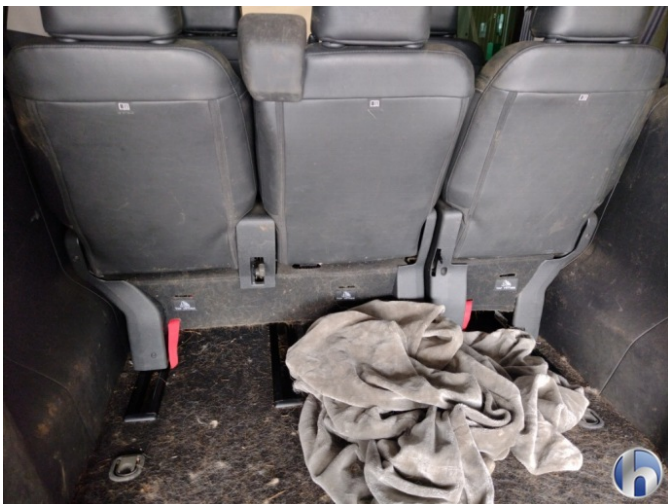
| component | Damage | Rep kind |
|---|---|---|
| 23. | Dirty (animal hair) | |

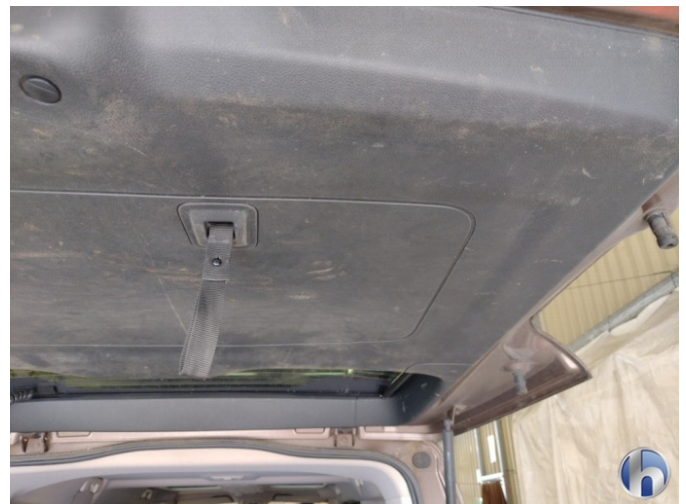
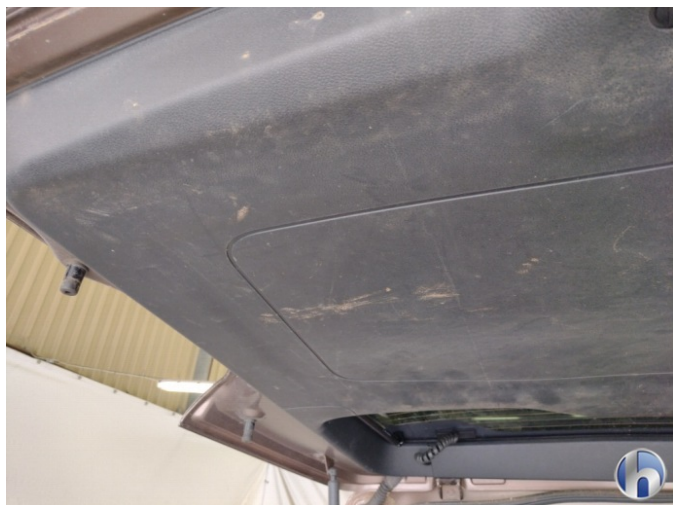
| component | Damage | Rep kind |
|---|---|---|
| 25. tailgate trim | Damaged | Smart repair |

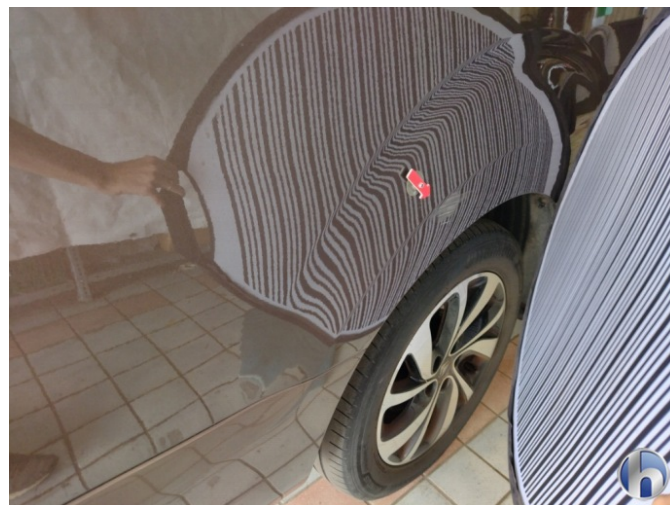
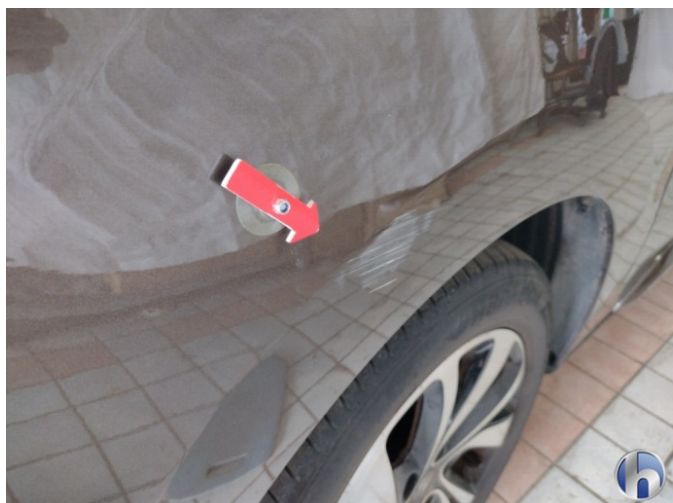
| component | Damage | Rep kind |
|---|---|---|
| 26. Sidewall - Rear - right | Deformed | Refurbish and paint |

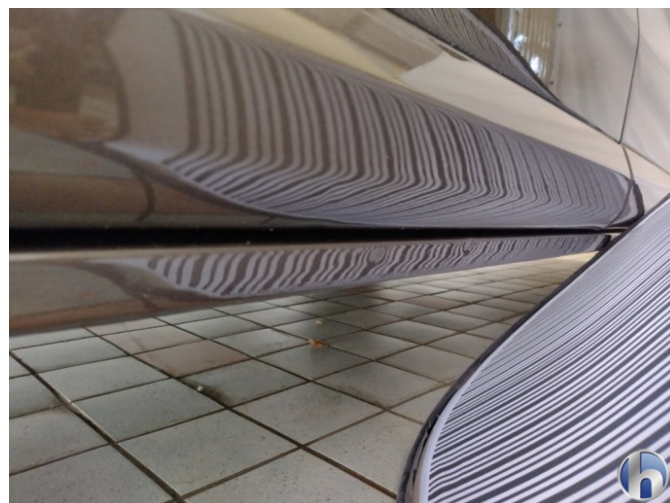
| component | Damage | Rep kind |
|---|---|---|
| 27. side skirt - right | Deformed | Refurbish and paint |

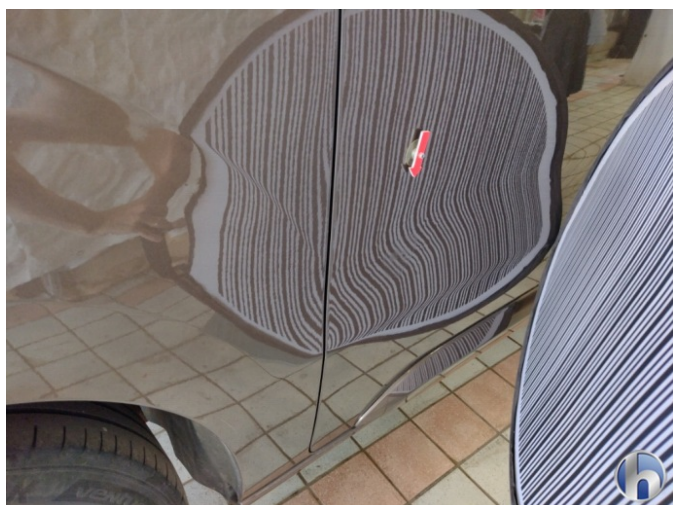
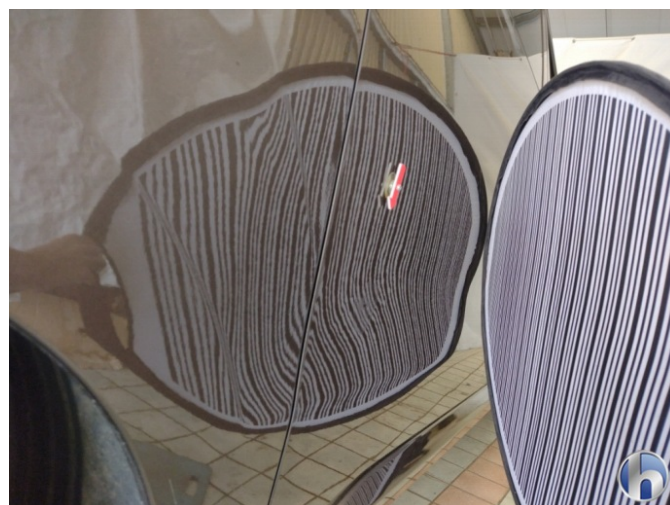
| component | Damage | Rep kind |
|---|---|---|
| 28. Door Rear - right | Execution defect | Refurbish and paint |

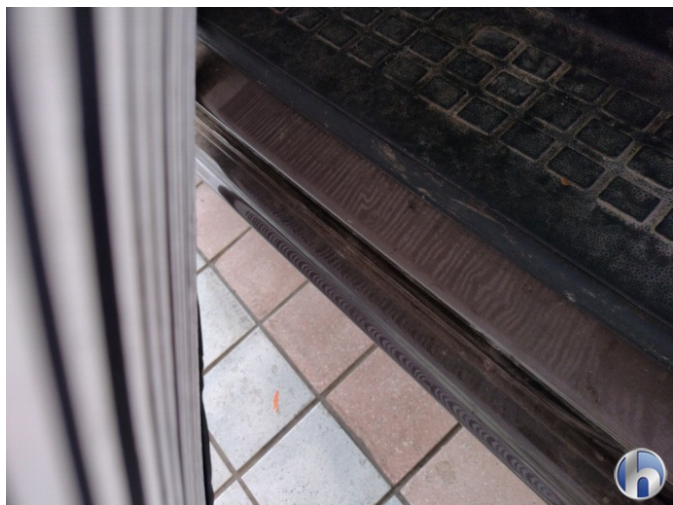
| component | Damage | Rep kind |
|---|---|---|
| 29. Türeinstieg Hinten - Rechts | Deformed | Refurbish and paint |

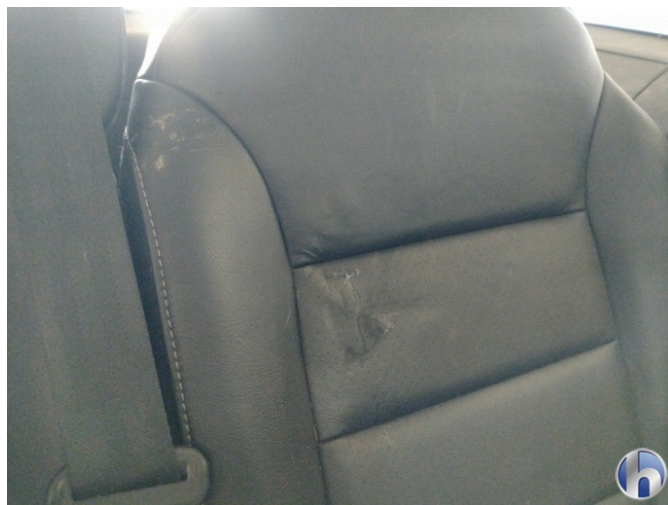
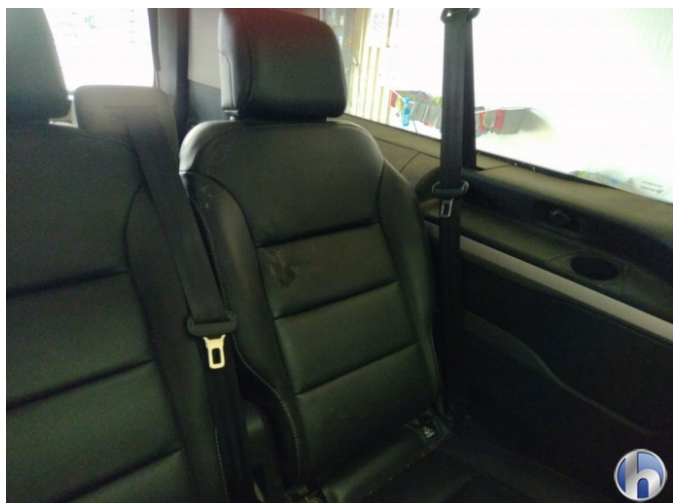
| component | Damage | Rep kind |
|---|---|---|
| 30. 3. Sitzreihe Sitze Lehne Links | Damaged | Replace |

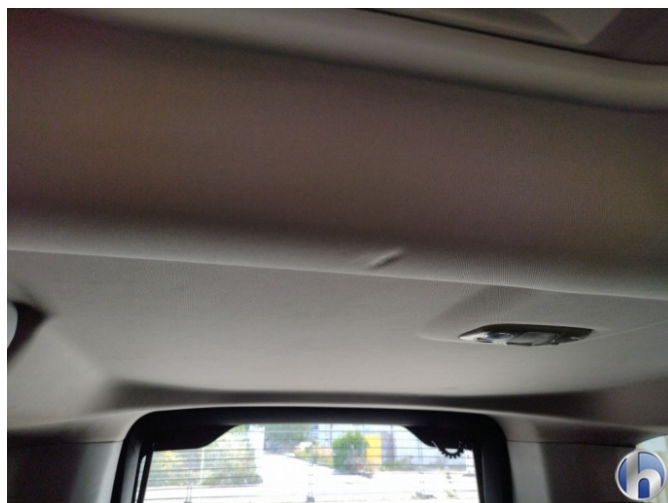
| component | Damage | Rep kind |
|---|---|---|
| 31. headlining | Damaged | Smart repair |

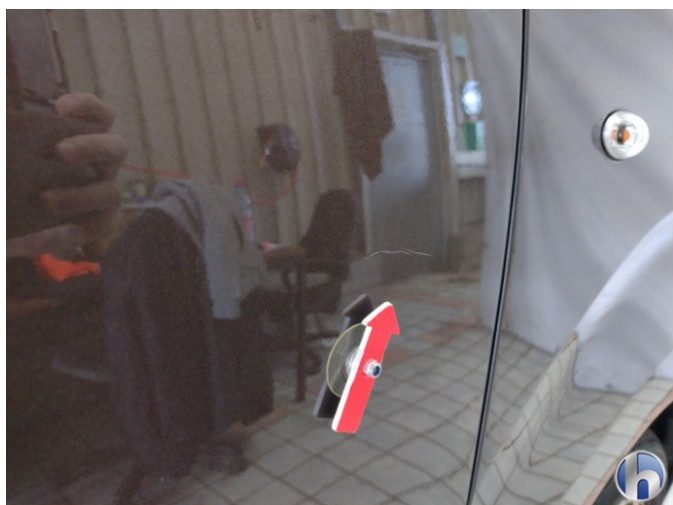
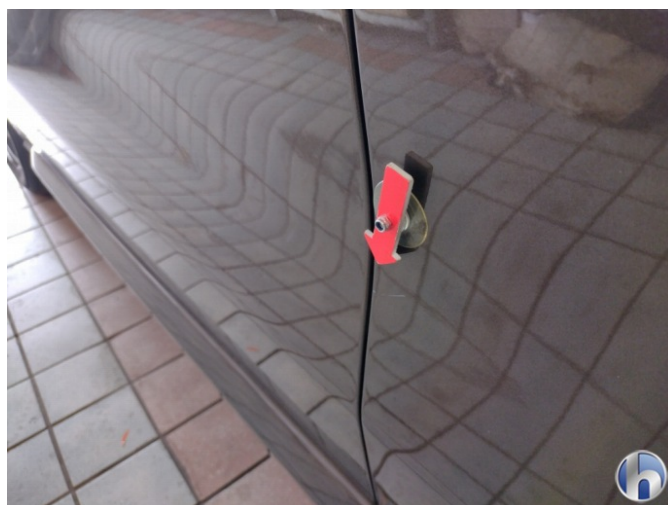
| component | Damage | Rep kind |
|---|---|---|
| 32. Front door - right | Scratch(es) | Paint |

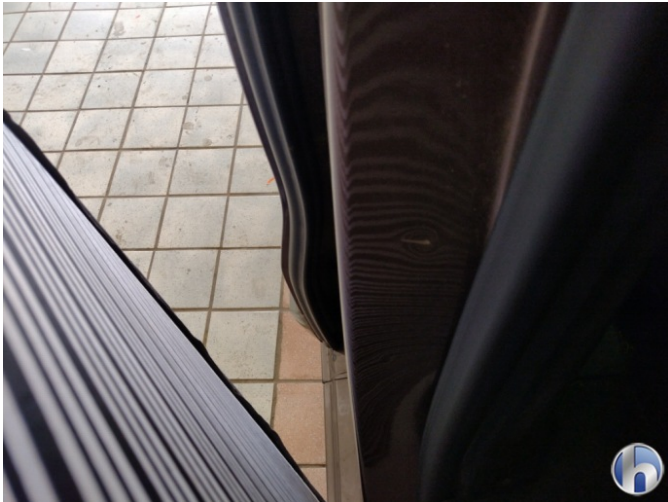
| component | Damage | Rep kind |
|---|---|---|
| 33. Türeinstieg Vorne - Rechts | Damaged | Refurbish and paint |

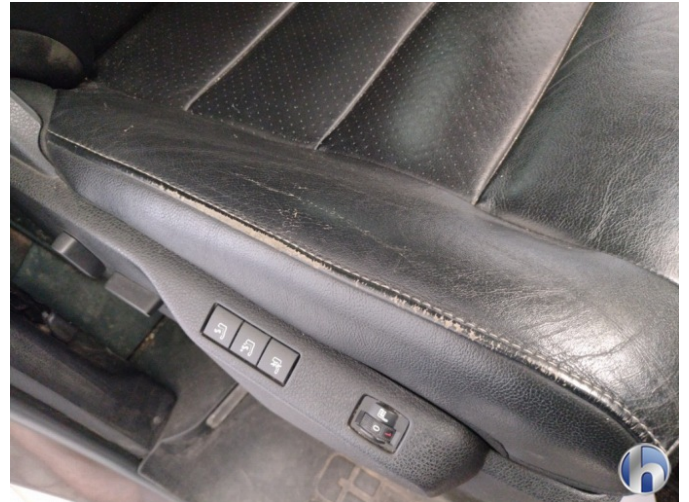
| component | Damage | Rep kind |
|---|---|---|
| 34. | Damaged | Smart repair |

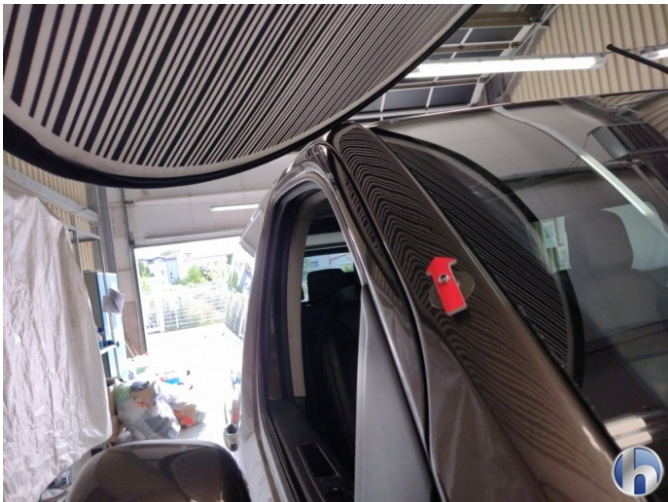
| component | Damage | Rep kind |
|---|---|---|
| 35. A-pillar Front - right | Delle | Smart repair |

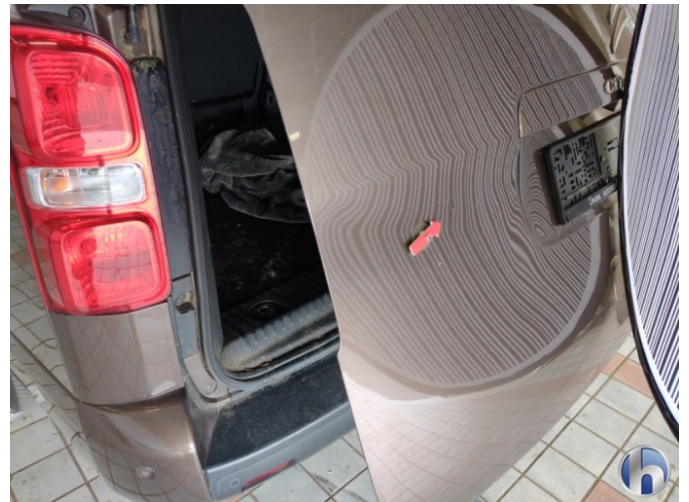
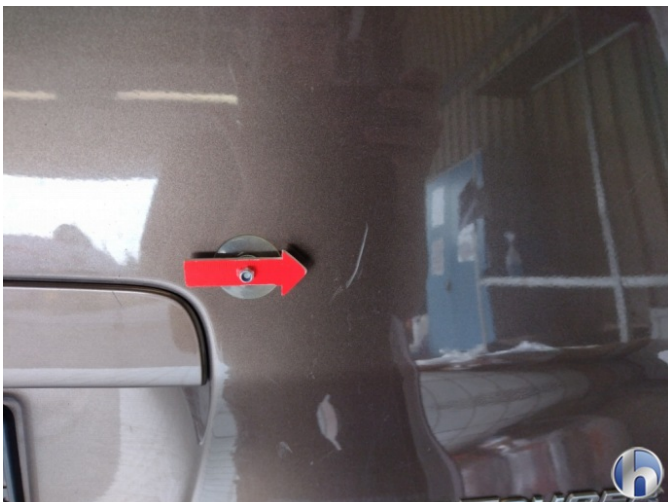
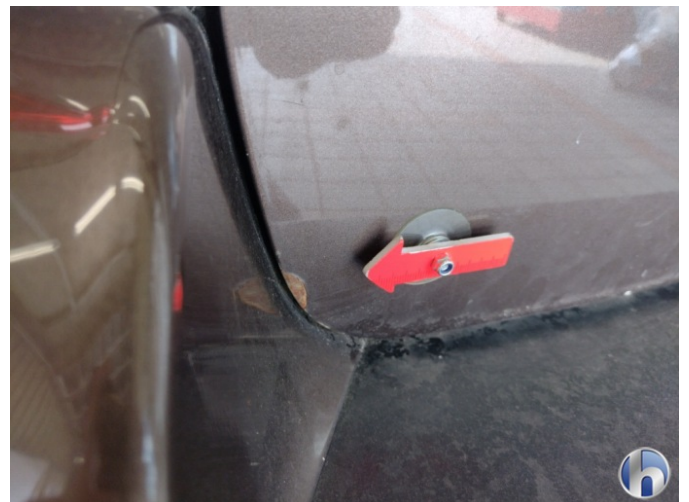
| component | Damage | Rep kind |
|---|---|---|
| 36. tailgate | Damaged | Refurbish and paint |

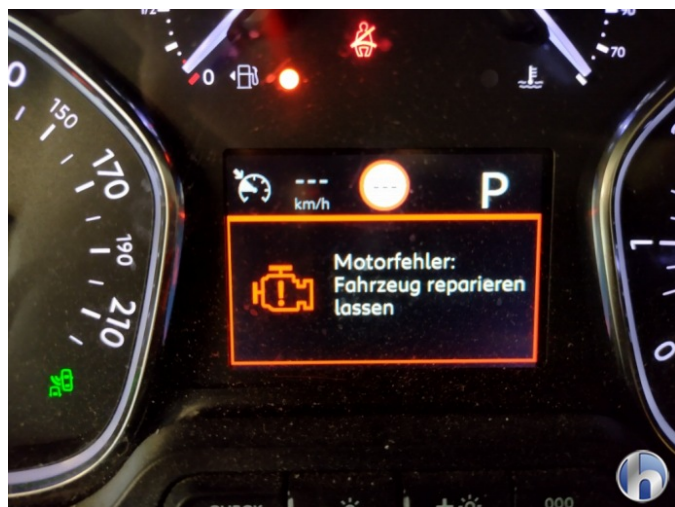
| Performed testing technology | |
|---|---|
| <b>engine running:</b> | A field test of the engine had to acoustic or visual defects for visiting time .<br>*Fehlermeldung |

| component | Damage | Rep kind |
|---|---|---|
| 37. motor | Error message | Carry out a fault diagnosis |
