CITROEN JUMPER (30)
JUMPER TOLE 35 L2H2 3.0 HDi 180 FAP
CLUB

VIN NO VF7YCPMFB12085910
Registration Number BW012QQ

Inspection Report Summary

Customer	BCAauto Encheres	Report Number	P20251022175324
Inspection Date / Place	2025-10-22 / BCA INGRANDES	Cosmetic Grade	3

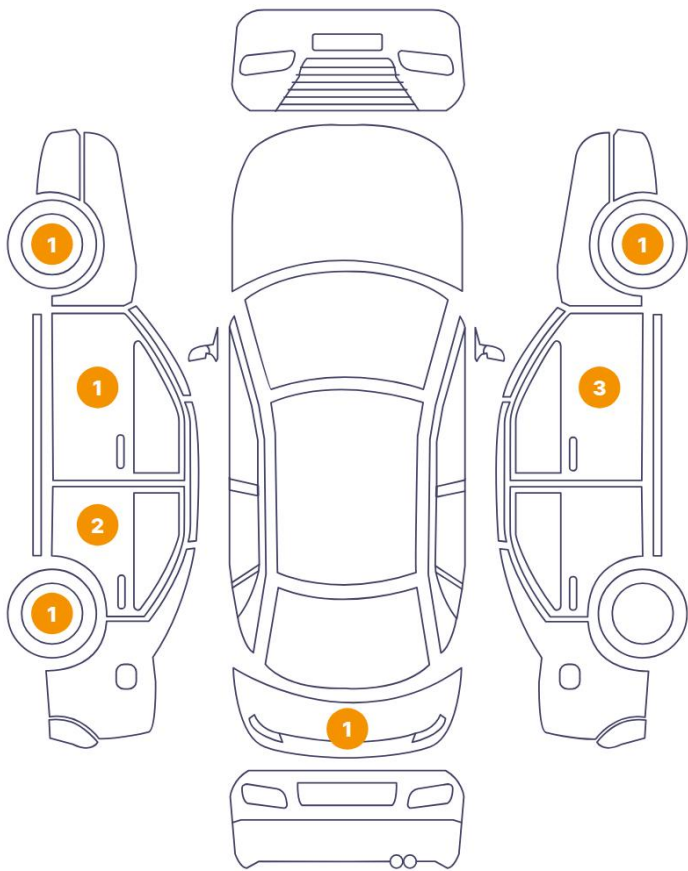
10 Dommages

Component		Damage	Comments
1	Side Panel CL*	Paint / Other	
2	Rim / Front Left	Out of Bodywork / Scratch	
3	Hubcap / Front Right	Out of Bodywork / Scratch	
4	Rim / Back Left	Out of Bodywork / Scratch	
5	Tailgate	Paint / Other	
6	Door / Front Left	Paint / Scratch / Line	
7	Door / Front Right	Paint / Other	
8	Door / Front Right	Paint / Scratch / Line	
9	Side Panel CL*	Paint / Other	
10	Door / Front Right	Bodywork / Dent / Deformation

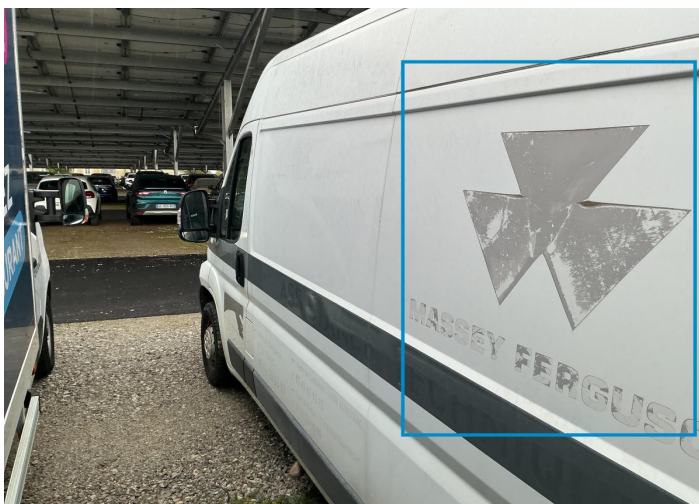
1. Side Panel CL*
Paint / Other -

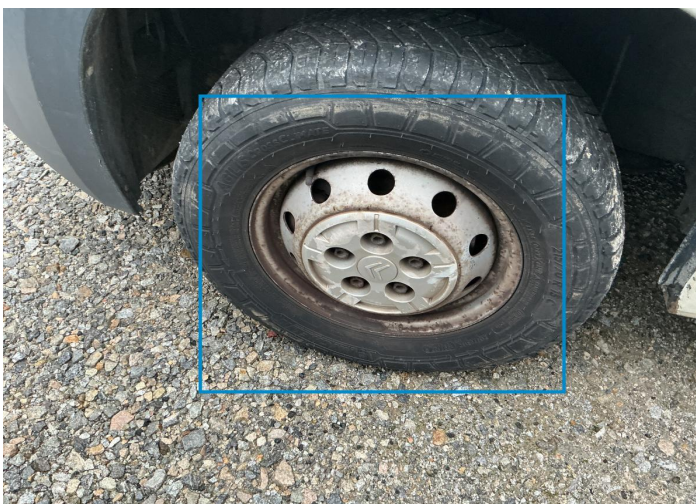
2. Rim / Front Left
Out of Bodywork / Scratch -

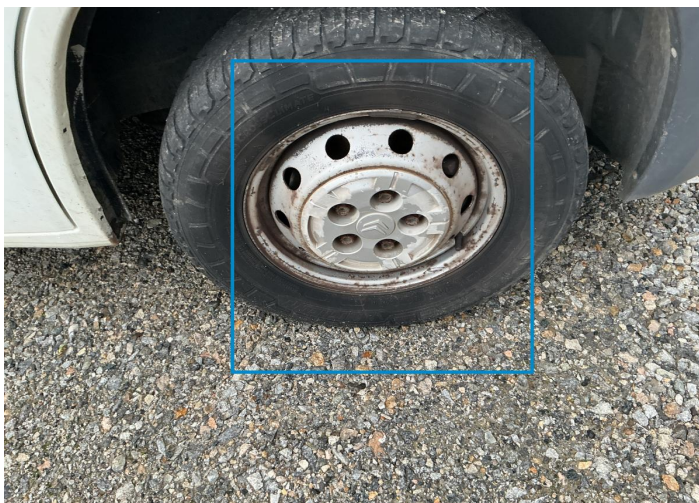
3. Hubcap / Front Right
Out of Bodywork / Scratch -

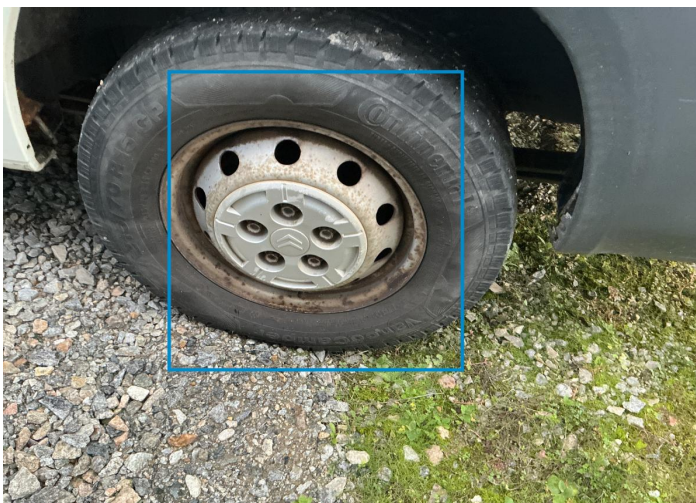
4. Rim / Back Left
Out of Bodywork / Scratch -

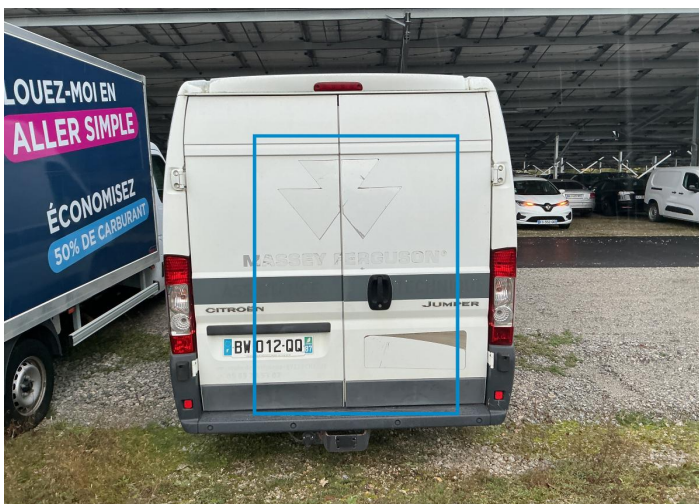
5. Tailgate
Paint / Other -

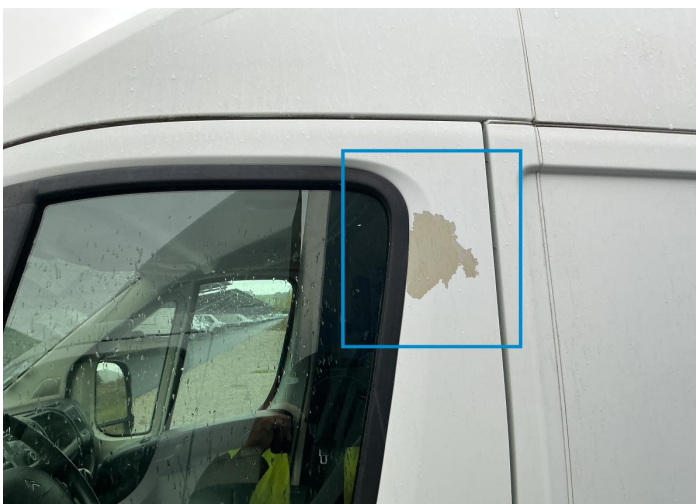
6. Door / Front Left
Paint / Scratch / Line -

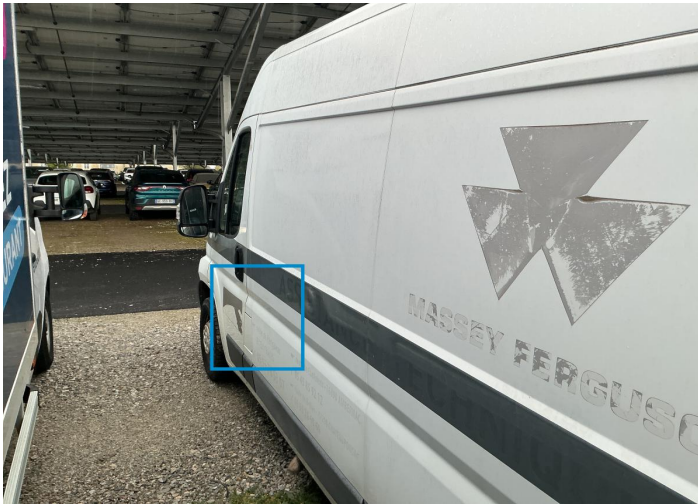
9. Side Panel CL*
Paint / Other -

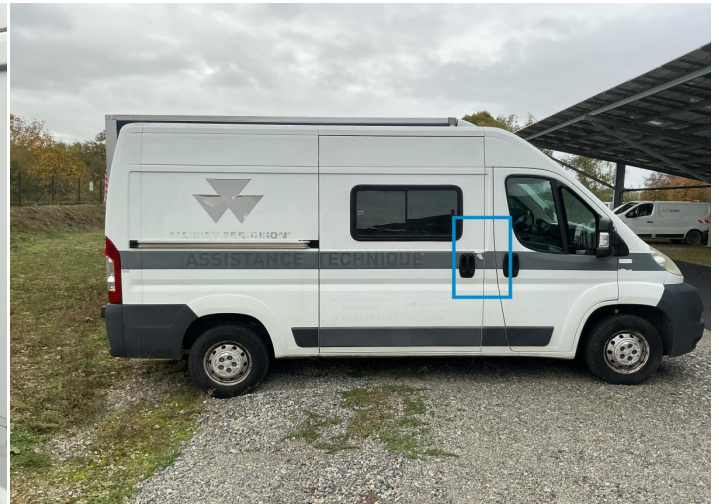
10. Door / Front Right
Bodywork / Dent / Deformation -
