# CITROEN JUMPER (30) JUMPER TOLE 4-35 L4H2 BLUEHDi 165 S&S BVM6 CLUB

VIN NO VF7YDCNFC12S28938  
Registration Number FX418XG

## Inspection Report Summary

Customer	BCAauto Encheres	Report Number	P20250808102944
Inspection Date / Place	2025-08-08 / BCA ANGOULEME	Cosmetic Grade	9

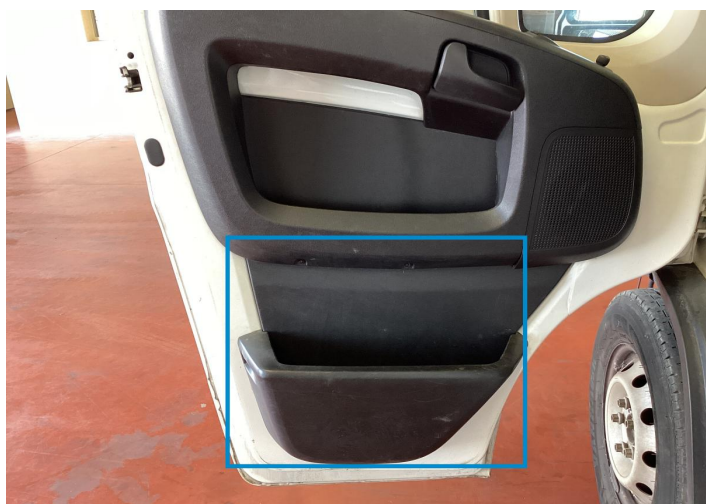
1. Panel Filling / Front Left  
Interior / Dirty -

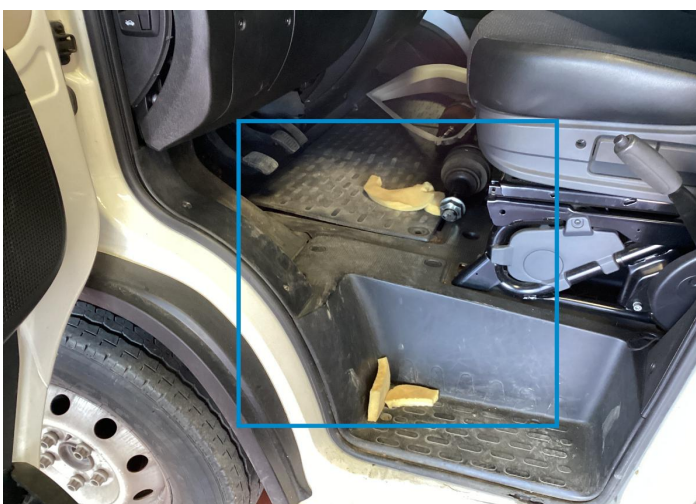
2. Floor Carpet  
Interior / Dirty -

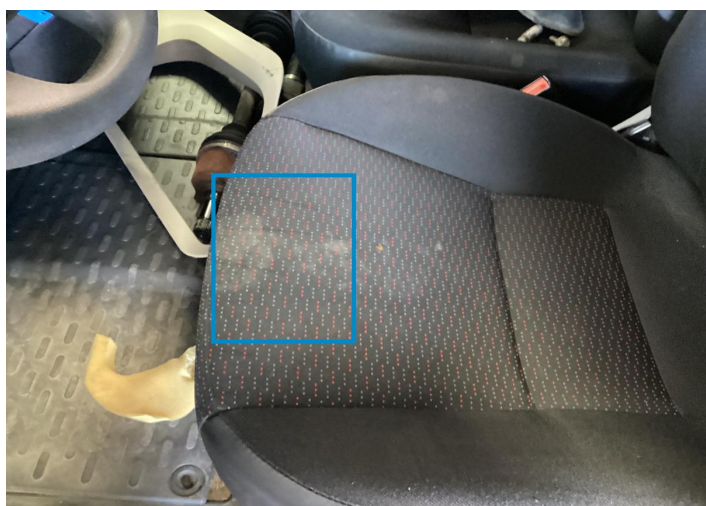
3. Seat Cushion / Front Left  
Interior / Dirty -

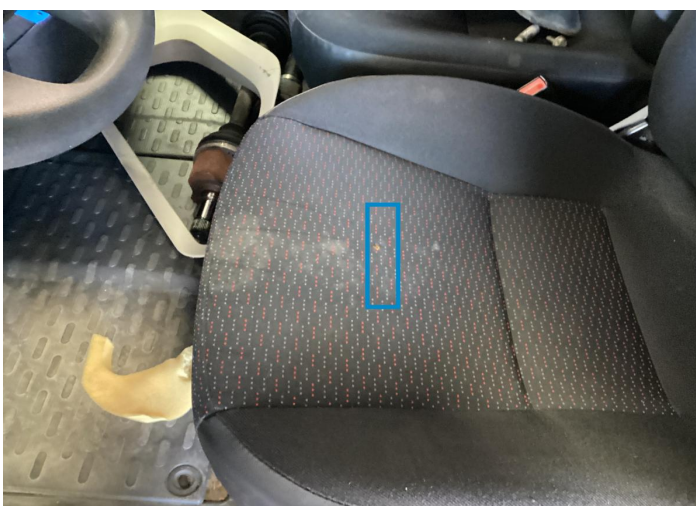
4. Seat Cushion / Front Left  
Interior / Holed -

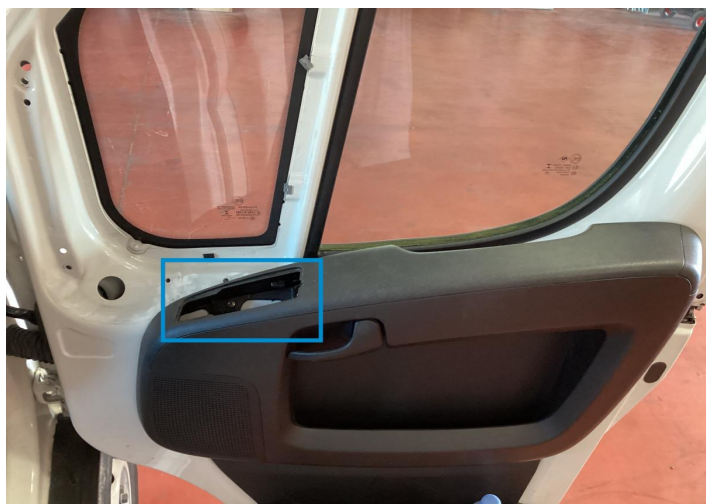
5. Window Switch / Front Right  
Interior / Missing -

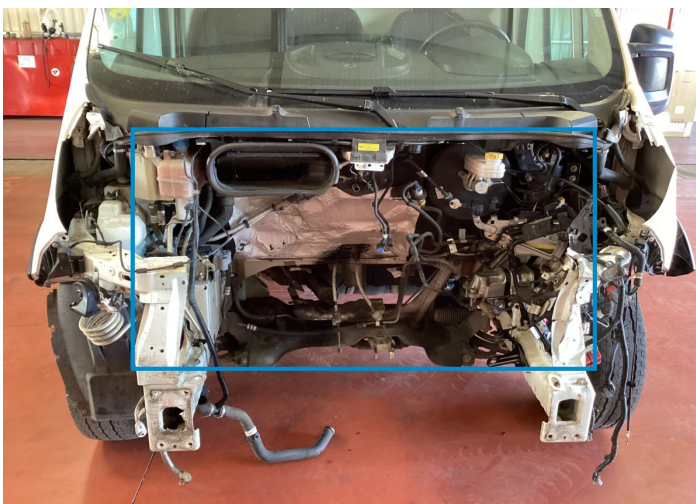
6. Hood  
Missing Part -

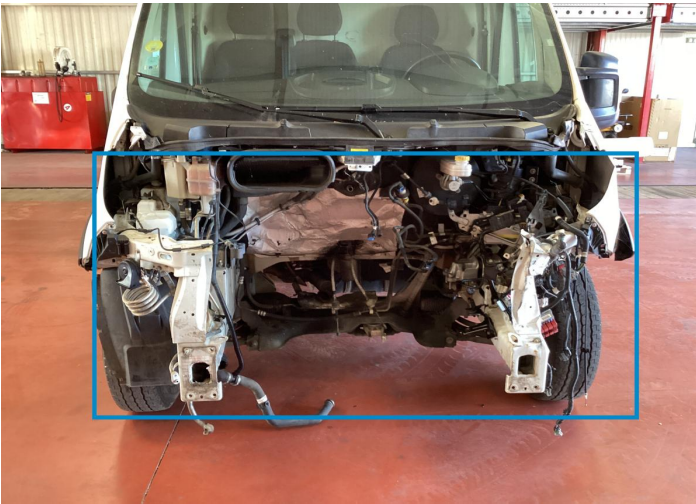
7. Shield / Front  
Missing Part -

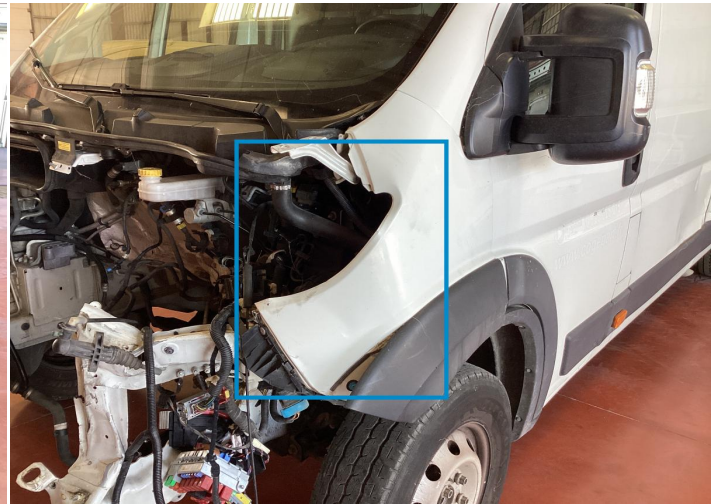
8. Fender / Front Left  
Bodywork / Dent / Deformation -

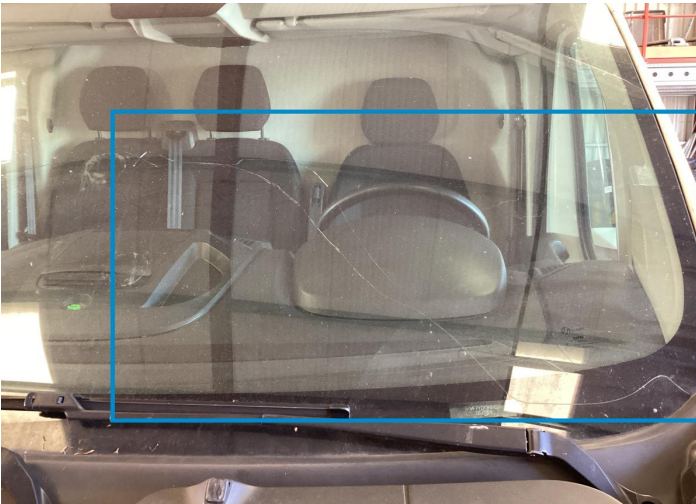
9. Windshield / Front  
Glass Break -

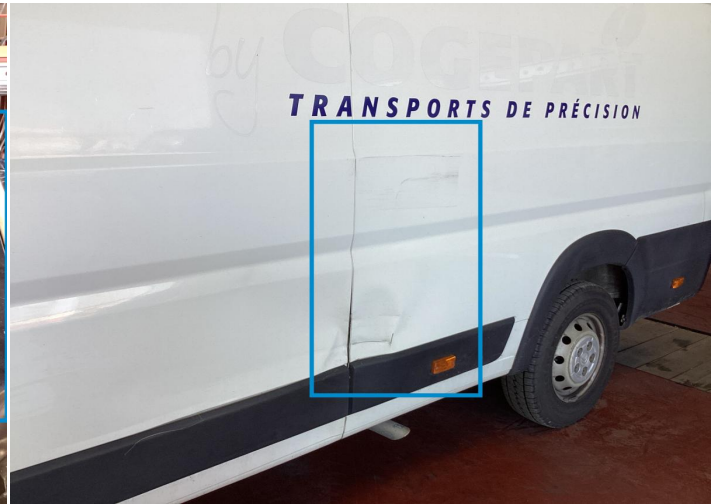
10. Side Panel / Back Left  
Bodywork / Dent / Deformation -

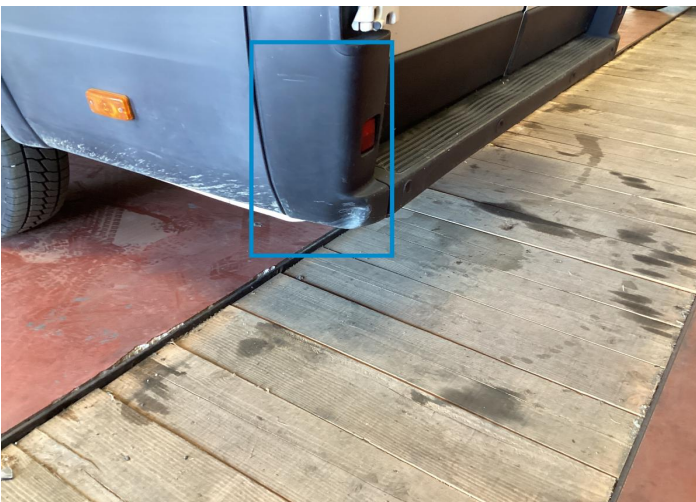
11. Corner Bumper / Back Left  
Bodywork / Dent / Deformation -

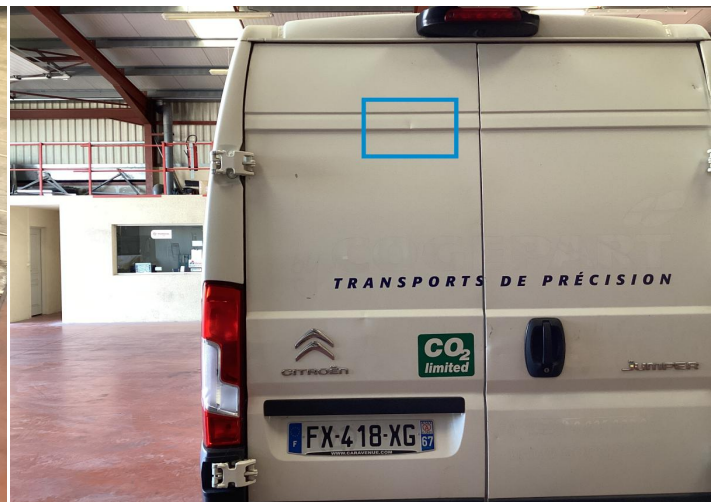
12. Swing Door / Back Left  
Bodywork / Dent / Dent -

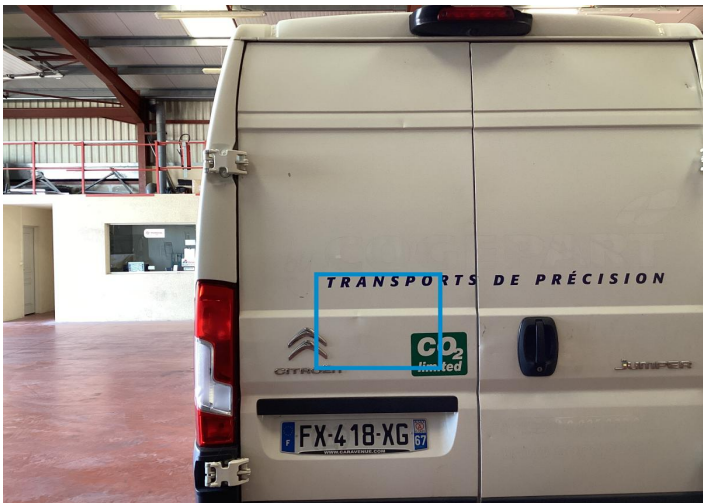
13. Swing Door / Back Left  
Bodywork / Dent / Dent -

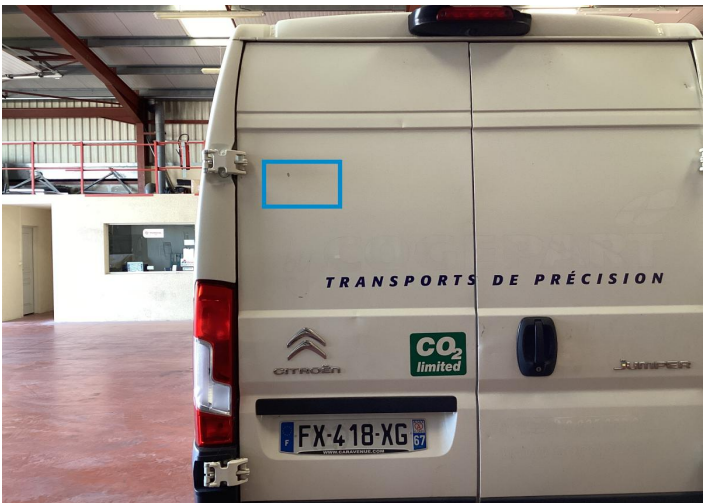
14. Swing Door / Back Left  
Paint / Chipping -

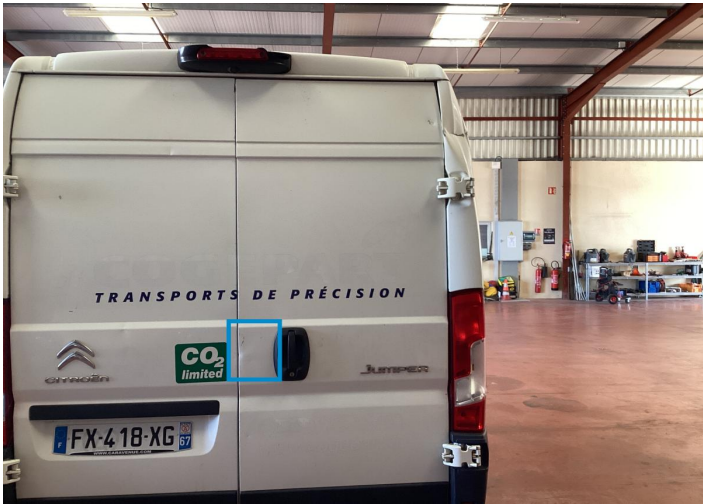
15. Swing Door / Back Right  
Bodywork / Dent / Deformation -

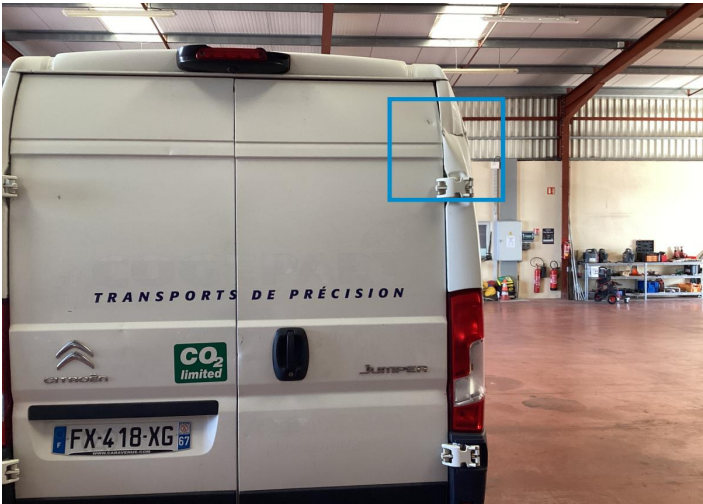
16. Swing Door / Back Right  
Bodywork / Dent / Deformation -

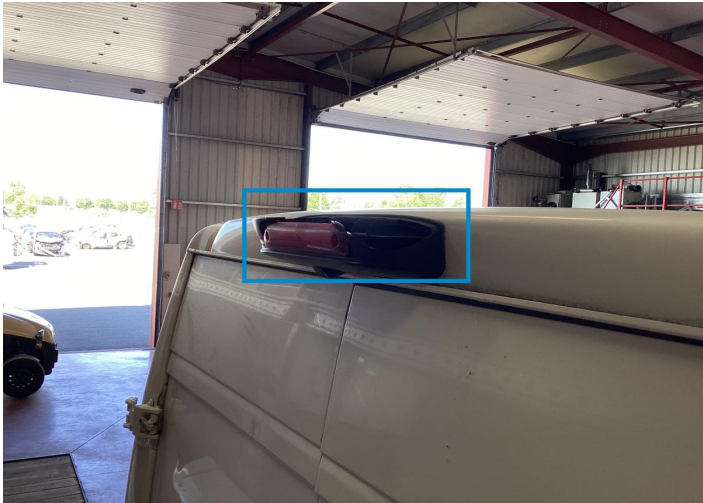
17. Additional Brake Light / Back Center Top  
Glass Break -

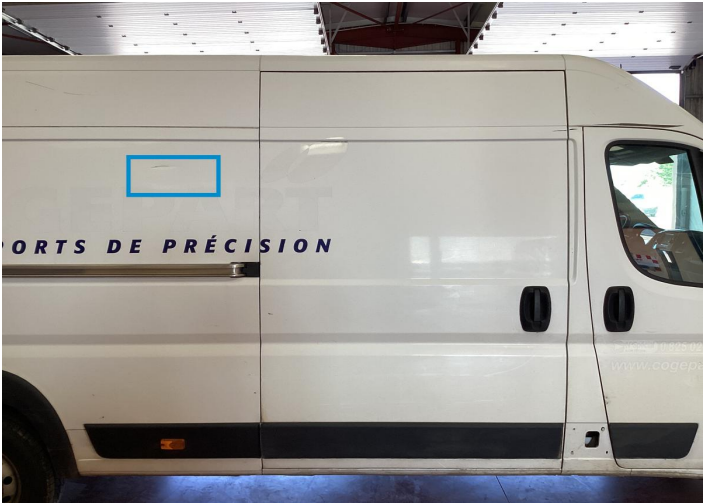
18. Side Panel / Back Right  
Bodywork / Dent / Deformation -

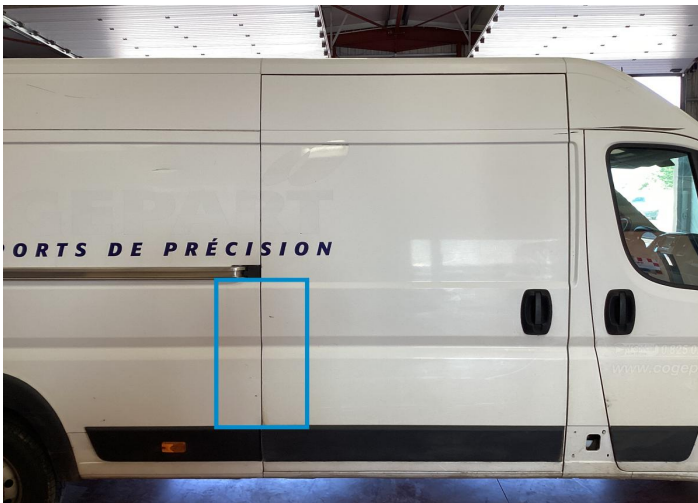
19. Side Panel / Back Right  
Paint / Scratch / Line -

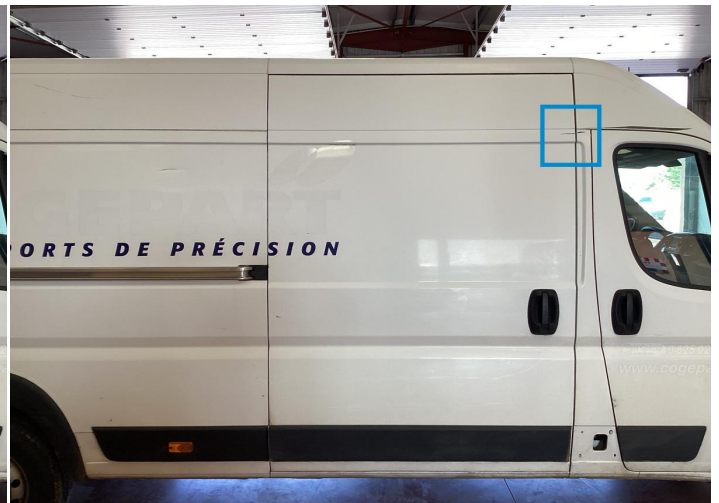
20. Side Panel / Back Right  
Paint / Scratch / Line -

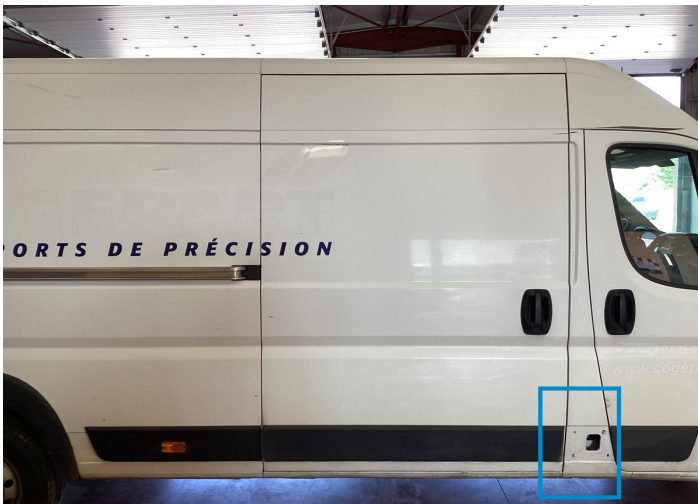
21. Side Panel / Back Right  
Missing Part -

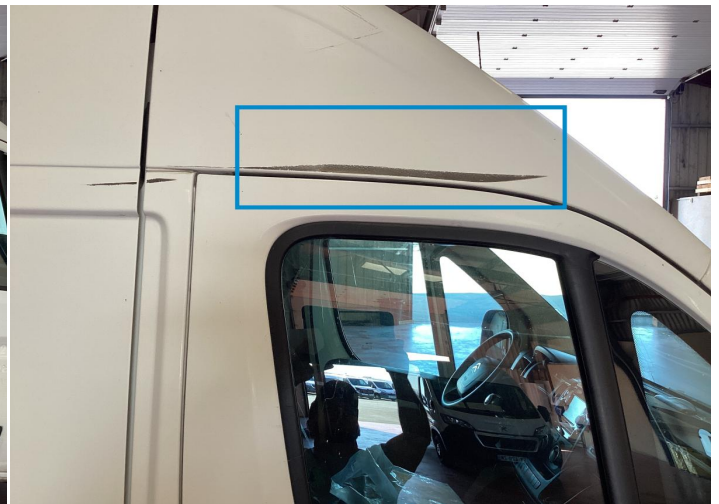
22. Roof  
Paint / Scratch / Line -

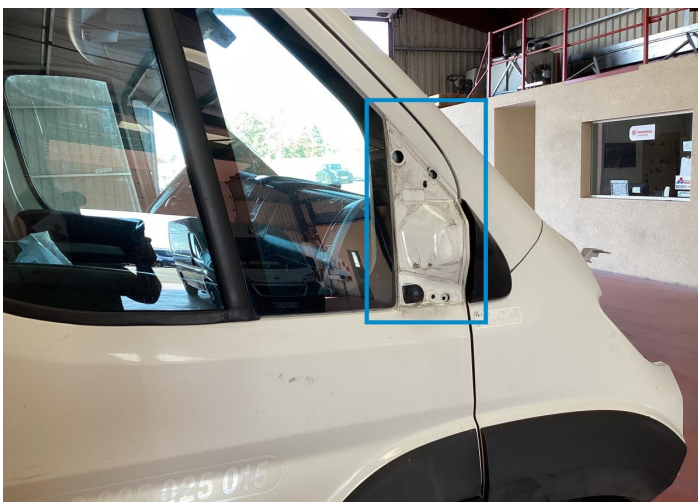
23. Mirror / Front Right  
Missing Part -
