TOYOTA Yaris

Yaris Hybrid 1.5 VVT-i

VIN NO VNKKD3D330A591767
Registration Number 330A591767

Inspection Report Summary

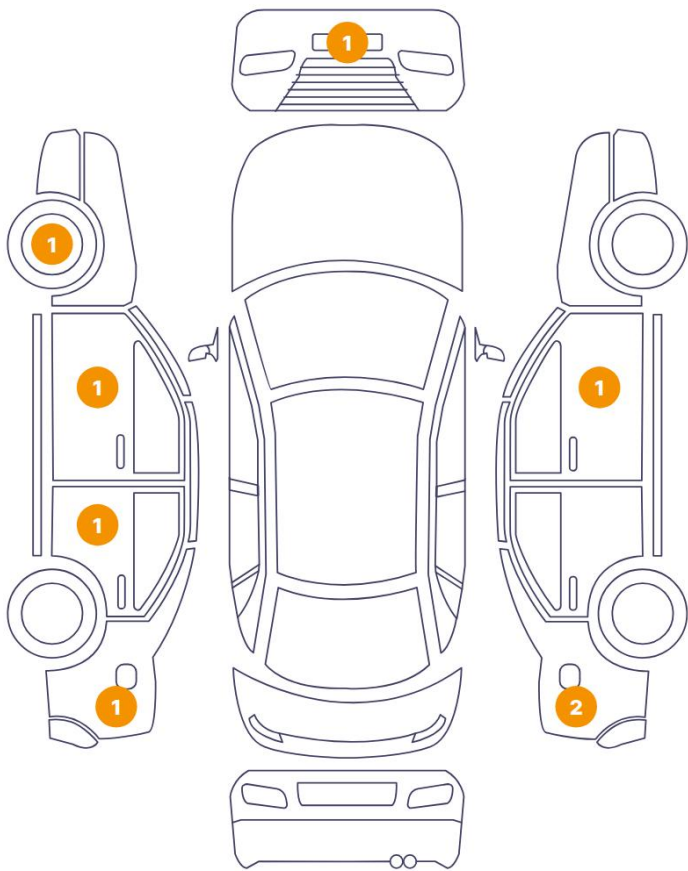
8 Schäden

Component	Damage	Comments
1 Bumper / Front	Paint / Scratch / Scuff	
2 Door / Front Right	Paint / Scratch / Scuff	
3 Side Panel / Back Right	Paint / Scratch / Scuff	
4 Side Panel / Back Right	Bodywork / Dent / Dent	
5 Side Panel / Back Left	Bodywork / Dent / Dent	
6 Door / Back Left	Paint / Scratch / Scuff	
7 Door / Front Left	Paint / Scratch / Scuff	
8 Rim / Front Left	Out of Bodywork / Scratch

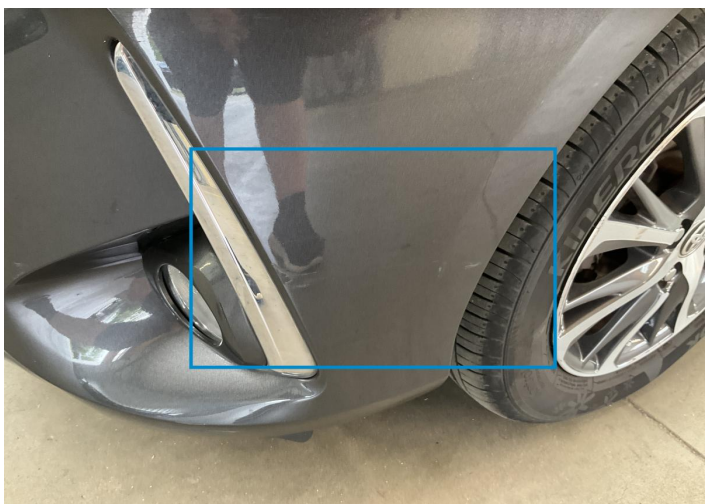
1. Bumper / Front
Paint / Scratch / Scuff -

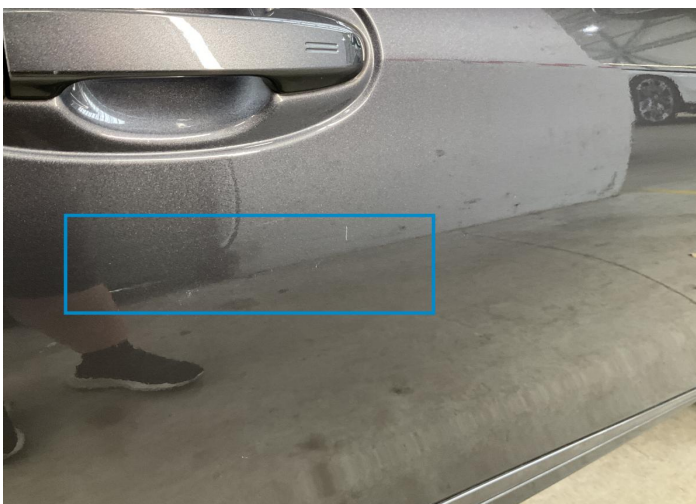
2. Door / Front Right
Paint / Scratch / Scuff -

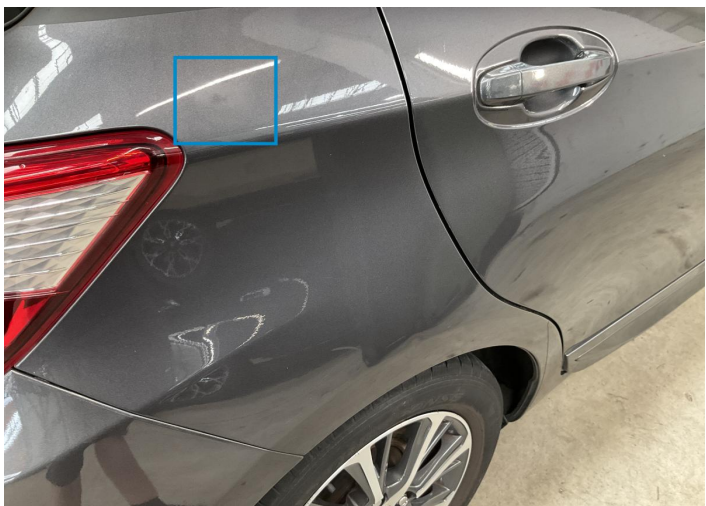
3. Side Panel / Back Right
Paint / Scratch / Scuff -

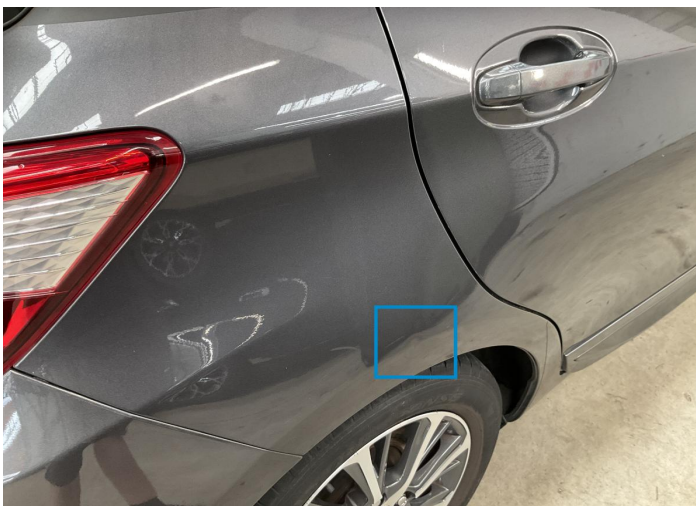
4. Side Panel / Back Right
Bodywork / Dent / Dent -

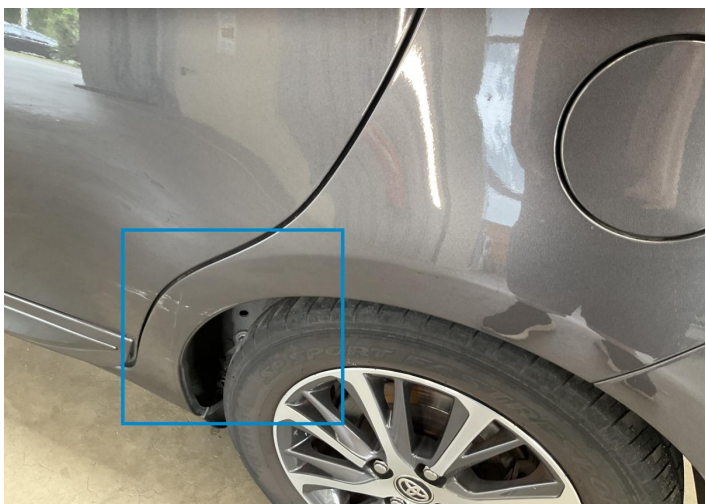
5. Side Panel / Back Left
Bodywork / Dent / Dent -

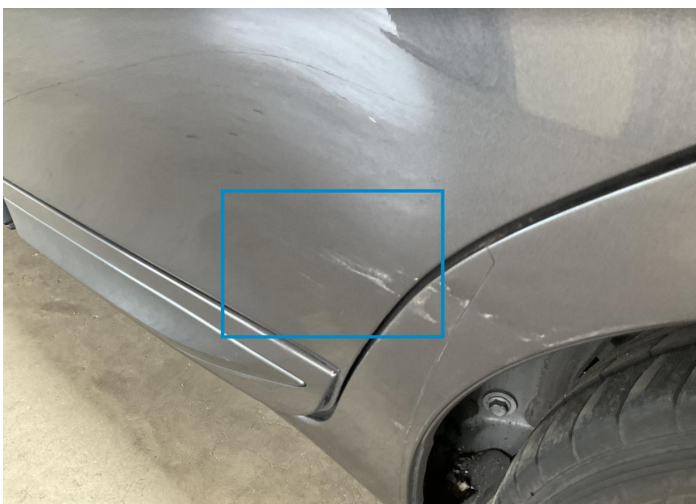
6. Door / Back Left
Paint / Scratch / Scuff -

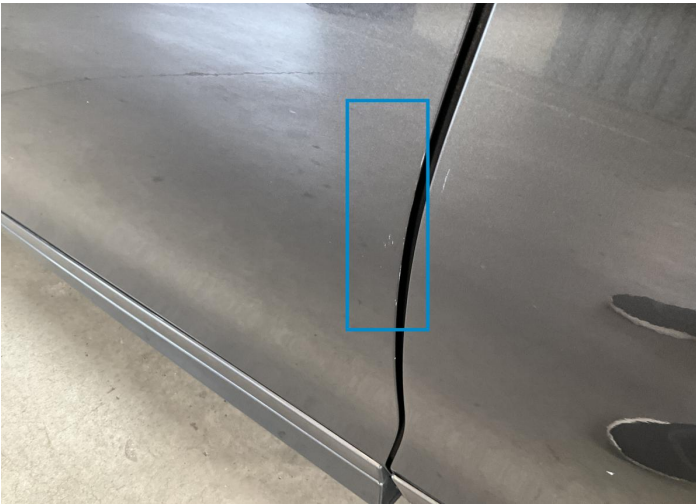
7. Door / Front Left
Paint / Scratch / Scuff -

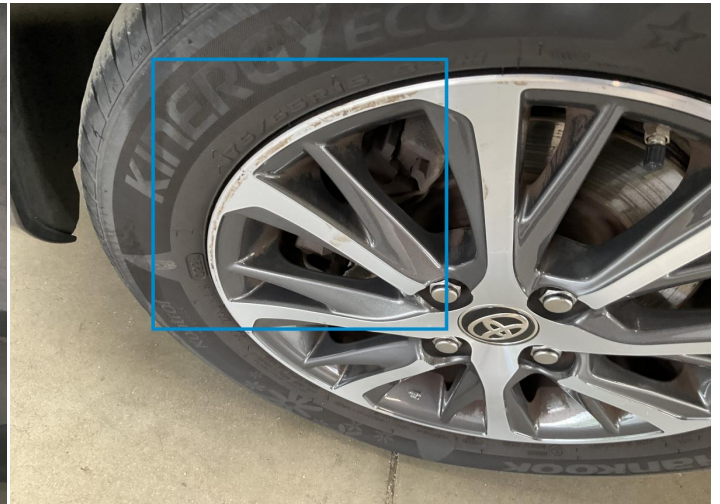
8. Rim / Front Left
Out of Bodywork / Scratch -
