TOYOTA Yaris III 2017 5p Benzina
Yaris 5p 1.5h Cool my18

VIN NO VNKKD3D390A486456
Registration Number FR275WZ

Inspection Report Summary

Customer	BCA Lodi	Report Number	P20251009104906
Inspection Date / Place	2025-10-09 / BCA Lodi	Cosmetic Grade	3

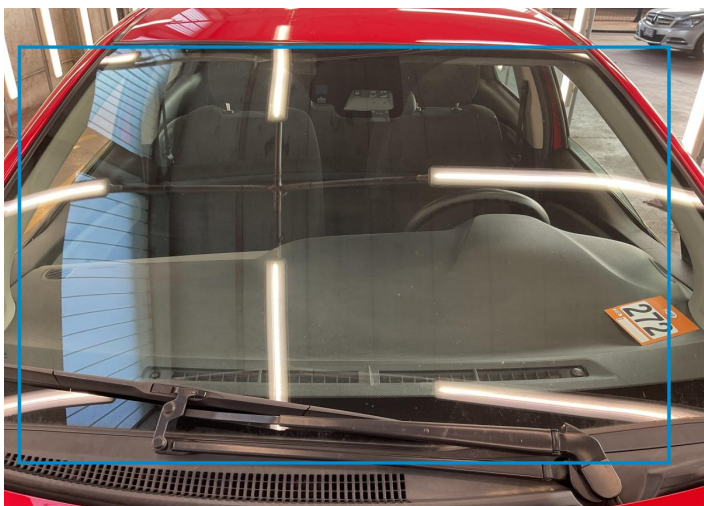
1. Windshield / Front
Glass Break / Impact -

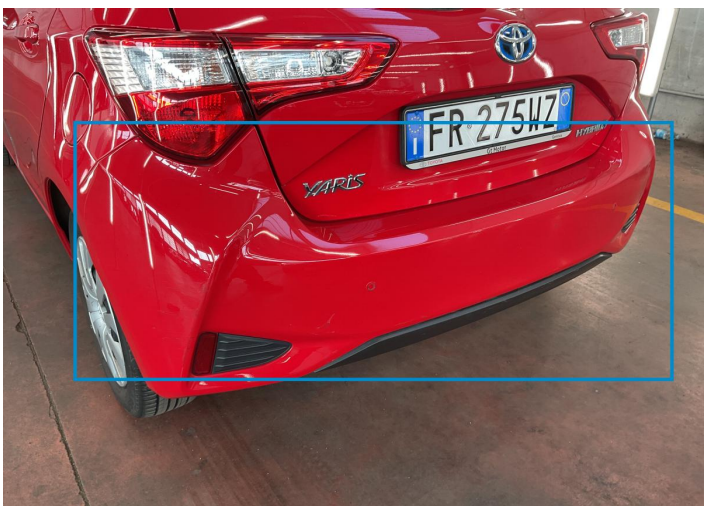
2. Bumper / Back
Bodywork / Dent -

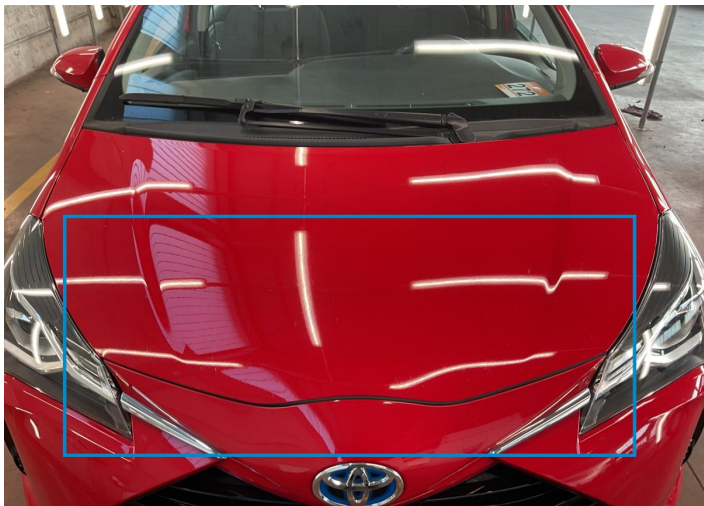
3. Hood
Paint / Chipping -

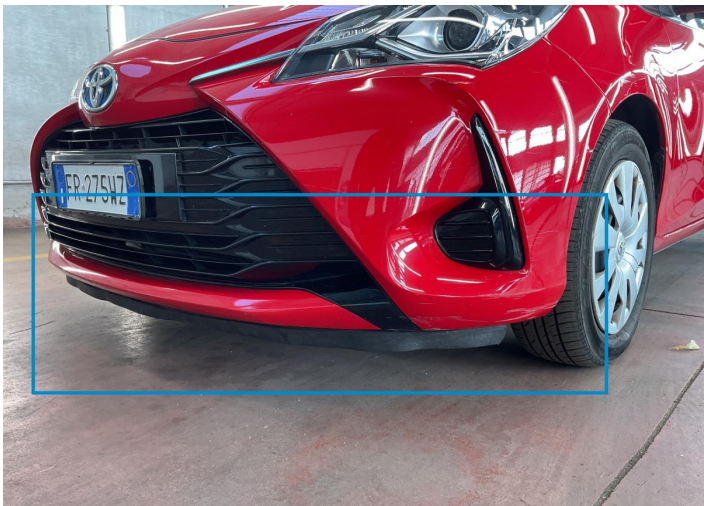
4. Bumper / Front
Bodywork / Dent -

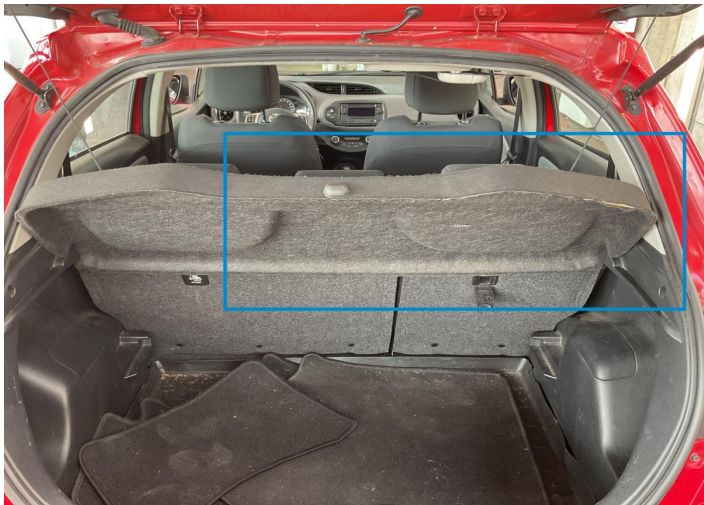
5. Luggage Space Cover / Back
Interior / Scratched -

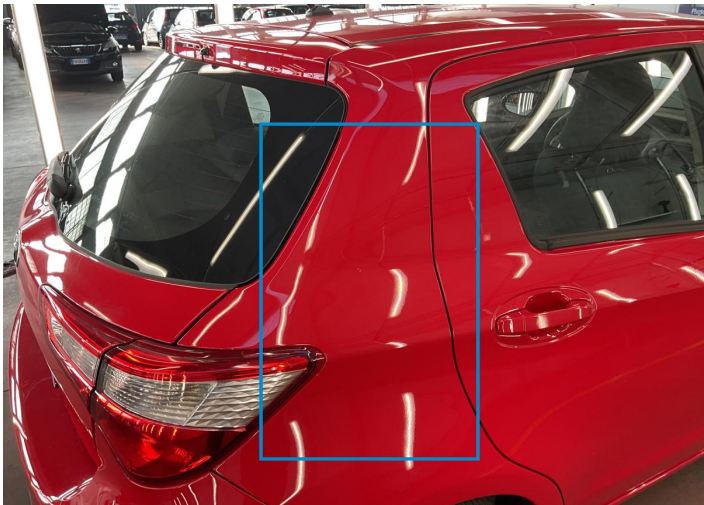
6. Fender / Back Right
Paint / Chipping -

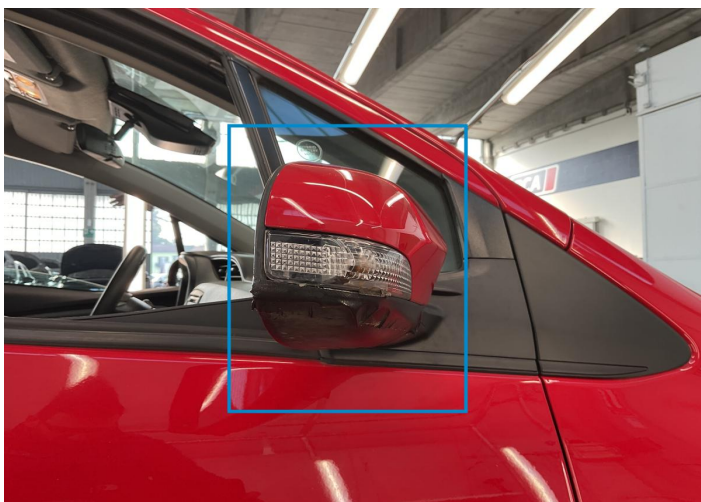
7. Mirror Shell / Front Right
Bodywork / Breakage -

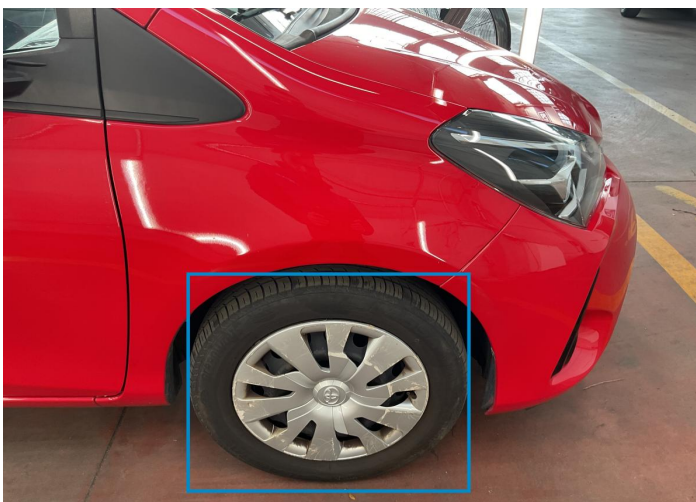
8. Hubcap / Front Right
Out of Bodywork / Scratch -

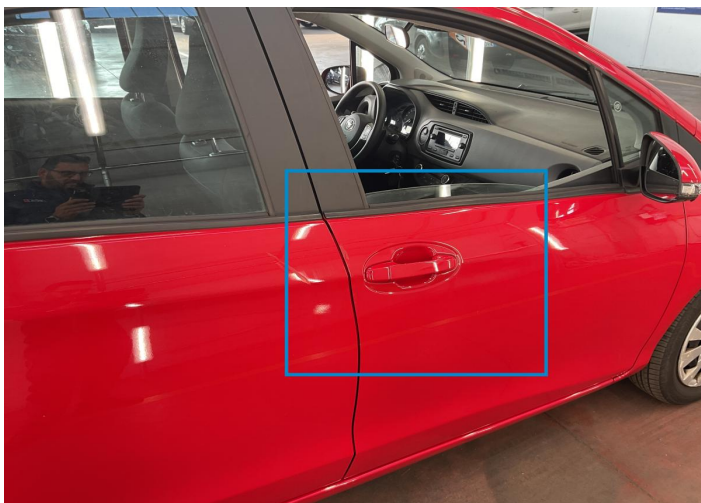
9. Door / Front Right
Paint / Scratch / Line -

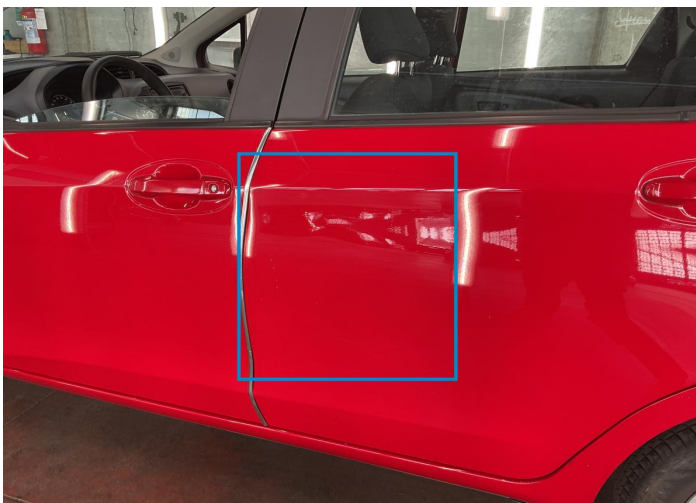
10. Door / Back Left
Paint / Scratch / Line -

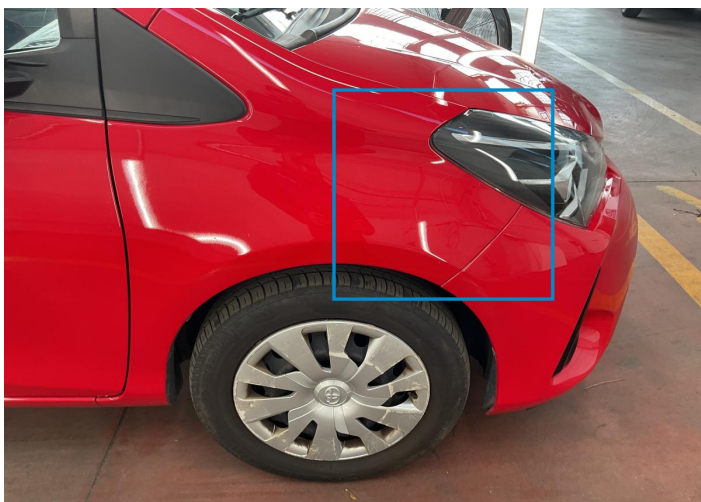
11. Fender / Front Right
Bodywork / Poor Previous Repair -

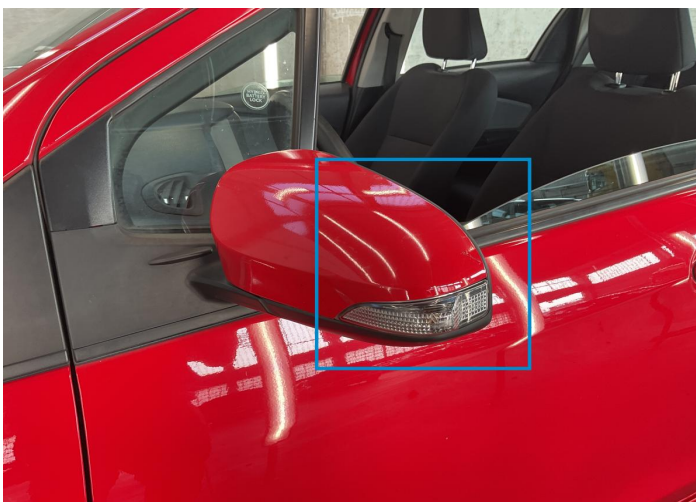
12. Mirror Shell / Front Left
Paint / Scratch / Line -

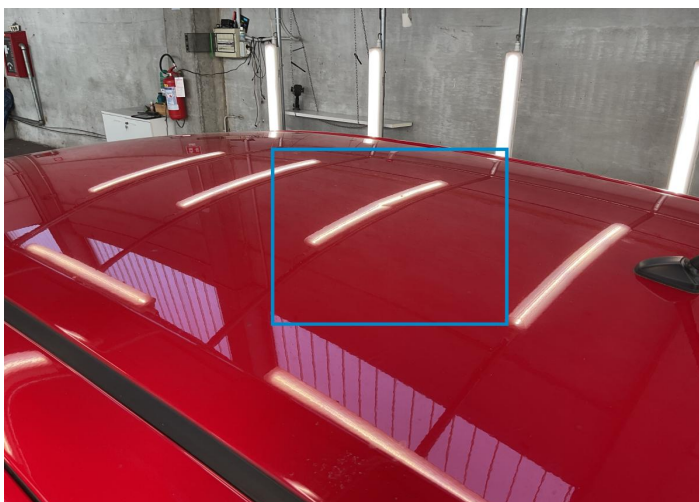
13. Roof
Bodywork / Dent / Small Dent -

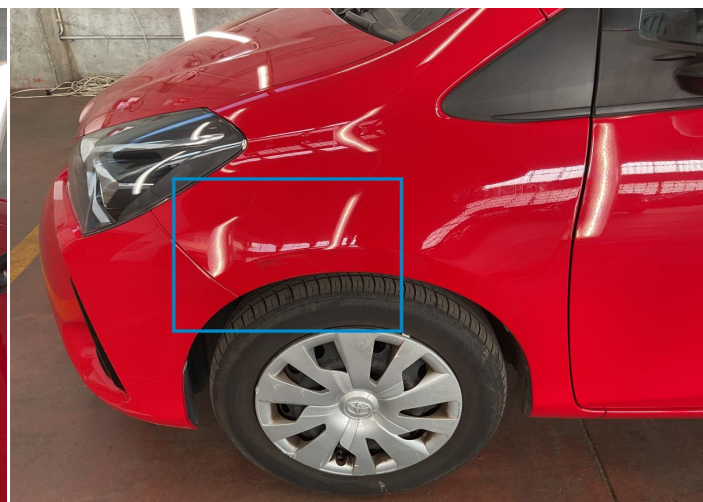
14. Fender / Front Left
Bodywork / Dent -

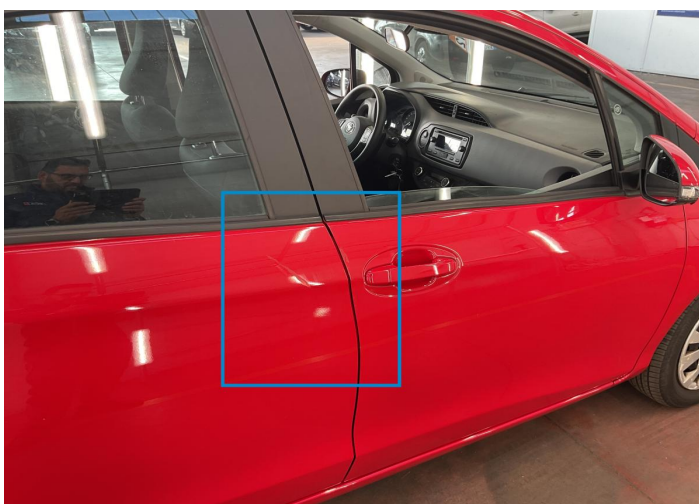
15. Door / Back Right
Paint / Scratch / Line -

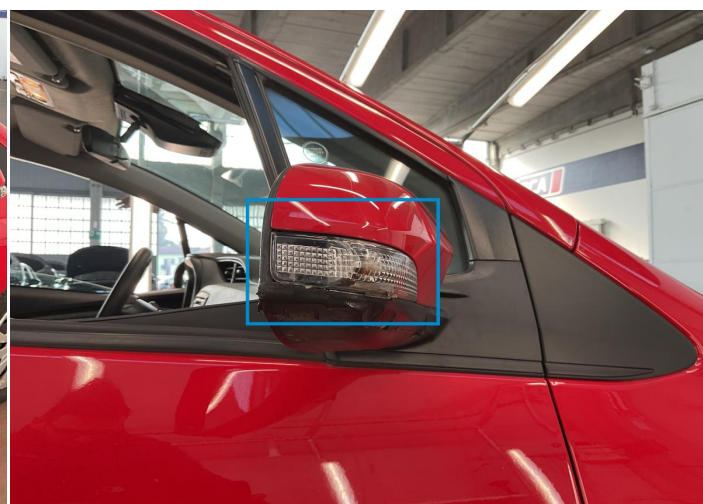
16. Mirror Repeater / Right
Bodywork / Breakage -

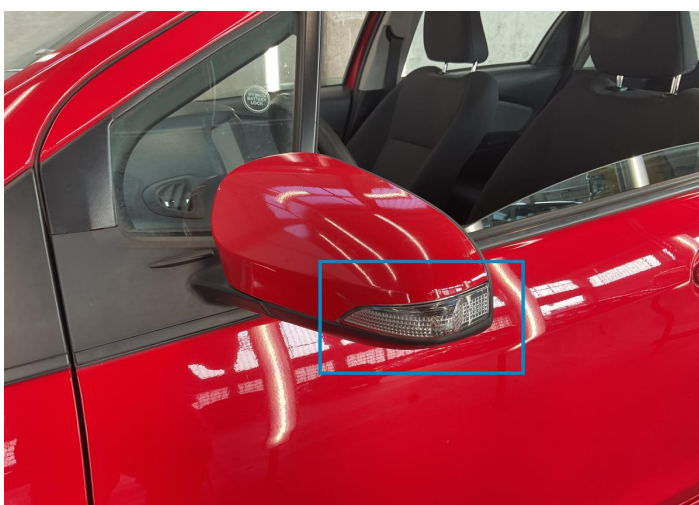
17. Mirror Repeater / Left
Glass Break / Scratch -
