TOYOTA Yaris

Yaris 1.0

VIN NO VNKKV18390A469717

Inspection Report Summary

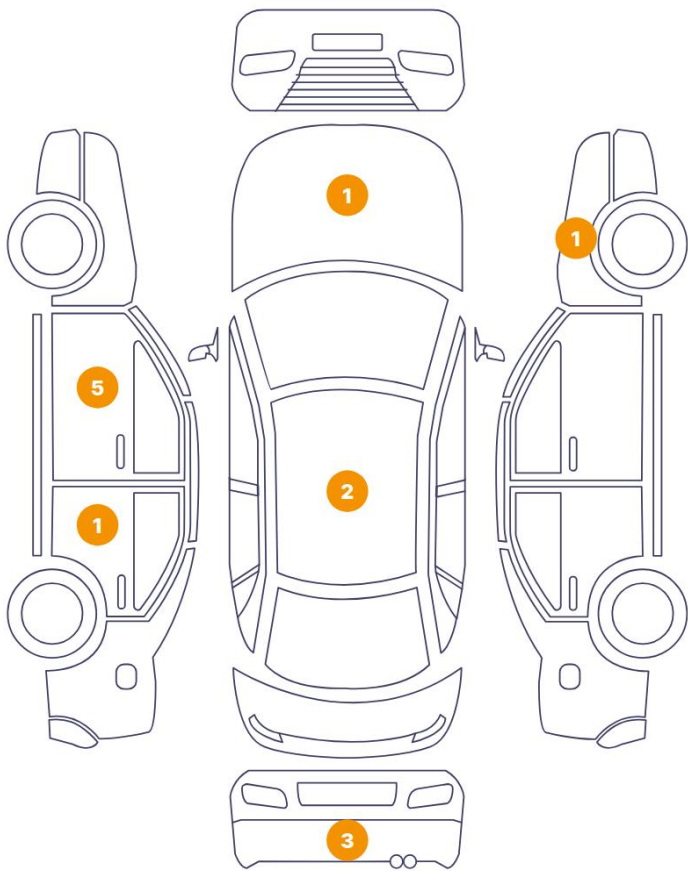
13 Schäden

Component		Damage	Comments
1	Door / Front Left	Bodywork / Dent	
2	Door / Front Left	Bodywork / Dent / Dent	
3	Door / Front Left	Bodywork / Dent / Dent	
4	Door / Front Left	Paint / Poor Previous Repair	
5	Door / Front Left	Bodywork / Dent / Dent	
6	Door / Back Left	Paint / Chipping	
7	Corner Bumper / Back Left	Bodywork / Breakage	
8	Bumper / Back	Paint / Chipping	
9	Bumper / Back	Paint / Chipping	
10	Wing Repeater / Right	Glass Break	
11	Hood	Paint / Chipping	
12	Roof	Paint / Scratch / Scuff

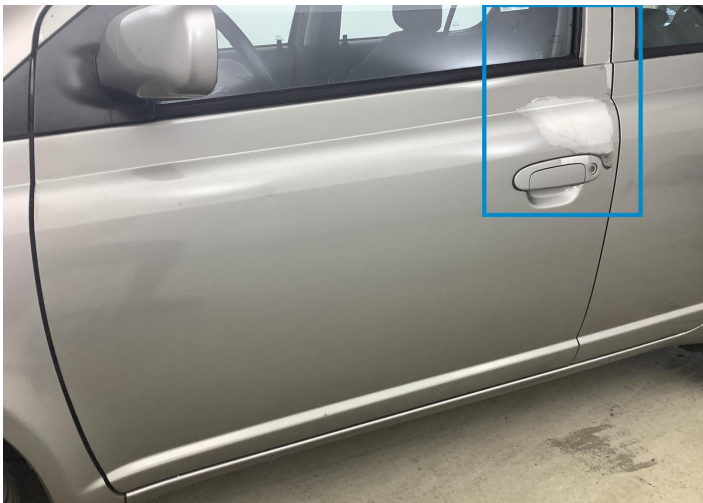
1. Door / Front Left
Bodywork / Dent -

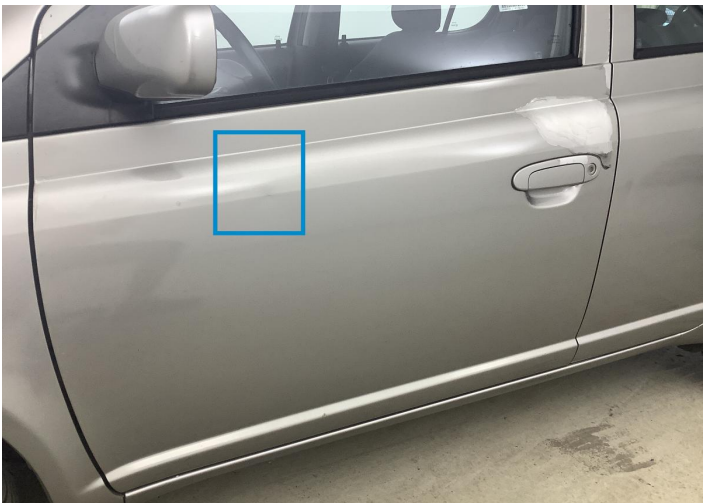
2. Door / Front Left
Bodywork / Dent / Dent -

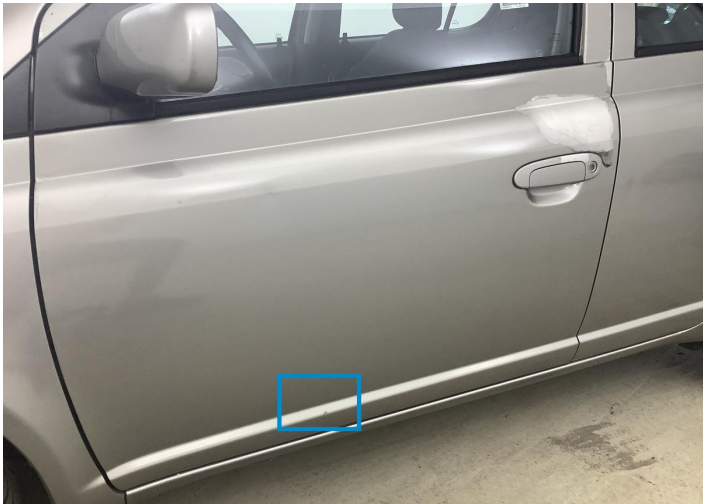
3. Door / Front Left
Bodywork / Dent / Dent -

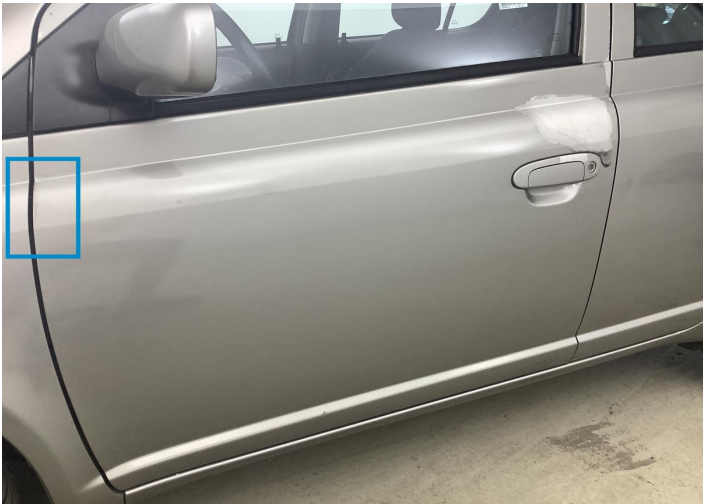
4. Door / Front Left
Paint / Poor Previous Repair -

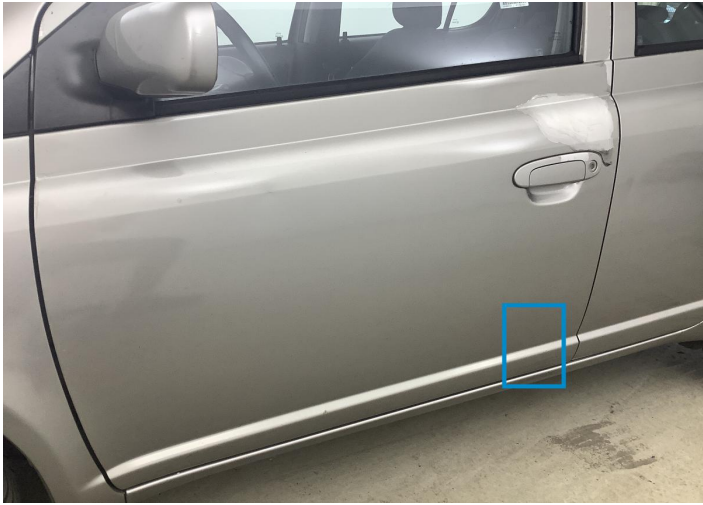
5. Door / Front Left
Bodywork / Dent / Dent -

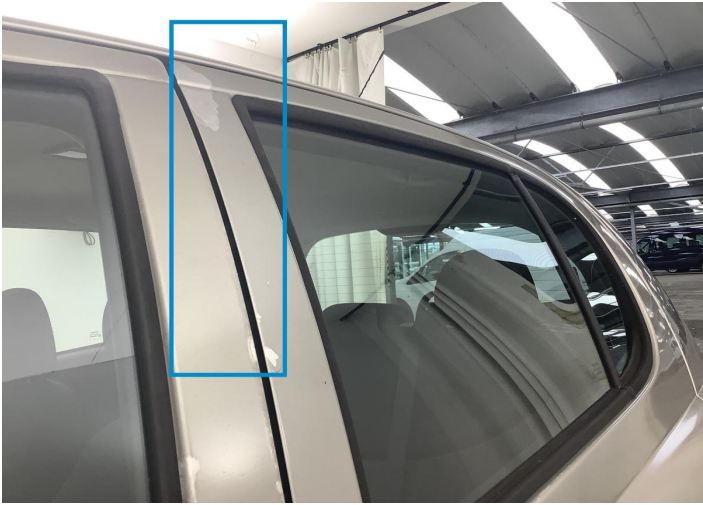
6. Door / Back Left
Paint / Chipping -

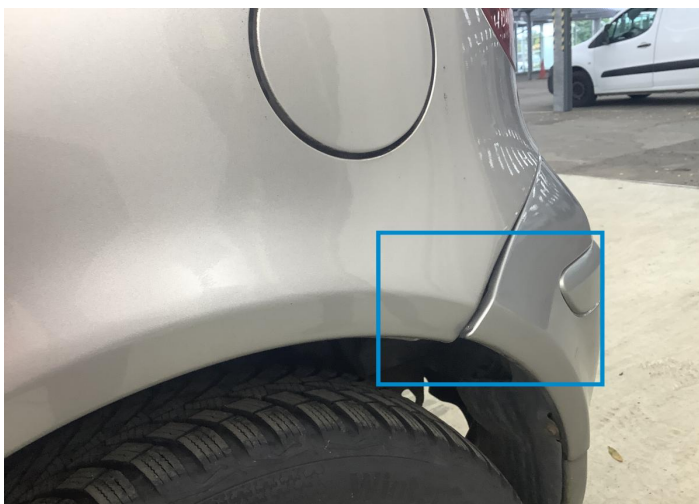
7. Corner Bumper / Back Left
Bodywork / Breakage -

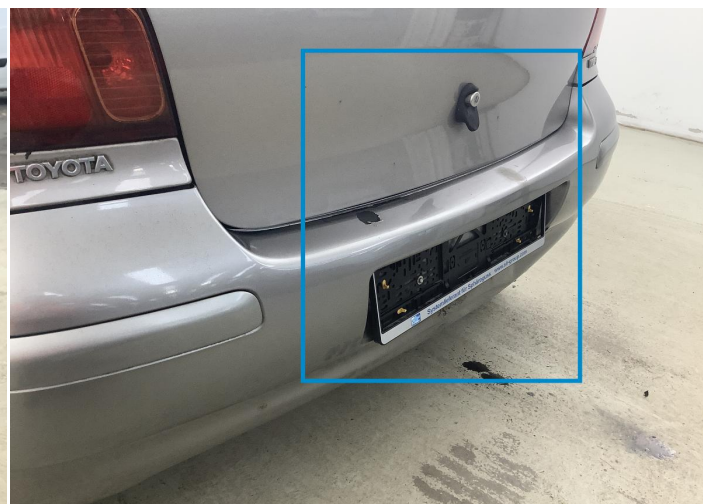
8. Bumper / Back
Paint / Chipping -

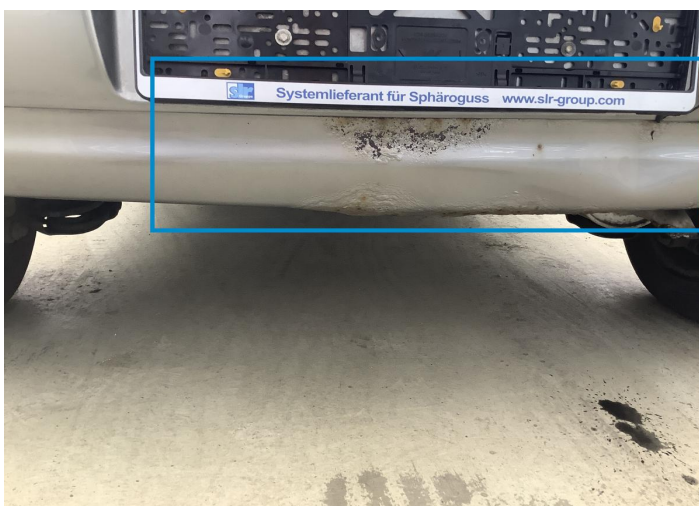
9. Bumper / Back
Paint / Chipping -

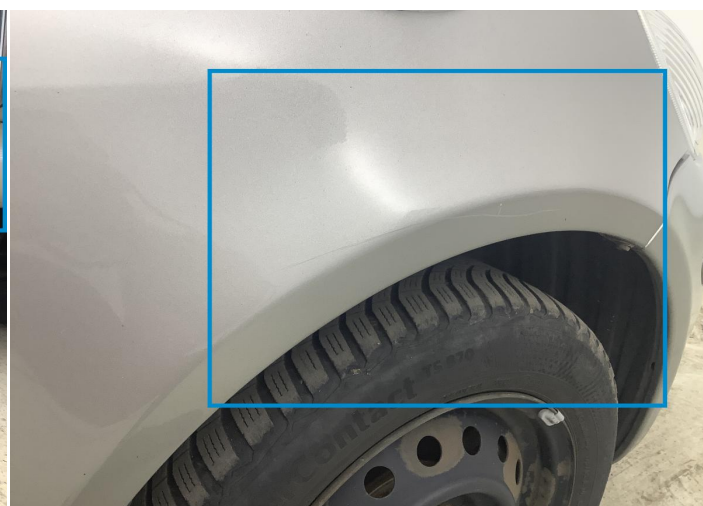
10. Wing Repeater / Right
Glass Break -

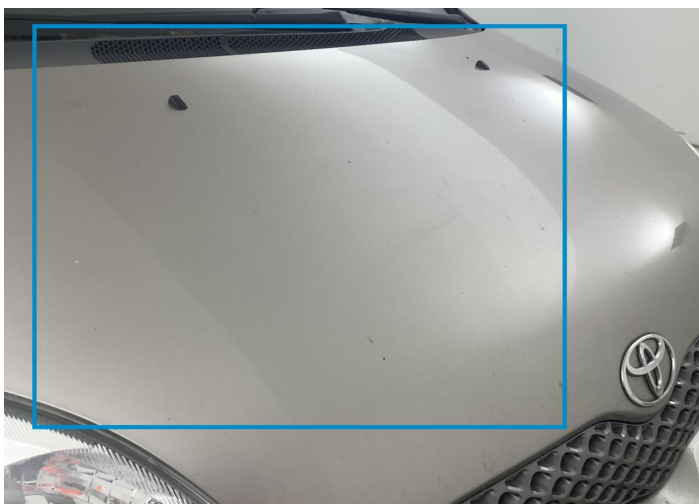
11. Hood
Paint / Chipping -

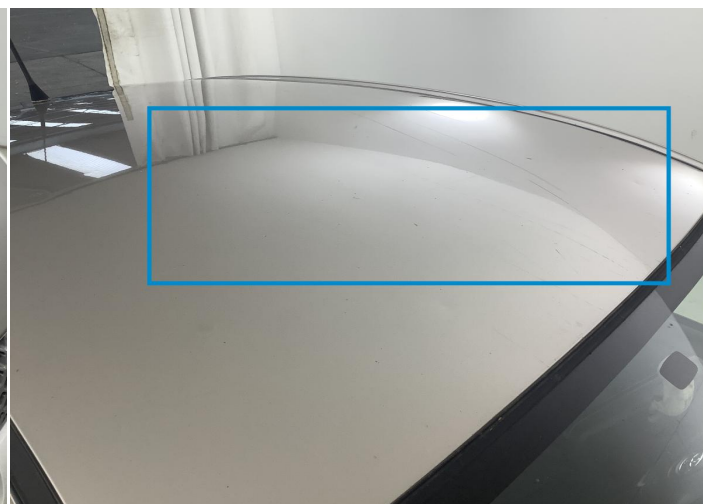
12. Roof
Paint / Scratch / Scuff -

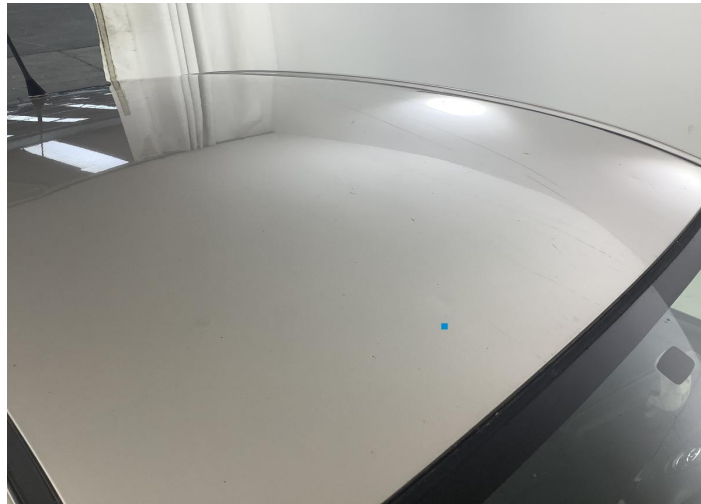
13. Roof
Bodywork / Dent / Dent -
