Expertise

Protocol number: 41755436
Order number / reference: 25186799
Inspection date: 26 Sept 2025

Manufacturer: Peugeot

Model: Partner 1.5 BlueHDi 130 L2 EHZ S&S Premium

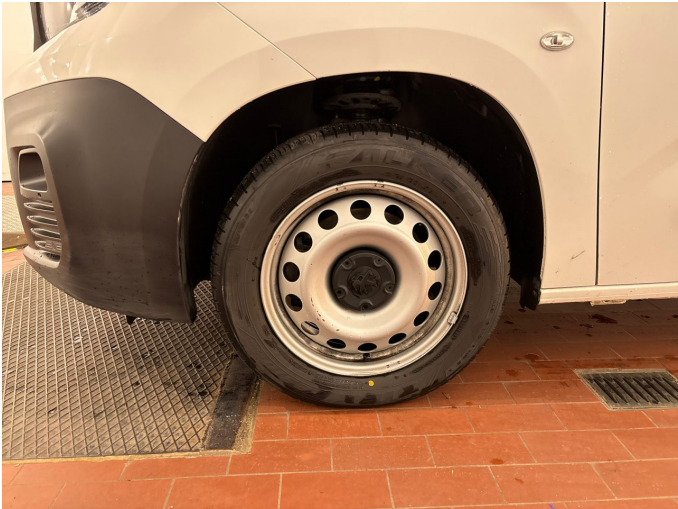
Figure 12: Mounted tyres

#	Tyre size	Type of tyre	Manufacturer	Tread depth
1)	205/60 R16 96W	Summer tyres on Steel	Falken	4mm / 4mm
2)	205/60 R16 96W	Summer tyres on Steel	Falken	6mm / 6mm

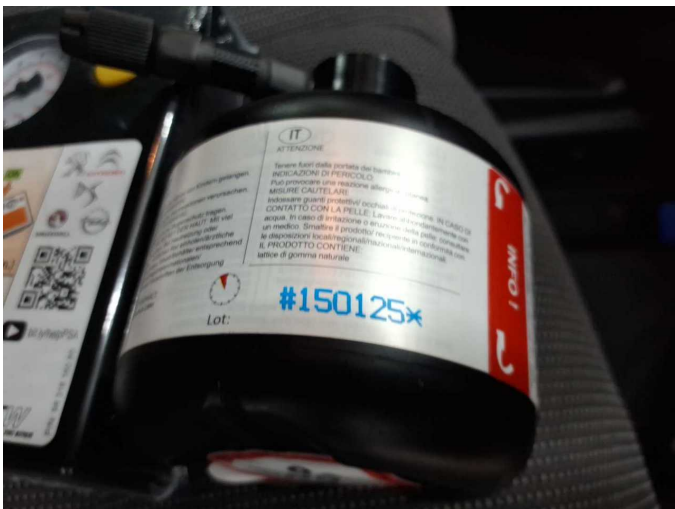
No.	Component group	Description
1	Equipment	Tirefit filler - Expired - Replace

Damage 1: Equipment: Tirefit filler - Expired - Replace

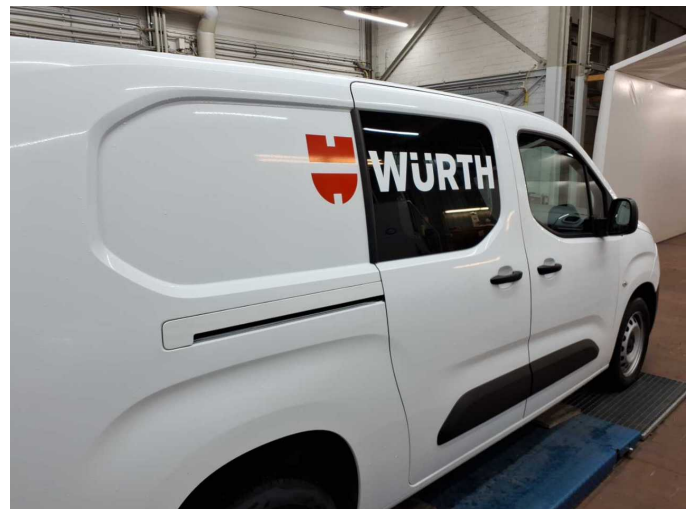
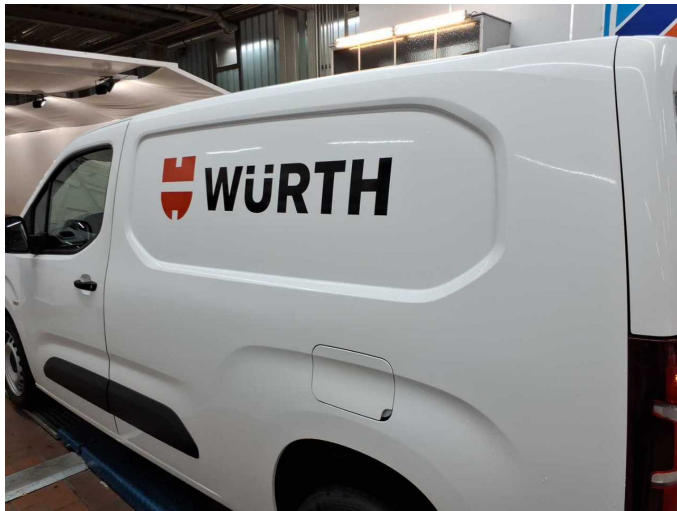
No.	Component group	Description
2	Body	Body - Glued / labelled - De-glue / neutralise
3	Front bumper	Front bumper - Scratched - Loss in value
4	Rear bumper	Rear bumper - Scratched - Loss in value

Damage 2: Body: Body - Glued / labelled - De-glue / neutralise

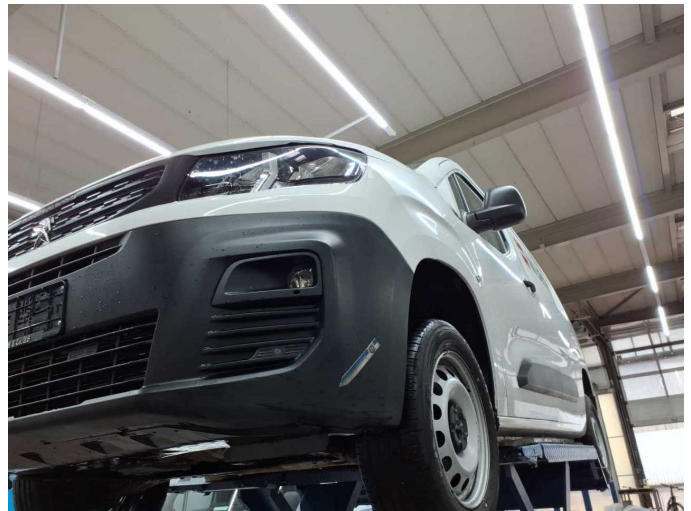
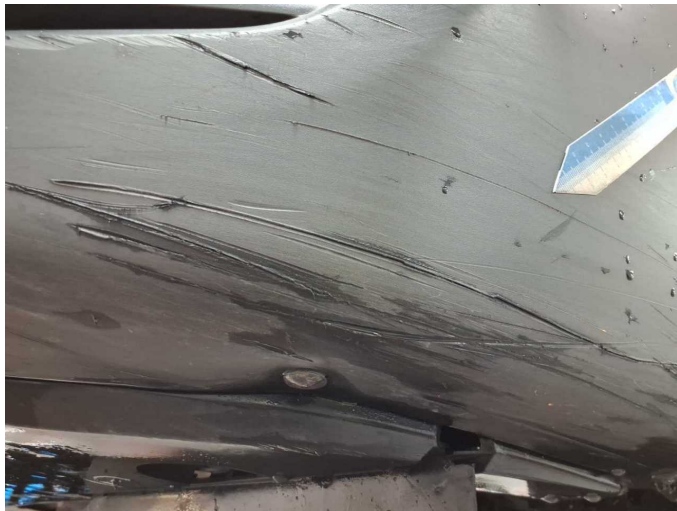
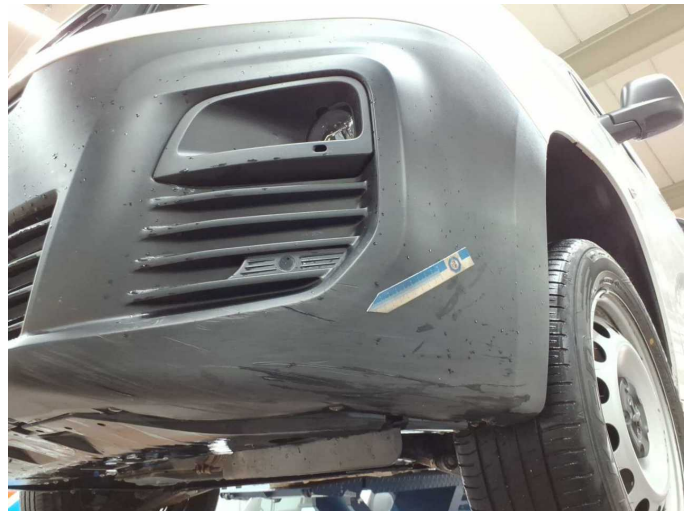
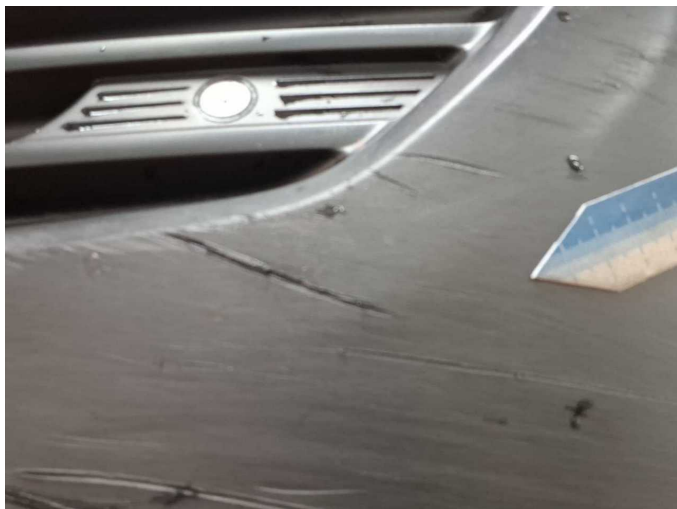
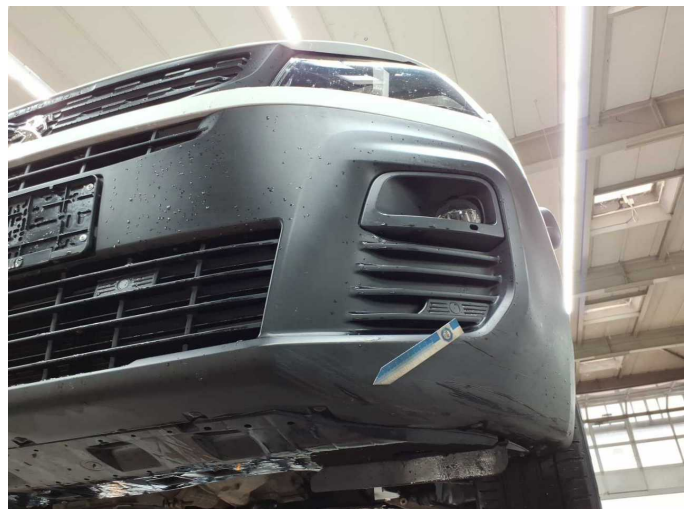
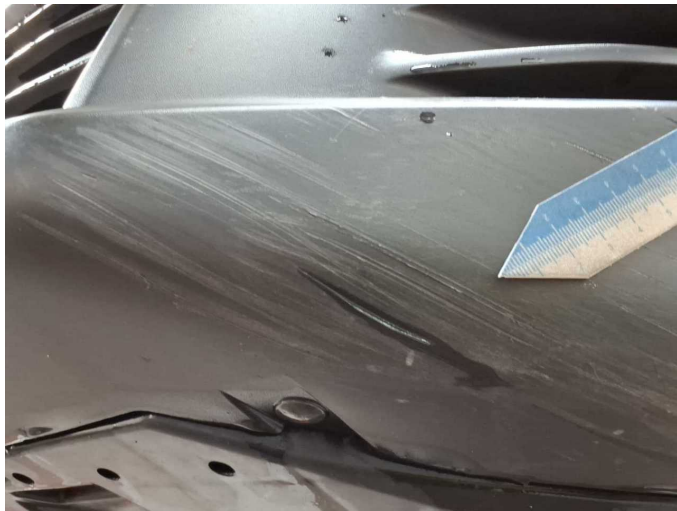
Damage 3: Front bumper: Front bumper - Scratched - Loss in value

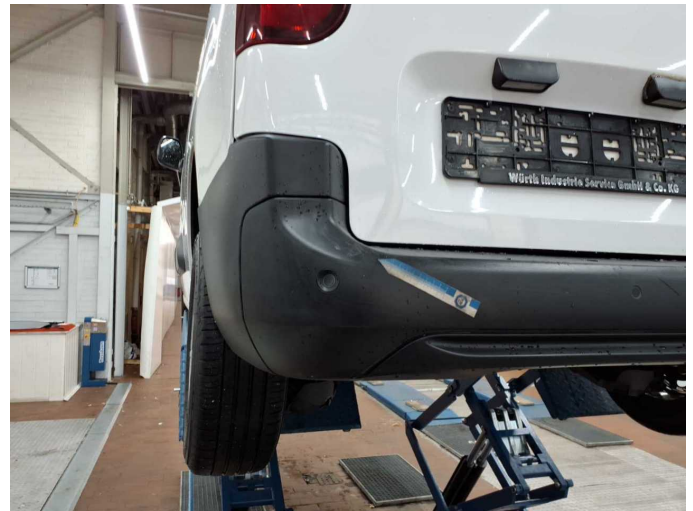
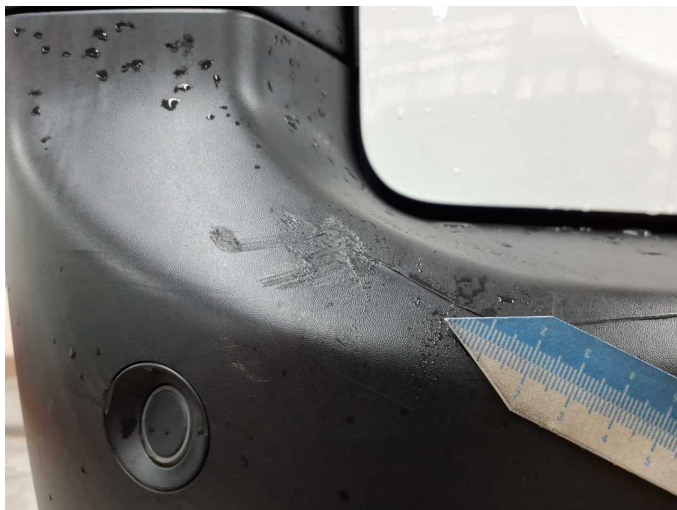
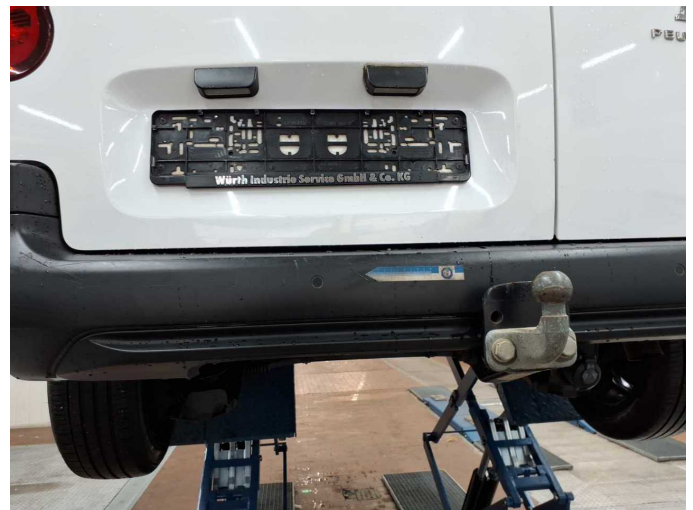
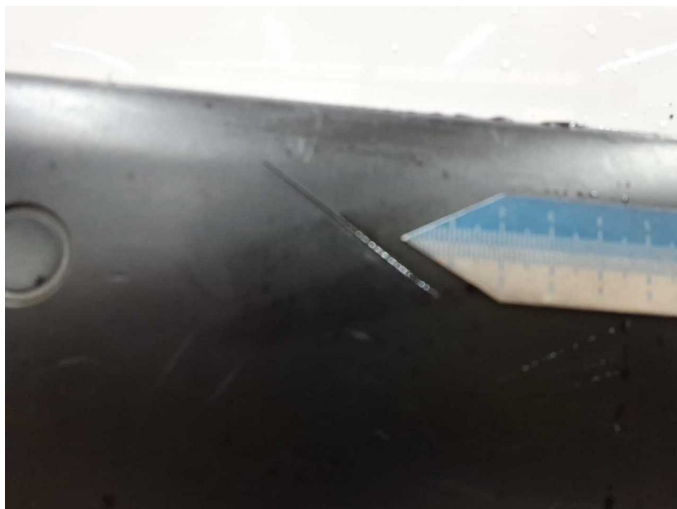
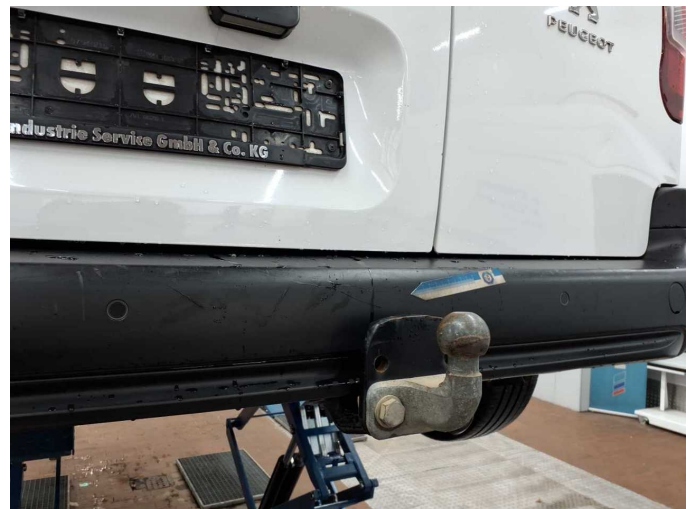
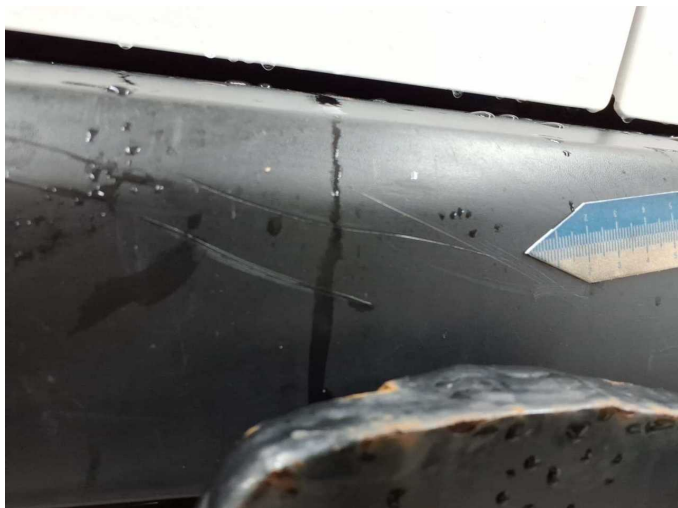
Damage 4: Rear bumper: Rear bumper - Scratched - Loss in value
