Expertise

Protocol number: 39786213
Order No. / Reference: 24714127
Inspection date: 19 May 2025

Manufacturer: Peugeot	Model: 508 SW Hybrid e-EAT8 GT
VIN: VR3F4DGZTLY055701

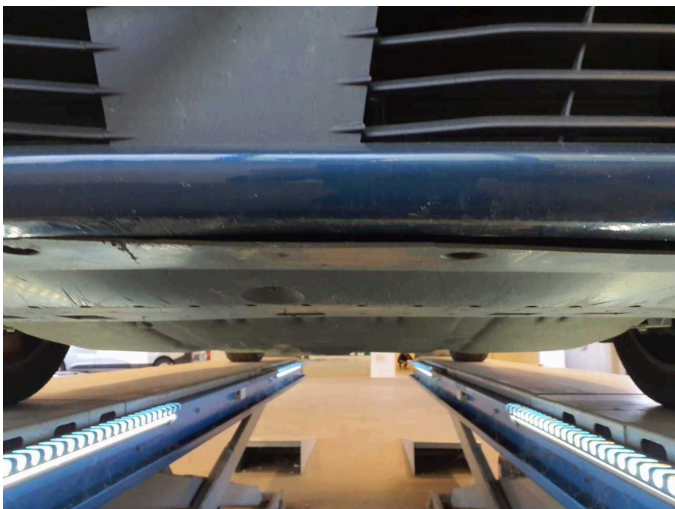
Damage 2: Body: Underbody panelling (+verkratzt) - Malposition - Un- / install

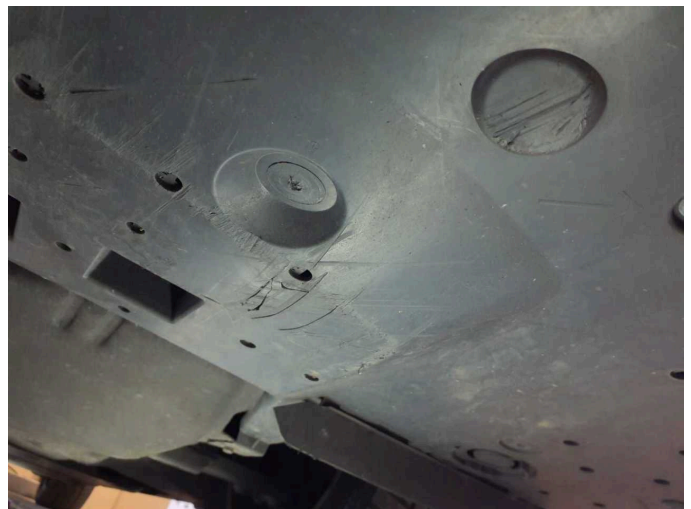
Damage 2: Body: Underbody panelling (+verkratzt) - Malposition - Un- / install

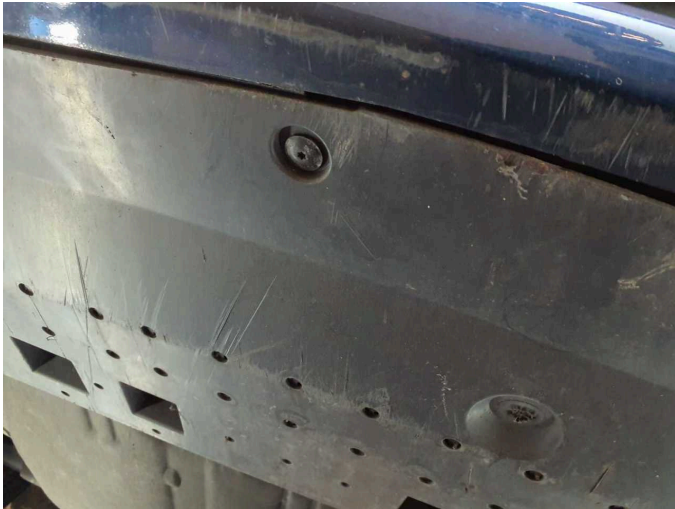
Damage 2: Body: Underbody panelling (+verkratz) - Malposition - Un- / install

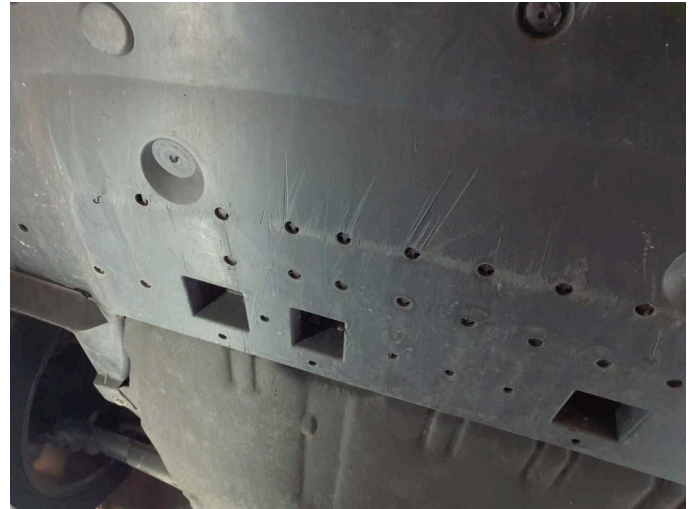
Damage 2: Body: Underbody panelling (+verkratz) - Malposition - Un- / install

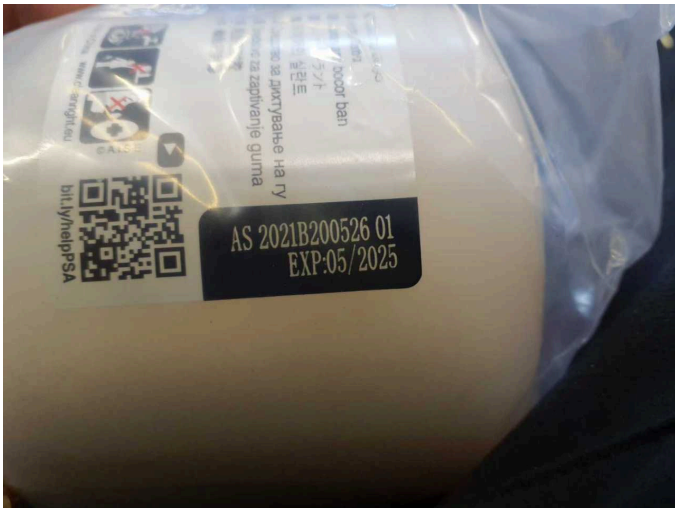
Damage 3: Equipment: Tirefit filler - Expired - Replace

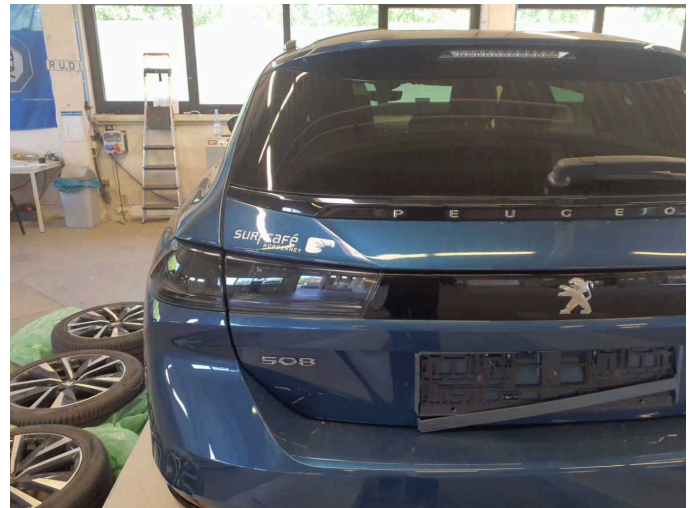
Damage 4: Boot lid / rear door: Boot lid - Glued / labelled - De-glue / neutralise

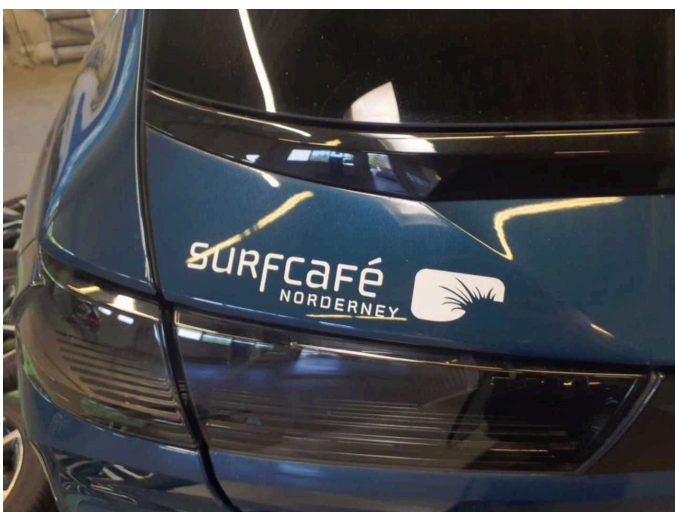
Damage 4: Boot lid / rear door: Boot lid - Glued / labelled - De-glue / neutralise

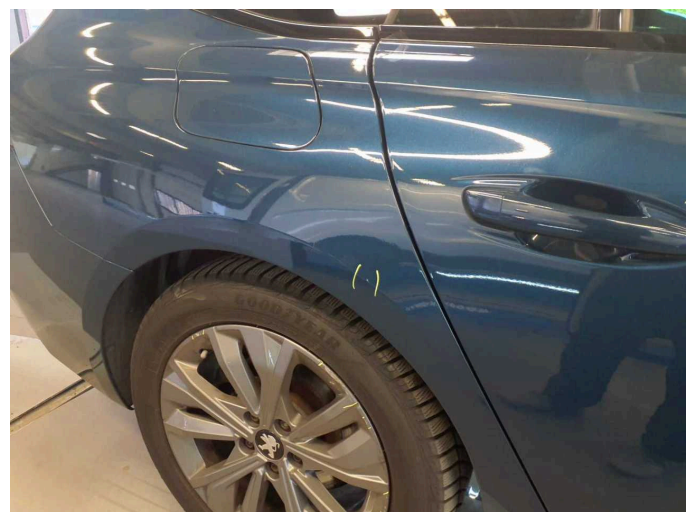
Damage 5: Side panel - rear right side: Side panel - Scratch(es) - Smart repair

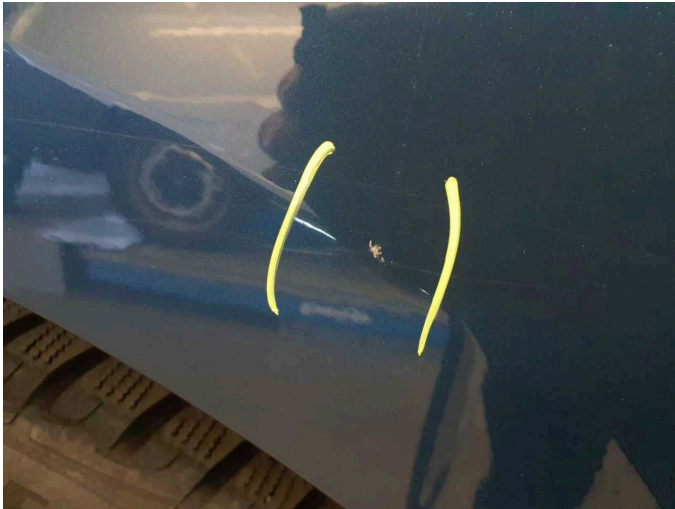
Damage 5: Side panel - rear right side: Side panel - Scratch(es) - Smart repair

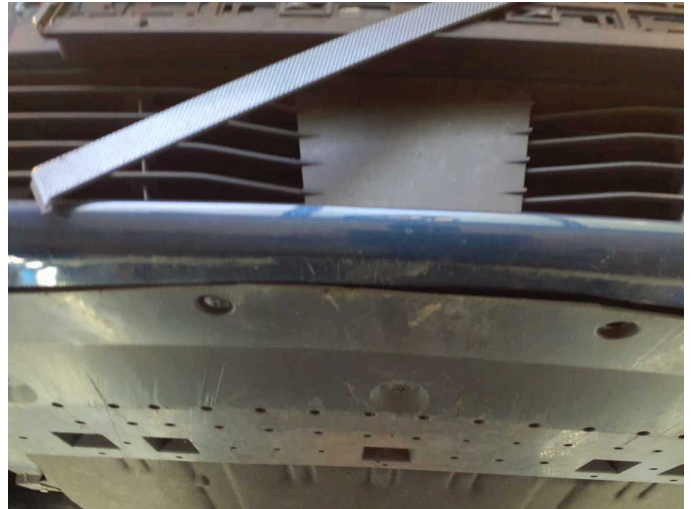
Damage 6: Front bumper: Front bumper (unterhalb) - Scratched - Smart repair

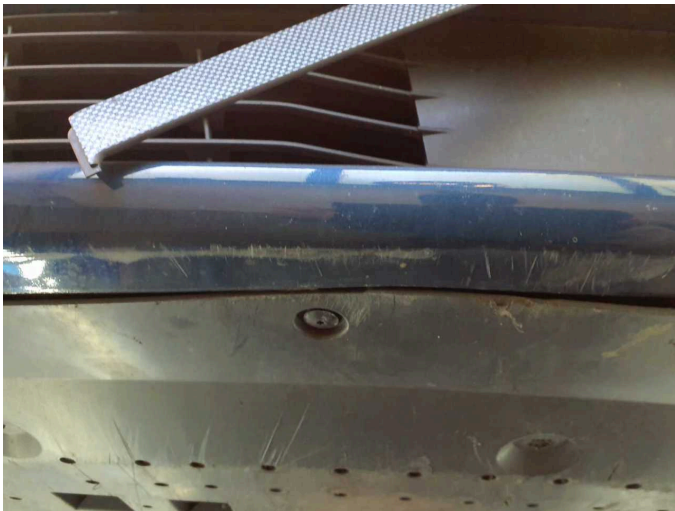
Damage 6: Front bumper: Front bumper (unterhalb) - Scratched - Smart repair

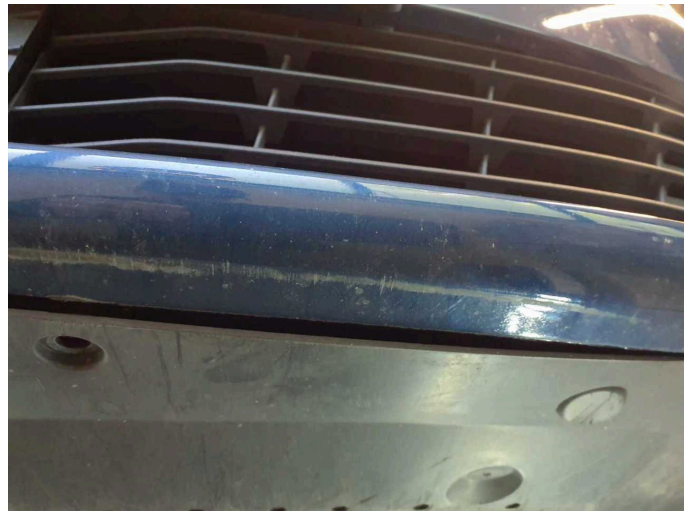
Damage 6: Front bumper: Front bumper (unterhalb) - Scratched - Smart repair

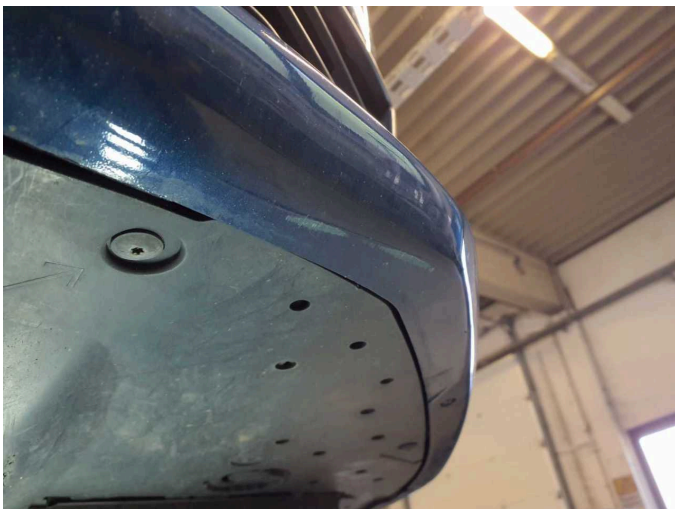
Damage 6: Front bumper: Front bumper (unterhalb) - Scratched - Smart repair

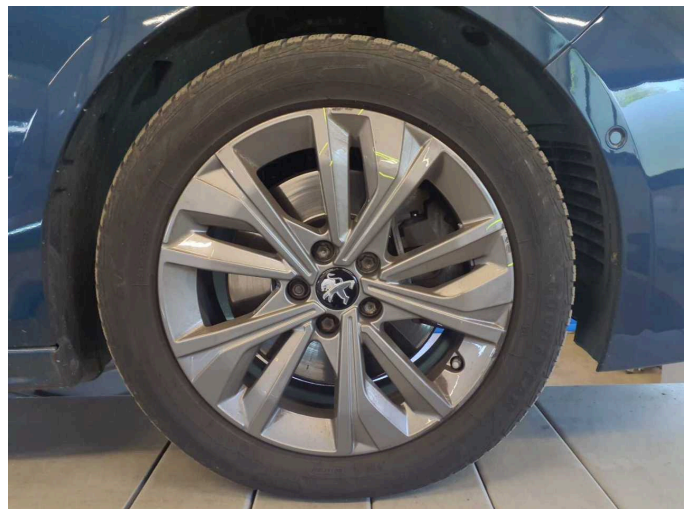
Damage 7: Wheel / tyres: Alloy rim - front right side - Scratch(es) - Loss in value

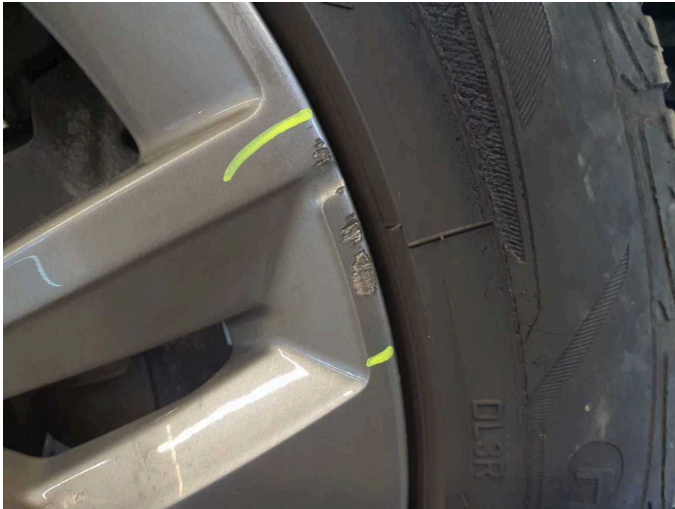
Damage 7: Wheel / tyres: Alloy rim - front right side - Scratch(es) - Loss in value

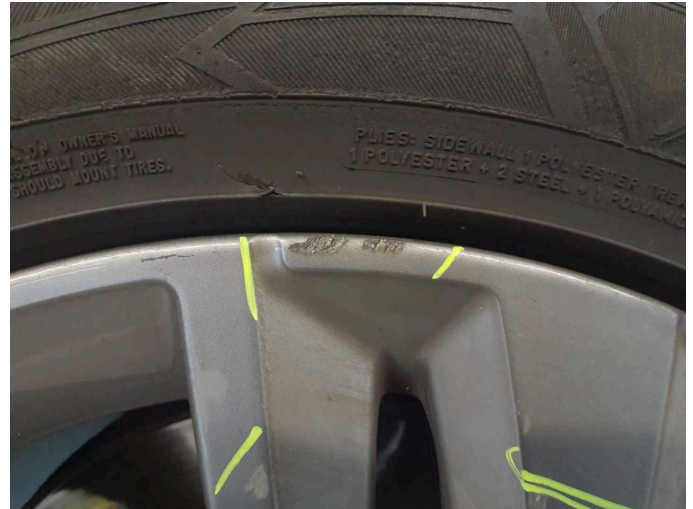
Damage 7: Wheel / tyres: Alloy rim - front right side - Scratch(es) - Loss in value

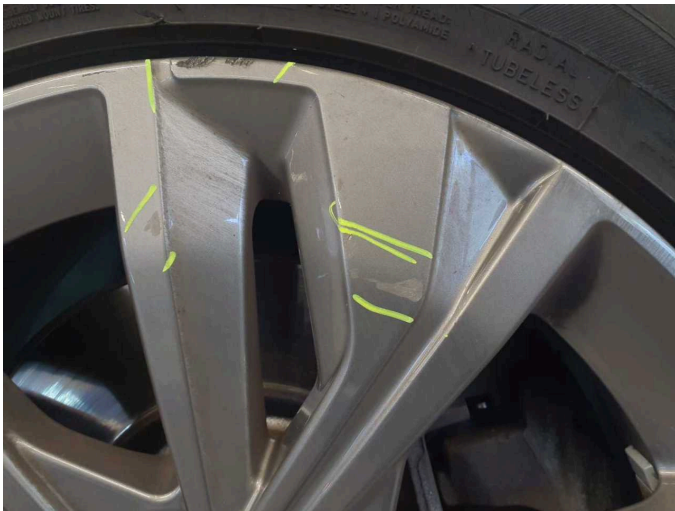
Damage 7: Wheel / tyres: Alloy rim - front right side - Scratch(es) - Loss in value

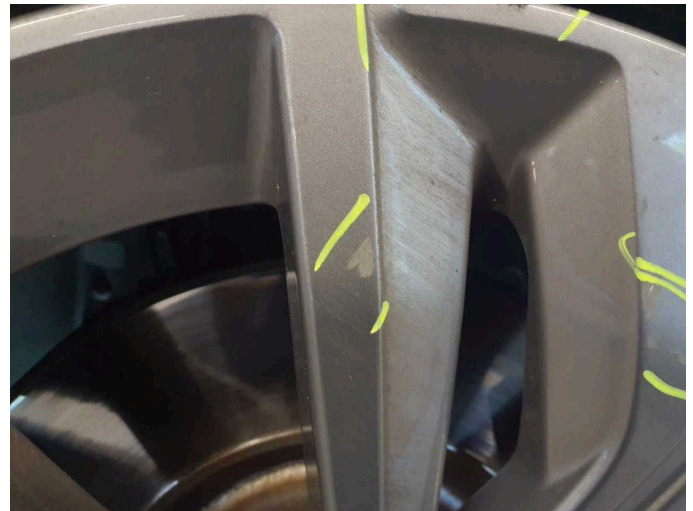
Damage 7: Wheel / tyres: Alloy rim - front right side - Scratch(es) - Loss in value

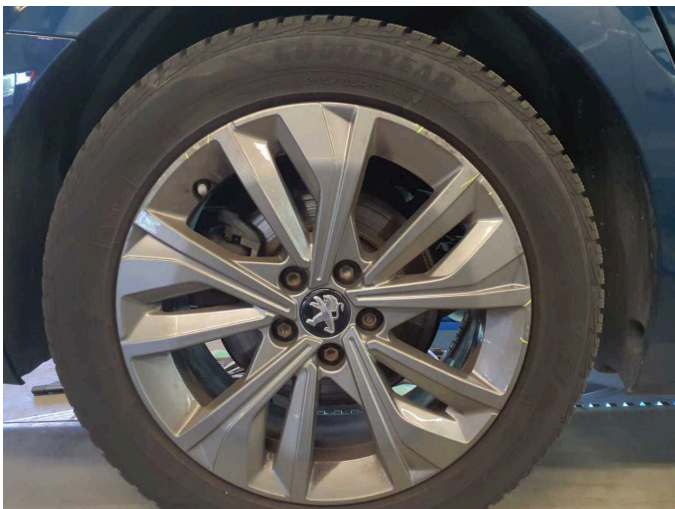
Damage 8: Wheel / tyres: Alloy rim - rear right side - Scratch(es) - Loss in value

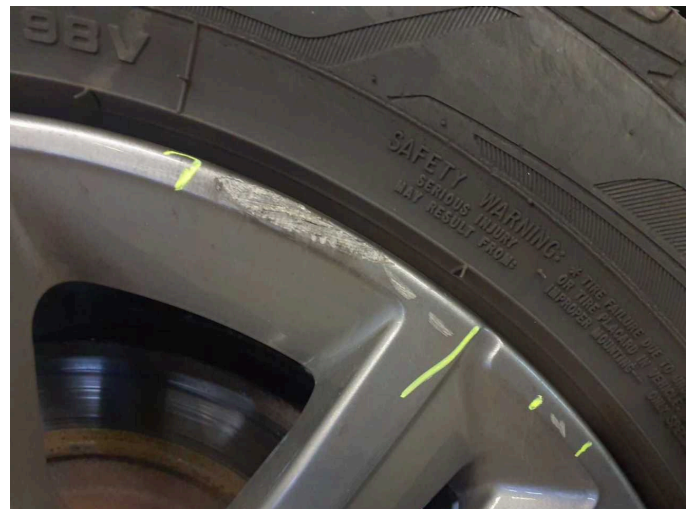
Damage 8: Wheel / tyres: Alloy rim - rear right side - Scratch(es) - Loss in value

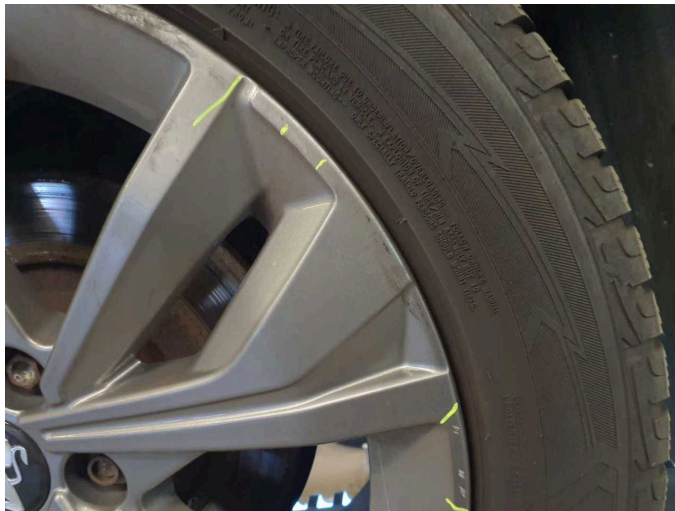
Damage 8: Wheel / tyres: Alloy rim - rear right side - Scratch(es) - Loss in value

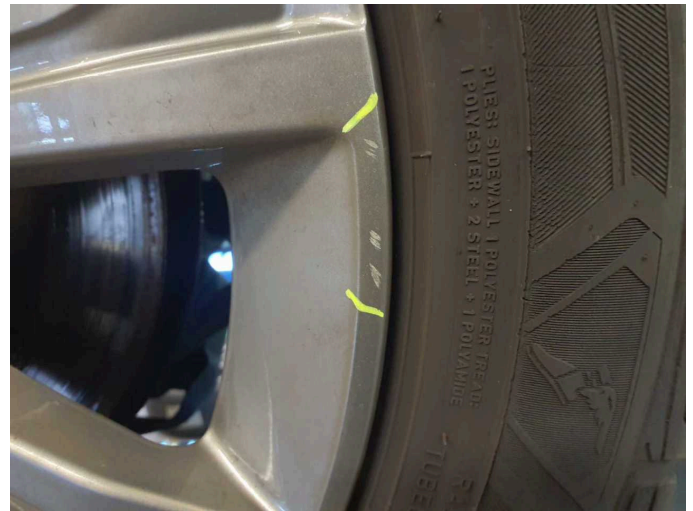
Damage 8: Wheel / tyres: Alloy rim - rear right side - Scratch(es) - Loss in value

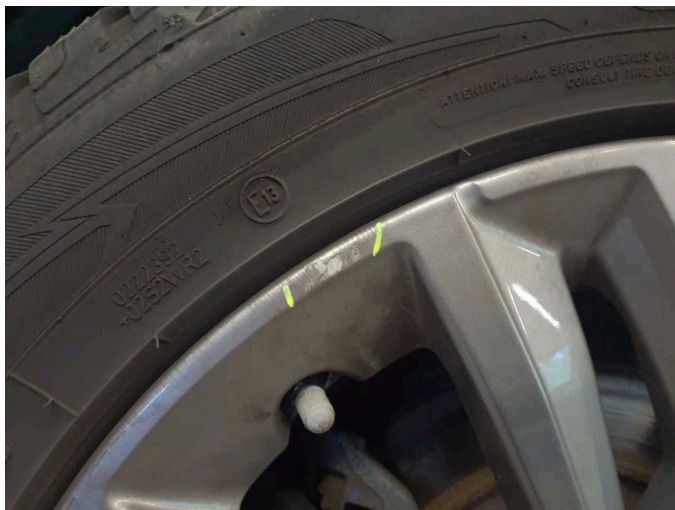
Damage 8: Wheel / tyres: Alloy rim - rear right side - Scratch(es) - Loss in value

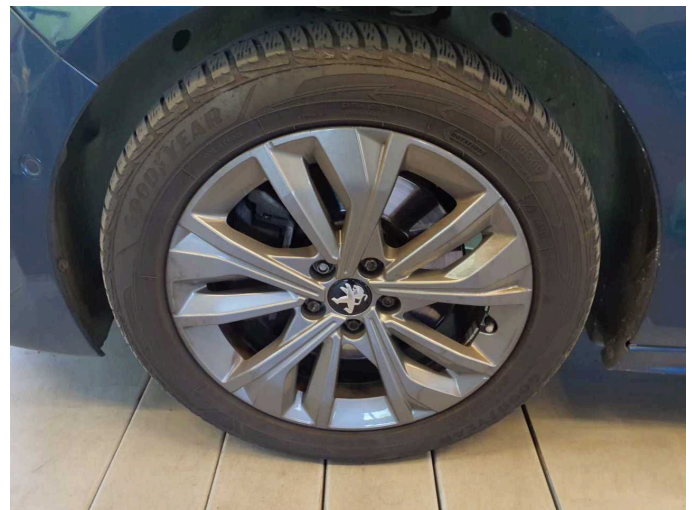
Damage 9: Wheel / tyres: Tyre - front (3mm) - Does not meet the leasing specifications - Replace

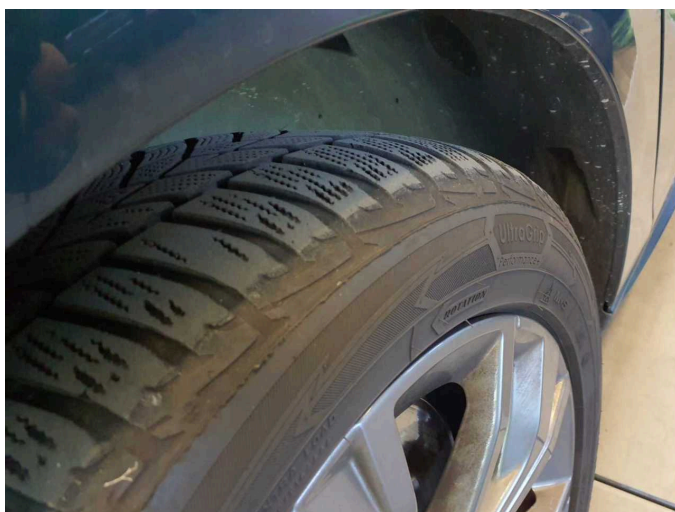
Damage 9: Wheel / tyres: Tyre - front (3mm) - Does not meet the leasing specifications - Replace

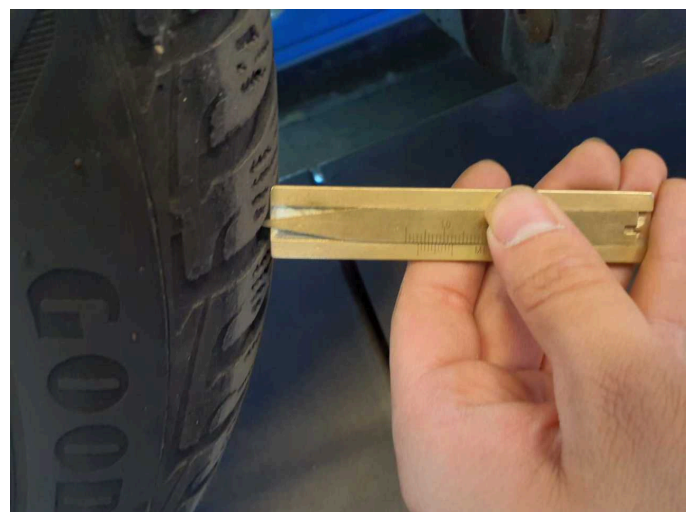
Damage 9: Wheel / tyres: Tyre - front (3mm) - Does not meet the leasing specifications - Replace

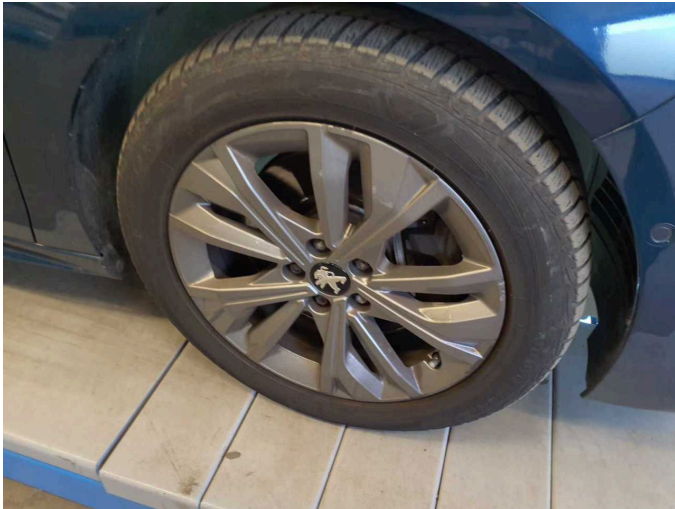
Damage 9: Wheel / tyres: Tyre - front (3mm) - Does not meet the leasing specifications - Replace

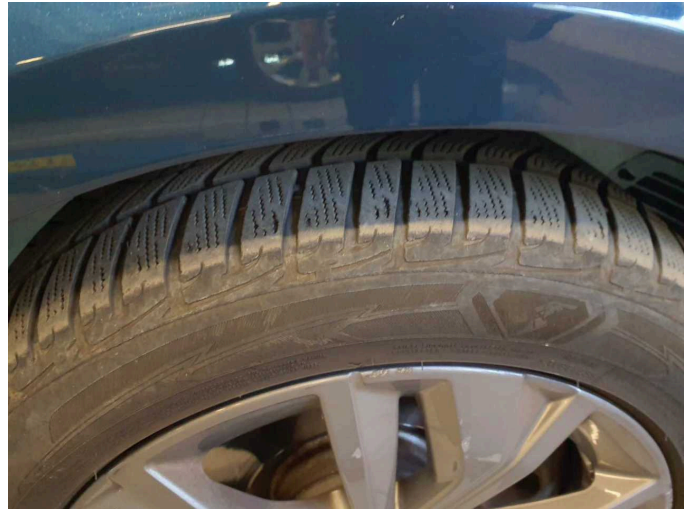
Damage 9: Wheel / tyres: Tyre - front (3mm) - Does not meet the leasing specifications - Replace

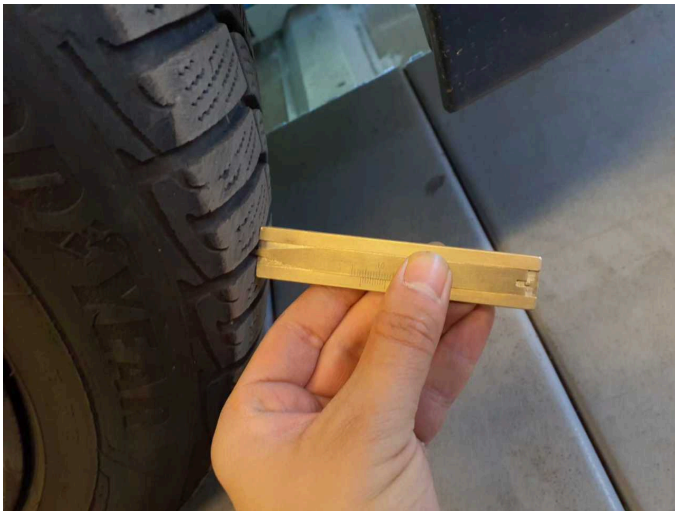
Damage 9: Wheel / tyres: Tyre - front (3mm) - Does not meet the leasing specifications - Replace

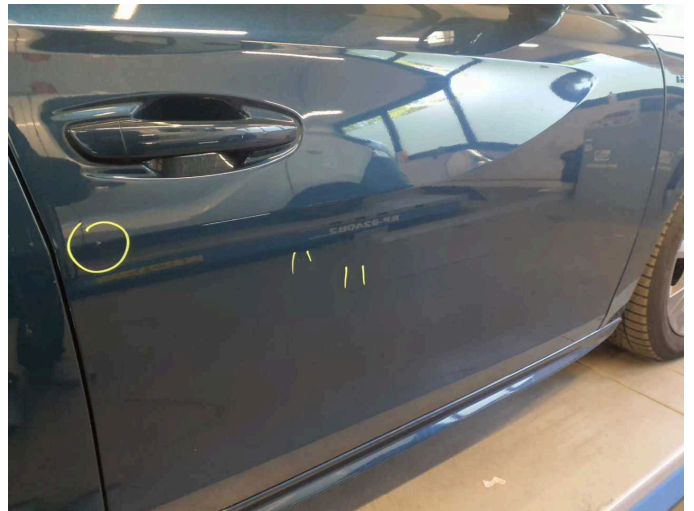
Damage 10: Door - front right side: Door (+delle) - Scratch(es) - Repair and paint

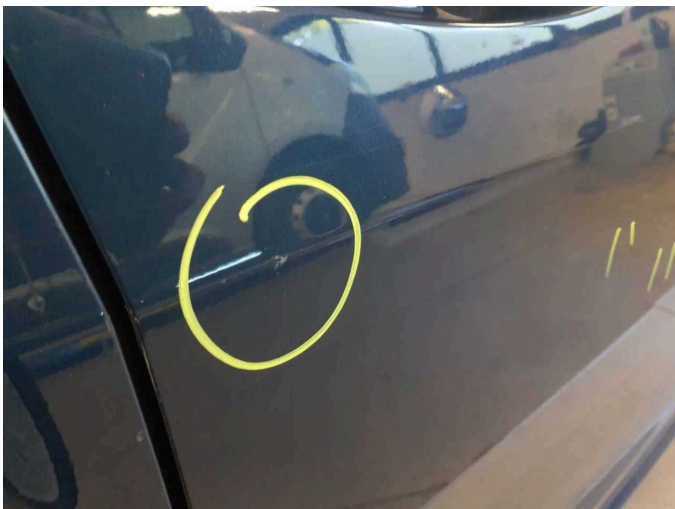
Damage 10: Door - front right side: Door (+delle) - Scratch(es) - Repair and paint

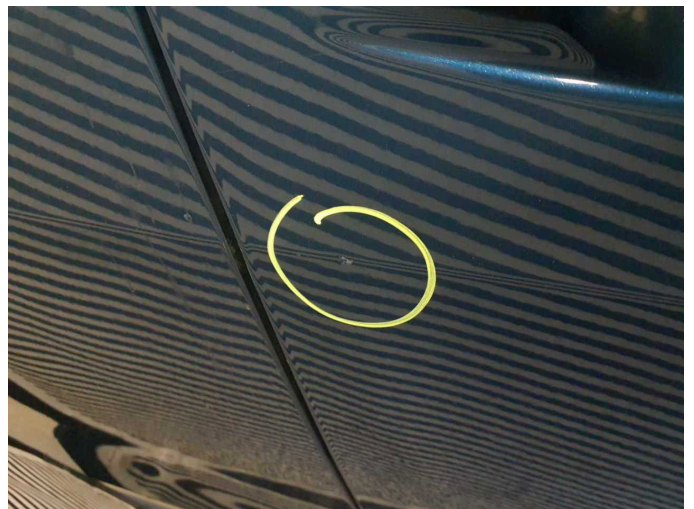
Damage 10: Door - front right side: Door (+delle) - Scratch(es) - Repair and paint

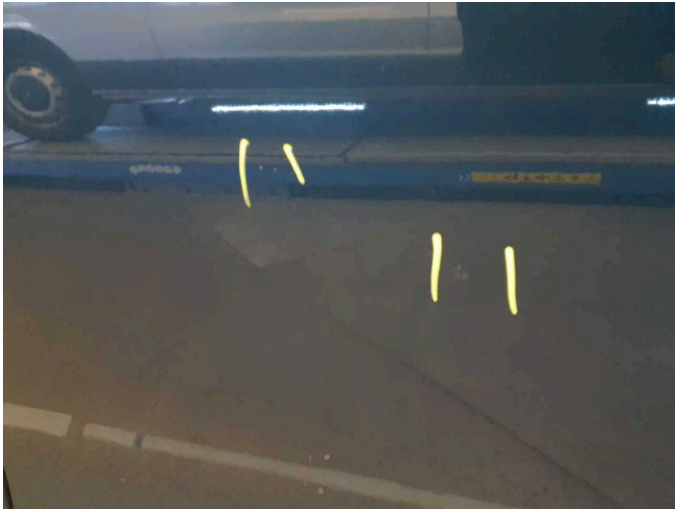
Damage 10: Door - front right side: Door (+delle) - Scratch(es) - Repair and paint

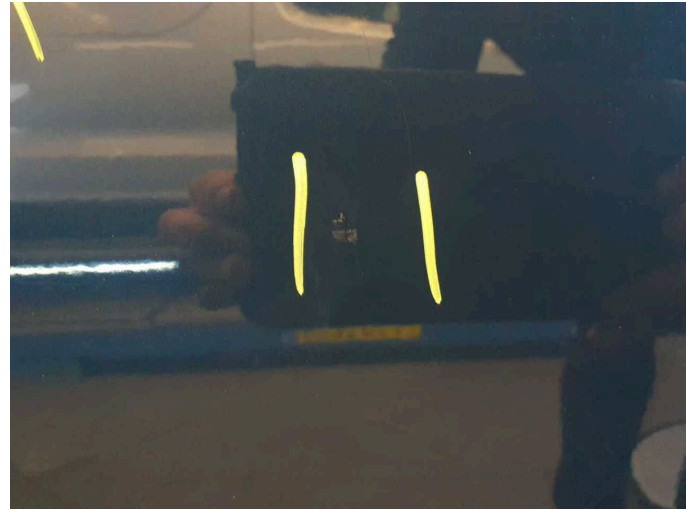
Damage 10: Door - front right side: Door (+delle) - Scratch(es) - Repair and paint

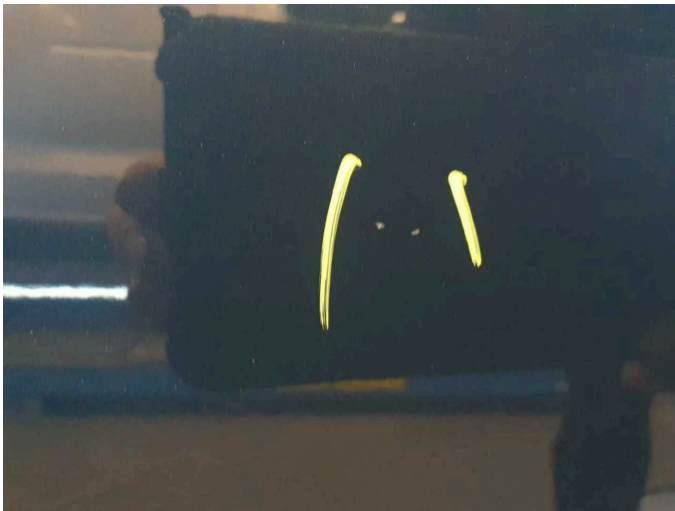
Damage 10: Door - front right side: Door (+delle) - Scratch(es) - Repair and paint

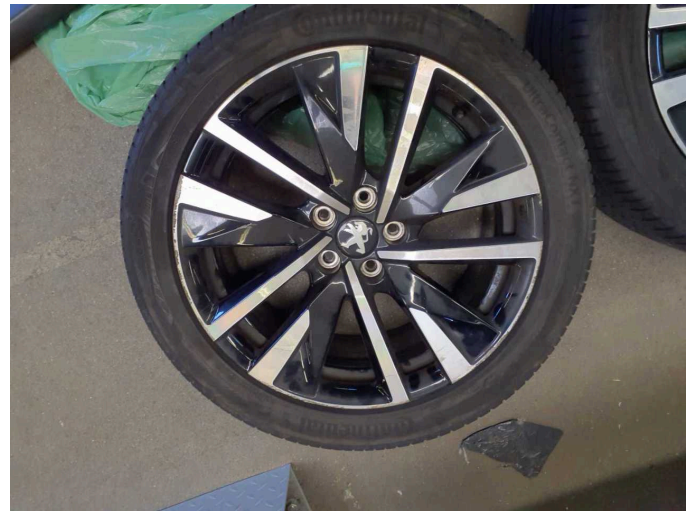
Damage 11: 2nd wheel set: 2 alloy rims - Scratched - Replace

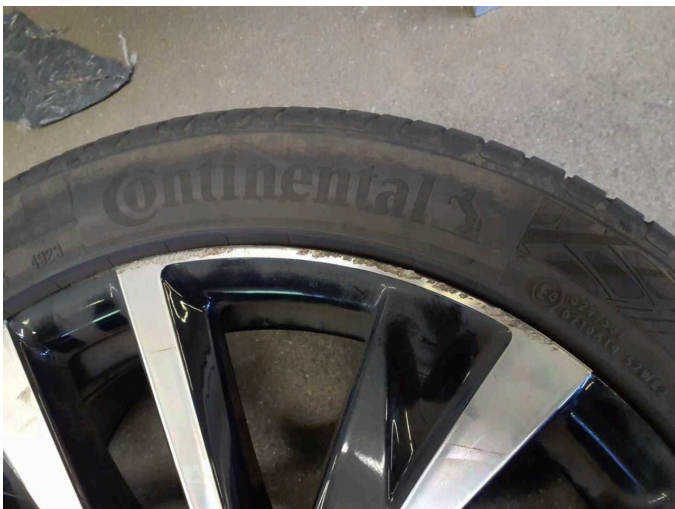
Damage 11: 2nd wheel set: 2 alloy rims - Scratched - Replace

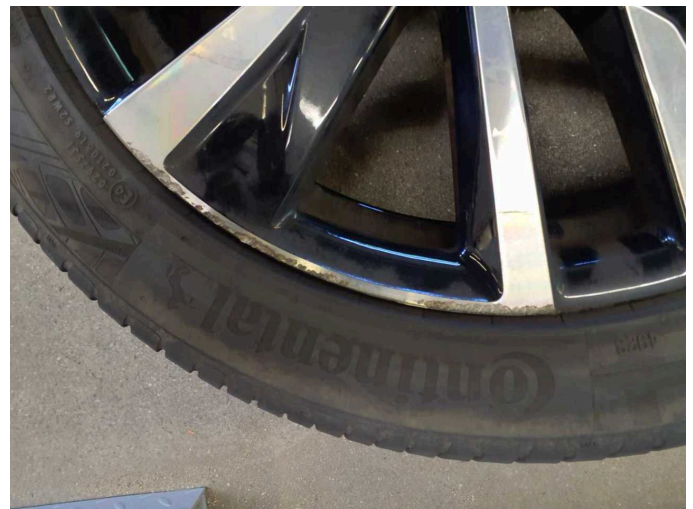
Damage 11: 2nd wheel set: 2 alloy rims - Scratched - Replace

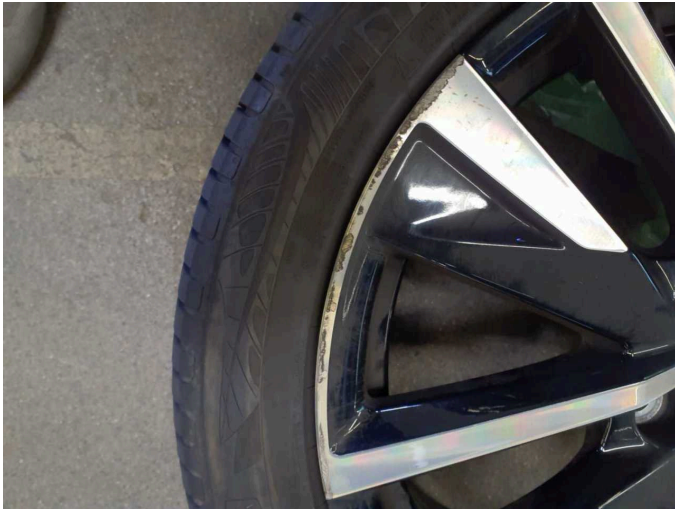
Damage 11: 2nd wheel set: 2 alloy rims - Scratched - Replace

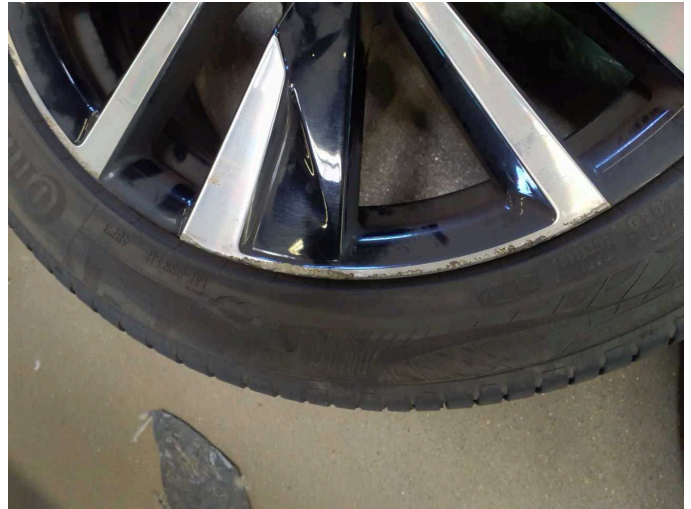
Damage 11: 2nd wheel set: 2 alloy rims - Scratched - Replace

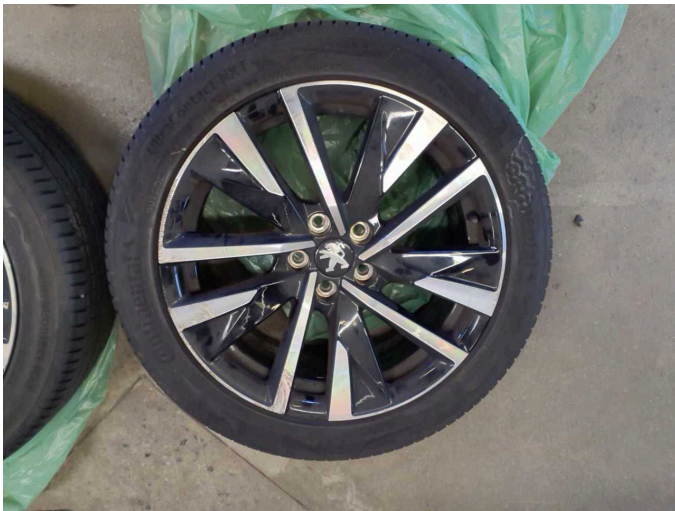
Damage 11: 2nd wheel set: 2 alloy rims - Scratched - Replace

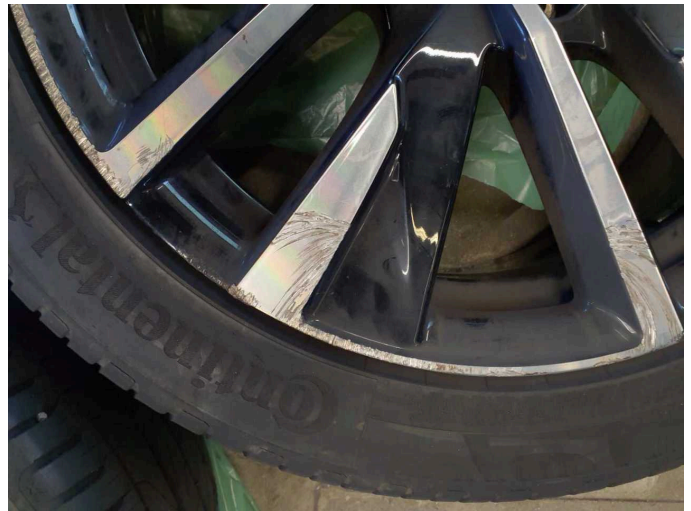
Damage 11: 2nd wheel set: 2 alloy rims - Scratched - Replace

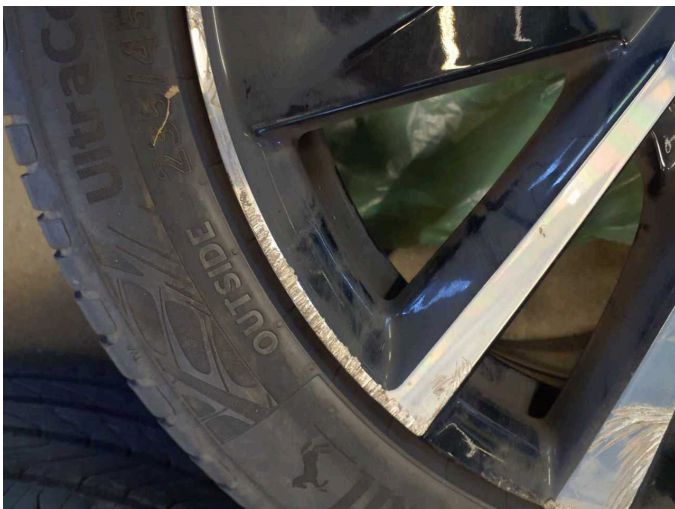
Damage 11: 2nd wheel set: 2 alloy rims - Scratched - Replace

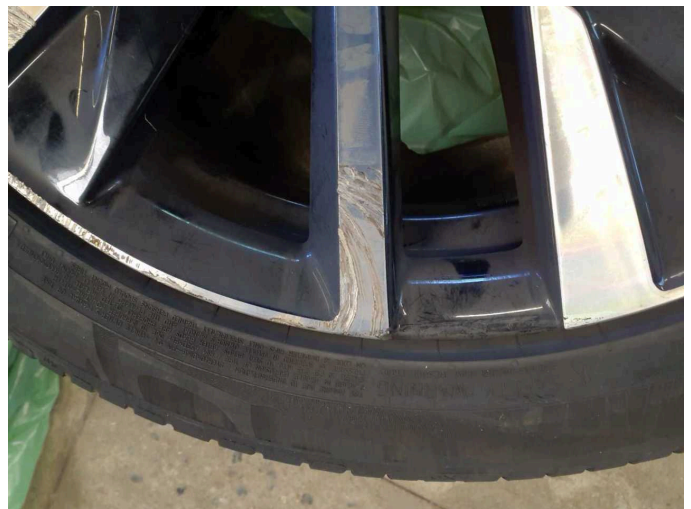
Damage 11: 2nd wheel set: 2 alloy rims - Scratched - Replace

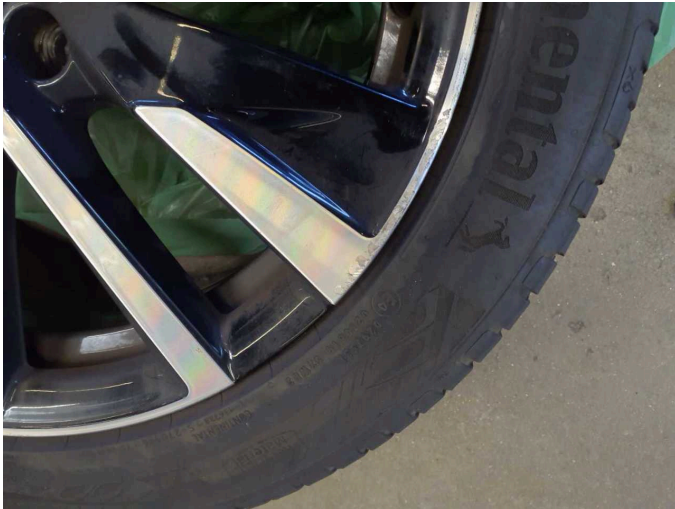
Damage 11: 2nd wheel set: 2 alloy rims - Scratched - Replace

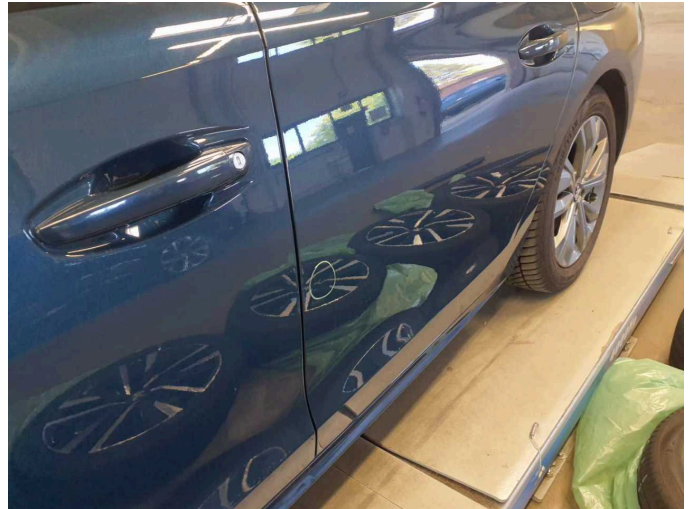
Wear and tear 1: Door - rear left side: Door - dent(s) - No deduction

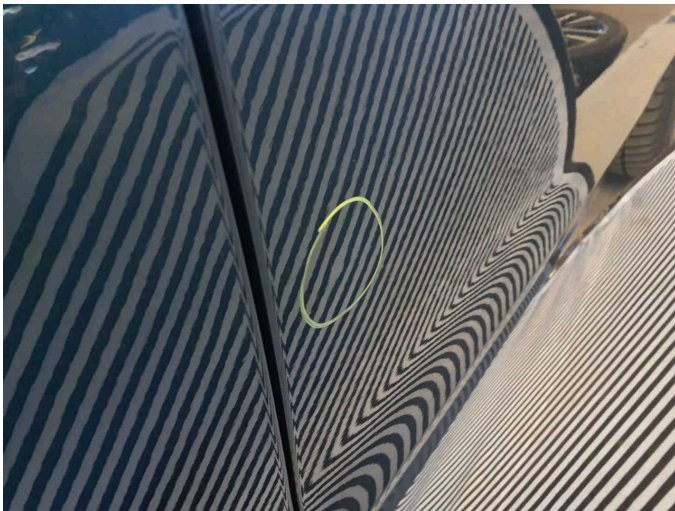
Wear and tear 1: Door - rear left side: Door - dent(s) - No deduction

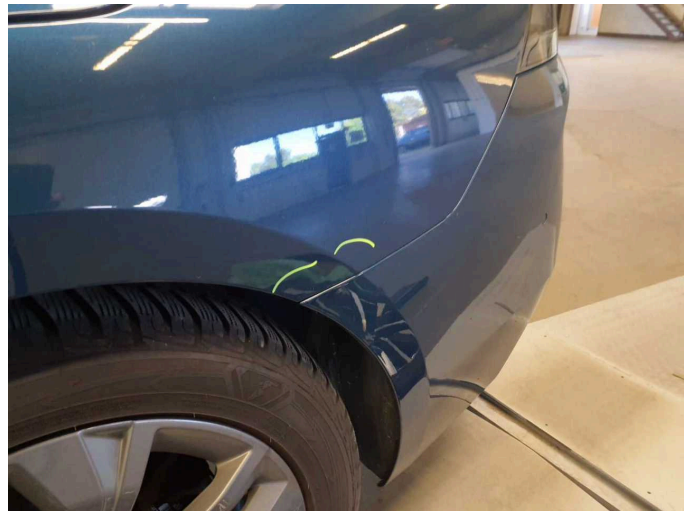
Wear and tear 2: Side panel - rear left side: Side panel - dent(s) - No deduction

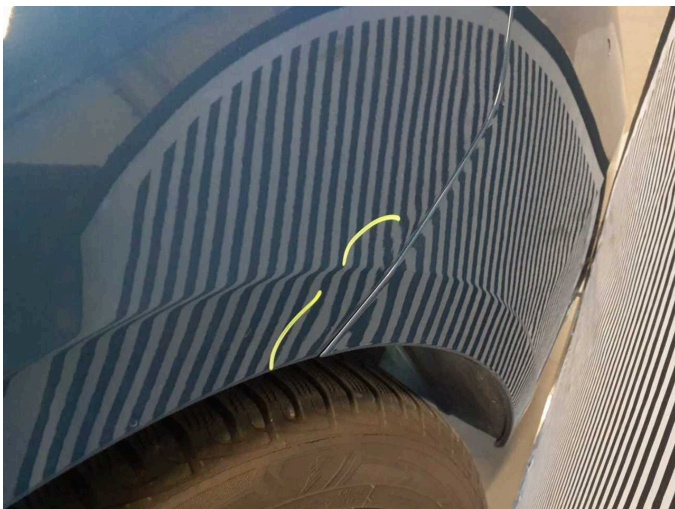
Wear and tear 2: Side panel - rear left side: Side panel - dent(s) - No deduction

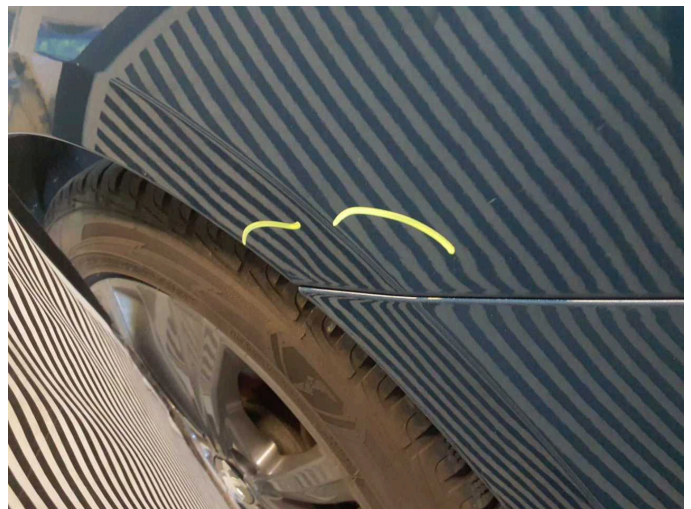
Wear and tear 2: Side panel - rear left side: Side panel - dent(s) - No deduction

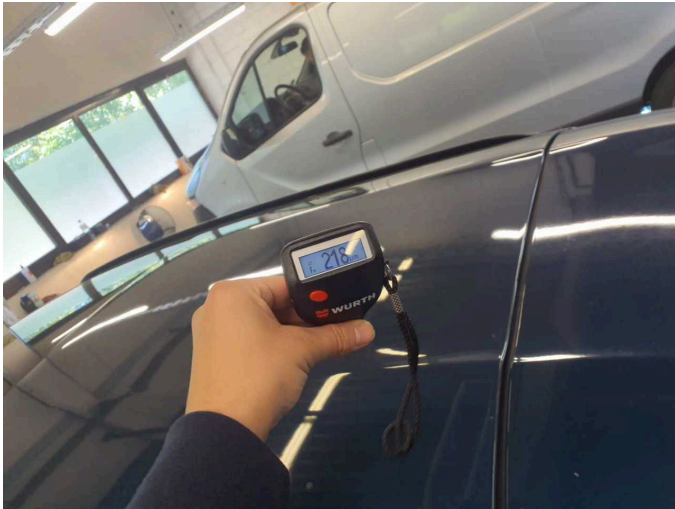
Repainting 1: Roof, Door - rear left side, Door - front left side

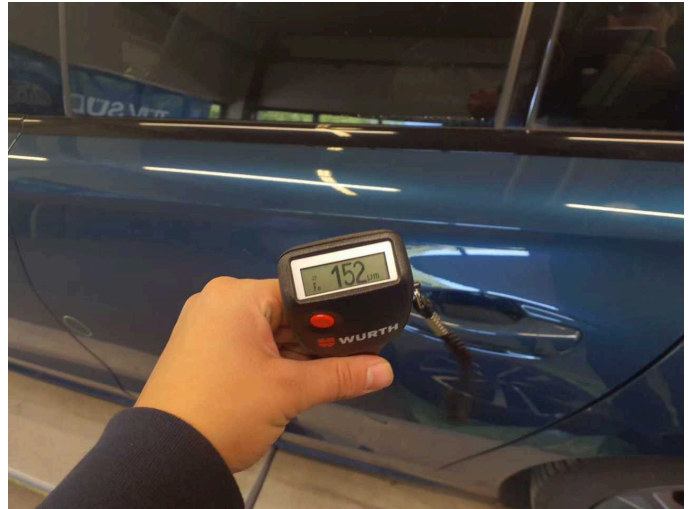
Repainting 1: Roof, Door - rear left side, Door - front left side
