## status report

| <b>report Number:</b> | <b>0000001258969-EN18</b> |

| vehicle data | | | |
|---|---|---|---|
| <b>Peugeot 308 GT</b> | | | |
| Vehicle identification number | <b>VR3FPHNSTPY622977</b> | mileage read: | <b>23001 km</b> |

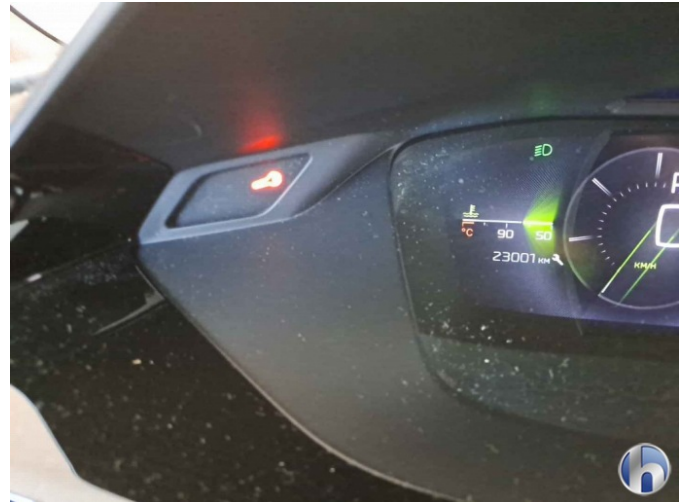
| component | Damage | Rep kind |
|---|---|---|
| 4. warning light | Error message | Carry out a fault diagnosis |

**Error message**

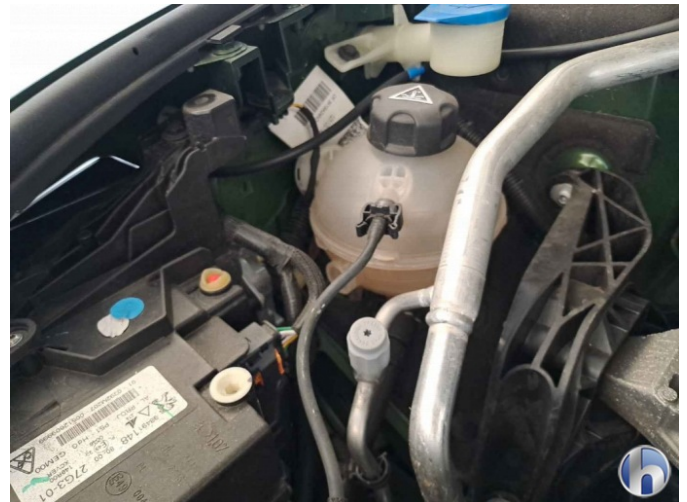
| component | Damage | Rep kind |
|---|---|---|
| 7. Kühlmittel | | Fill Up |

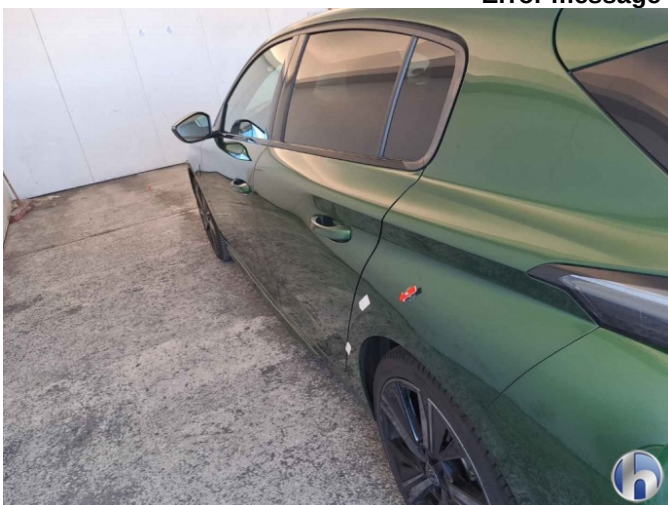
| component | Damage | Rep kind |
|---|---|---|
| 8. Sidewall - Rear - Left | Damaged | Refurbish and paint |

**Damaged**

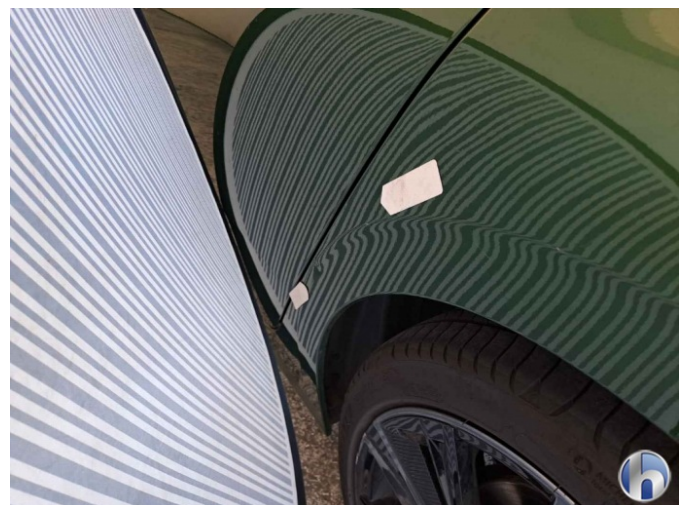
8. Sidewall - Rear - Left

**Damaged**

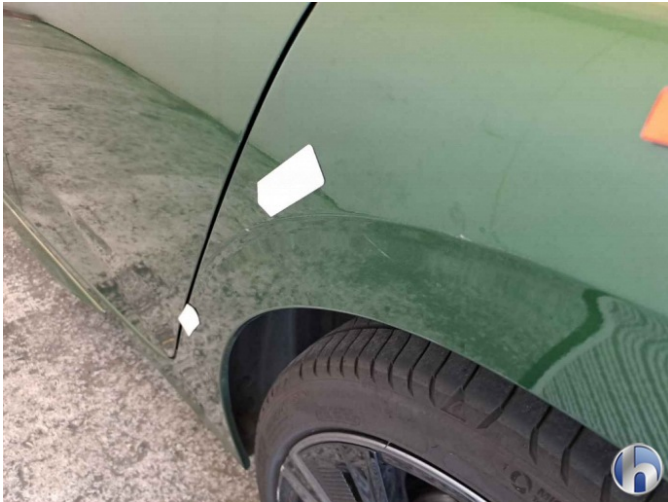
8. Sidewall - Rear - Left

**Damaged**

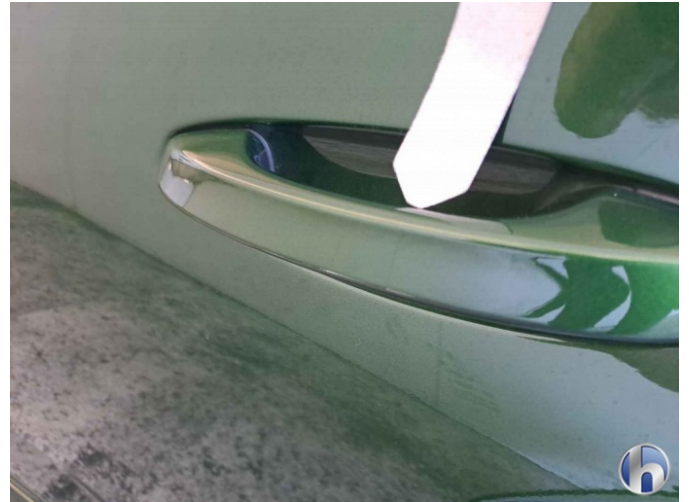
| component | Damage | Rep kind |
|---|---|---|
| 9. Outside Door Handle Rear - Left | Scratch(es) | Paint |

**Scratch(es)**

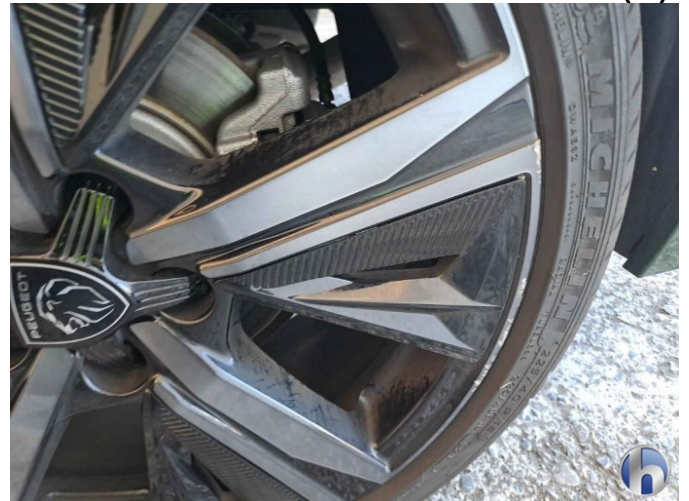
| component | Damage | Rep kind |
|---|---|---|
| 10. | Scratch(es) | Replace |

**Scratch(es)**

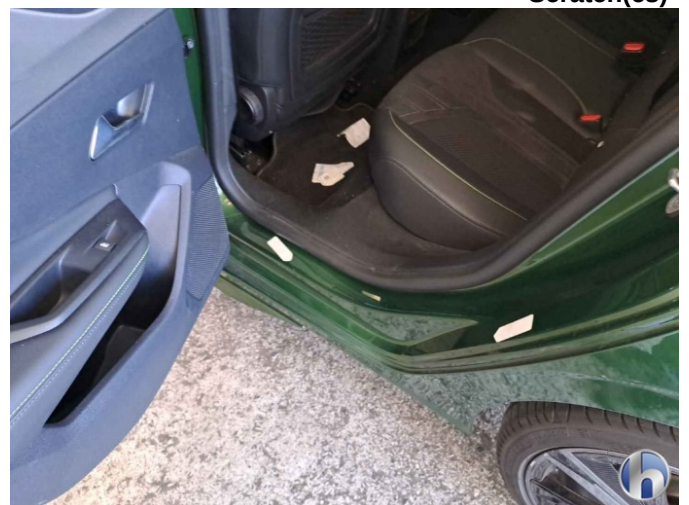
| component | Damage | Rep kind |
|---|---|---|
| 11. Türeinstieg Hinten - Links | Damaged | Refurbish and paint |

**Damaged**

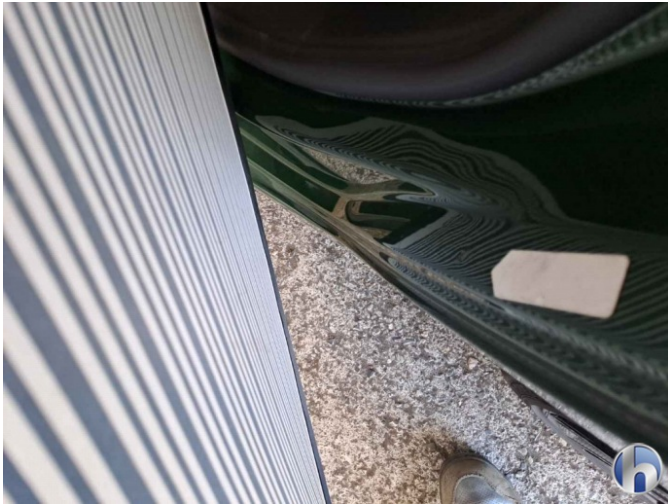
11. Türeinstieg Hinten - Links

**Damaged**

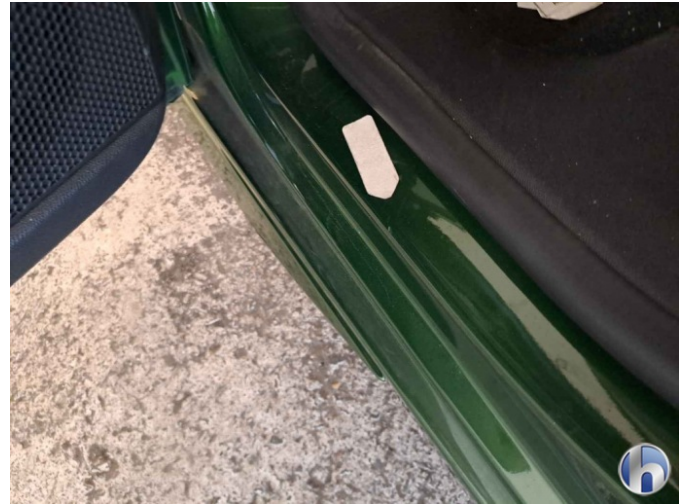
11. Türeinstieg Hinten - Links

**Damaged**

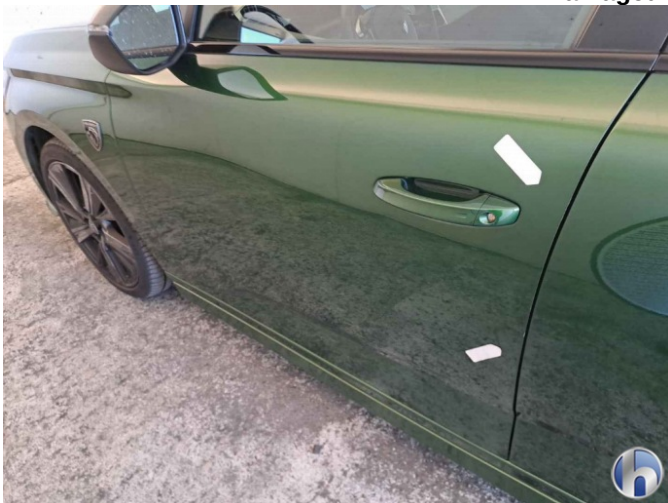
| component | Damage | Rep kind |
|---|---|---|
| 12. Front door - left | Scratch(es) | Paint |

**Scratch(es)**

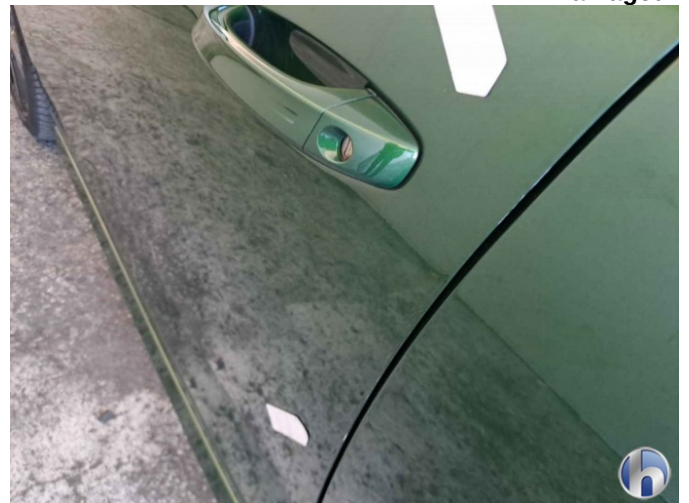
12. Front door - left

**Scratch(es)**

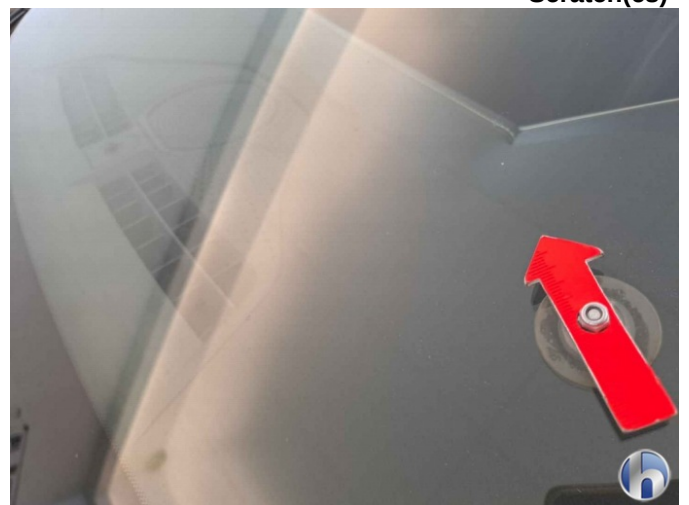
| component | Damage | Rep kind |
|---|---|---|
| 13. Windshield | Chipping from stones in field of view | Replace |

**Chipping from stones in field of view**

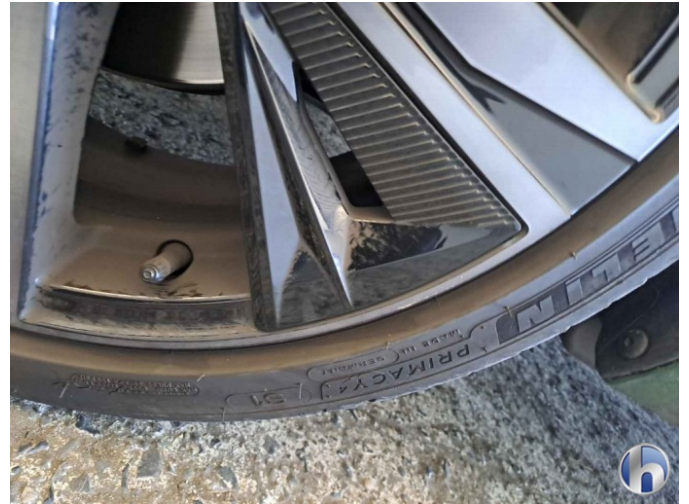
14. Scratch(es)

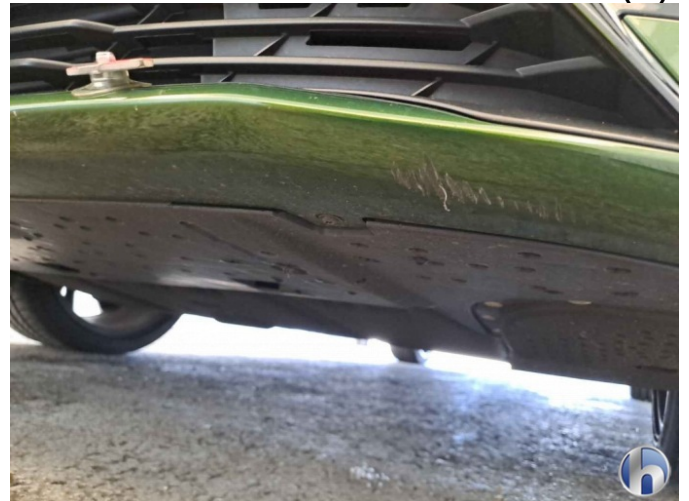
| component | Damage | Rep kind |
|---|---|---|
| 15. Front bumper | Scrape | Refurbish and paint |

15. Front bumper Scrape

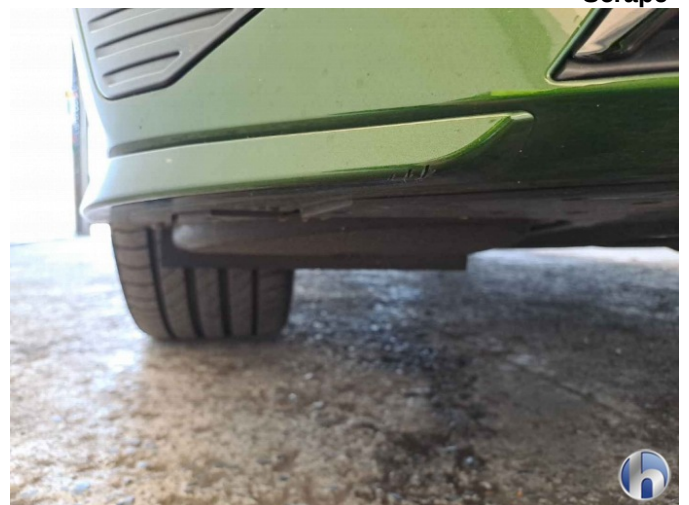
| component | Damage | Rep kind |
|---|---|---|
| 16. spoiler | Scrape | Replace |

16. spoiler Scrape

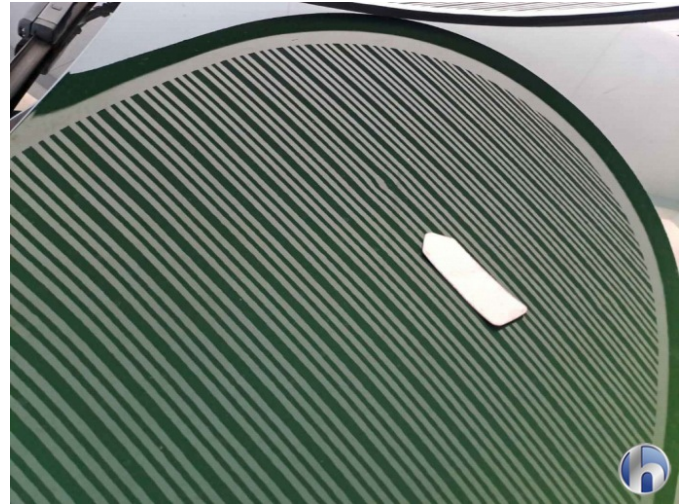
| component | Damage | Rep kind |
|---|---|---|
| 17. hood | Deformed | Refurbish and paint |

**Deformed**

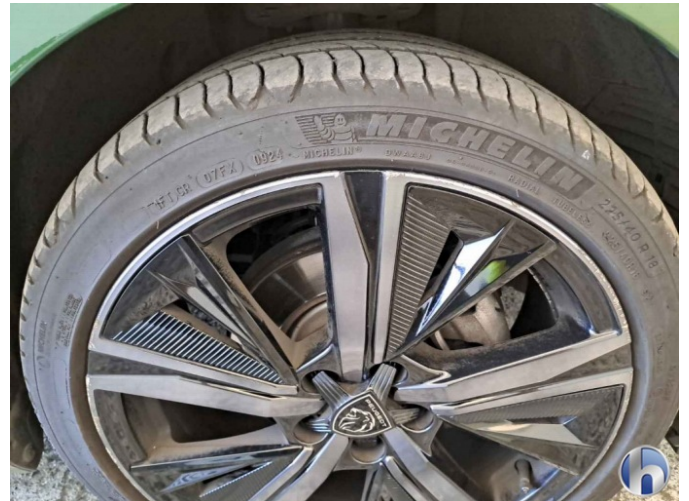
18.

**Scratch(es)**

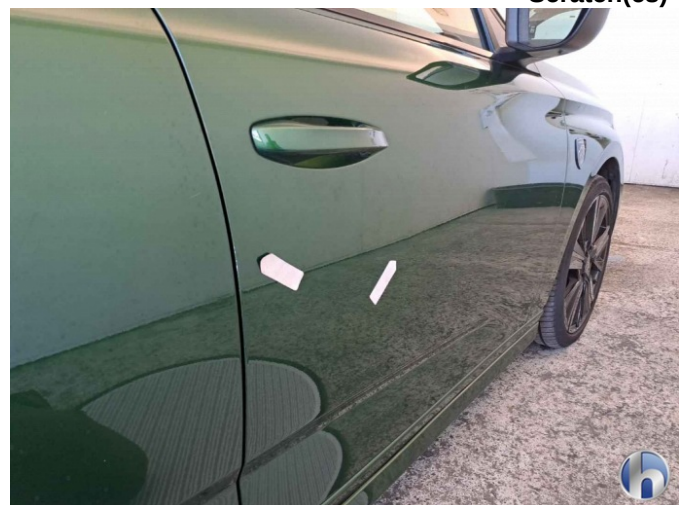
| component | Damage | Rep kind |
|---|---|---|
| 19. Front door - right | Damaged | Refurbish and paint |

**Damaged**

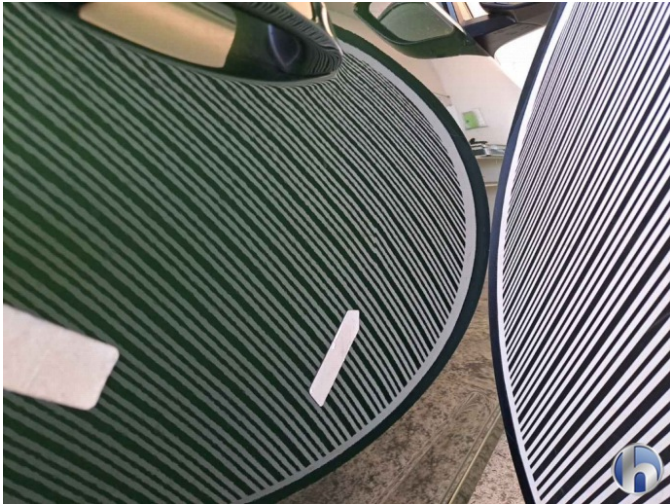
19. Front door - right

**Damaged**

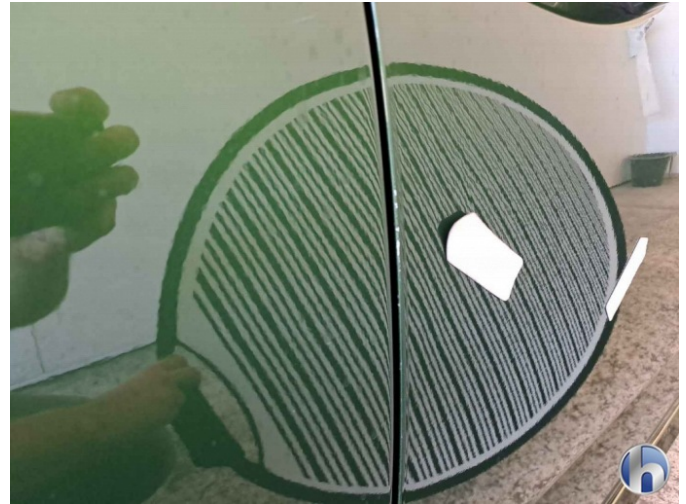
19. Front door - right

**Damaged**

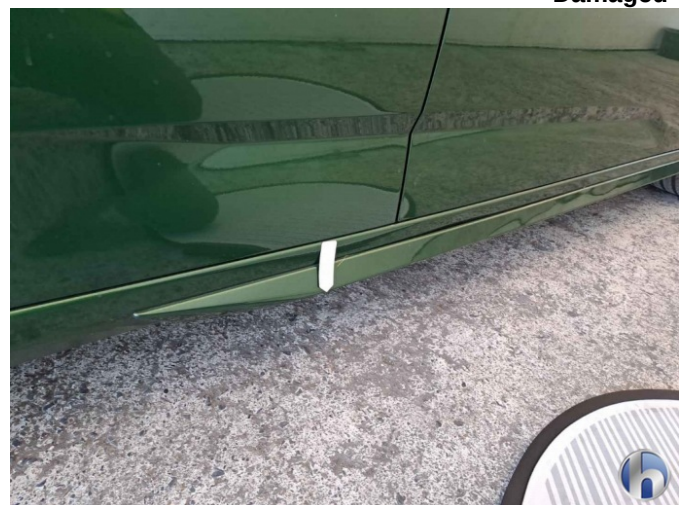
| component | Damage | Rep kind |
|---|---|---|
| 21. side skirt - right | Damaged | Refurbish and paint |

**Damaged**

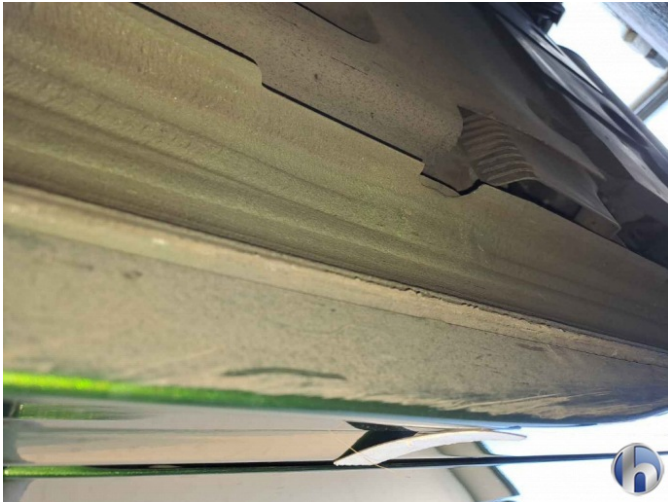
21. side skirt - right

**Damaged**

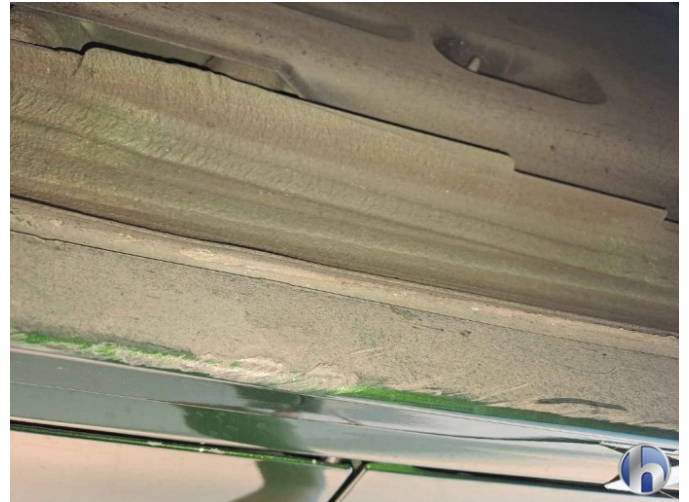
21. side skirt - right

**Damaged**

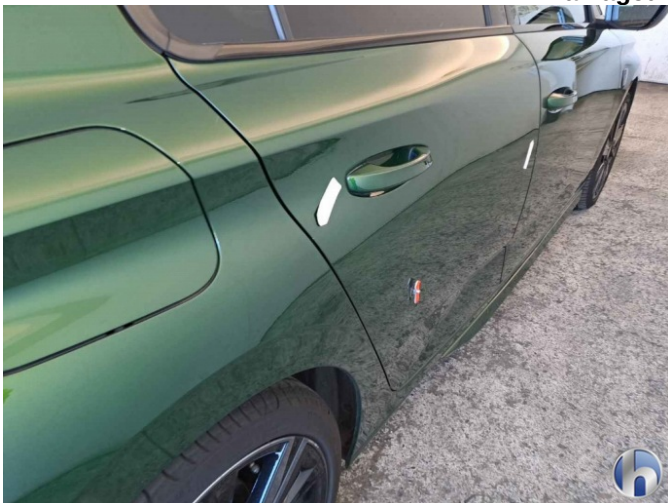
| component | Damage | Rep kind |
|---|---|---|
| 22. Door Rear - right | Scratch(es) | Paint |

**Scratch(es)**

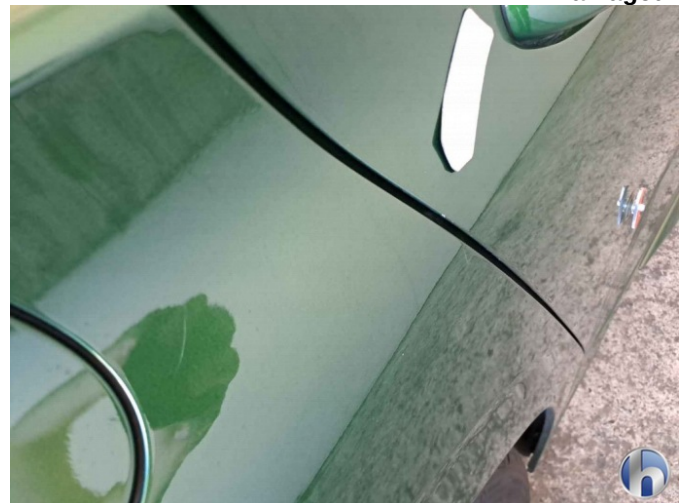
22. Door Rear - right

**Scratch(es)**

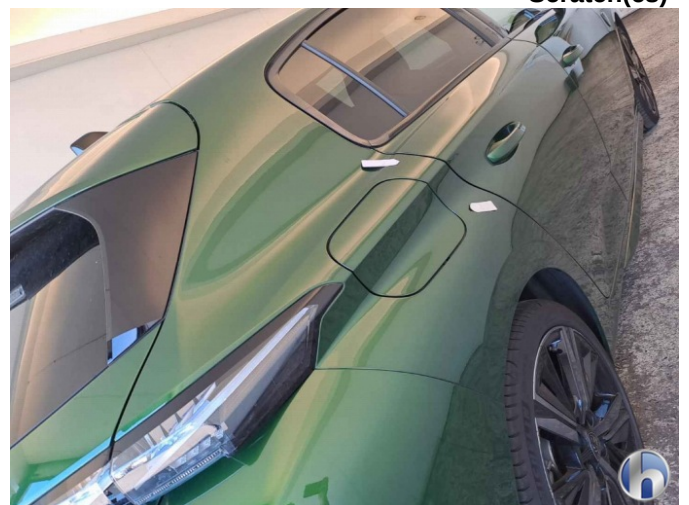
| component | Damage | Rep kind |
|---|---|---|
| 23. Sidewall - Rear - right | Scratch(es) | Paint |

**Scratch(es)**

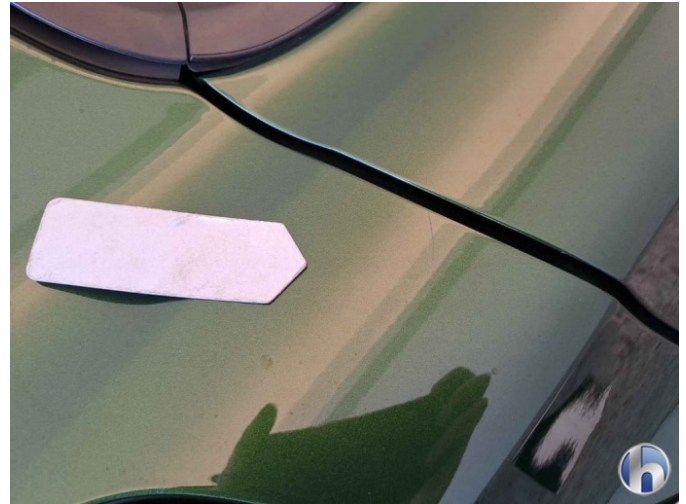
23. Sidewall - Rear - right

**Scratch(es)**

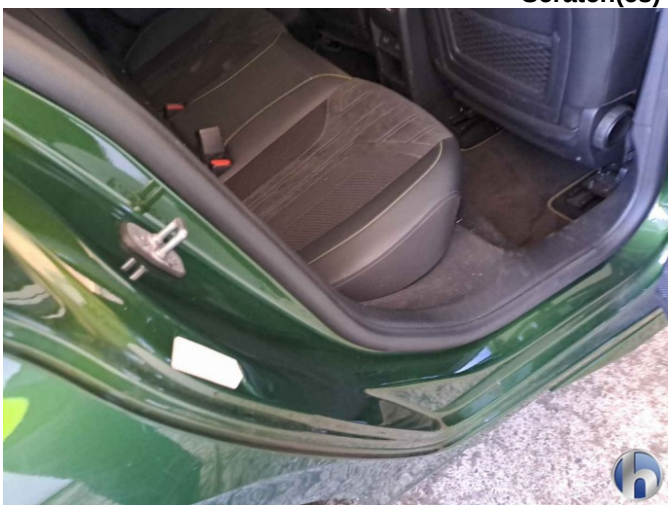
| component | Damage | Rep kind |
|---|---|---|
| 25. Türeinstieg Hinten - Rechts | Damaged | Refurbish and paint |

**Damaged**

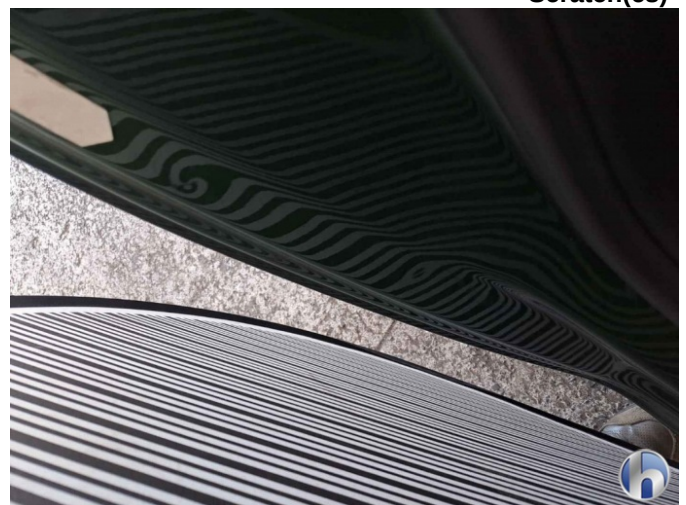
25. Türeinstieg Hinten - Rechts

**Damaged**

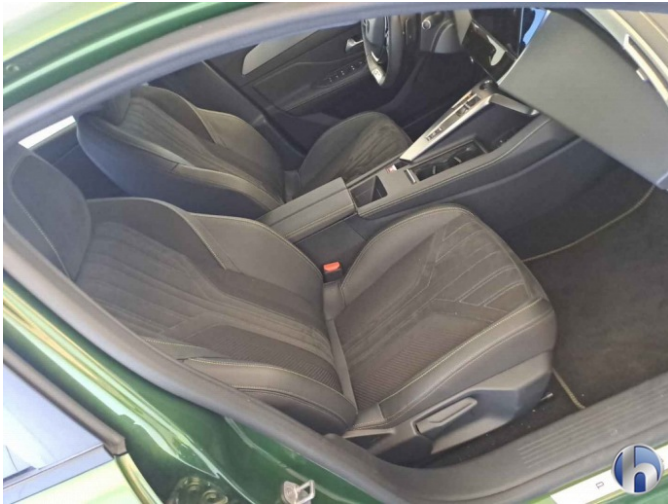
26.

**Dirty**

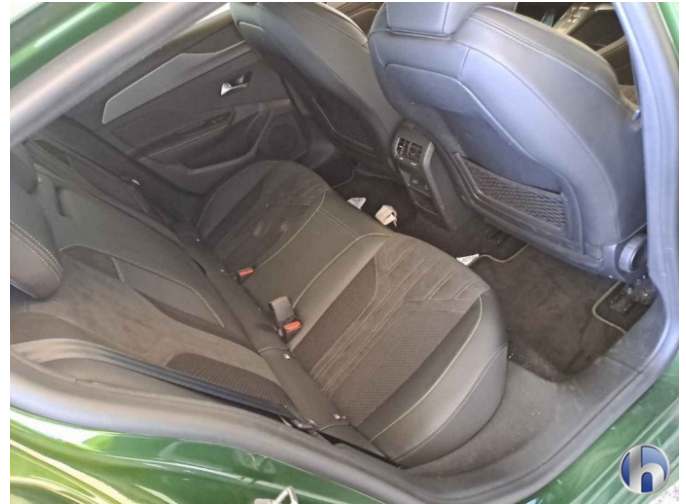
26.

**Dirty**

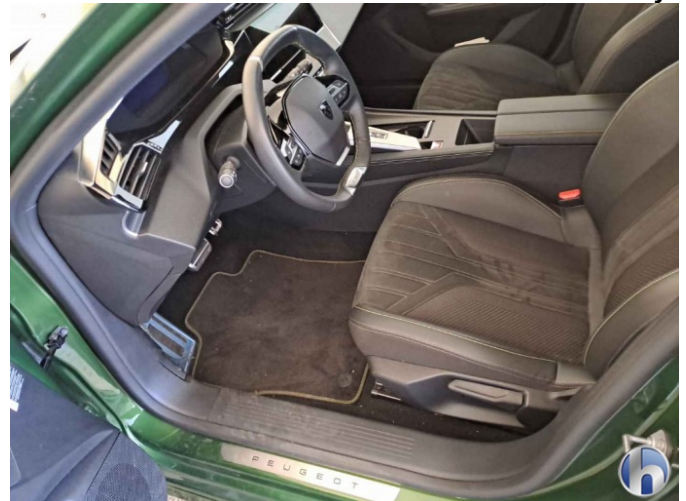
26.

**Dirty**

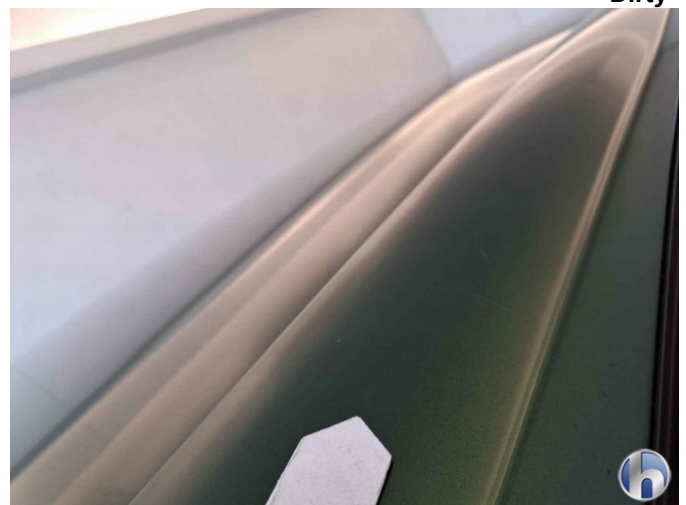
| component | Damage | Rep kind |
|---|---|---|
| 27. Roof frame - right | Scratch(es) | Paint |

**Scratch(es)**

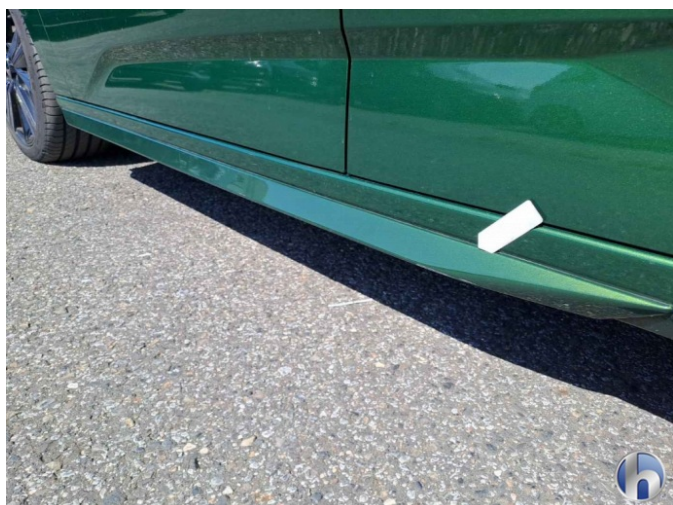
28.

**Scrape**

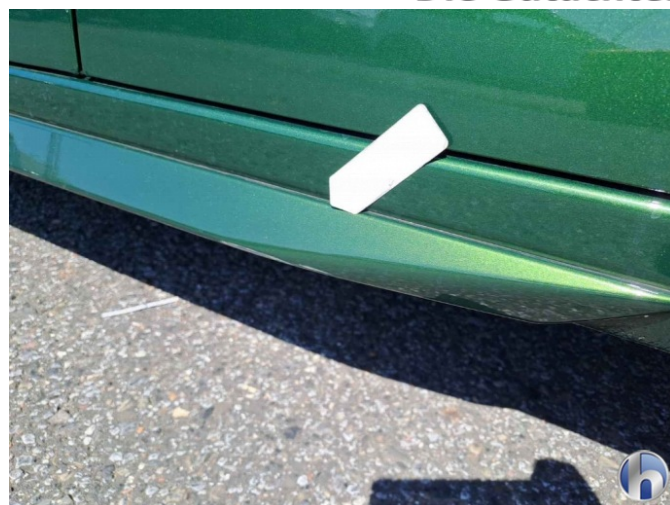
28.

**Scrape**

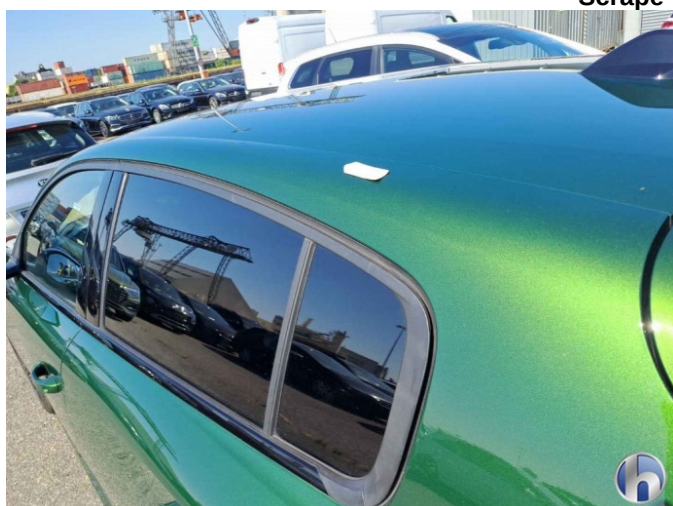
| component | Damage | Rep kind |
|---|---|---|
| 29. Roof frame - left | Scratch(es) | Paint |

**Scratch(es)**

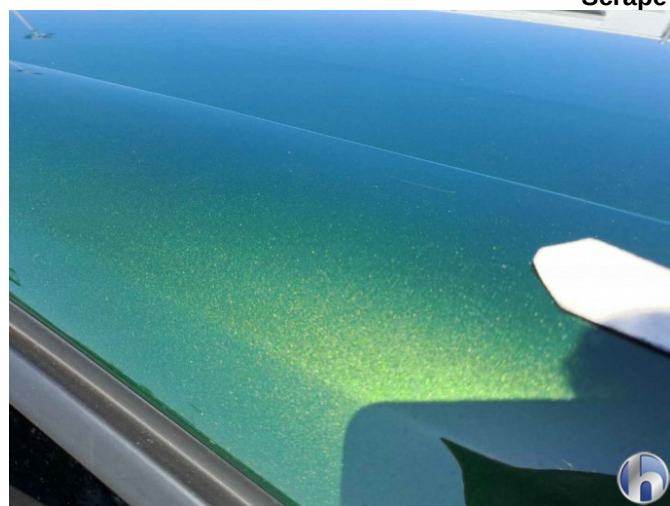
29. Roof frame - left

**Scratch(es)**

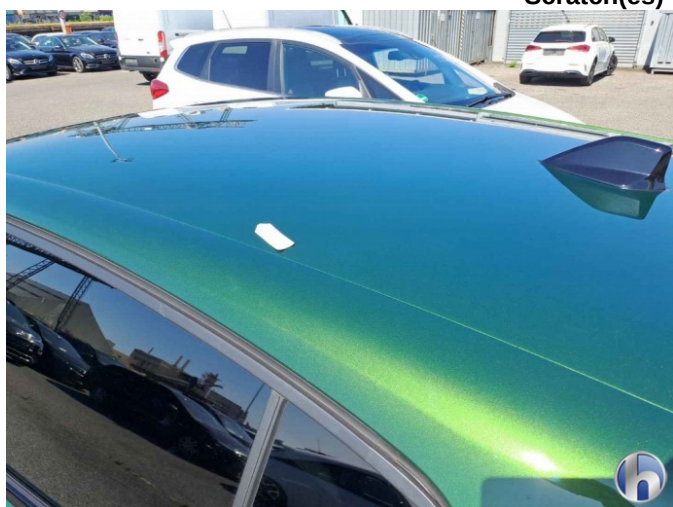
| component | Damage | Rep kind |
|---|---|---|
| 30. roof | Scratch(es) | Paint |

**Scratch(es)**

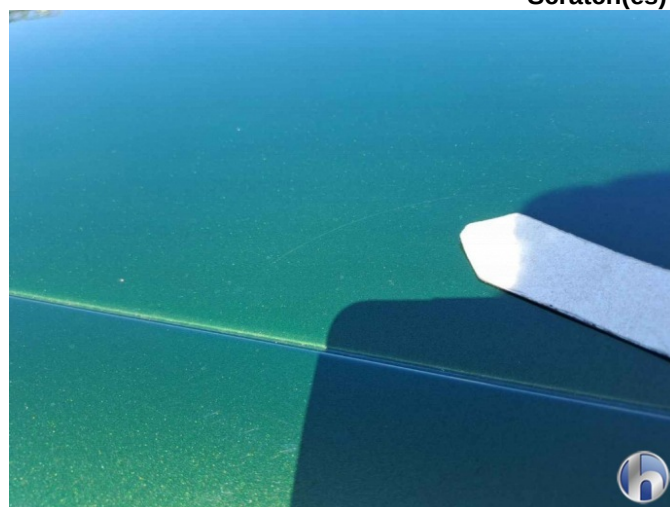
30. roof

**Scratch(es)**

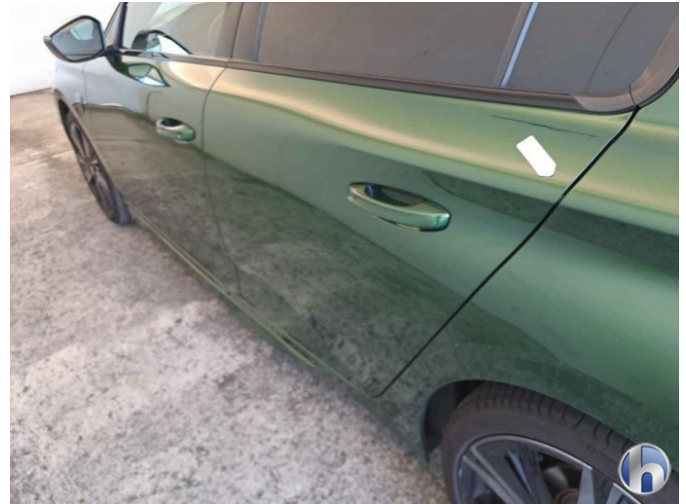
| component | Damage | Rep kind |
|---|---|---|
| 32. Rear door - left | Scratch(es) | Paint |

**Scratch(es)**

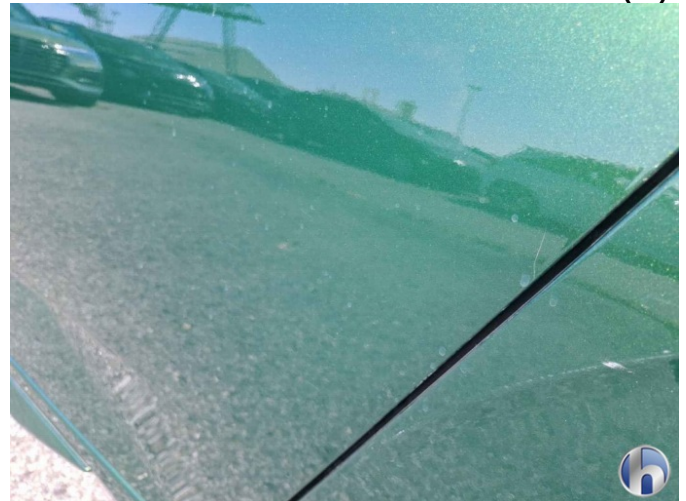
32. Rear door - left

**Scratch(es)**

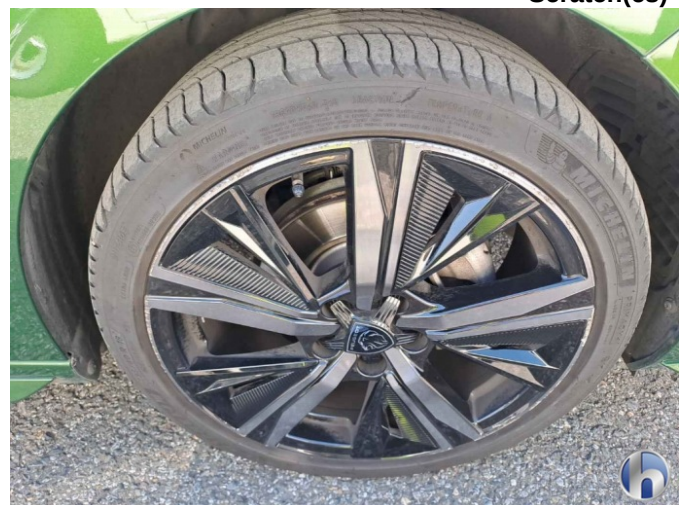
| component | Damage | Rep kind |
|---|---|---|
| 34. tire front - right | Damaged | Replace |

**Damaged**

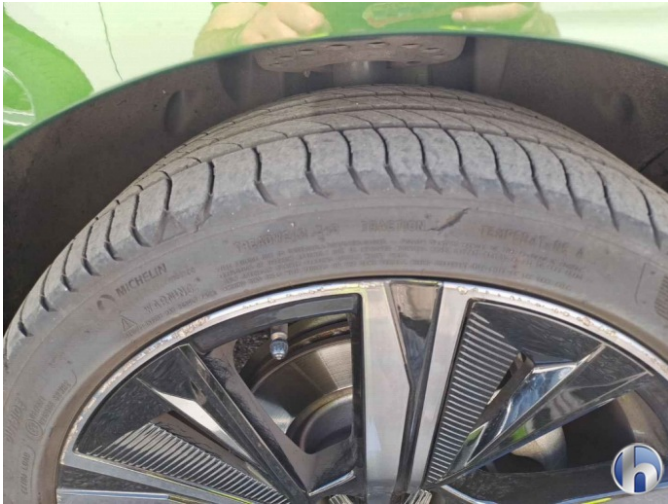
34. tire front - right

**Damaged**

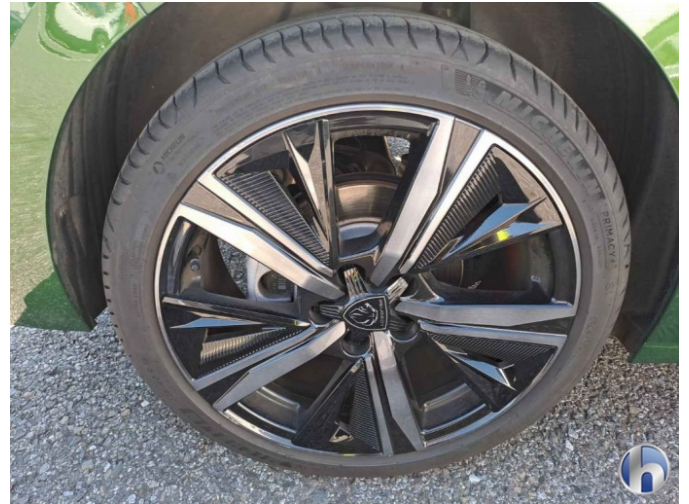
| component | Damage | Rep kind |
|---|---|---|
| 35. tire rear - right | Damaged | Replace |

**Damaged**

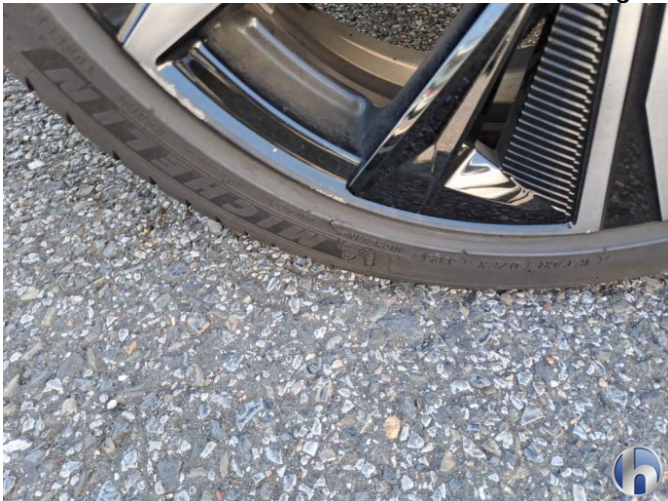
35. tire rear - right

**Damaged**

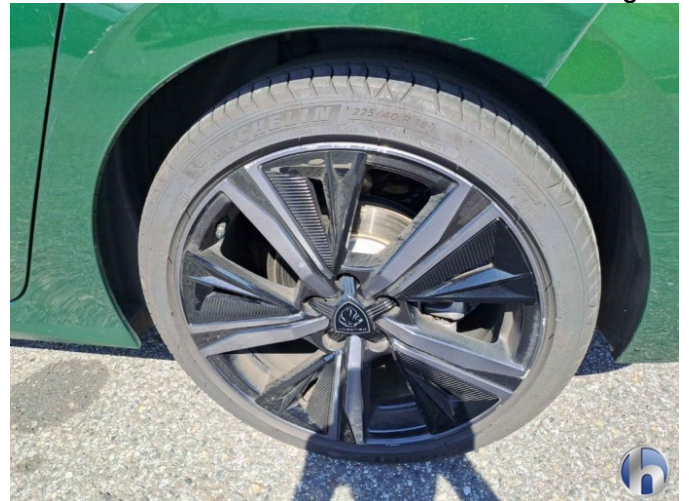
| component | Damage | Rep kind |
|---|---|---|
| 36. tire rear - left | Damaged | Replace |

**Damaged**

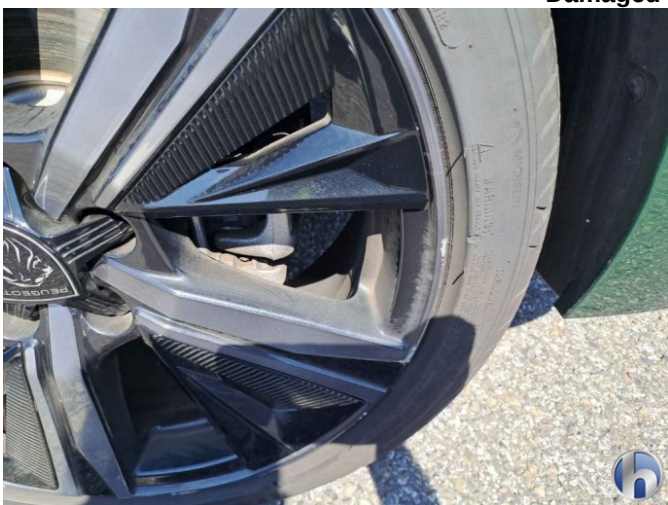
36. tire rear - left

**Damaged**

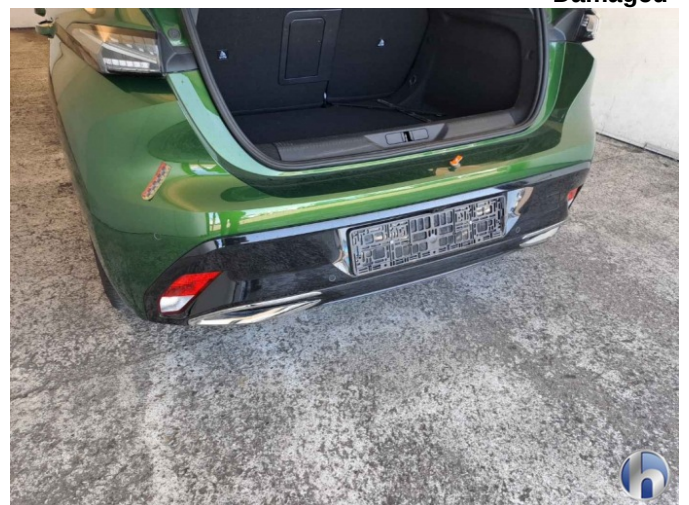
| component | Damage | Rep kind |
|---|---|---|
| 37. Rear bumper | Scratch(es) | Paint |

**Scratch(es)**

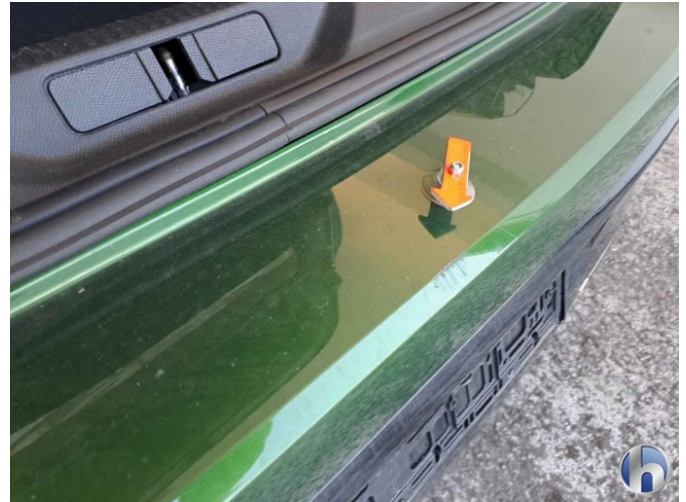
37. Rear bumper

**Scratch(es)**

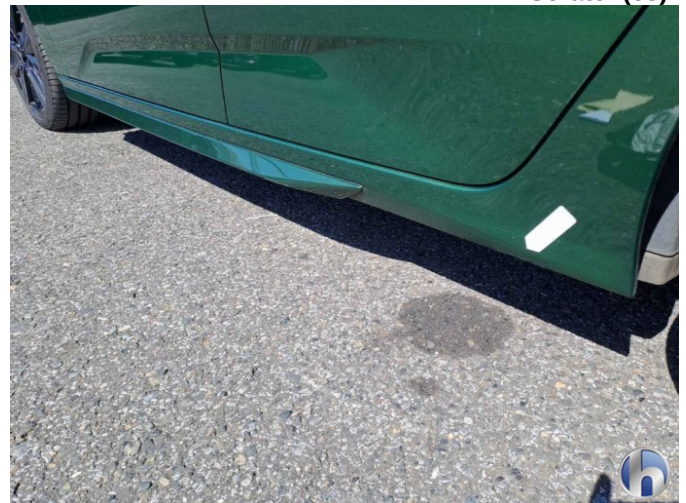
| component | Damage | Rep kind |
|---|---|---|
| 38. side skirt - left | Damaged | Refurbish and paint |

**Damaged**

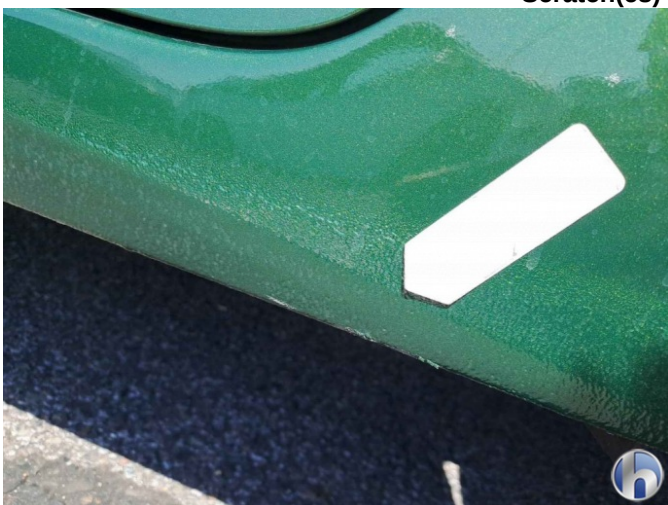
38. side skirt - left

**Damaged**

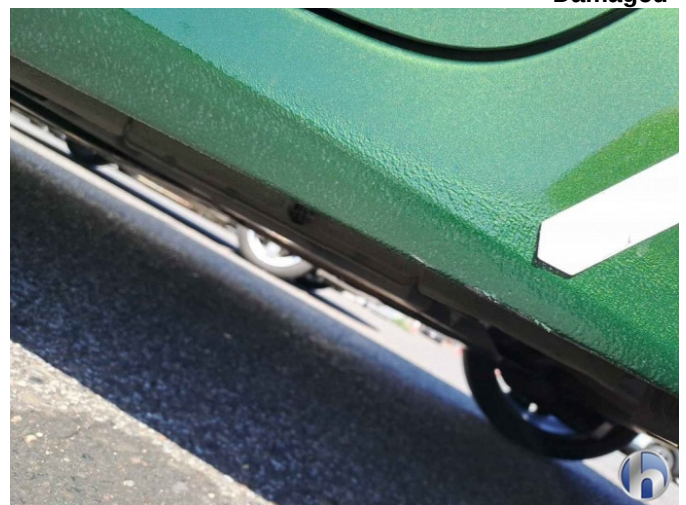
38. side skirt - left

**Damaged**

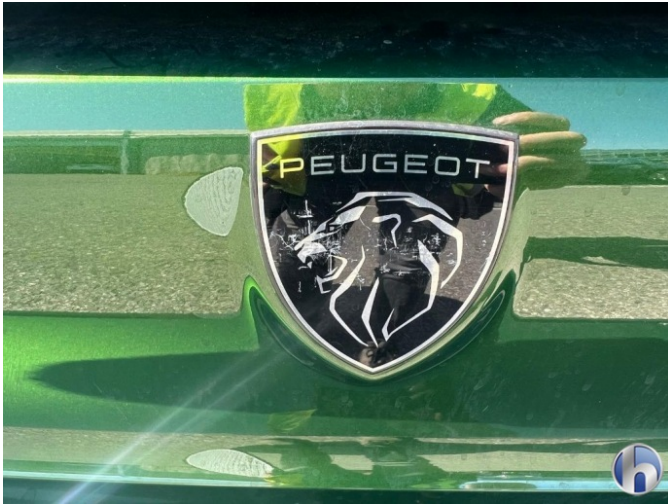
39.

Scrape
