Expertise

Protocol number: 41265400
Order No. / Reference: 25092023
Inspection date: 28 Aug 2025

Manufacturer: Peugeot

Model: 2008 Elektro GT

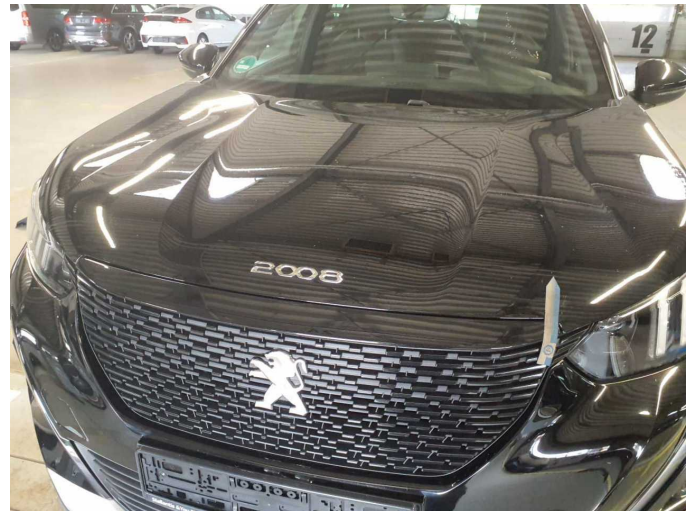
No.	Component group	Description
1	Bonnet	Bonnet - Stone chips - Paint

Damage 1: Bonnet: Bonnet - Stone chips - Paint

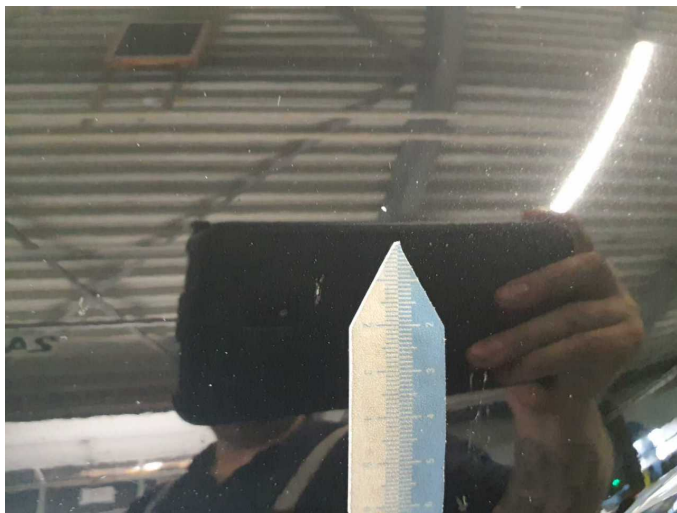
Damage 1: Bonnet: Bonnet - Stone chips - Paint

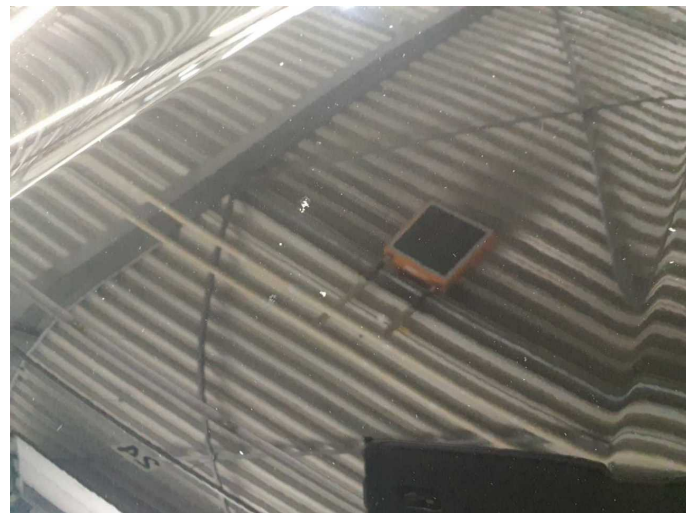
Damage 1: Bonnet: Bonnet - Stone chips - Paint

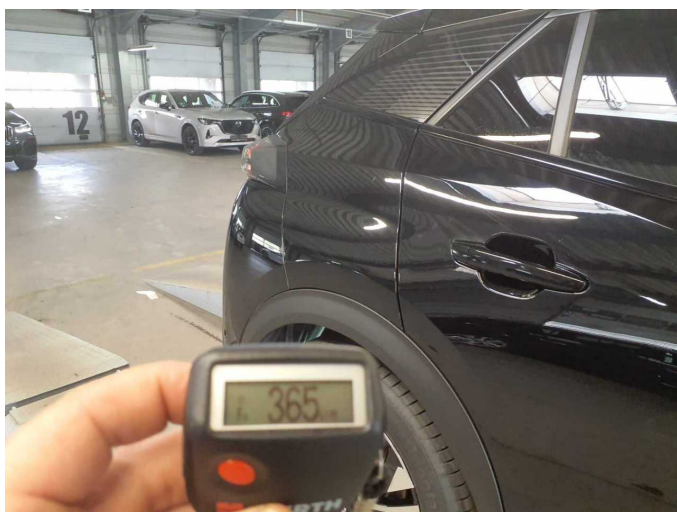
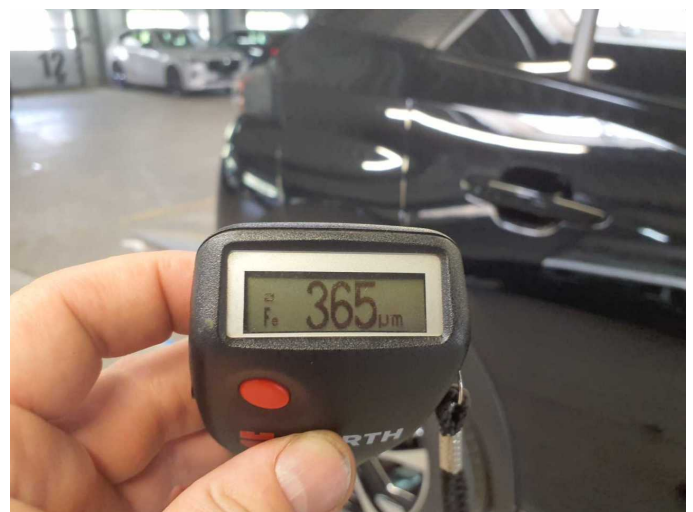
- 1 Side panel - rear right side, Professionally carried out, Invoice of repair done Non-existent
- 2 Door - rear left side, Professionally carried out, Invoice of repair done Non-existent
- 3 Door - rear right side, Professionally carried out, Invoice of repair done Non-existent
- 4 Door - front left side, Professionally carried out, Invoice of repair done Non-existent

Side panel - rear right side	365 µm	Door - rear left side	153 µm
Door - rear right side	195 µm	Door - front left side	533 µm

Repainting 1: Side panel - rear right side

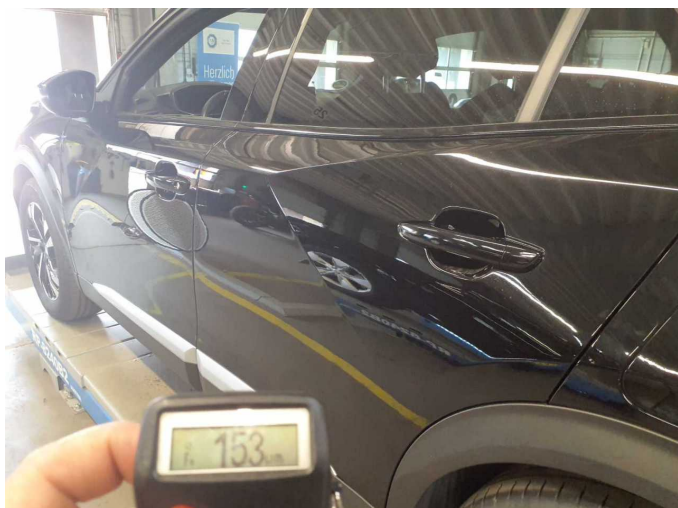
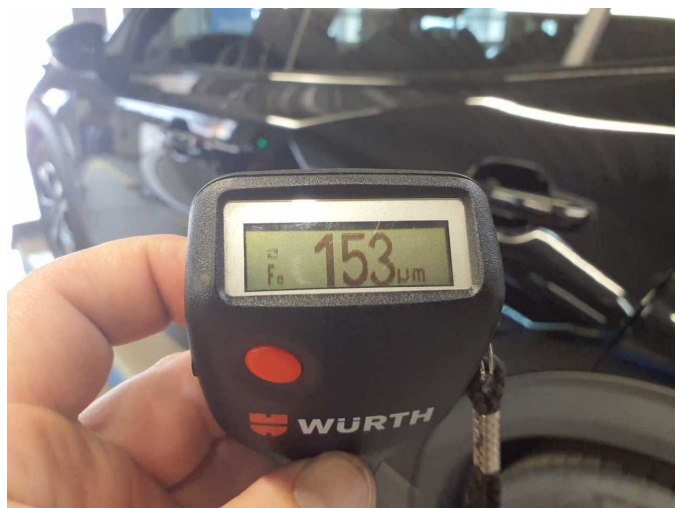
Repainting 2: Door - rear left side

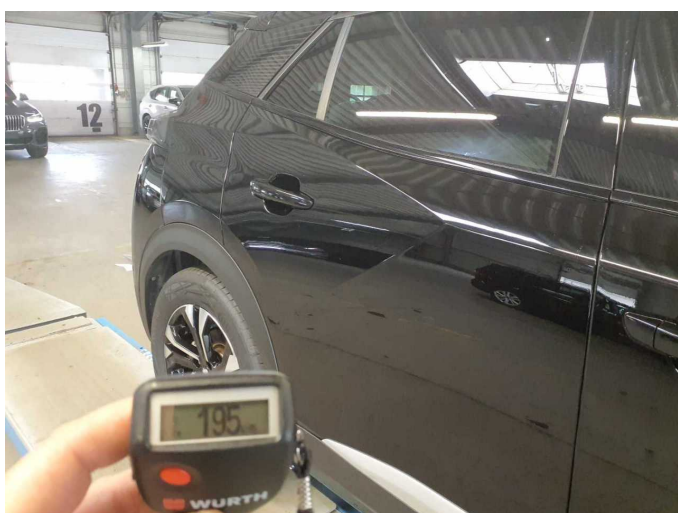
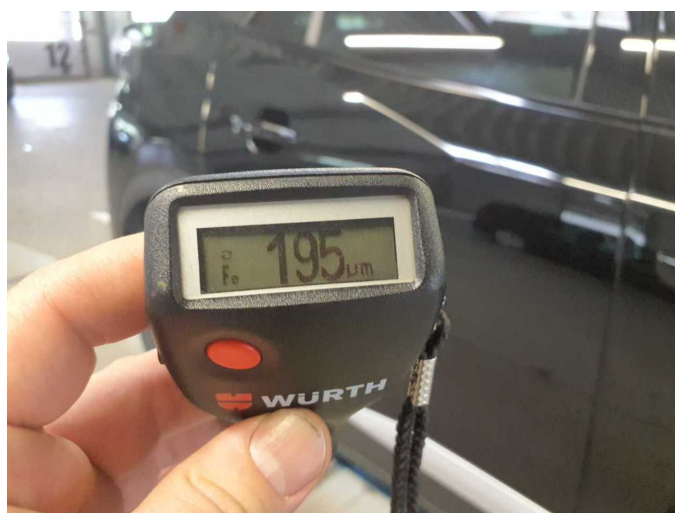
Repainting 3: Door - rear right side

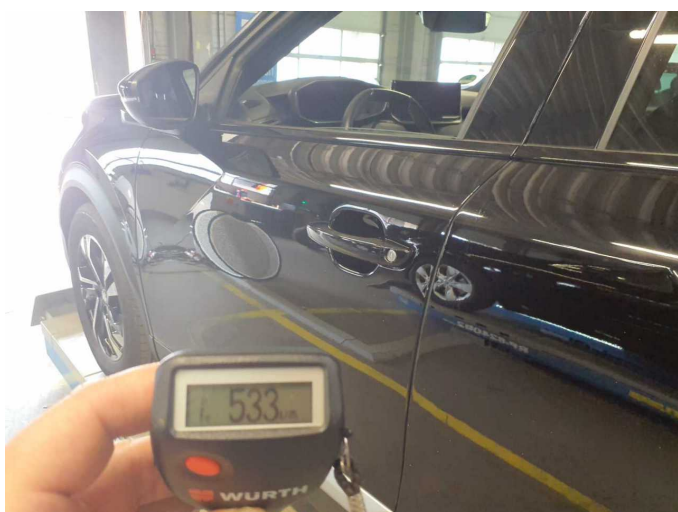
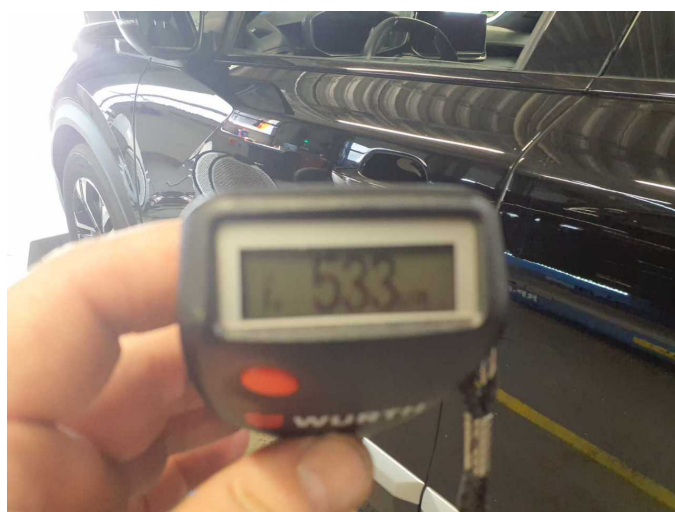
Repainting 4: Door - front left side
