# PEUGEOT 208

## 208 Hybrid 100 e-DCS6 Allure

VIN NO VR3UPHPX5S4051647  
Registration Number HC552BM

### Inspection Report Summary

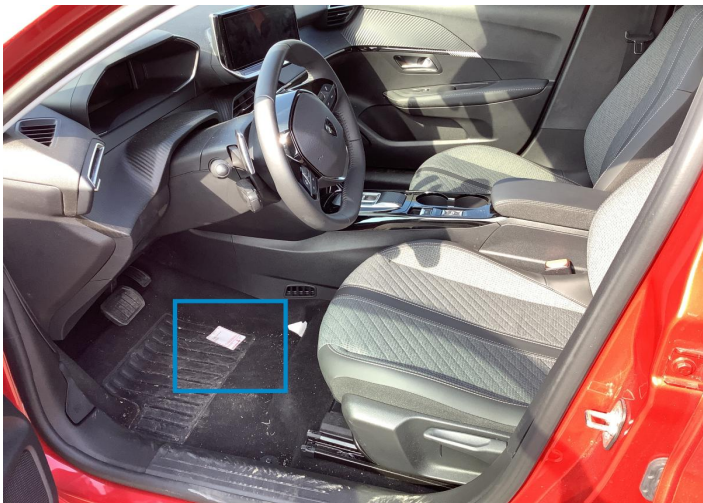
1. Floor Carpet  
Interior / Missing -

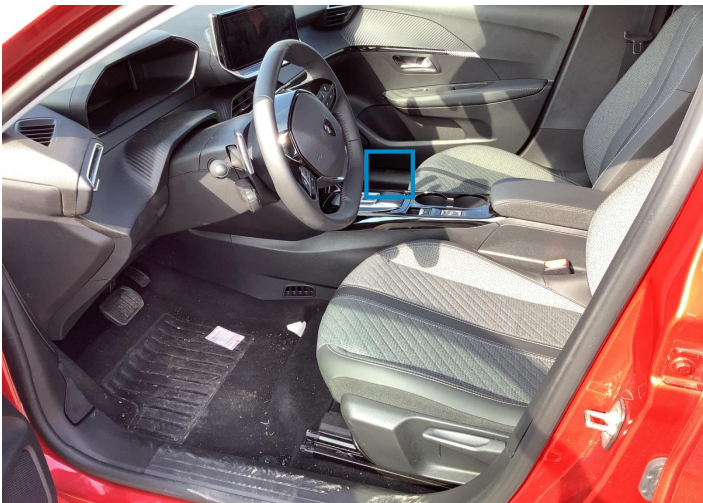
2. Floor Carpet  
Interior / Missing -

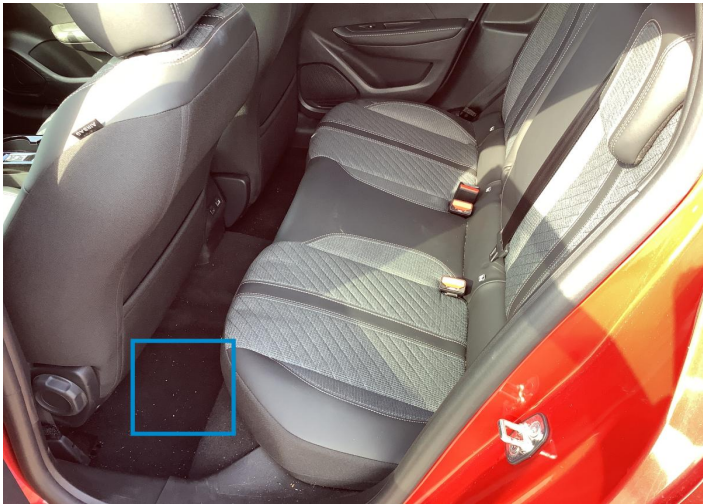
3. Floor Carpet  
Interior / Missing -

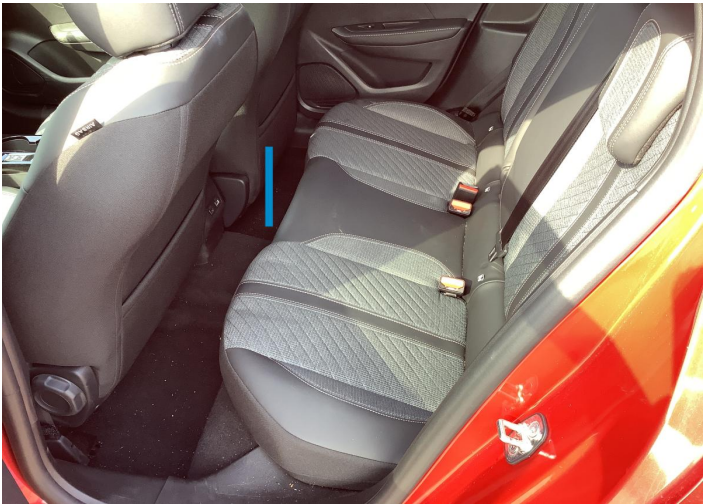
4. Floor Carpet  
Interior / Missing -

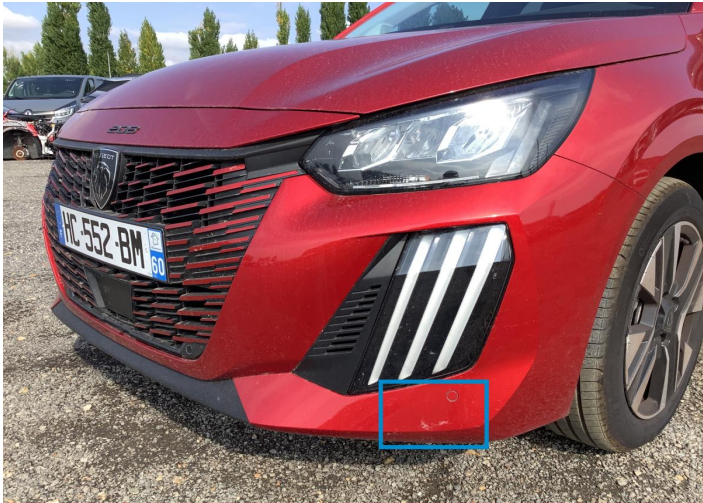
5. Corner Bumper / Front Left  
Paint / Scratch / Line -

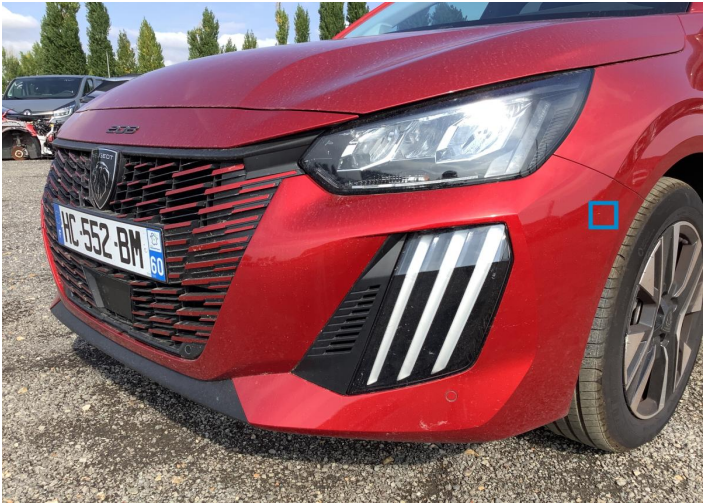
6. Corner Bumper / Front Left  
Paint / Scratch / Line -

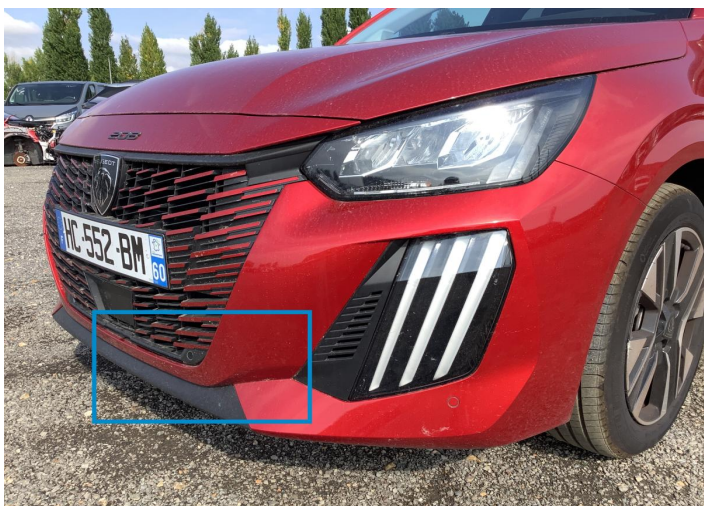
7. Corner Bumper / Front Left  
Paint / Scratch / Line -

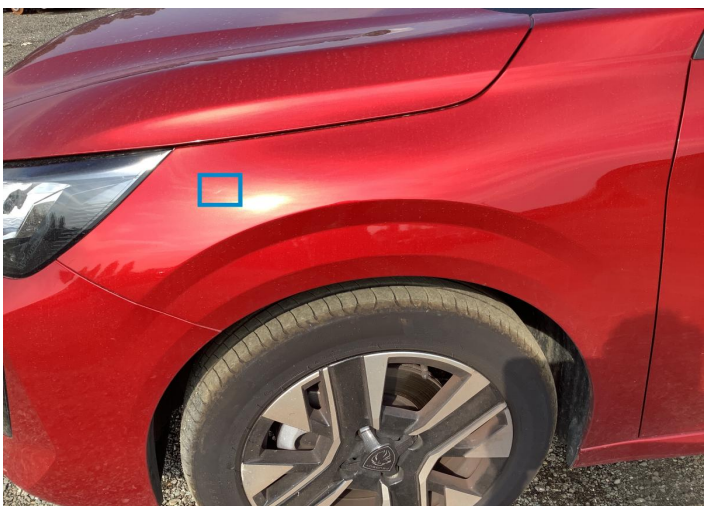
8. Fender / Front Left  
Paint / Scratch / Line -

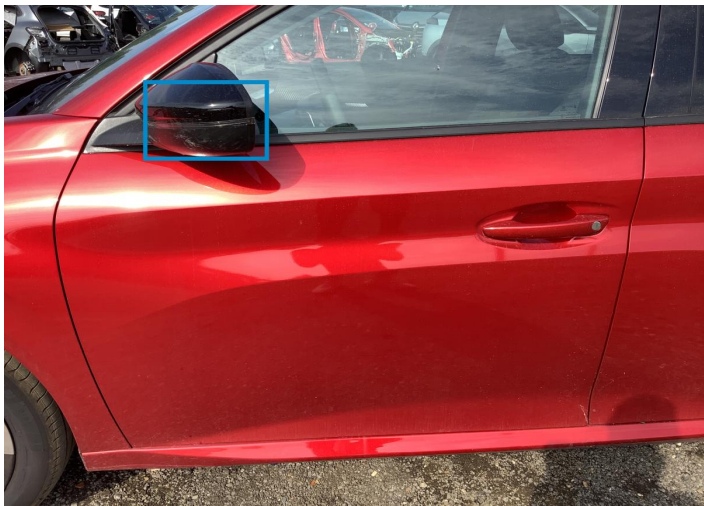
9. Door / Front Left  
Paint / Scratch / Line -

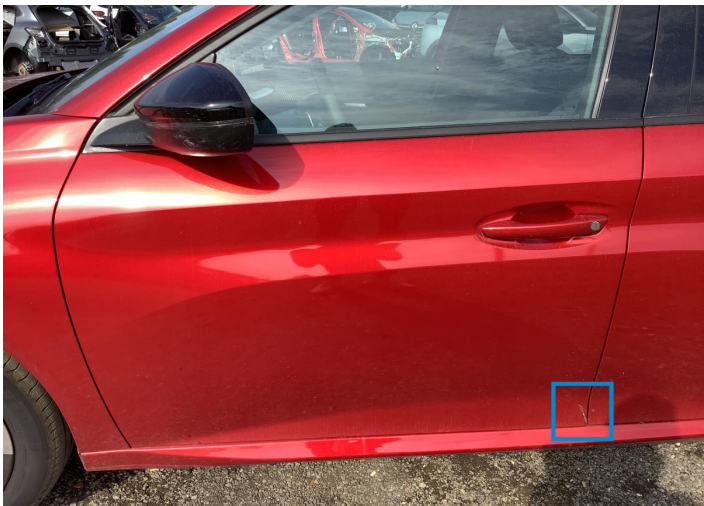
10. Door / Front Left  
Paint / Scratch / Line -

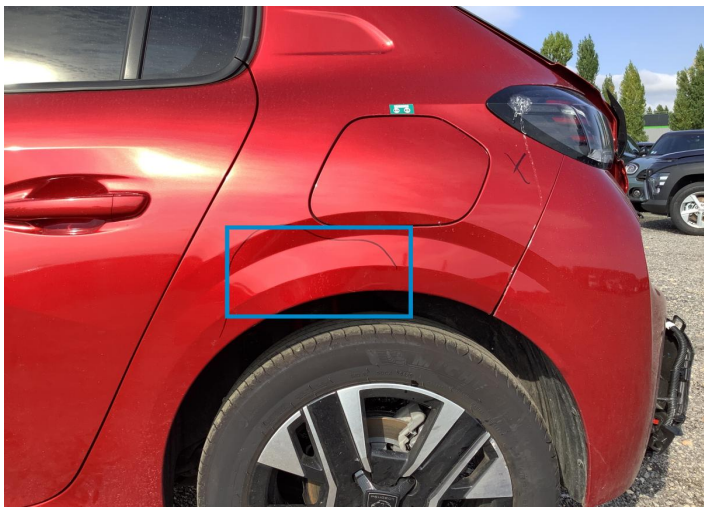
11. Fender / Back Left  
Bodywork / Dent / Deformation -

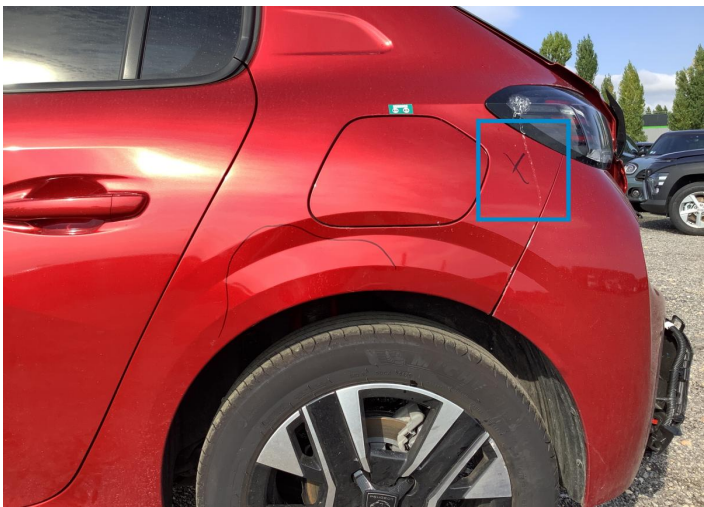
12. Fender / Back Left  
Paint / Scratch / Line -

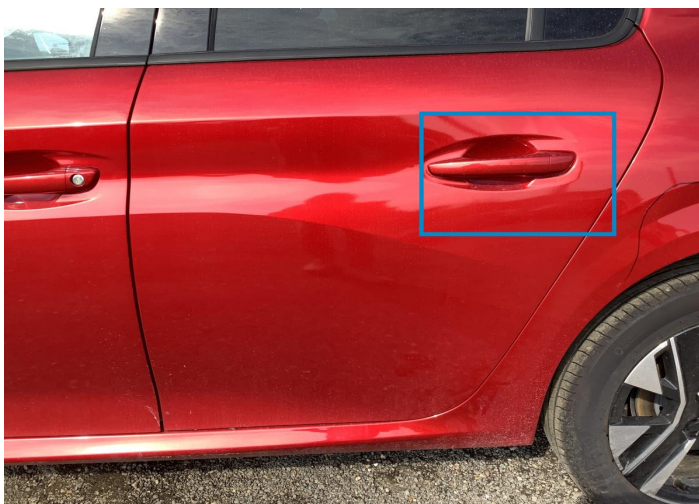
13. Door / Back Left  
Paint / Scratch / Line -

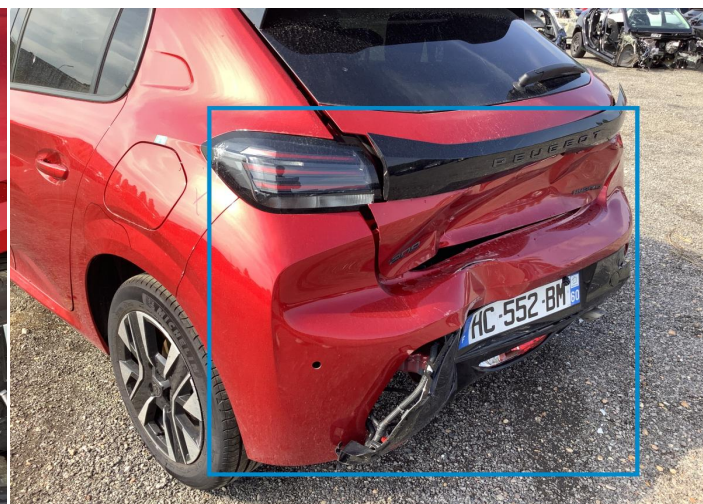
14. Corner Bumper / Back Left  
Bodywork / Dent / Deformation -

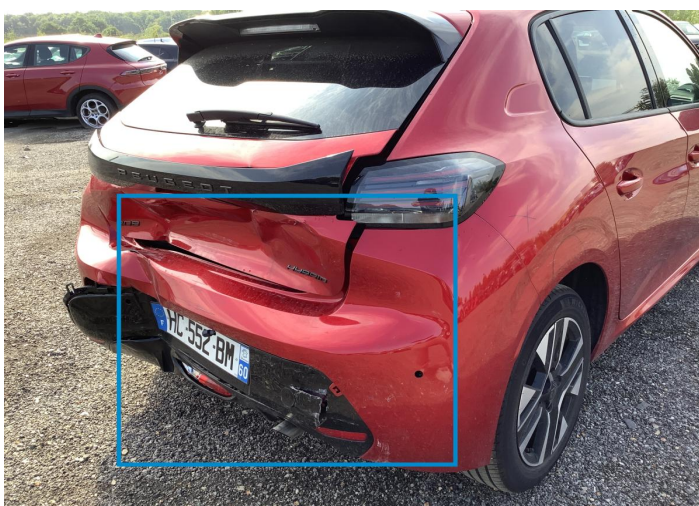
15. Corner Bumper / Back Right  
Bodywork / Dent / Deformation -

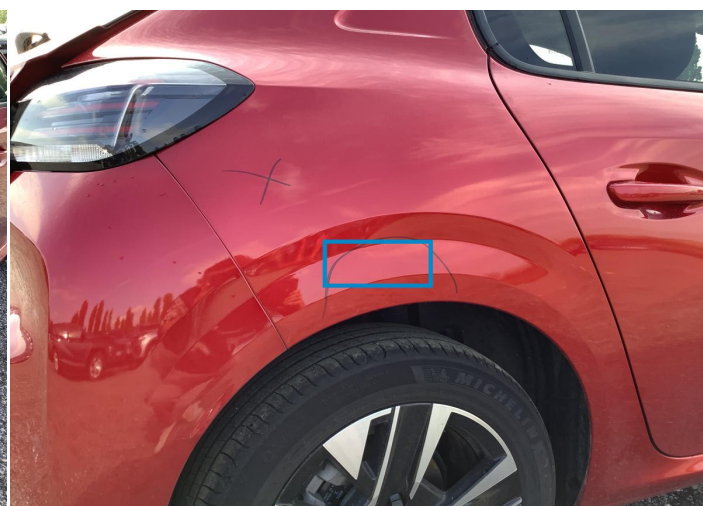
16. Fender / Back Right  
Bodywork / Dent / Deformation -

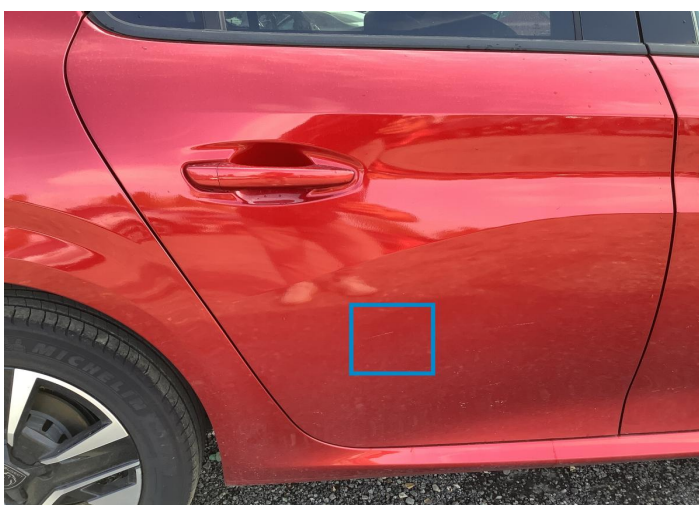
17. Door / Back Right  
Paint / Scratch / Line -

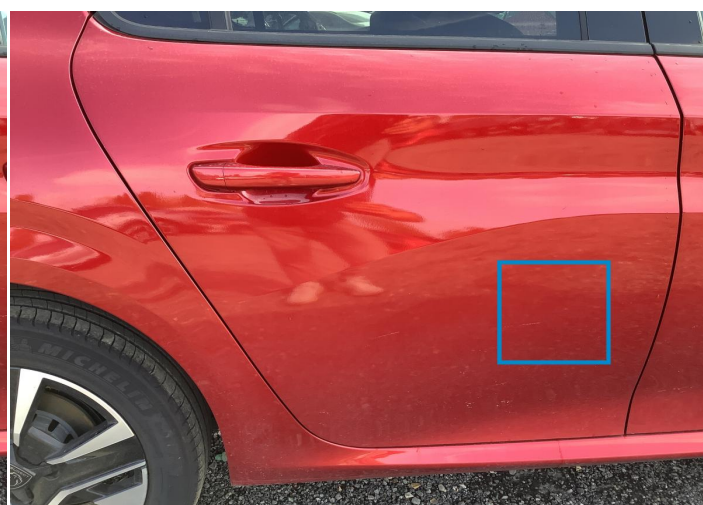
18. Door / Back Right  
Paint / Scratch / Line -

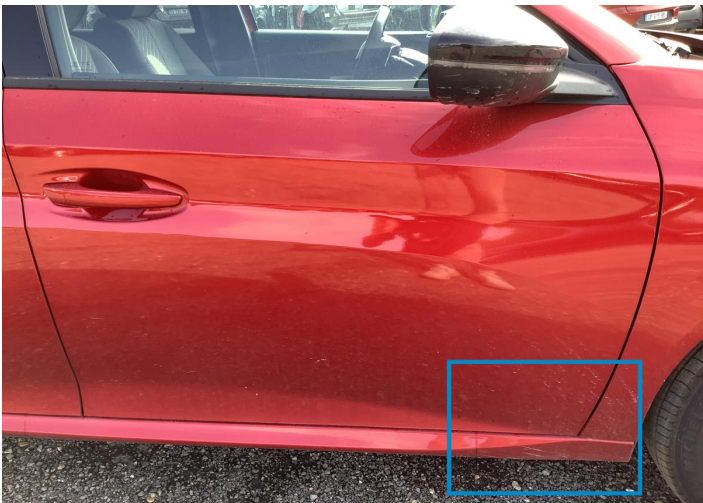
20. Door / Front Right  
Paint / Scratch / Line -

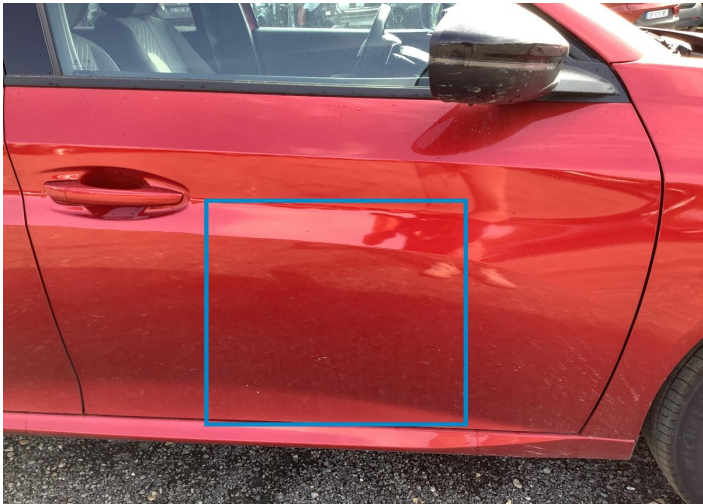
21. Door / Front Right  
Paint / Scratch / Line -

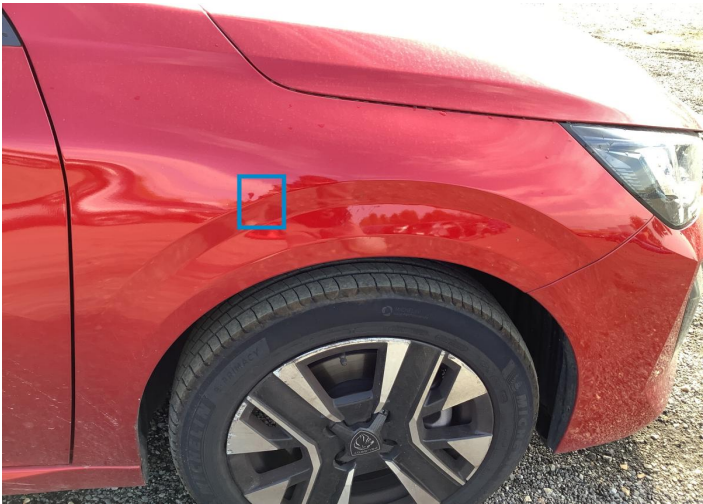
22. Fender / Front Right  
Bodywork / Dent / Deformation -

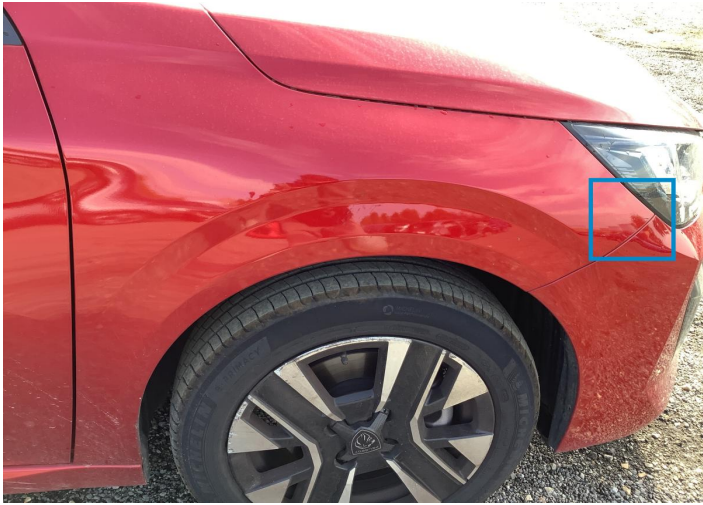
23. Fender / Front Right  
Paint / Scratch / Line -

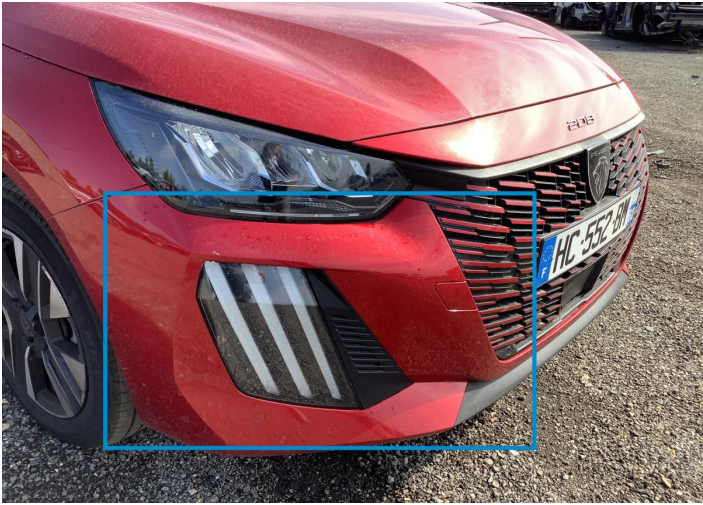
24. Corner Bumper / Front Right  
Paint / Scratch / Line -
