# SEAT LEON

## Leon 1.6 TDI 105 FAP CR Style E-Ecomotive

VIN NO VSSZZZ1PZBR032941  
Registration Number BH289LN

### Inspection Report Summary

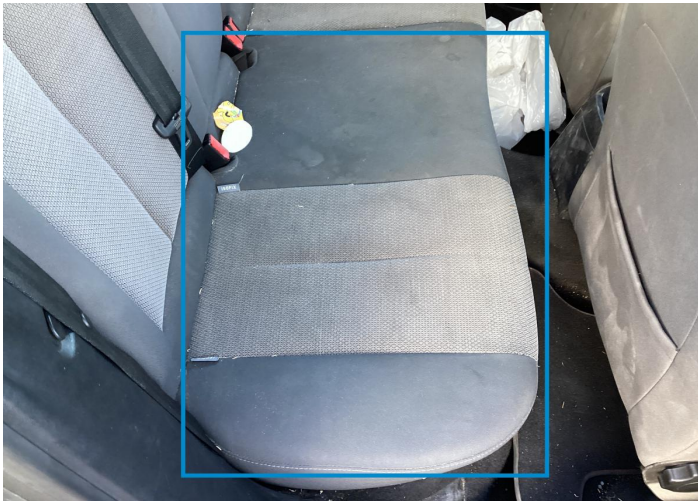
1. Seat Cushion / Back Right  
Interior / Dirty -

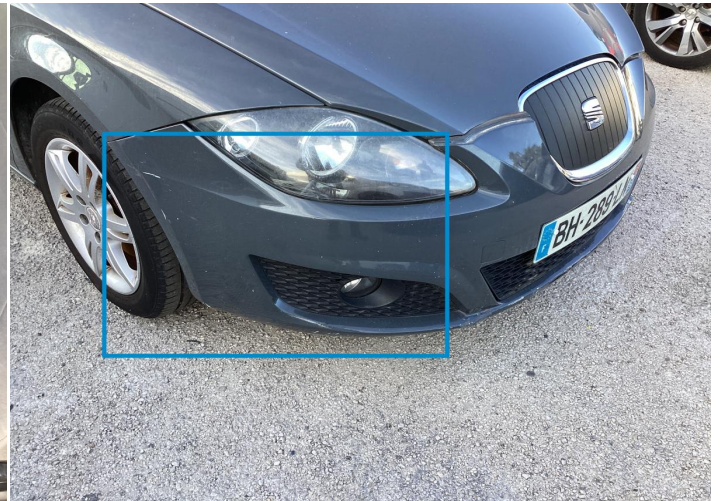
2. Shield / Front  
Paint / Scratch / Line -

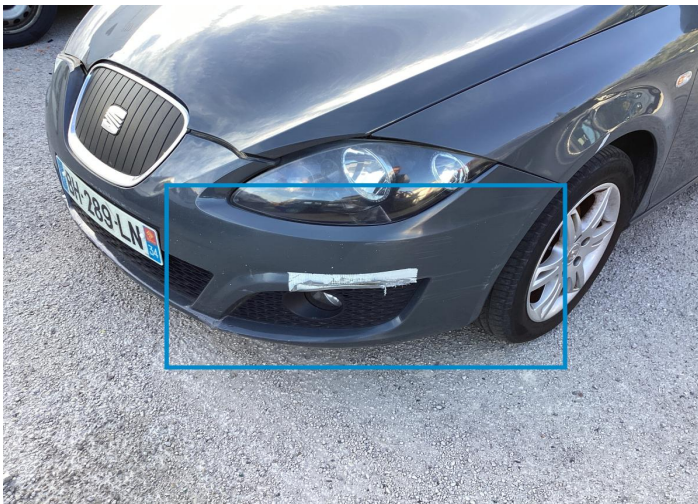
3. Shield / Front  
Paint / Scratch / Line -

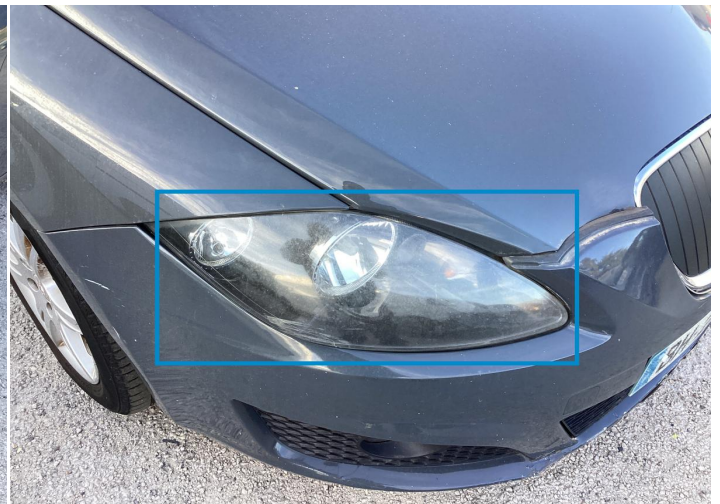
4. Front Light / Front Right  
Glass Break -

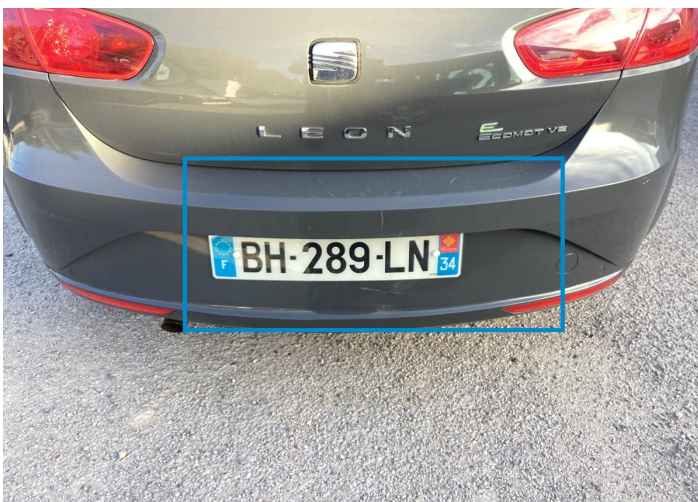
5. Shield / Back  
Paint / Scratch / Line -

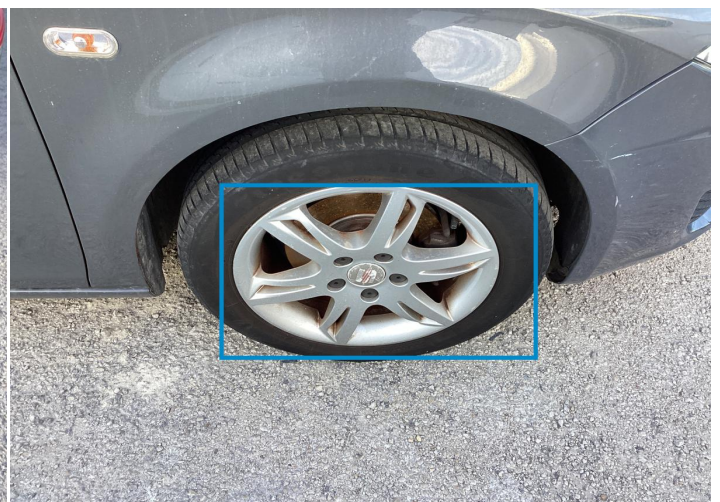
6. Rim  
Out of Bodywork / Scratch -

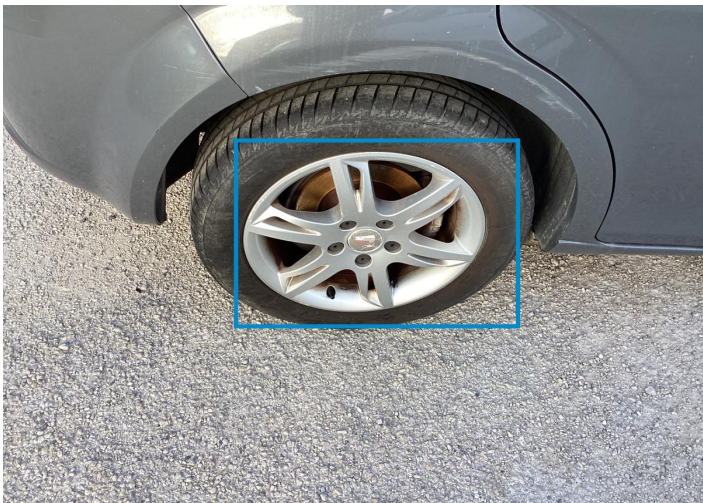
7. Rim Brake pads  
Out of Bodywork / Scratch -

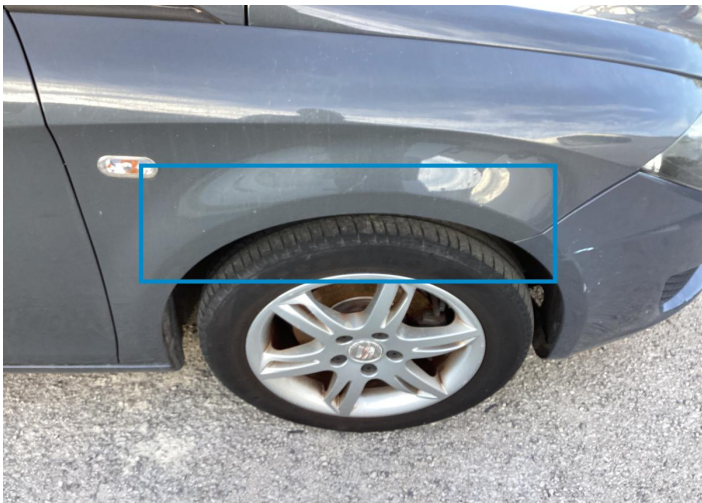
8. Fender / Front Right  
Bodywork / Dent / Deformation -

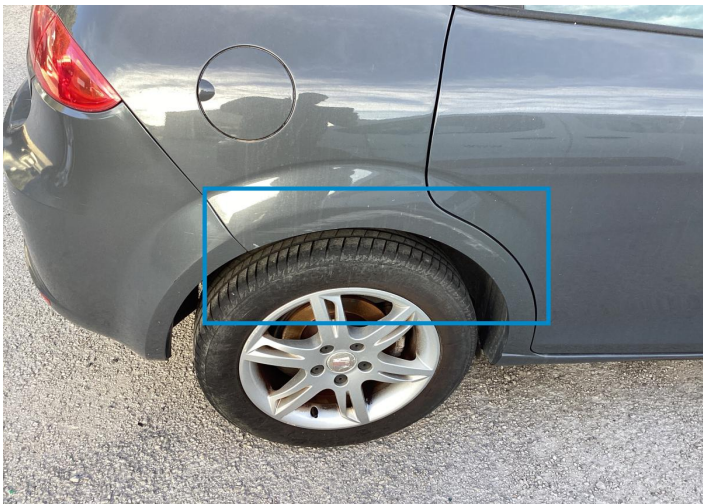
9. Fender / Back Right  
Bodywork / Dent / Deformation -

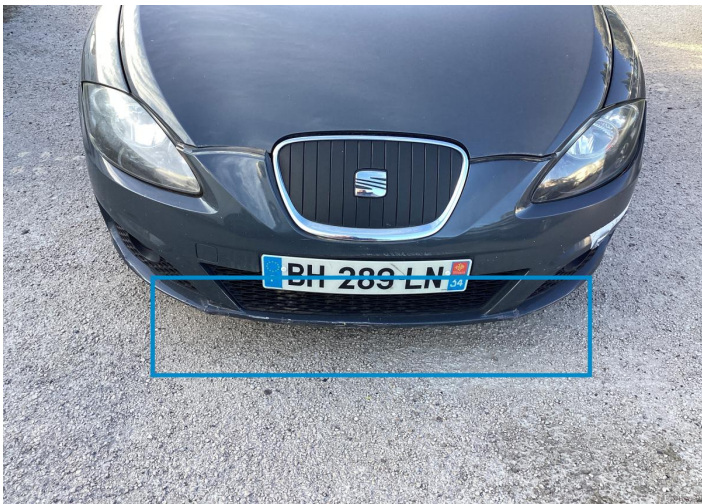
10. Shield / Front  
Bodywork / Dent / Deformation -

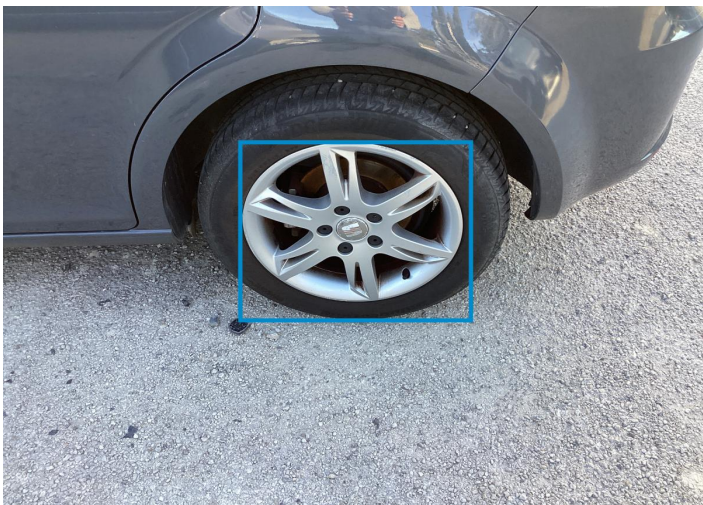
11. Rim  
Out of Bodywork / Scratch -

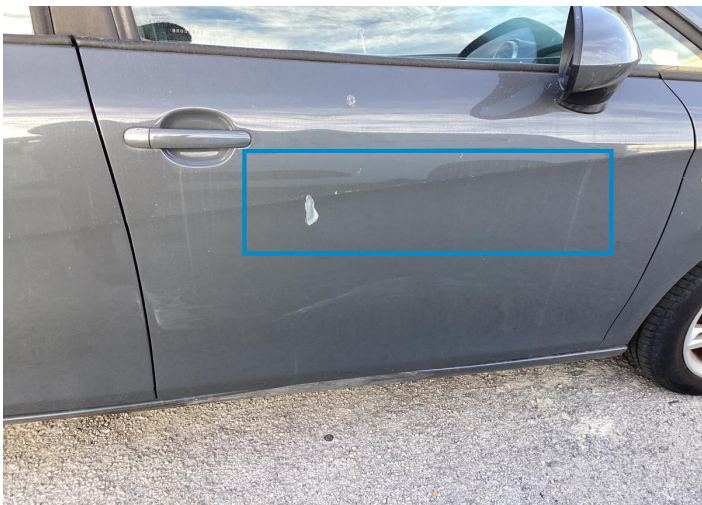
12. Door / Front Right  
Bodywork / Dent / Deformation -

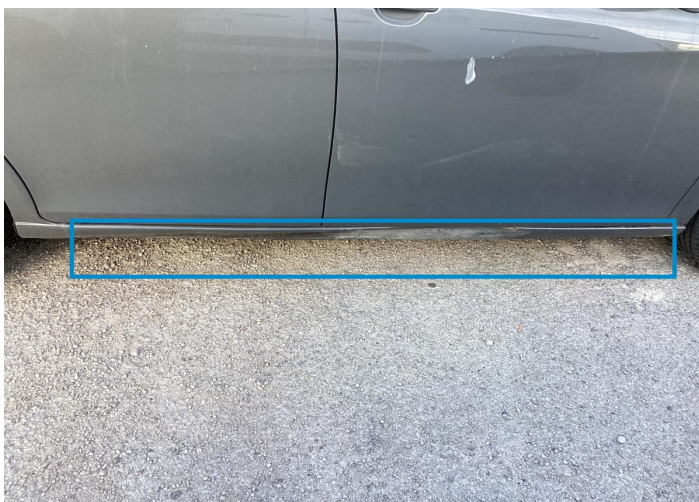
| 13 | Rocker Panel / Center Right | Bodywork / Dent / Deformation |

13. Rocker Panel / Center Right  
Bodywork / Dent / Deformation -

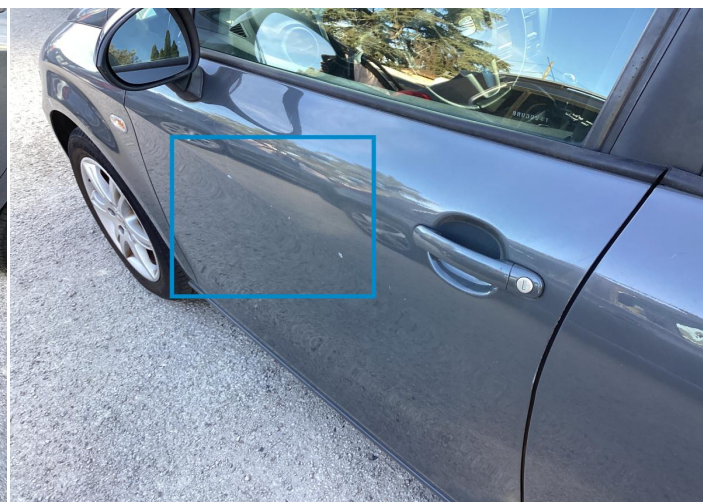
| 14 | Door / Front Left | Bodywork / Dent / Deformation |

14. Door / Front Left  
Bodywork / Dent / Deformation -

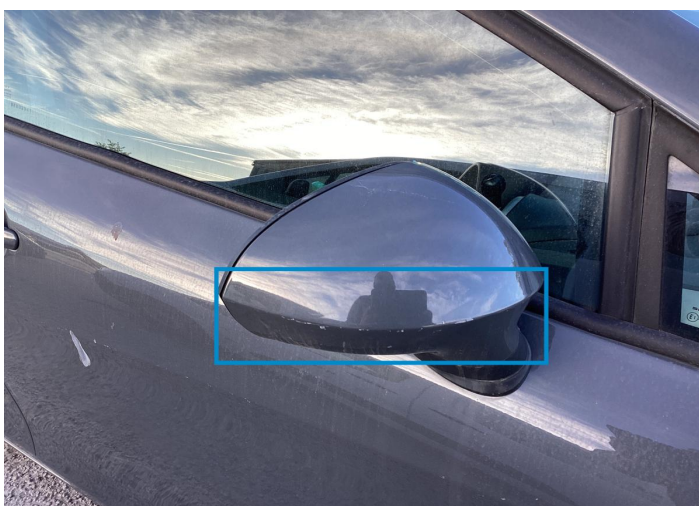
| 15 | Mirror / Front Right | Paint / Scratch / Line |

15. Mirror / Front Right  
Paint / Scratch / Line -

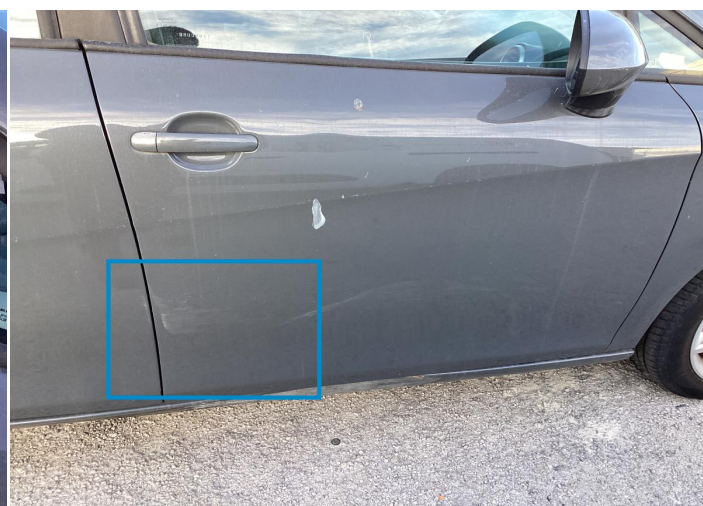
| 16 | Door / Front Right | Bodywork / Dent / Deformation |

16. Door / Front Right  
Bodywork / Dent / Deformation -

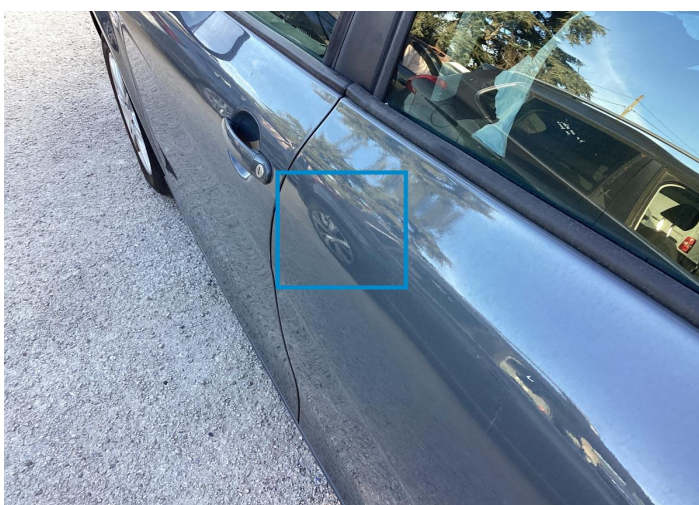
| 17 | Door / Back Left | Bodywork / Dent / Deformation |

17. Door / Back Left  
Bodywork / Dent / Deformation -

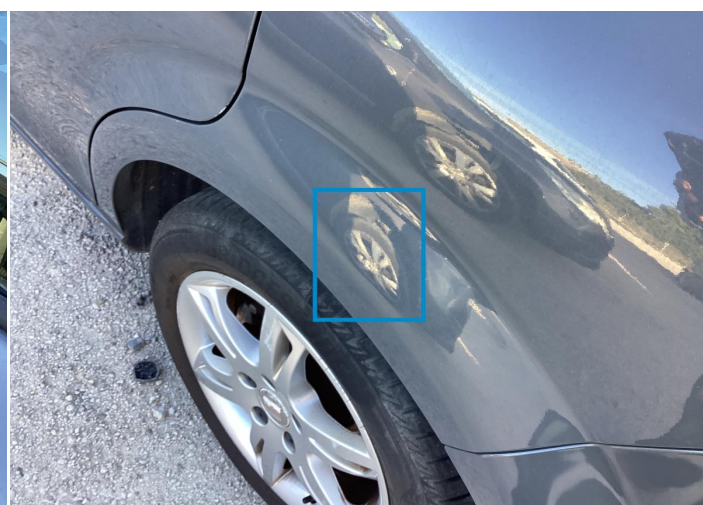
| 18 | Fender / Back Left | Bodywork / Dent / Deformation |

18. Fender / Back Left  
Bodywork / Dent / Deformation -

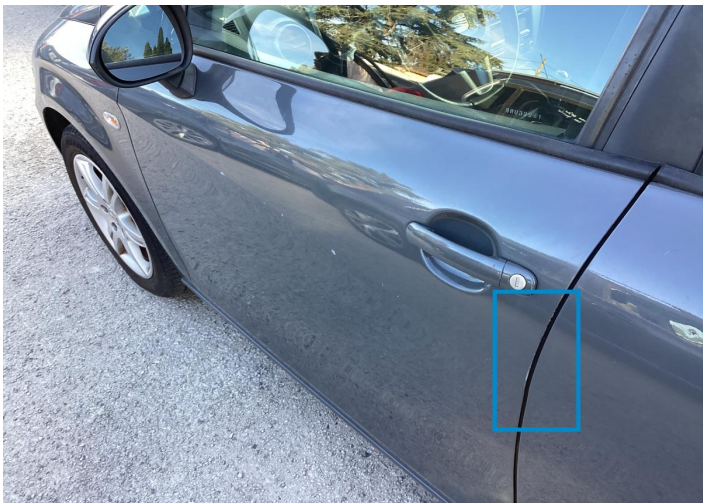
| 19 | Door / Front Left | Paint / Scratch / Line |

19. Door / Front Left  
Paint / Scratch / Line -

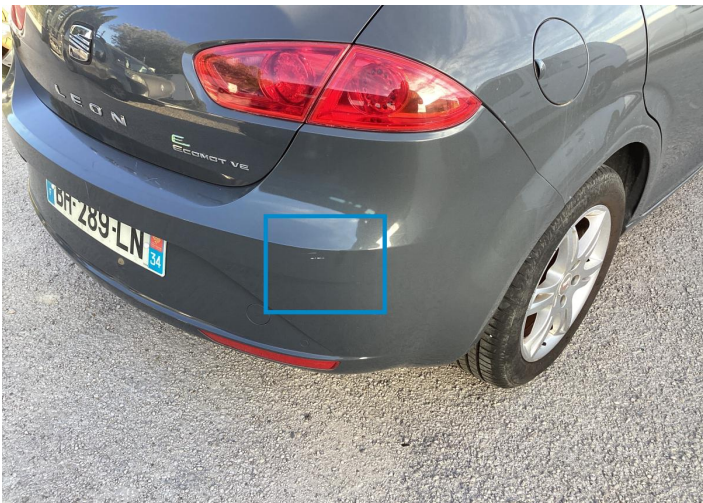
| 20 | Shield / Back | Paint / Scratch / Line |

20. Shield / Back  
Paint / Scratch / Line -

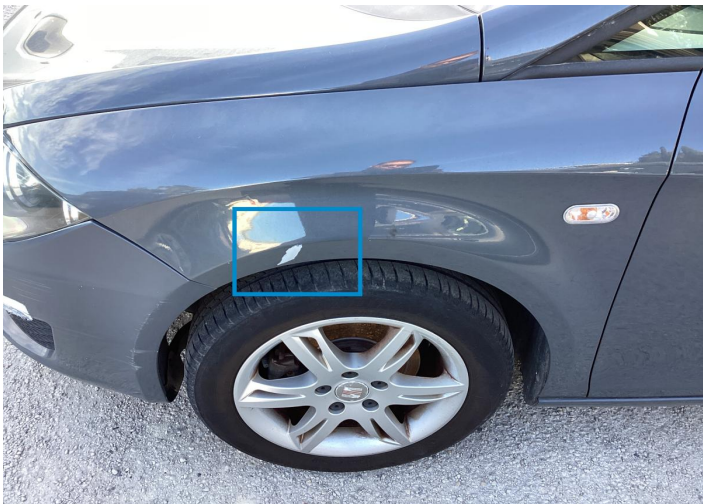
| 21 | Fender / Front Left | Paint / Poor Previous Repair |

21. Fender / Front Left  
Paint / Poor Previous Repair -

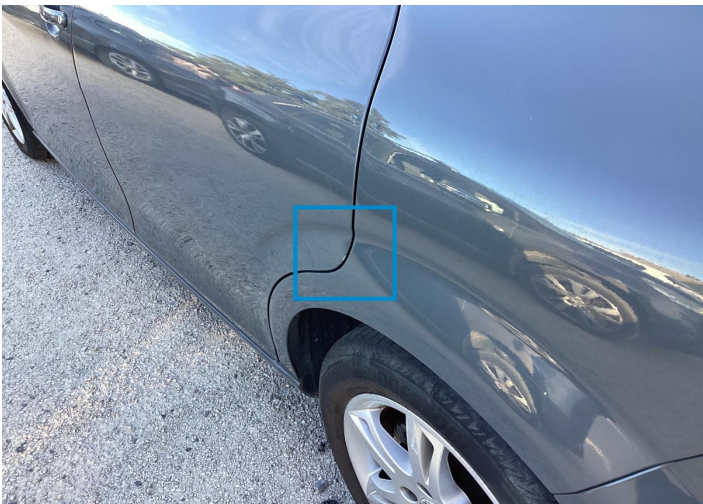
| 22 | Door / Back Left | Paint / Scratch / Line |

22. Door / Back Left  
Paint / Scratch / Line -

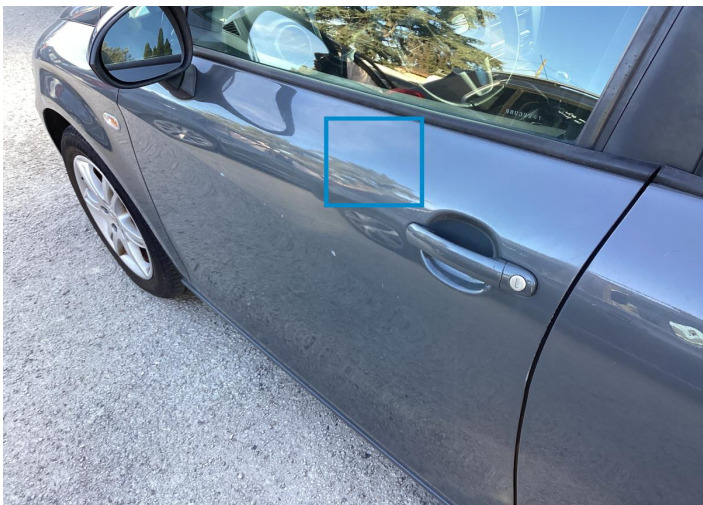
| 23 | Door / Front Left | Bodywork / Dent / Deformation |

23. Door / Front Left  
Bodywork / Dent / Deformation -

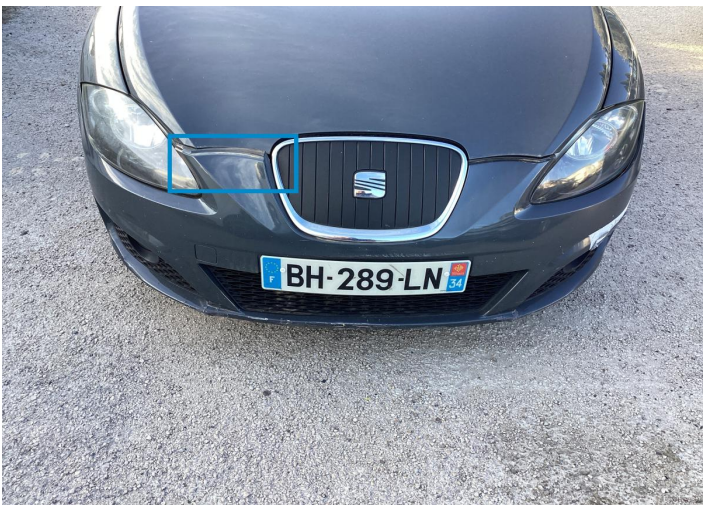
| 24 | Shield / Front | Bodywork / Assembly |

24. Shield / Front  
Bodywork / Assembly -
